Diving Service

- Marine Contractors

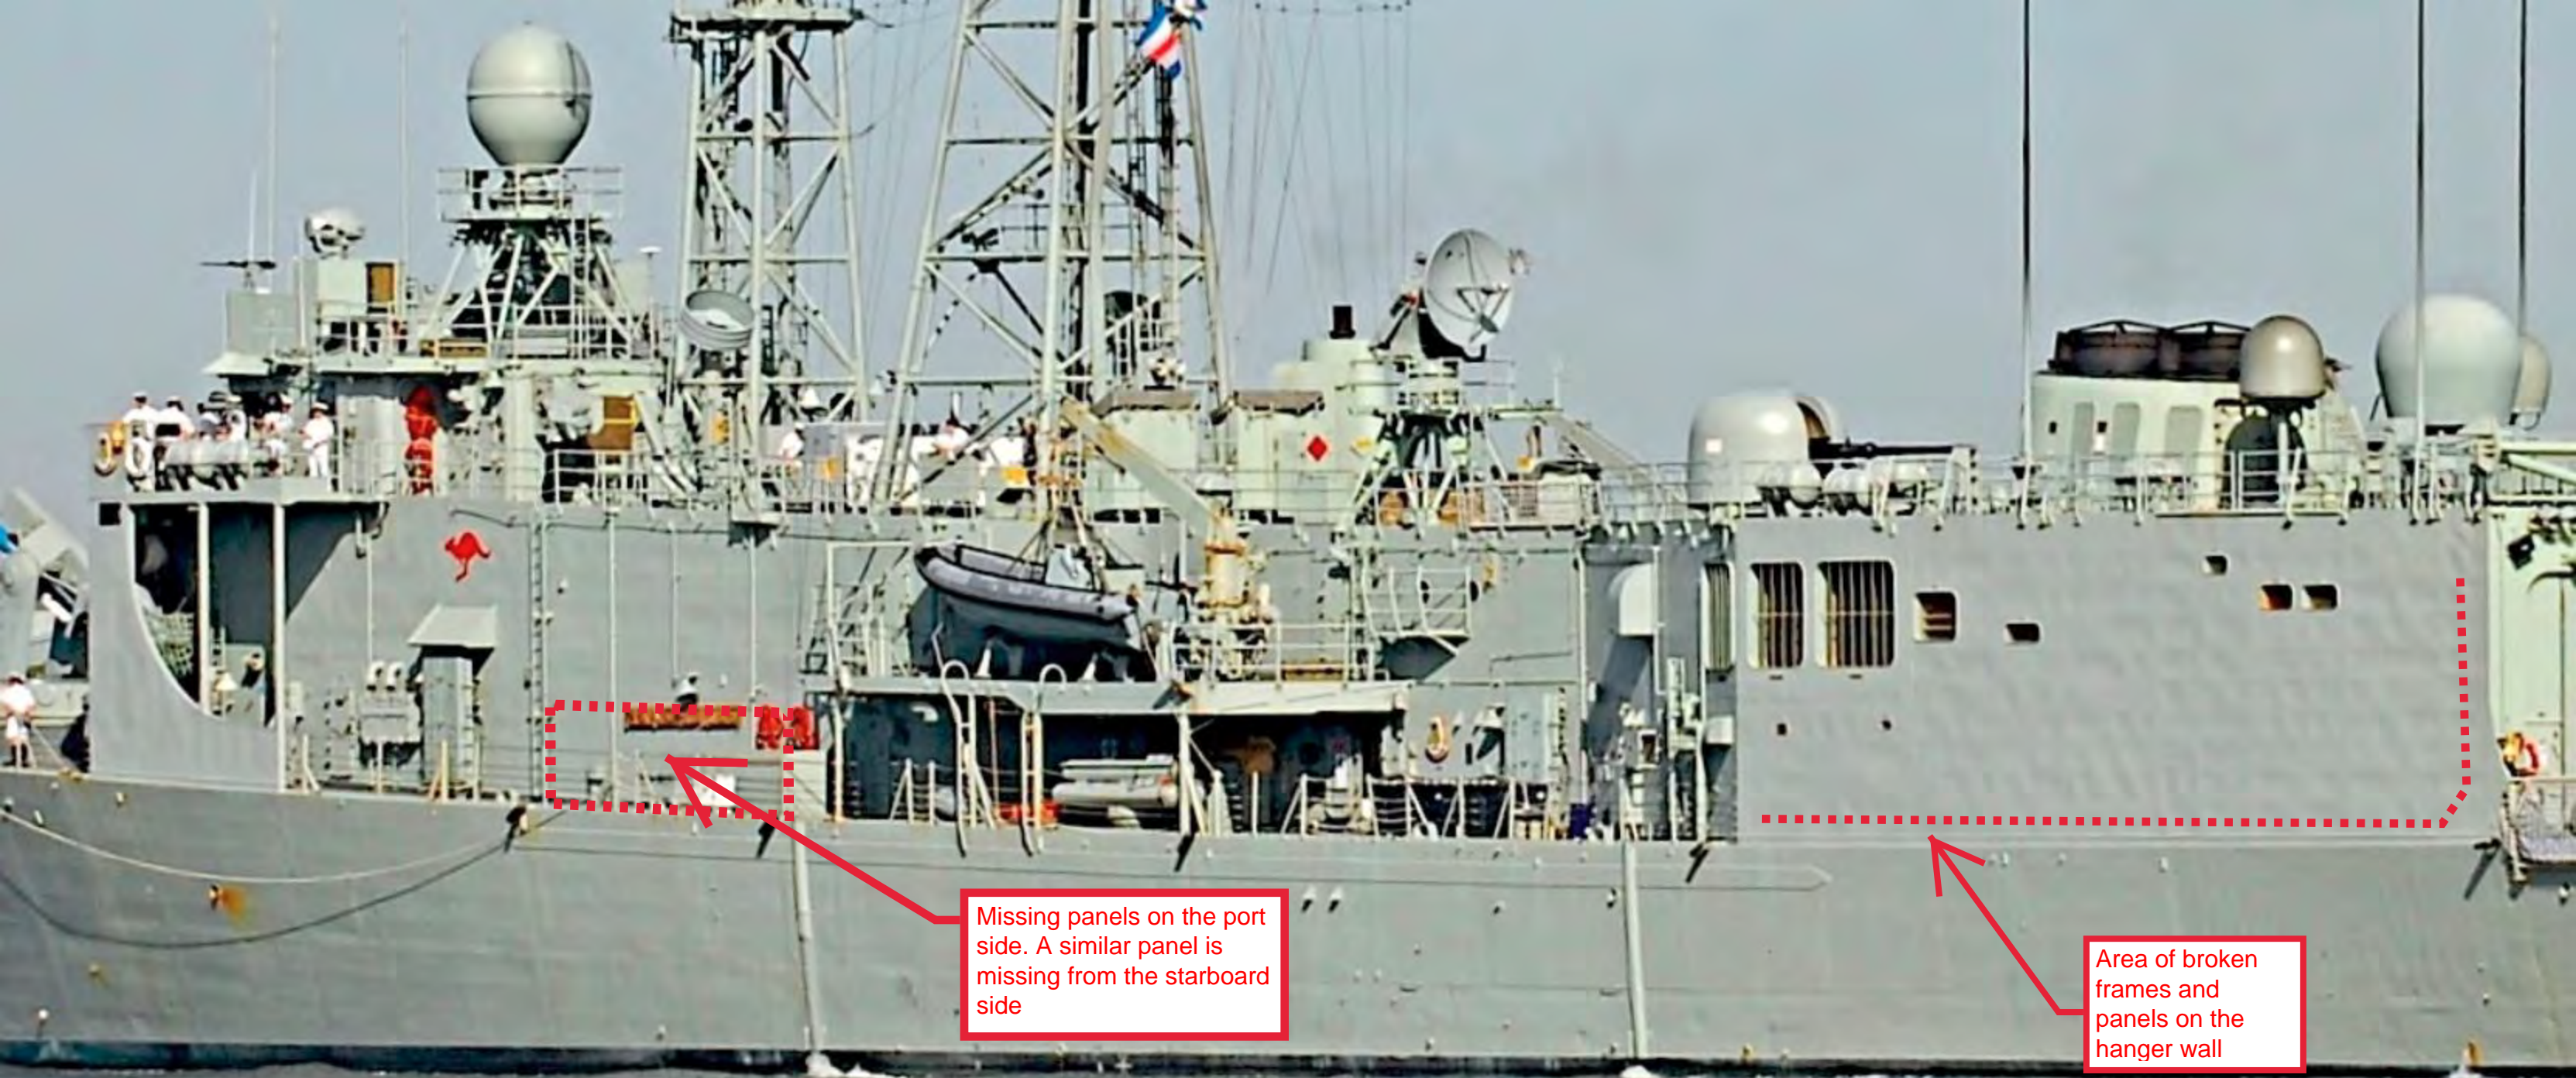
Missing panels on the port side. A similar panel is missing from the starboard side

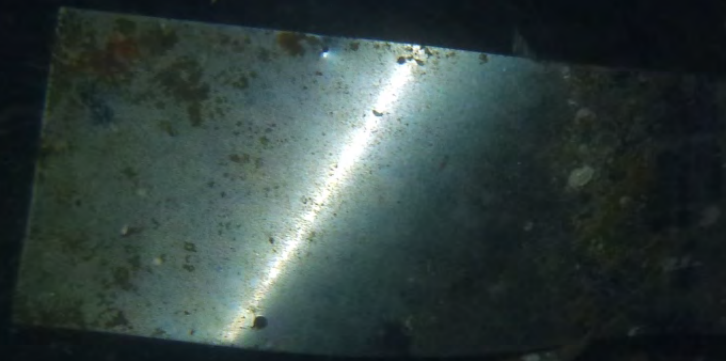
A smaller piece of stainless steel sheeting loose in the main deck compartments

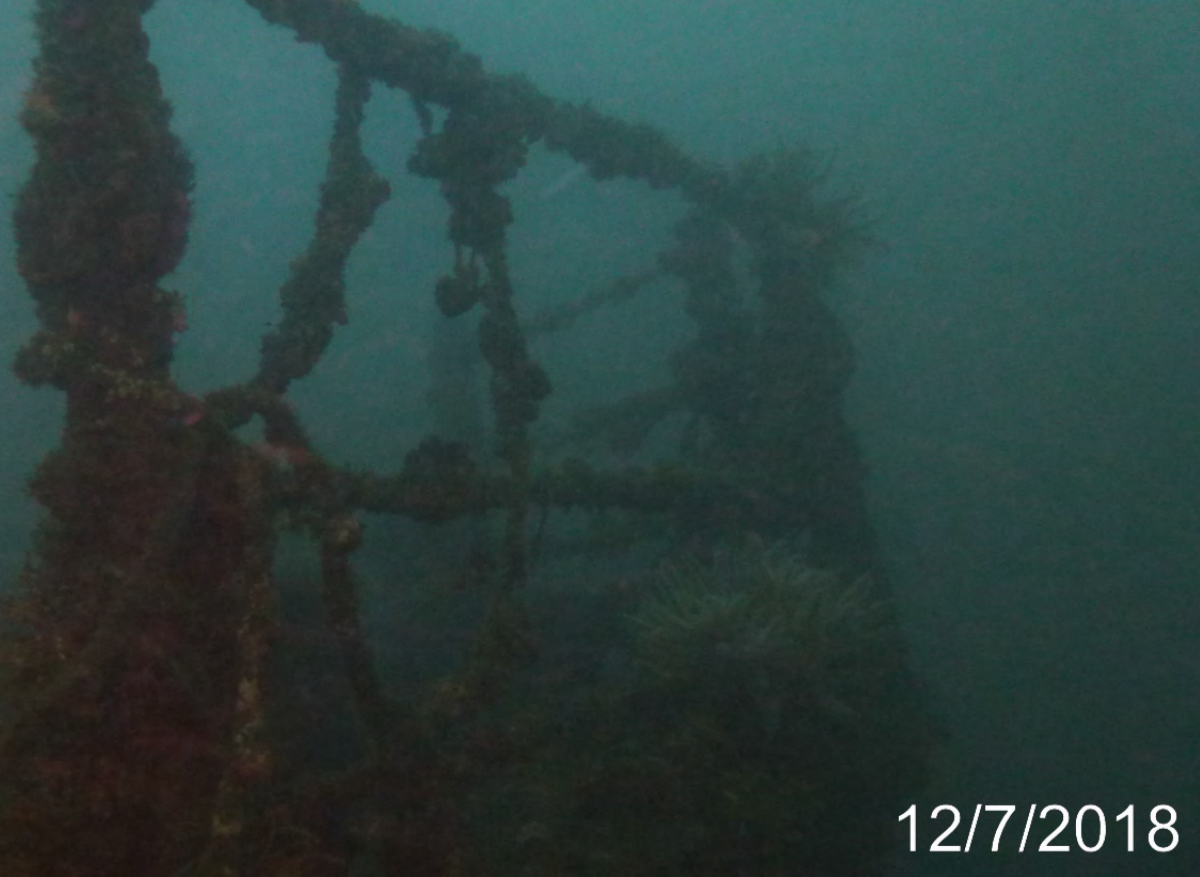
A view across the transom from starboard to port. There is little sign of deterioration in this area

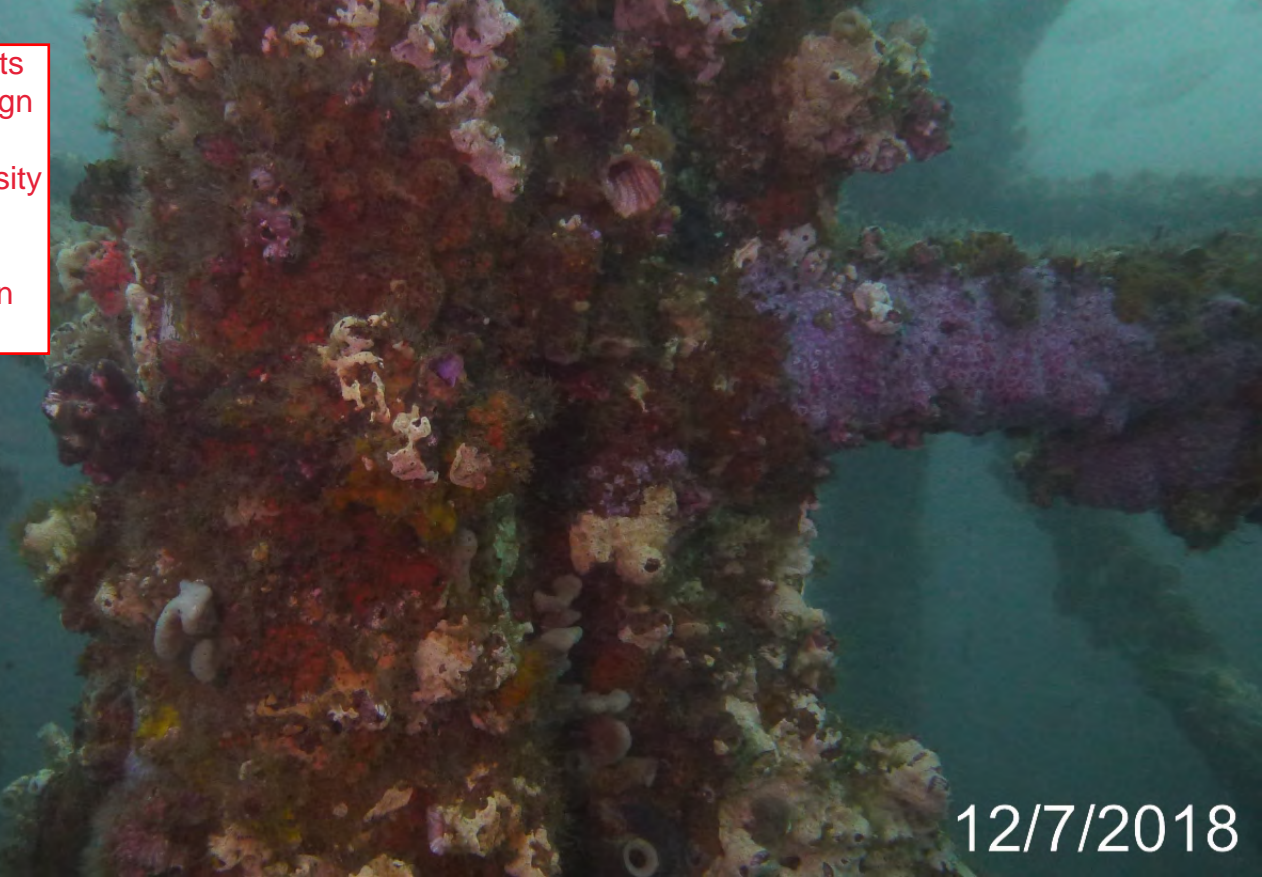
One of the mast connections to 02 deck. All connections are sound and unchanged form last year

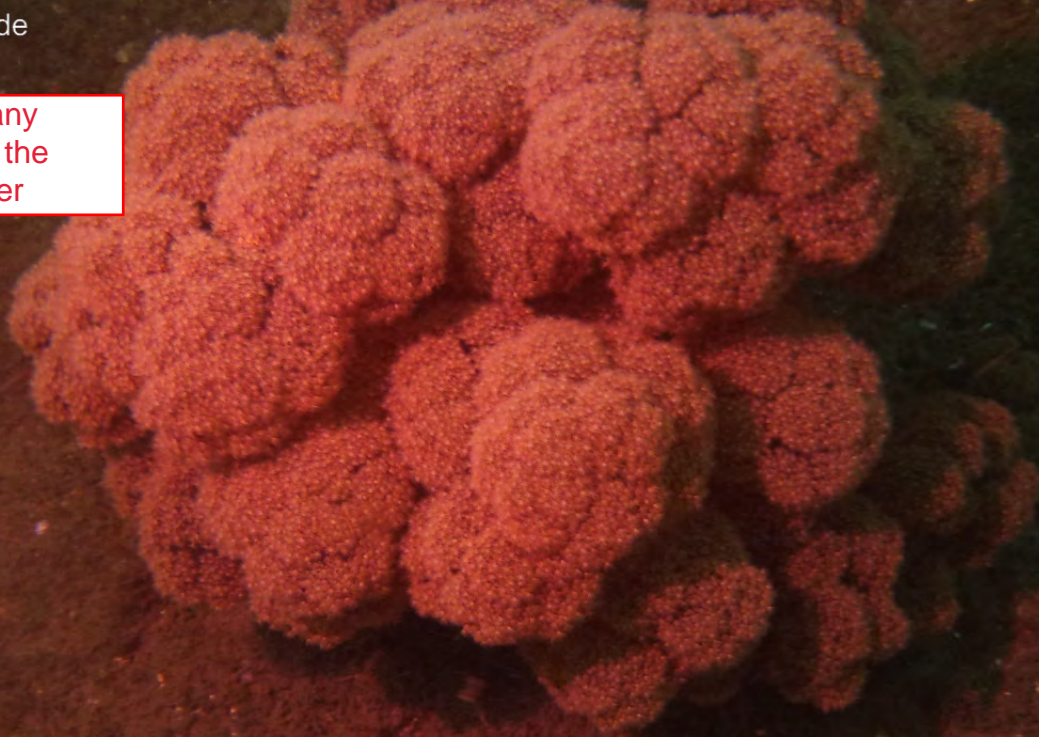
The "Captains Chair" is still in place on the bridge but the coverings have gone leaving just the frame.

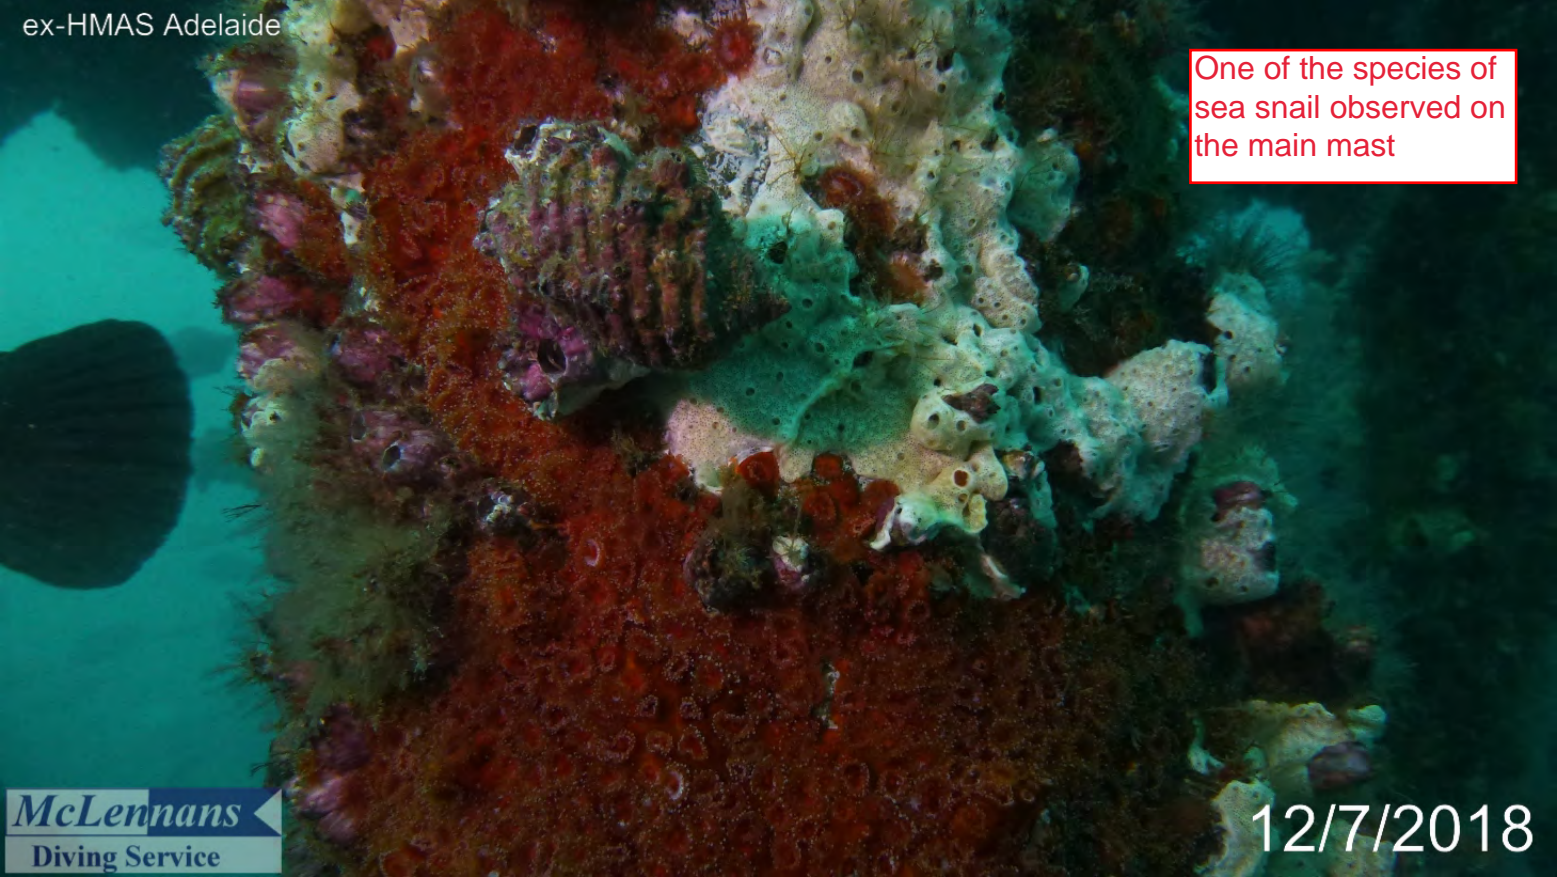
a Volute shell grazing
on the sponges at the
transom

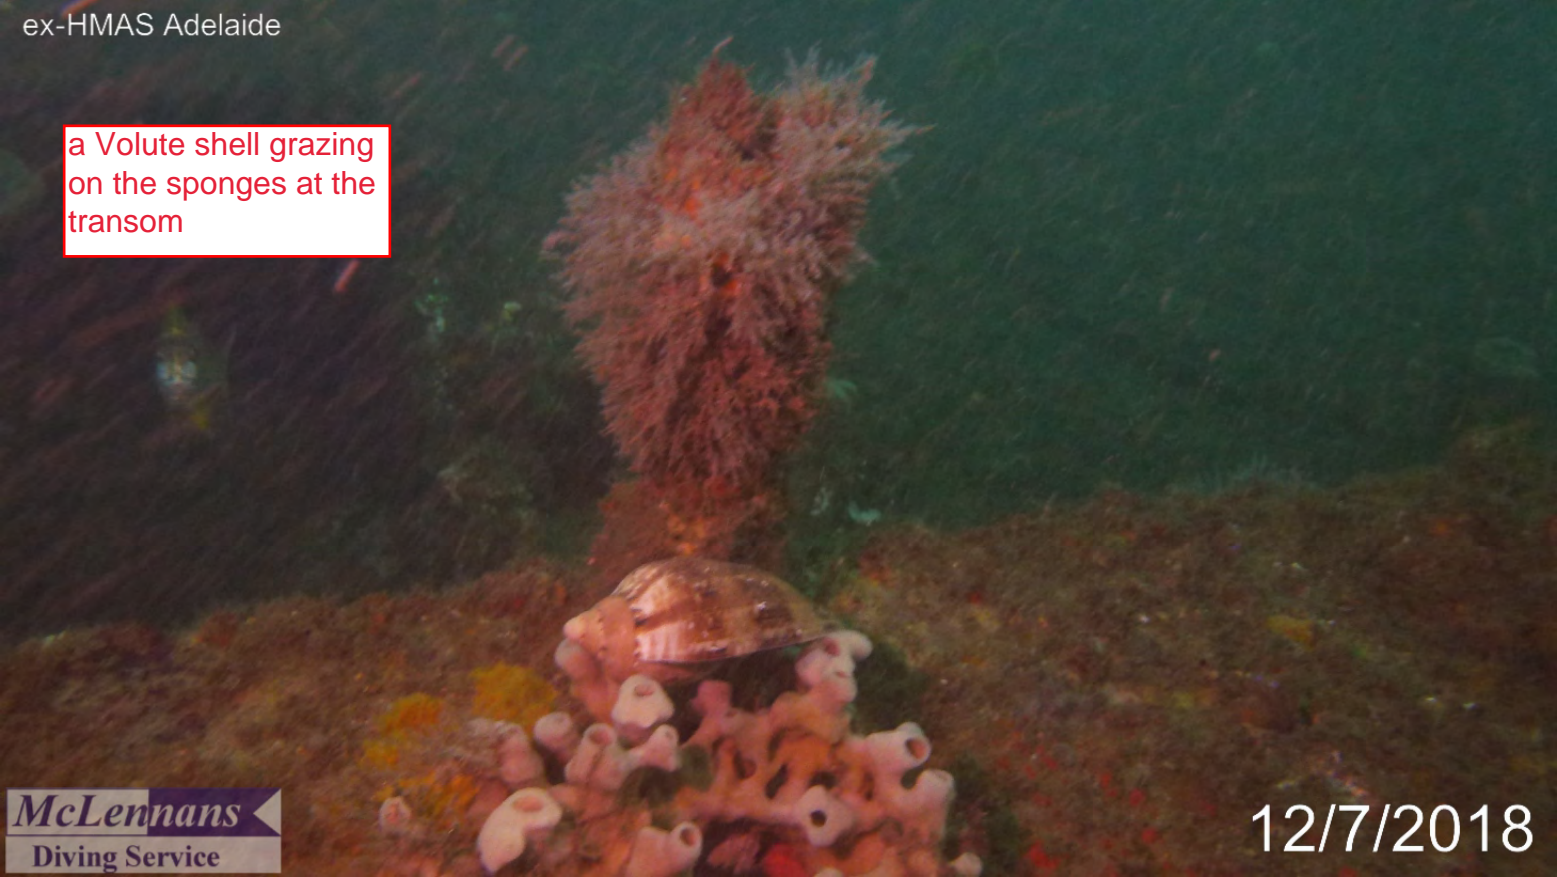
The vessel has attracted more fish life than observed during previous inspections.

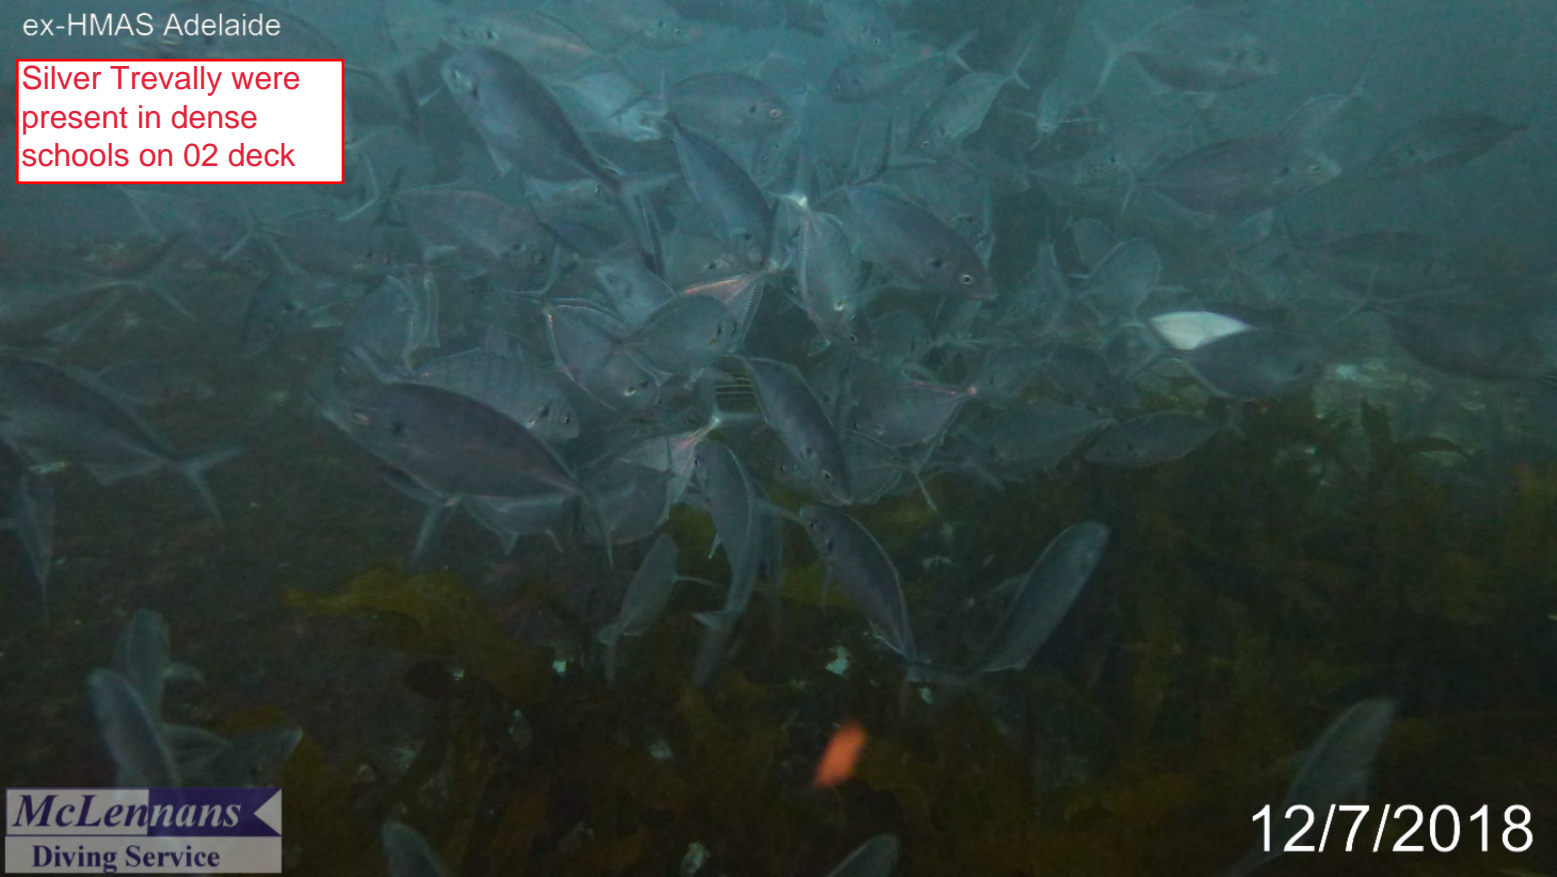
Silver Trevally were present in dense schools on 02 deck

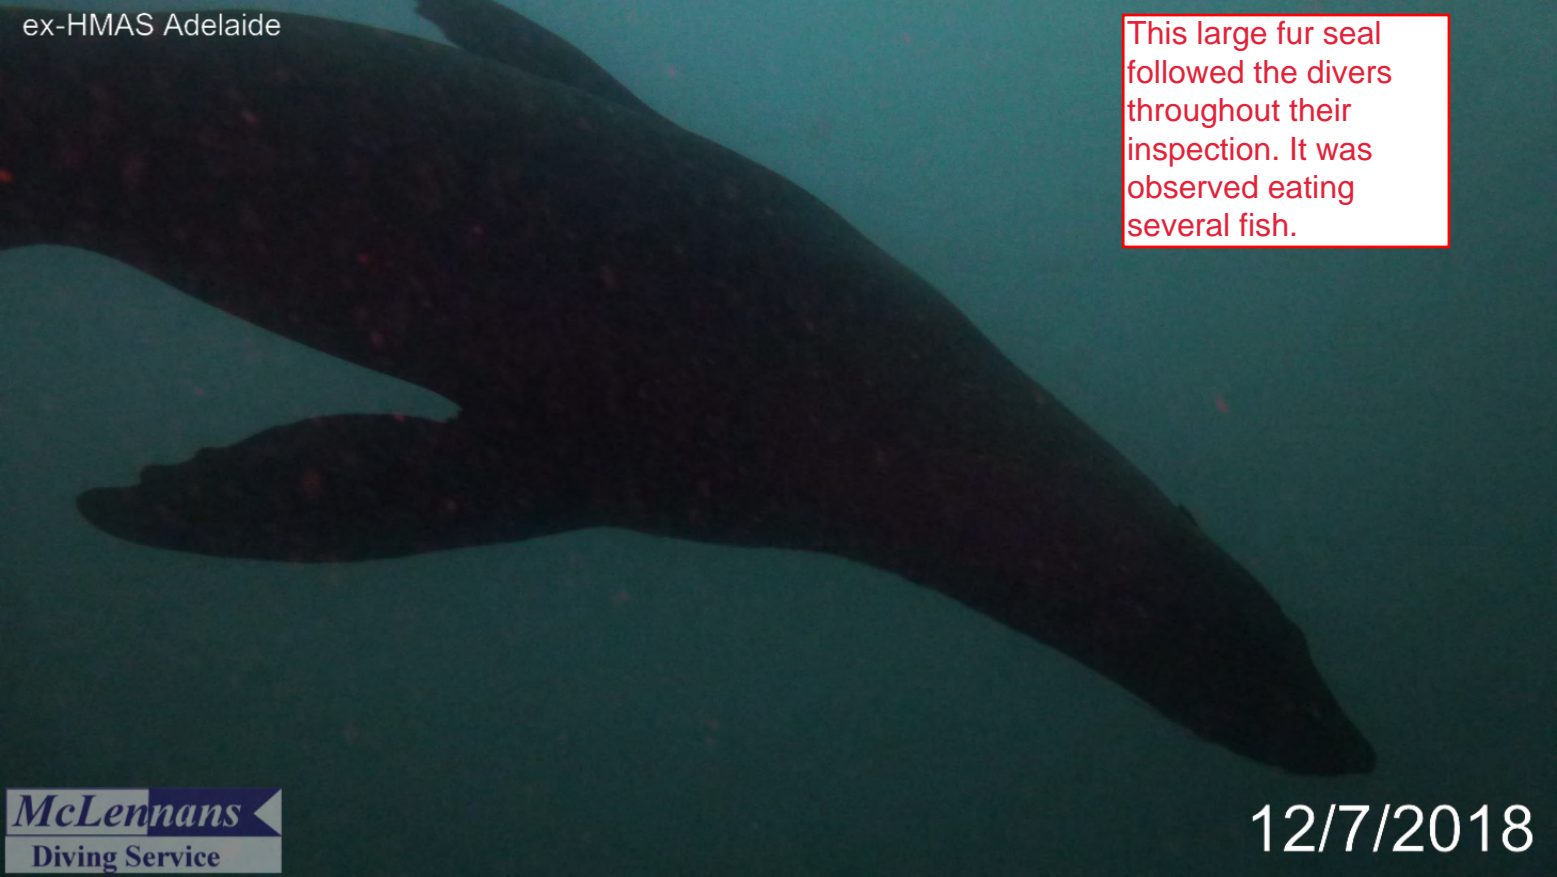
Sponges have
become well
established on the
stern
