Appendix 5: Slipway Inspection at
Brunswick Harbour
Wednesday 22.4.2015

RE: Slipway inspection at Brunswick Harbour, Wednesday 22.4.2015

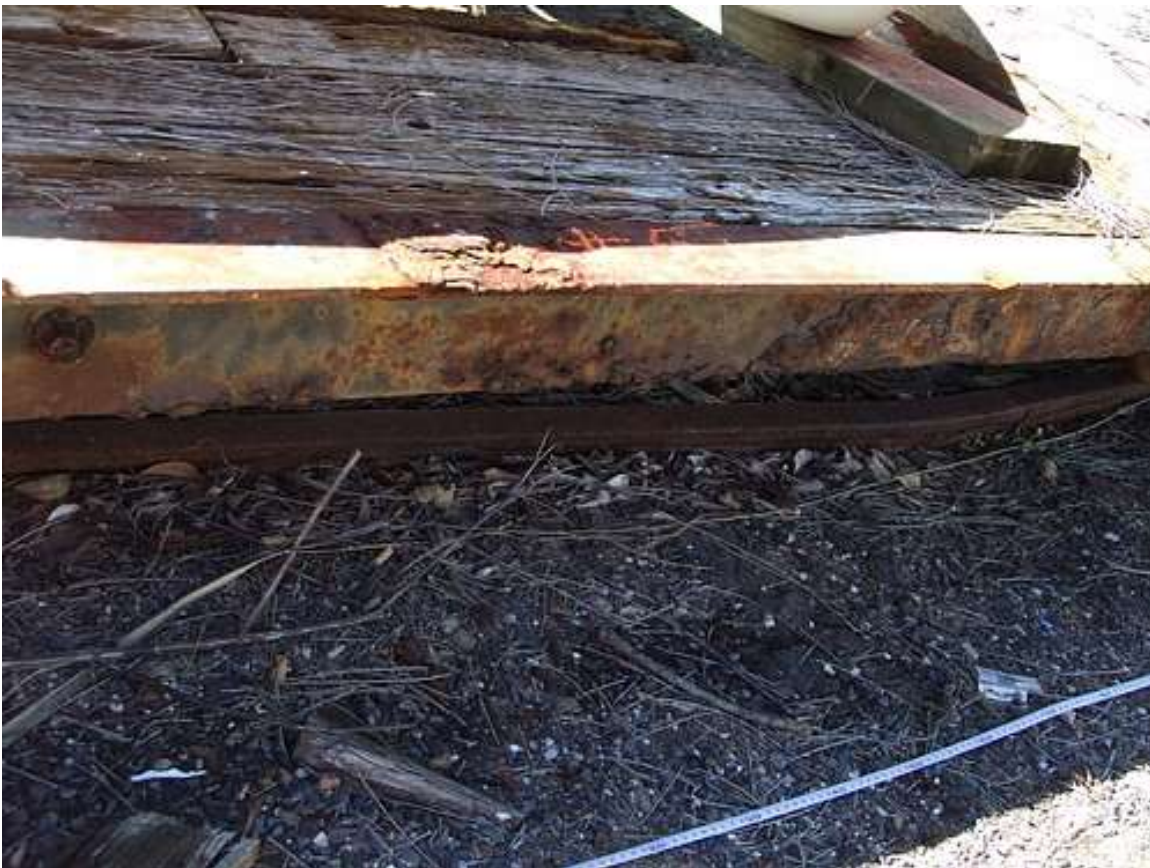
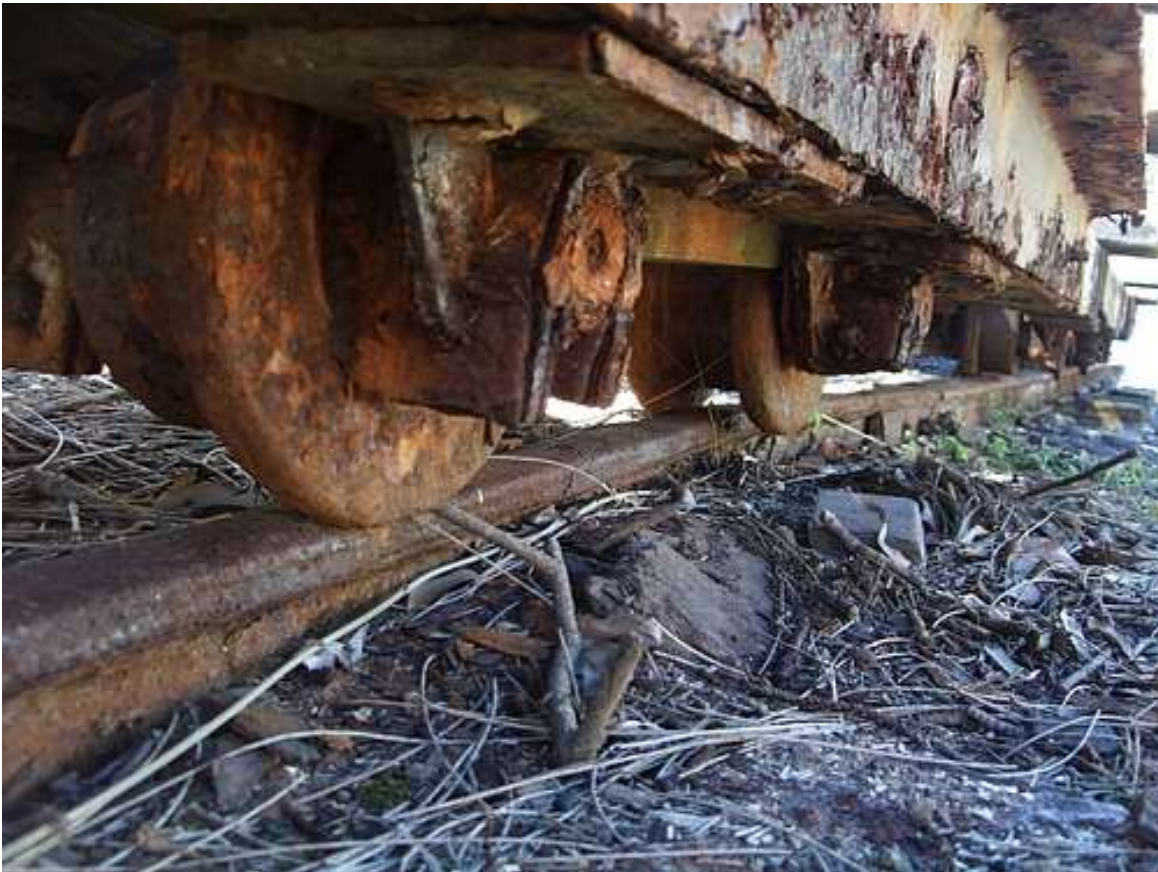
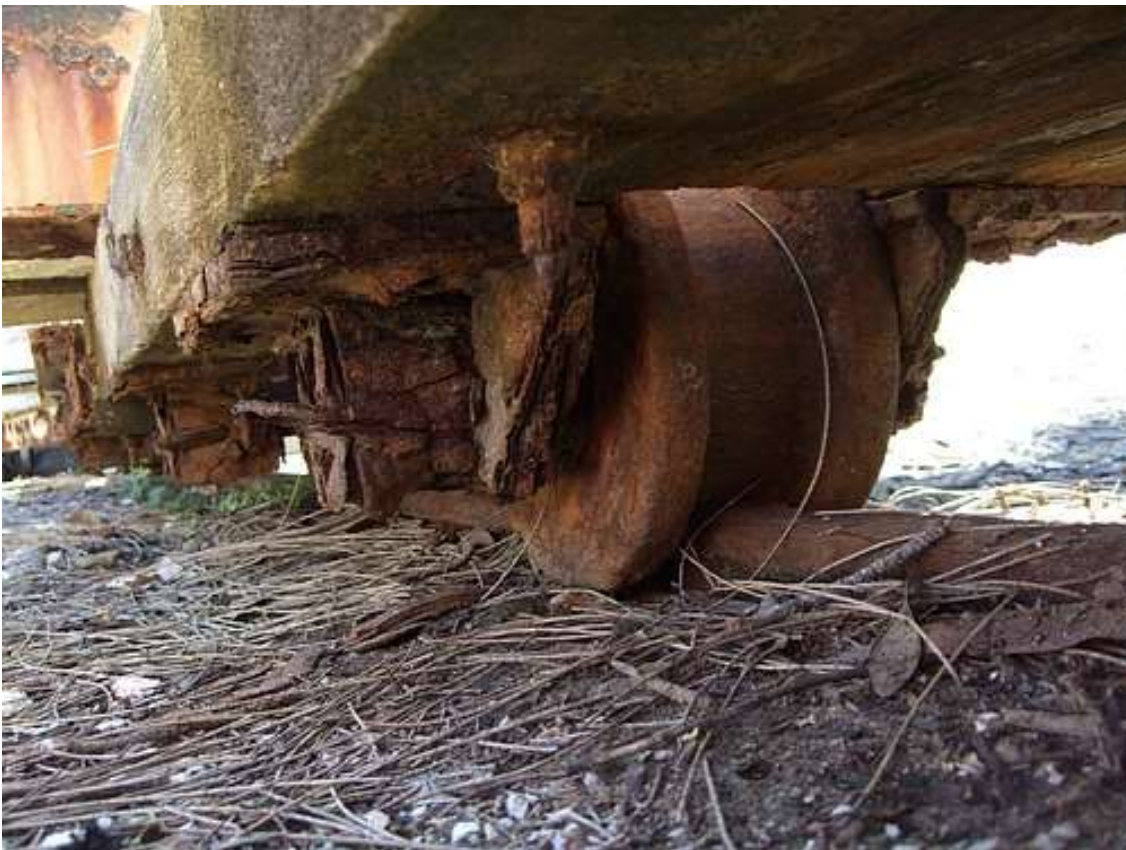
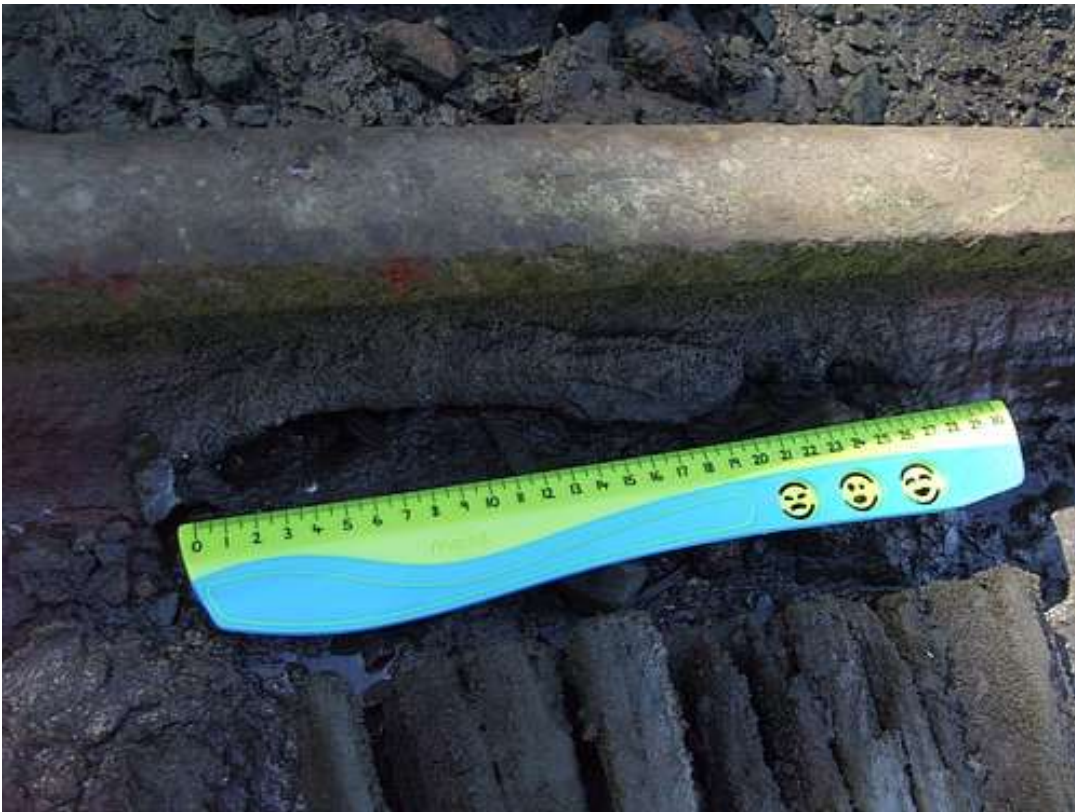
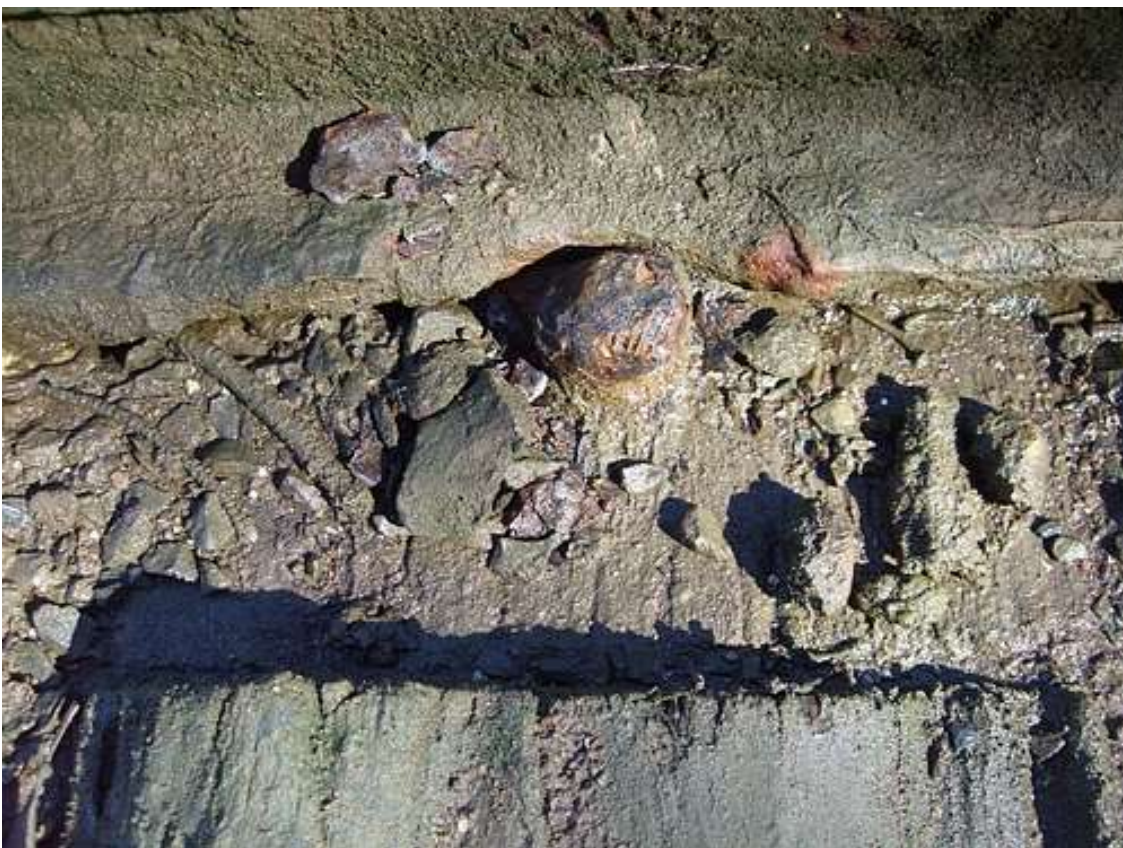
It is apparent very quickly that this slipway is no longer in working order. Deterioration of sleepers and rails is advanced, both in and above water. The rail track shows significant section loss and a lot of the dogs(holding down fittings) of the track have snapped or are breakable by hand due to severe corrosion. Additionally there is a severe deformation of the southern track near it's top end. The trolley is also in an unserviceable, advanced deteriorated stage.

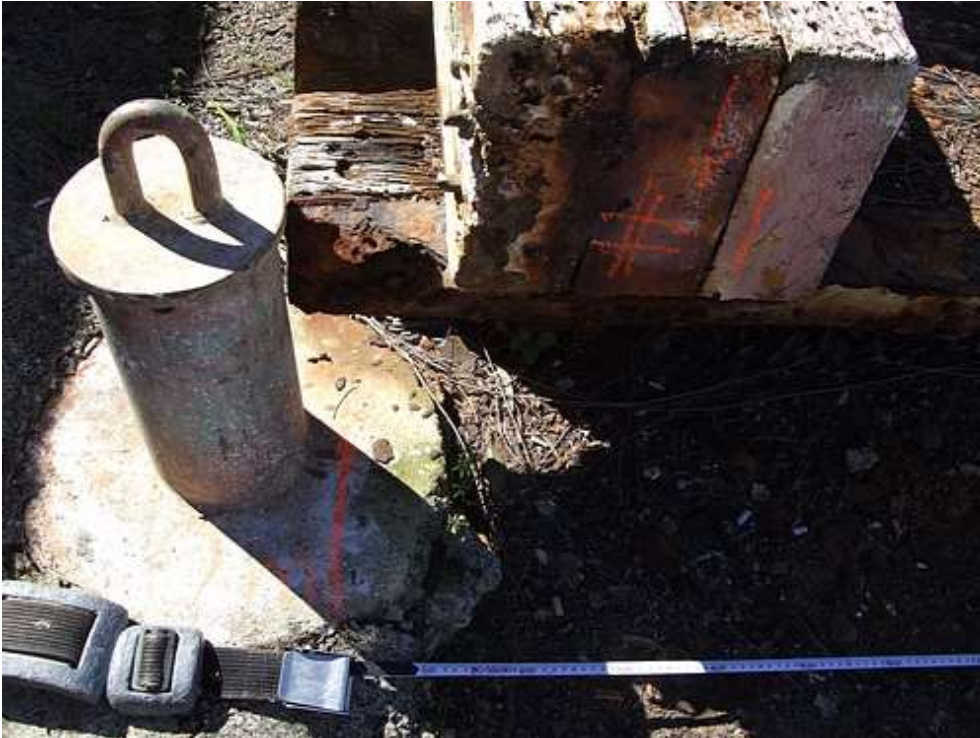
The reference height/datum 0.0m for level measurements was established and assumed at the top of the tracks, at the top of the concrete pad which is at the base of a bollard at the top of the southern track.

This is also the highest point of both the northern and southern track. The rails that begin at this point are also assumed chainage 0.0m for distance measurements towards and into the water.

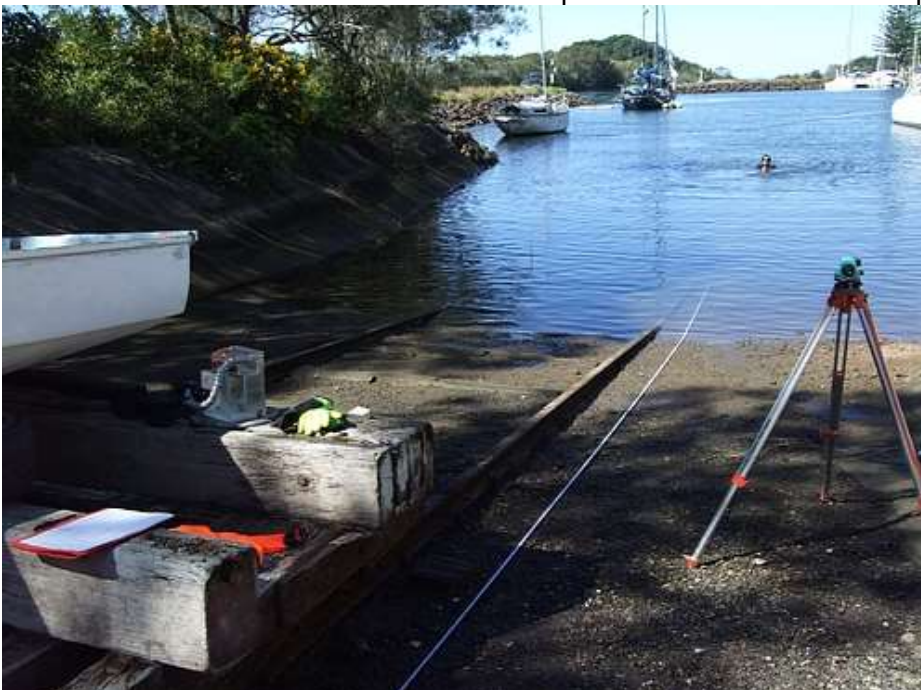
The track width is 2.4m and the timber sleepers are set a distance of approx. 1m apart.

The decline of the track is initially approx. 0.95m every 10m and appears to gradually increase to 1.2m to 1.4m every 10m from about chainage. 18-20m. At chainage 24m sand is covering the track, sleepers and ballast all the way out to the unknown termination of the rail.

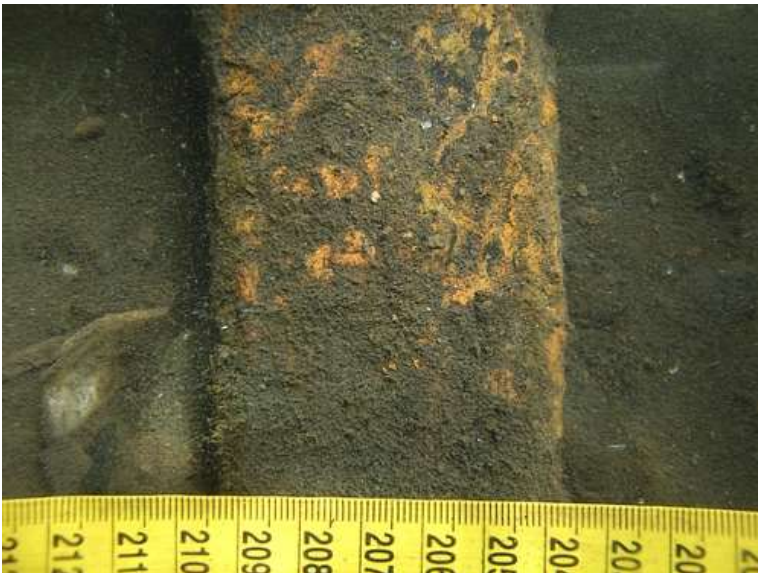
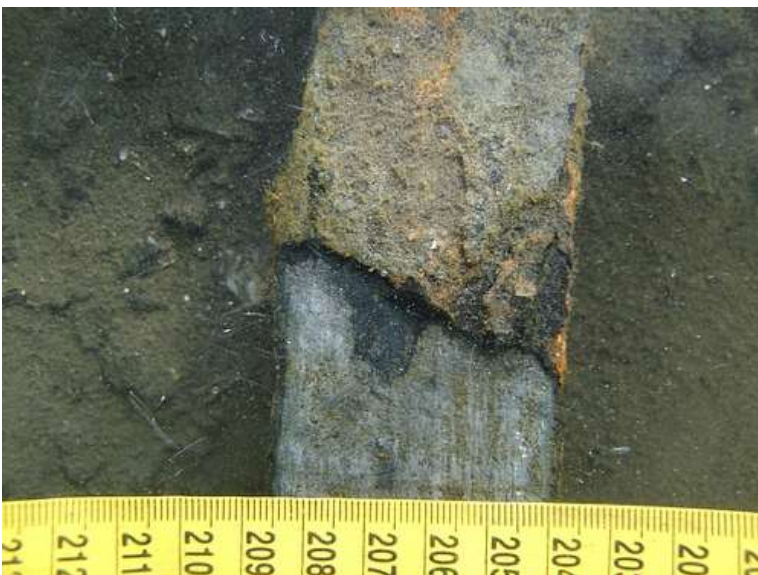
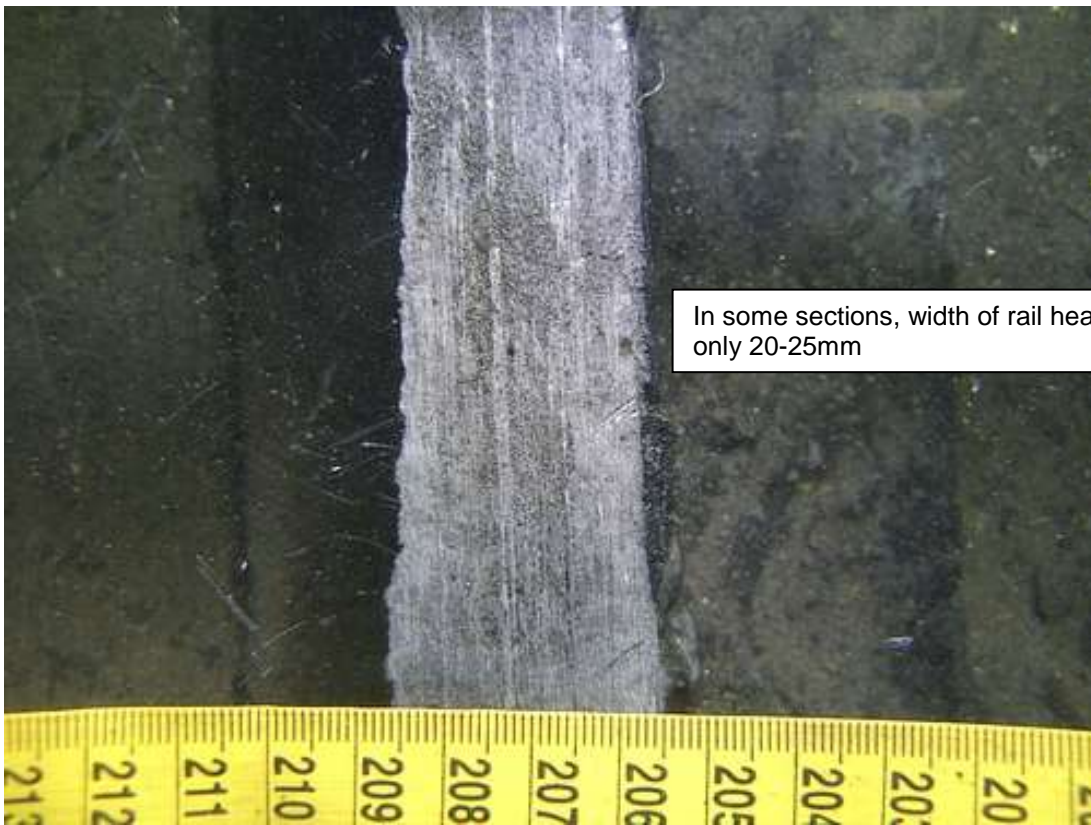
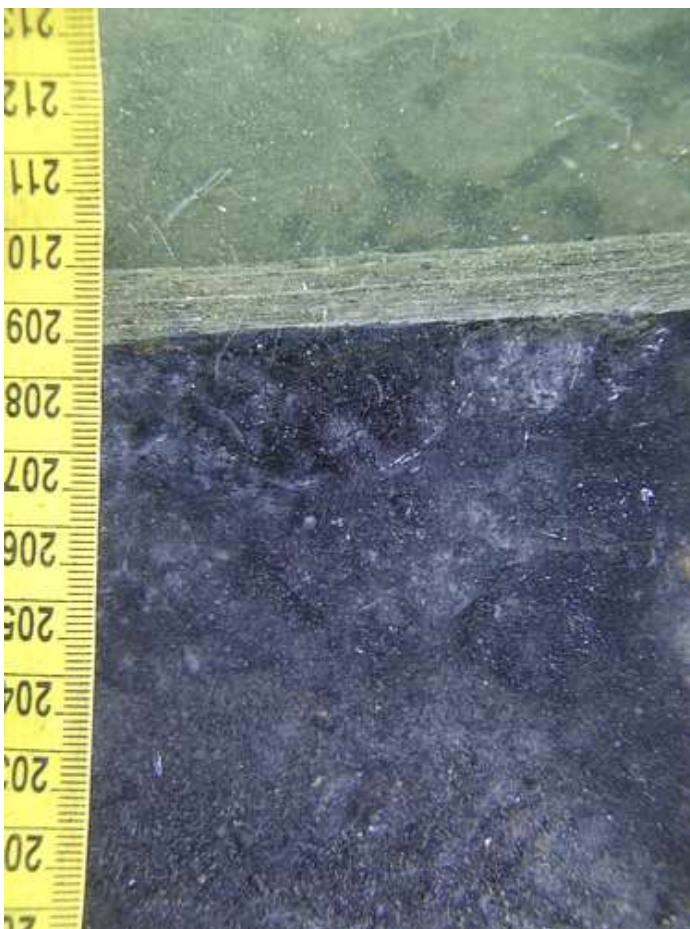
Please note that the condition of the track where visible is extremely poor, in some places the width of the head of the track is only about 20mm instead of the approx. 55mm full width, indicating total section loss due to corrosion. The section loss is also evident in the web of the tracks and at the base of the tracks. Most dogs also show advanced stage of corrosion, as some of them can be broken by hand, they no longer serve their function of holding the track in position.

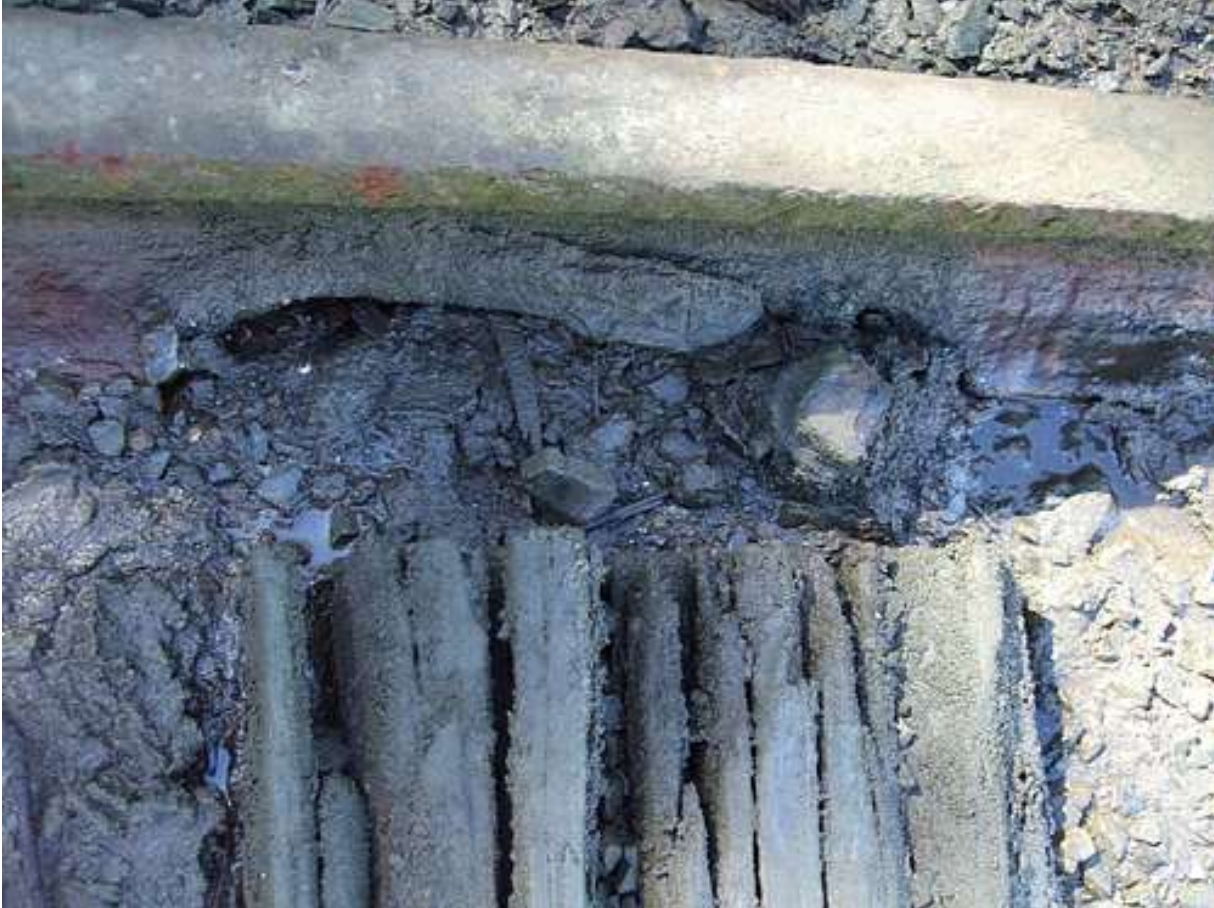
Most sleepers that were accessible underwater are in very poor condition, some of them show advanced stages of rot and borer infestation. In most areas the rotting, soft timber can be removed by diver's knife tip to depths of up to 30-50 mm. The picture below shows timber condition as well as advanced deterioration of rail and dogs.

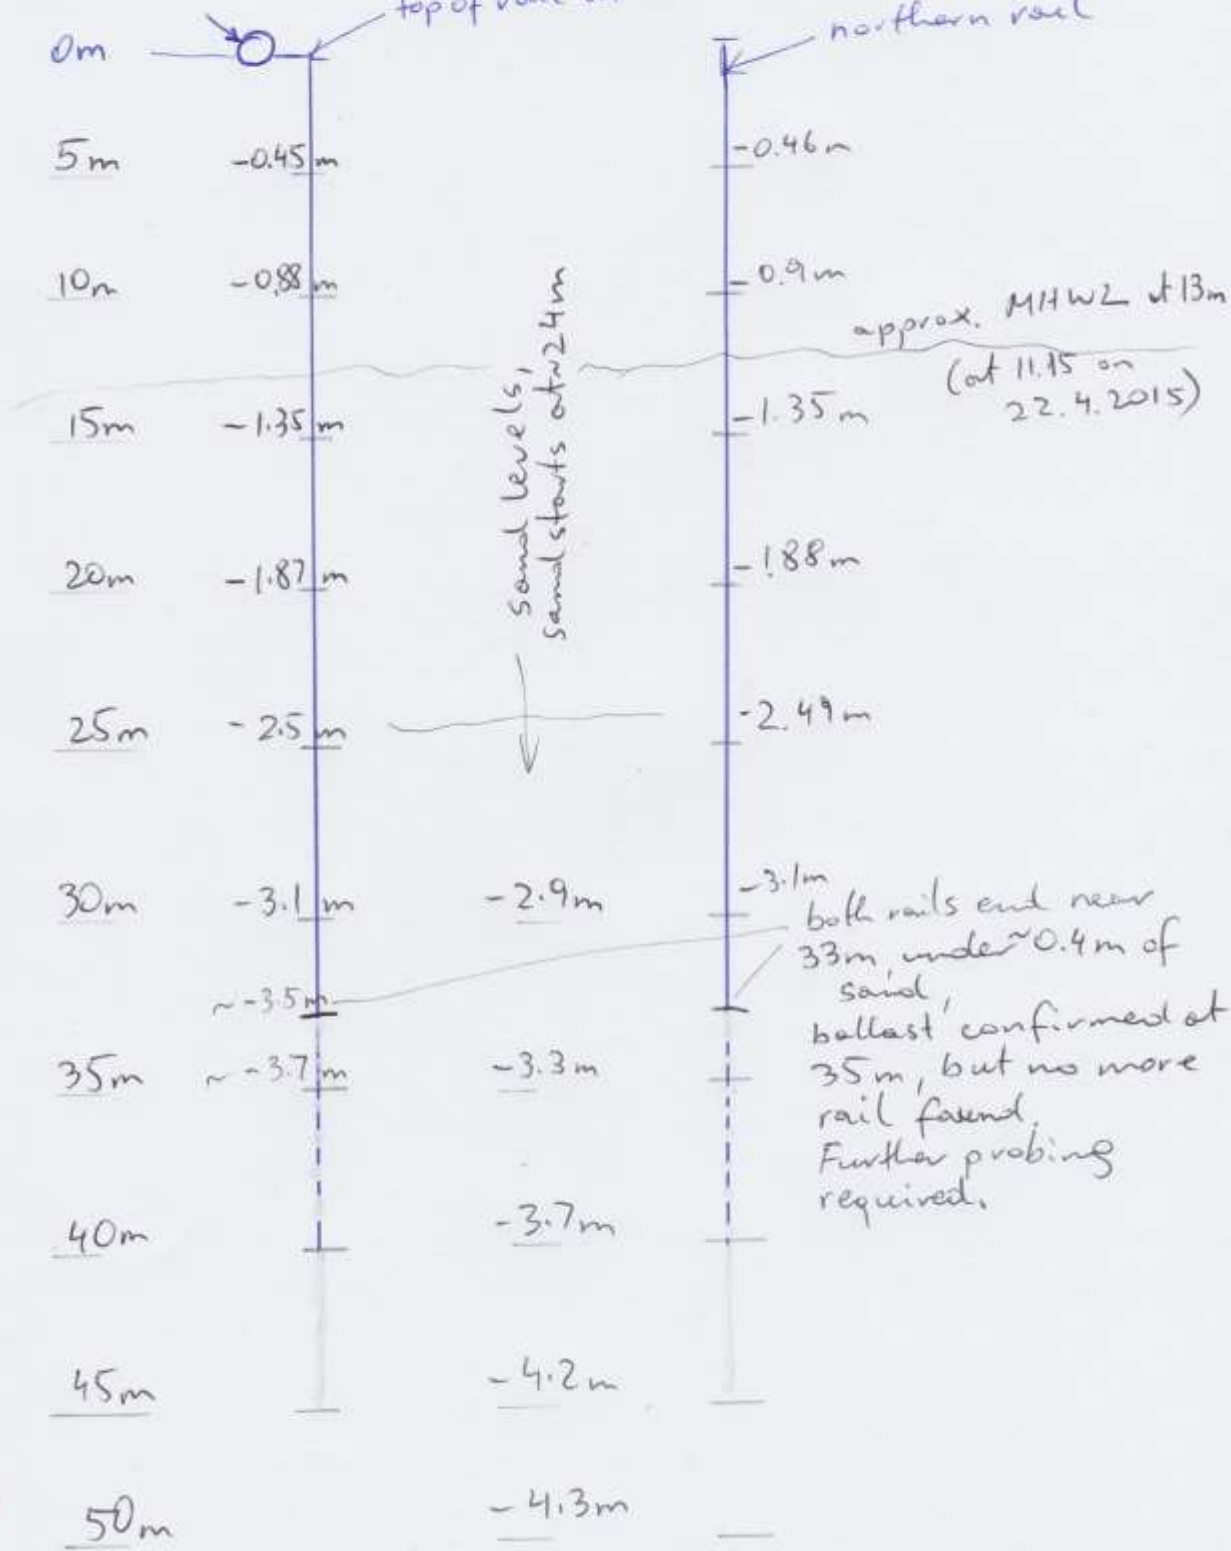
BRUNSWICK SLIPWAY 22.4.2015

Bollard at top of sthn rail, chainage 0.0m,
 top of rail at 0.0m at level 0.0m !!
 northern rail
