# Brunswick Heads Caravan Parks

## Preliminary concept designs for shoreline remediation and small boat access and storage

Prepared for: Byron Shire Holiday Parks Reserve Trust  
Project Manager: Charlie Hewitt  
Ref: 0910859  
Date: April 2007  
© GeoLINK, 2007

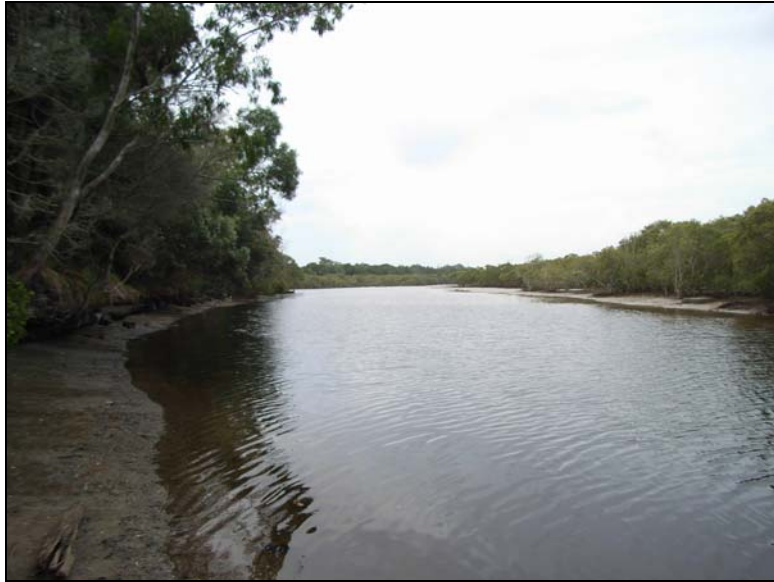
**Plate 1.1**      **A typical view of relatively undisturbed shoreline areas on Simpsons Creek**

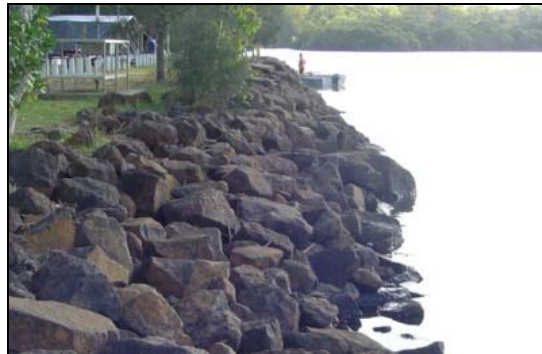
Plate 2.1 Example of a rock revetment seawall at Ferry Reserve Caravan Park

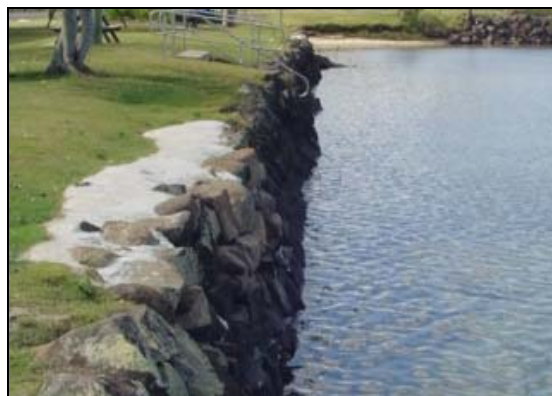
Plate 2.2 Example of a block seawall north of Terrace Reserve Caravan Park

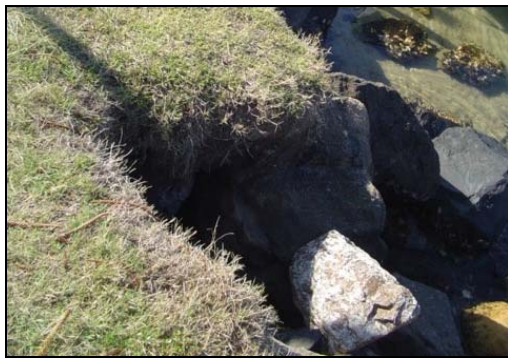
**Washaway:** the result of entrainment of sand and fines through a seawall caused by tidal energy, wave energy, or stormwater runoff which can lead to eventual failure of the seawall.

Plate 2.4 The initial stages of a washaway at Massey Greene Caravan Park

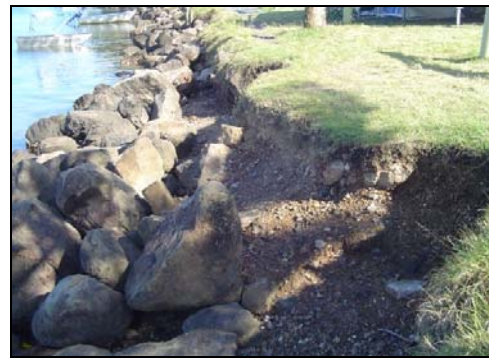
Plate 2.5 An advanced washaway at Massey Greene Caravan Park
