EX HMAS ADELAIDE ARTIFICIAL REEF AND DIVE SITE

POST SCUTTLING REPORT

19 April 2011

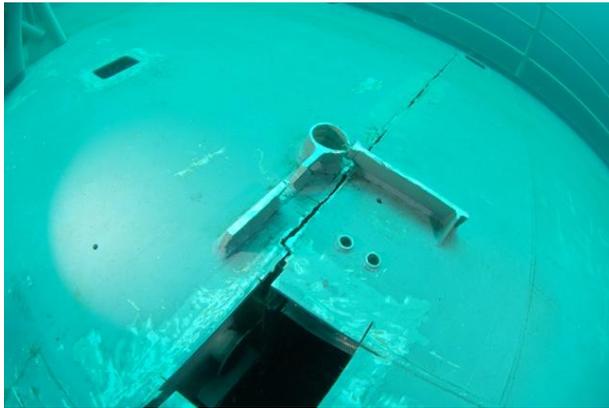
Inspected four cracks identified previous day, as described below. Each crack approx 5-15 mm wide. Crack # 1 runs along an old weld line on 02 Deck from aft end of hole into elevator shaft, running across to port side and down side of hull approx 0.5 metre (see photos below).

Crack # 1 - top view

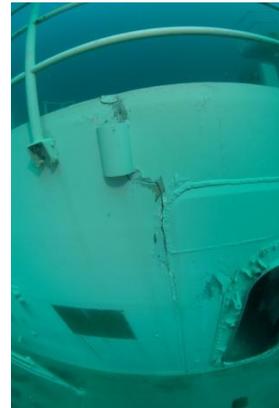
Crack # 1 - side view

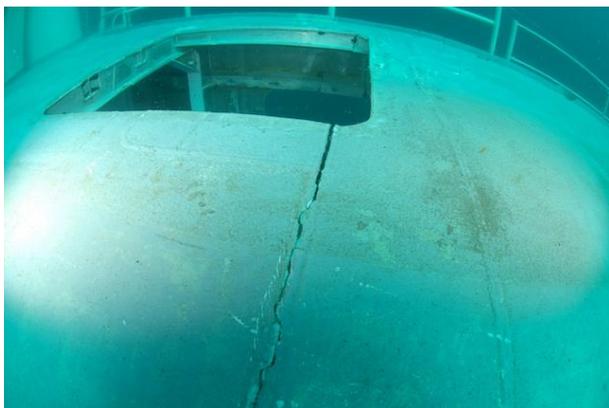
Crack # 2 on 02 Deck starts from the diver access hole immediately forward and to starboard side of elevator shaft. It runs from aft / port side of access hole and continues to midship.

Crack # 2 - top view

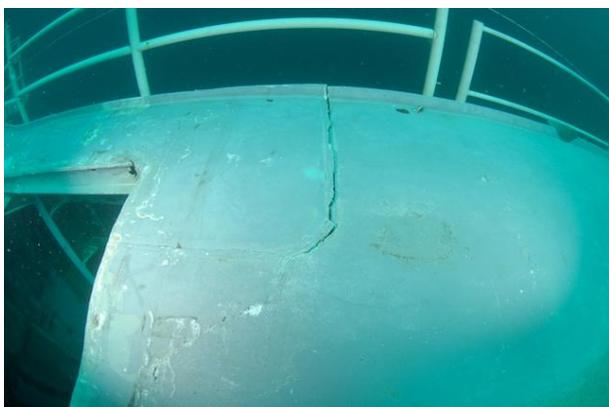
Crack # 3 runs approx 0.5m aft of the same diver access hole.

Crack # 3 - top view

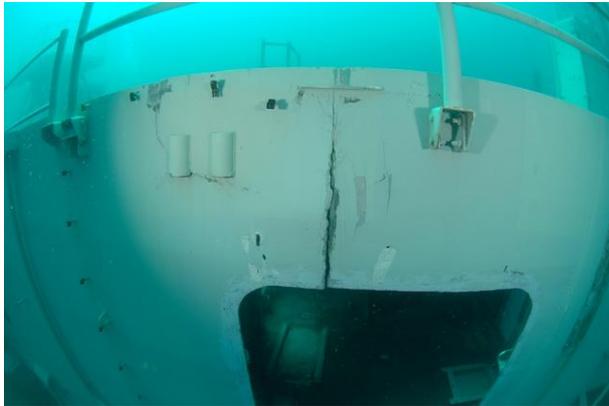
Crack # 4 is the larger crack running vertically down to the dive access hole into the STIR equipment room on the starboard side of ship. The smaller (curved) crack shown in the photo below is a continuation of Crack # 3.

Crack # 4 - side view
