Diving Service

- Marine Contractors

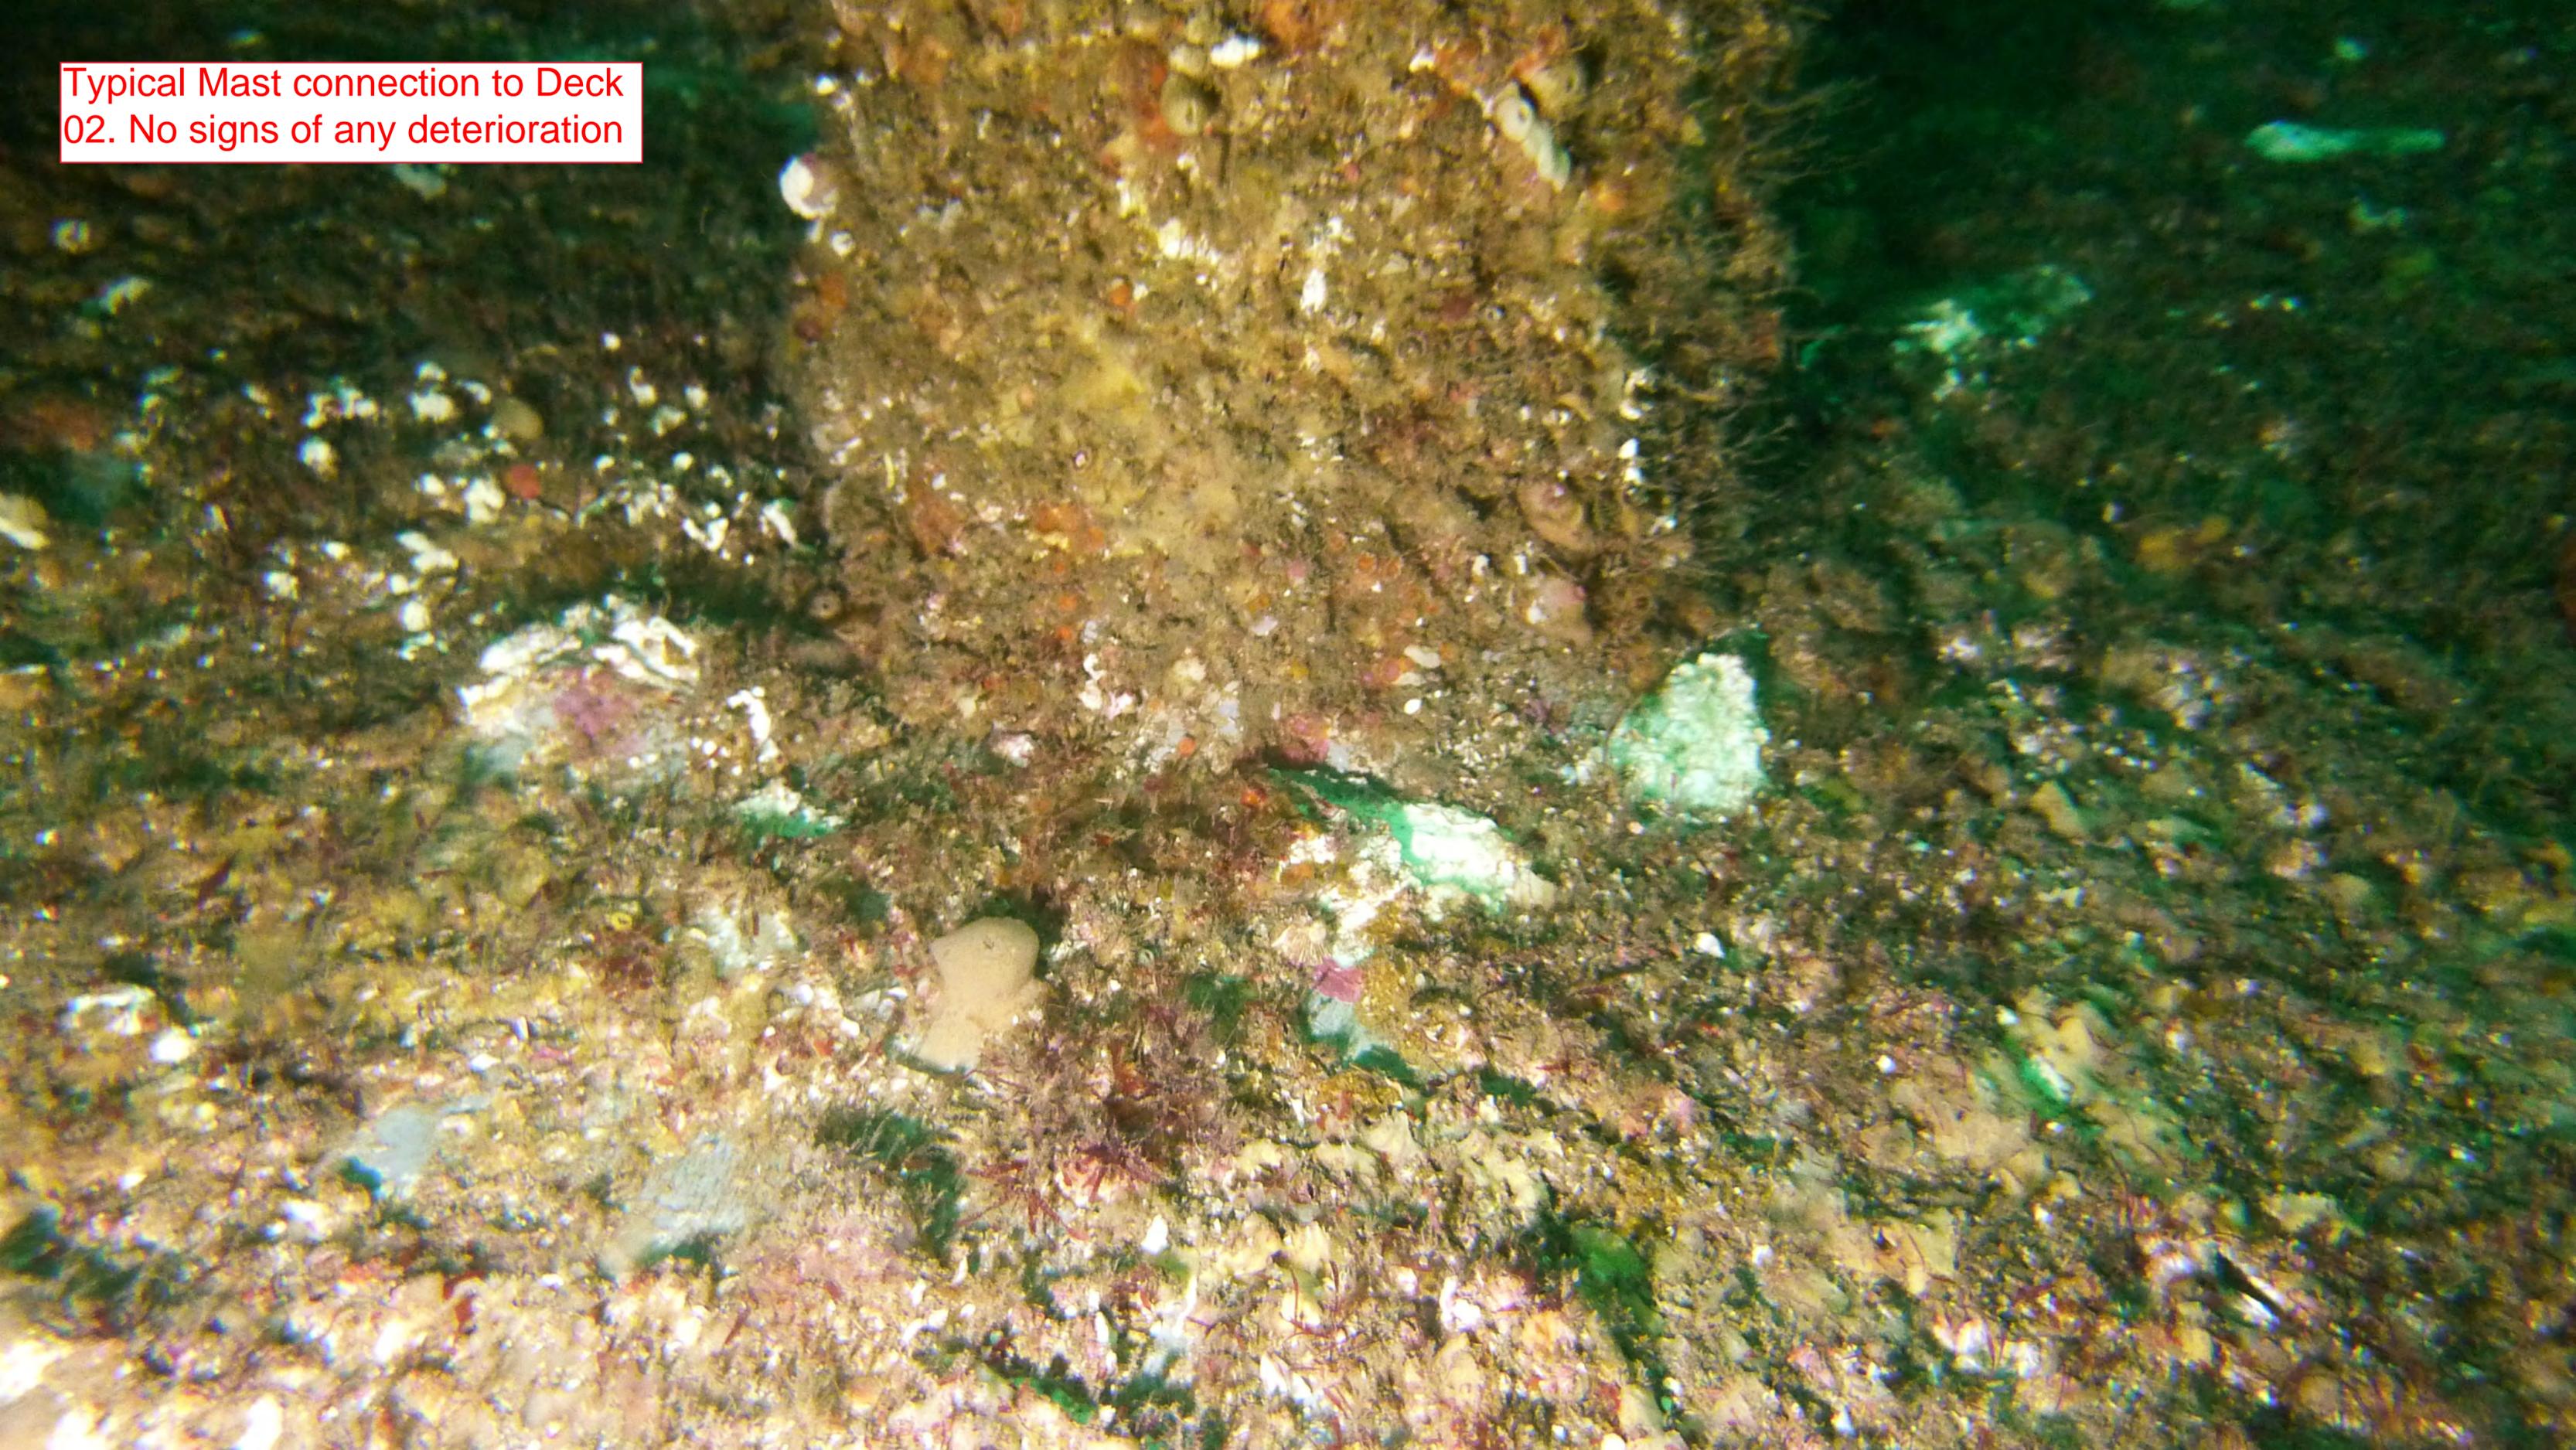
The Main Mast is intact and has no visible defects. It is heavily encrusted in marine life.

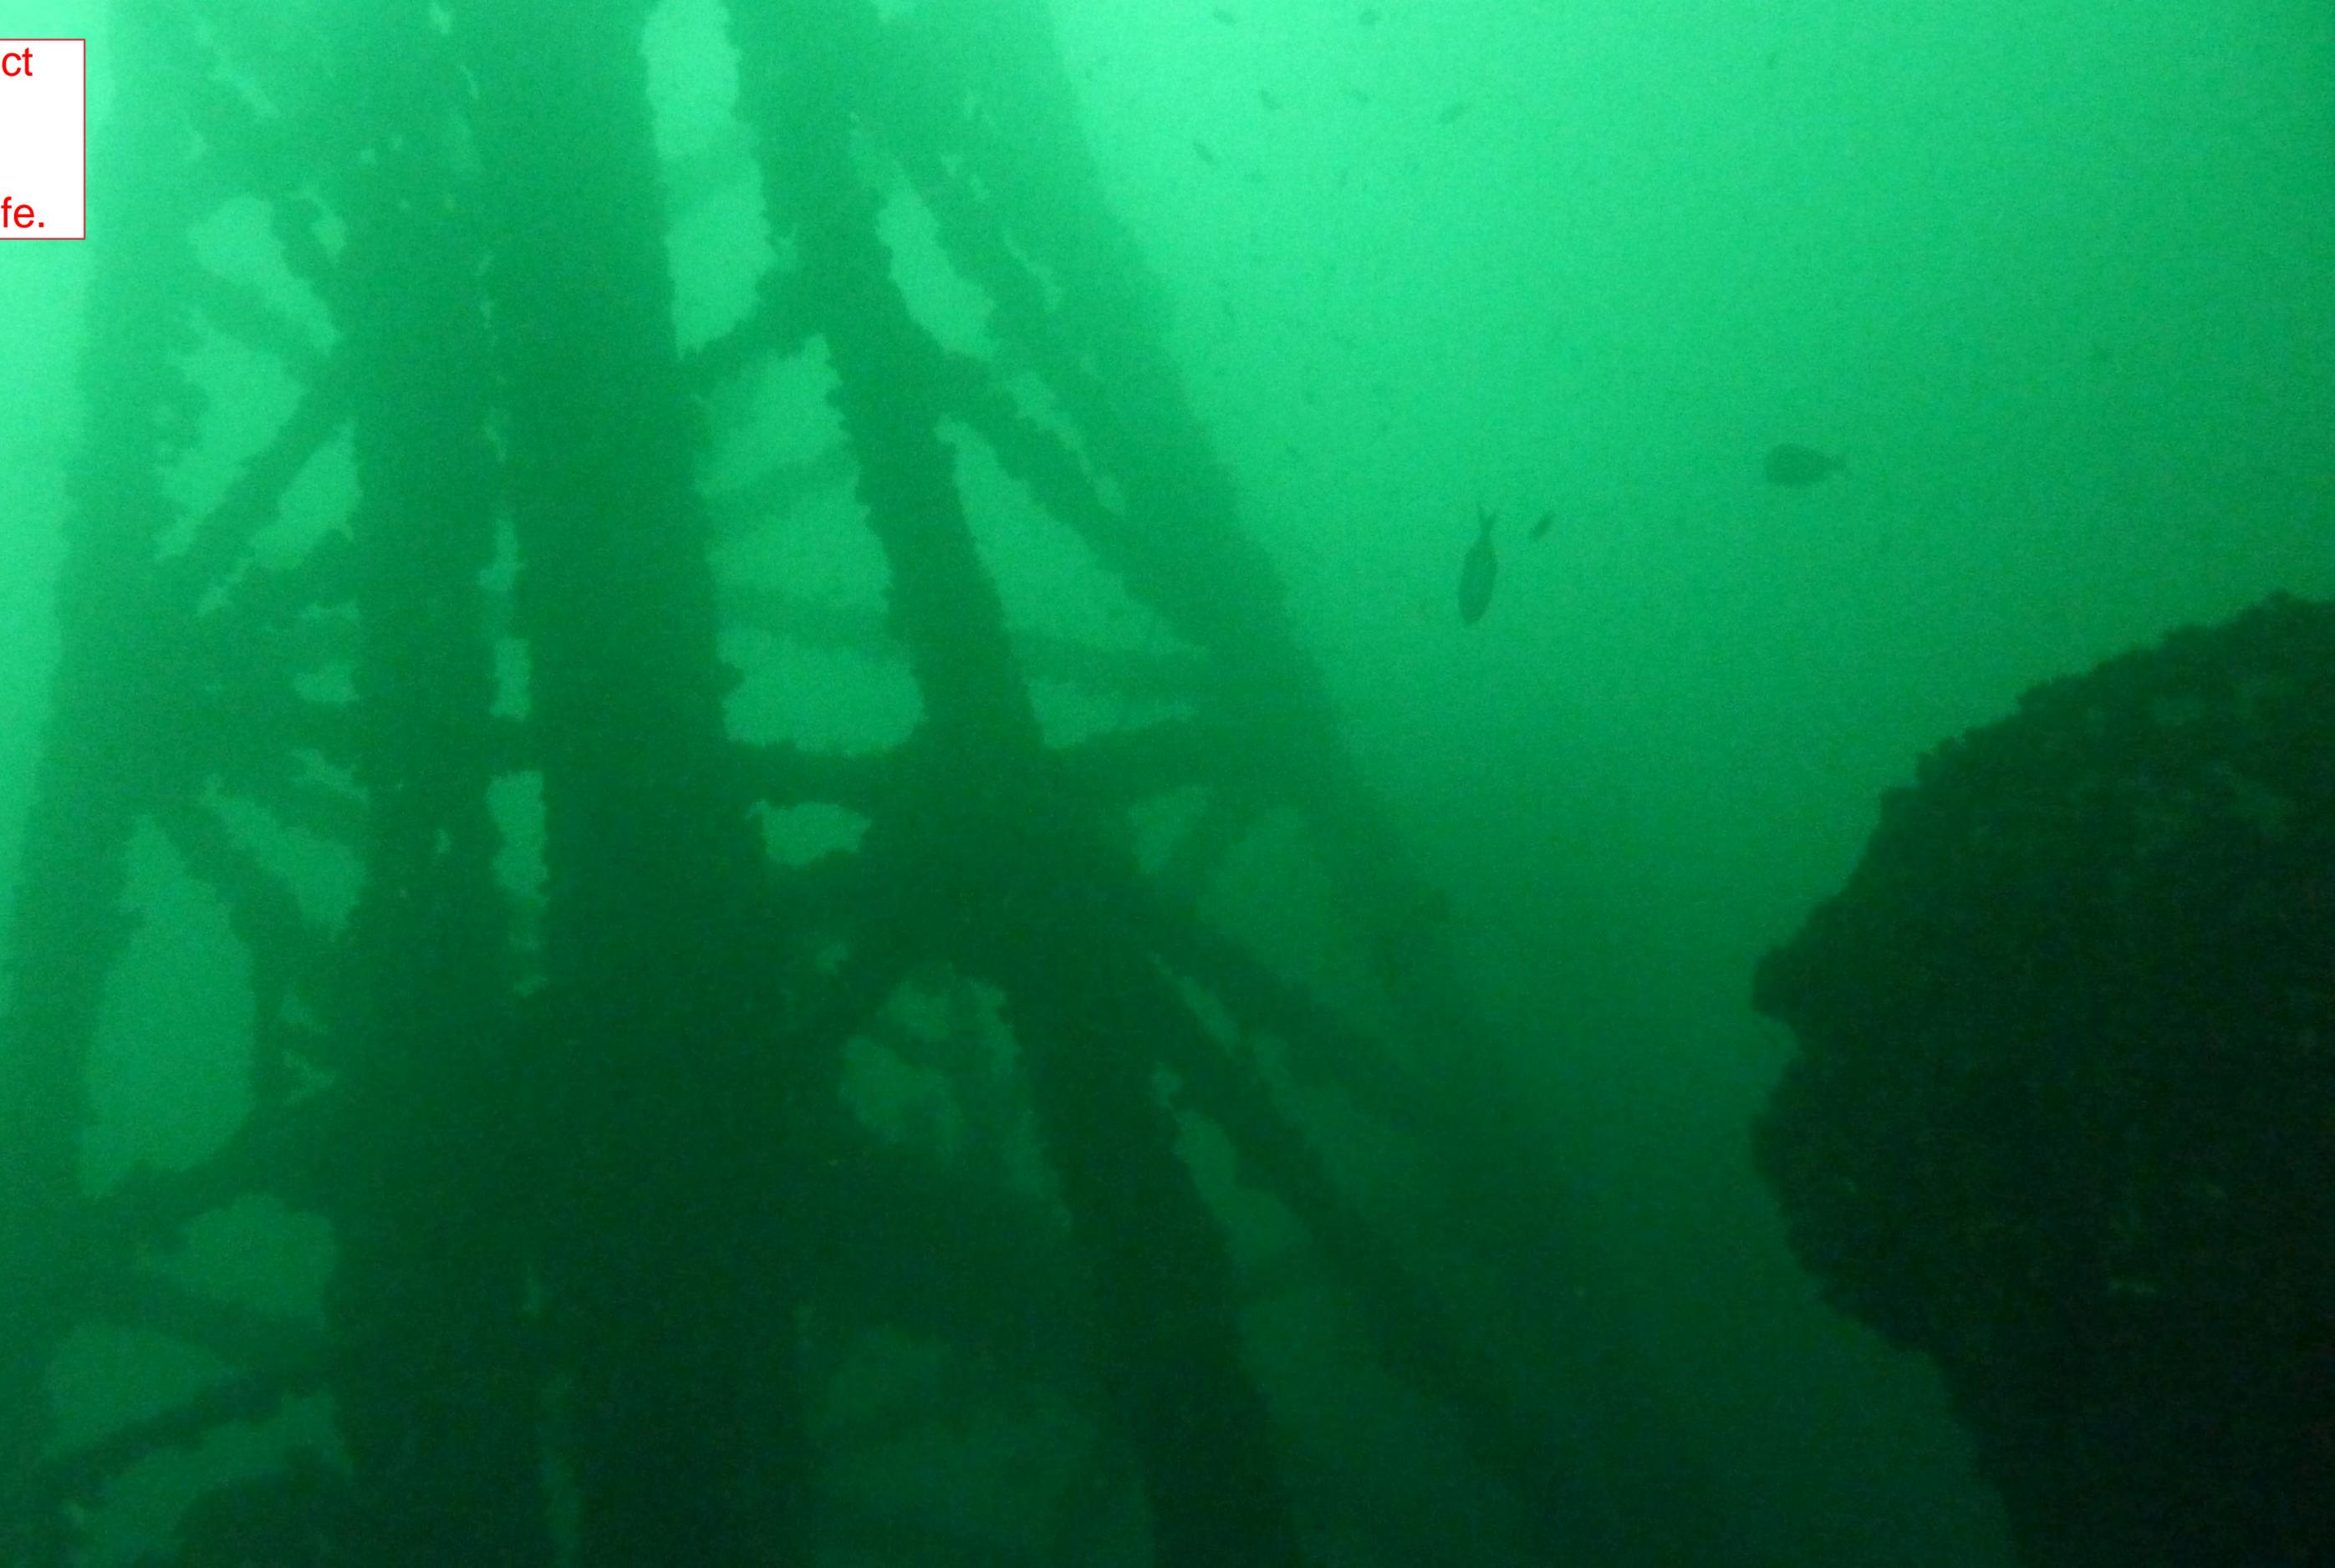
The small towers on top of the Bridge are intact and heavily encrusted with marine life

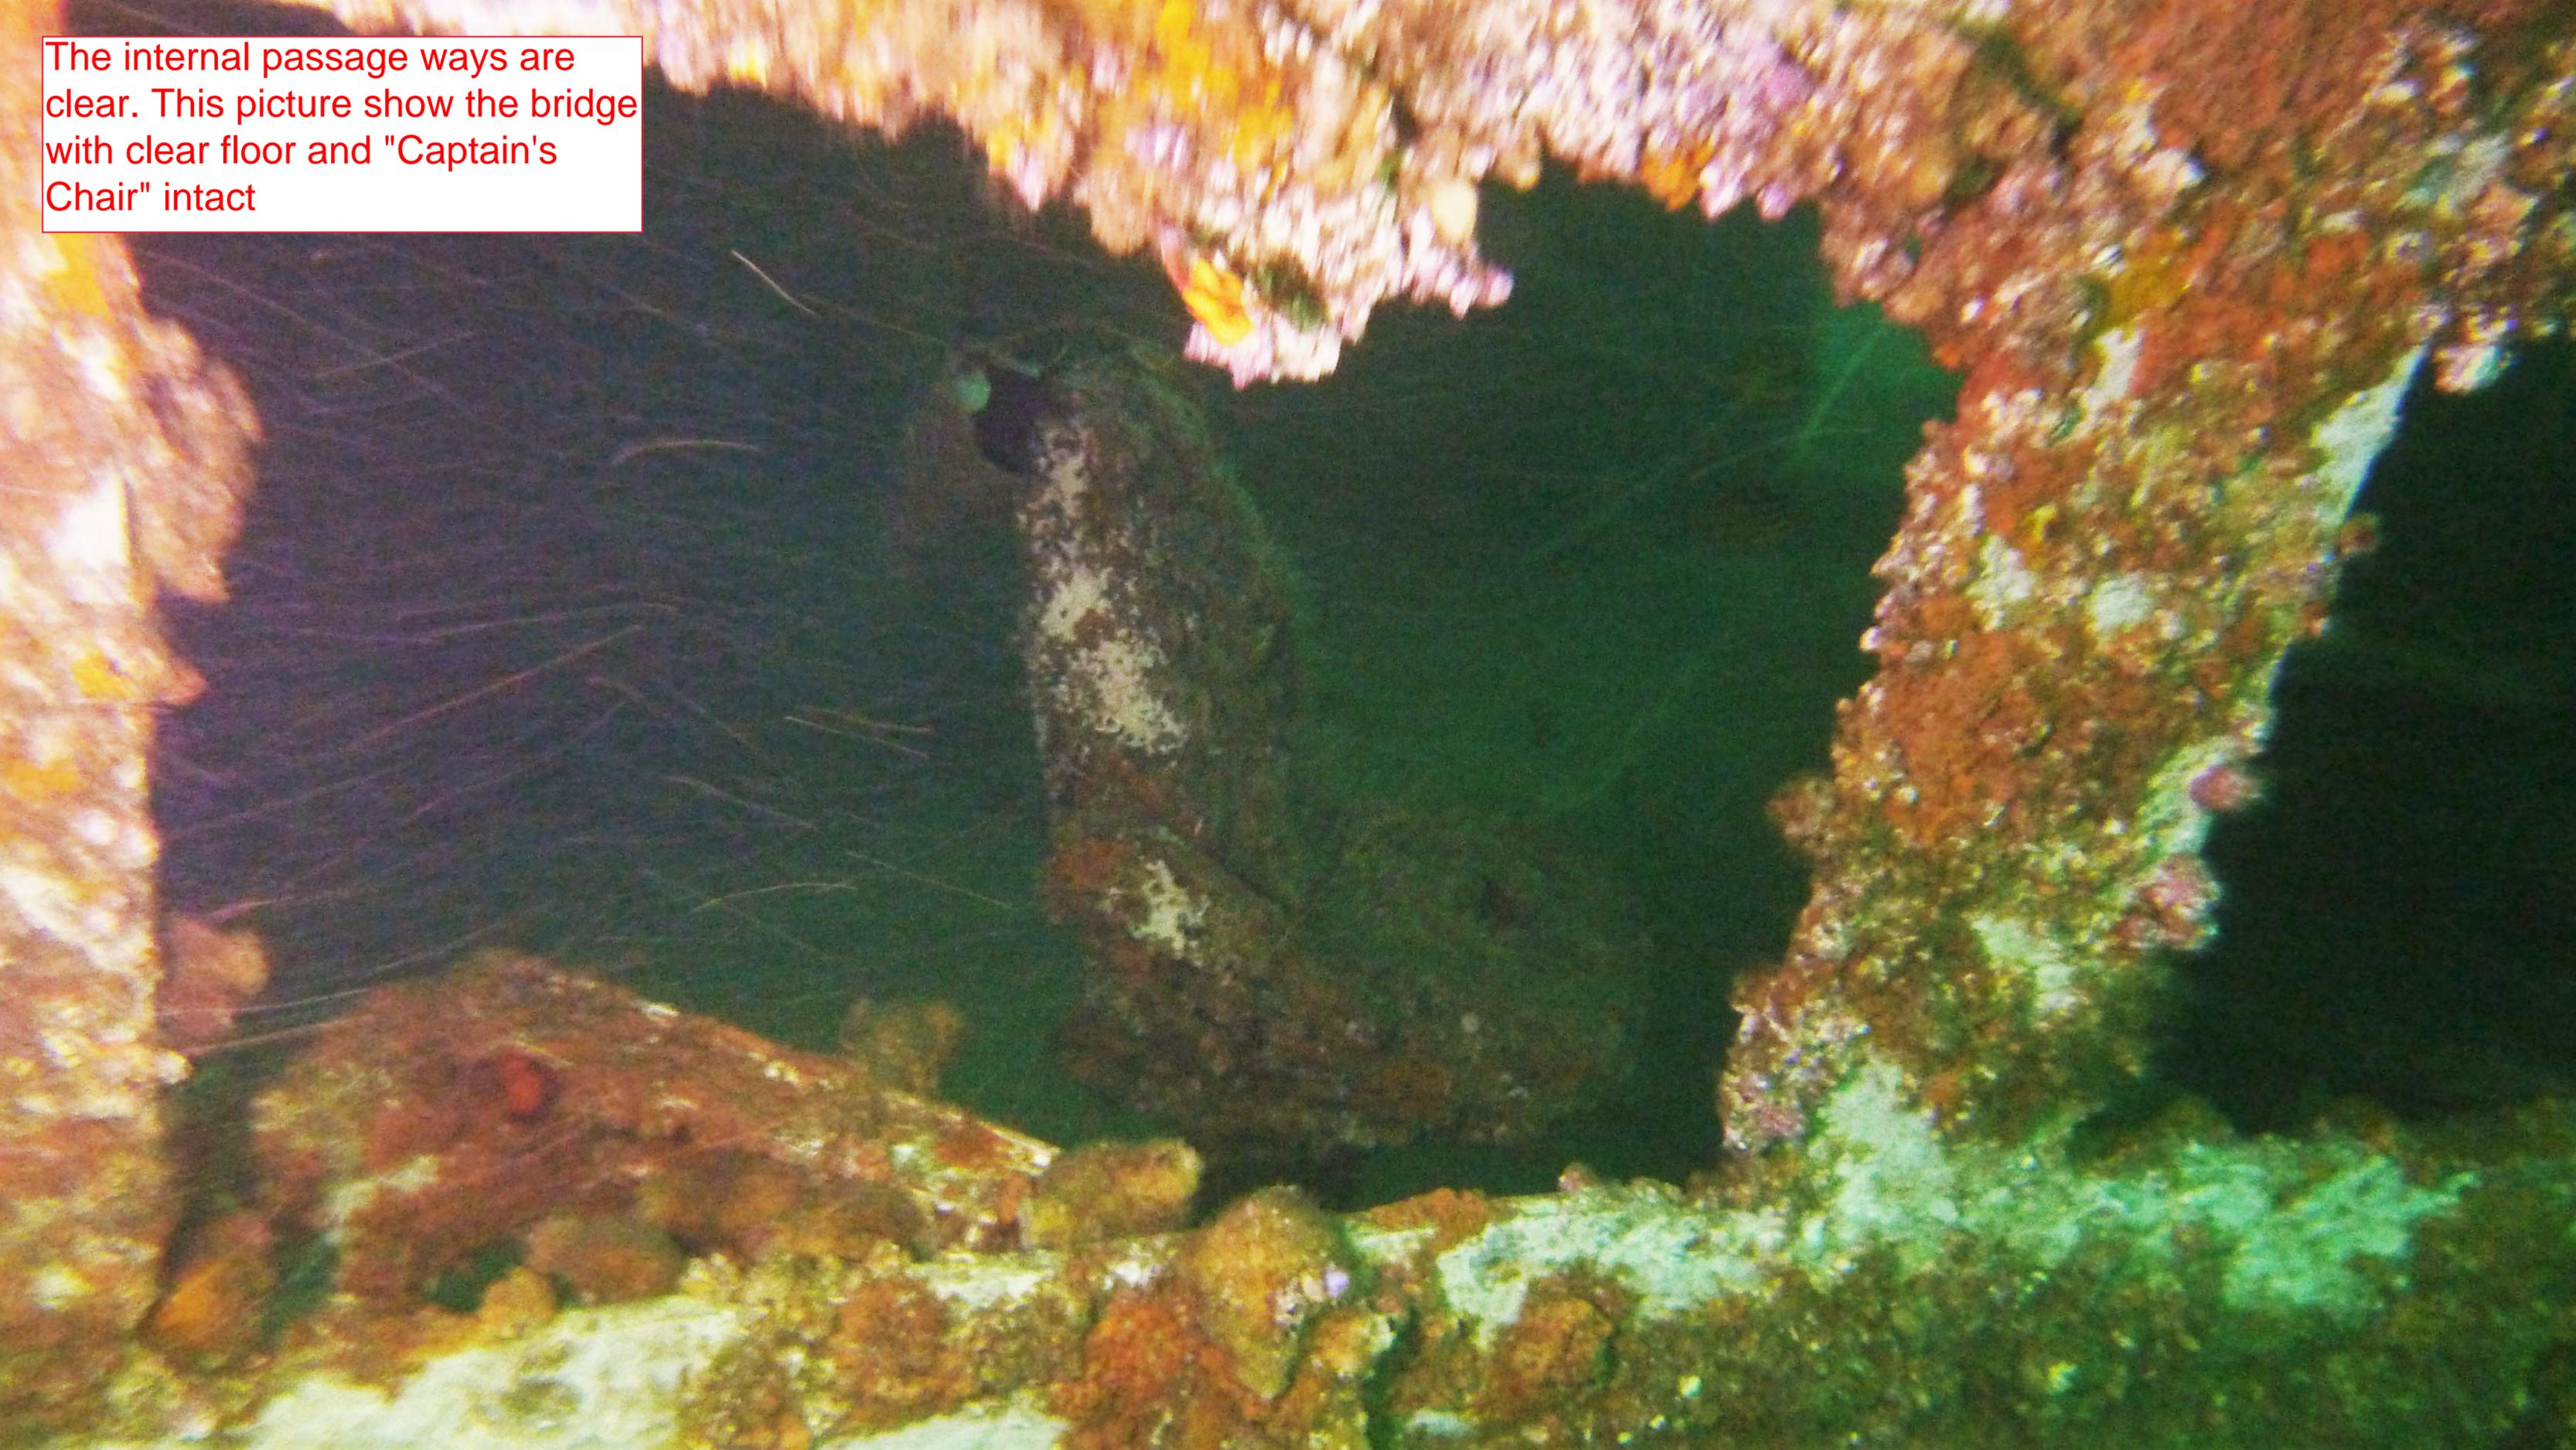
The area around the missile launcher on the forward deck is free of cracks or deformation.

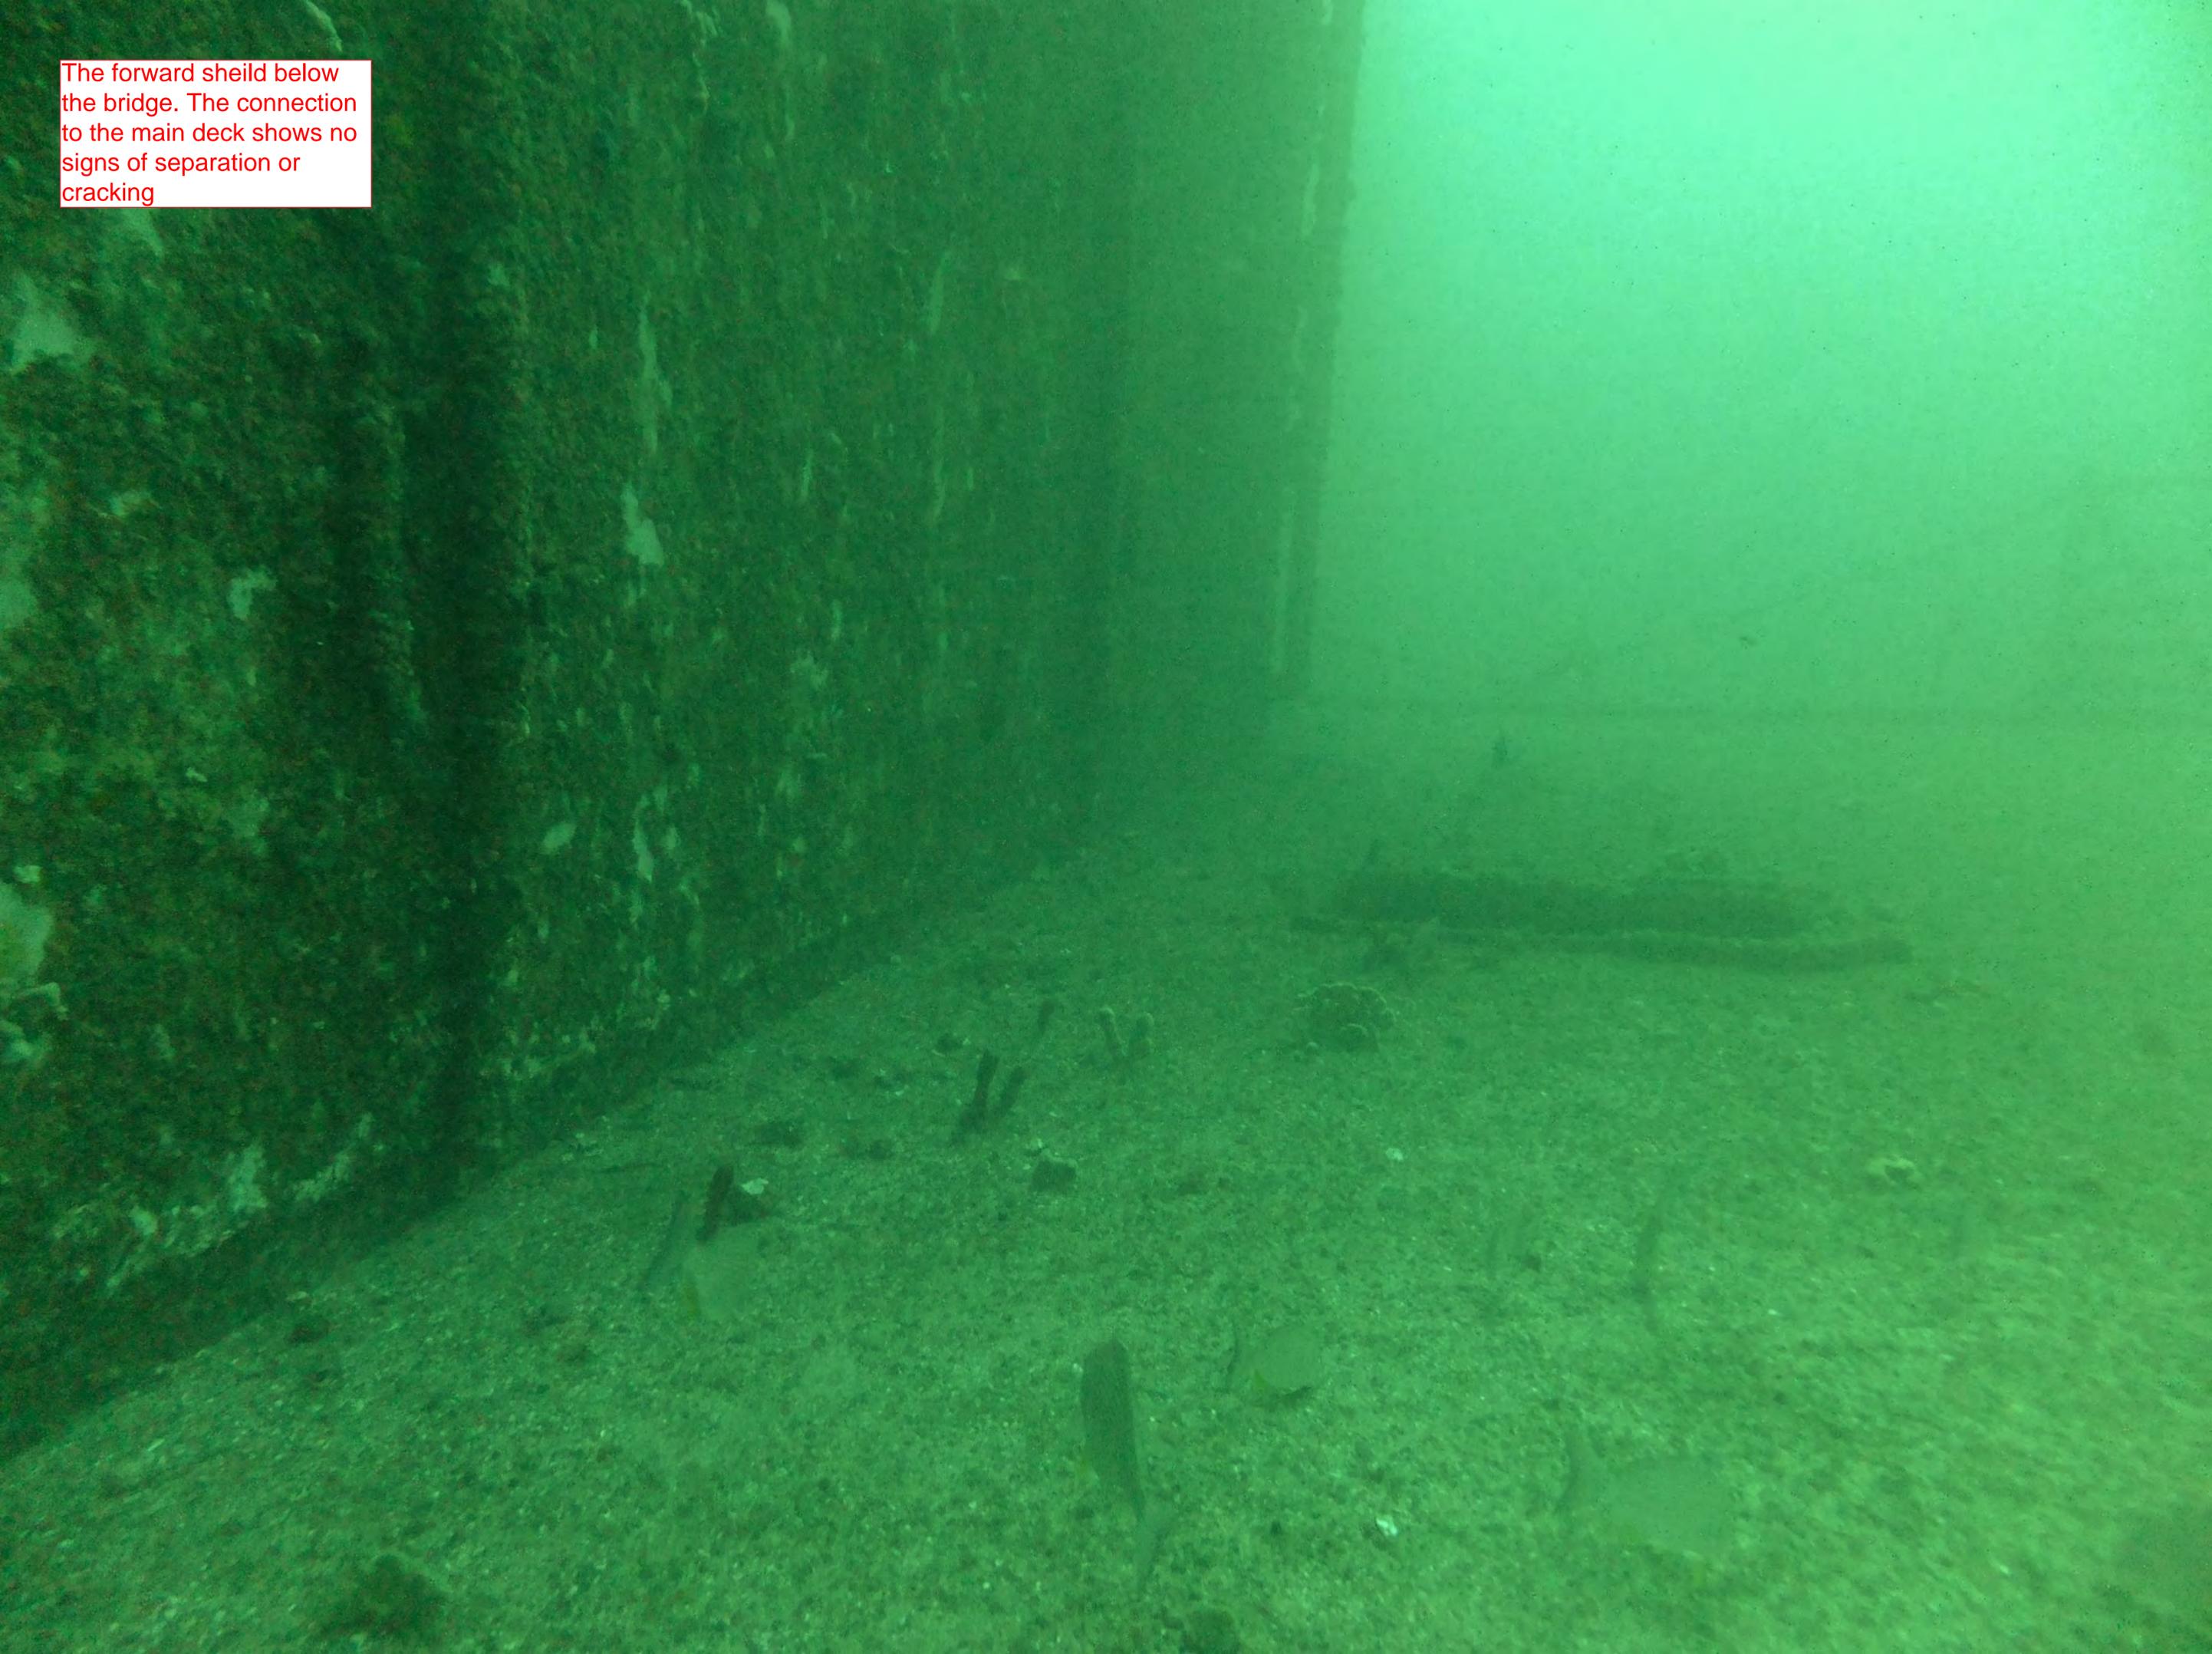
This is a view of the cracking across Deck 02. The crack is well disguised under marine growth and does not appear to be getting any worse

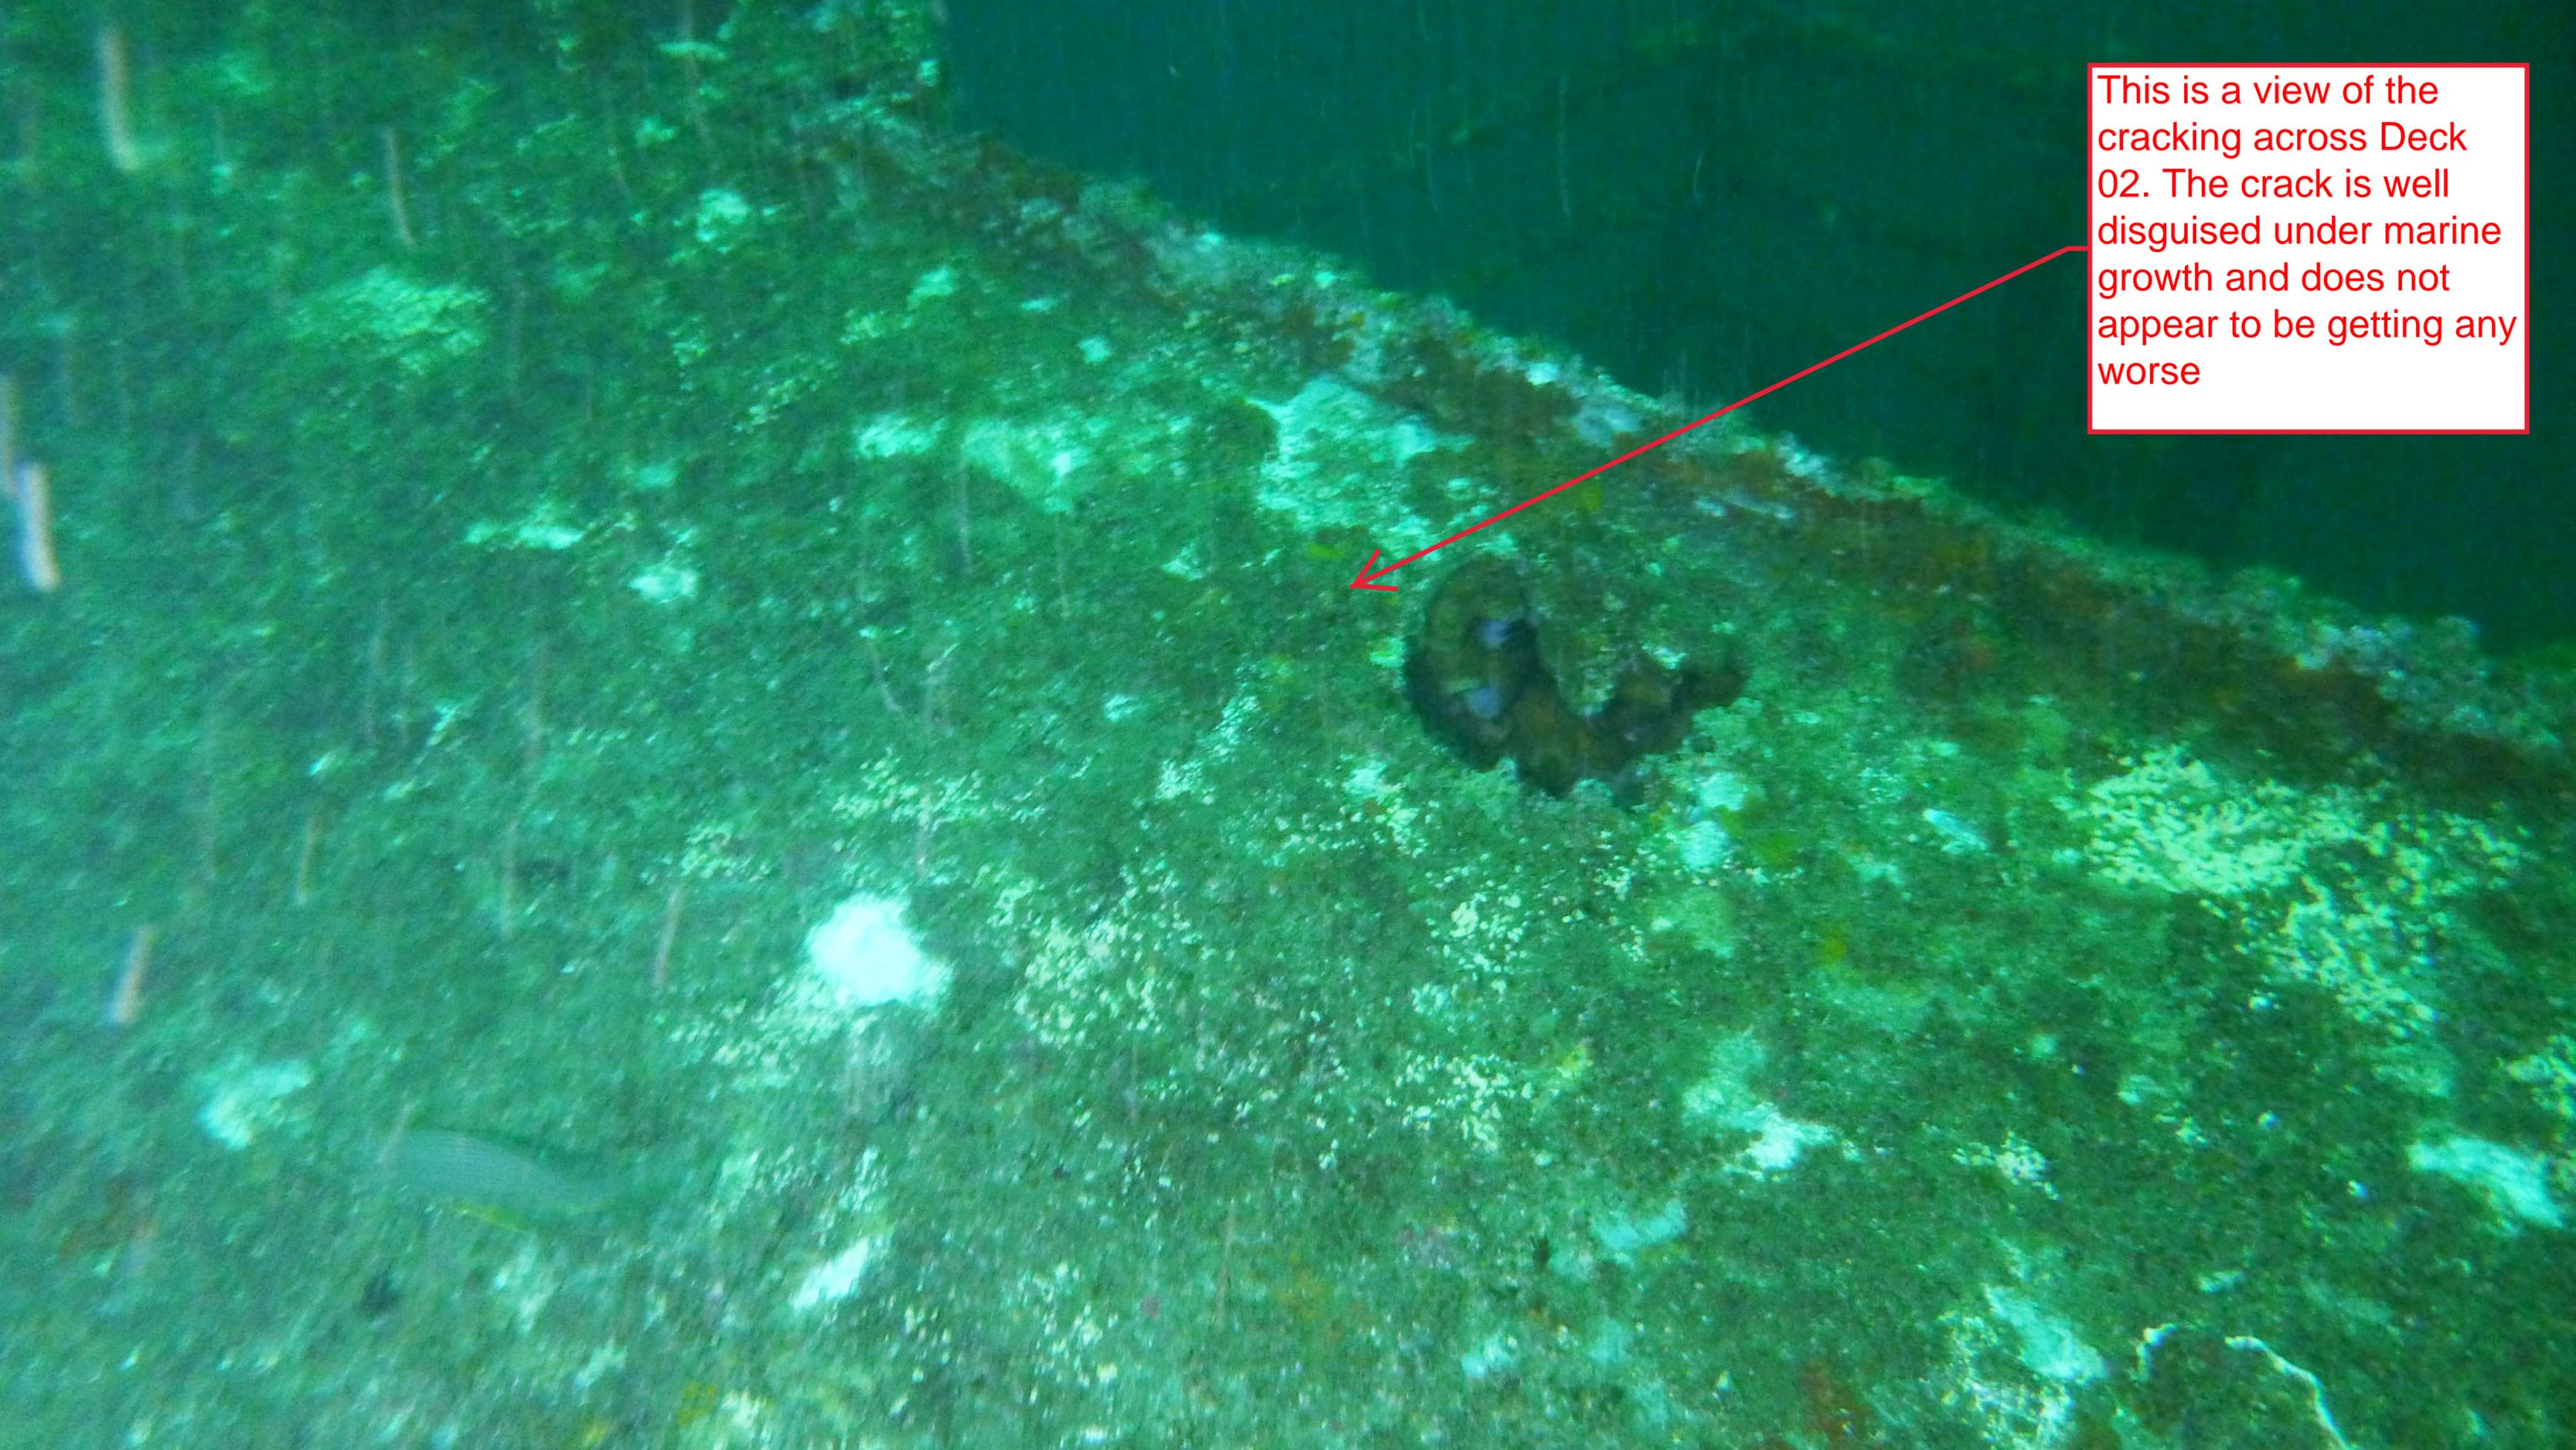
Another view of the 02 deck cracking. The elevator shaft is in the bottom right corner

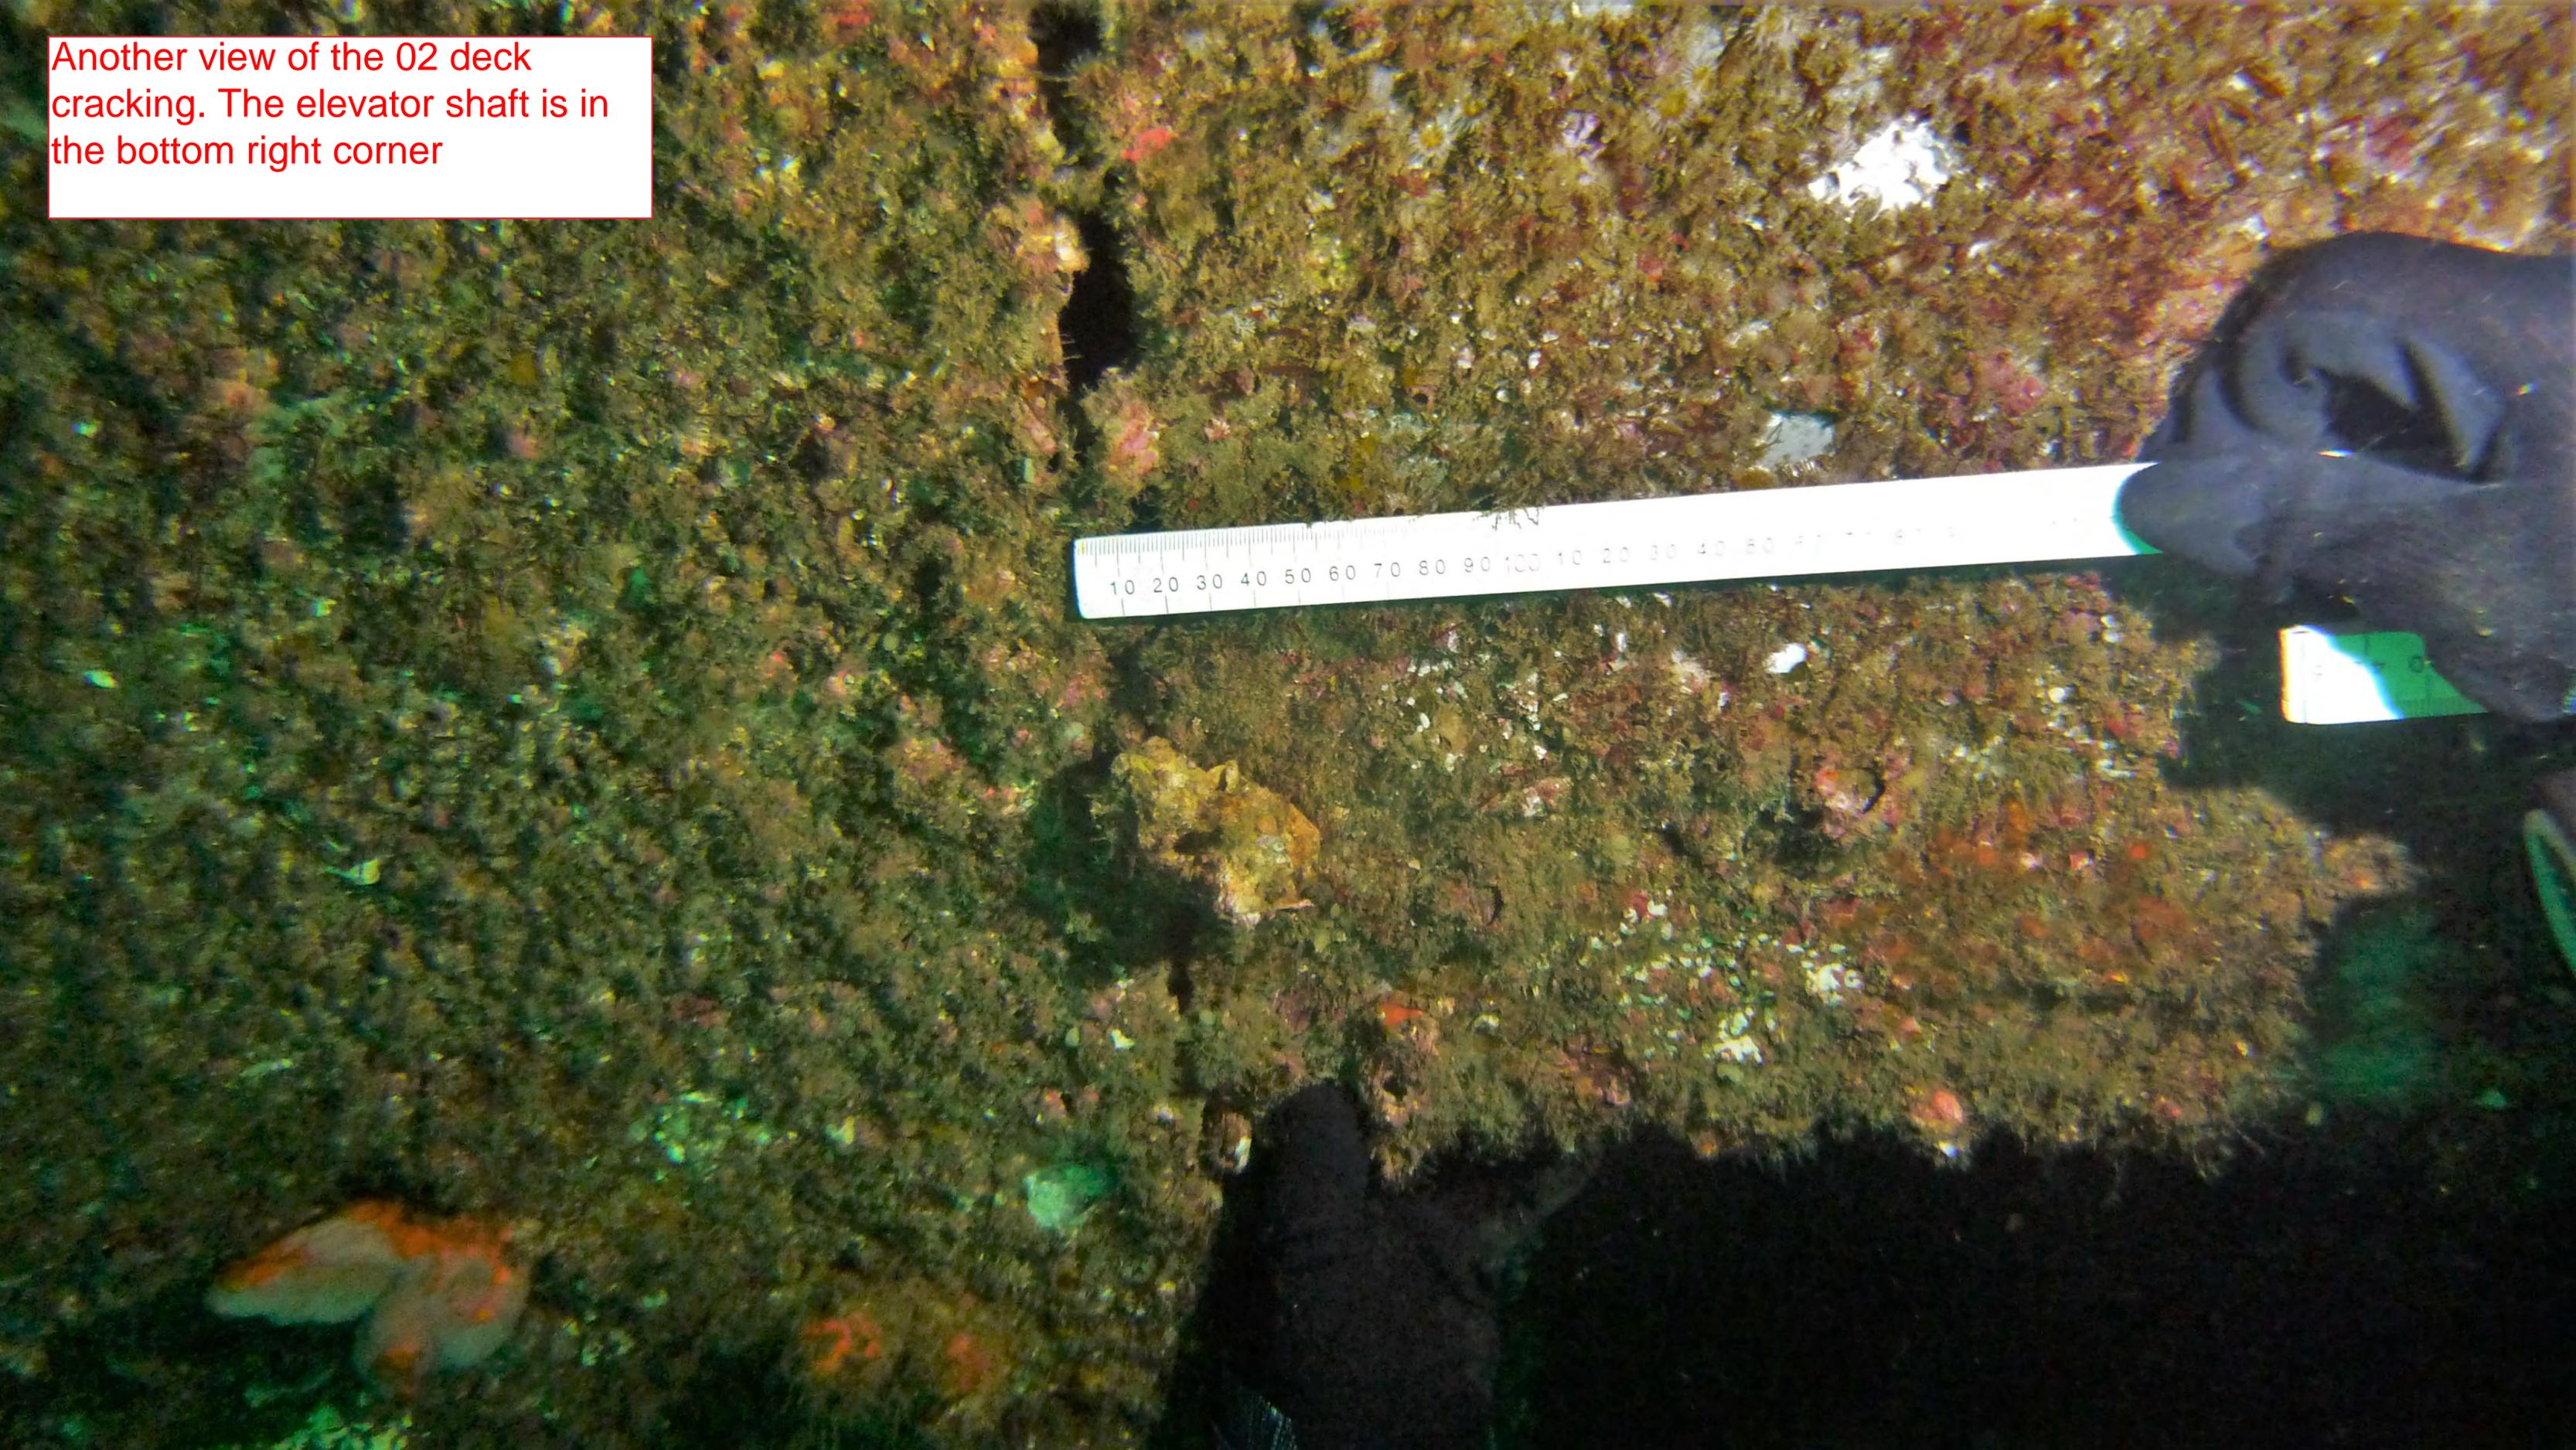
A view of the missing starboard hangar wall looking forward from the hangar door. There are no loose panel remaining.
