Diving Service

- Marine Contractors

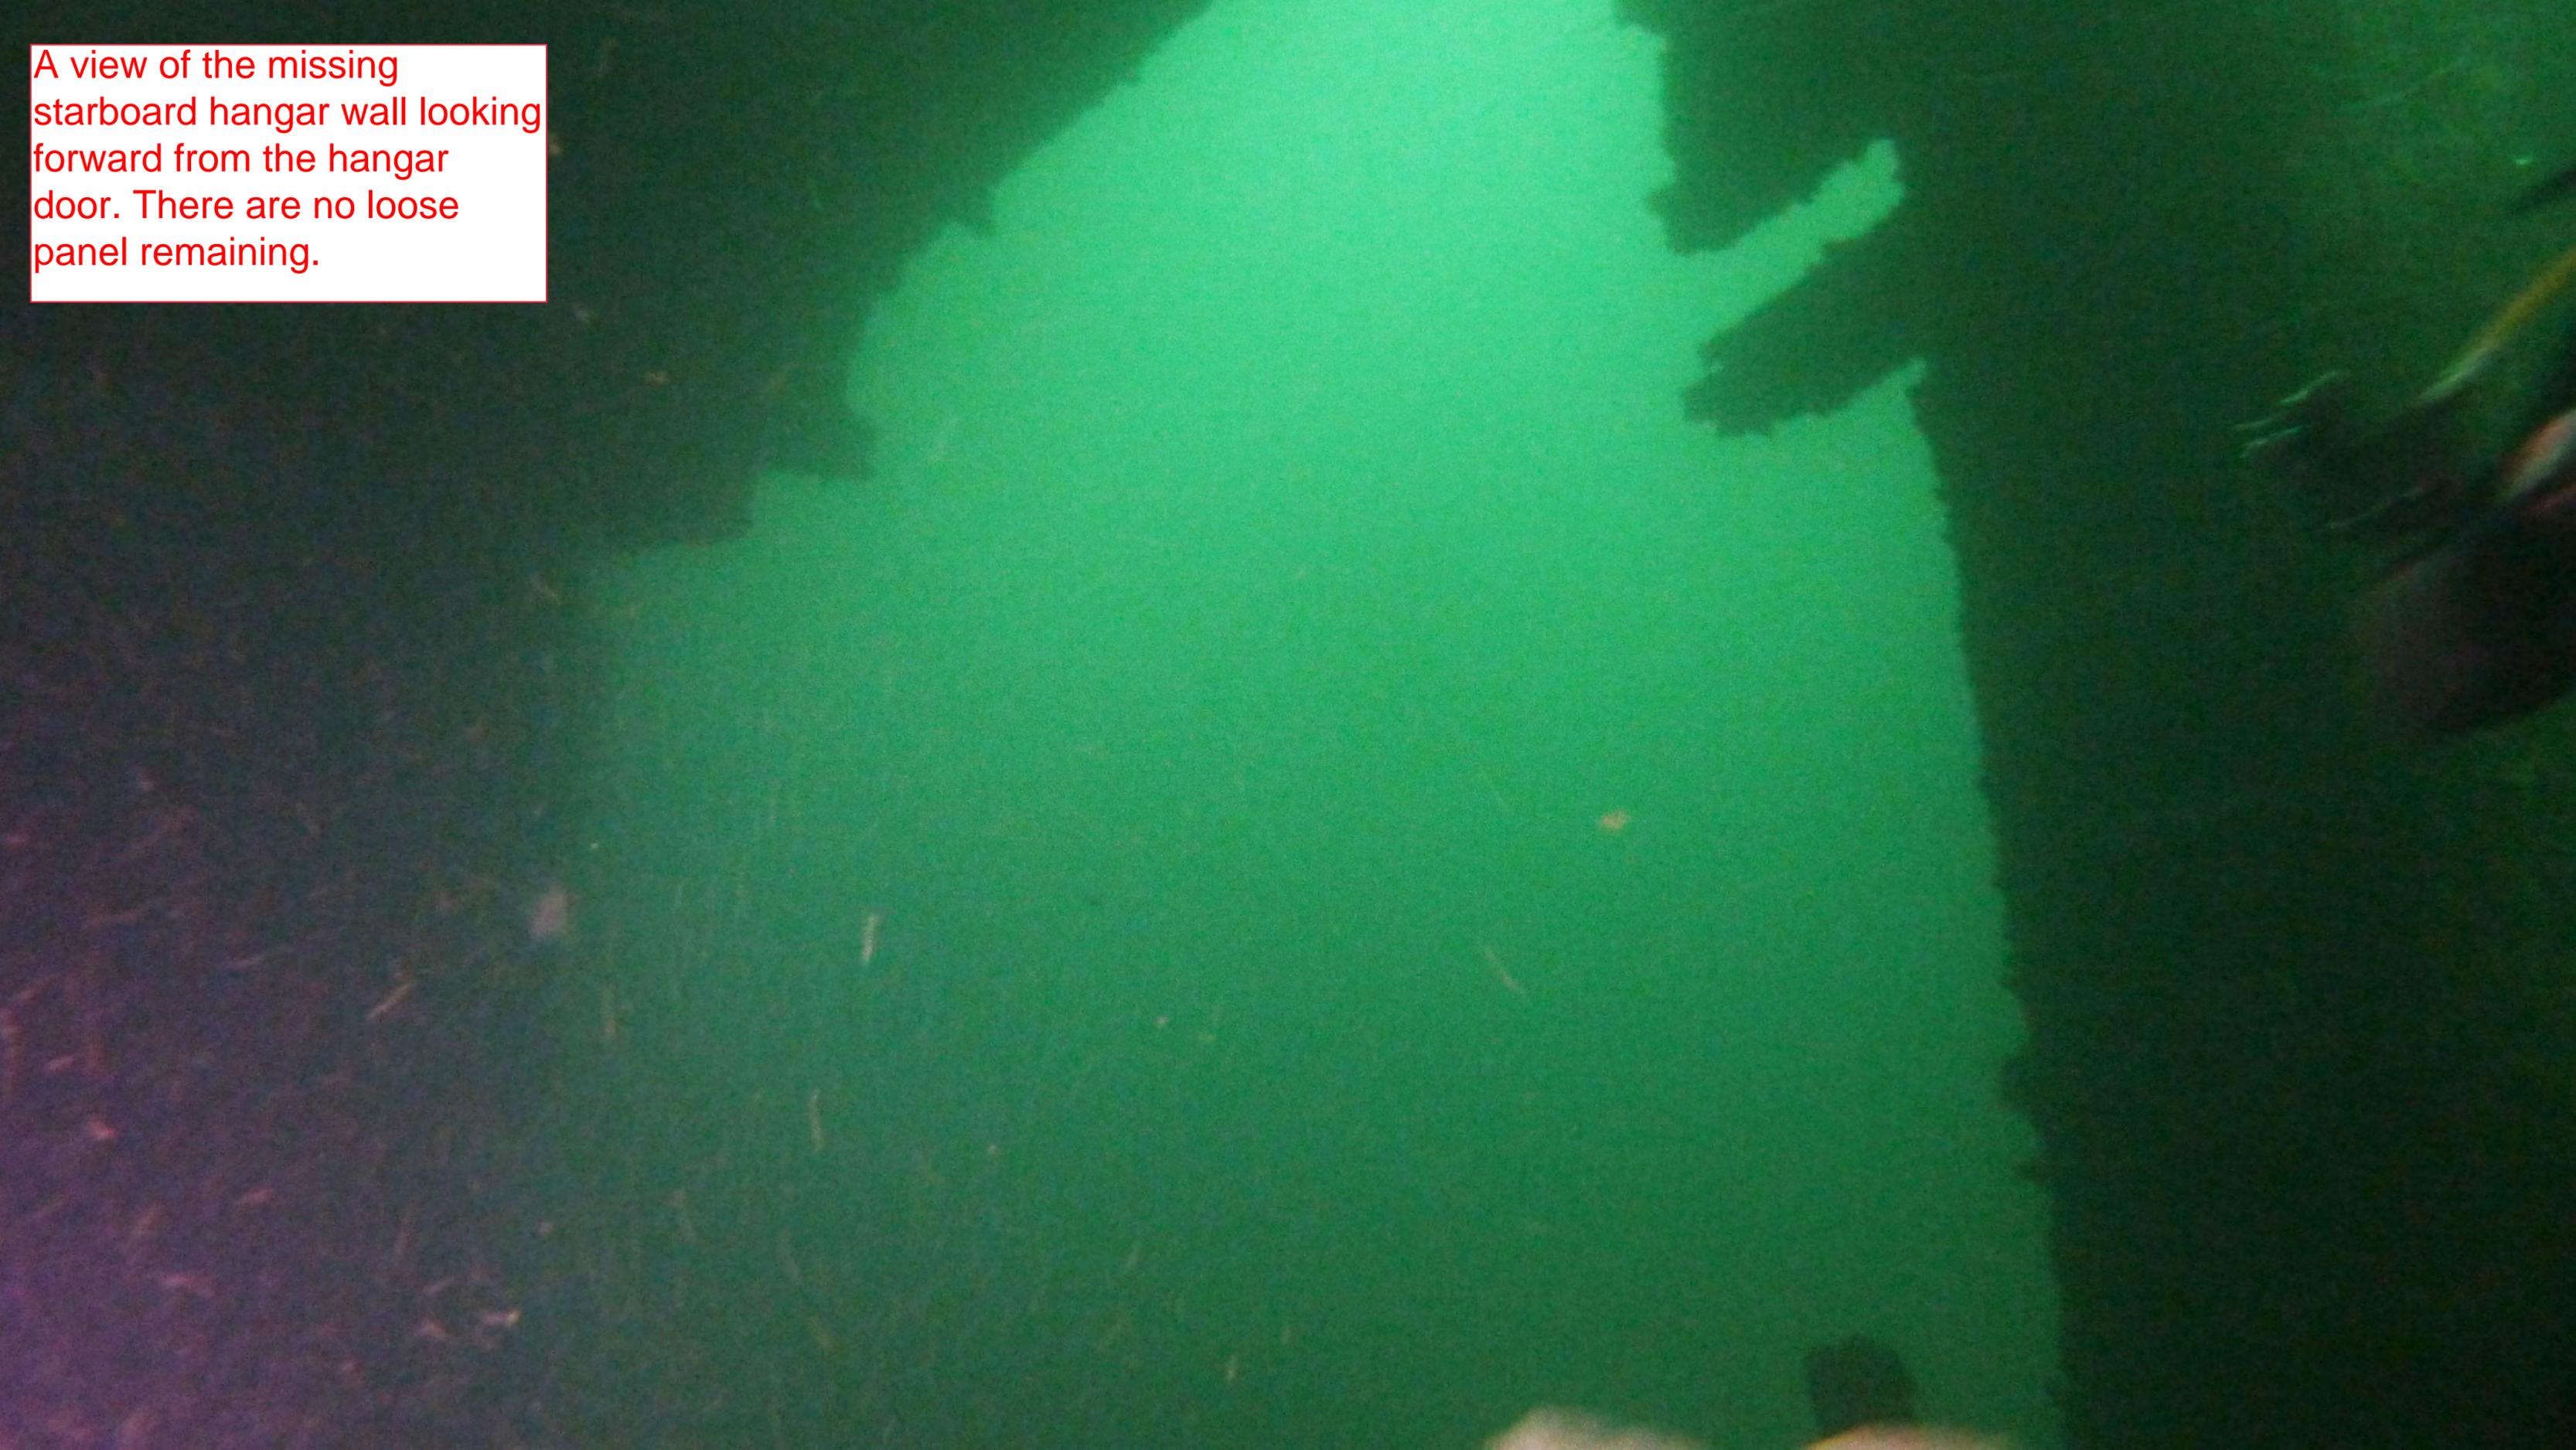
The port side hangar wall
looking forward from the
hangar door. It shows no
signs of separating

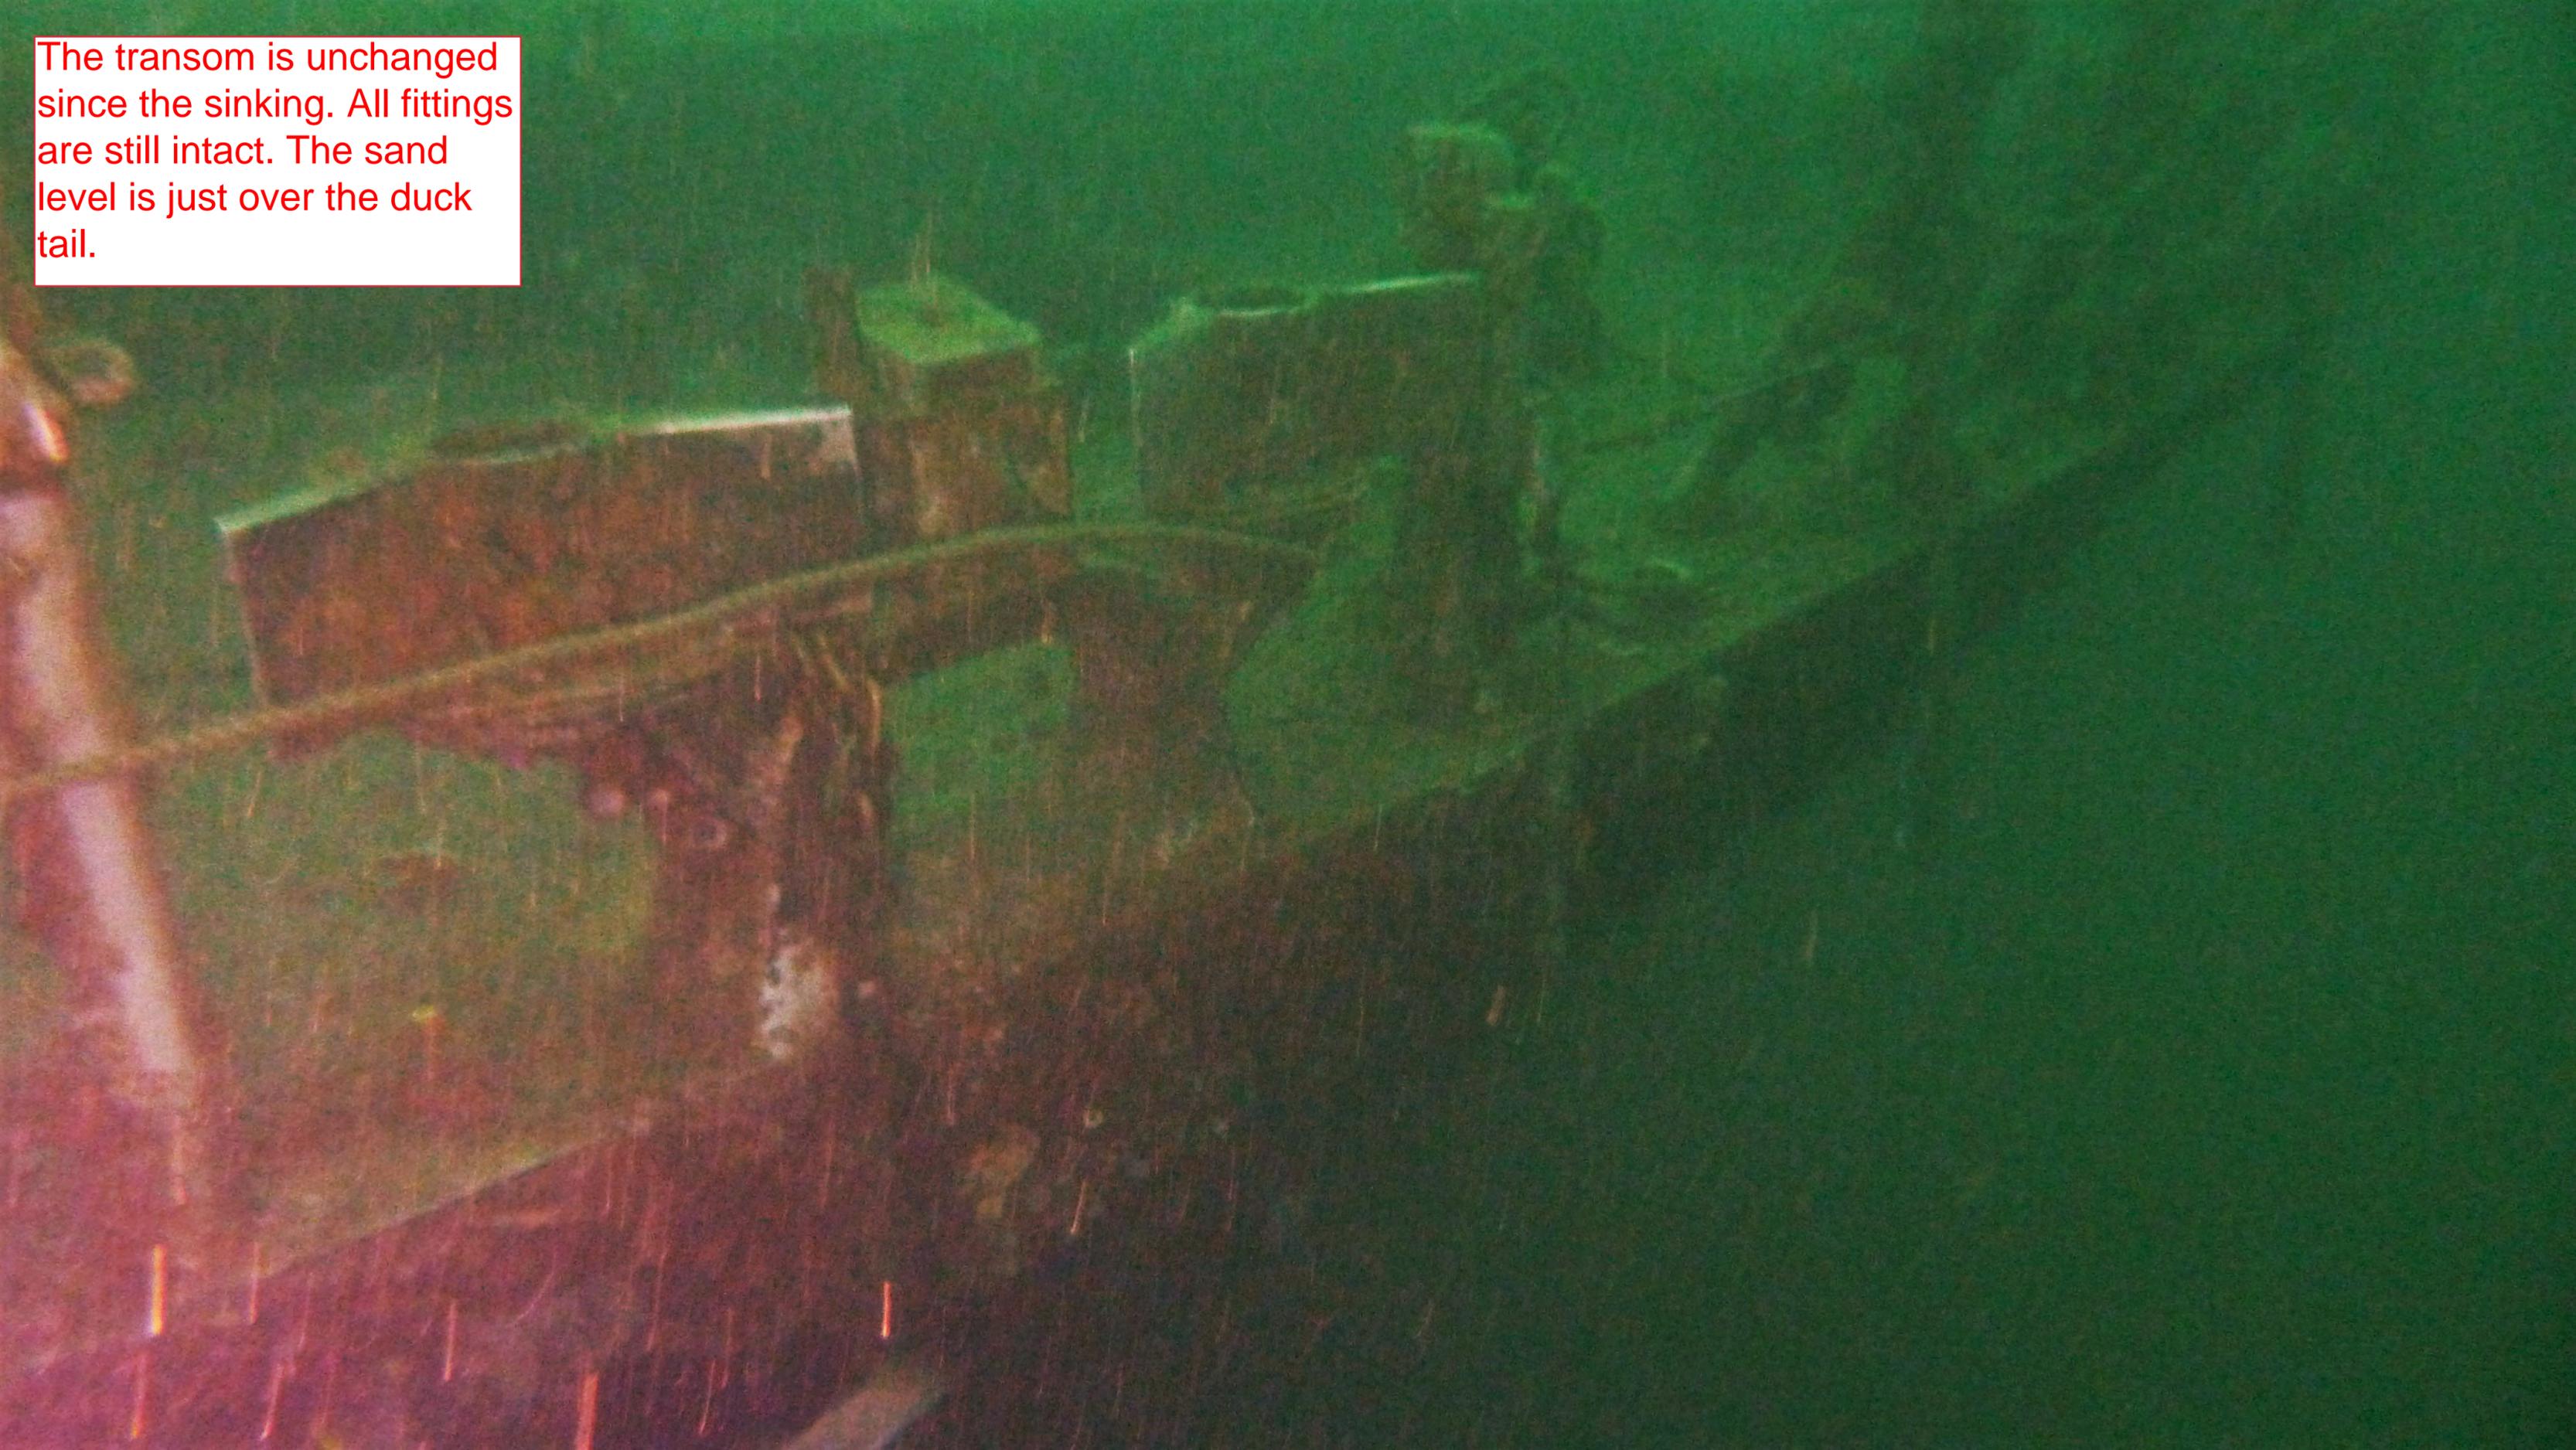
Port side gunwale on the main deck. There is no sign of deterioration on the main deck

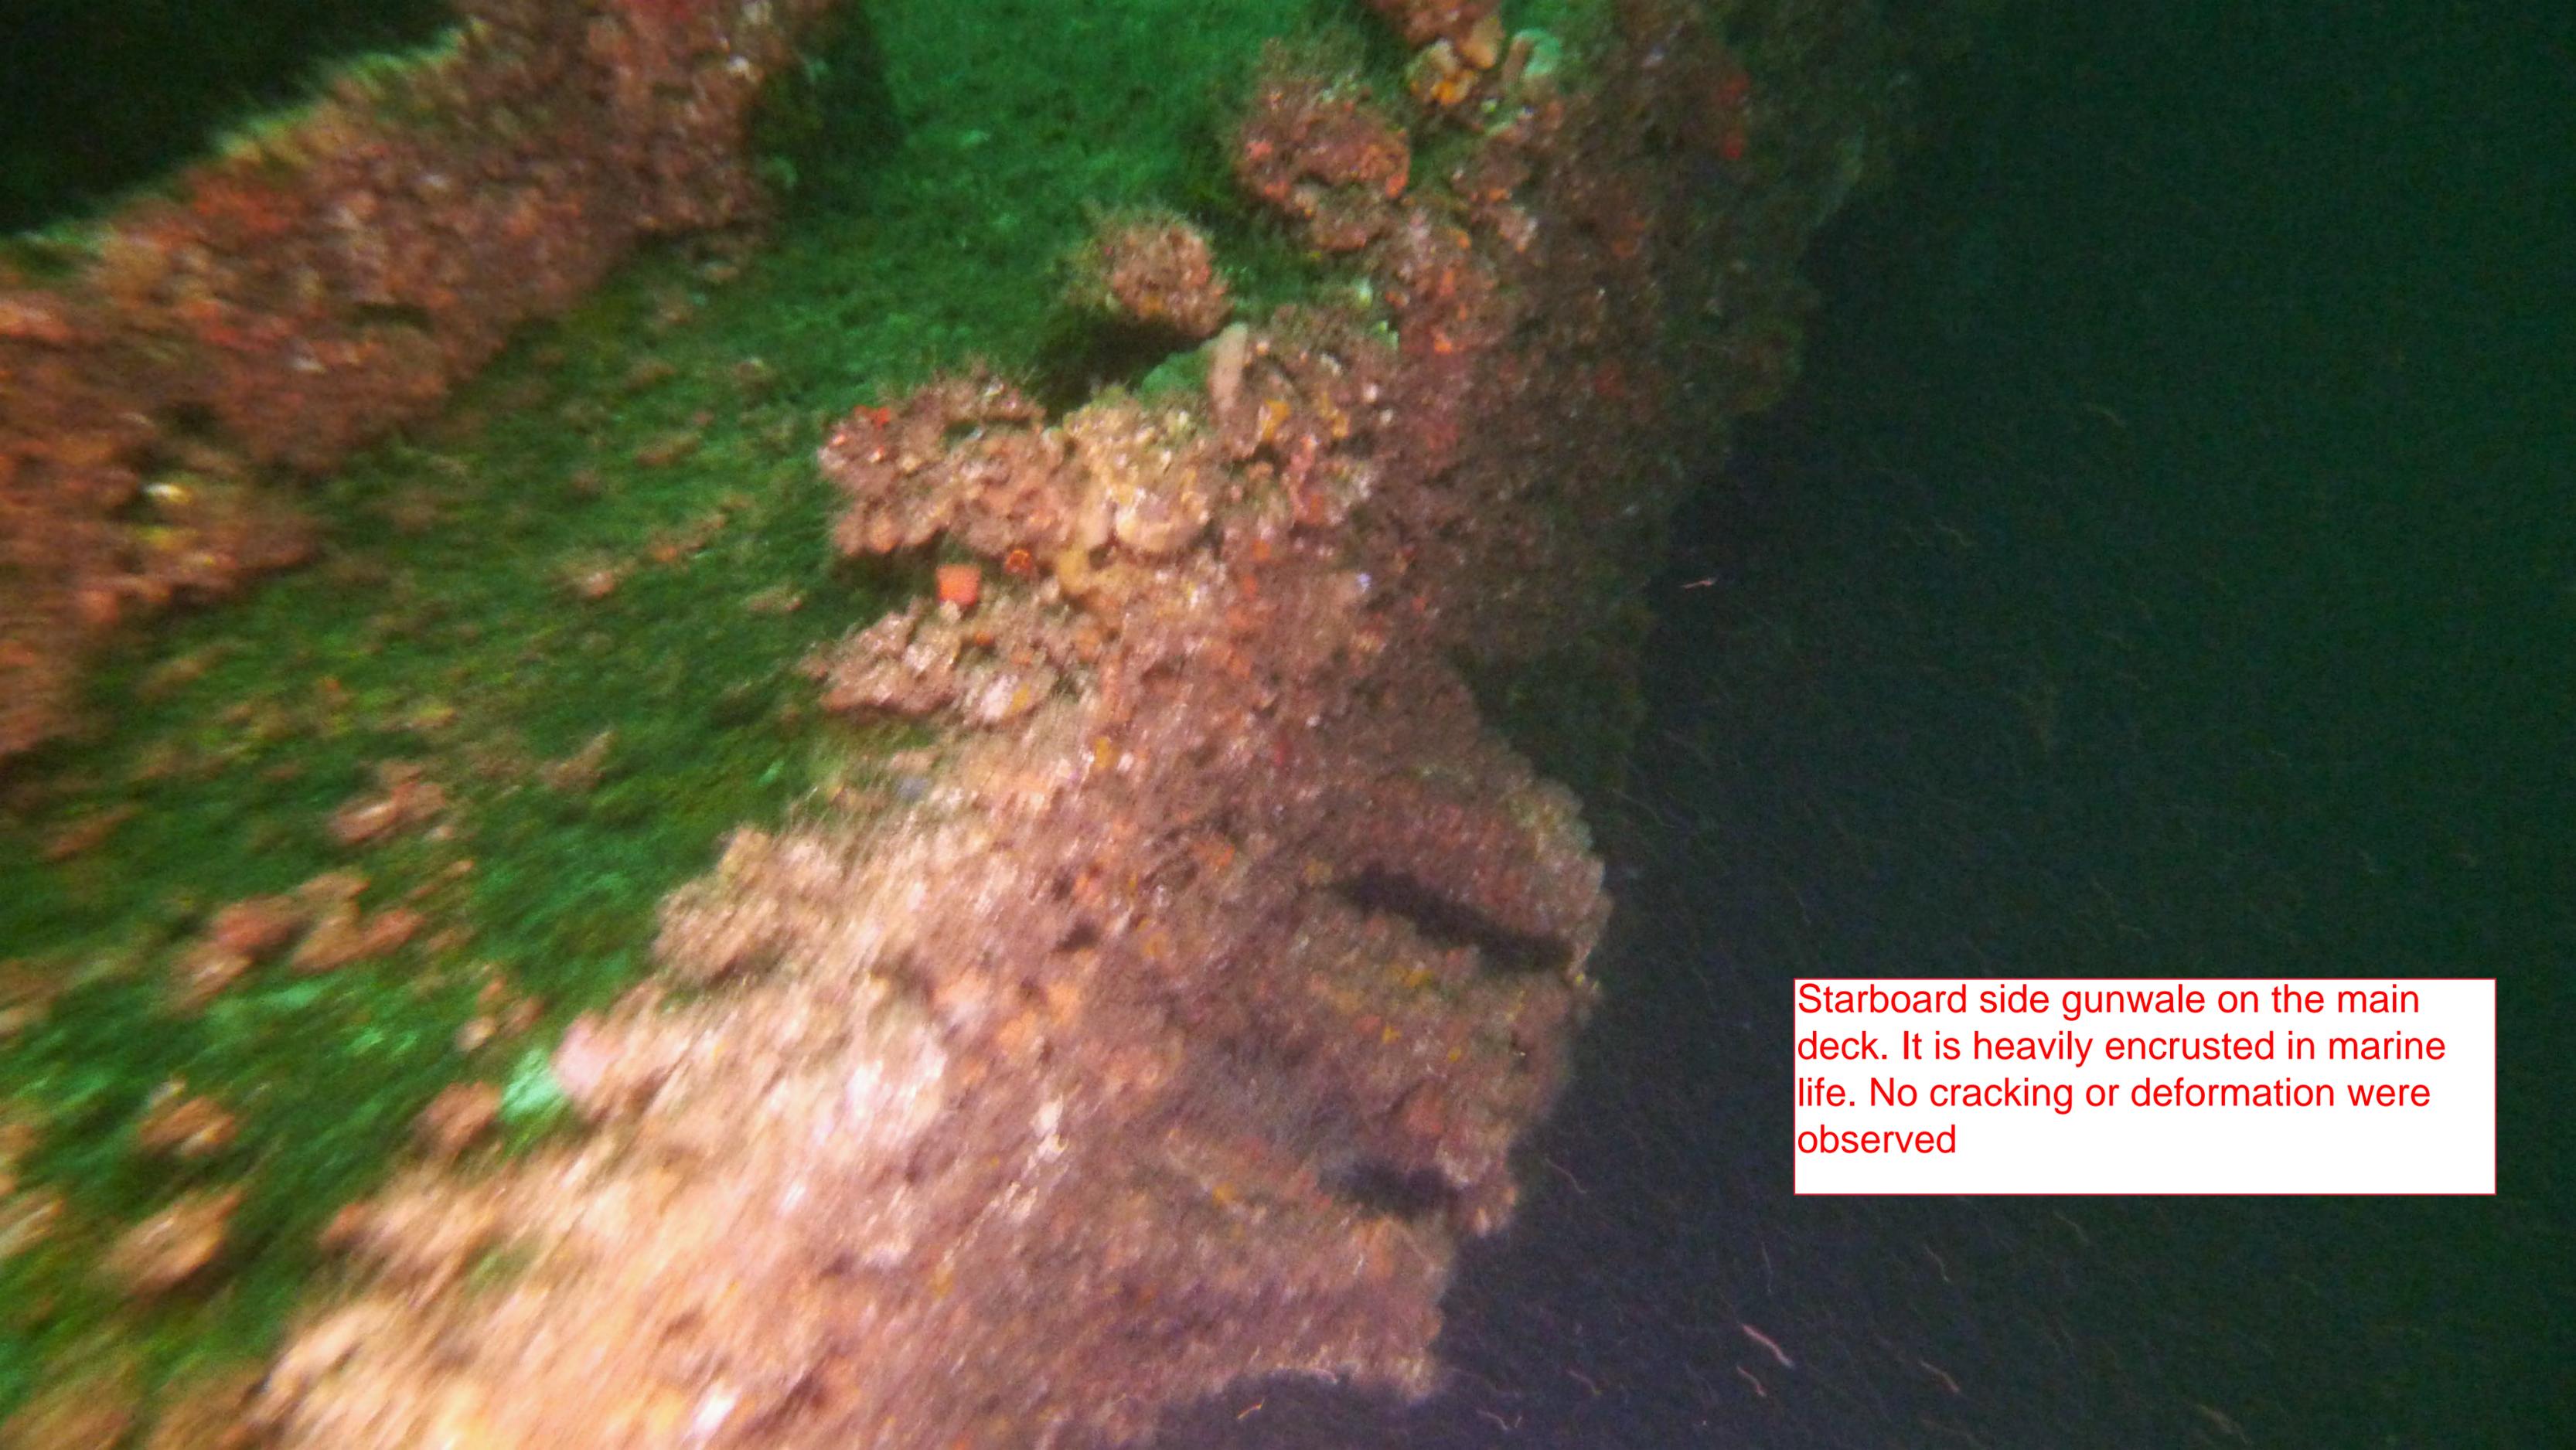
Starboard side gunwale on the main deck. It is heavily encrusted in marine life. No cracking or deformation were observed

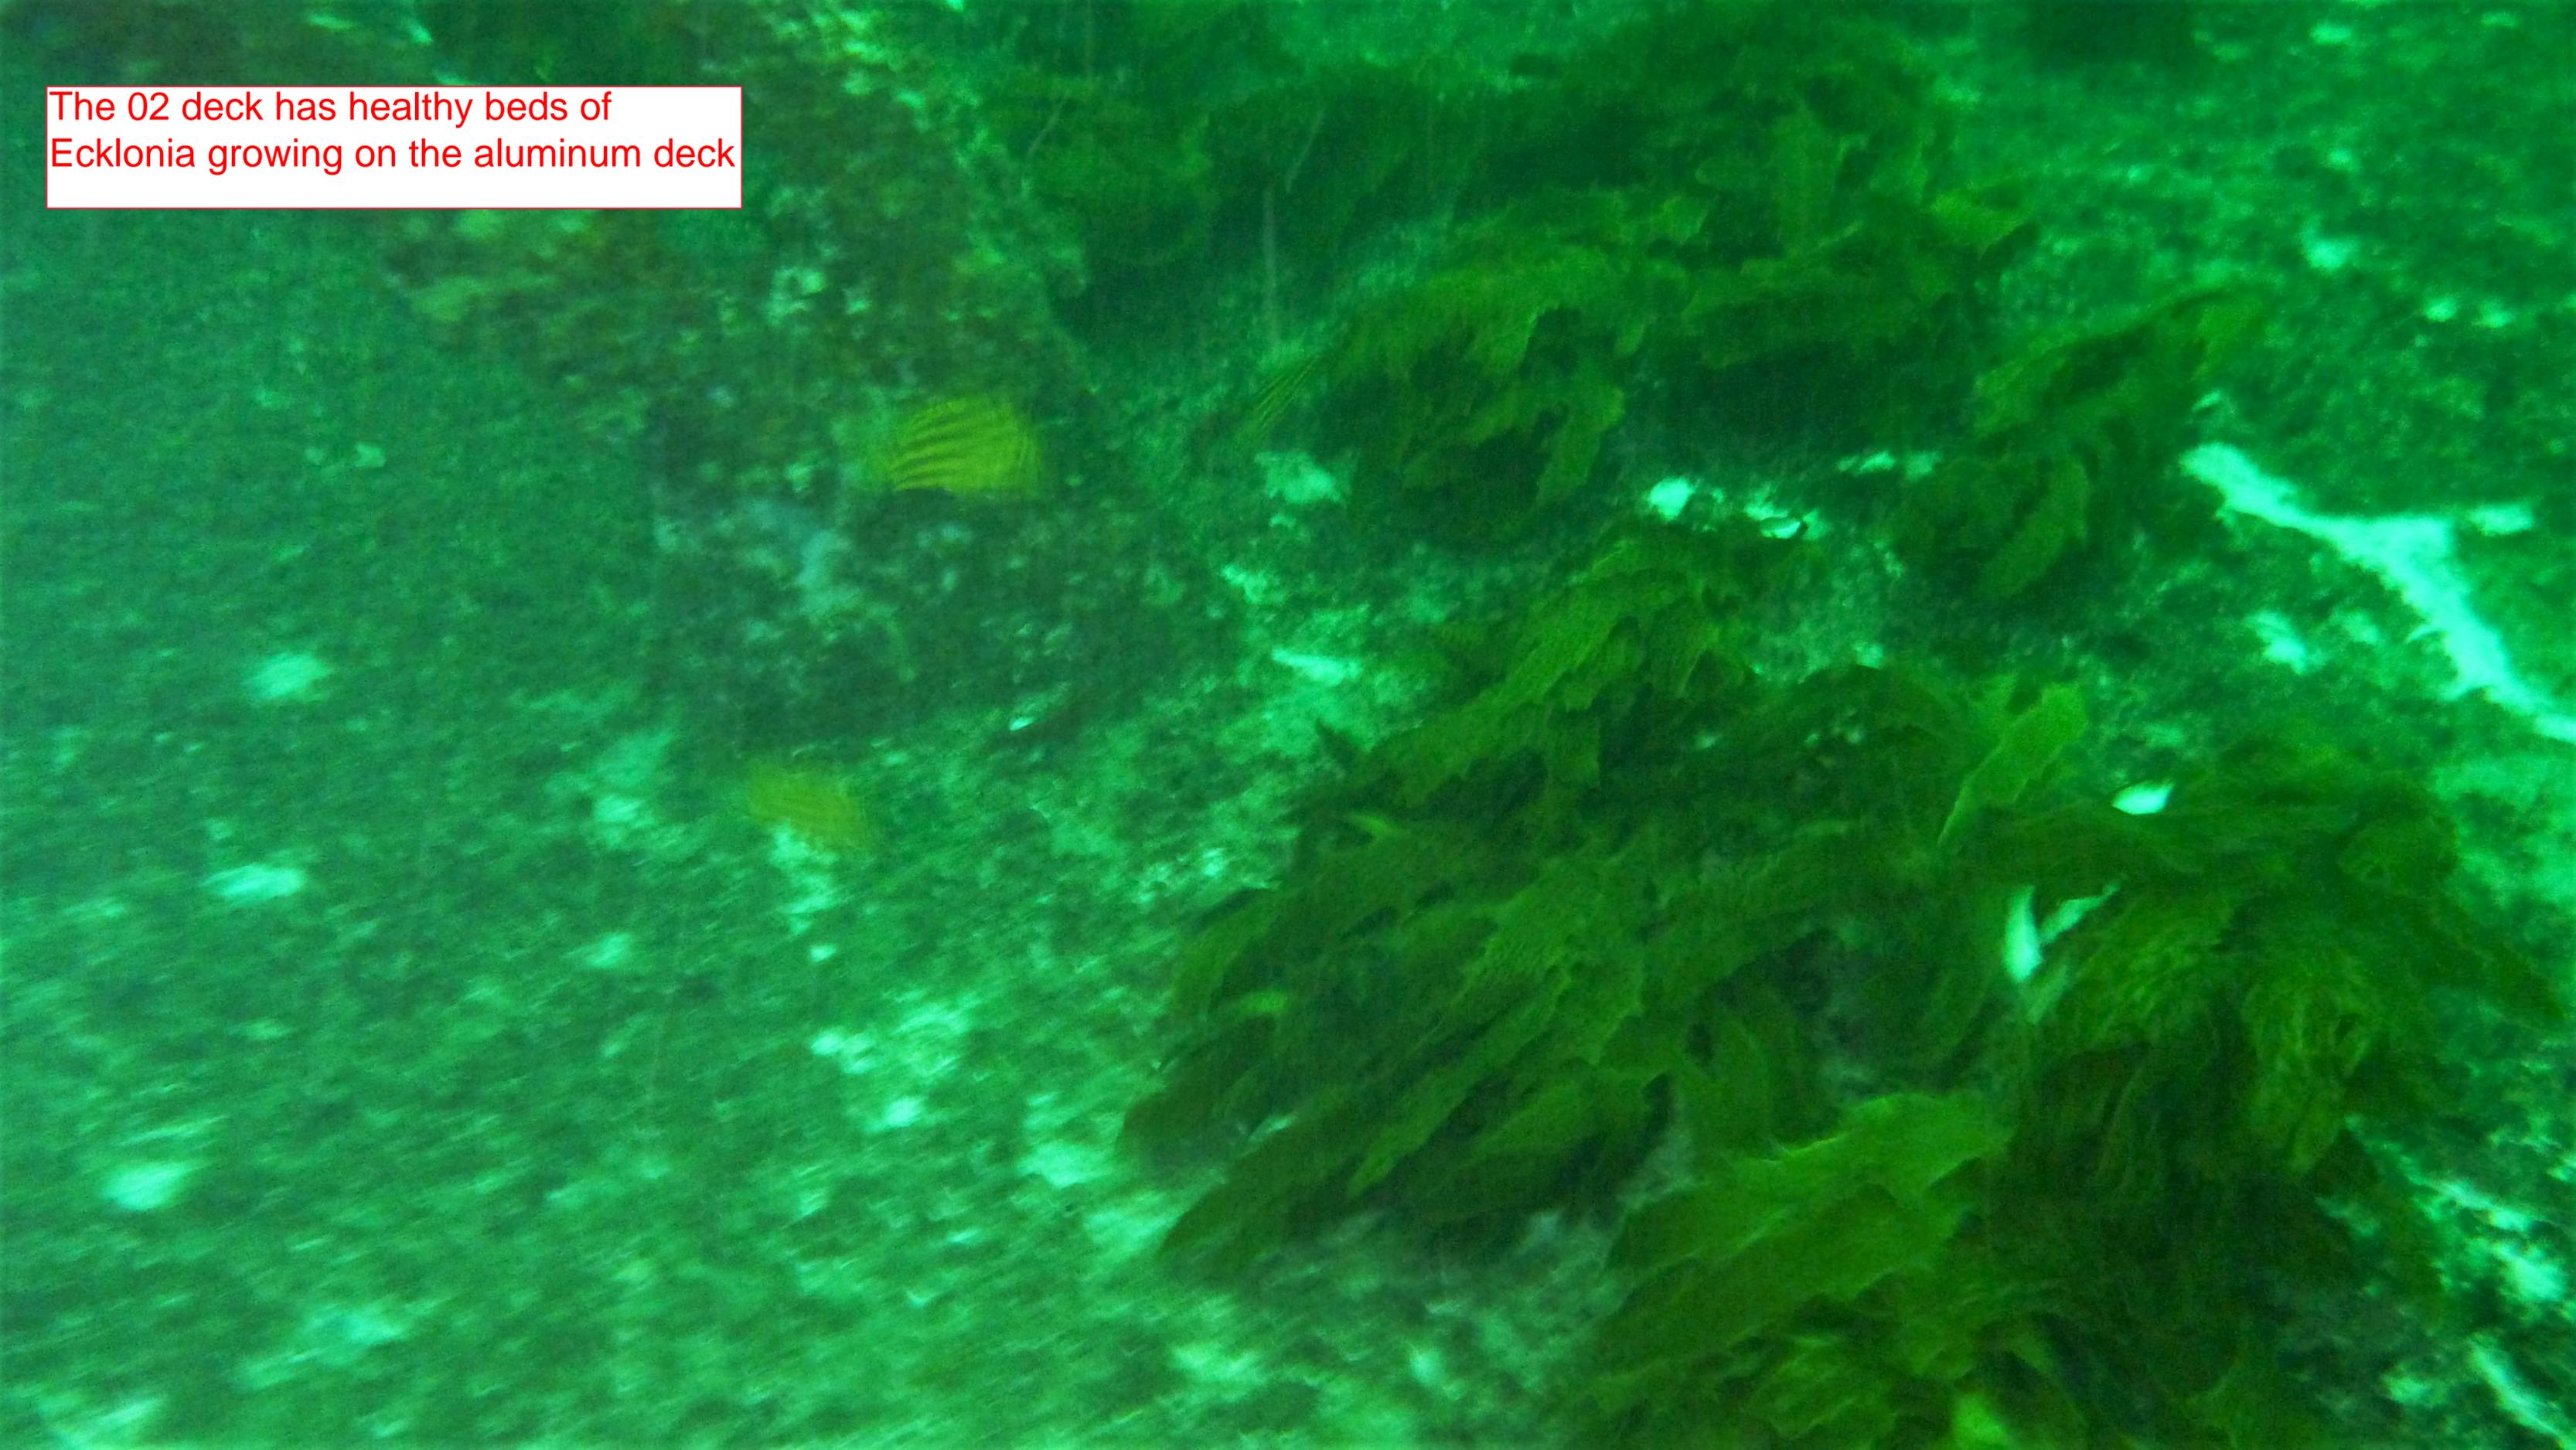
All parts of the masts are thickly covered in marine growth

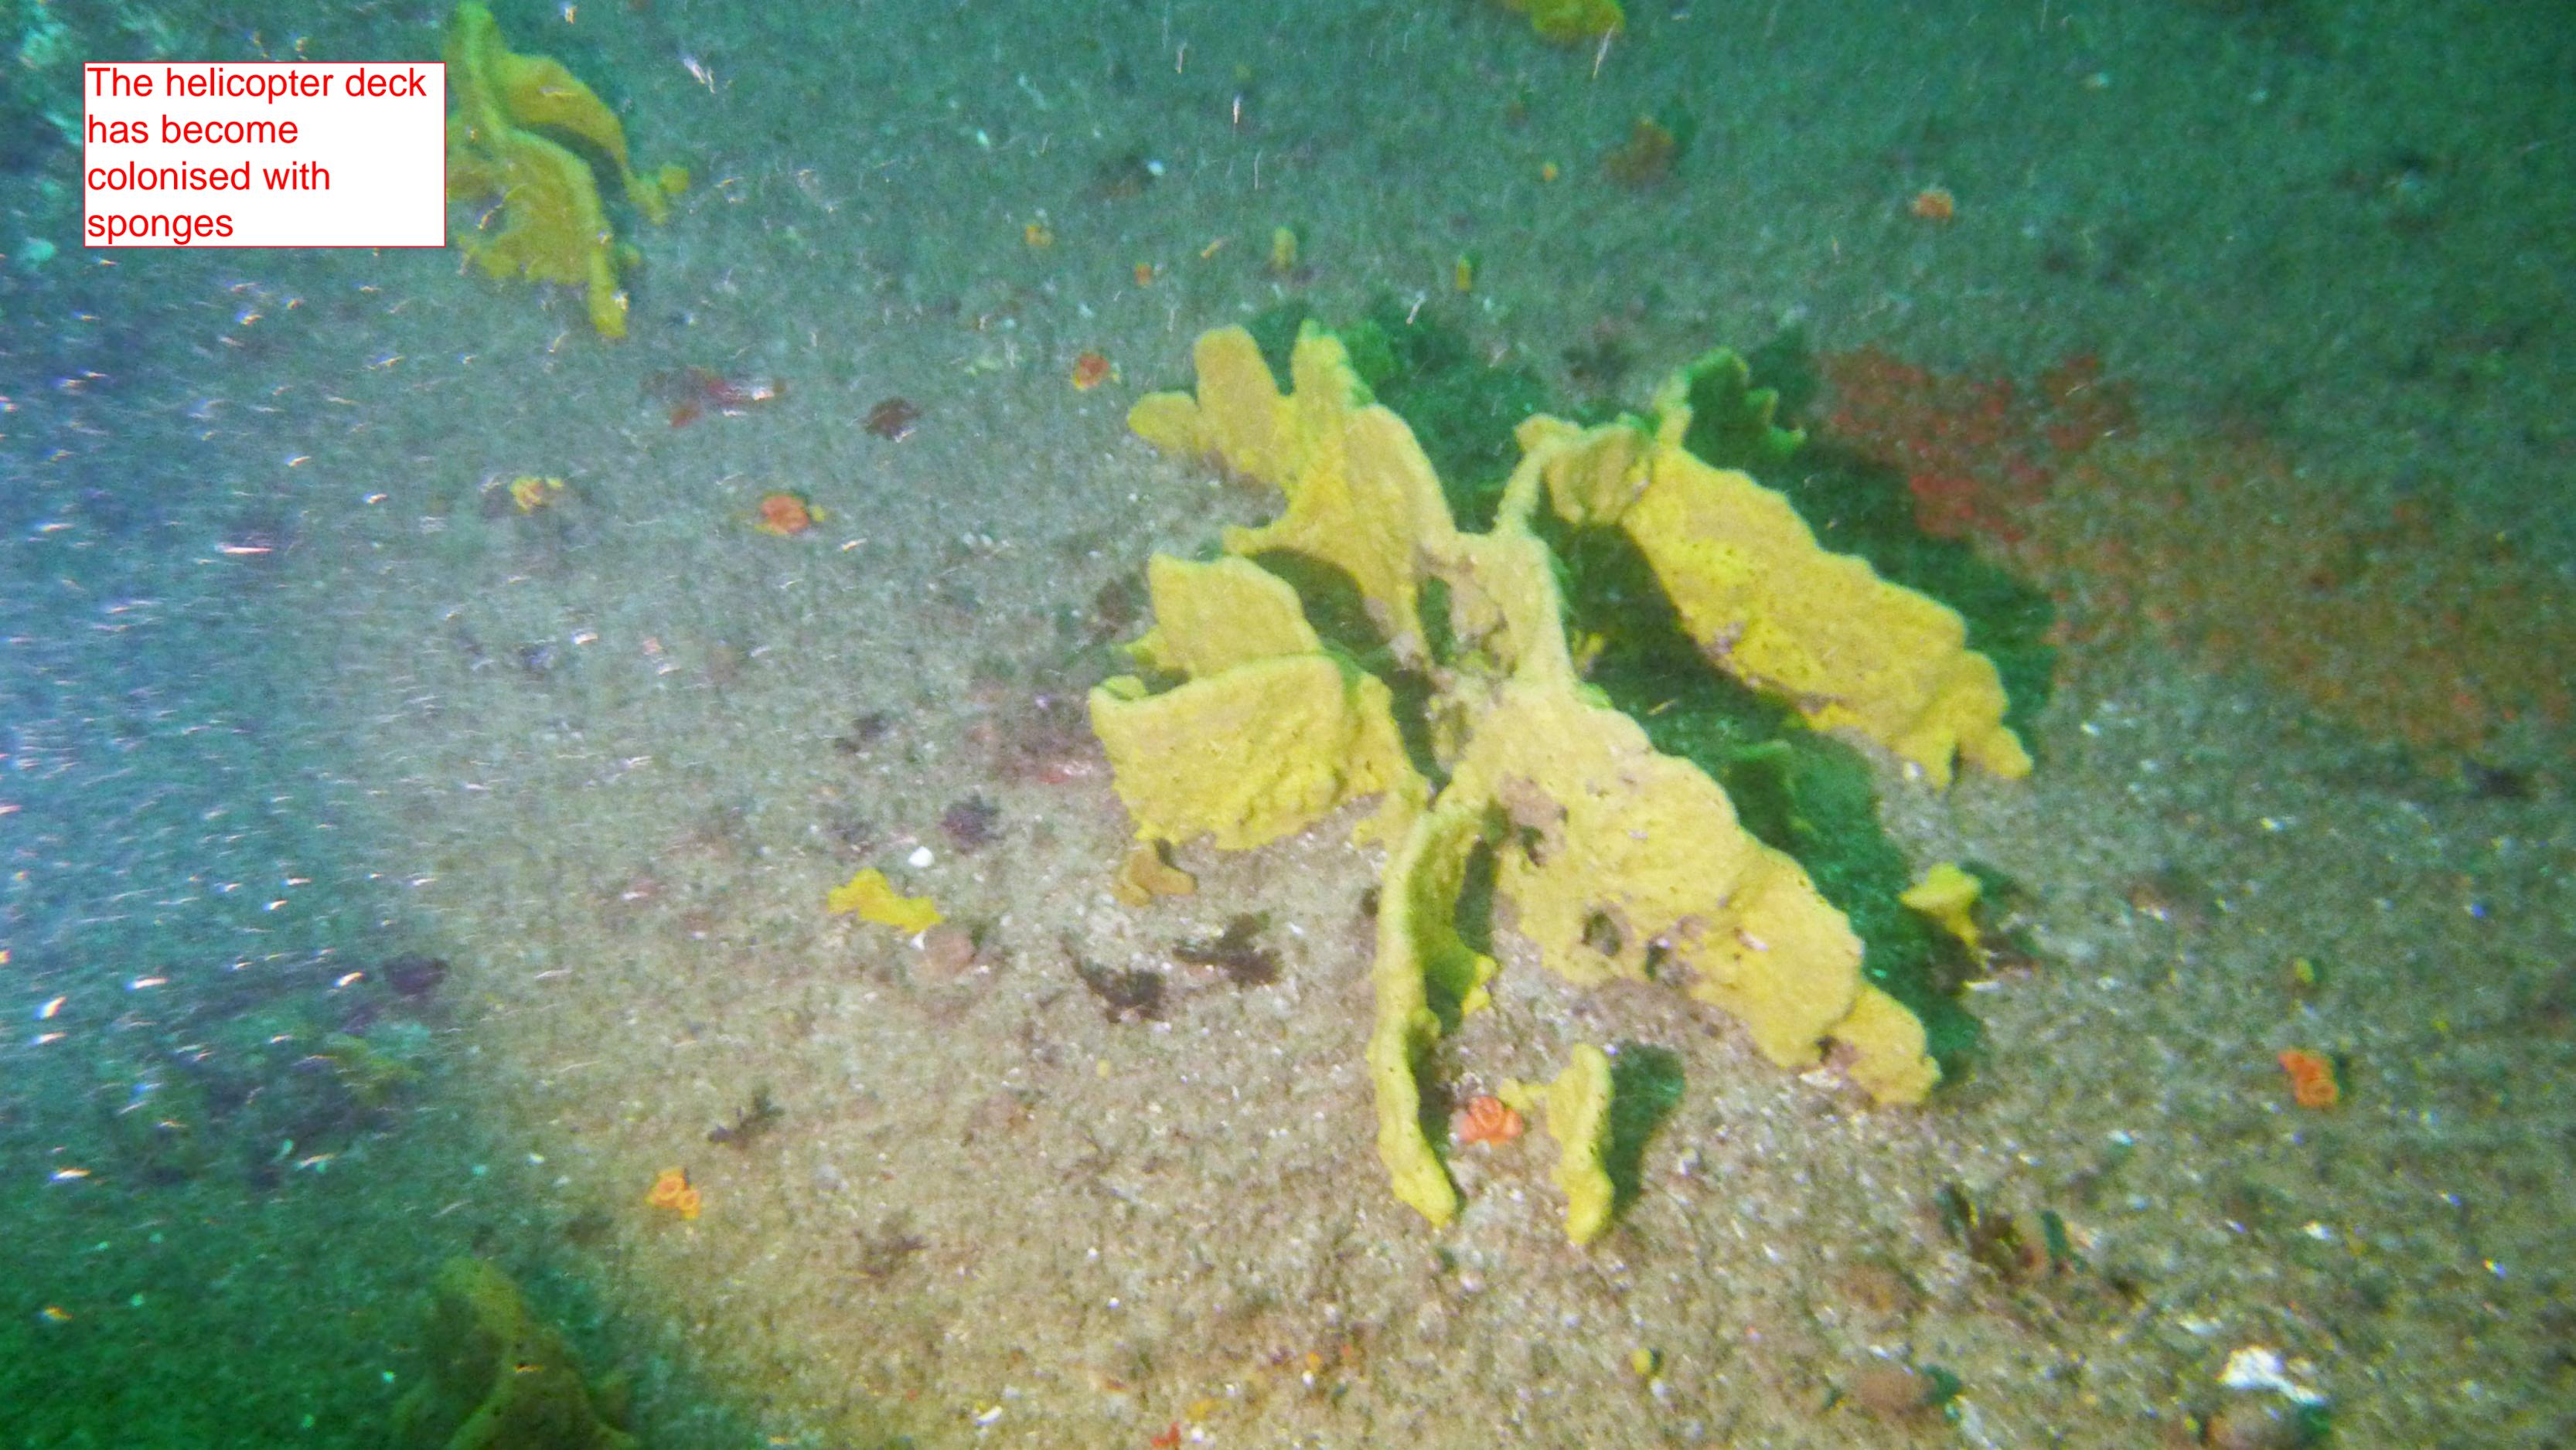
The sides of the hull are completely encrusted. There were no tell tale bare patches indicating active corrosion.
