McLennans Diving Service

To Guy Russell,
Department of Lands

Ex-HMAS Adelaide Starboard Hangar Wall Report

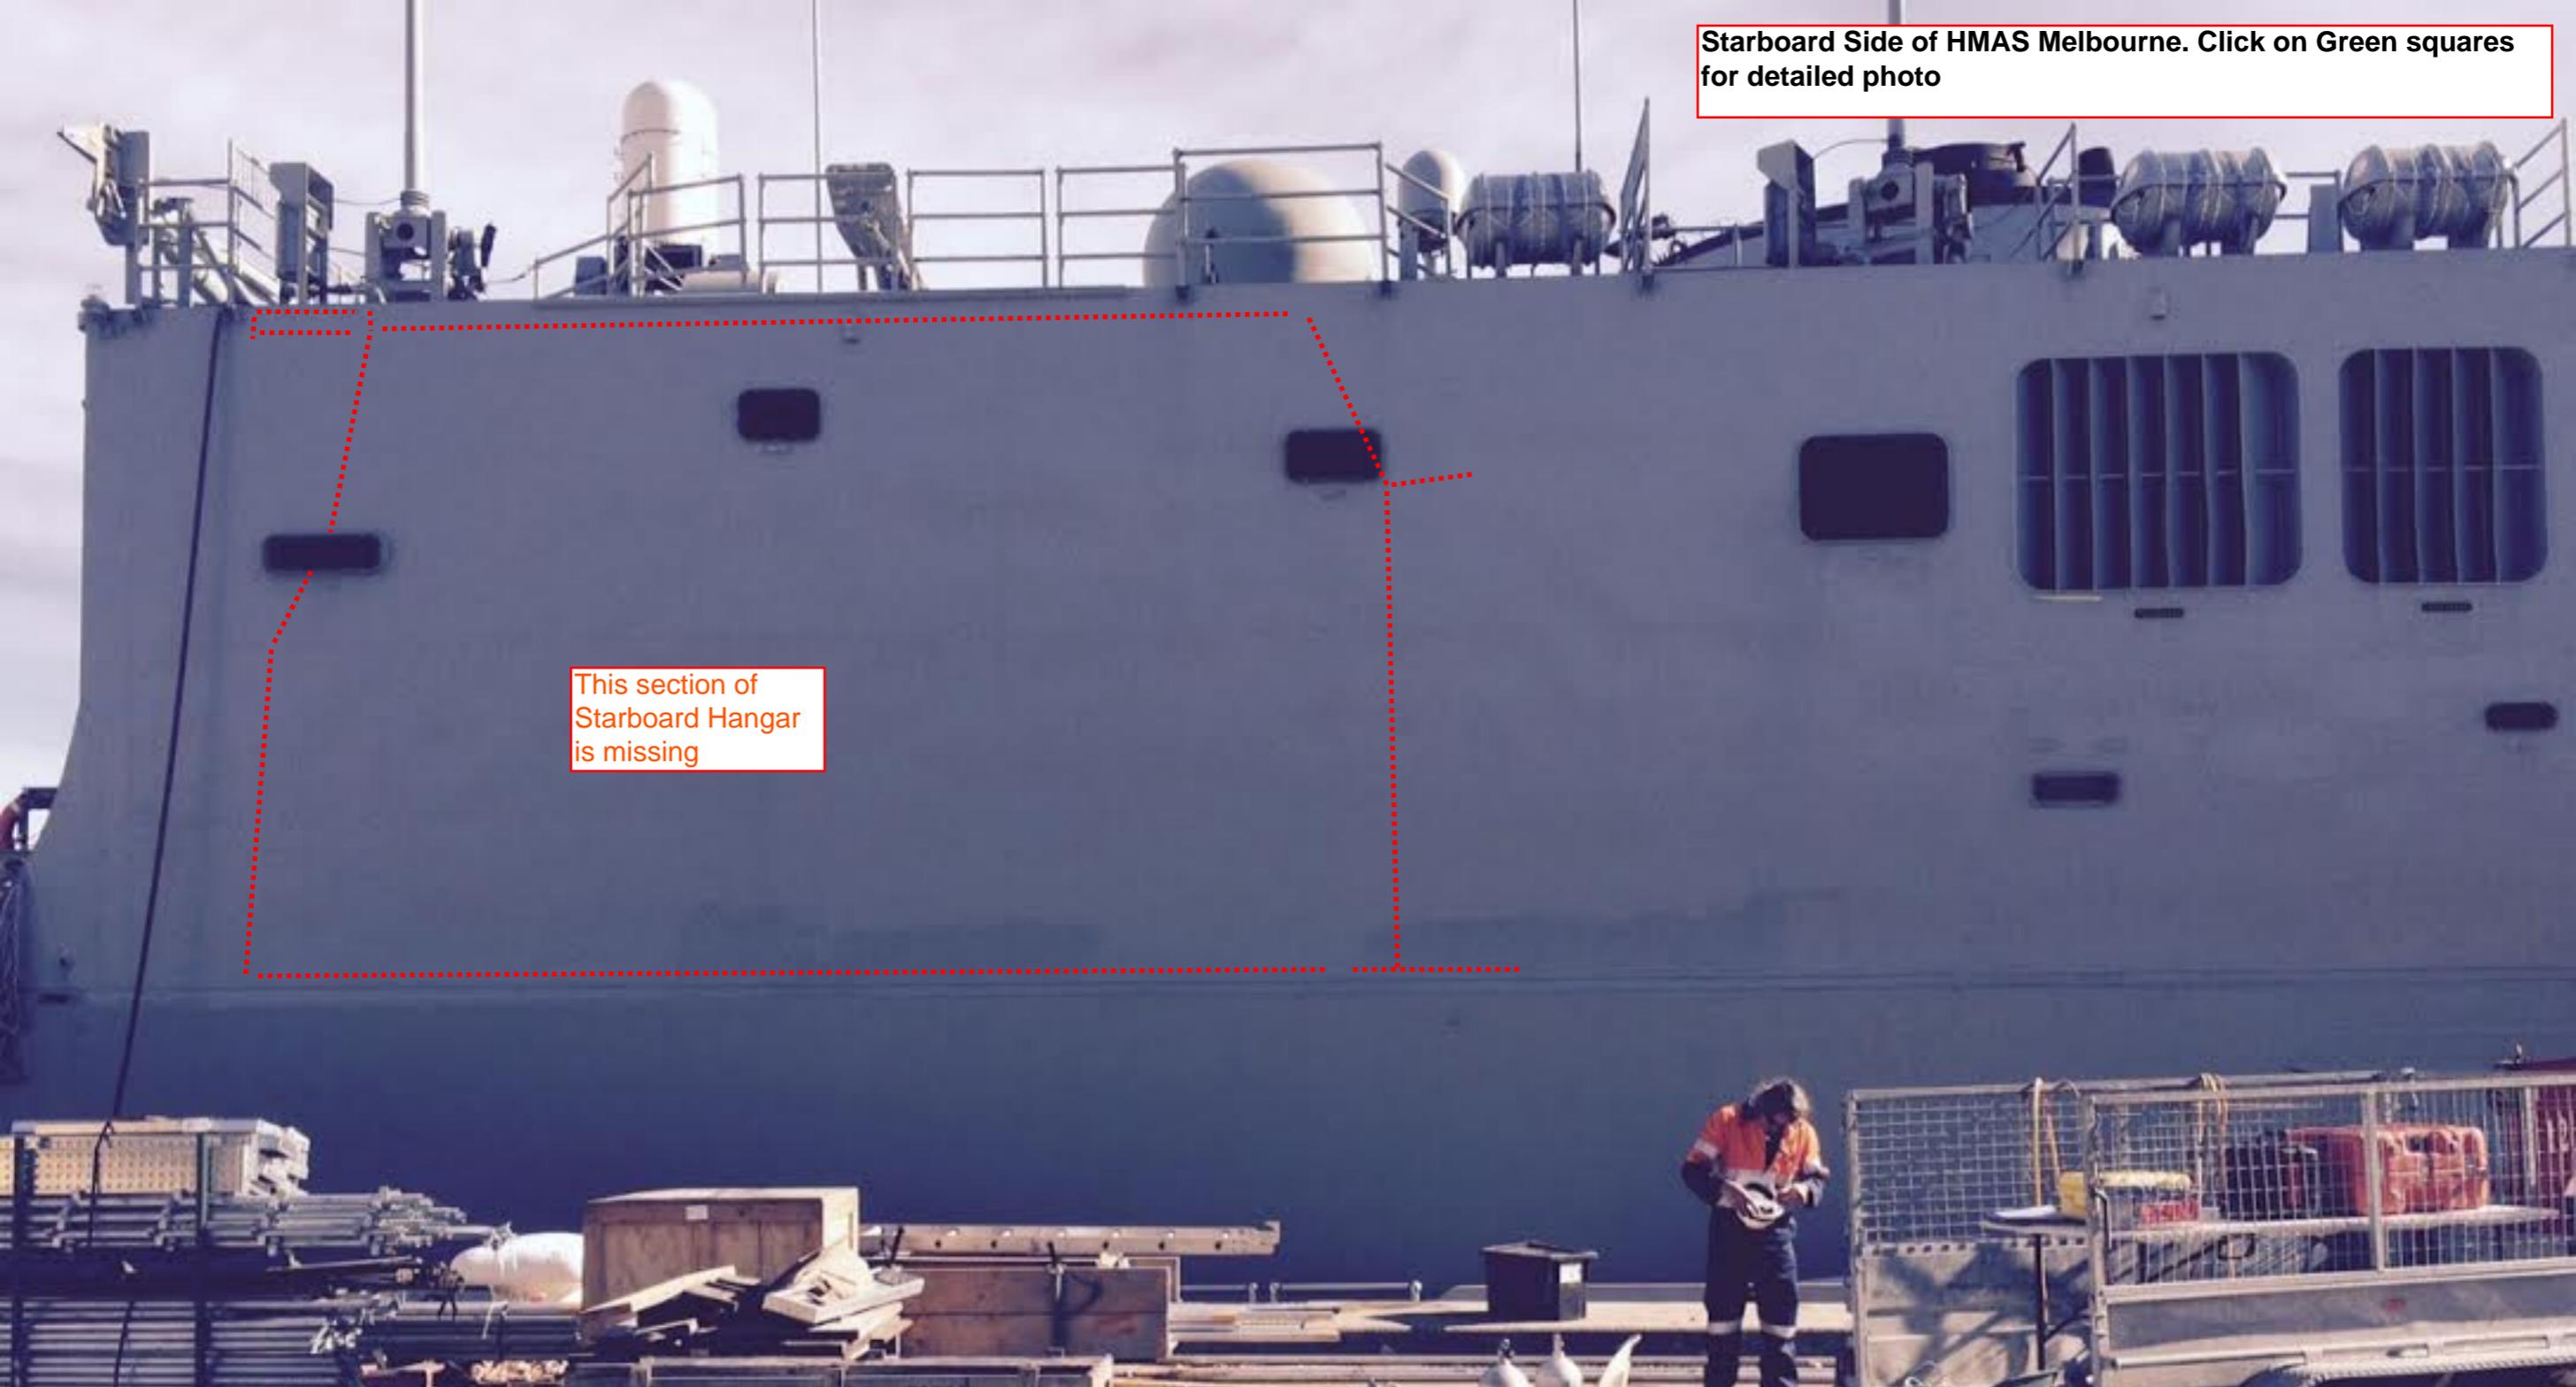
Starboard Side of HMAS Melbourne. Click on Green squares for detailed photo

This section of Starboard Hangar is missing

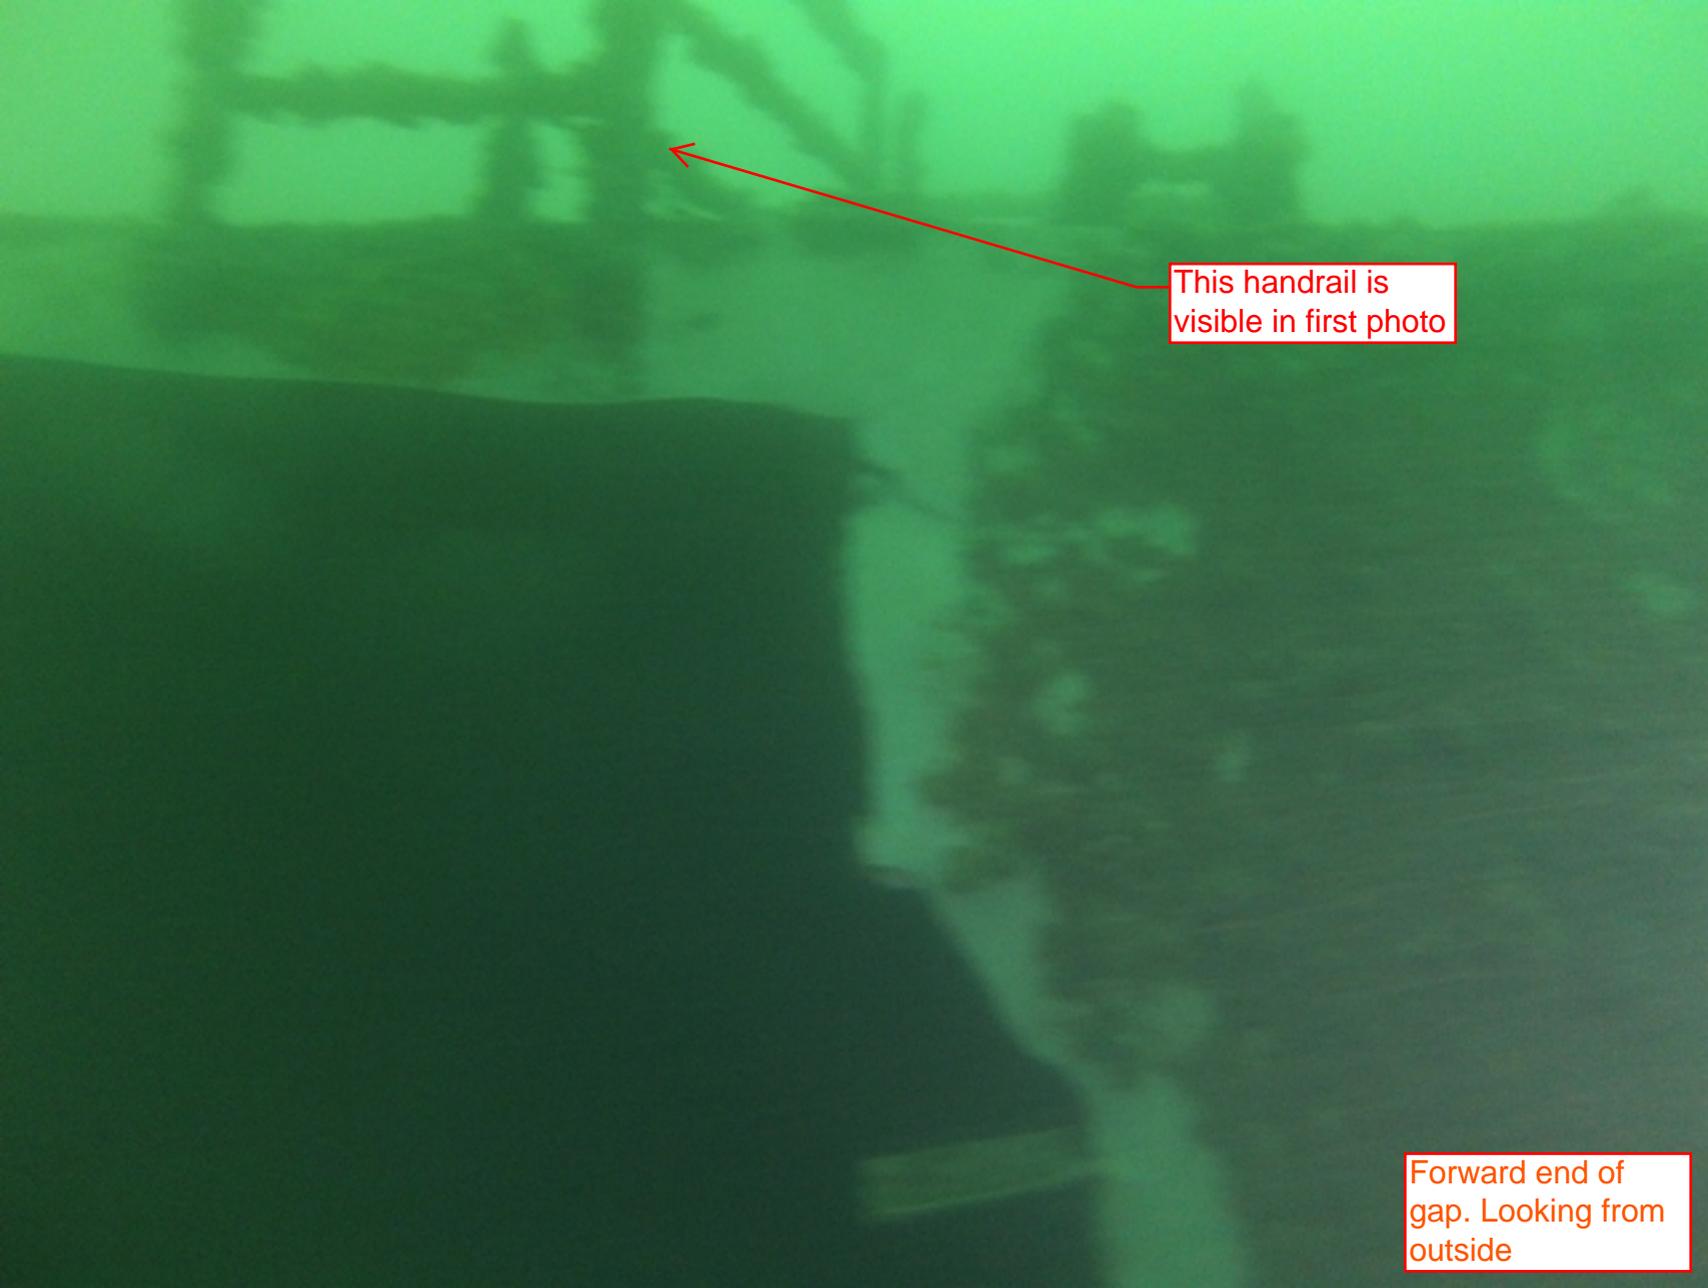
This handrail is visible in first photo

Forward end of gap. Looking from outside

Remains of AC
intake

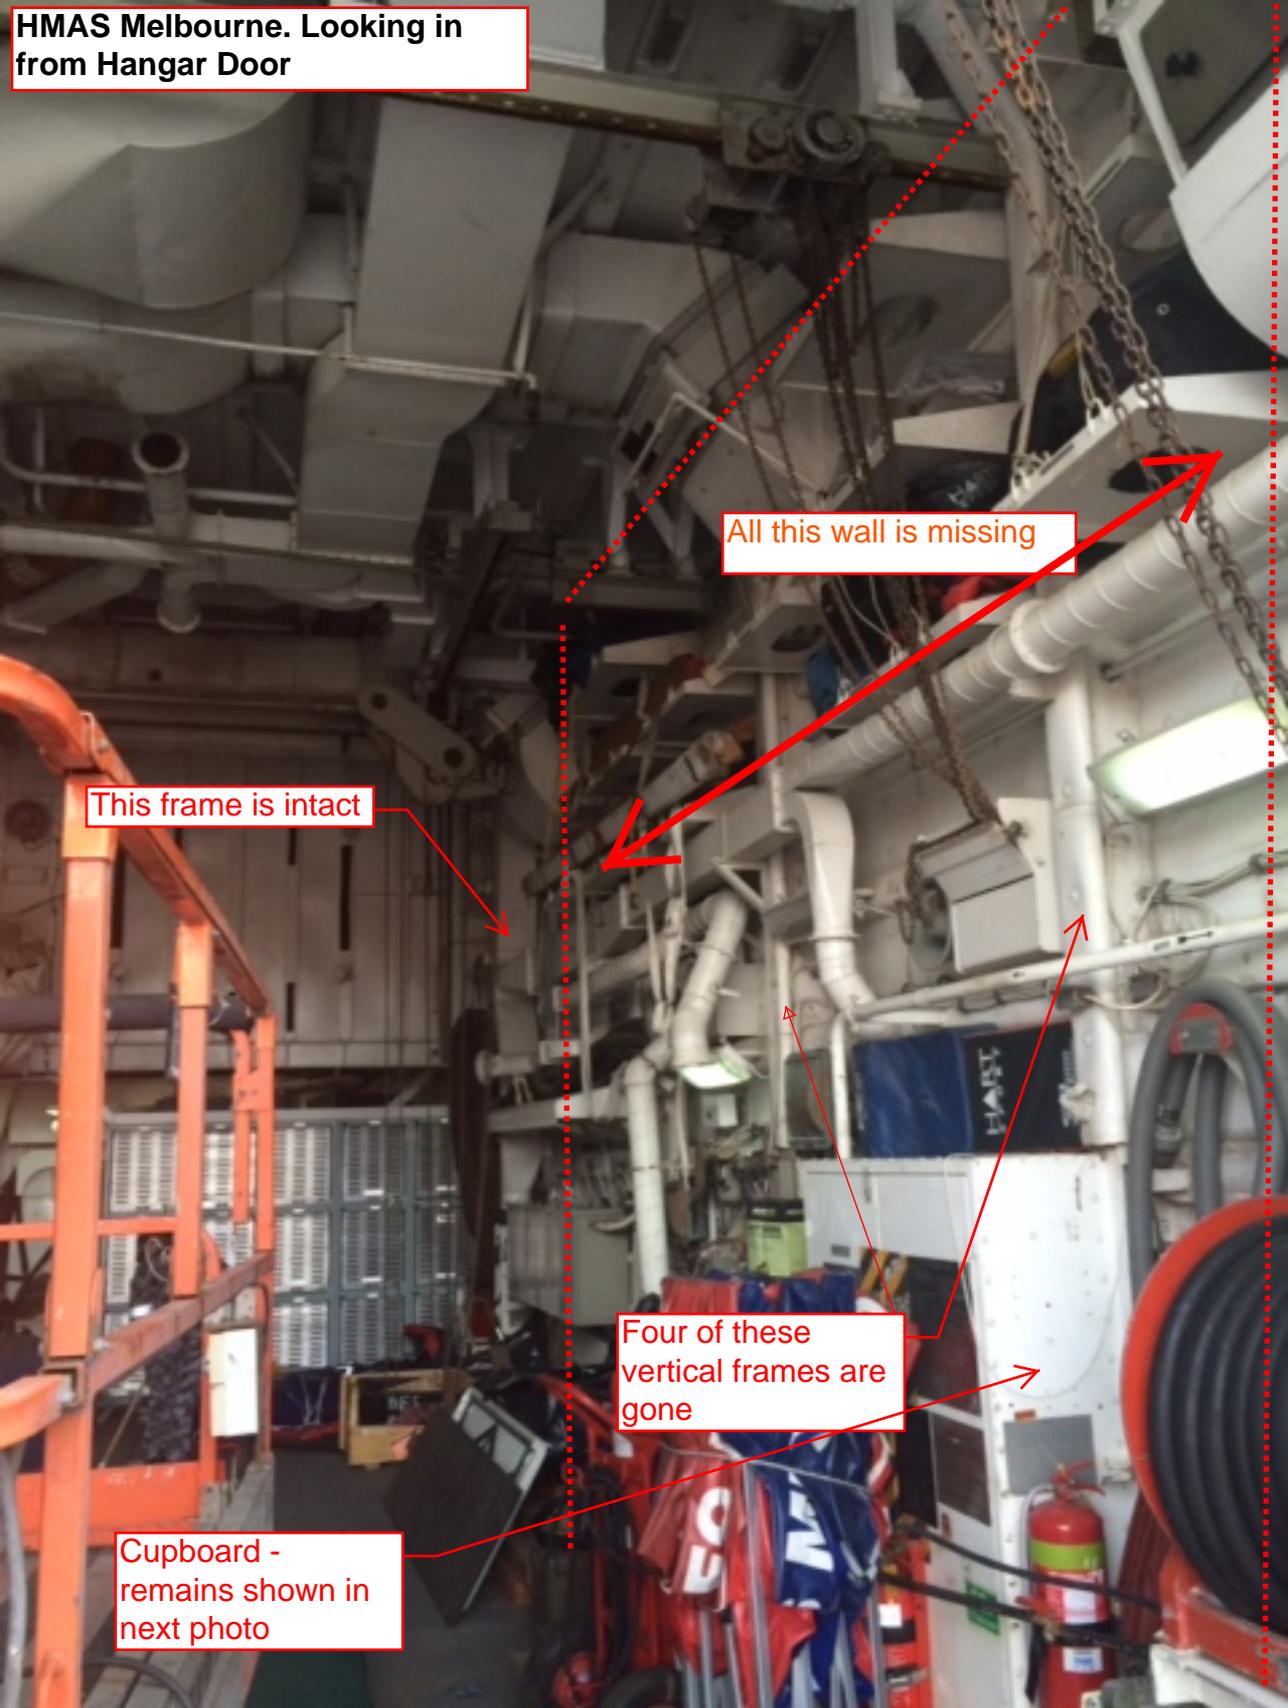
HMAS Melbourne. Looking in from Hangar Door

This frame is intact

All this wall is missing

Four of these vertical frames are gone

Cupboard - remains shown in next photo

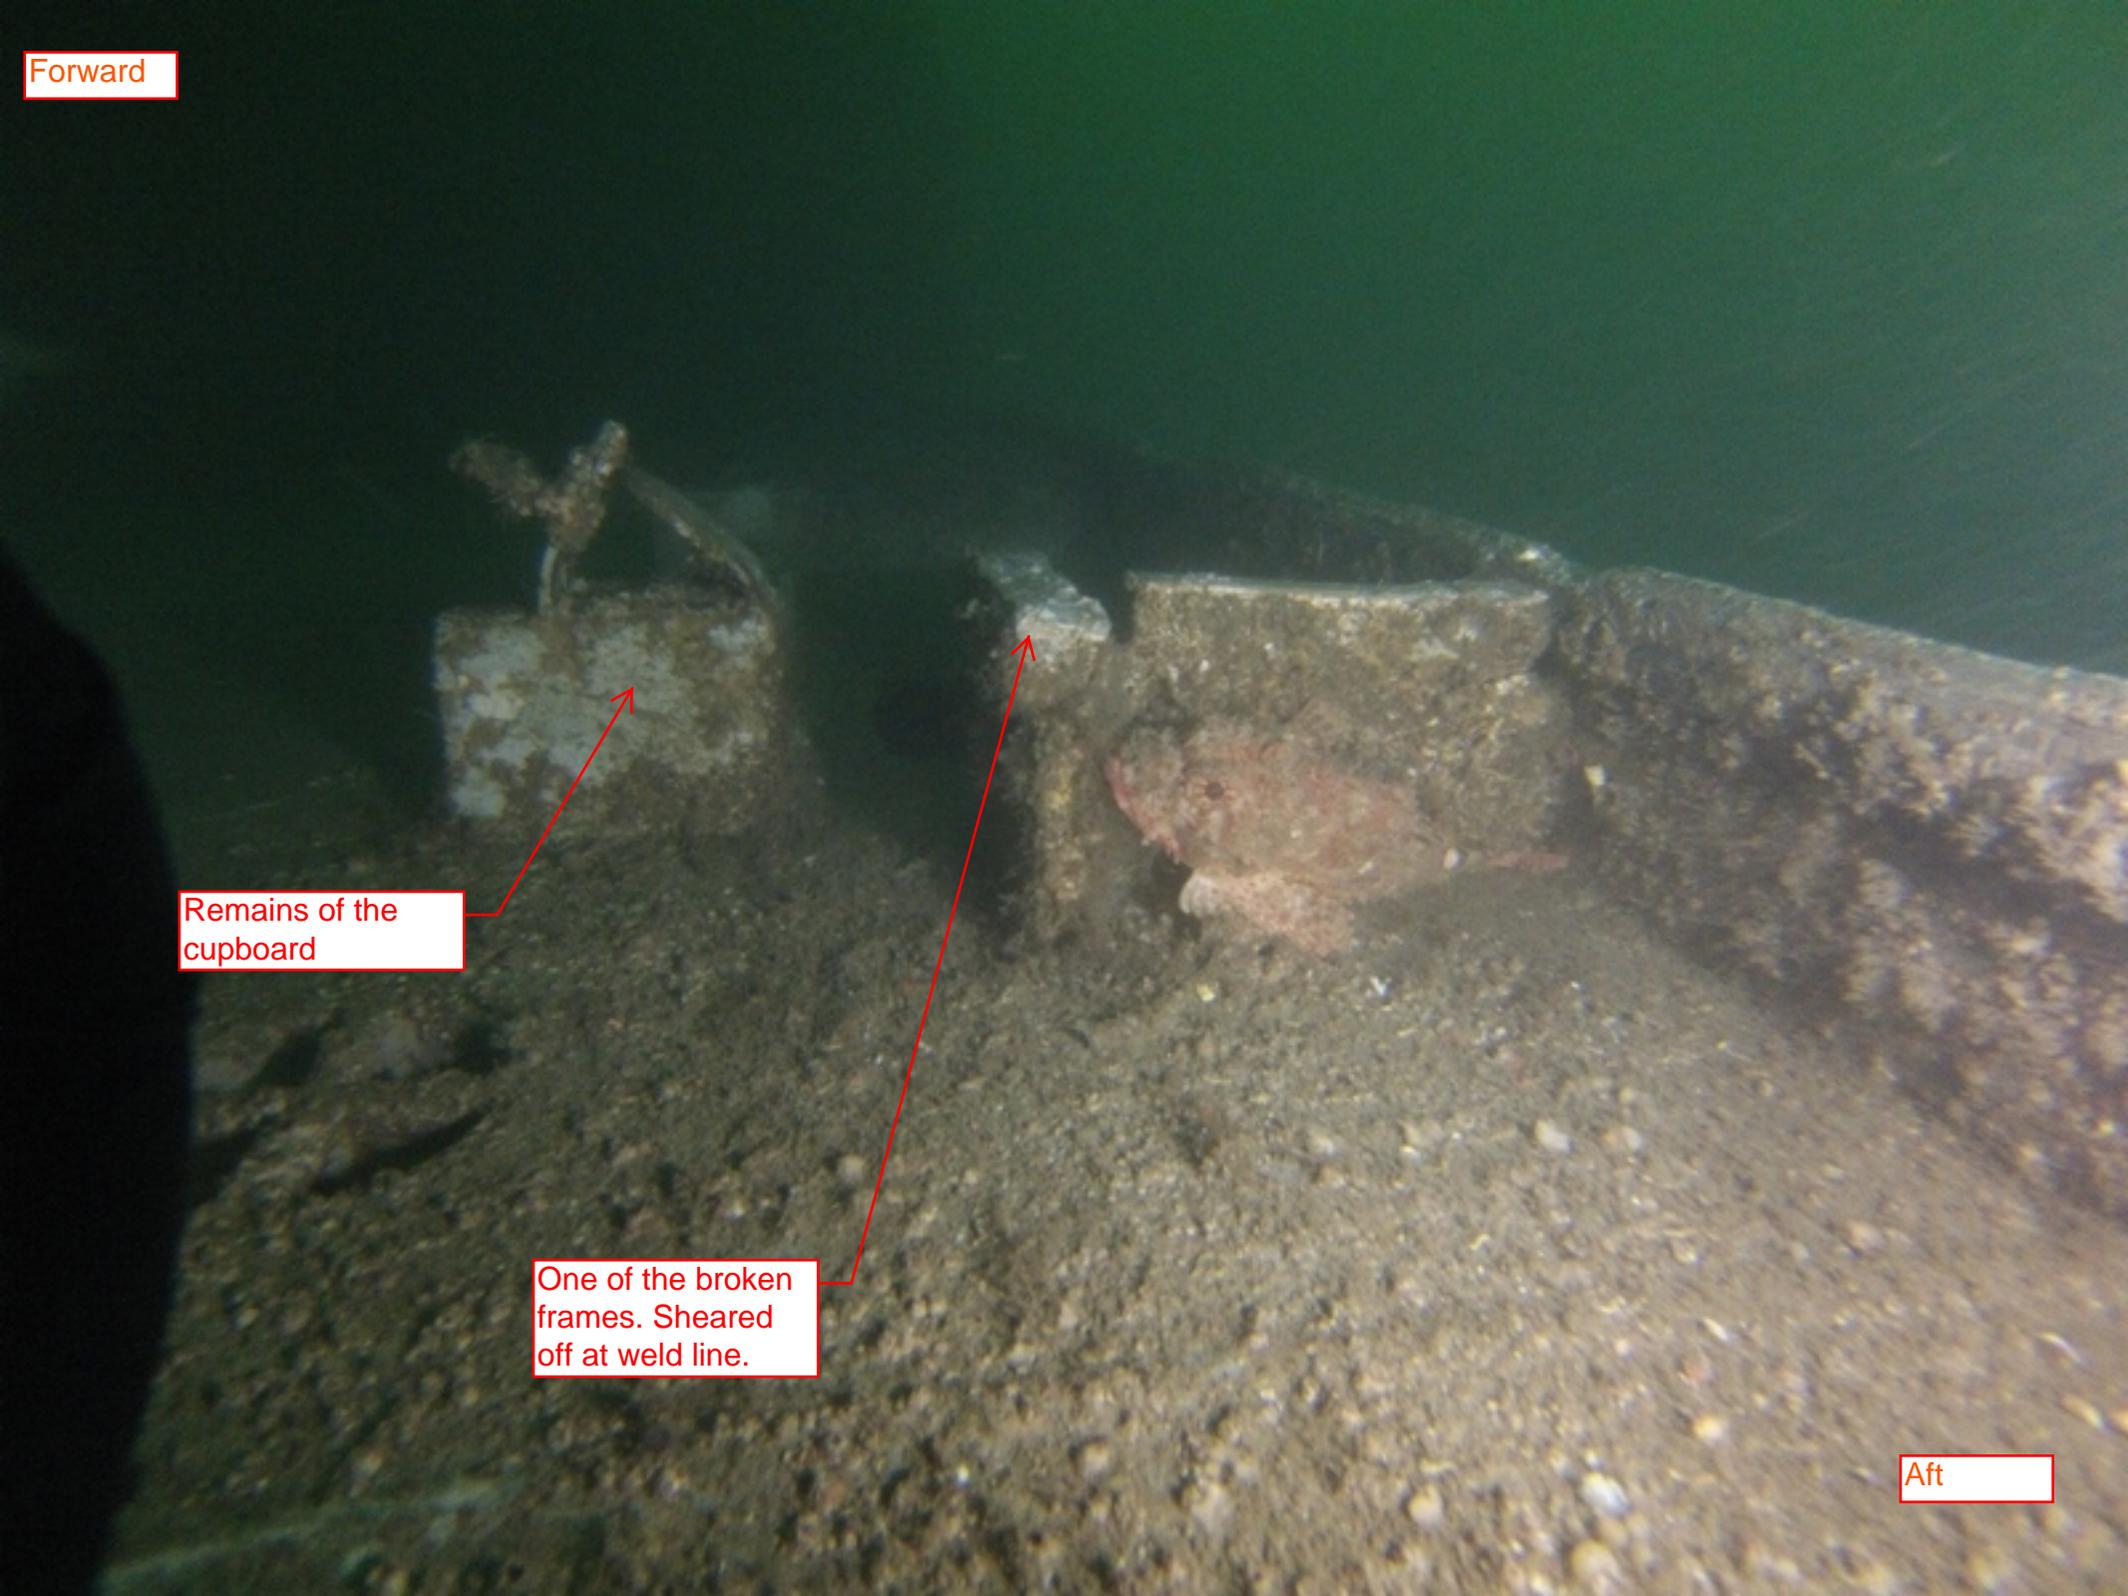
Remains of the
cupboard

One of the broken
frames. Sheared
off at weld line.

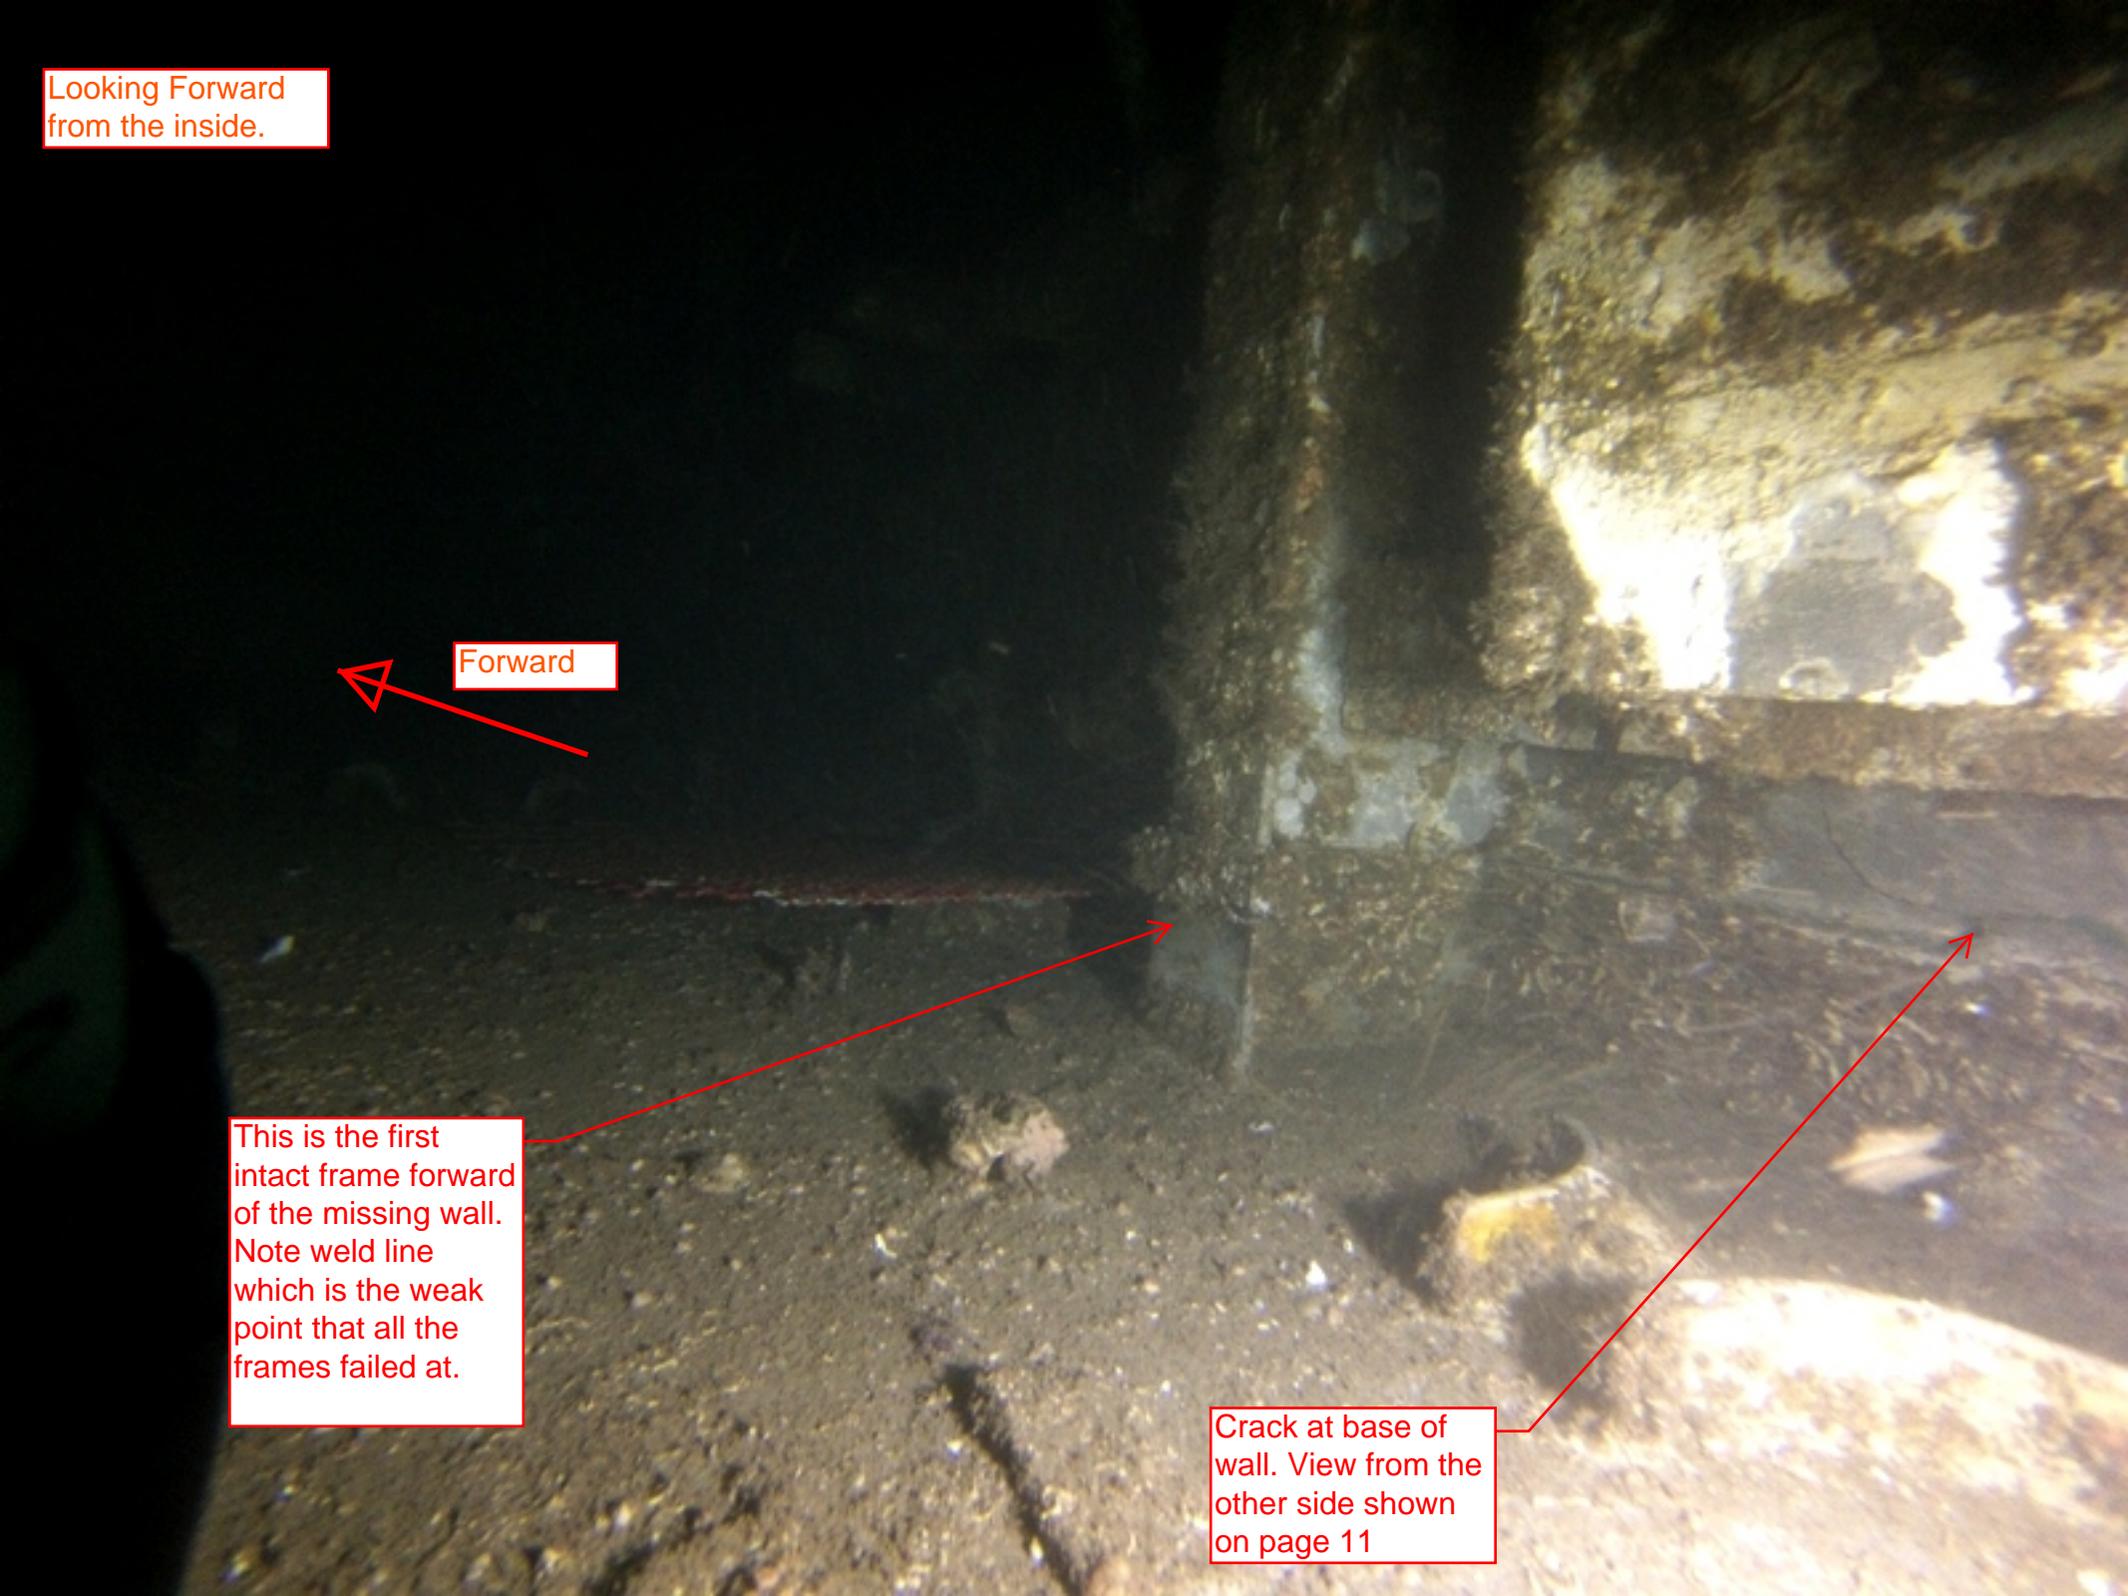
Looking Forward
from the inside.

This is the first
intact frame forward
of the missing wall.
Note weld line
which is the weak
point that all the
frames failed at.

Crack at base of
wall. View from the
other side shown
on page 11

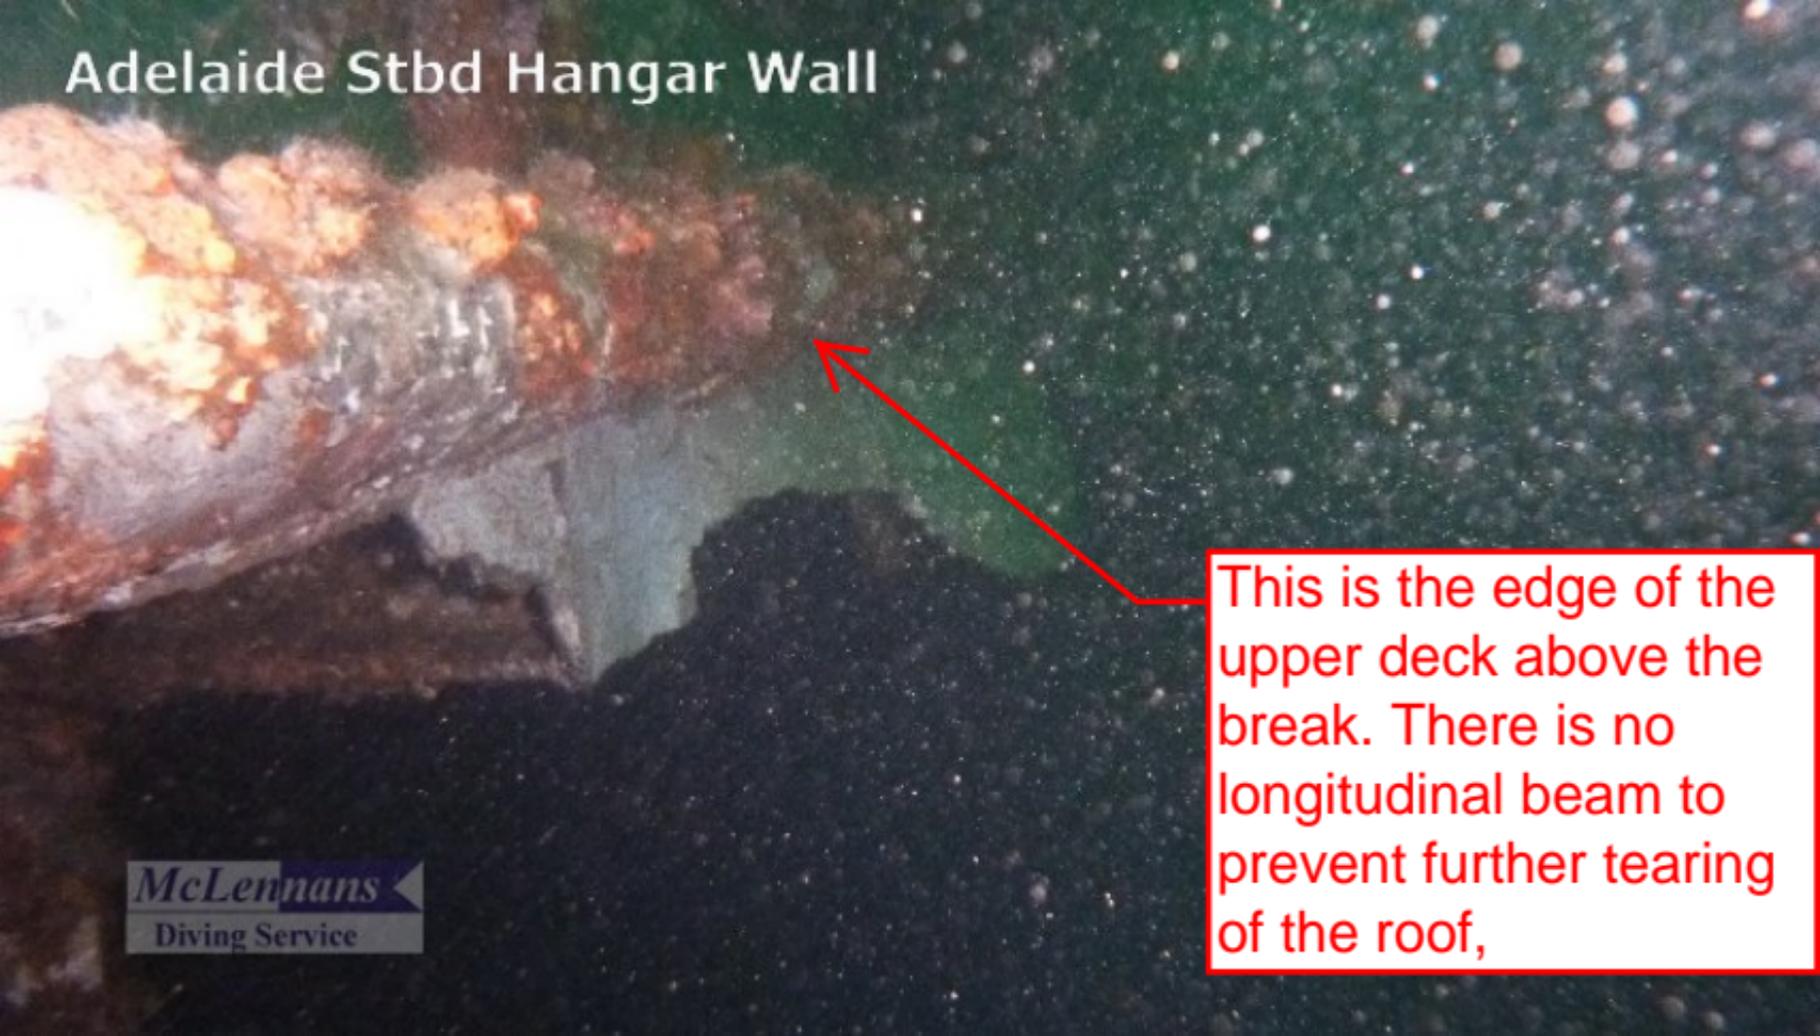
This is the edge of the upper deck above the break. There is no longitudinal beam to prevent further tearing of the roof,

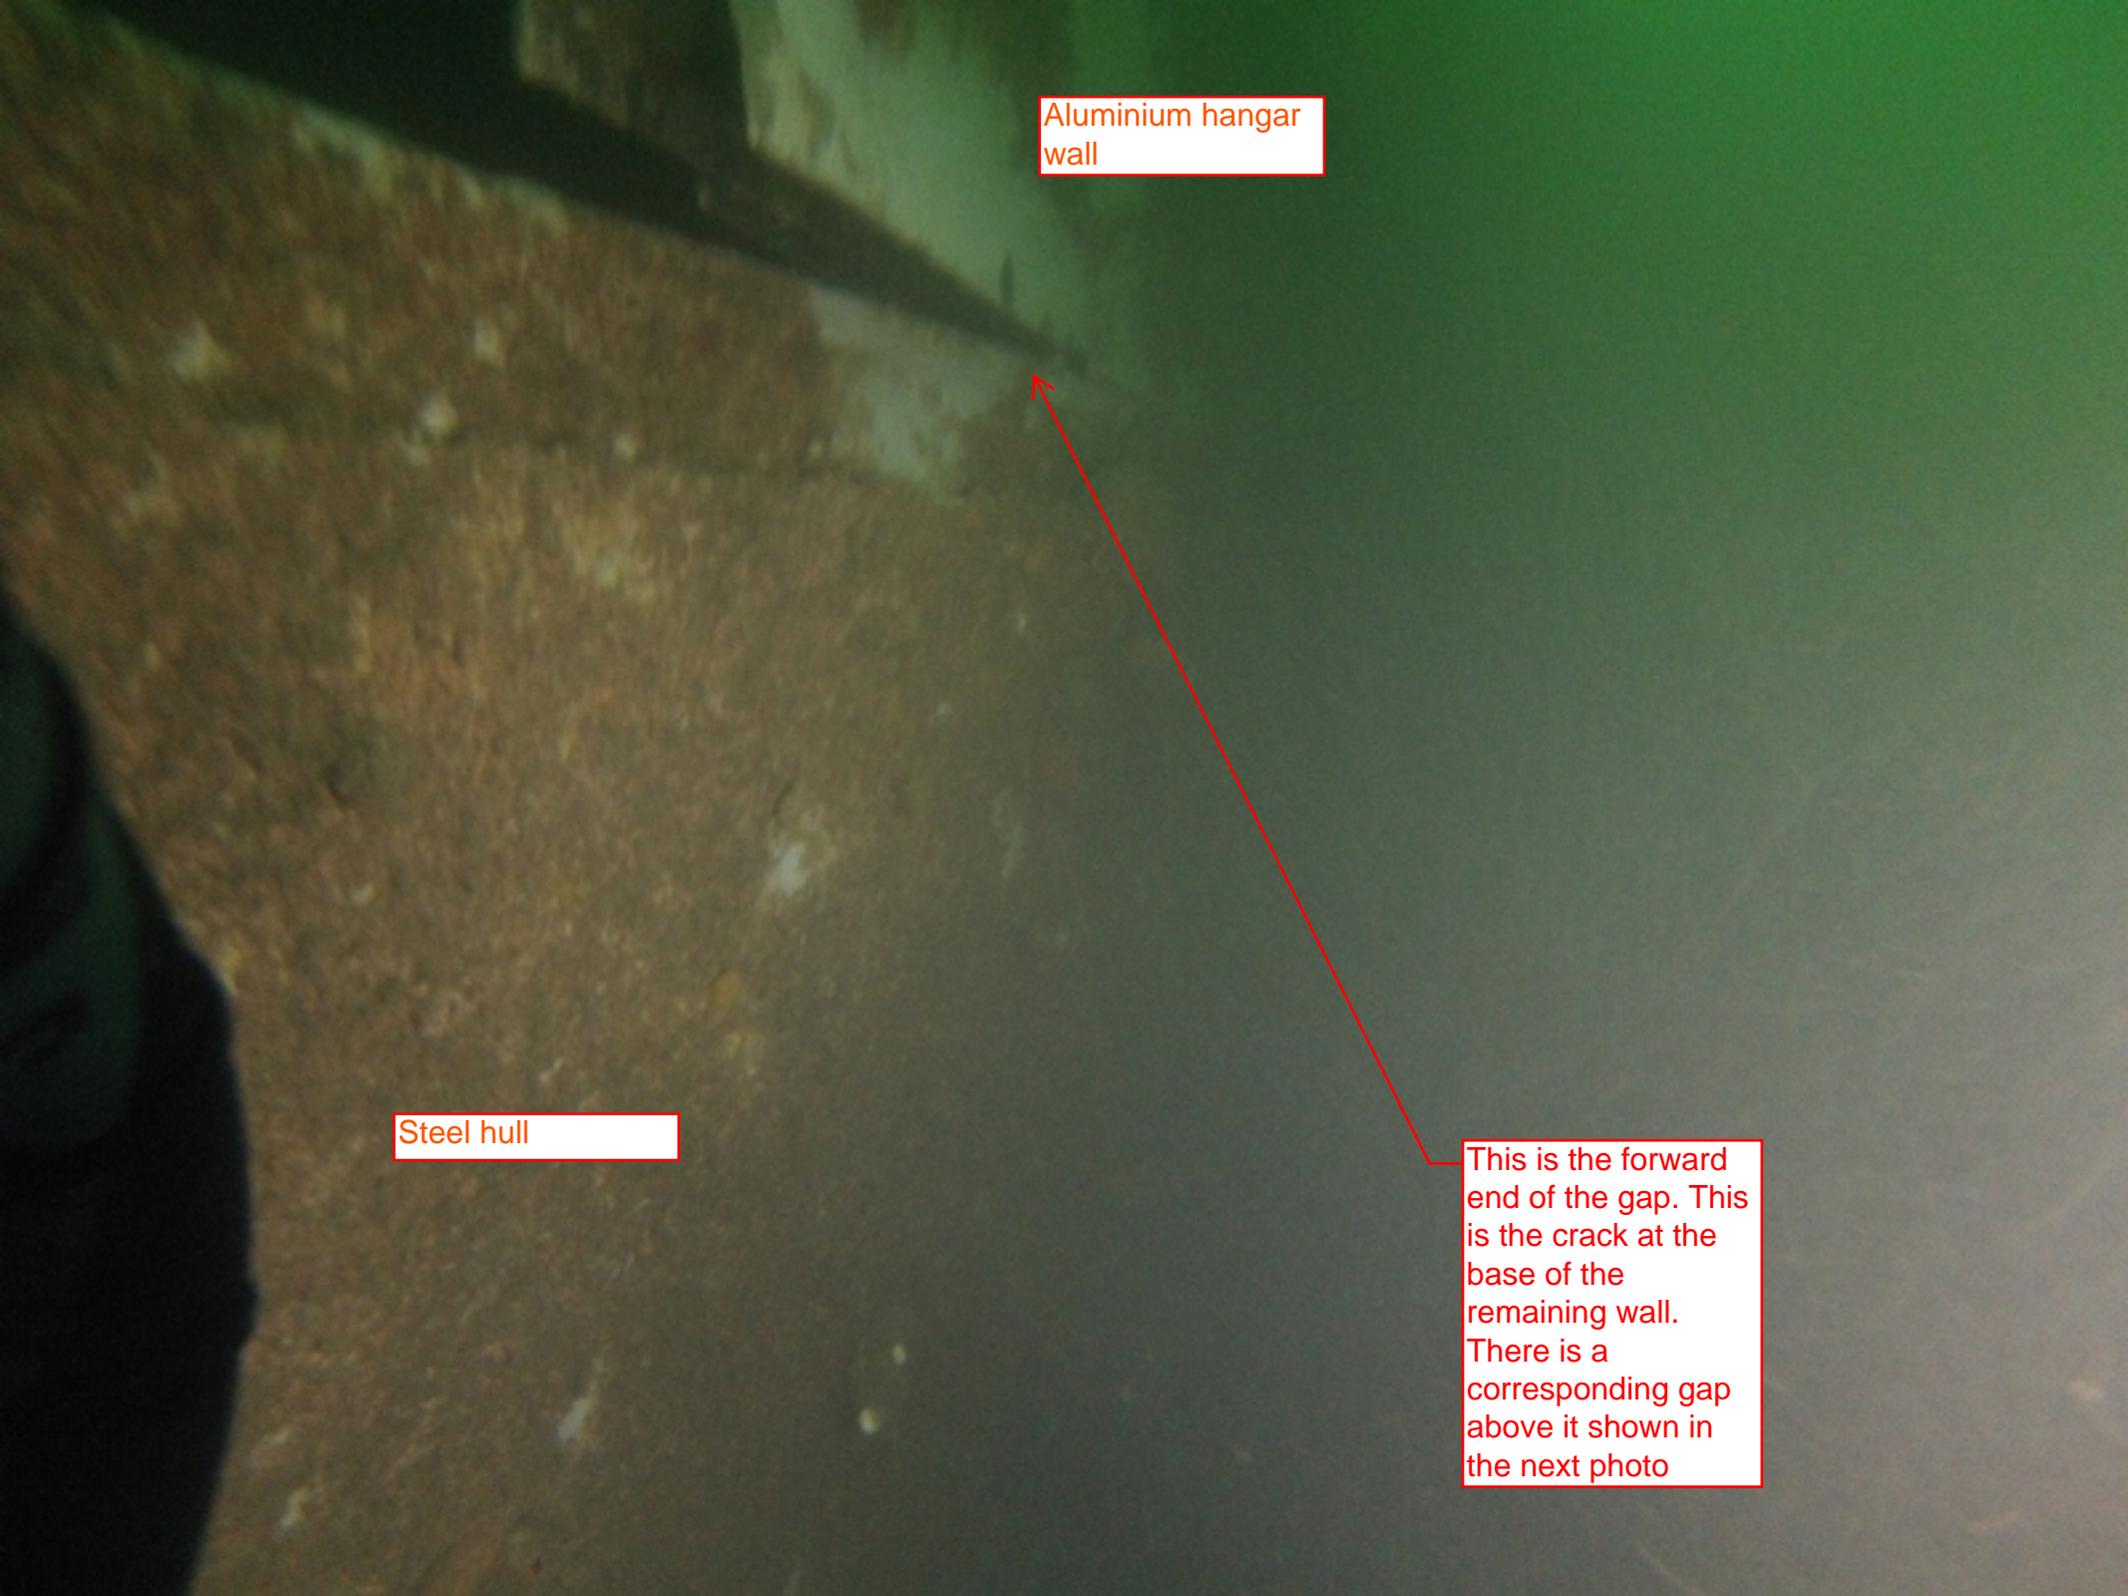
This is the forward
end of the gap. This
is the crack at the
base of the
remaining wall.
There is a
corresponding gap
above it shown in
the next photo
