McLennans Diving Service

To Guy Russell,
Department of Lands

Ex-HMAS Adelaide Starboard Hangar Wall Report

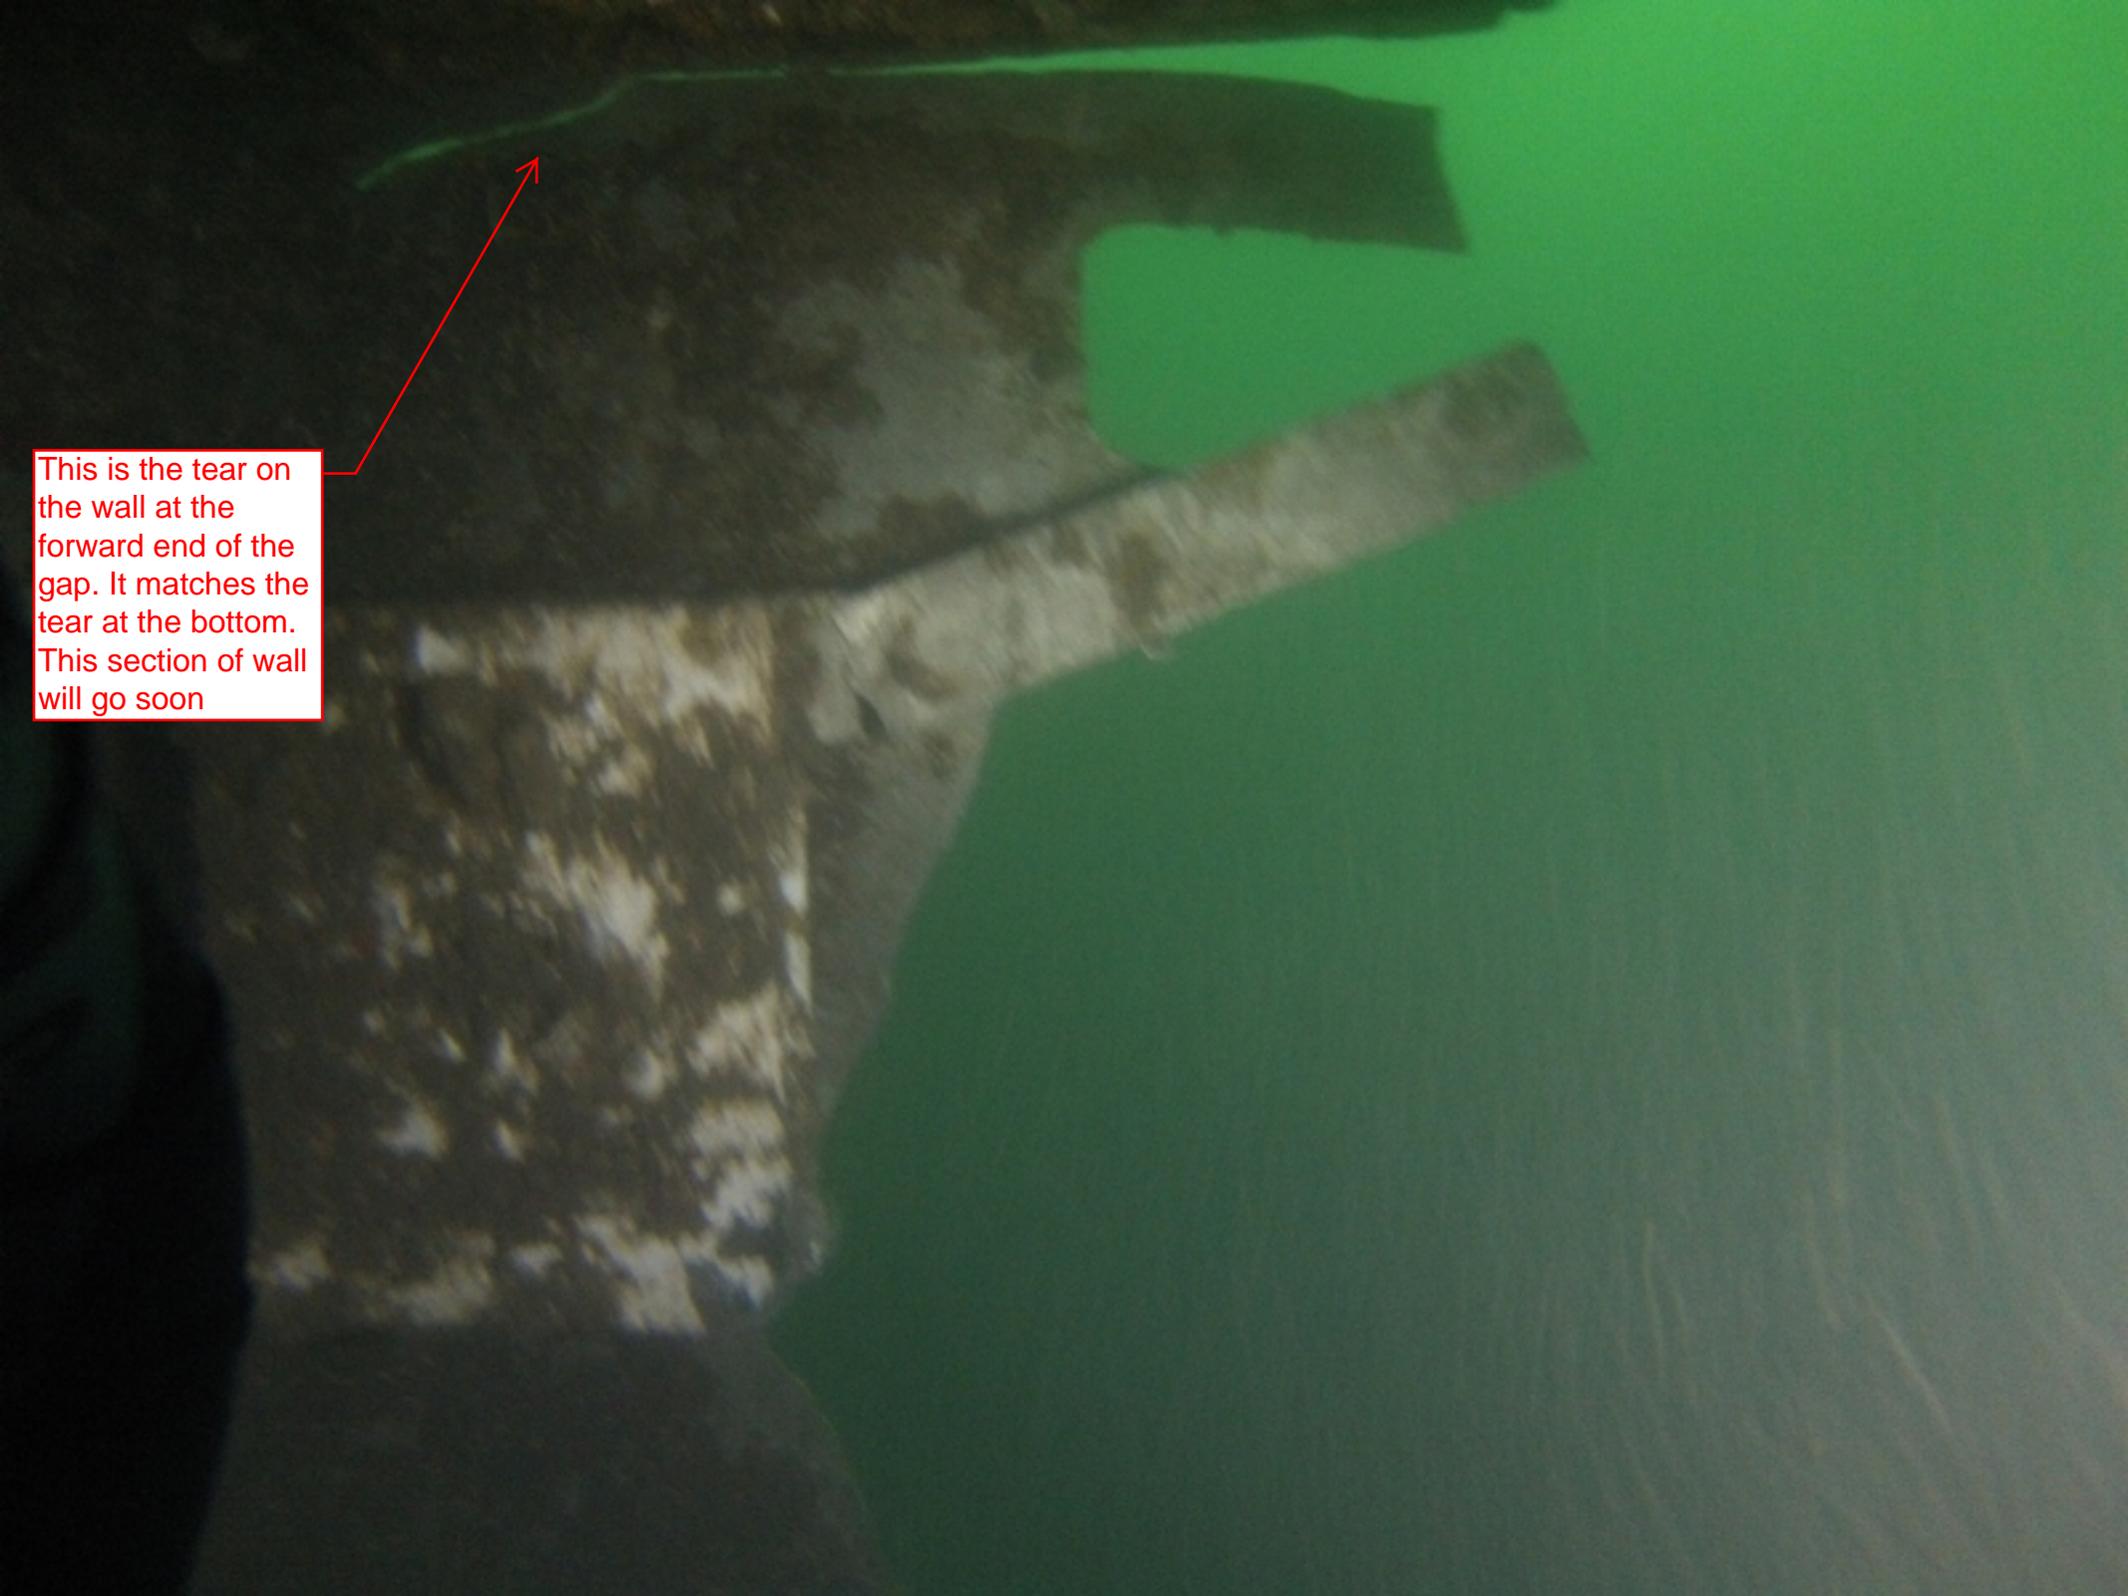
This is the tear on the wall at the forward end of the gap. It matches the tear at the bottom. This section of wall will go soon
