# Diving Service

- Marine Contractors

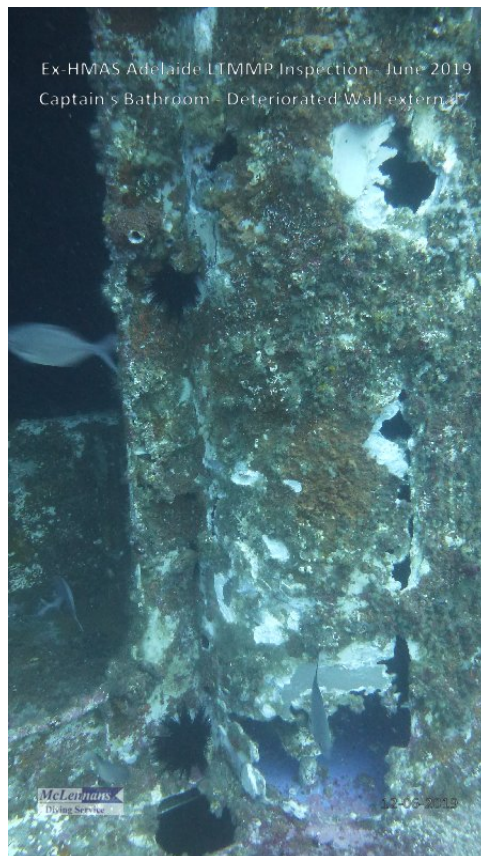
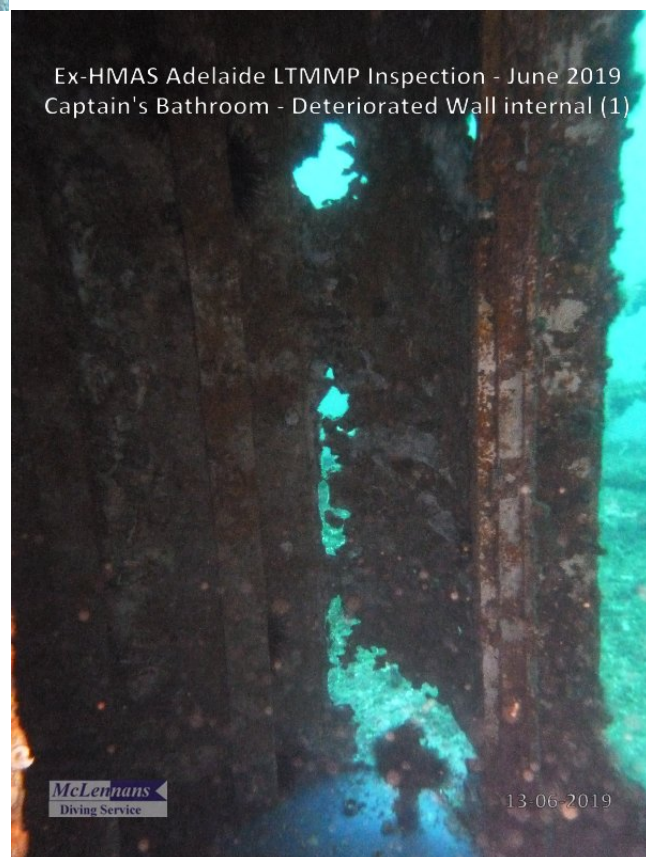
**Figure 1: A view of the Captains Bathroom – (01-108-2-L) from the outside (top) and the inside (bottom). The extreme state of the corrosion in the aluminum paneling is obvious**

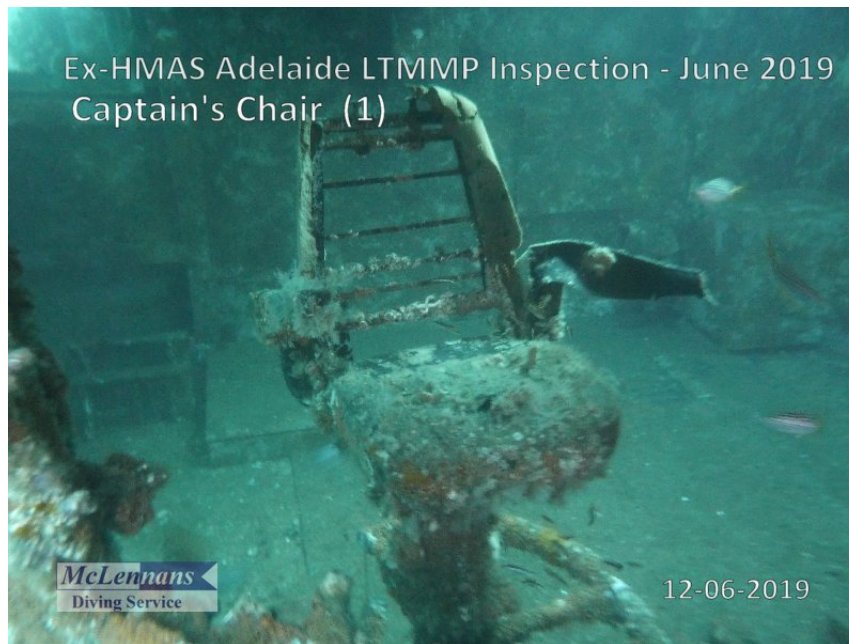
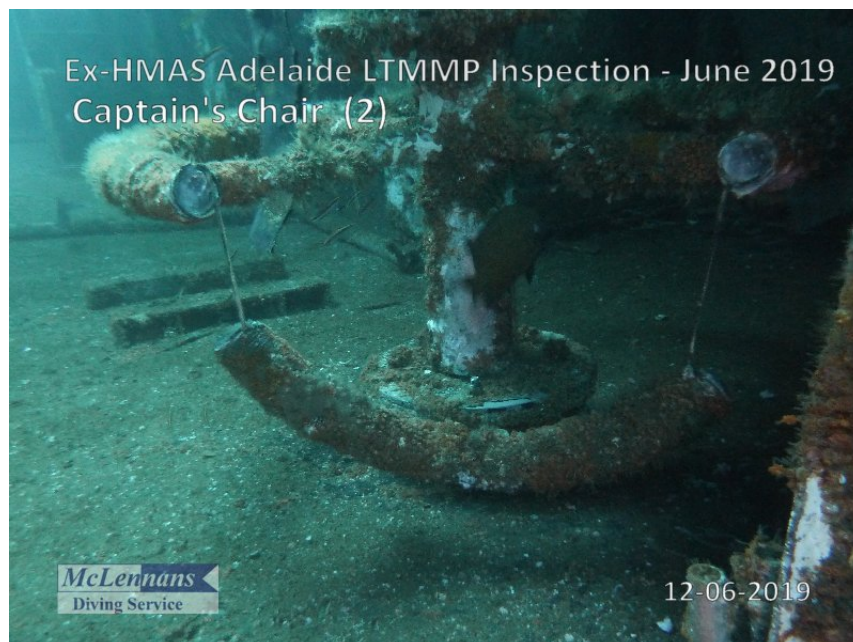
**Figure 2: The Captain's Chair which is a popular site in the bridge has lost its coverings and the footring has snapped.**

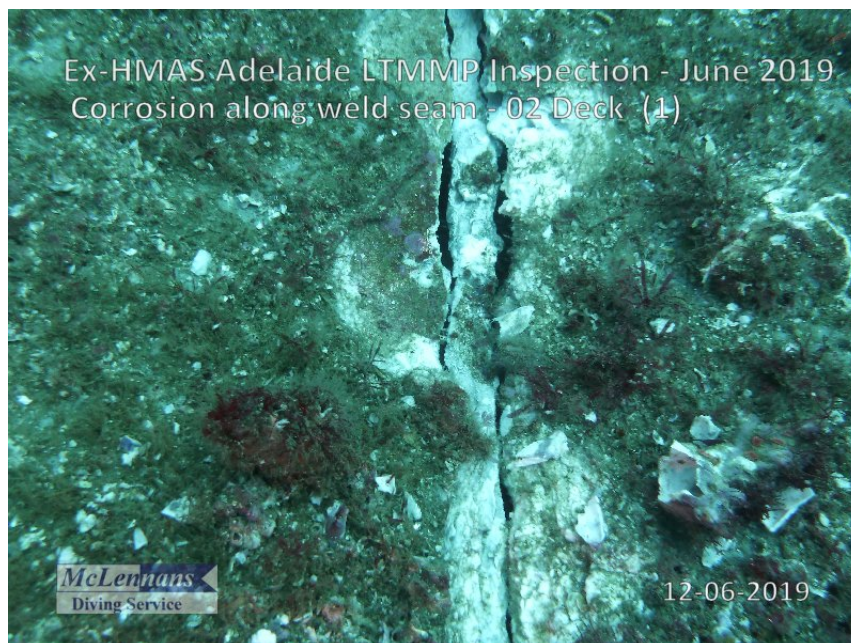
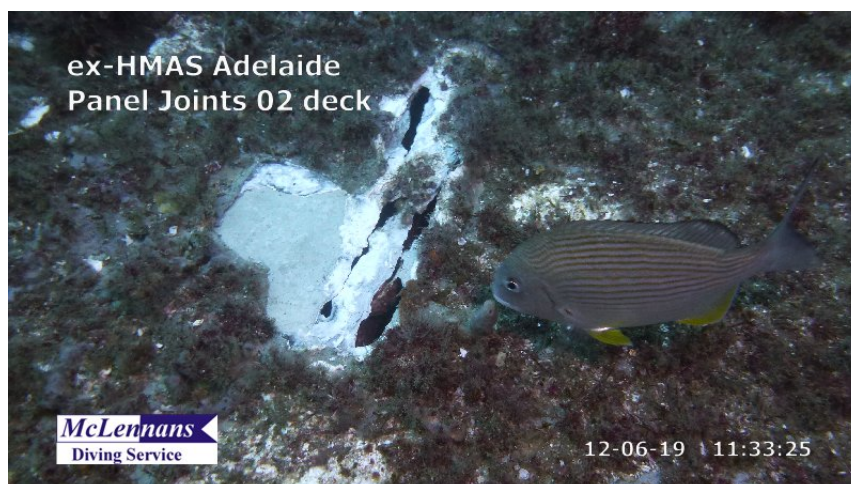
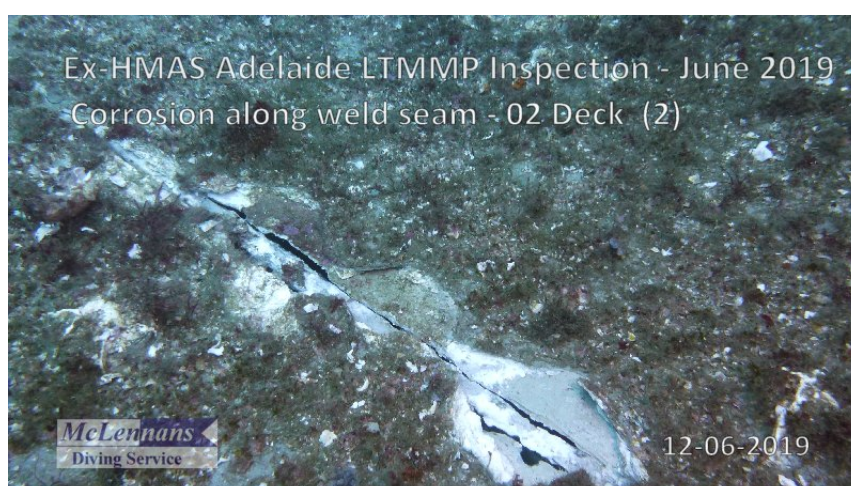
**Figure 3: These photos show the typical condition of the panel joints on the aluminum superstructure. The weld seam has corroded away leaving the panels unsupported.**

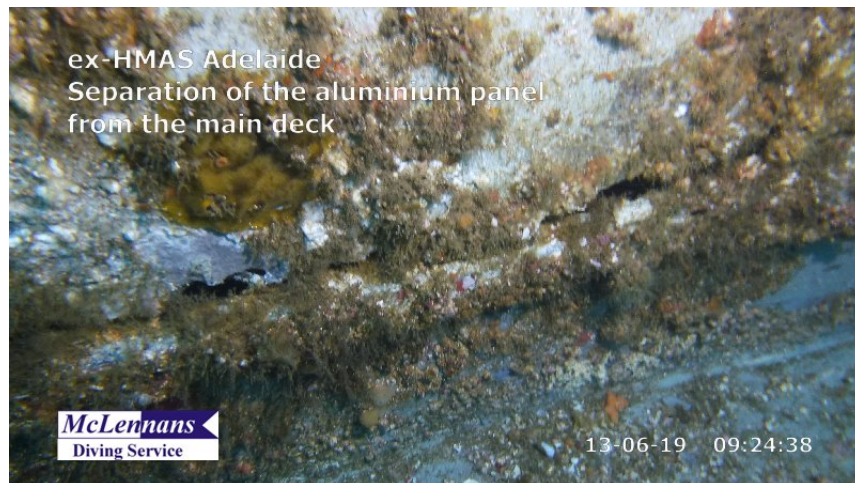
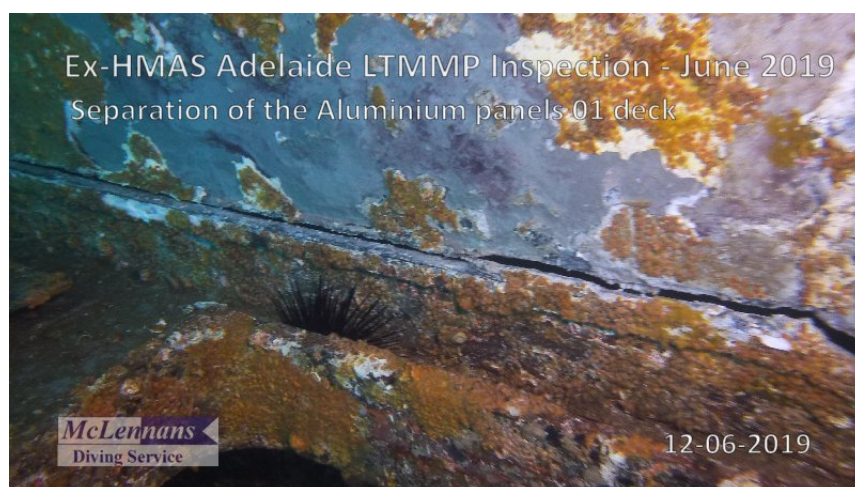
**Figure 4: Typical connection of the aluminum wall panel to the main deck. The panel is corroded away along the joint in many areas. The top photo is from outside. The bottom photo is from inside. Deck 1 Frame 215 Stbd**

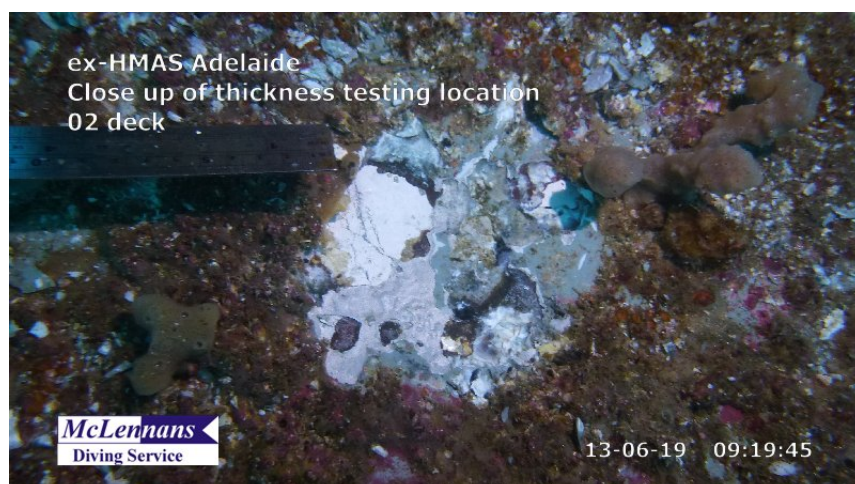
**Figure 5. The aluminum deck at the base of the main mast. The surface is highly corroded with deep pitting. There is no value in attempting thickness testing on this deck. Deck 02 Frame 180**

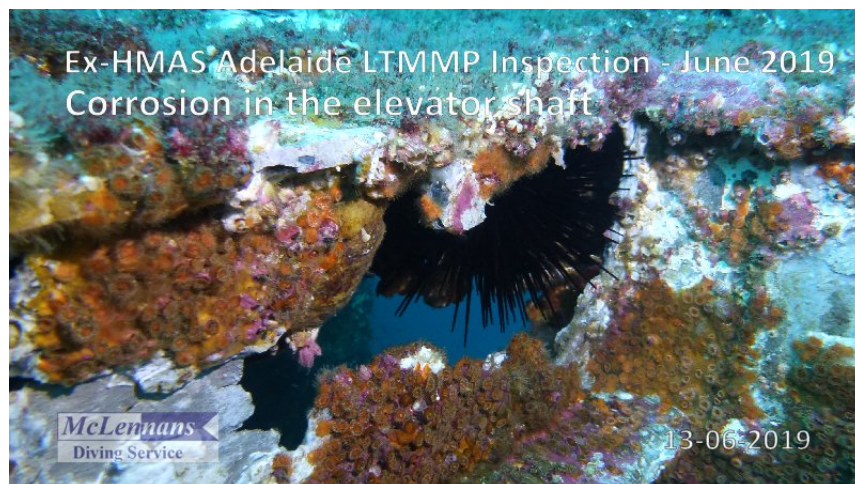
**Figure 6:** This photo shows the aluminium frame and panelling at the top of the elevator shaft Deck 02 Frame 210 . This is a typical hole found in the upper decks

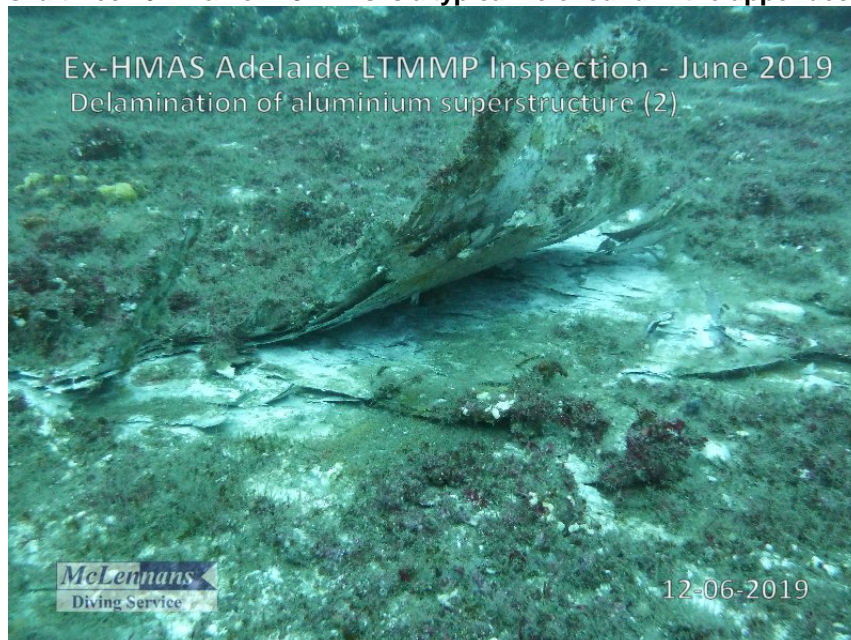
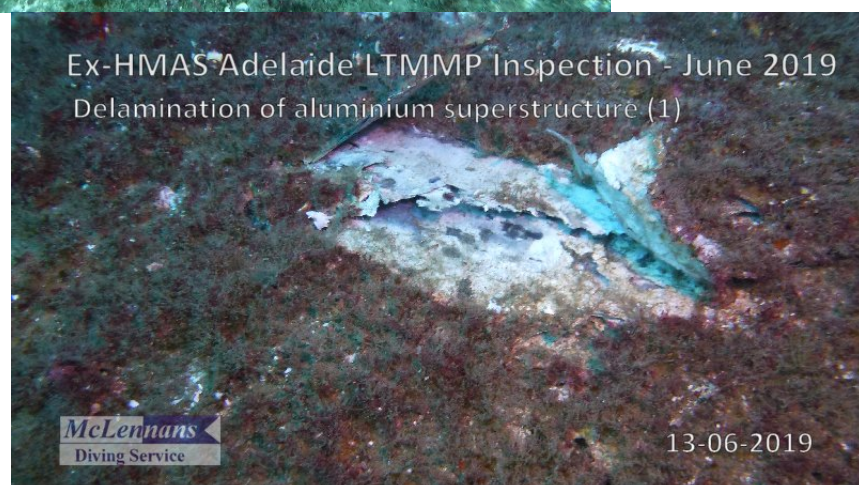
**Figure 7:** The two photos above show the delamination of the aluminum paneling on top of 02 deck.

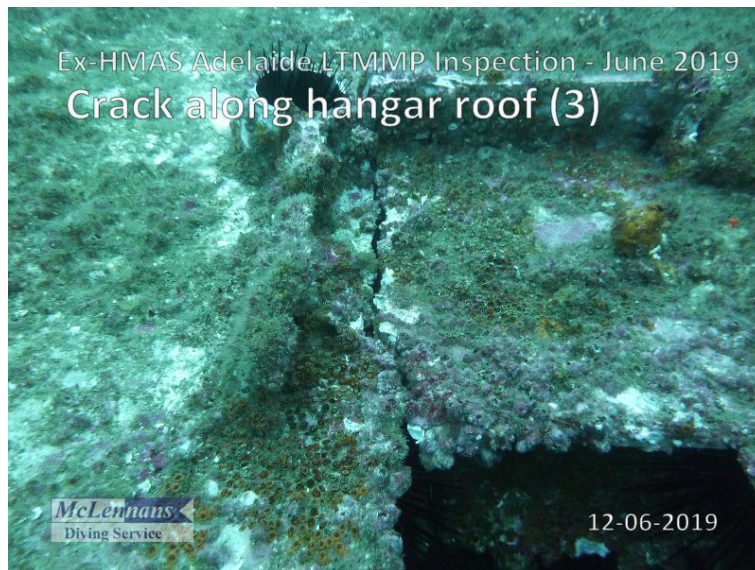
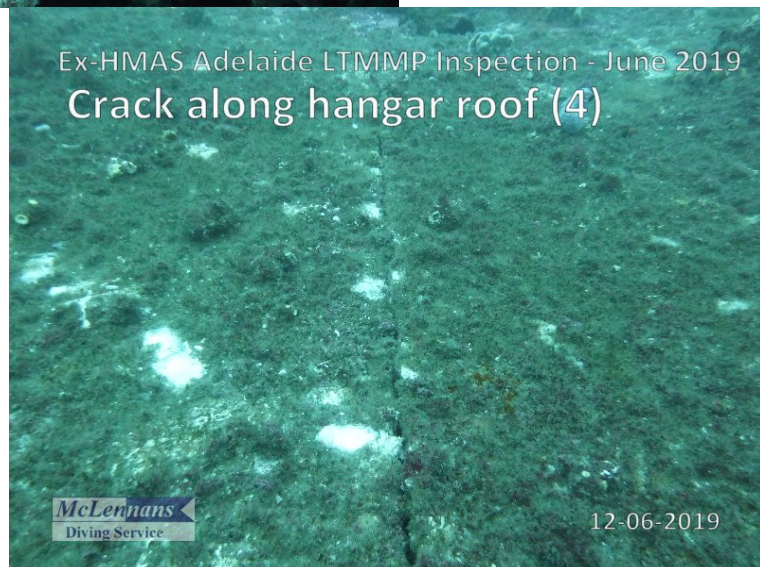
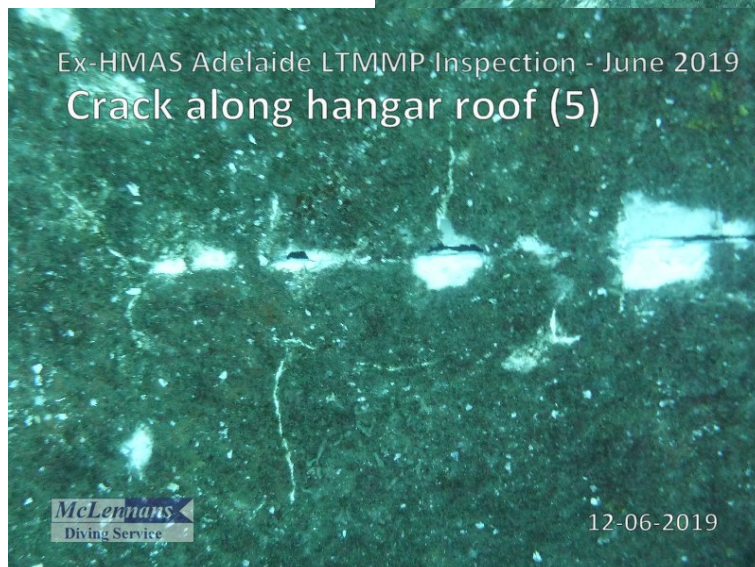
**Figure 8: These pictures show the crack which runs through superstructure amidships. The crack appeared soon after the sinking, but has not become any worse since then. Deck 02 Frame 210.**

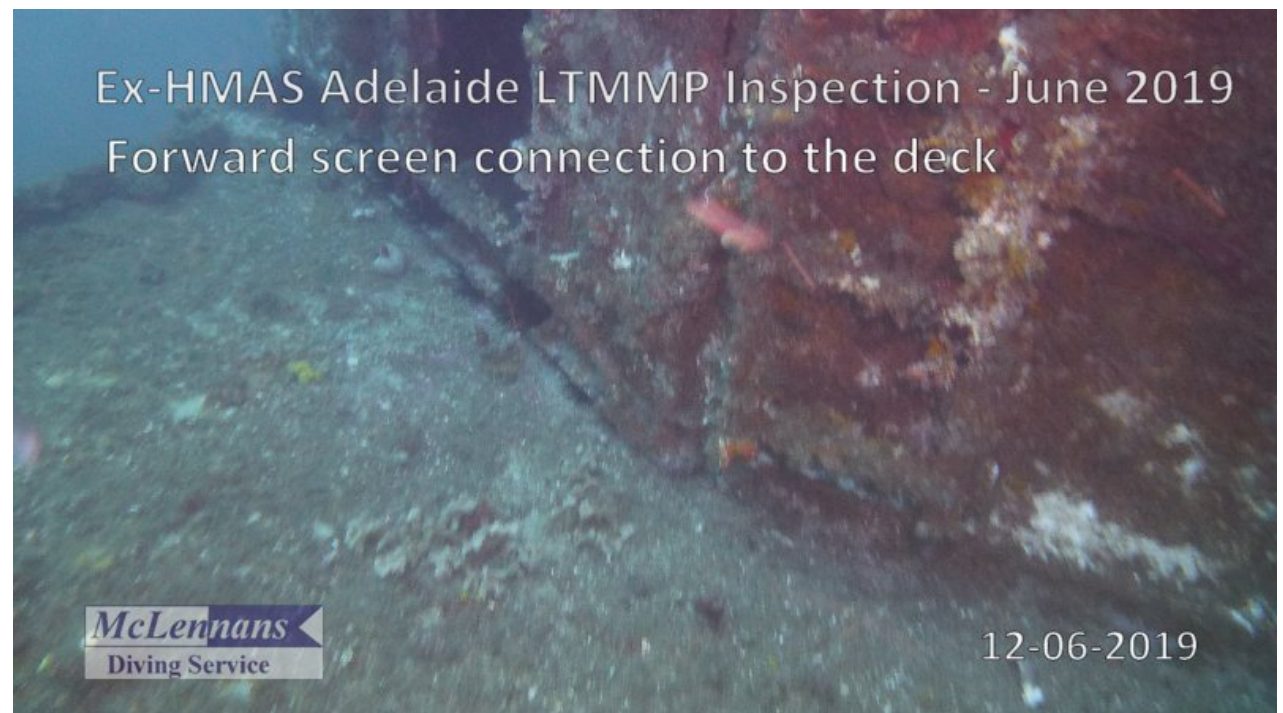
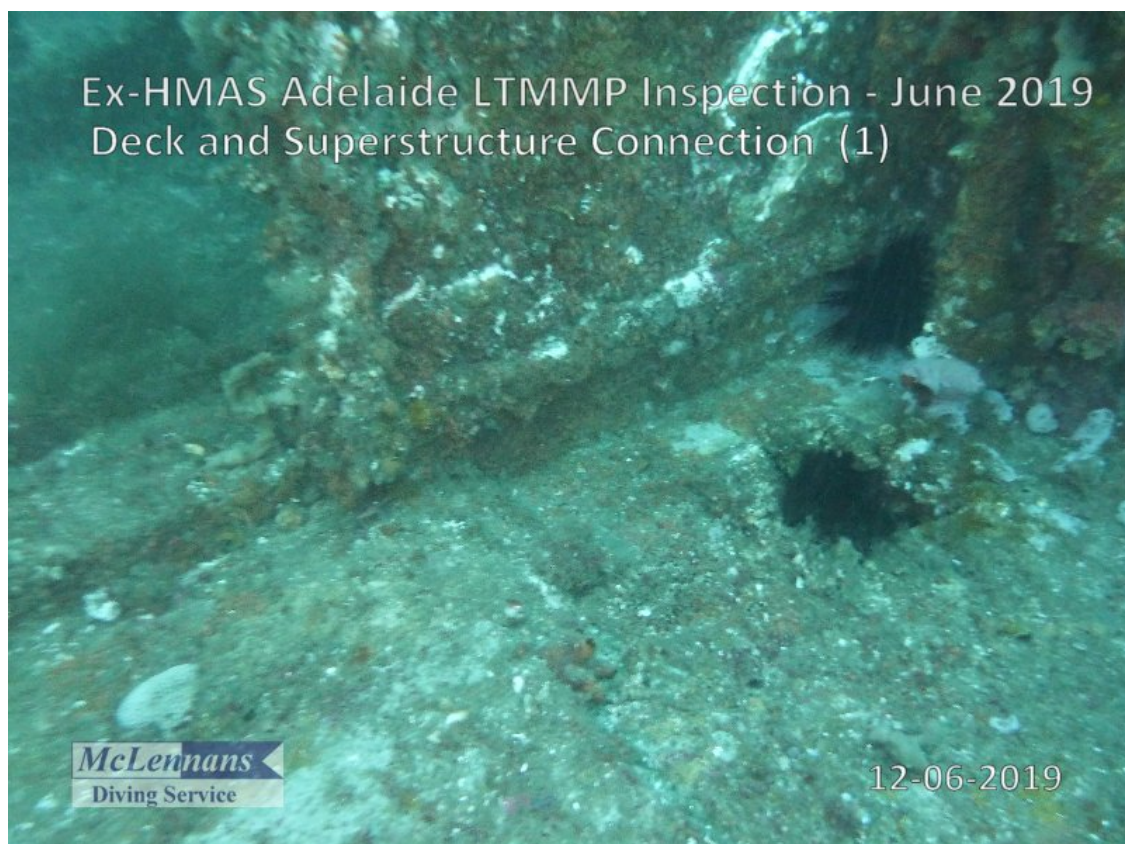
**Figure 9: The base of the weather shield where it attaches to the main deck. There is no sign of any deterioration in this area. Thickness test and visual inspection reveal that there has been no loss of metal in the steel work of the main deck. All coatings are intact.**

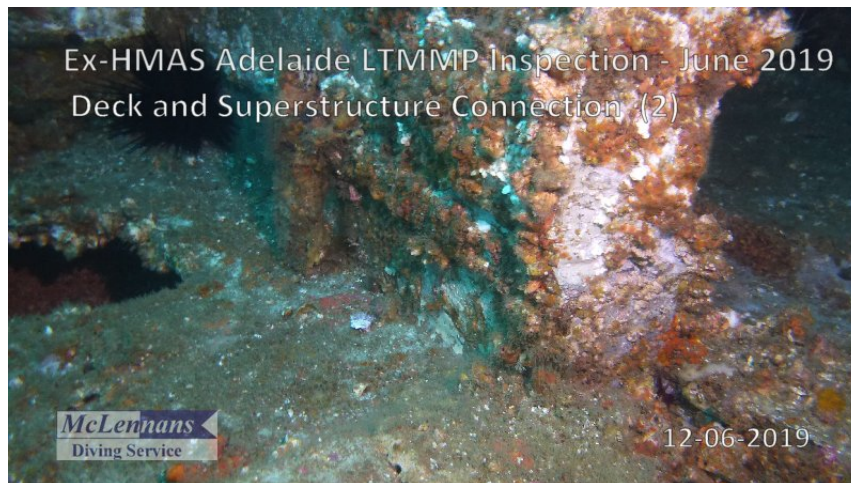
**Figure 10: The centre frame of the helicopter hangar, attachment point to the main deck. There is no sign of deterioration in any part of the steel frame of the hangar.**

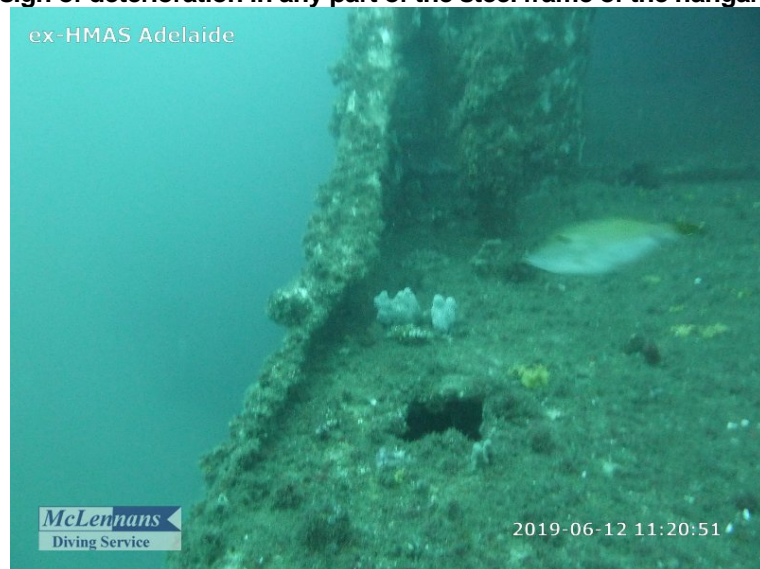
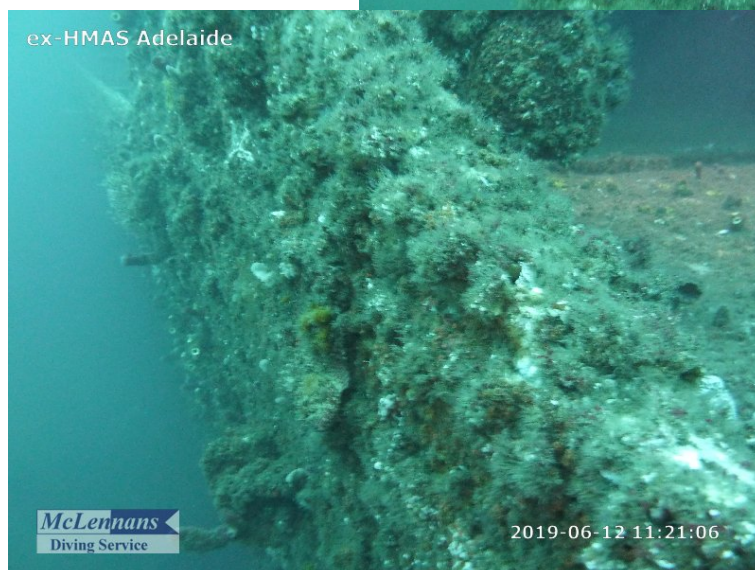
**Figure 11: Two views looking forward to the end of the hangar at Frame 330. All the steel surface are free of corrosion.**

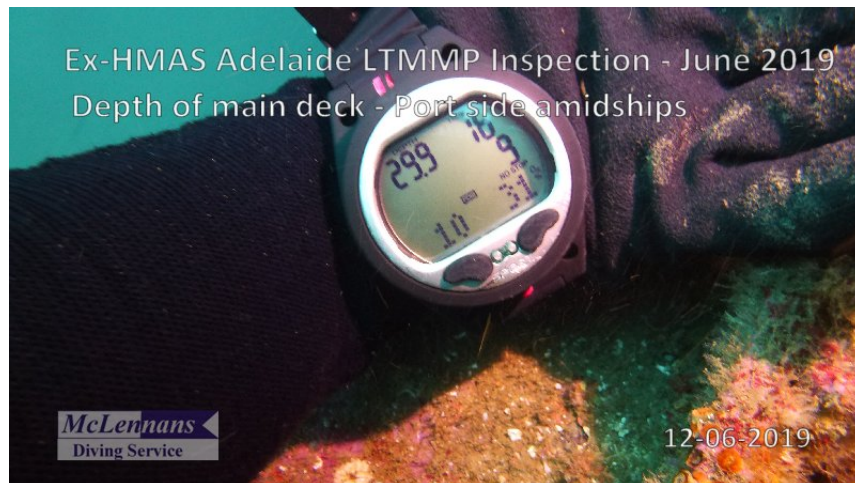
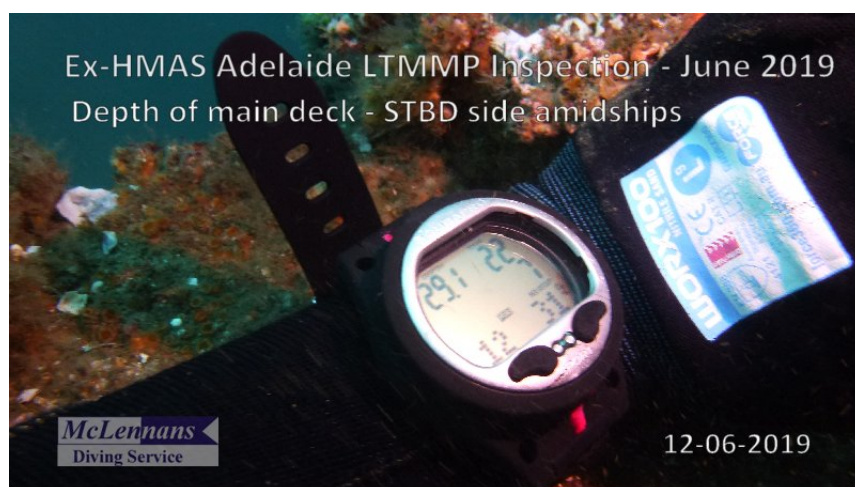
**Figure 12: The depths on the opposite gunwales amidships. These indicate the vessel has a list of approximately 4 degrees. The vessel has been stable in this position since quite soon after the sinking.**

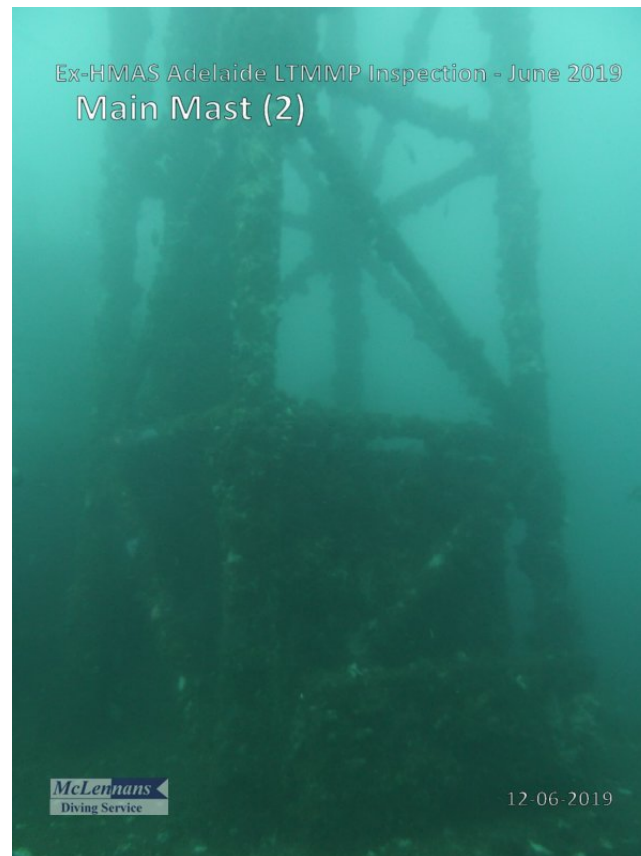
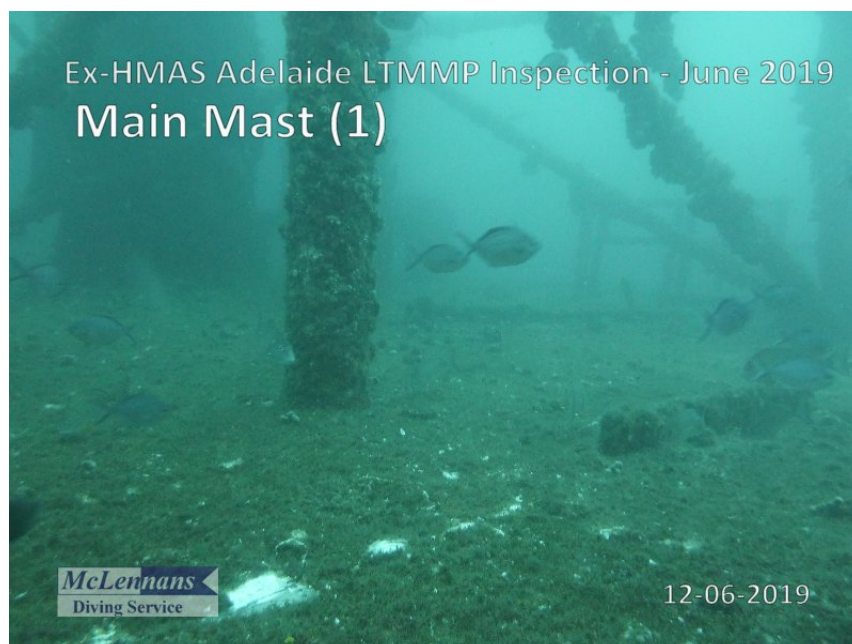
**Figure 14: The main mast shows no sign of deterioration and supports an abundance of marine life. Note the white corrosion deposits on the aluminum deck.**

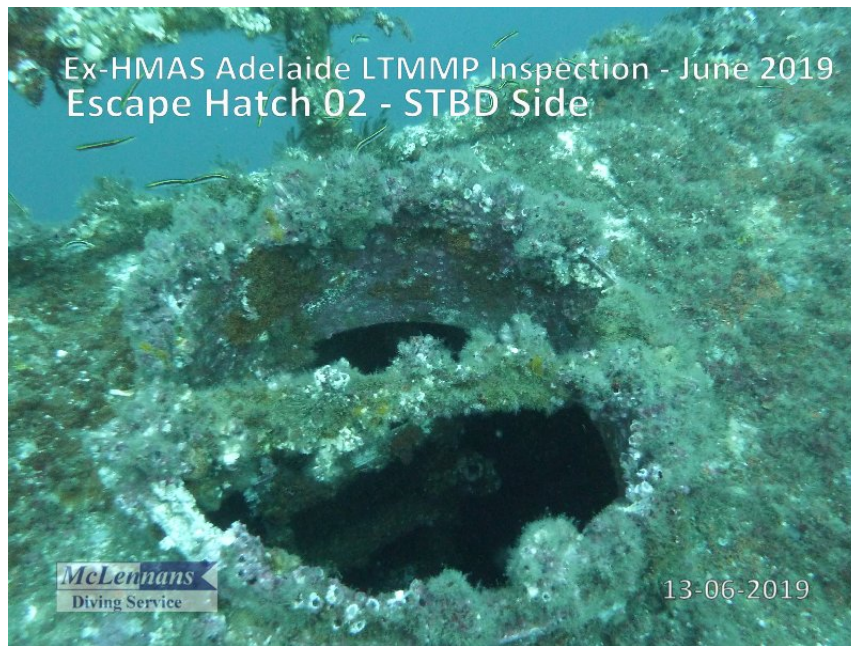
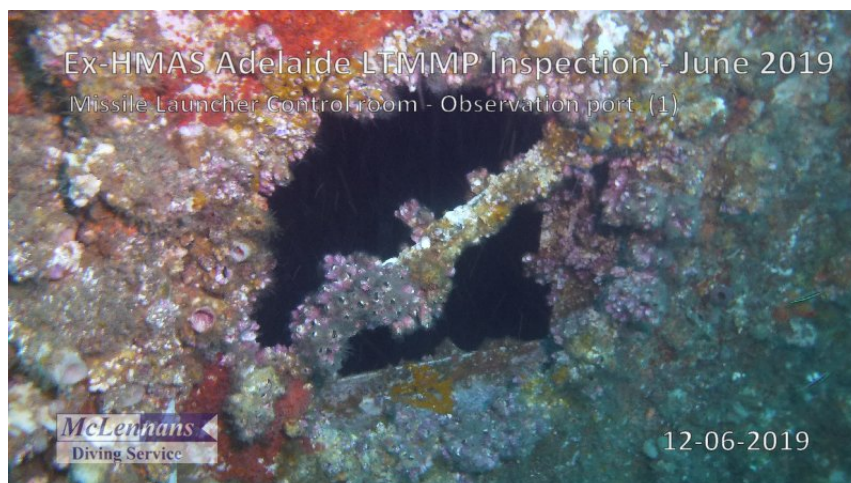
Figure 15: The above photos showed barred off areas.

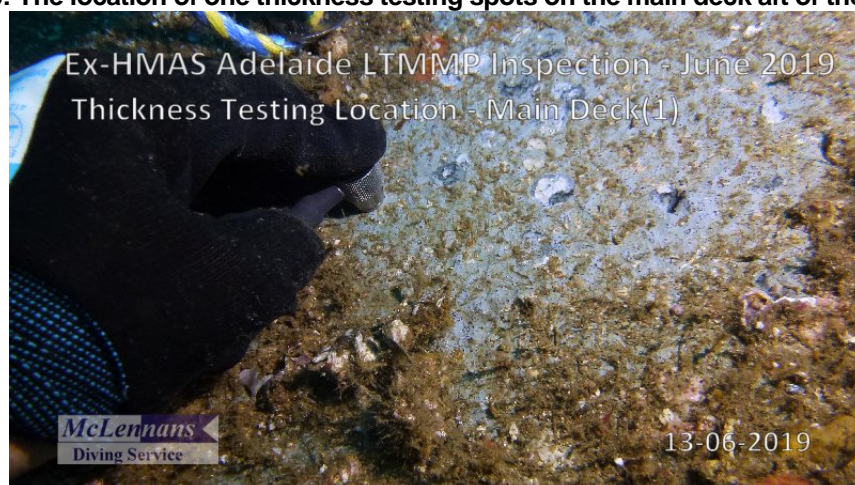
**Figure 21: The main deck aft of the Hangar after scraping away the biofouling. Note that the steel is well covered in grey paint with no corrosion. The diver is holding the thickness testing probe.**

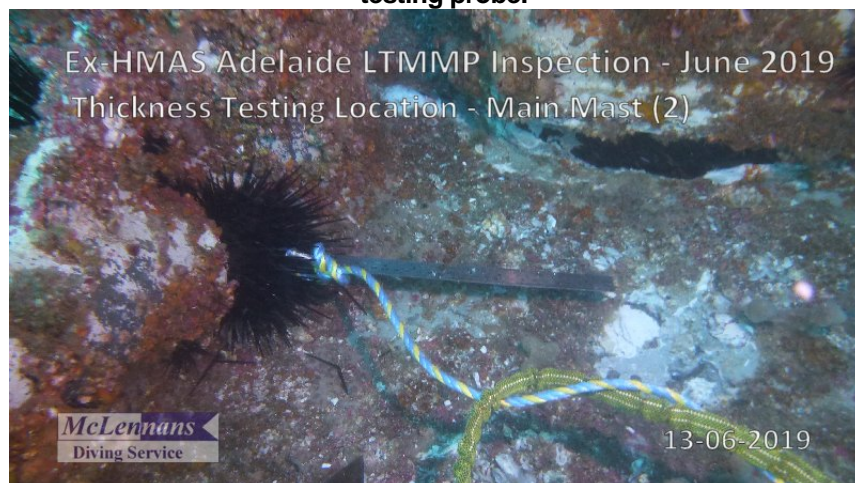
**Figure 22: Thickness testing at the base of the main mast. Note the hole in the aluminum deck and the rough highly corroded aluminum where it has been scraped near the end of the ruler.**

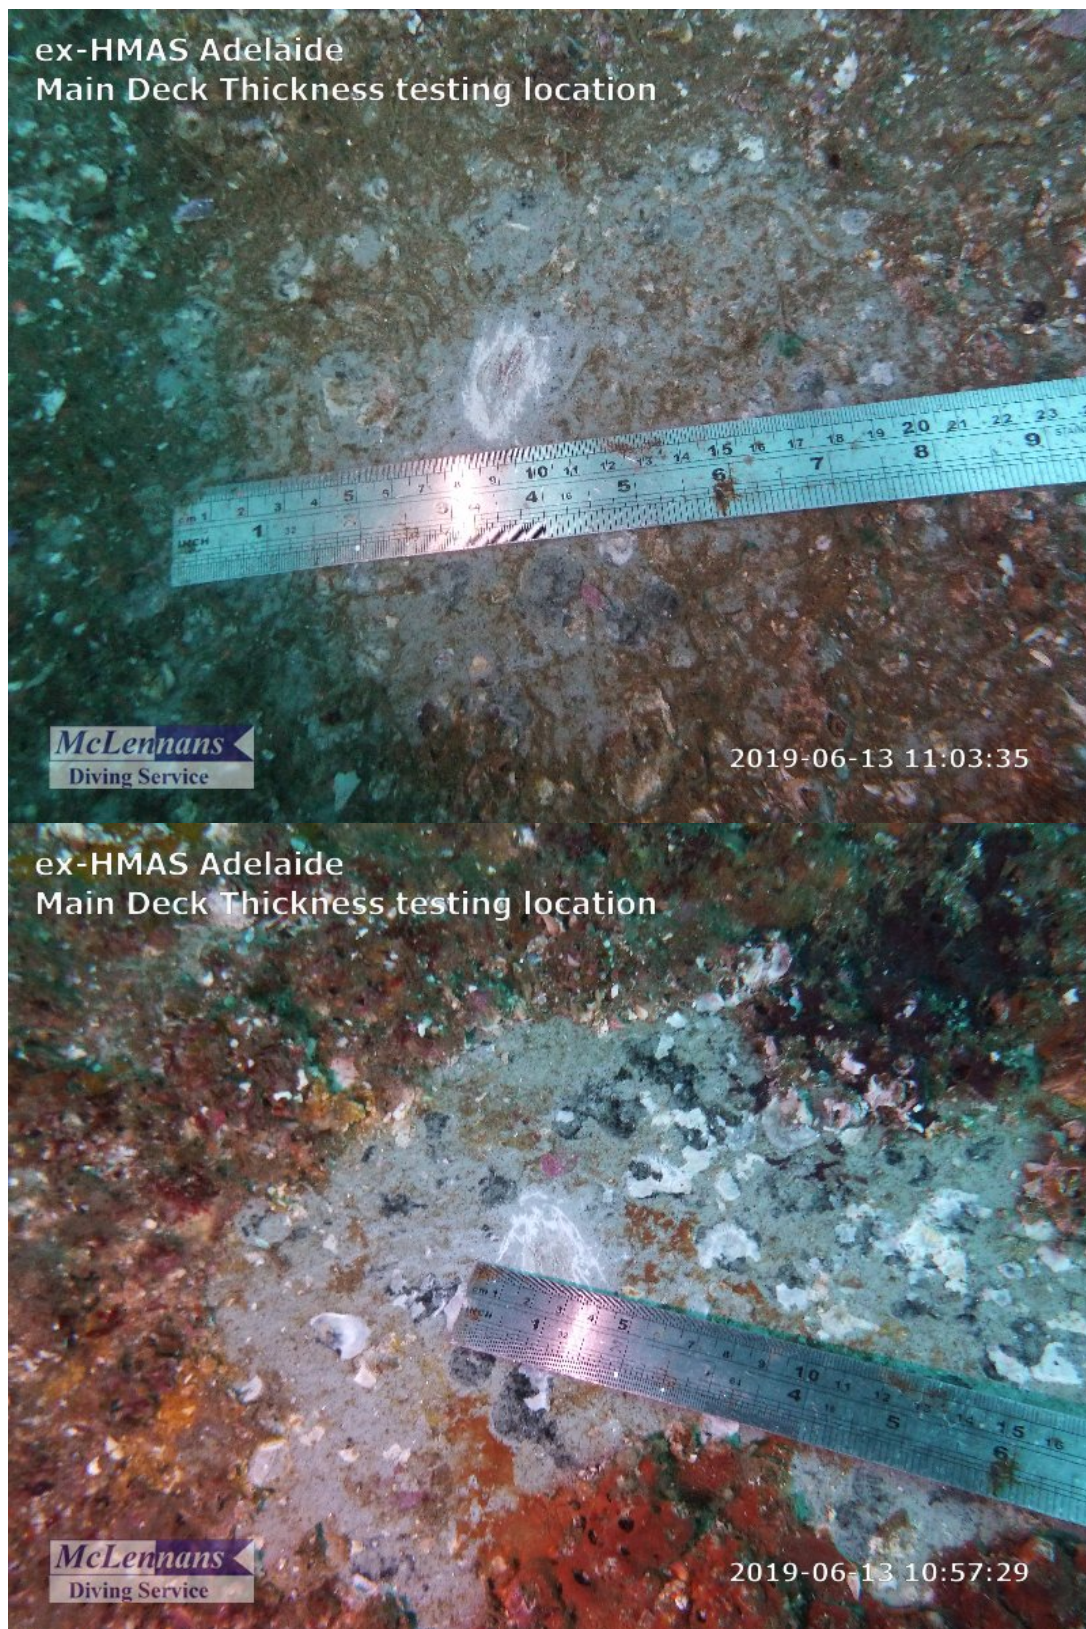
Figure 23: Two locations prepared for Thickness testing on the main deck. Note the paint coating is intact and no sign of corrosion
