## BUILDING CONDITION REPORT

| Subject property address: | Empire Bay Marina<br>16B Sorrento Rd, Empire Bay NSW 2257 |
| Date of inspection: | 2 <sup>nd</sup> April 2020 |
| Inspection purpose: | Inspect and assess the condition of the structures comprising the Empire Bay Marina. The subject site is shown on Figure 1 |

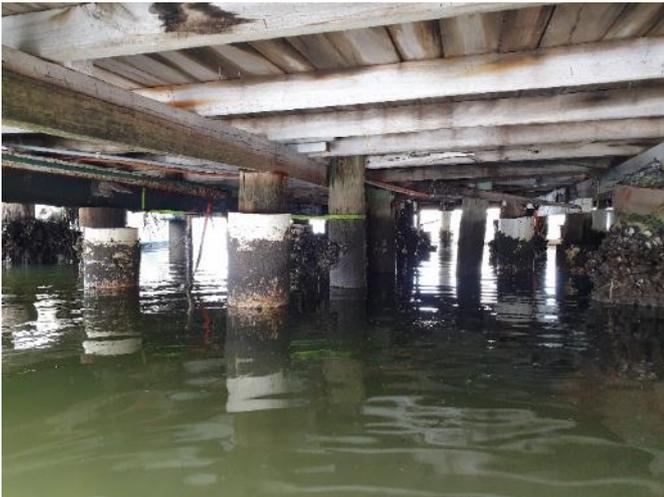
Photograph 1 shows overview of subfloor framing and supporting piers.

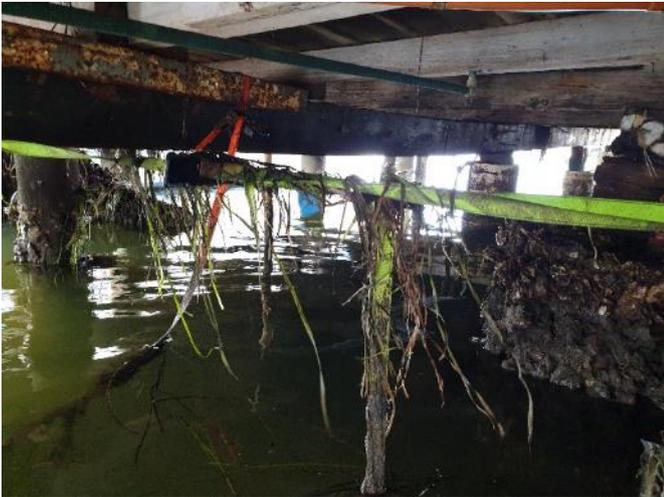
Photograph 3 shows a close up view of the same location.

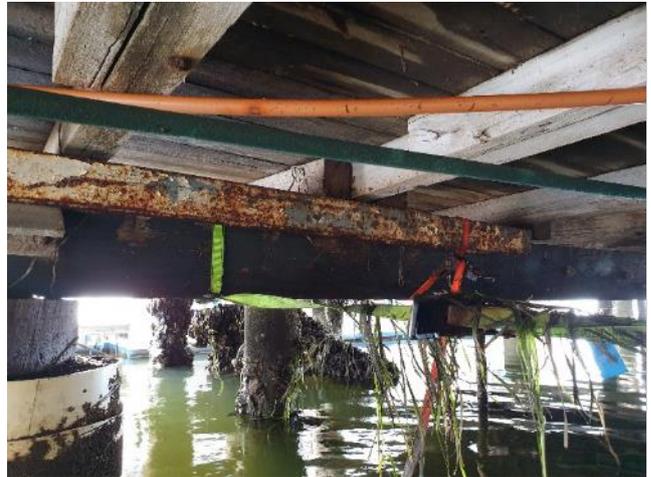
Photograph 4 shows ratchet straps securing a steel beam and old bearer / beam support. This is not a satisfactory repair method.

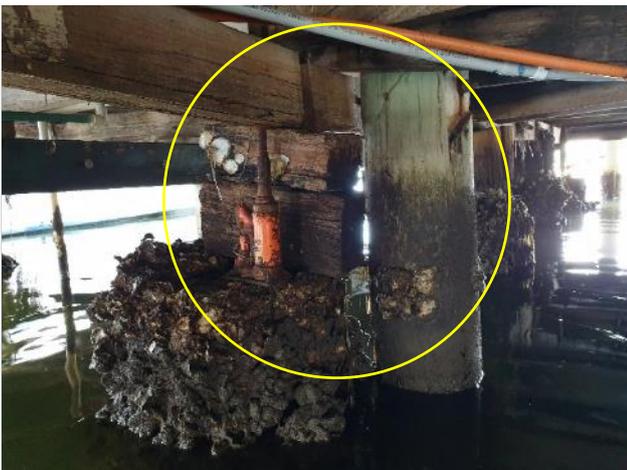
Photograph 5 shows a bottle jack positioned upon a very old pier that now supports the subfloor loading, again an inadequate method of repair. Note – there is 1x threaded rod that connects the green coloured pier to bearer, but that is again not an adequate means of supporting loading.

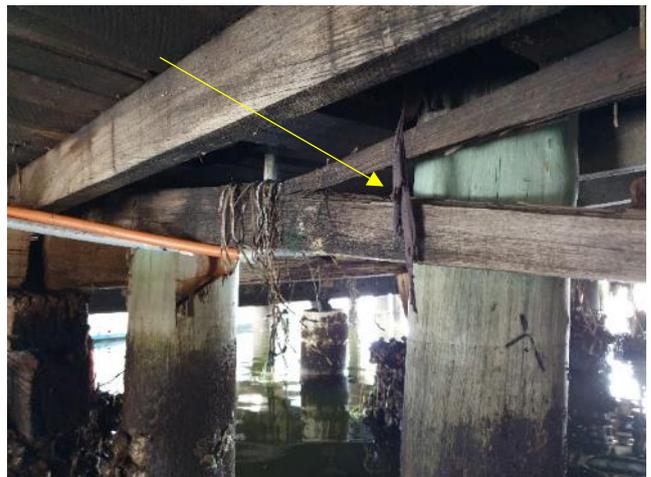
Photograph 6 shows a failed ('split') bearer.

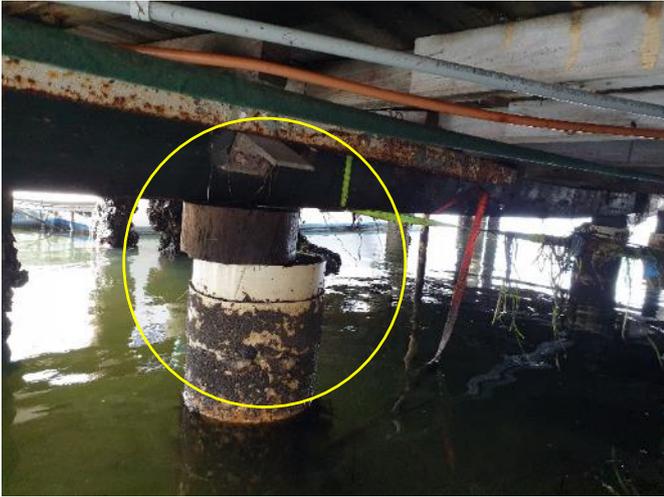
Photograph 7 shows where a pier continues to subside, with evidence of 'blocking' (packing) being placed upon each other. No visible tie downs to this location, meaning if the pier was to rotate, this section of floor would collapse.

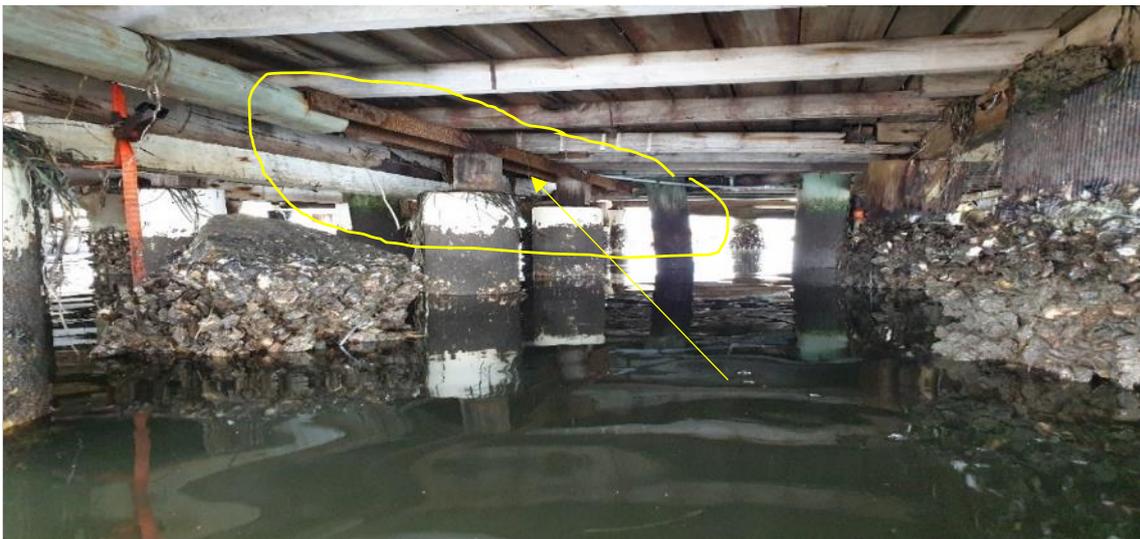
Photograph 11 shows steel C section placed in lieu where one would expect to see a timber bearer. Furthermore, there is timber packing blocks placed upon the piers to support the C section. An inadequate repair method. Again, ratchet straps are in use to tie supporting timber framing members together.

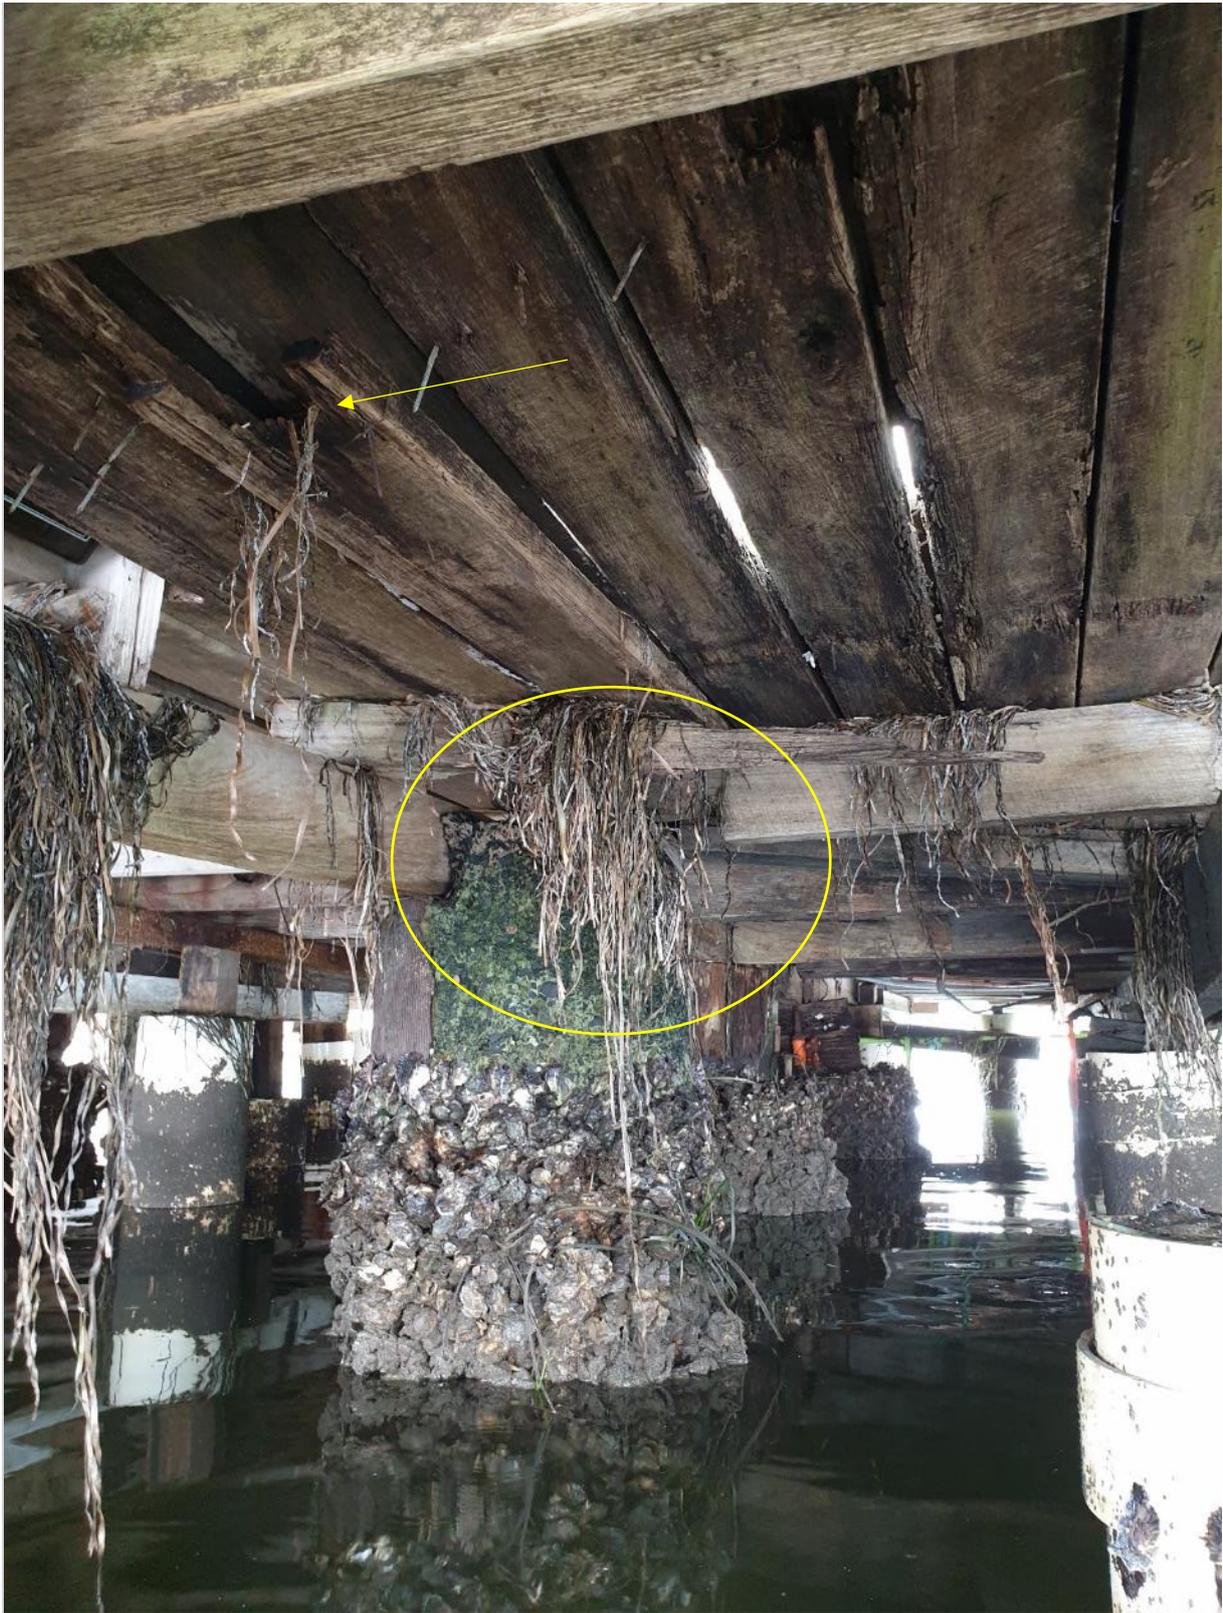
Photograph 12 shows decayed timbers and separation at pier – bearer connection points.

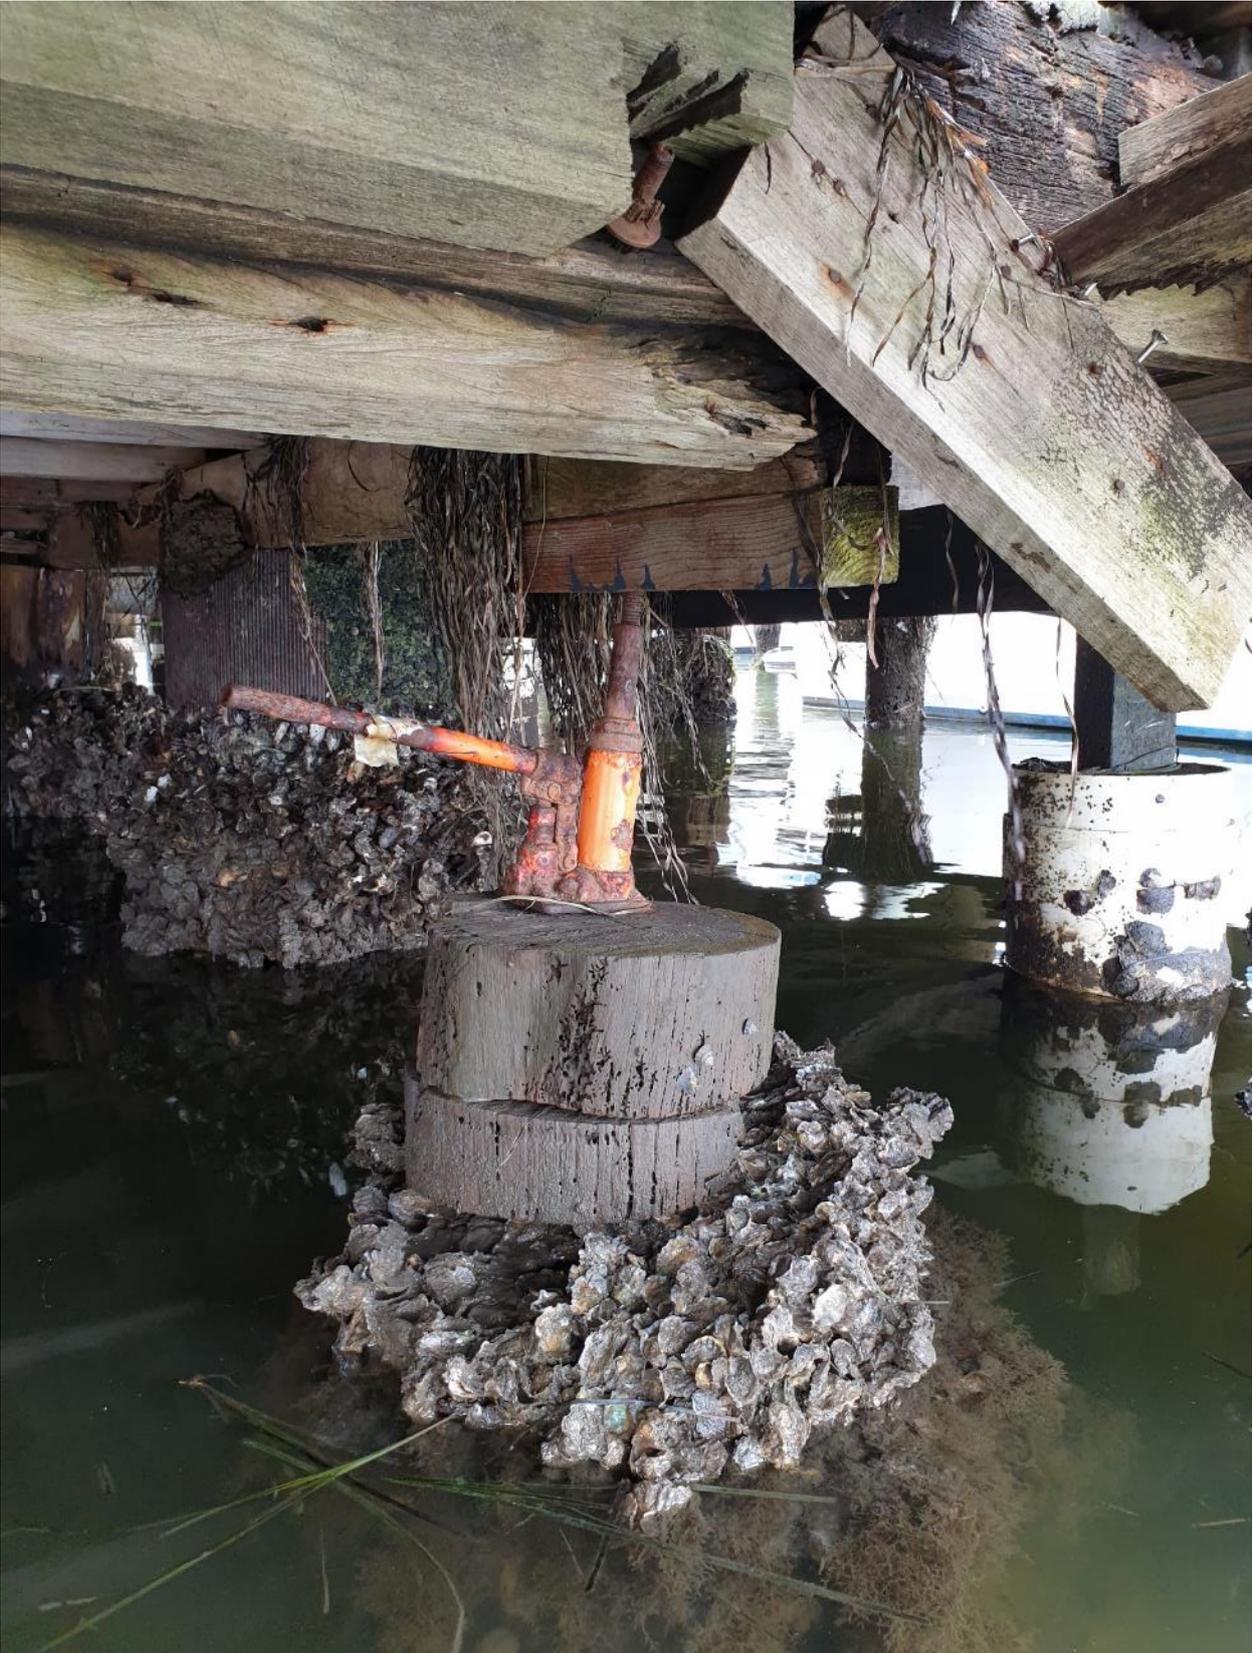
Photograph 13 shows a bottle jack, placed upon 2x timber packers, supporting 'structural' bearer and floor loads. It appears this has been in place for a 'long' period of time. Furthermore, we have other supporting timber framing members for decking that have fallen away.

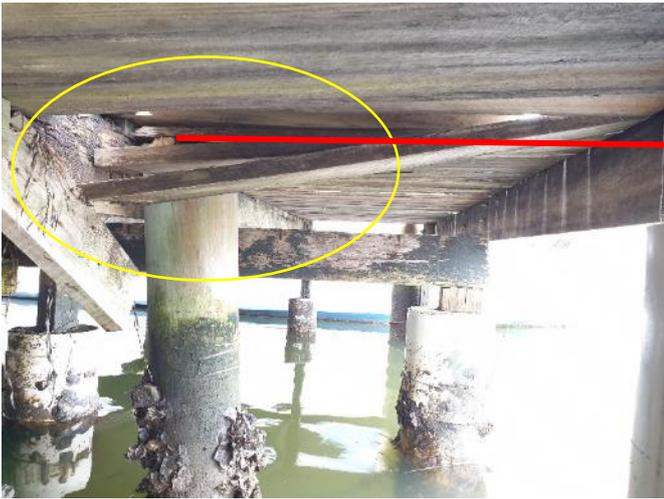
Photograph 14 shows the decking boards to Southern side that are collapsing due to lack of bearer support.

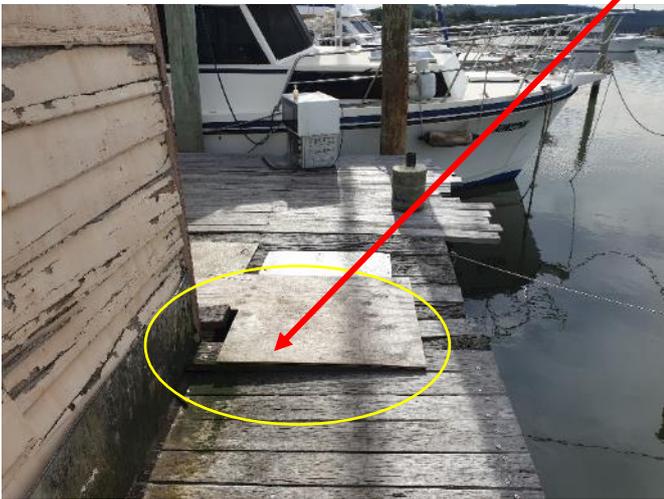
Photograph 16 shows the same location with a trip hazard present due to defective repair method.

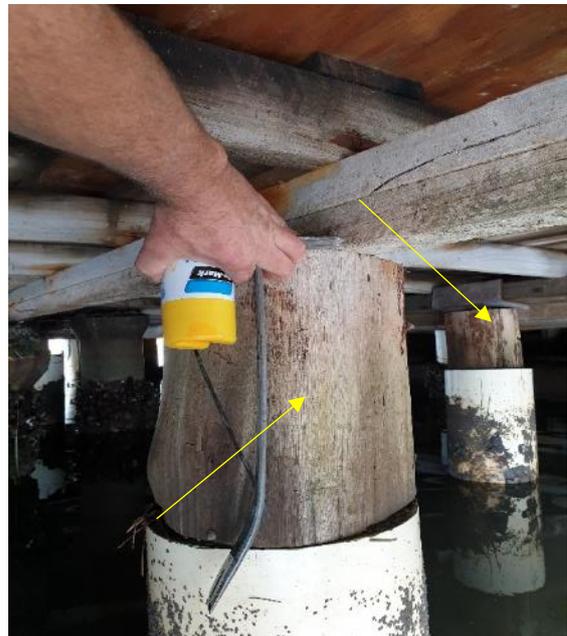
Photograph 17 shows another example of timber blocks placed upon the piers with no connection ties.

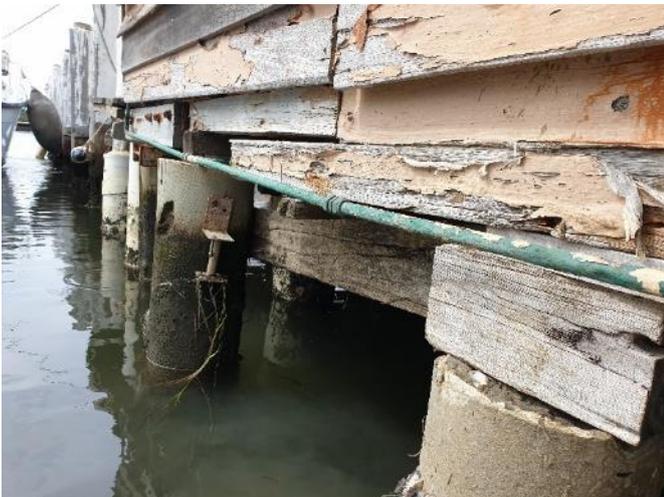
Photograph 18 shows Northern elevation with various timber blocks and 'add-ons' being utilised to support the subfloor structure.

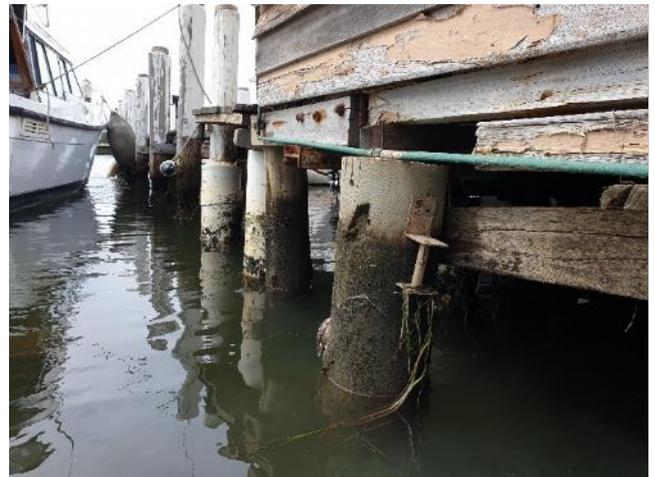
Photograph 19 shows another view of the same location with the same defects.

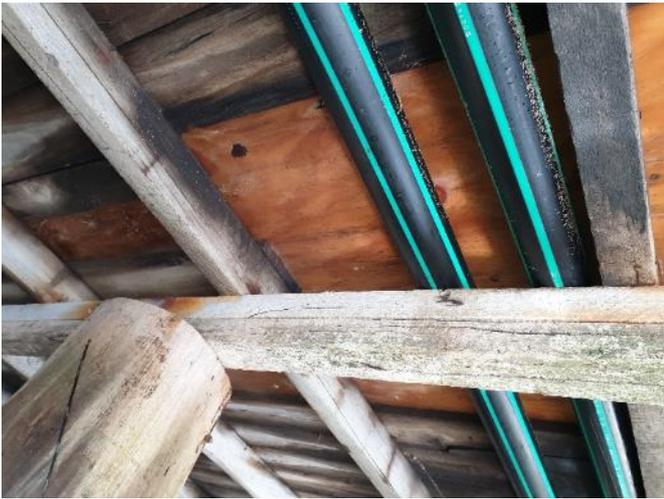
Photograph 20 shows missing portions of timber flooring, being covered over with plywood sheeting.

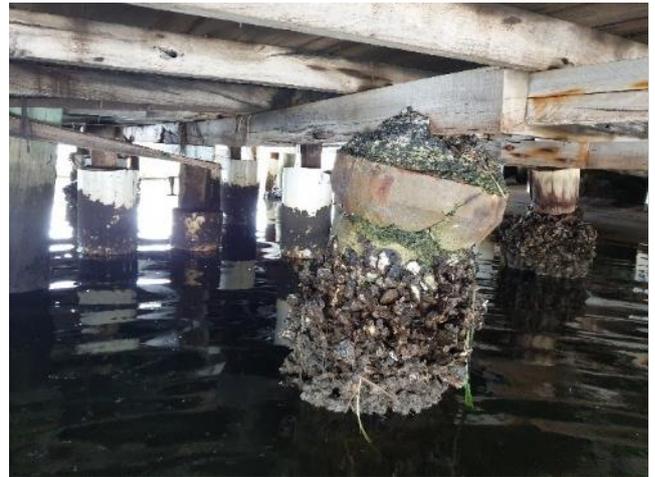
Photograph 21 shows a dilapidated cast concrete column that has been packed with concrete as means of supporting timber bearer. Again, inadequate repair type.

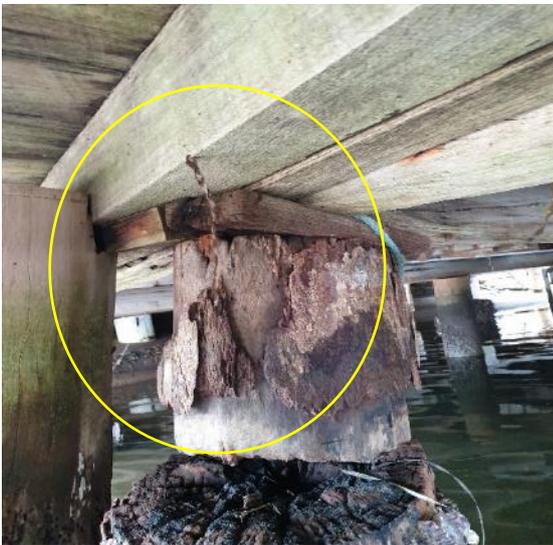
Photograph 22 shows timber wedges, blocking and lack of shoulder support for bearer.

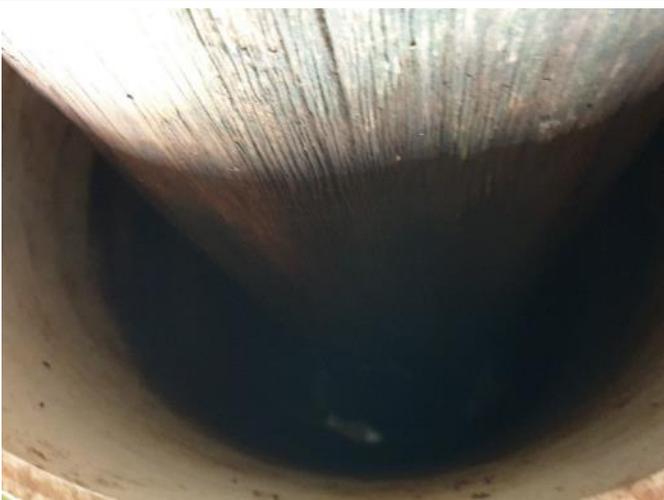
Photograph 24 shows example of many PVC shrouds are NOT filled with concrete (to encase decayed timber piers), even though that would be the anticipated purpose of these shrouds.

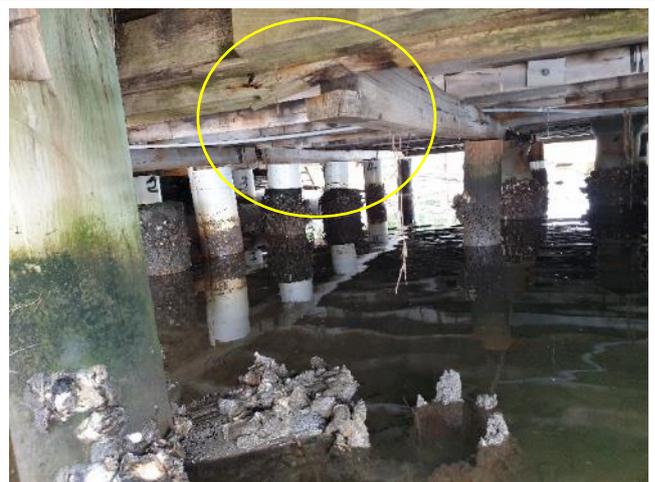
Photograph 25 shows a bearer with no support and furthermore breaking away from joist.

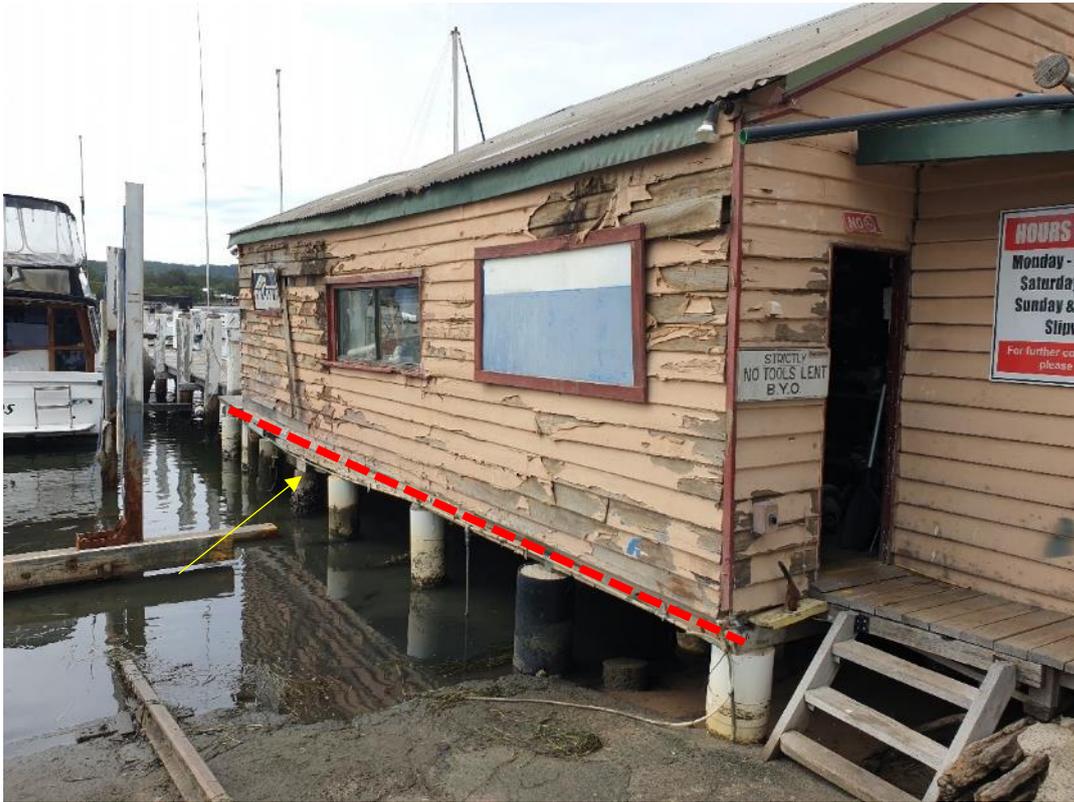
Photograph 30 shows an example of the deformation – sagging along bottom edge of external wall, due to dilapidated subfloor framing and pier subsidence.

| Recommendation: | <p>Effectively the leaning (out of plumb) walls are due to rotation of supporting piers. Additionally, the walls are not level, in horizontal plane.</p> <p>In other words, consequential damage due to failings within subfloor framing and pier supports.</p> <p>As per Subsection 6.1 - Essentially the entire marina building structure will need to be either replaced or strengthened. We anticipate the strengthening measure would be significantly more expensive than rebuilding. All strengthening/rebuilding of the structure must be undertaken in accordance with structural engineering direction.</p> |

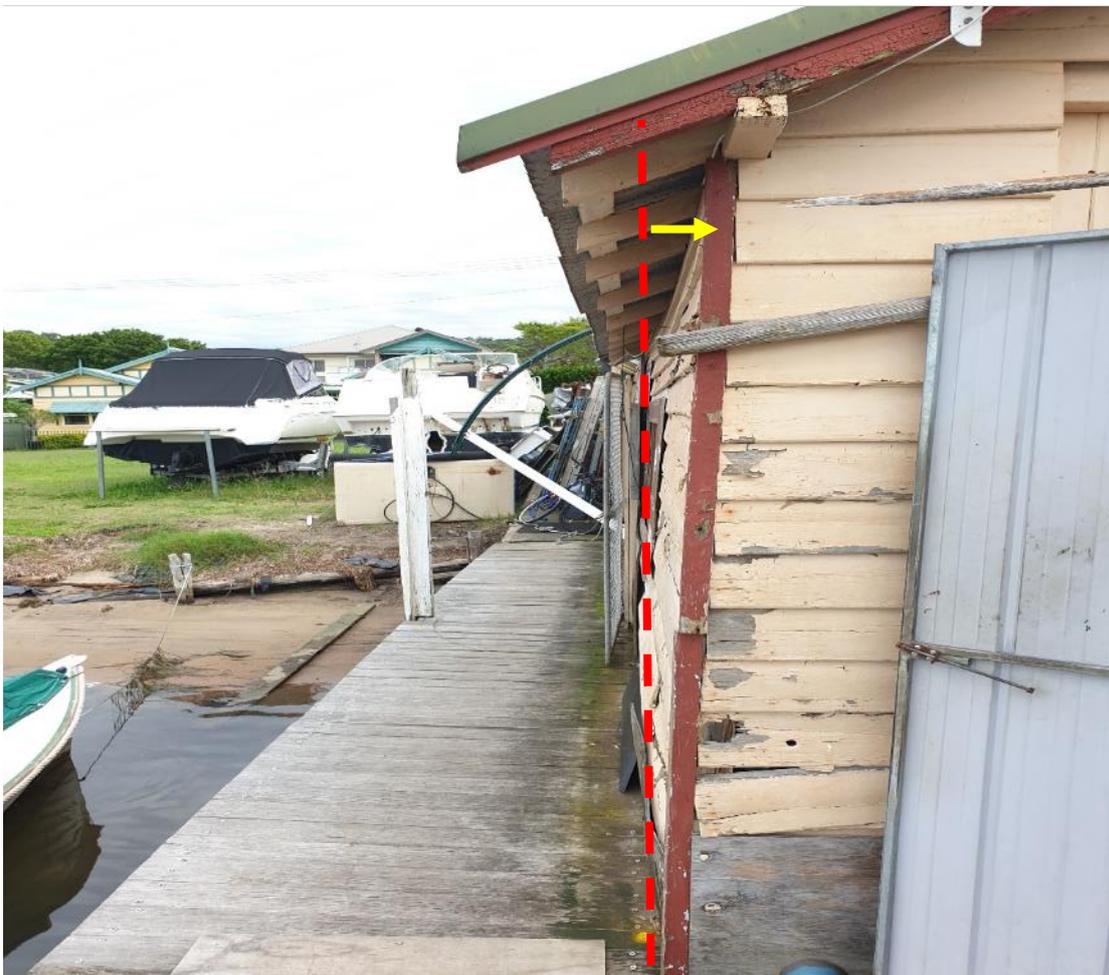
Photograph 31 shows the Eastern corner wall out of plumb, leaning to the right, again due to dilapidated subfloor and pier subsidence.

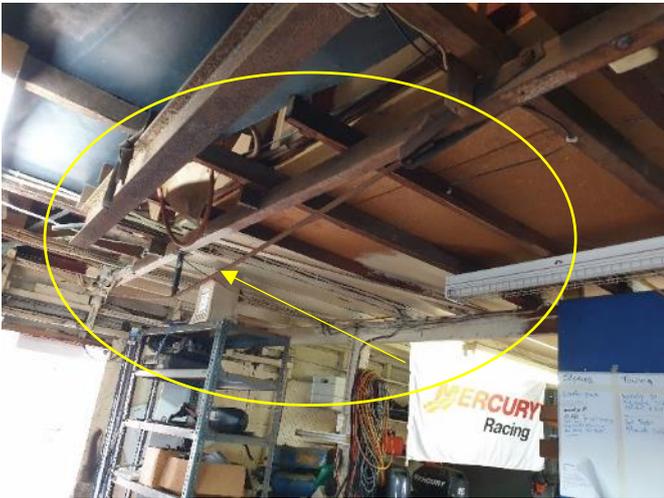
Photograph 34 shows the original ceiling frame has been modified with the addition of steel tension braces to underside of ceiling joists as a means of supporting the mezzanine loads.

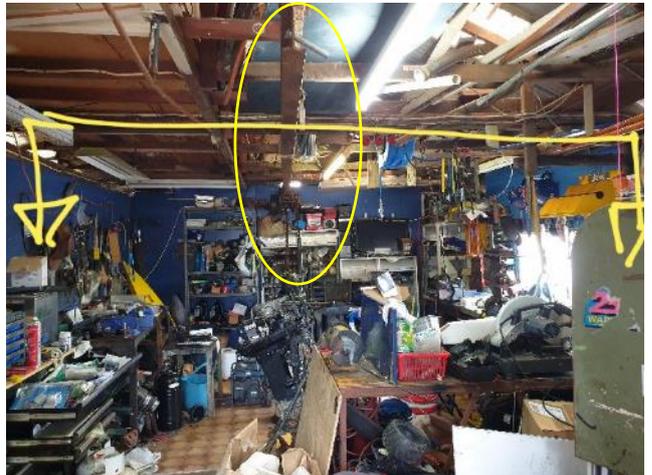
Photograph 35 shows the steel UB crane girder with drawing illustrating the distributed load points to wall framing. The issue with this is, if any live load is applied to the UB steel beam (i.e. engine lifting) then those loads are transferred down to subfloor and piles / piers which have serious structural defects.

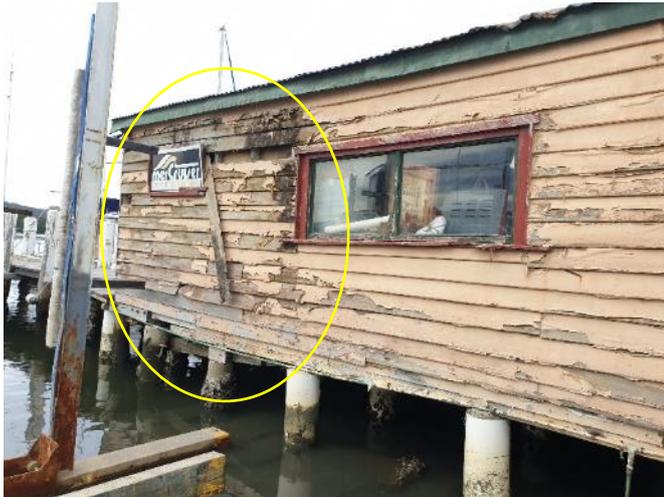
Photograph 38 shows an example of deteriorating weatherboards and failing fixings resulting in fallen cladding.

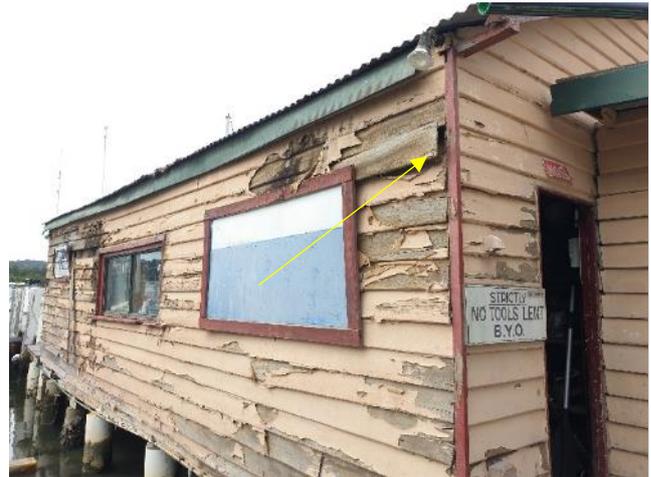
Photograph 39 shows loose weatherboard.

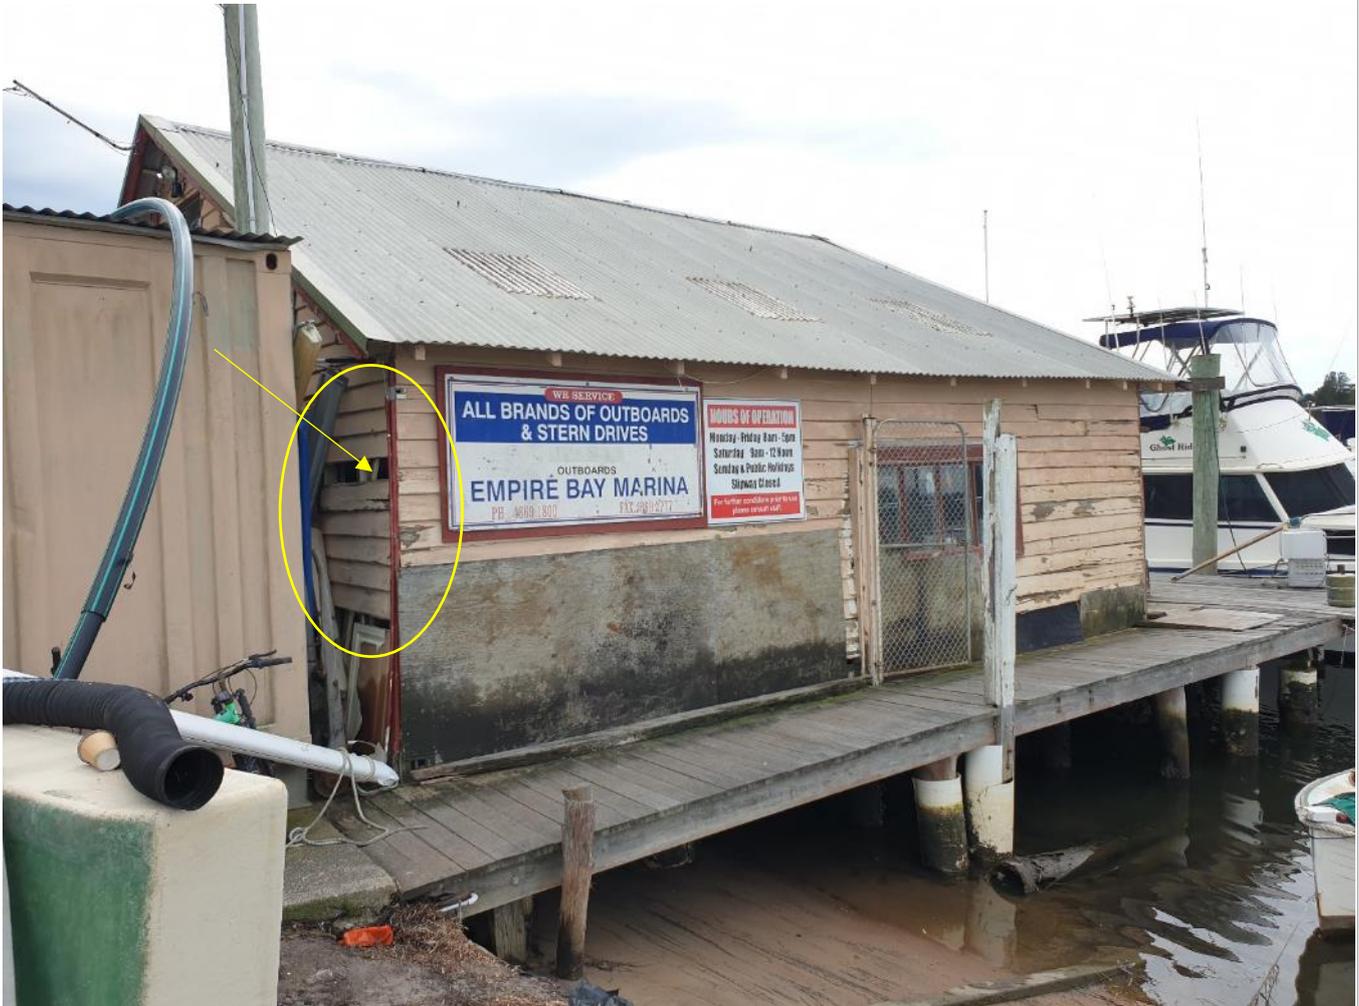
Photograph 40 shows missing weatherboards in which plywood now covers the area.  
Note - where areas are still open to 'weather' elements (rain etc) that is where main switch board is located.

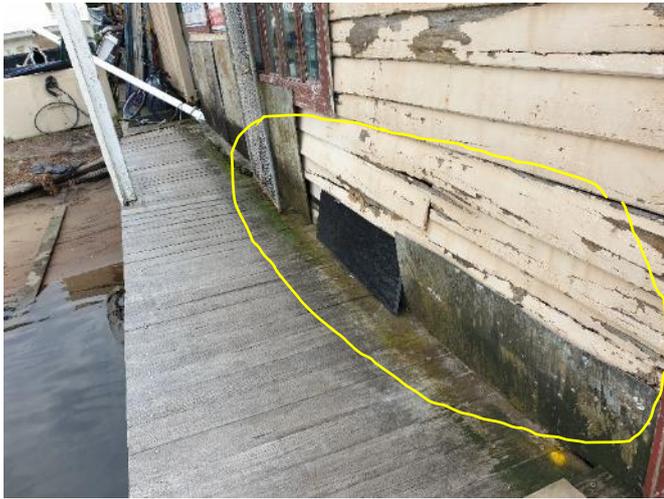
Photograph 41 shows weatherboards have fallen away and then the area has been covered over, but above that is more weatherboards which are loose.

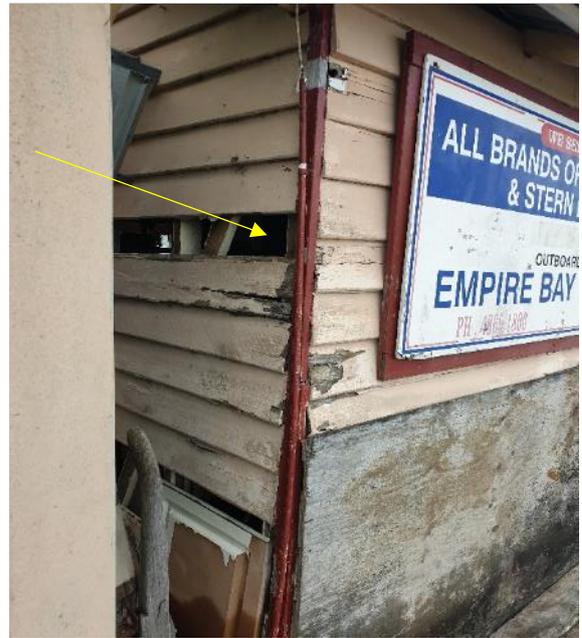
Photograph 42 shows the location where wind driven rain could affected the main switch board located behind this wall.

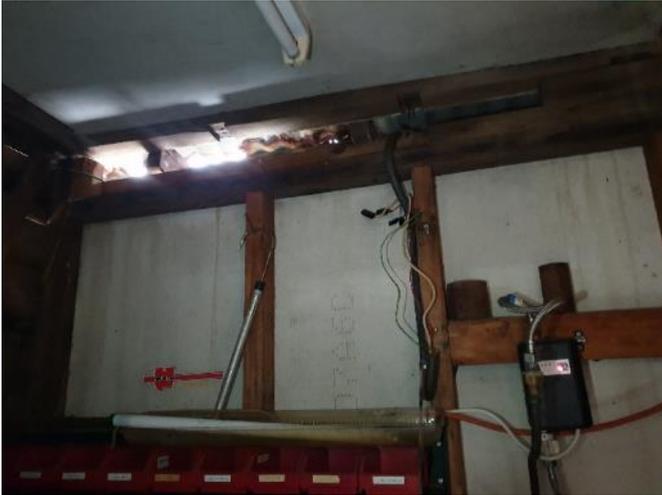
Photograph 43 shows where rusted roof sheeting above outdoor shower area is in fact allowing weather elements to enter a small storage area in the boatshed. Electrical wiring in close proximity.

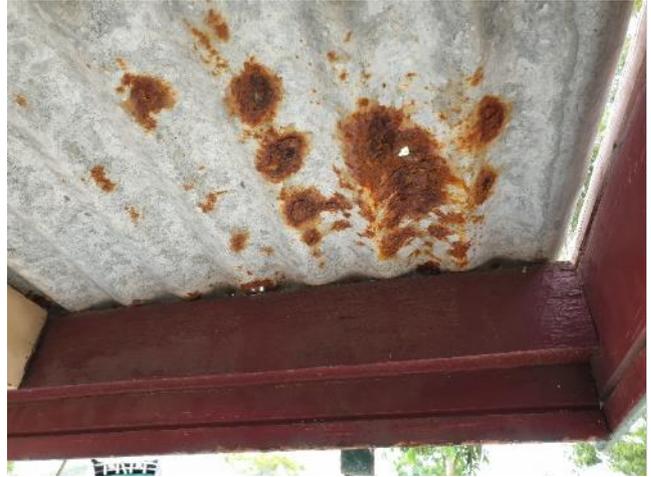
Photograph 44 shows corrosion to roof sheets is occurring.

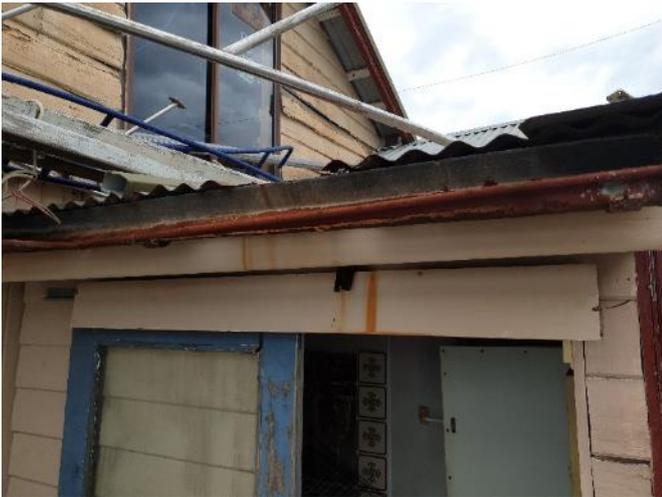
Photograph 45 shows corrosion to guttering.

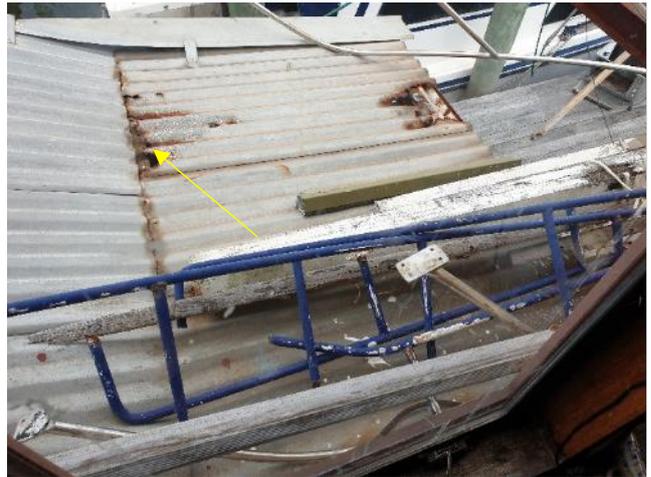
Photograph 46 shows corrosion of roof sheets above outdoor shower area.

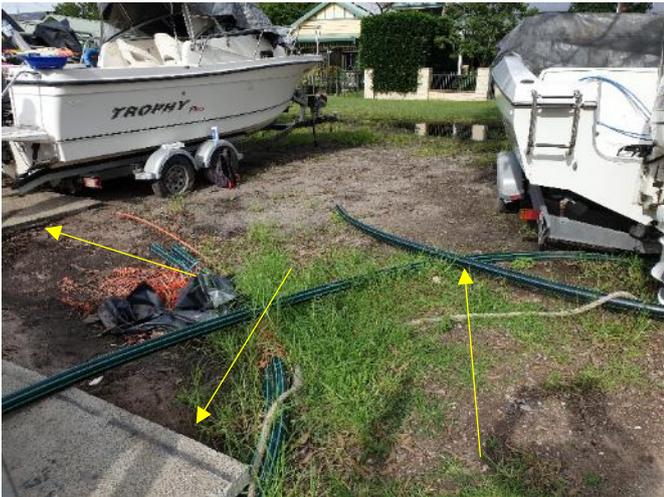
Photograph 49 shows the piping that lays upon the ground – trip hazard. Furthermore, trip hazards exist where concrete meets soil.

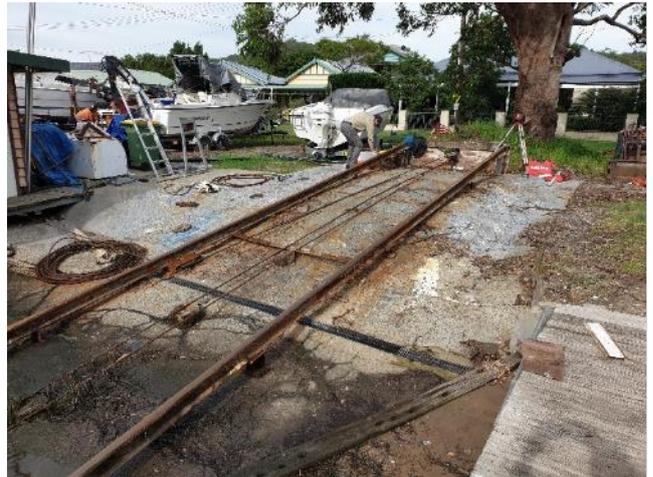
Photograph 50 shows operational slipway and it's fixtures are fully accessible to the general public.

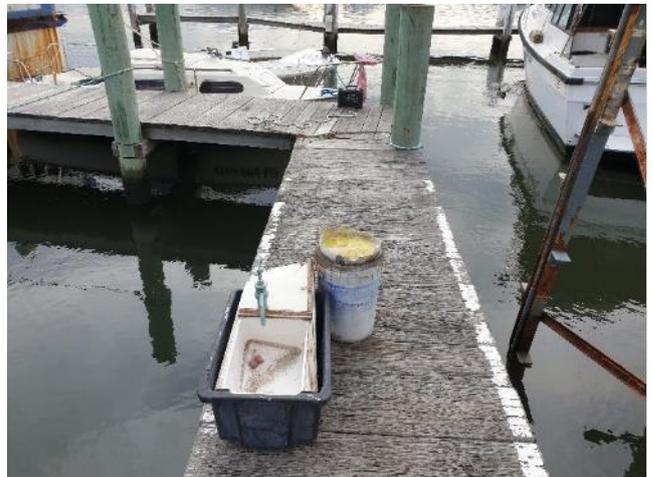
Photograph 52 shows stored items on jetty which hinders safe passage, especially in the case of an emergency, or simply if a member of the public failed to see and trip over these items.

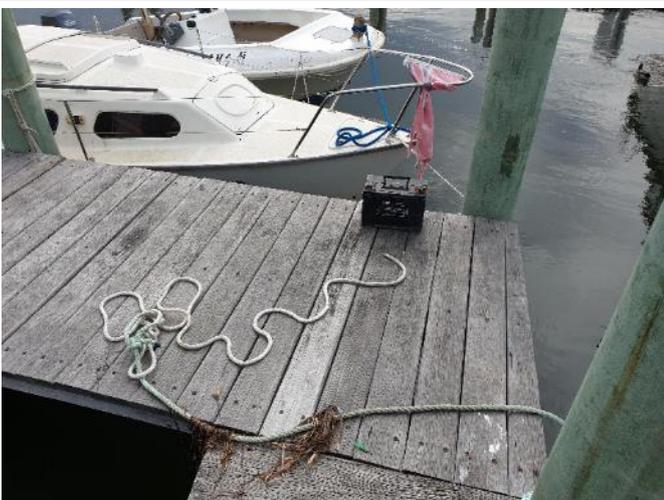
Photograph 53 shows more potential trip hazards.

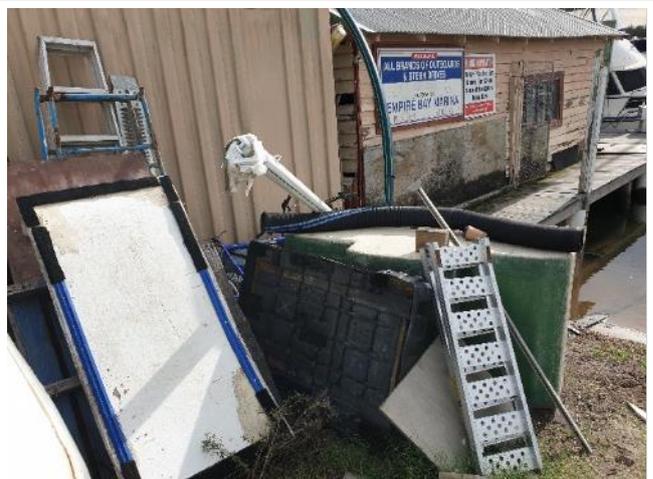
Photograph 54 shows stored items to Southern elevation that hinders safe egress, especially in an emergency situation.

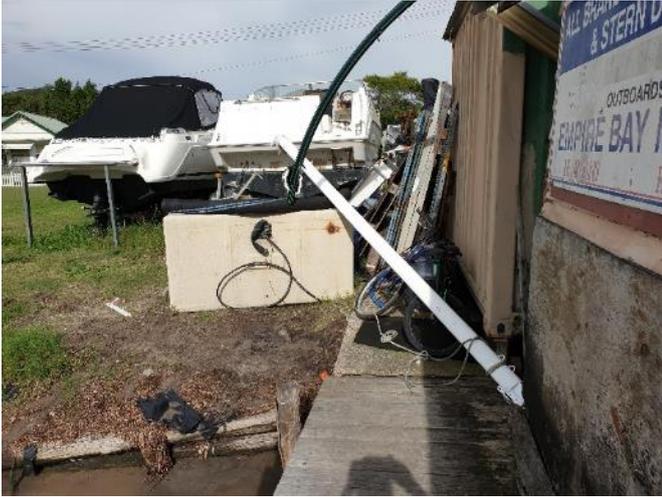
Photograph 55 shows another view of Southern elevation with stored items preventing a safe passage for general public.

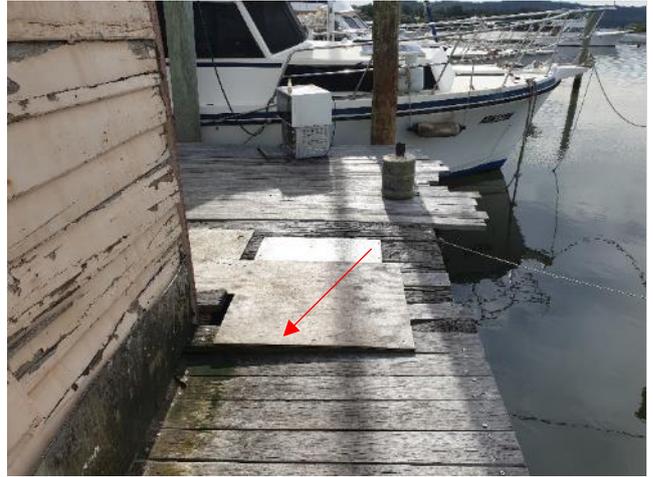
Photograph 56 shows trip hazard to jetty area.

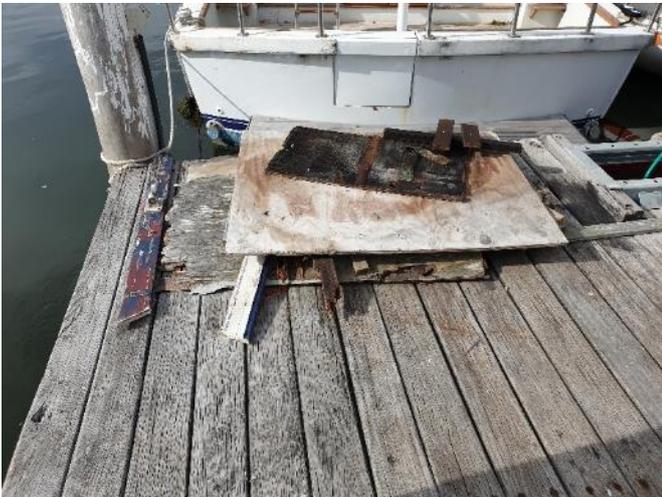
Photograph 57 shows stored items on jetty, again potential safety hazard in the event of an emergency, or simply if a member of the public failed to see and trip over these items.

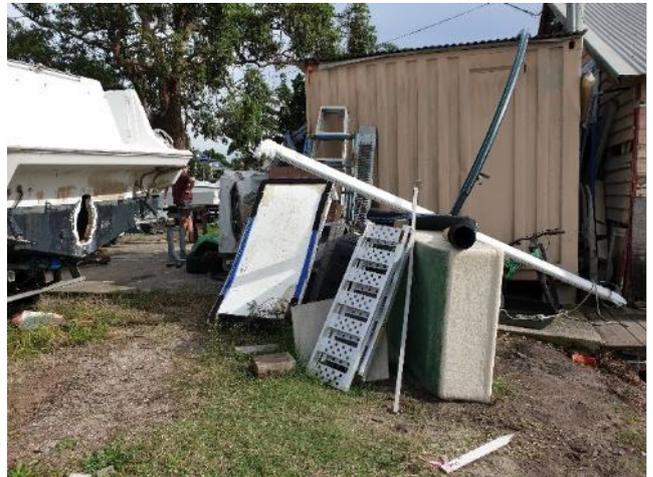
Photograph 58 shows many obstacles that may inflict harm to general public in the case of an emergency.

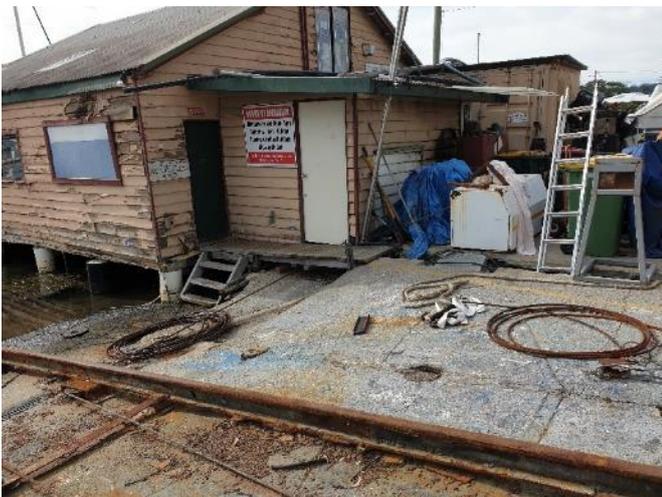
Photograph 59 shows another view of 'work' zones fully accessible by general public, with **no** signage to advise them of the hazards that exist associated with a 'working' marina.

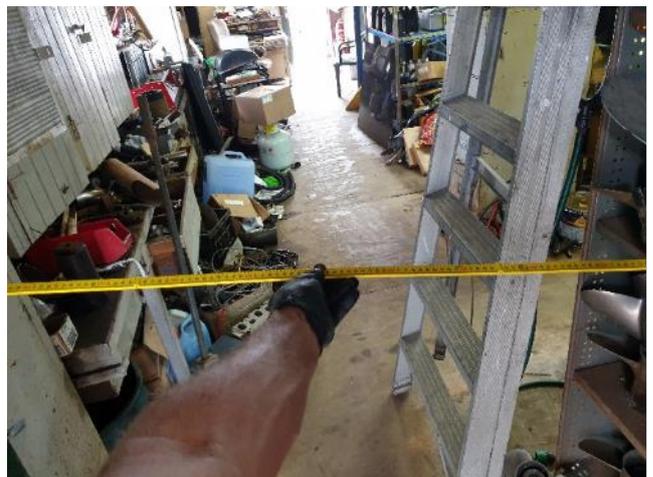
Photograph 60 shows general access width of 700mm wide at this location. Note all the stored items on the floor, which can pose a risk in the event of an emergency.

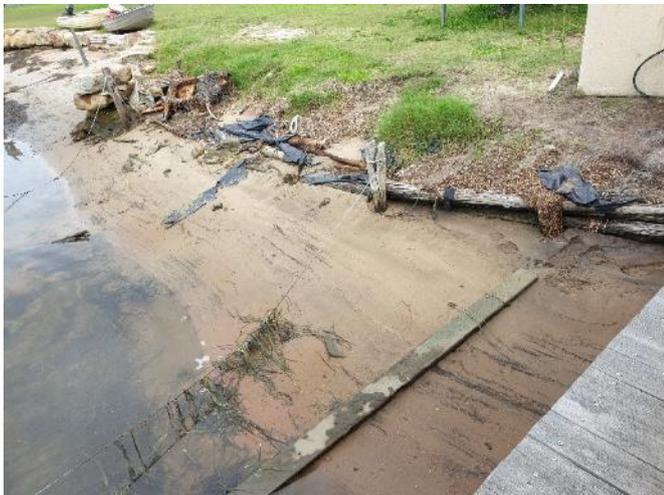
Photograph 63 shows Southern retaining wall in a collapsed / eroded state.

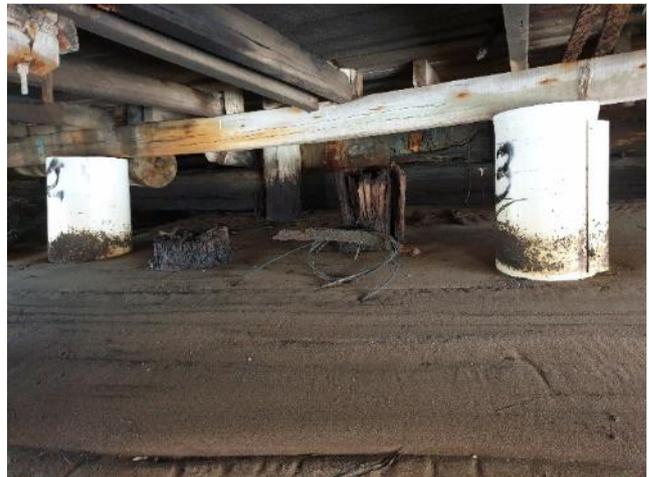
Photograph 64 shows retaining wall under boatshed with general deterioration.

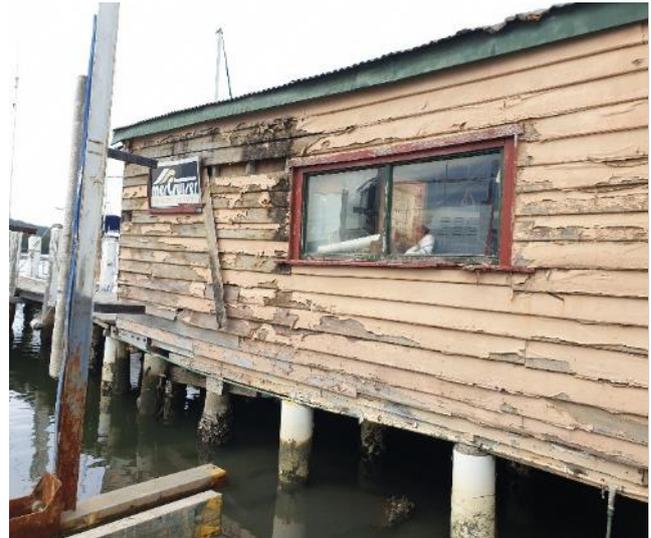
Photograph 68 shows any peeling paint is highly probably to fall into waterways causing potential harm to aquatic marine life. Note – recreational fishing carried out within the area.
