## BUILDING CONDITION REPORT

| Subject property address: | Empire Bay Marina<br>16B Sorrento Rd, Empire Bay NSW 2257 |
| Date of inspection: | 2 <sup>nd</sup> April 2020 |
| Inspection purpose: | Inspect and assess the condition of the structures comprising the Empire Bay Marina. The subject site is shown on Figure 1 |

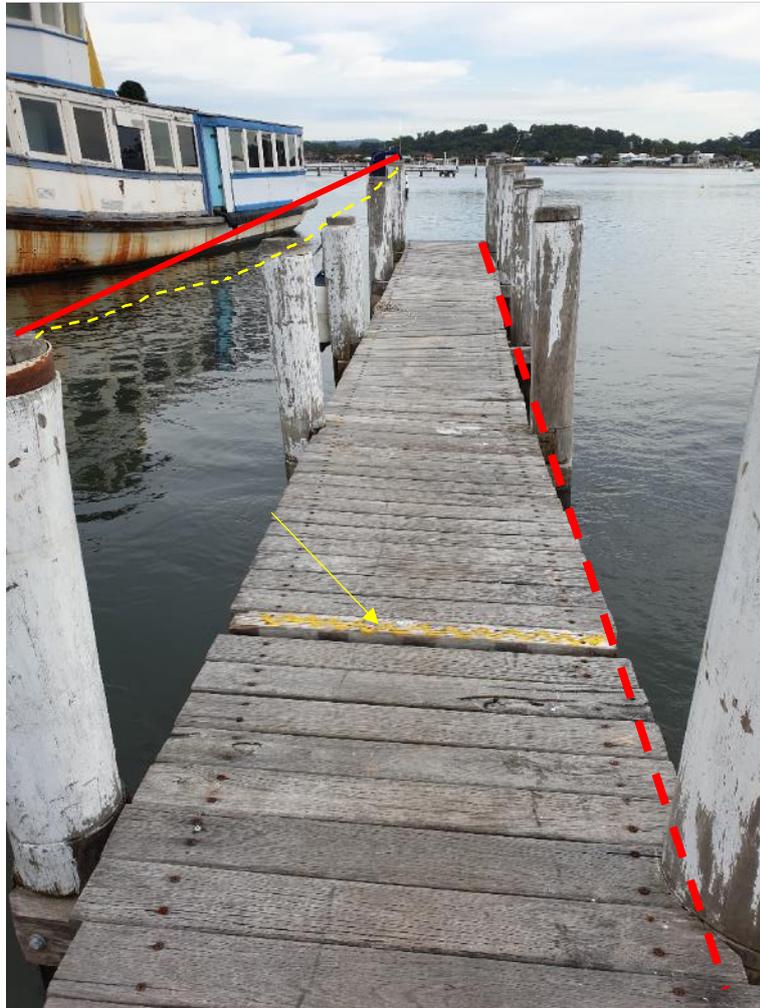
Photograph 69 shows the main jetty that has subsidence due to previous impact incident by moored ferry. The 'yellow' section of decking is an inadequate repair, leading to a trip hazard.

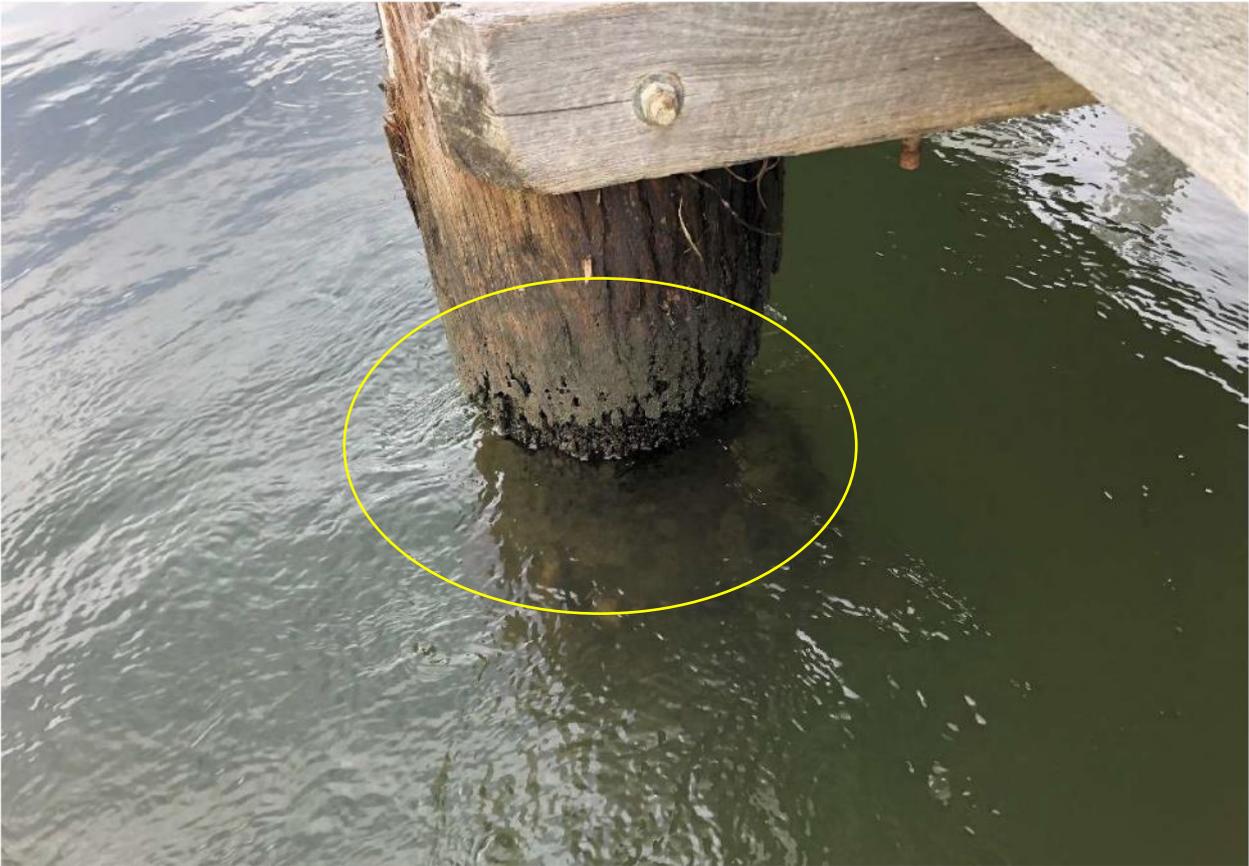
Photograph 70 shows an example of sectional loss as identified by structural engineer.

- 4.1.4 The Jetty structures above water level are in reasonable conditions with some areas of decking boards requiring replacement.
- 4.1.5 The piles on the main jetty should be replaced where there has been significant section loss to ensure structural adequacy under anticipated loads.

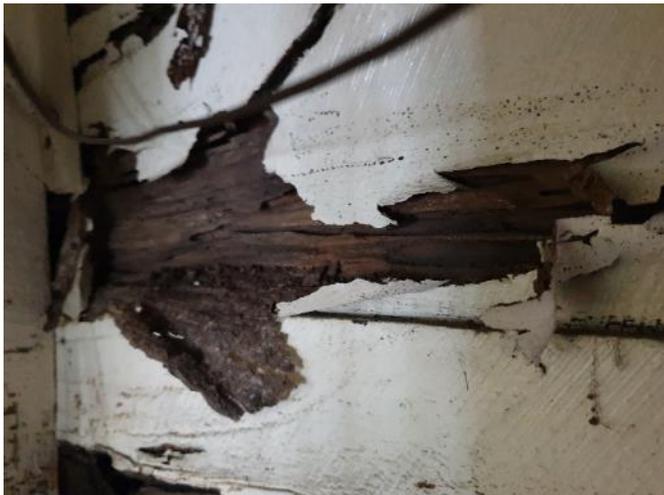
Photograph 75 shows termite damage to weatherboards.

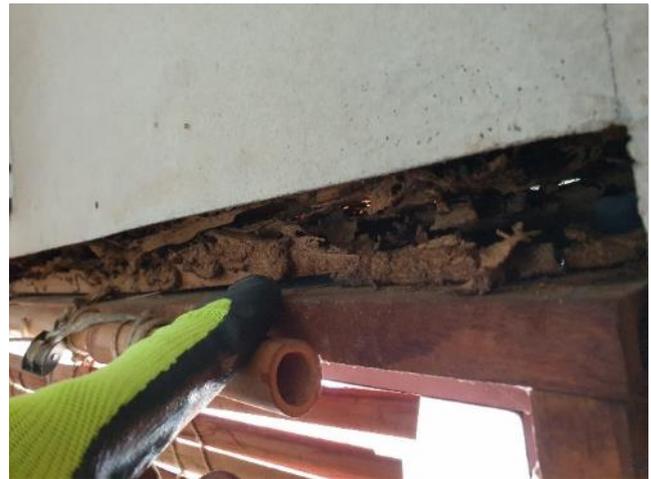
Photograph 76 shows termite damage to timber wall framing, located to loft / mezzanine area to Western wall.

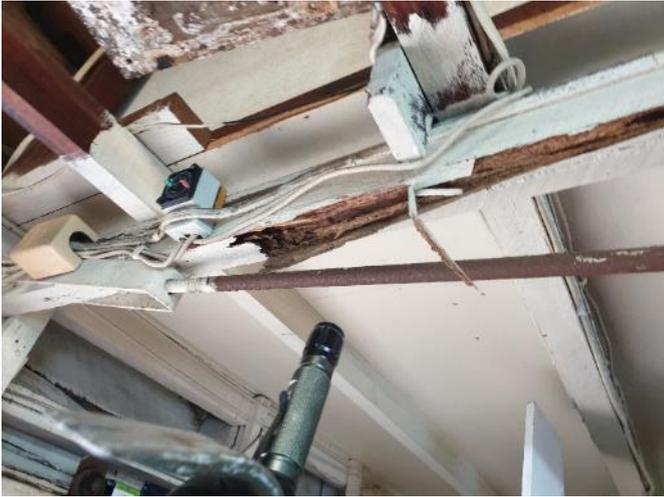
Photograph 77 shows termite damage ceiling joist which are in fact acting as mezzanine floor joists. Note - steel tension brace connected to subject timber. There's a heavy 'structural' reliance on this timber member.

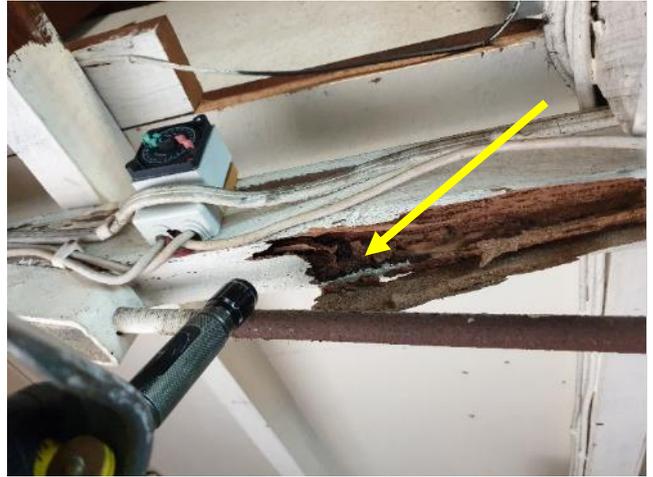
Photograph 78 shows large sectional loss to the structural timbers due to termite.

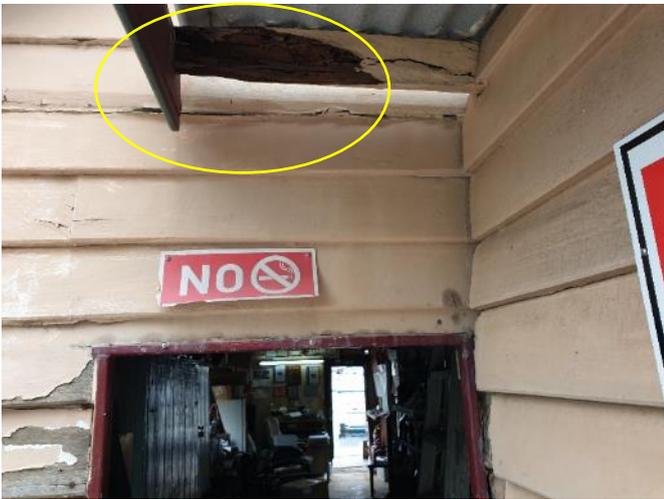
Photograph 79 shows obvious termite damage to rafters above door entry point.

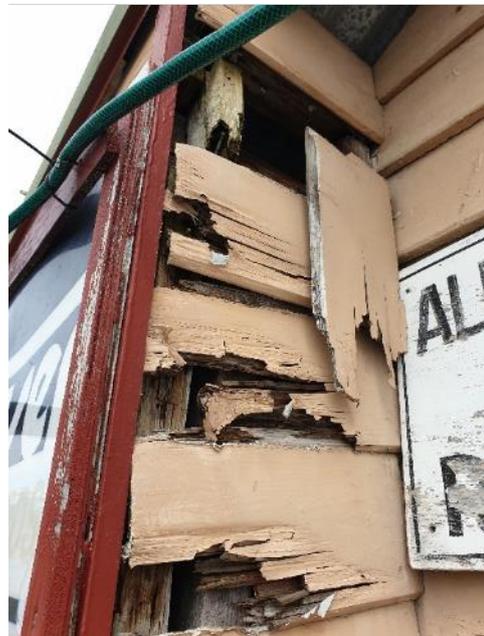
Photograph 80 shows obvious fungal decay (wood rot) to outdoor shower location.

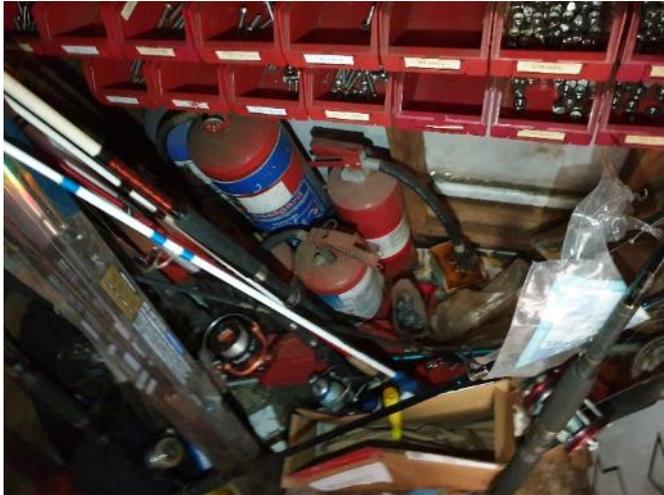
Photograph 81 shows stored fire extinguishers in hard to find location. (Maybe old equipment)
