Structural Report
for
Empire Bay Marine Structure
for Crown Lands

Project:	16B Sorrento Rd, Empire Bay
Document Title:	Structural Report
Client:	Department of Planning and Environment – Crown Lands
Revision:	D
Status:	Issue for Information
Revision Date:	18 November 2022
Author:	Karlie Collis
Verifier:	Neil Petherbridge

Northrop Consulting Engineers Pty. Ltd. ("Northrop") has developed this report in order to assess the existing condition of the boatshed, jetties, slipway and hardstand at 16B Sorrento Road, Empire Bay.

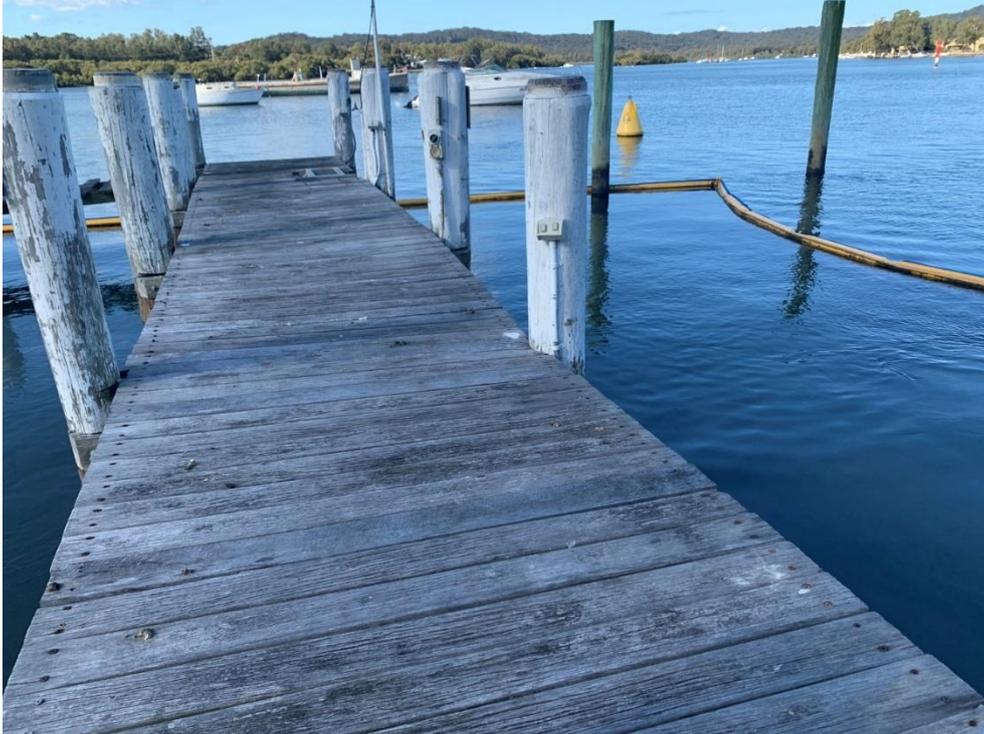
Figure 2 - Jetty attached to boatshed

The attached jetty is shown in Figures 2, 3 and 6-10. The jetty showed evidence of settlement/displacement of timber piles. The length of jetty parallel to the shoreline was in a highly dilapidated state with floorboards missing and horizontal displacement of the piles. Timber piles also showed a reduction in cross-sectional area just below water level (refer Figures 8 and 9). Timber pile softening was noted to the inside face of the pile as shown in Figure 6 where timber was easily removed by hand. Figure 48 below shows the measured change in levels of the structures between 2020 and 2022. Note that the jetty has been largely unused during this time and as such has been subject to minimal imposed loads apart from wave action and tidal effects. Even so, the jetty has experienced between 18mm and 62mm of vertical displacement which, in my opinion, suggests inadequate pile bearing materials or failure of the pile itself.

The jetties have, in my opinion, suffered settlement and displacement issues most likely due to inadequate pile depth. Existing piles are considered structurally inadequate due to the decay and loss of section at water level. Both jetties have in my opinion passed their service life.

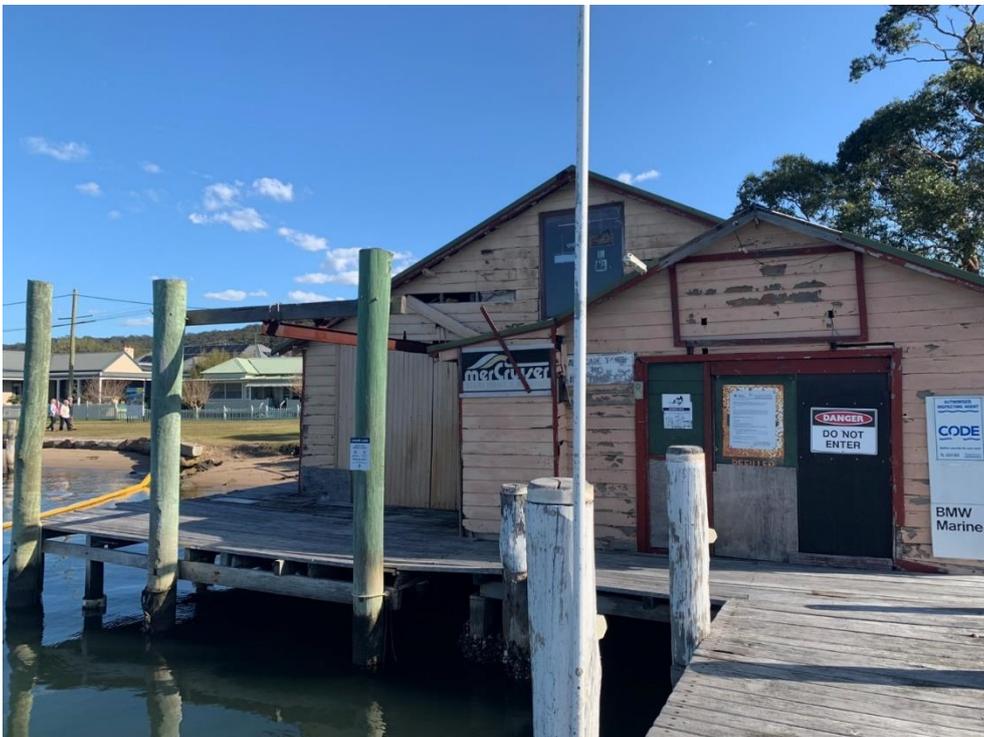
Figure 3 - Water-side of boatshed

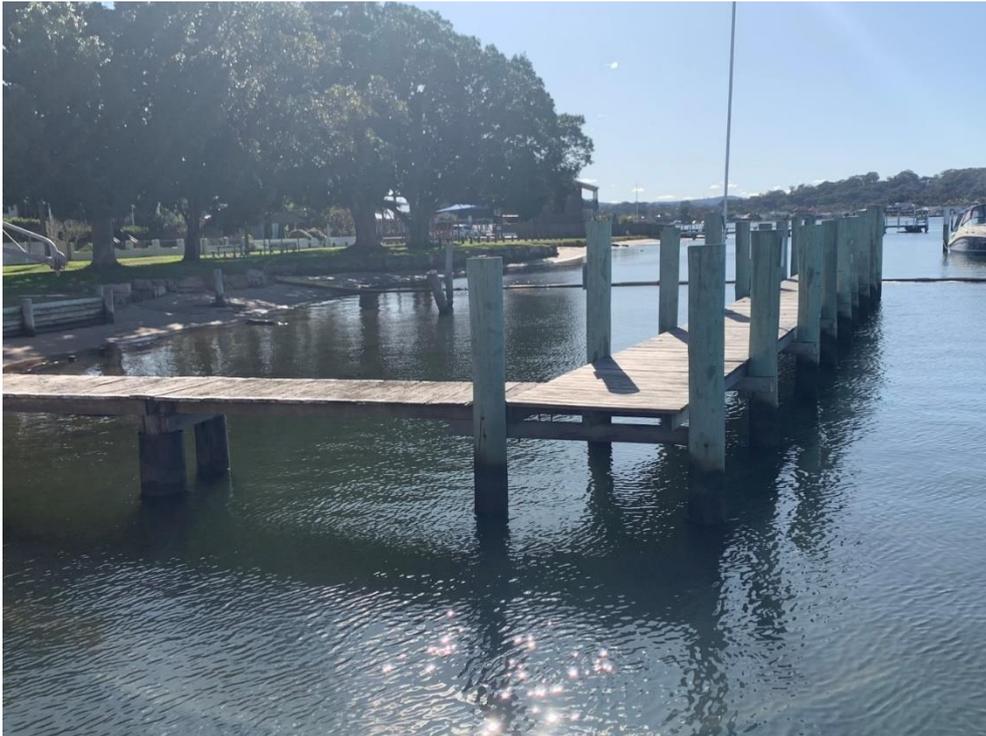
Figure 4 - Unattached northernmost jetty

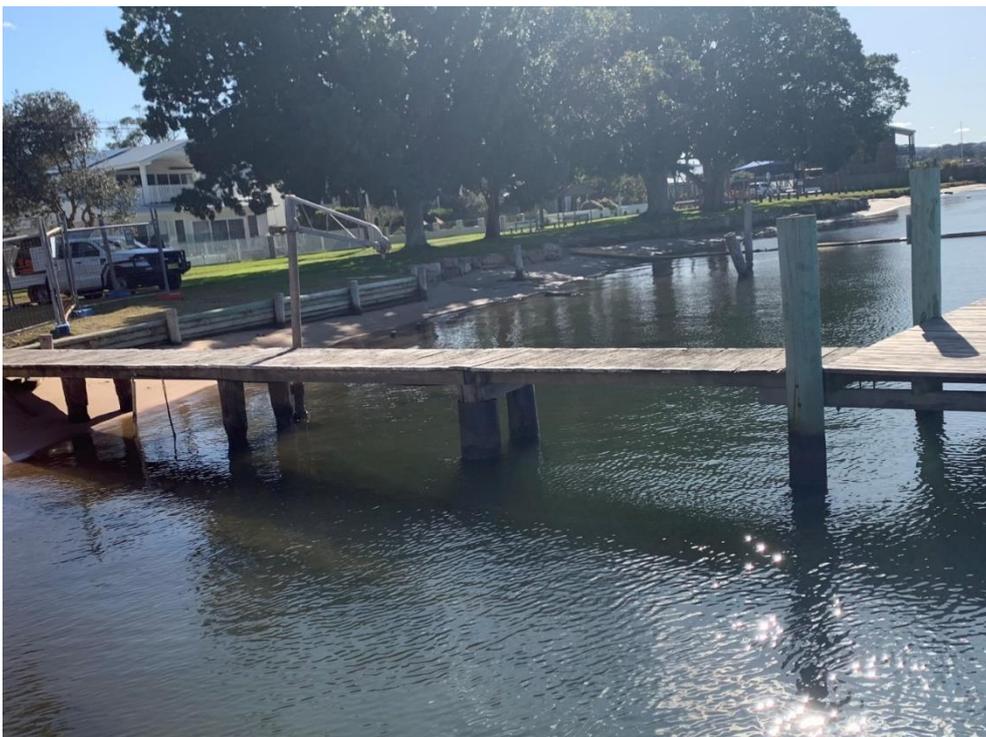
Figure 5 - Unattached northernmost jetty where section loss of piles can be seen just above water level.

The unattached jetty appeared to have suffered less displacement, although piles were noted to have suffered section loss just below water level (refer Figure 5).

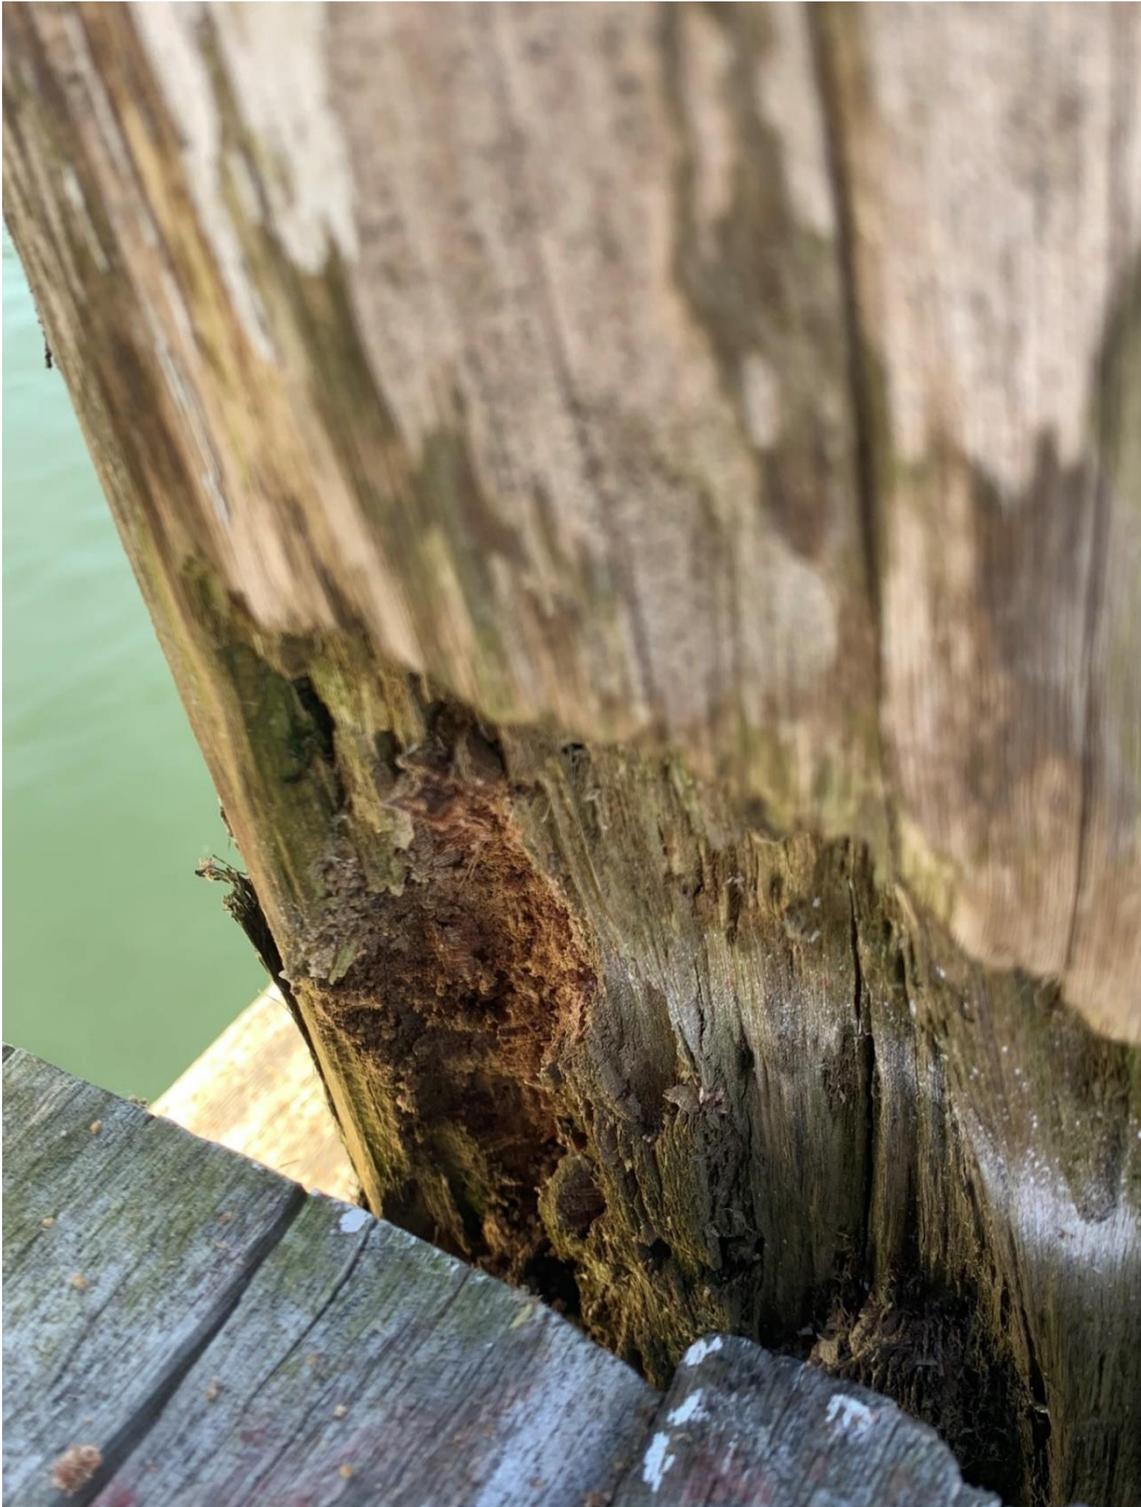
Figure 6 – Rot to timber pile in attached jetty

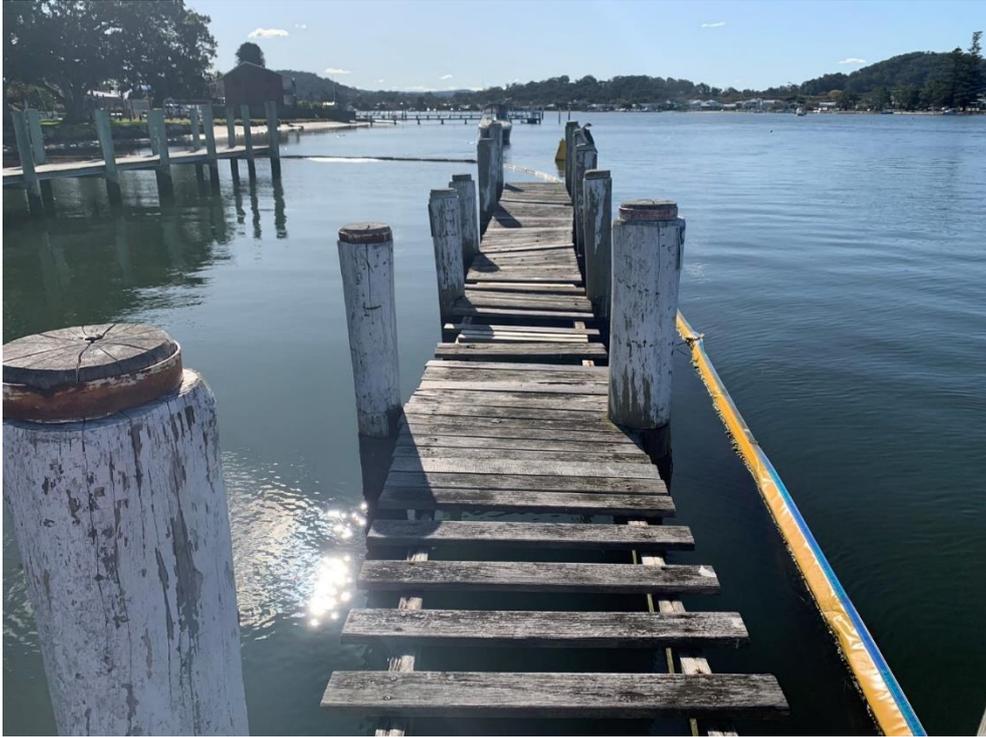
Figure 7 - Attached jetty with missing decking boards, obvious displacement and deteriorated timber members

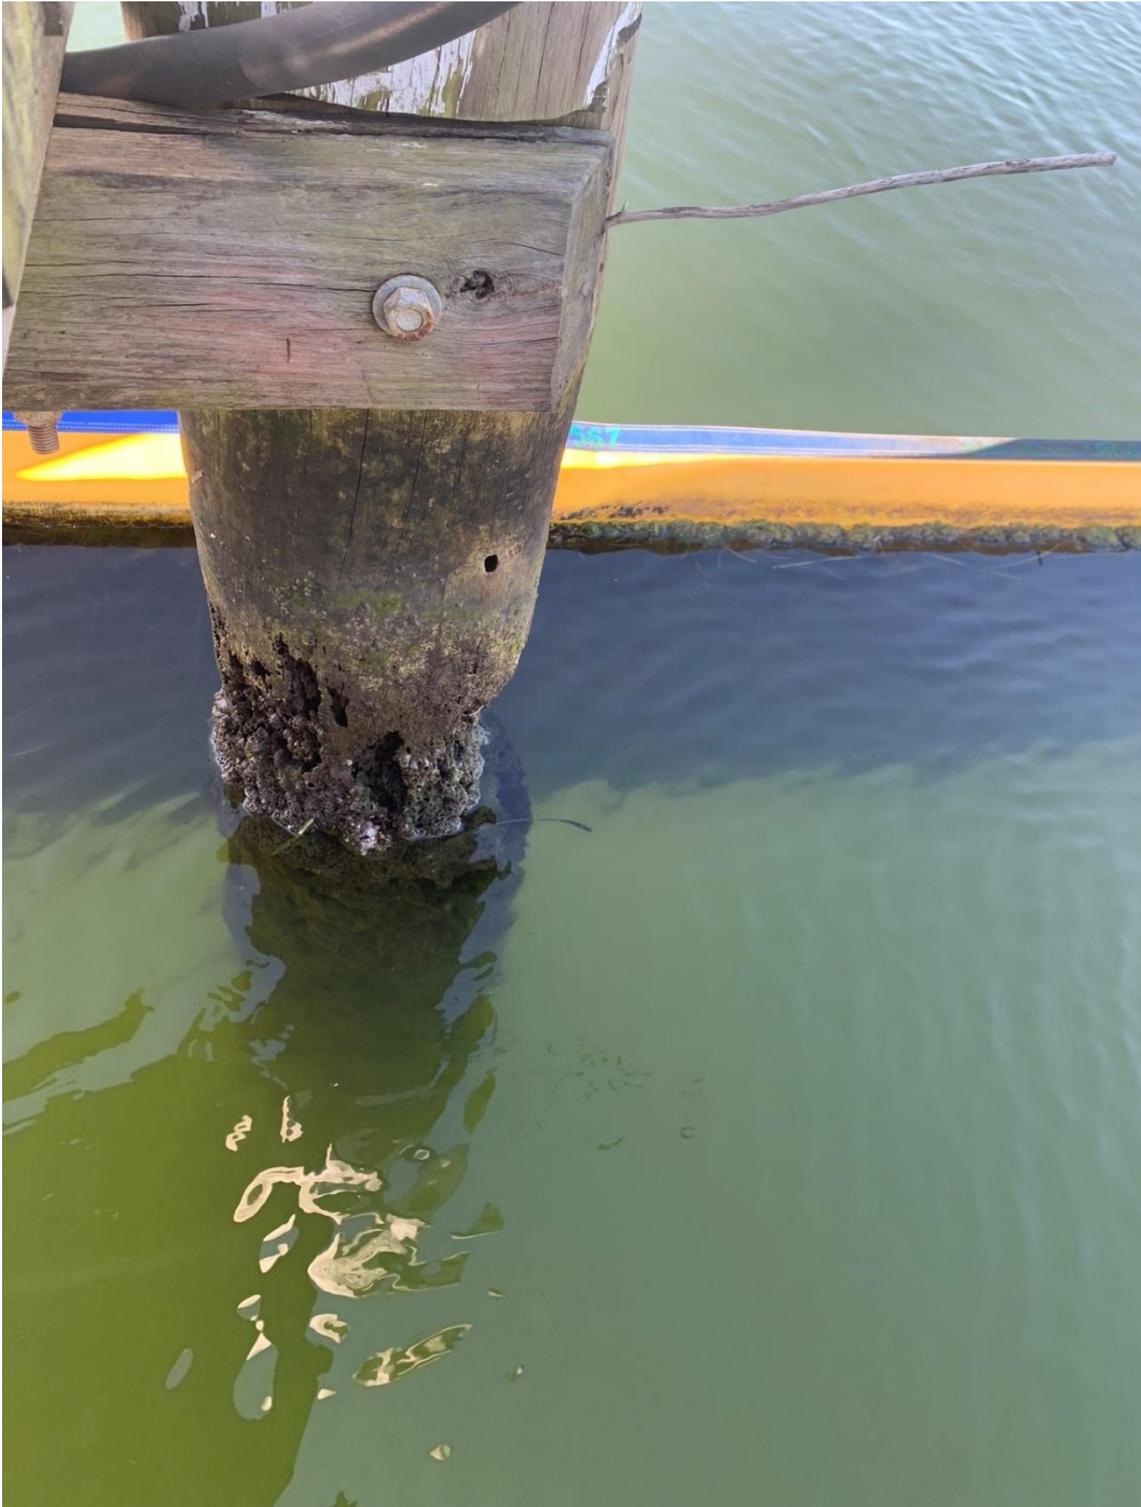
Figure 8 - Pile to attached jetty showing loss of section

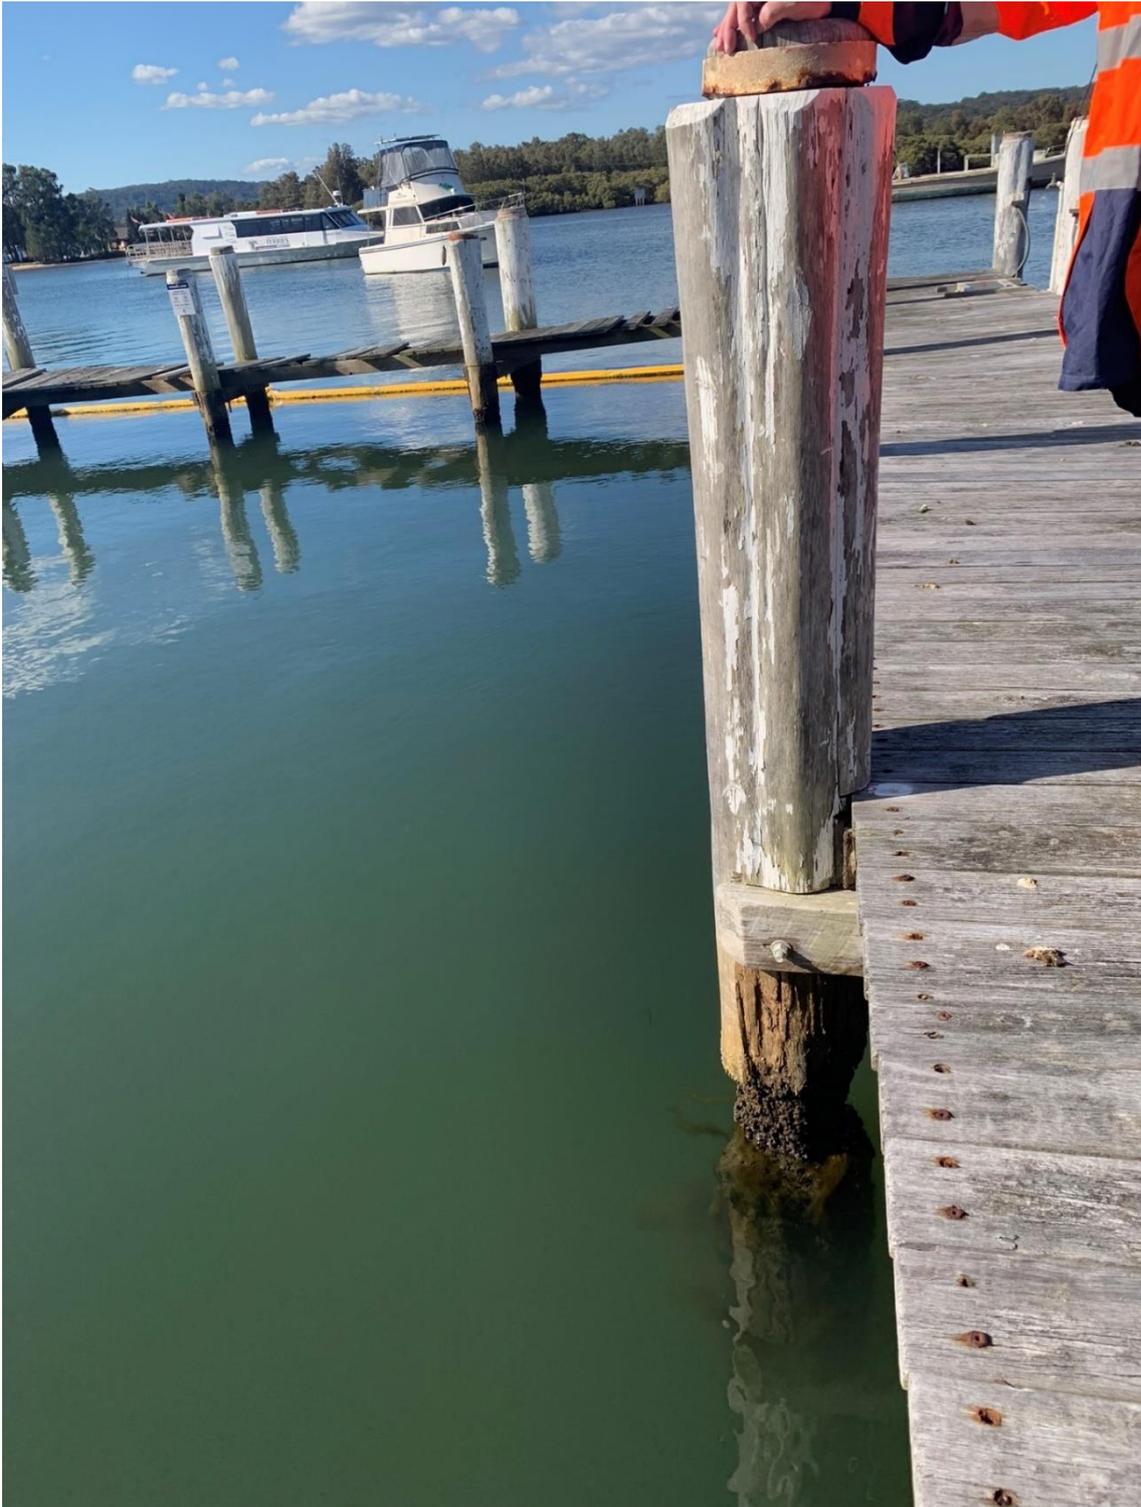
Figure 9 - Pile to attached jetty with section loss at water level

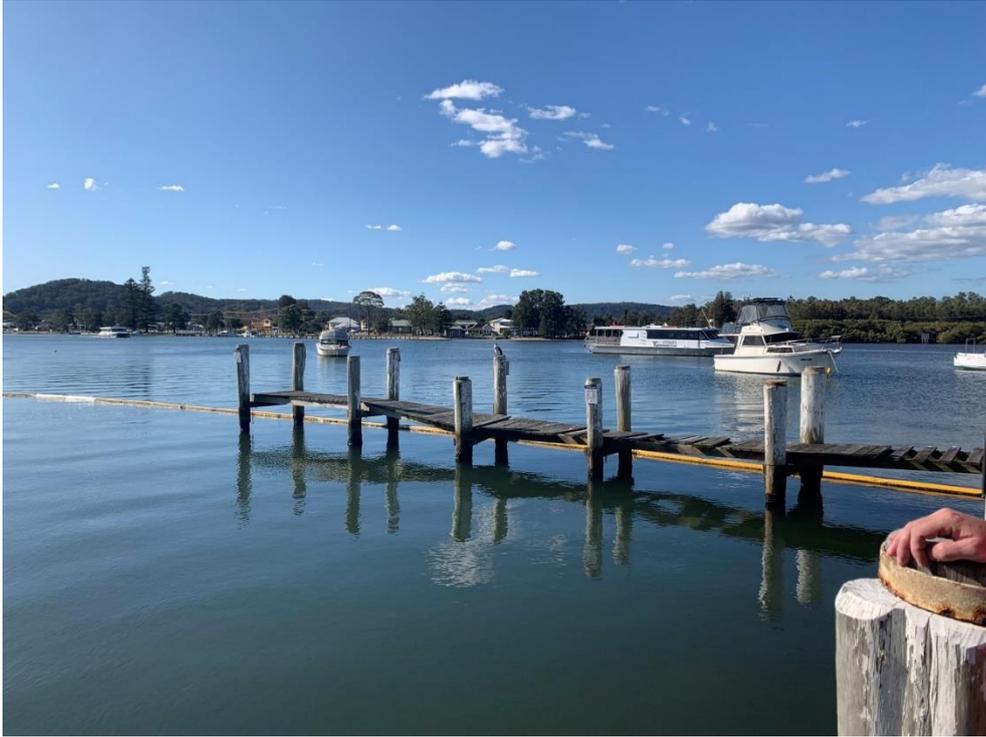
Figure 10 - Attached jetty with missing decking boards, displacement and deteriorated timber members

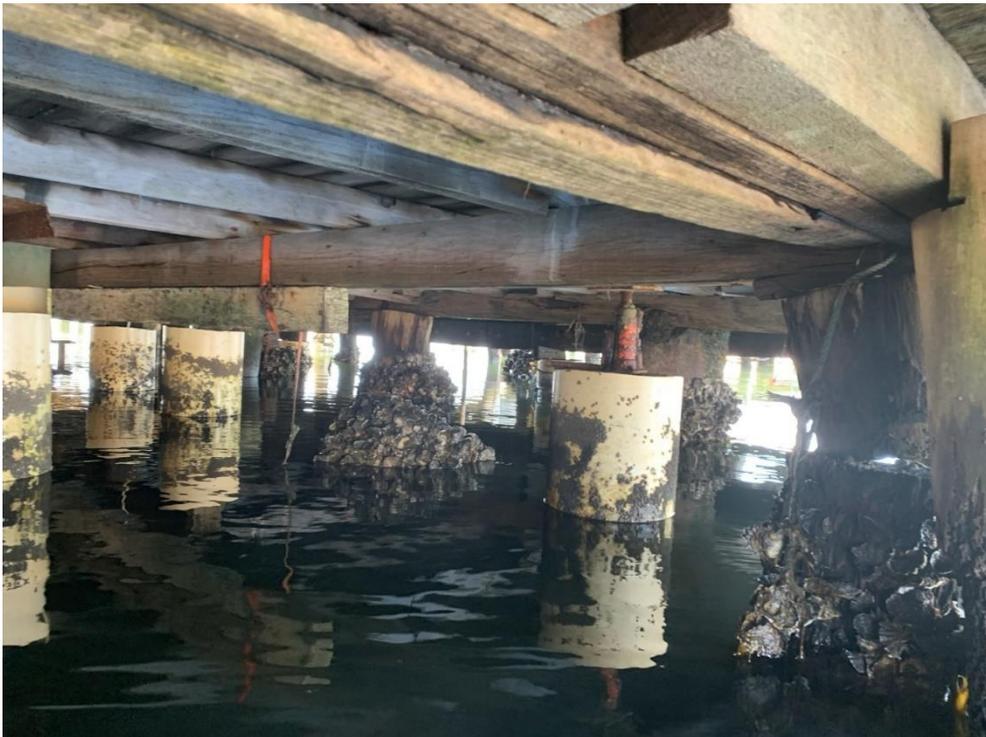
Figure 11 - Subfloor structure with ratchet straps, ropes, carjacks and loose packing used in previous remediation attempts

Figures 11-31 show the condition of the subfloor structure of the boatshed. The subfloor framing exhibited several structural issues including inadequate, ad-hoc repair attempts using ratchet straps, car jacks and various packing measures.

Piles were constructed of timber, some with PVC pipe surrounds, some concrete filled. Failed piles supporting the structure are shown in Figures 11, 13, 15, 18, 19, 23, 27, 29 and 30. Much of the subfloor floor framing was packed by various means with no fasteners or tie-down noted between the packing elements. Vertical subsidence experienced between 2020 and 2022 (refer Figure 48) is significant in magnitude. It suggests that, in my opinion, inadequate pile bearing materials or failure of the piles themselves.

Following my inspections and review, I am of the opinion that the boatshed subfloor structure is in a dilapidated and structurally unsound state and is at risk of collapse due to adverse weather events or vertical loading of the floor. I recommend that access to the boatshed and surrounds is strictly prohibited for safety reasons.

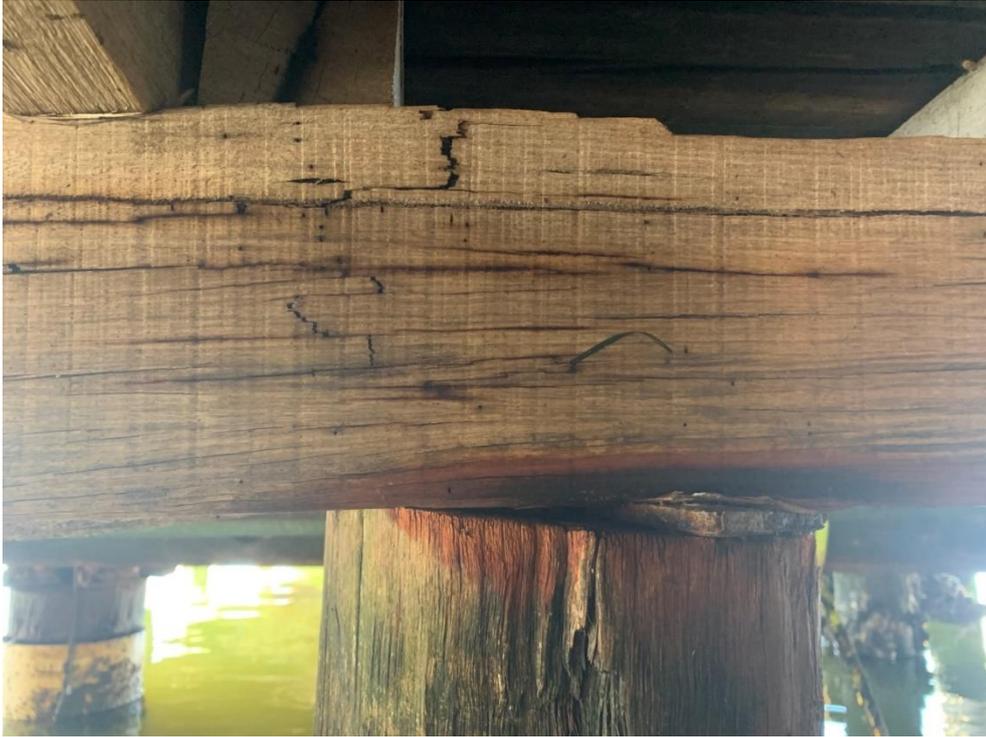
Figure 12 – Failed bearer in subfloor, resulting in structurally unsound support to structure over

Many timber bearers and joists showed signs of failure in bending and/or section loss. Those with cracking to the tension face (midspan in bottom and in the top over supports) have failed in bending. Examples can be seen in Figures 12, 17, 20, 27 and 28. Others have failed due to material deterioration such as those shown in Figures 22, 23, 24, 25 and 26.

Where members have failed and or are unsupported, the floor system is, in my opinion, not structurally sound and unable to support imposed loads.

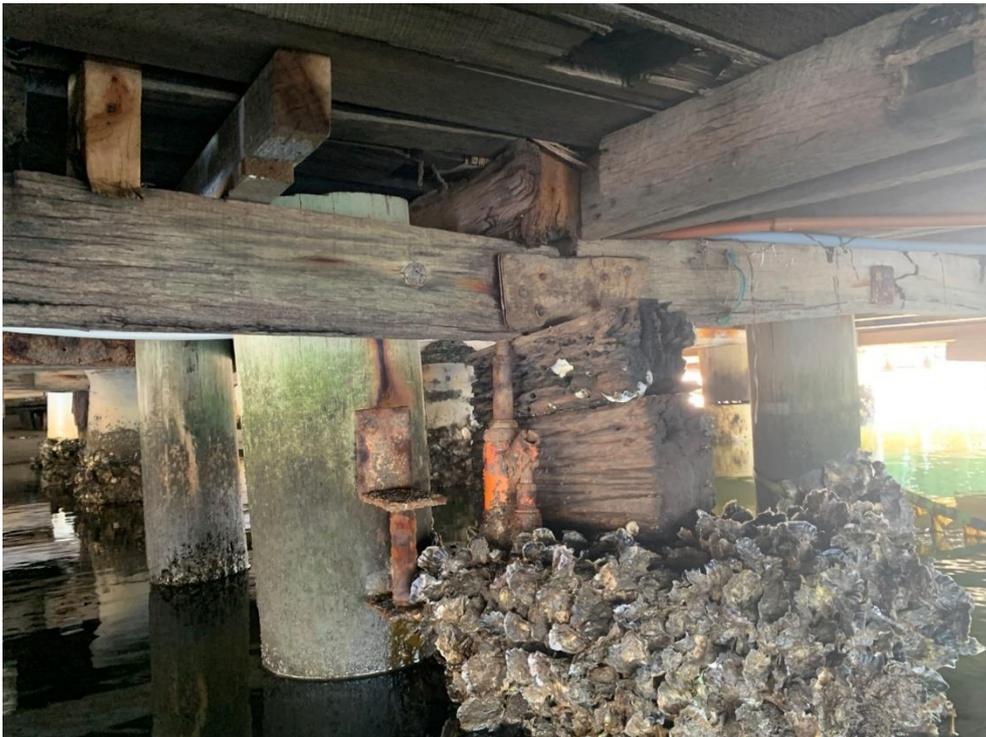
Figure 13 - Subfloor structure with car-jack, deteriorated timber packer and failed bearer (to right)

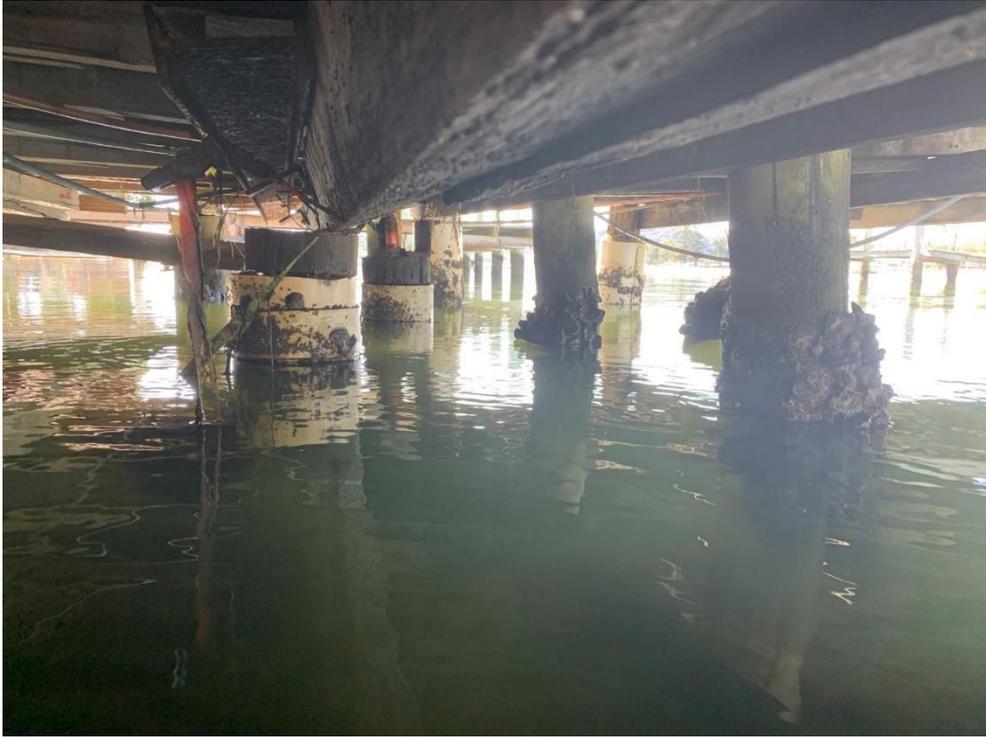
Figure 14 - Subfloor structure with rotated bearer and deteriorated timbers

A number of bearers appeared largely unsupported (refer Figures 14 and 16). Other bearers had ad-hoc support using car jacks (noted to be corroded) and corroded fasteners.

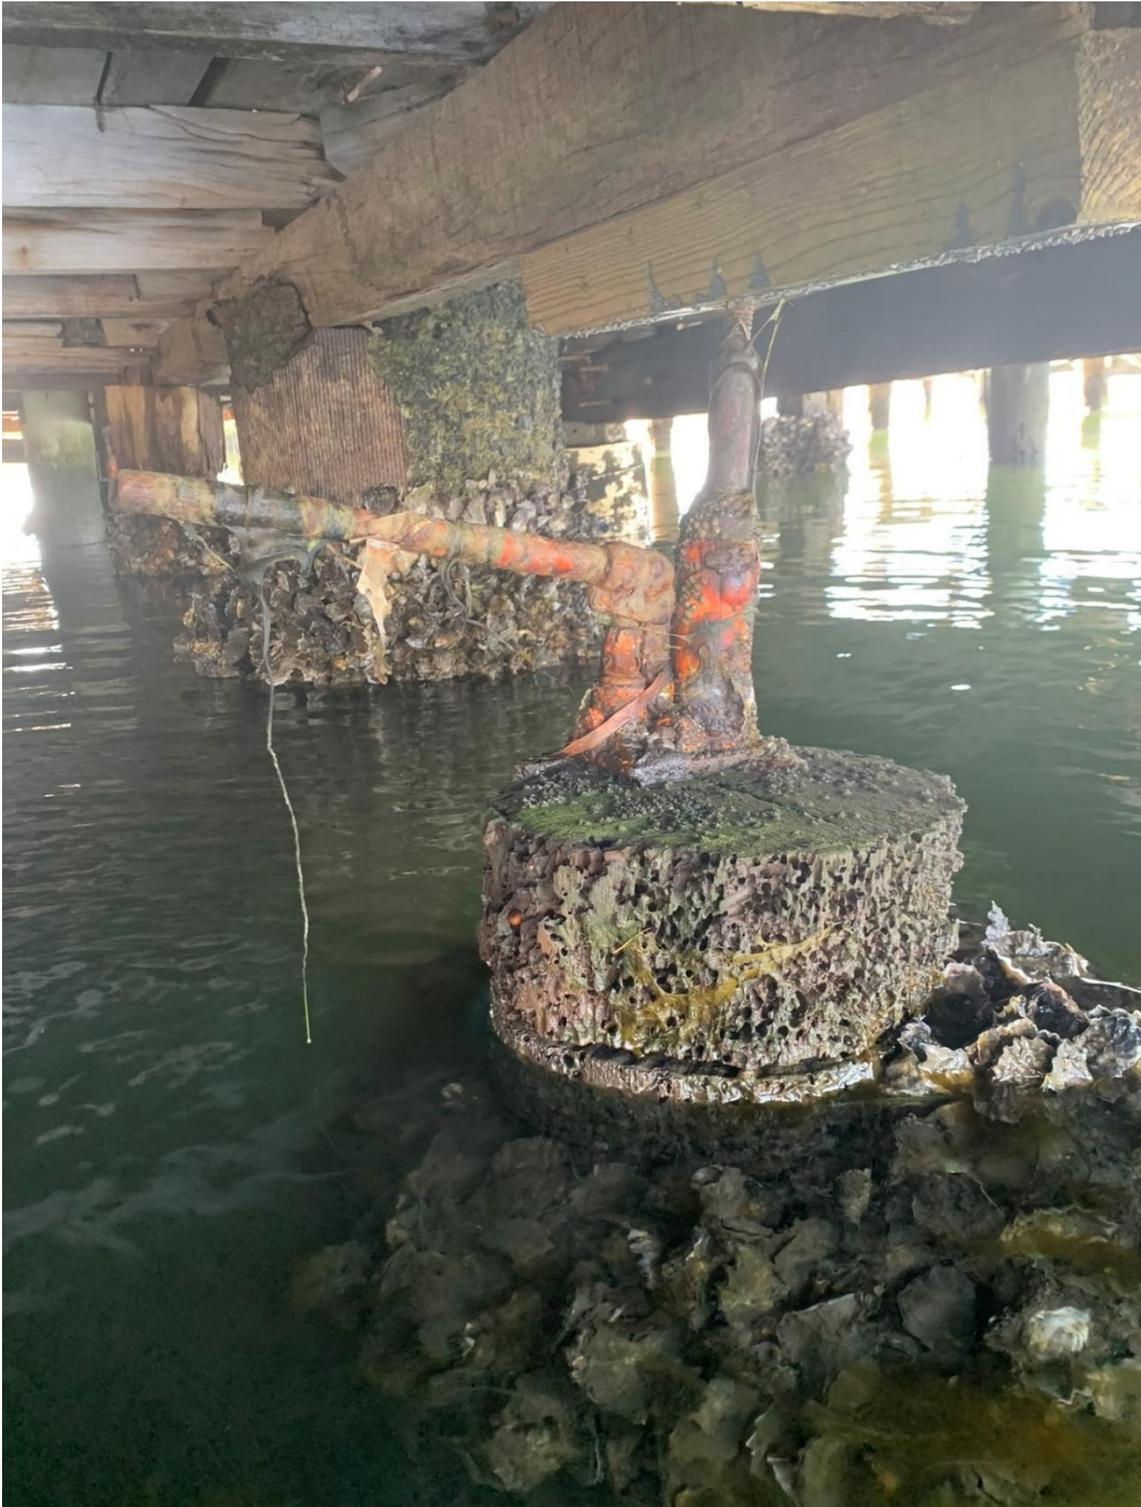
Figure 15 - Subfloor structure including car jack, packing and deteriorated timber members

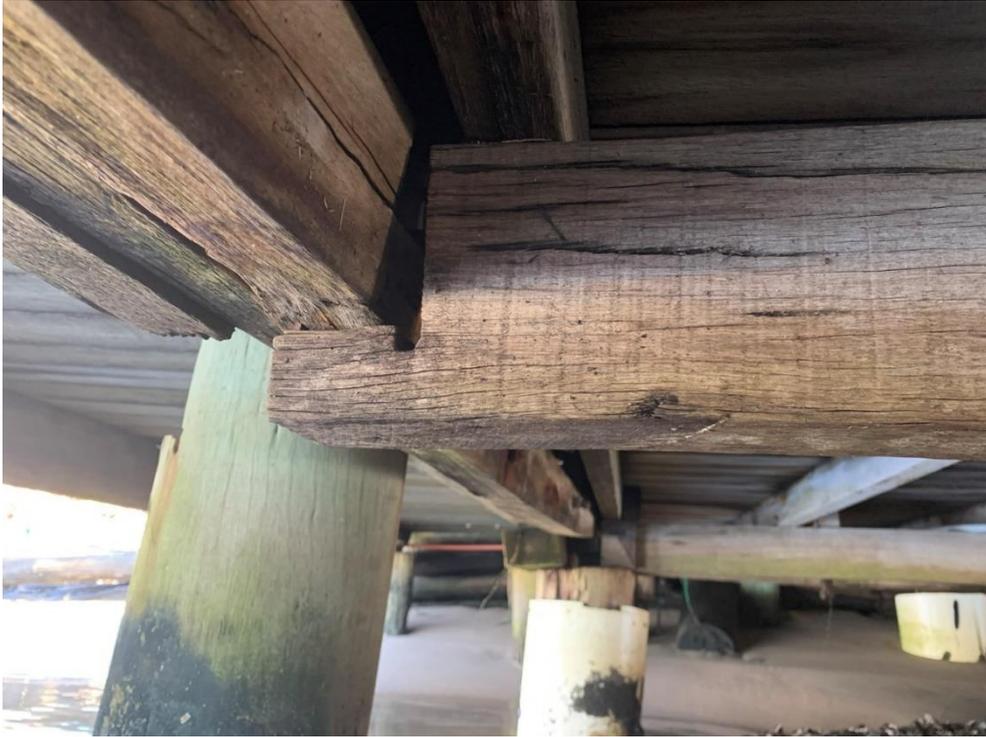
Figure 16 - Bearer unsupported at end, resulting in unsupported structure over

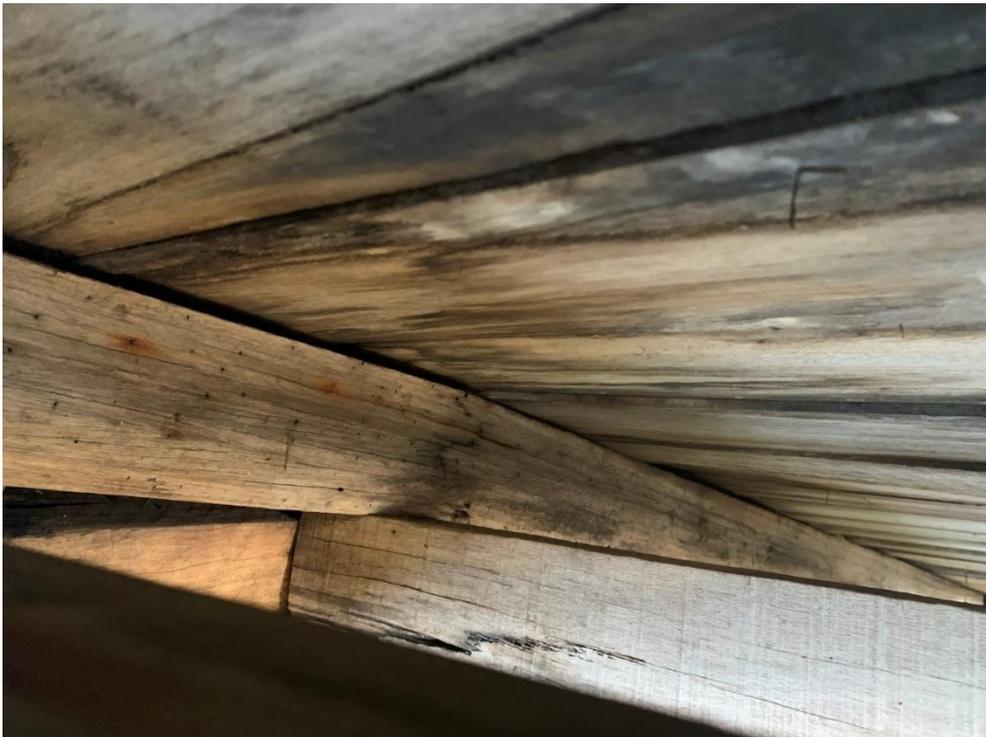
Figure 17 - Failed floor joist and bearer

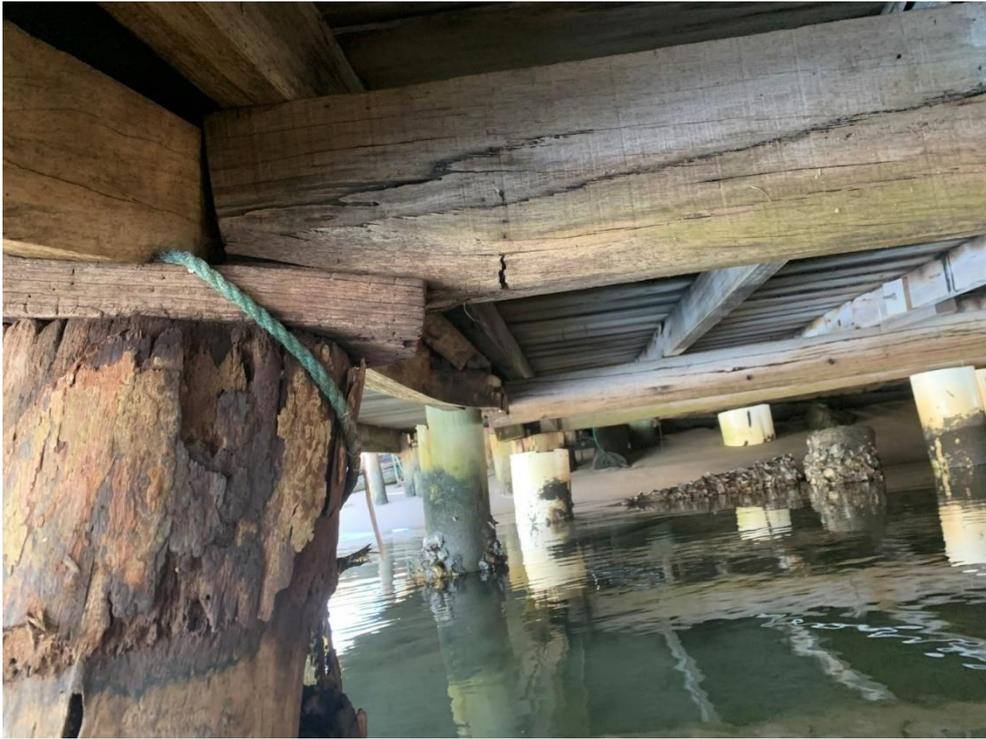
Figure 18 - Failed bearer, apparent shear failure near support

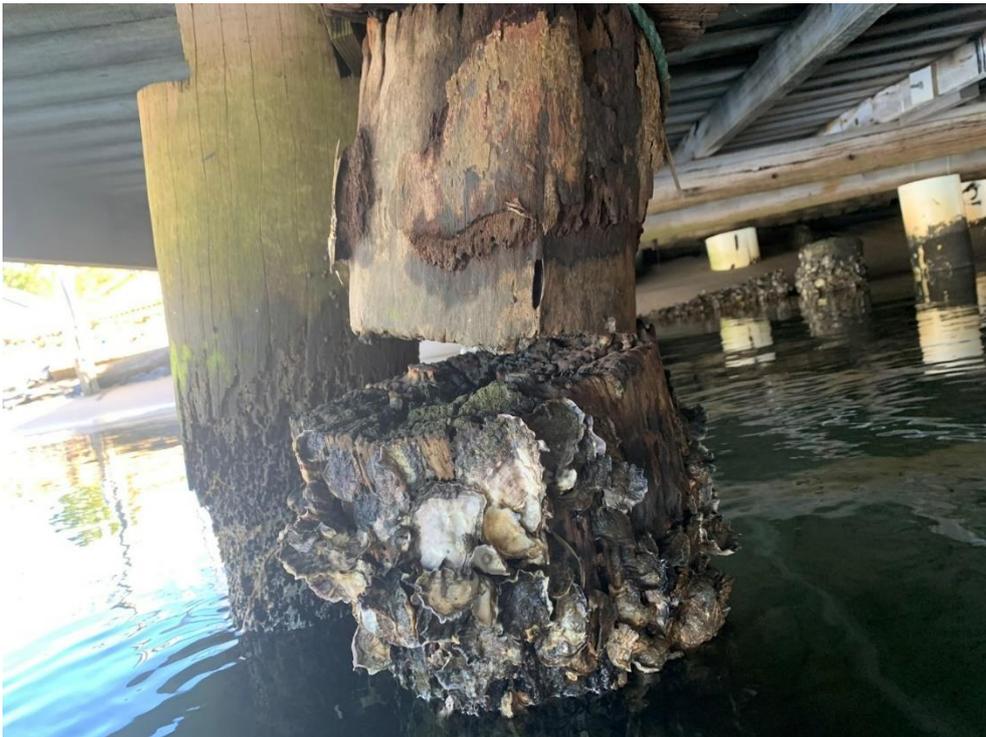
Figure 19 – Displaced, deteriorated timber pile packer

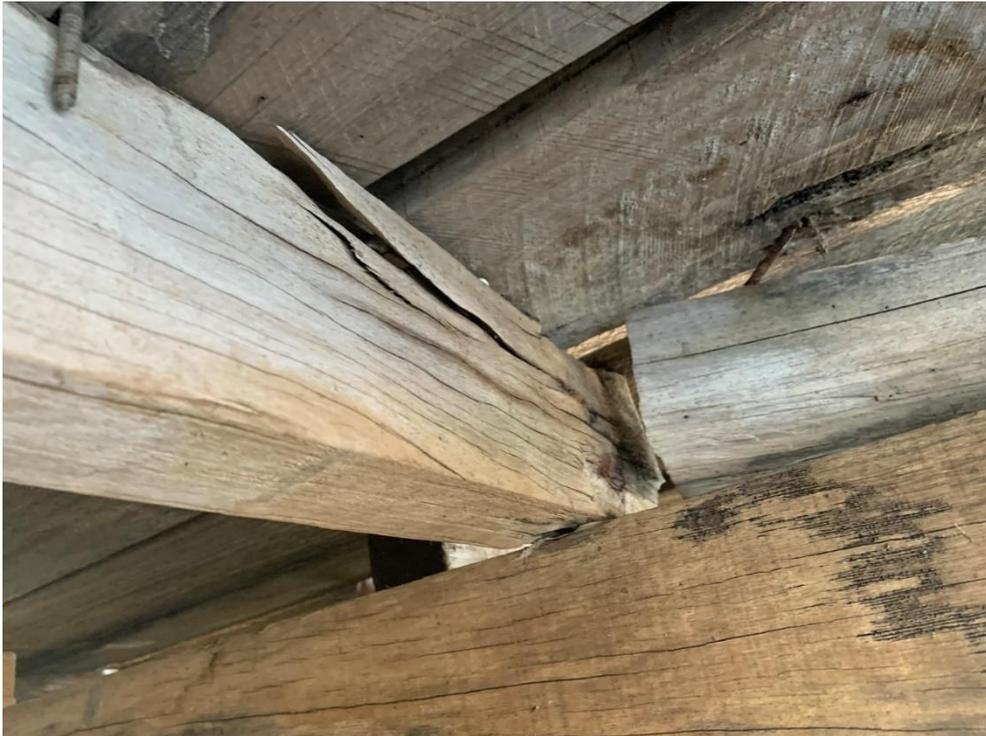
Figure 20 - Failed floor joist

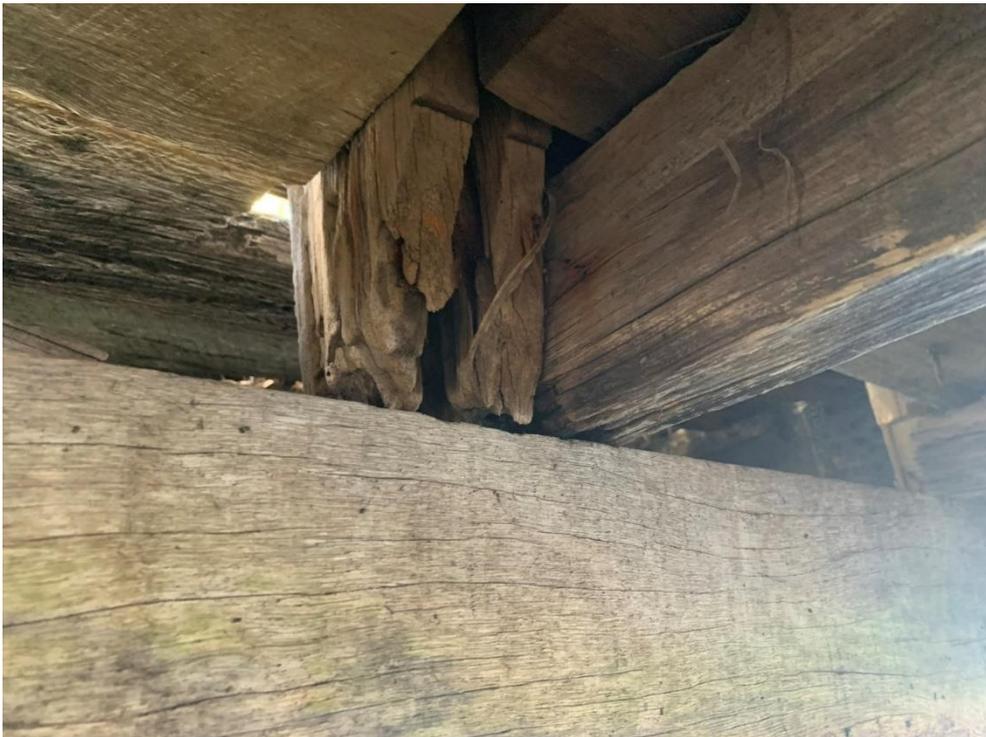
Figure 21 - Base of wall frame showing section loss

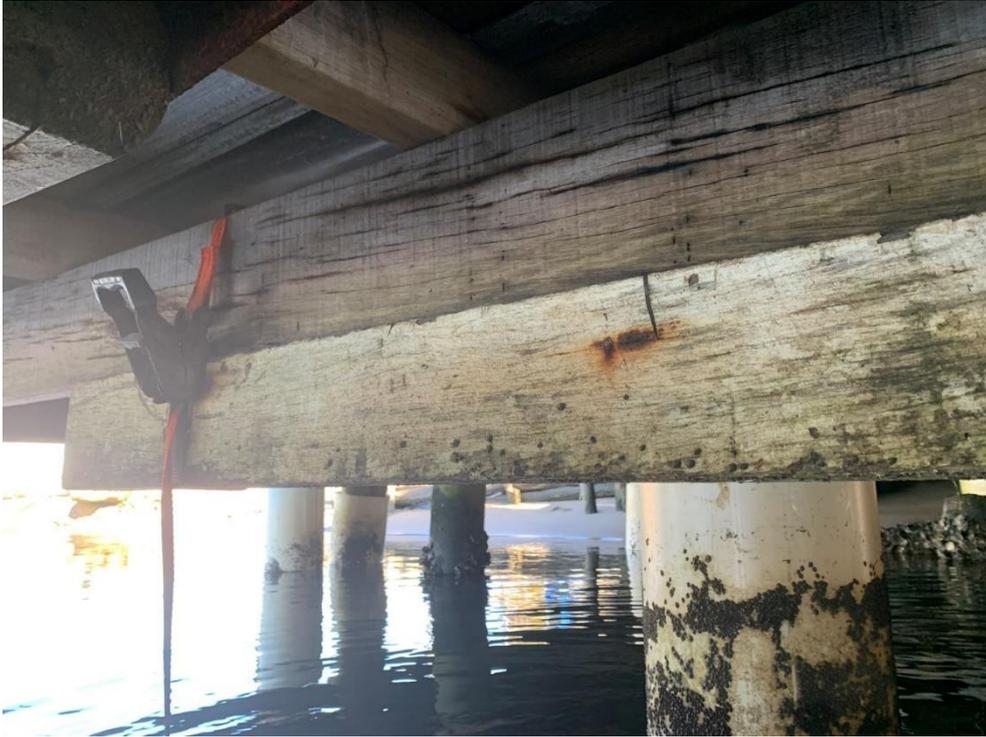
Figure 22 - Timber member strapped to underside of failed bearer

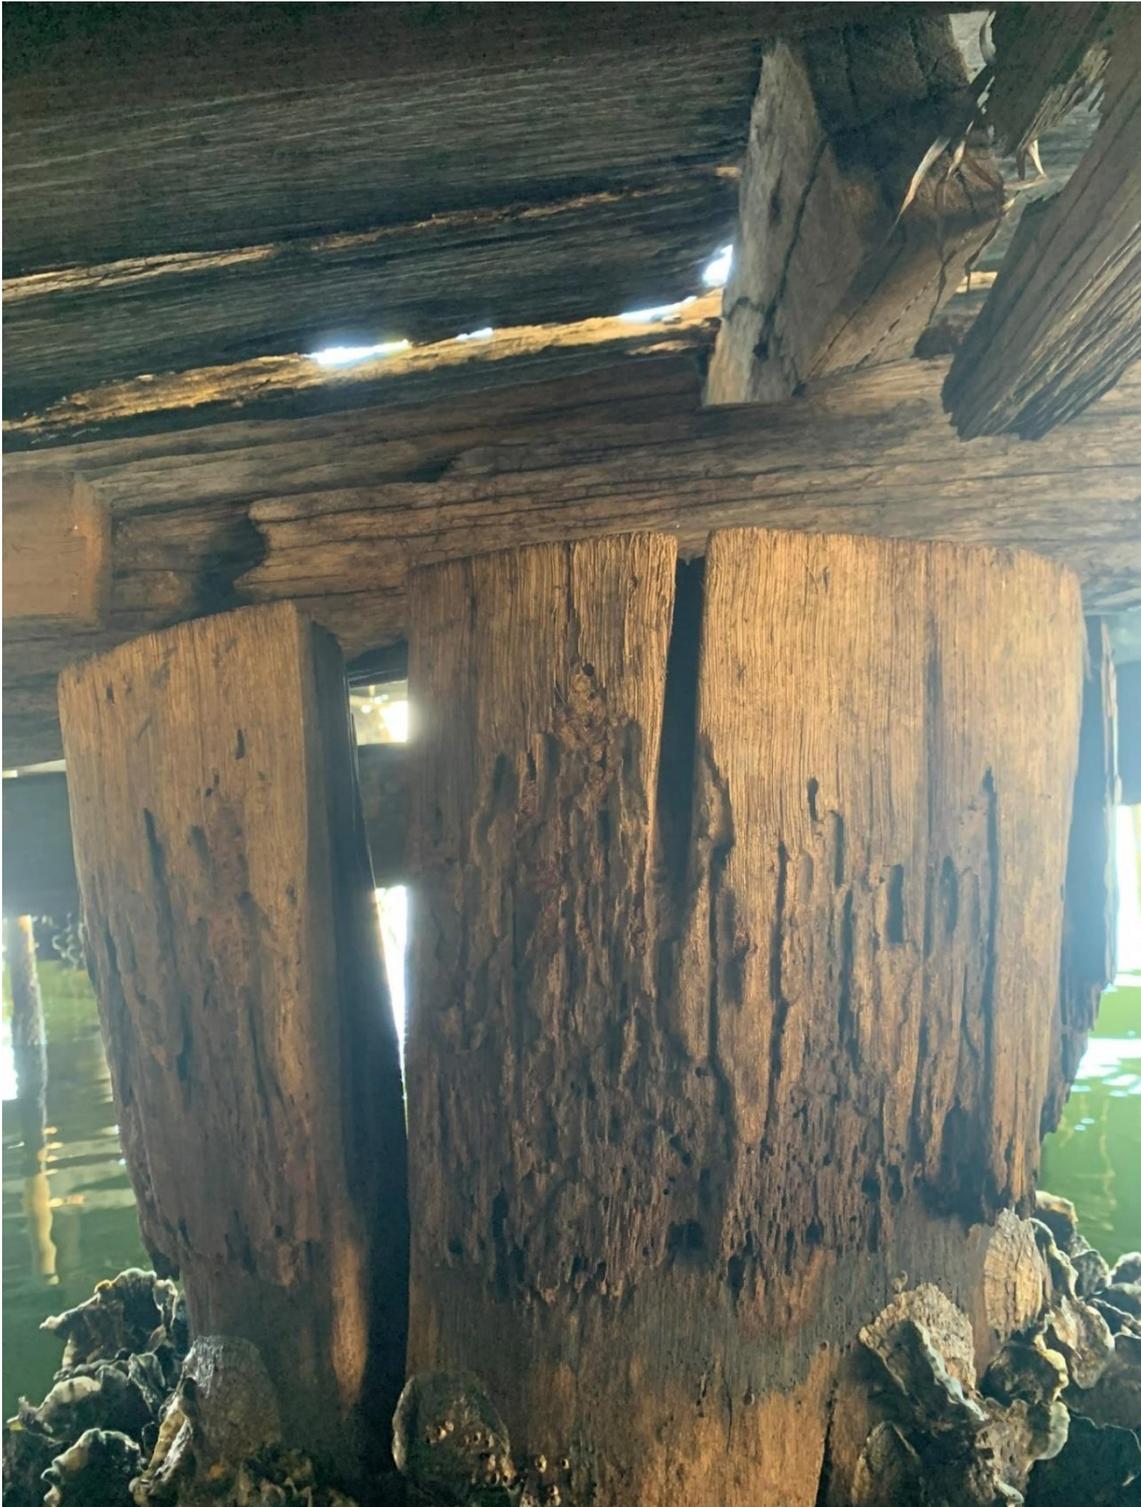
Figure 23 – Deteriorated bearers and joists over split and deteriorated timber pile
