Structural Report
for
Empire Bay Marine Structure
for Crown Lands

Project:	16B Sorrento Rd, Empire Bay
Document Title:	Structural Report
Client:	Department of Planning and Environment – Crown Lands
Revision:	D
Status:	Issue for Information
Revision Date:	18 November 2022
Author:	Karlie Collis
Verifier:	Neil Petherbridge

Northrop Consulting Engineers Pty. Ltd. ("Northrop") has developed this report in order to assess the existing condition of the boatshed, jetties, slipway and hardstand at 16B Sorrento Road, Empire Bay.

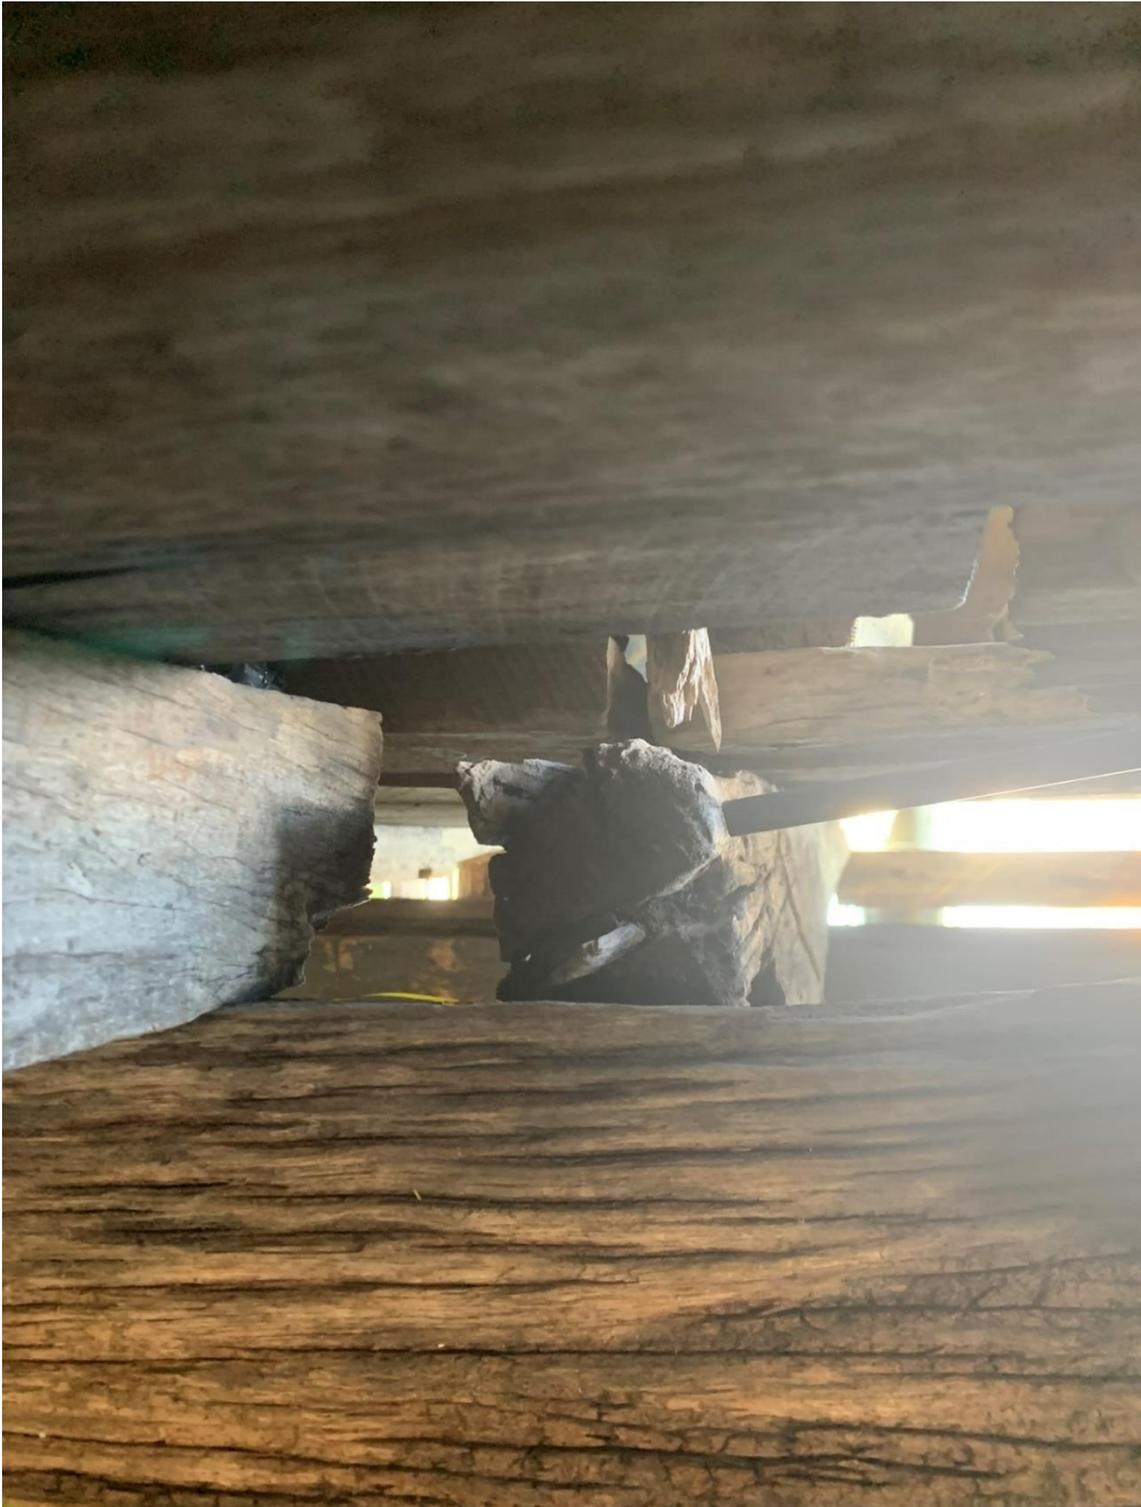
Figure 24 - Floor joists and bearer, deteriorated with section loss

Many timber bearers and joists showed signs of failure in bending and/or section loss. Those with cracking to the tension face (midspan in bottom and in the top over supports) have failed in bending. Examples can be seen in Figures 12, 17, 20, 27 and 28. Others have failed due to material deterioration such as those shown in Figures 22, 23, 24, 25 and 26.

Following my inspections and review, I am of the opinion that the boatshed subfloor structure is in a dilapidated and structurally unsound state and is at risk of collapse due to adverse weather events or vertical loading of the floor. I recommend that access to the boatshed and surrounds is strictly prohibited for safety reasons.

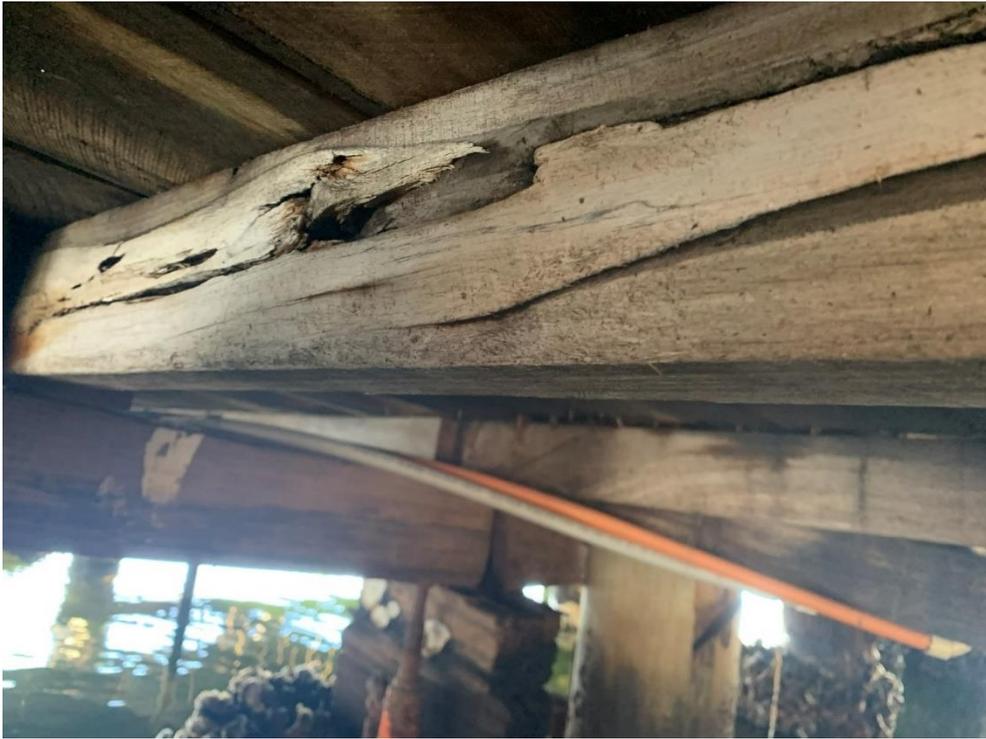
Figure 25 – Deteriorated floor joist with section loss

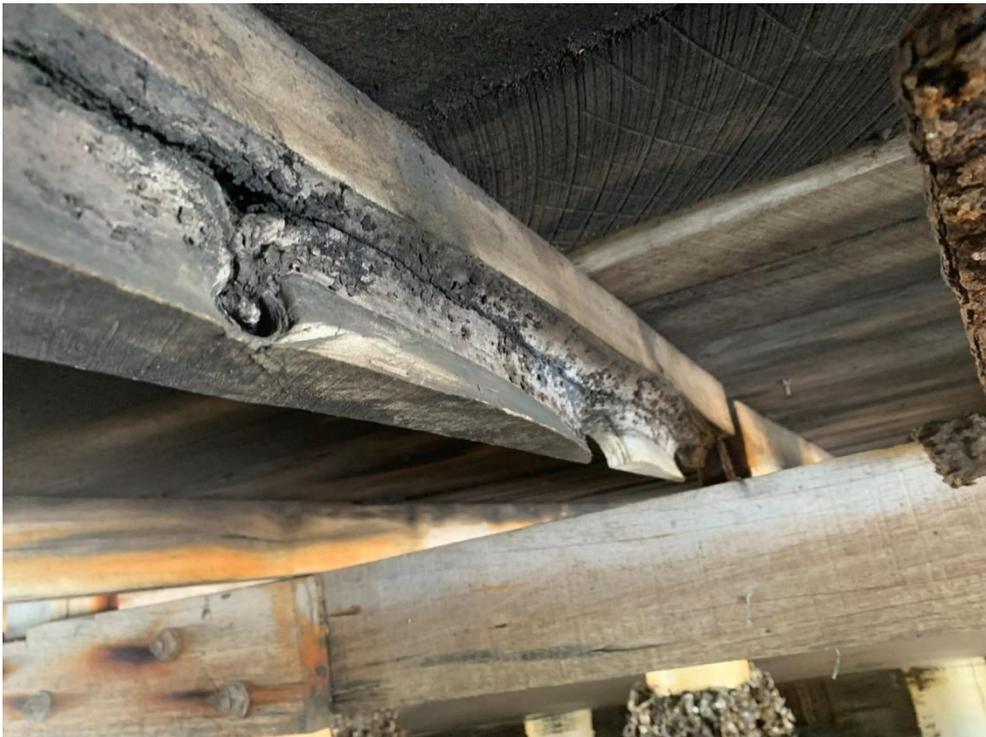
Figure 26 – Deteriorated floor joist with section loss

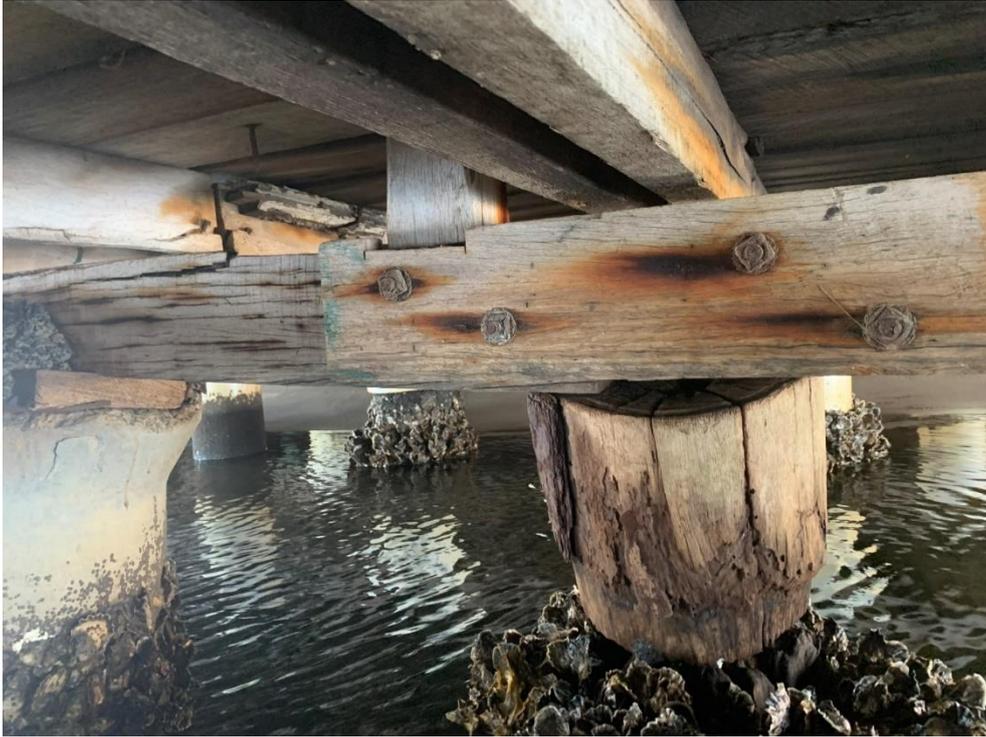
Figure 27 - Bearer showing signs of failure to the left of previous repairs with displaced and deteriorated pile under

Piles were constructed of timber, some with PVC pipe surrounds, some concrete filled. Failed piles supporting the structure are shown in Figures 11, 13, 15, 18, 19, 23, 27, 29 and 30. Much of the subfloor floor framing was packed by various means with no fasteners or tie-down noted between the packing elements. Vertical subsidence experienced between 2020 and 2022 (refer Figure 48) is significant in magnitude. It suggests that, in my opinion, inadequate pile bearing materials or failure of the piles themselves.

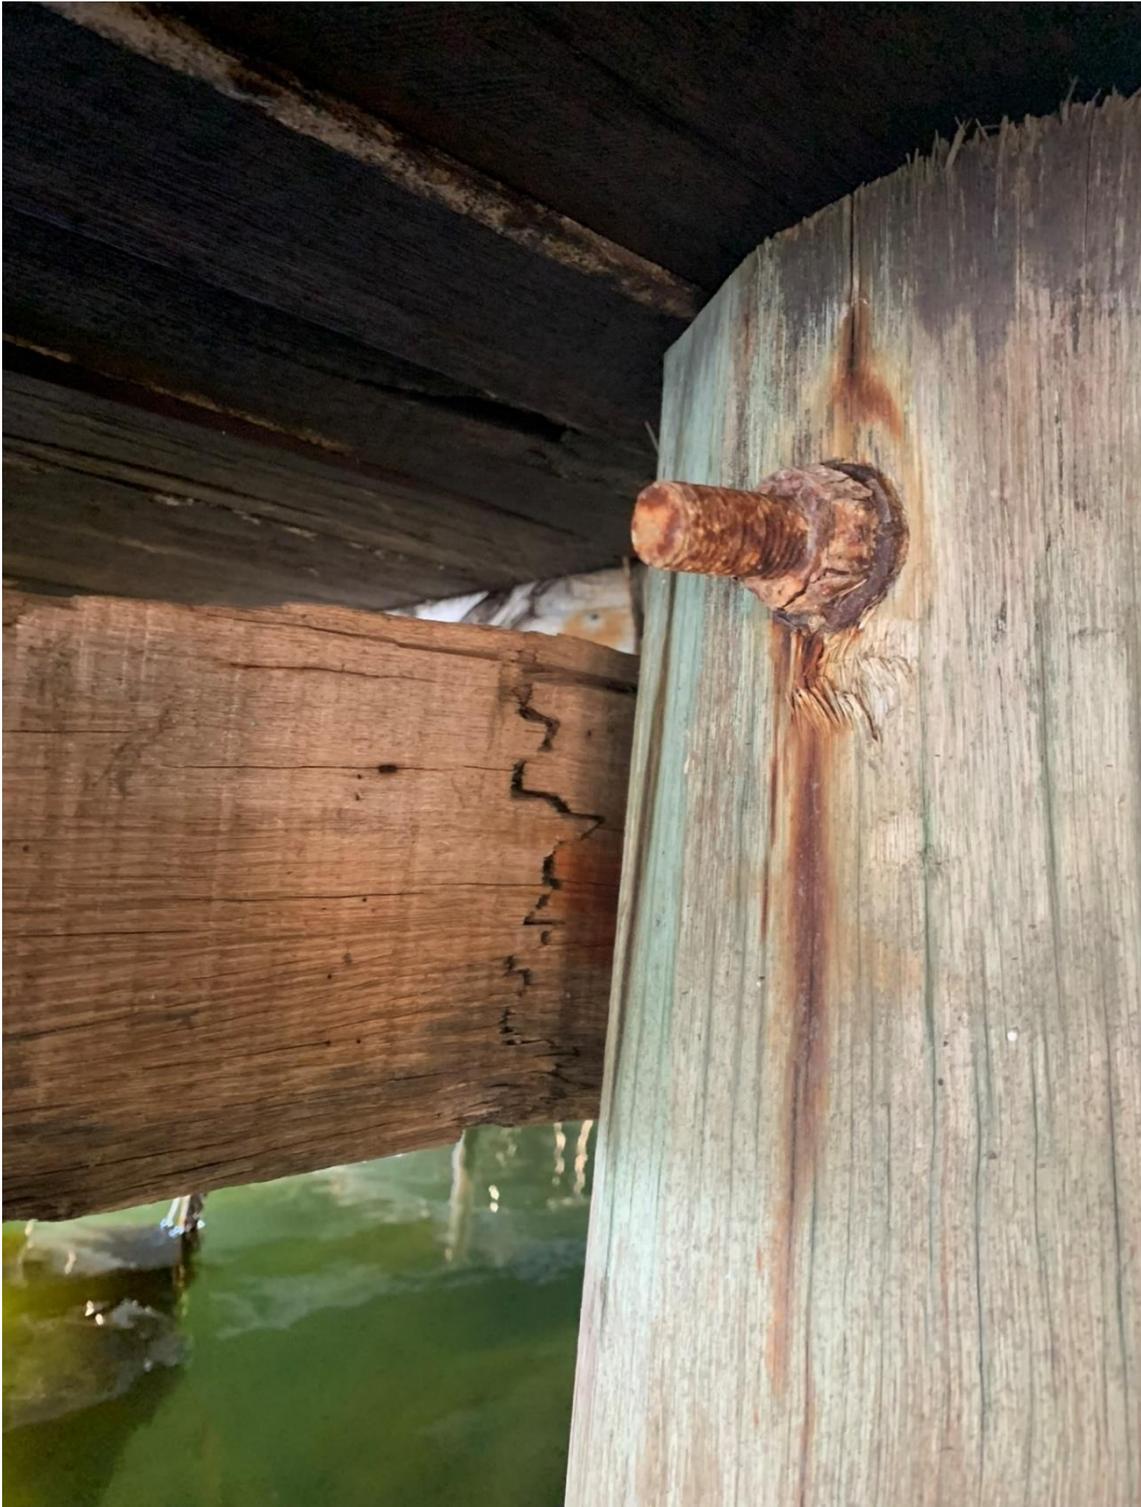
Figure 28 - Failed bearer resulting in unsupported structure over

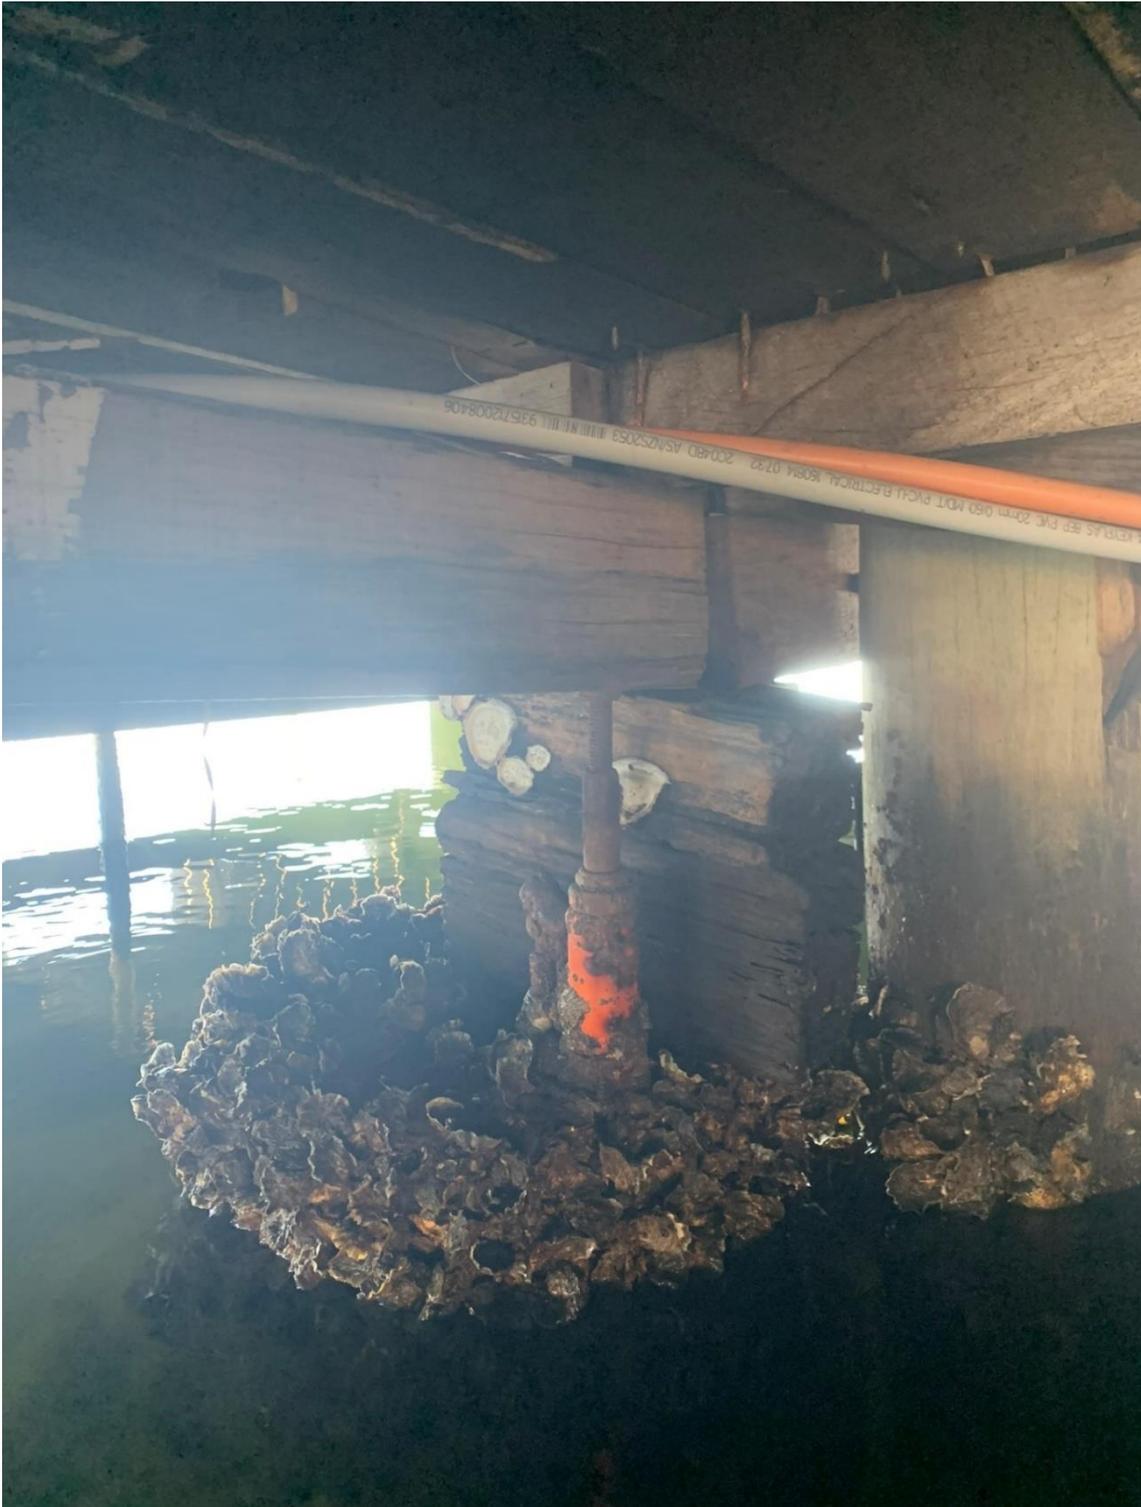
Figure 29 - Car jack providing support to bearer

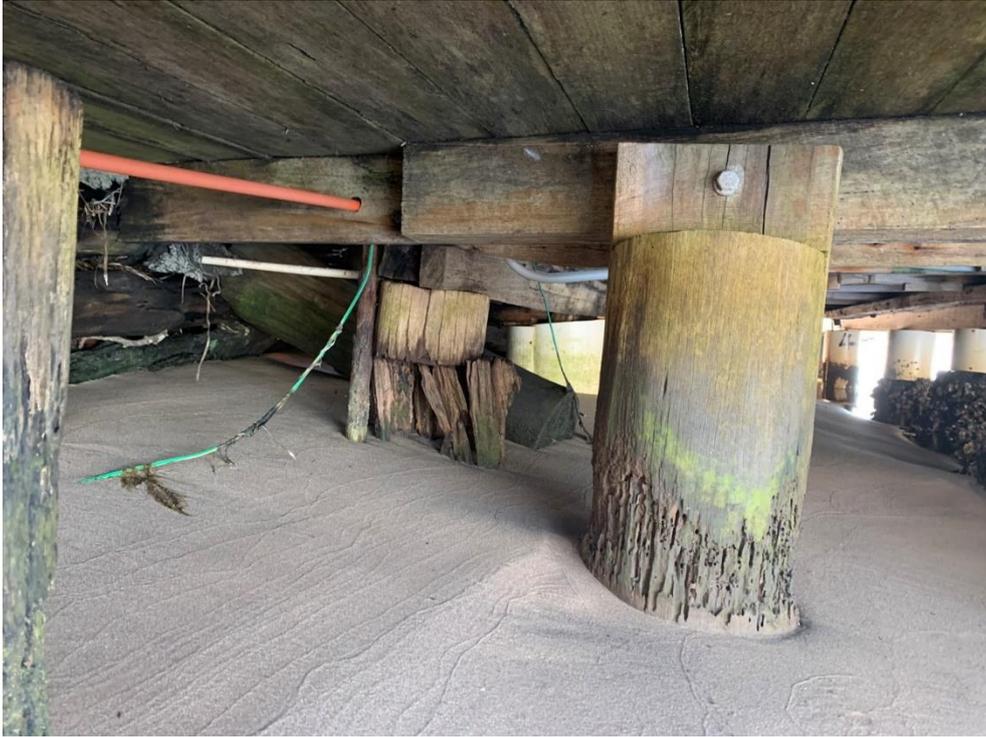
Figure 30 - Pile support failing below packing member resulting in unsupported structure over

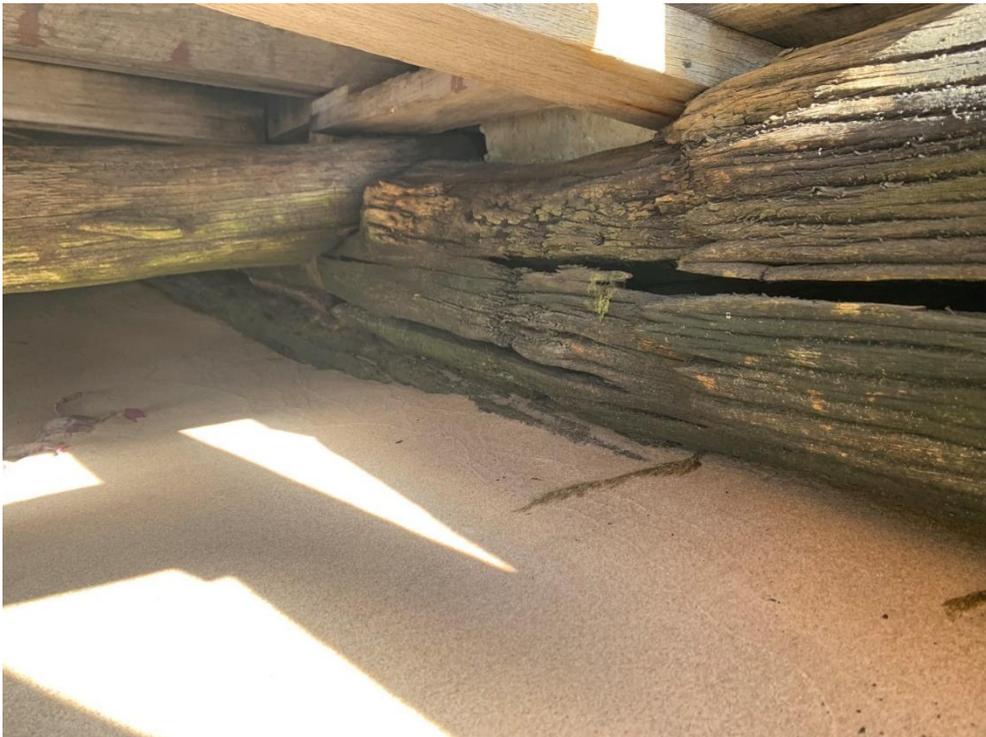
Figure 31 – Deteriorated and displaced subfloor timber adjacent to hardstand area

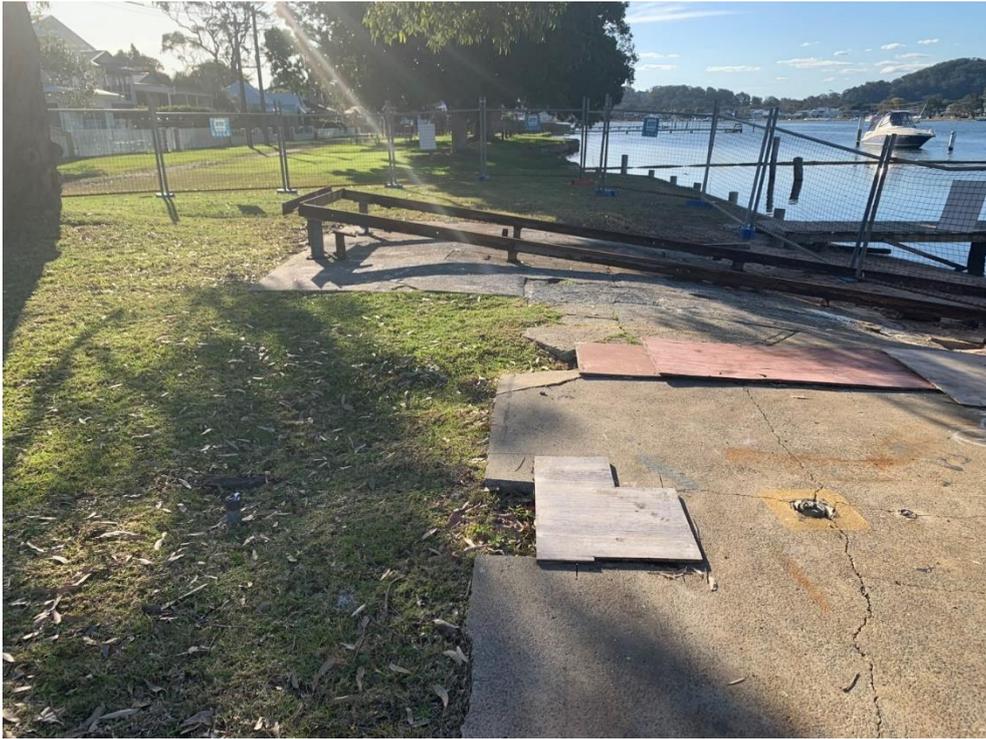
Figure 32 - Hardstand area – note tank access to right of photo and steel slipway beyond

The concrete hardstand was noted to be cracked and damaged in many areas (refer Figures 32 and 33). It is understood fuel tanks located beneath the slab are subject to an Improvement Notice from SafeWork NSW, requiring the removal of underground tanks and associated equipment by 18th November 2022; however, we understand SafeWork has extended this timeframe until 1st August 2023.

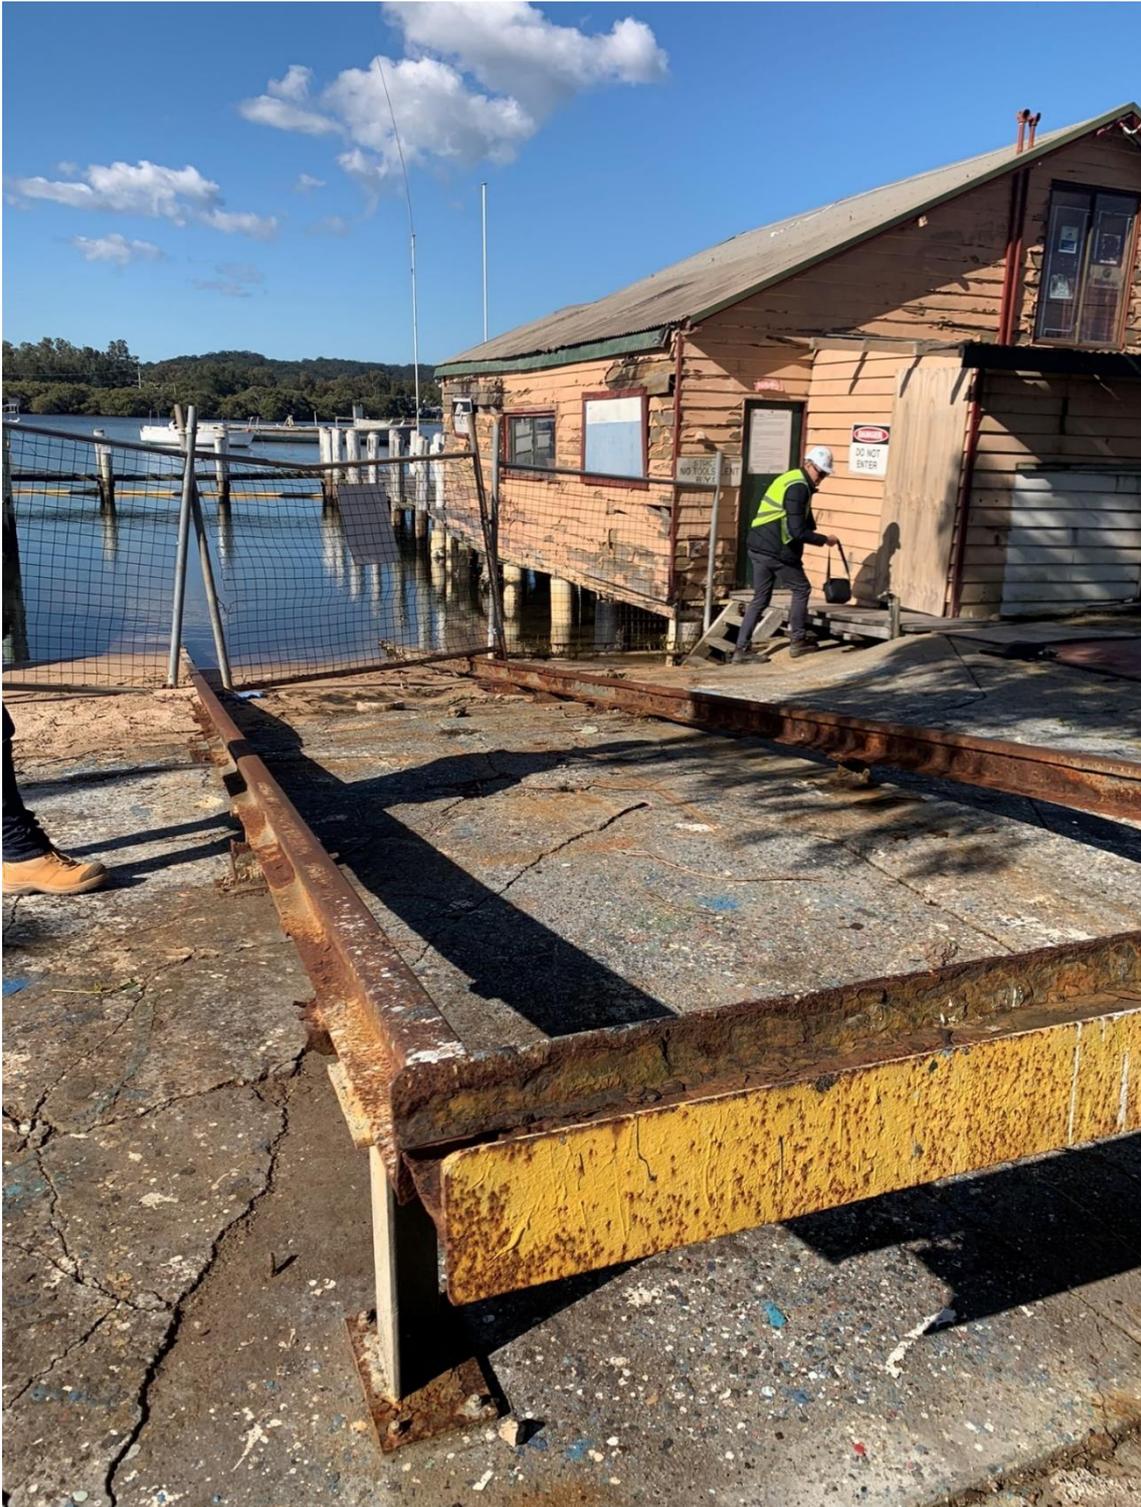
Figure 33 - Steel slipway rails

The concrete slipway was also cracked with some corrosion to the rails over.

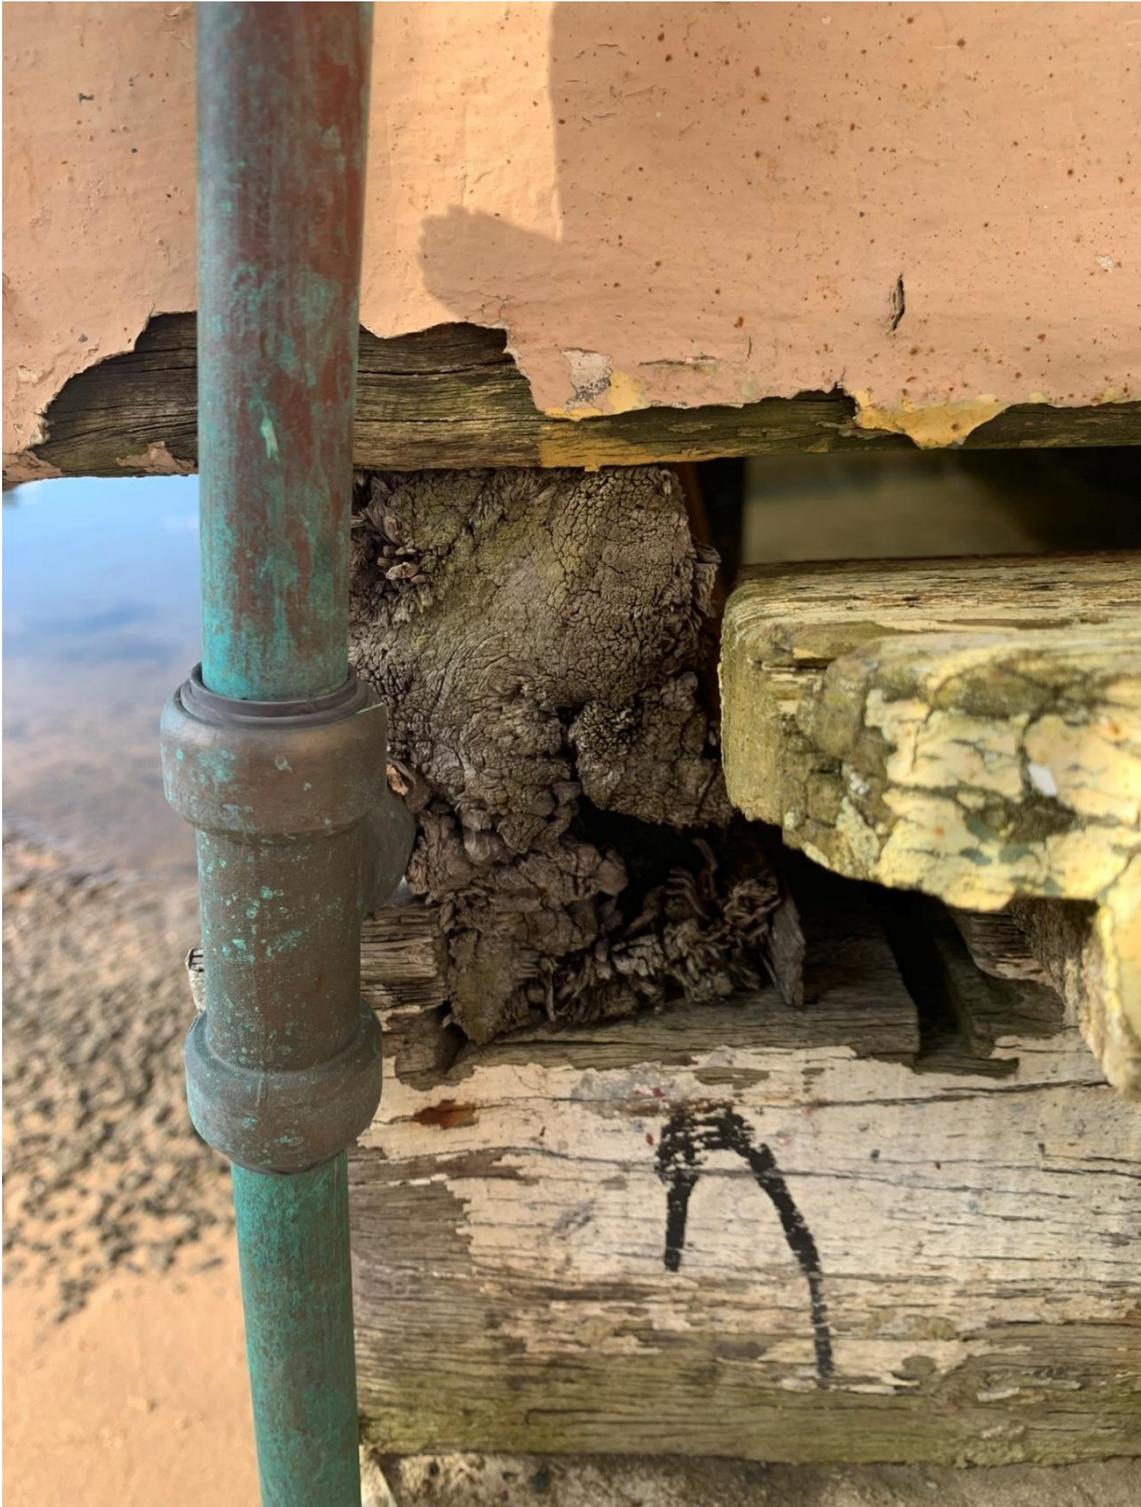
Figure 34 - External north-western corner of the boatshed showing deterioration of timbers

As expected, externally exposed timber framing (often due to damaged cladding) was decayed and weathered (refer Figures 34 and 37).

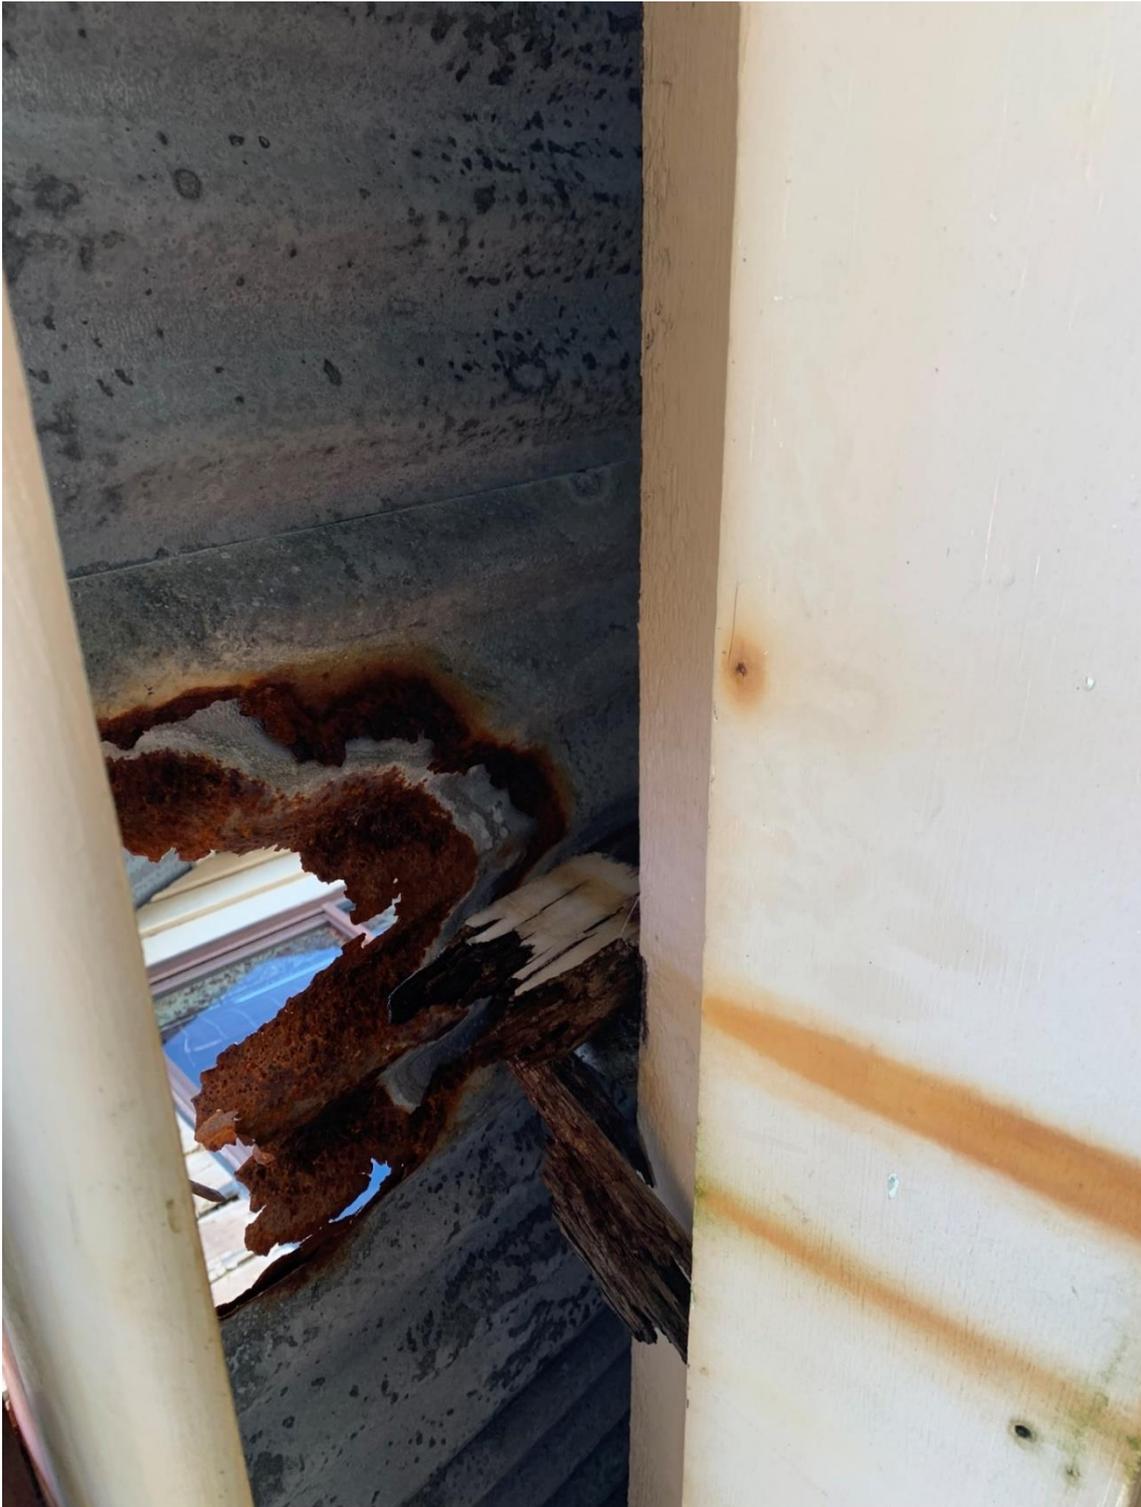
Figure 35 - Corrosion to roof sheet and failed timber roof member (South-eastern corner)

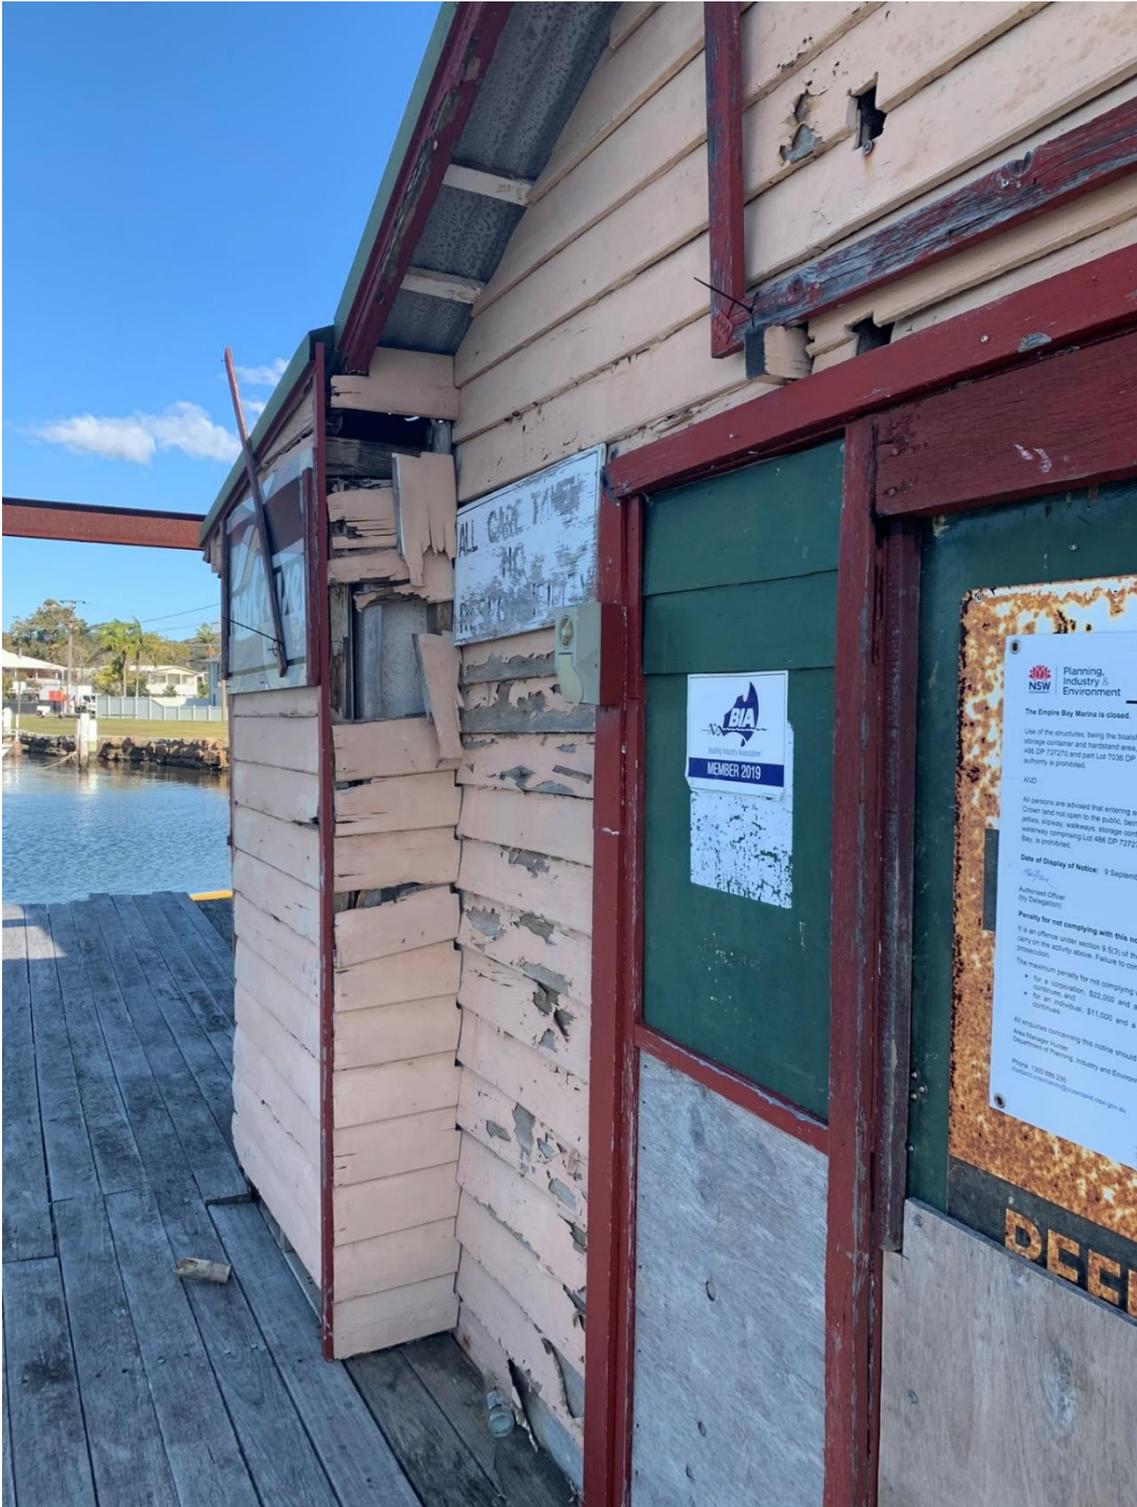
Figure 36 - Eastern external boatshed with deteriorated timber cladding, some missing and warped flooring due to substructure failure

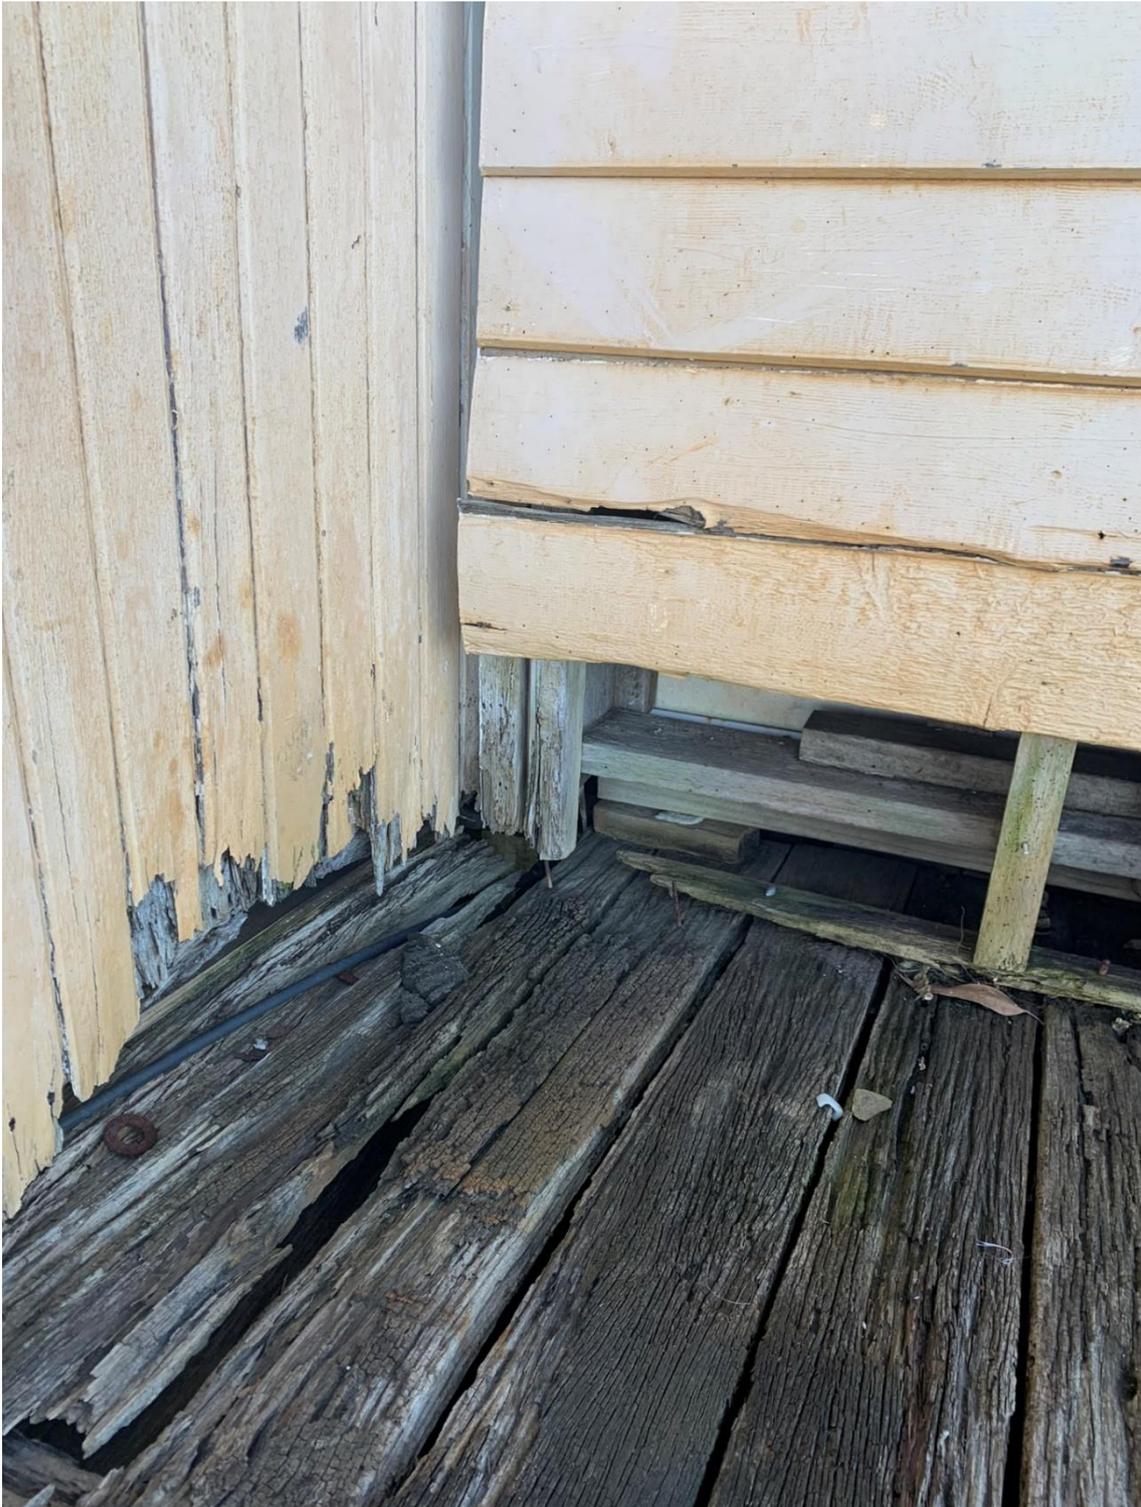
Figure 37 - Eastern deck and base of external wall of boatshed showing deteriorated timber

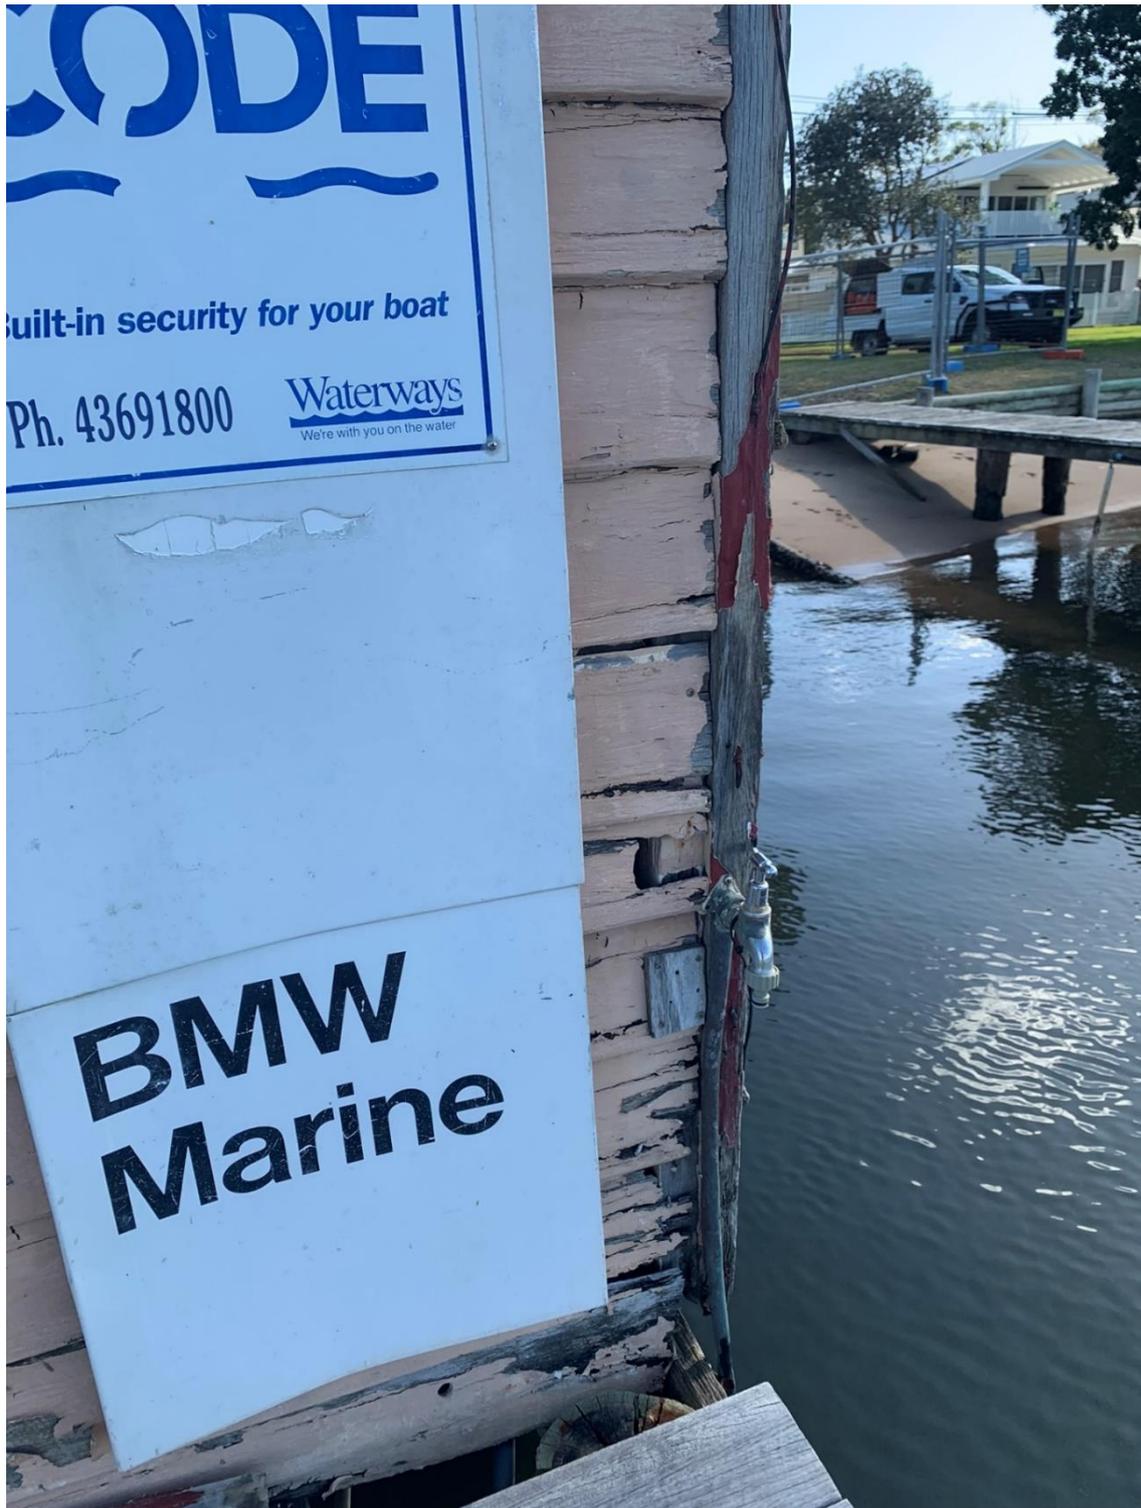
Figure 38 - North-eastern external corner of boatshed showing deteriorated timber cladding

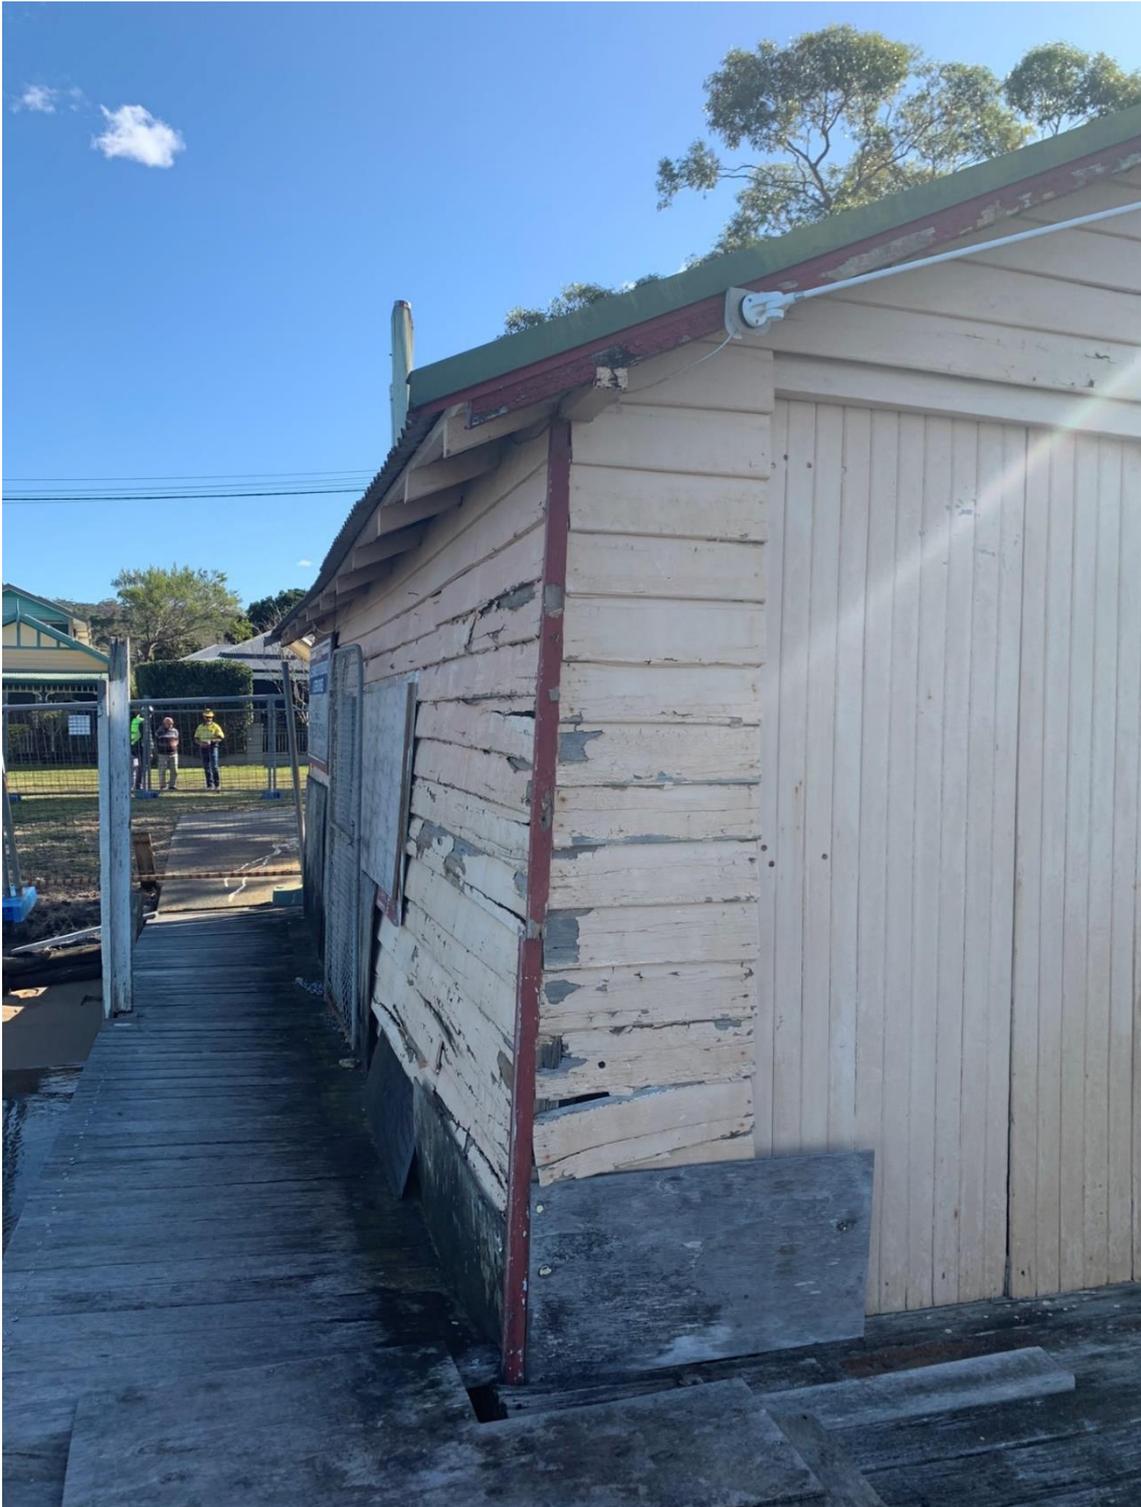
Figure 39 - External south-eastern corner of boatshed showing plywood patching to both decking and wall framing. Obvious distortion of wall alignment noted.
