Structural Report
for
Empire Bay Marine Structure
for Crown Lands

Project:	16B Sorrento Rd, Empire Bay
Document Title:	Structural Report
Client:	Department of Planning and Environment – Crown Lands
Revision:	D
Status:	Issue for Information
Revision Date:	18 November 2022
Author:	Karlie Collis
Verifier:	Neil Petherbridge

Northrop Consulting Engineers Pty. Ltd. ("Northrop") has developed this report in order to assess the existing condition of the boatshed, jetties, slipway and hardstand at 16B Sorrento Road, Empire Bay.

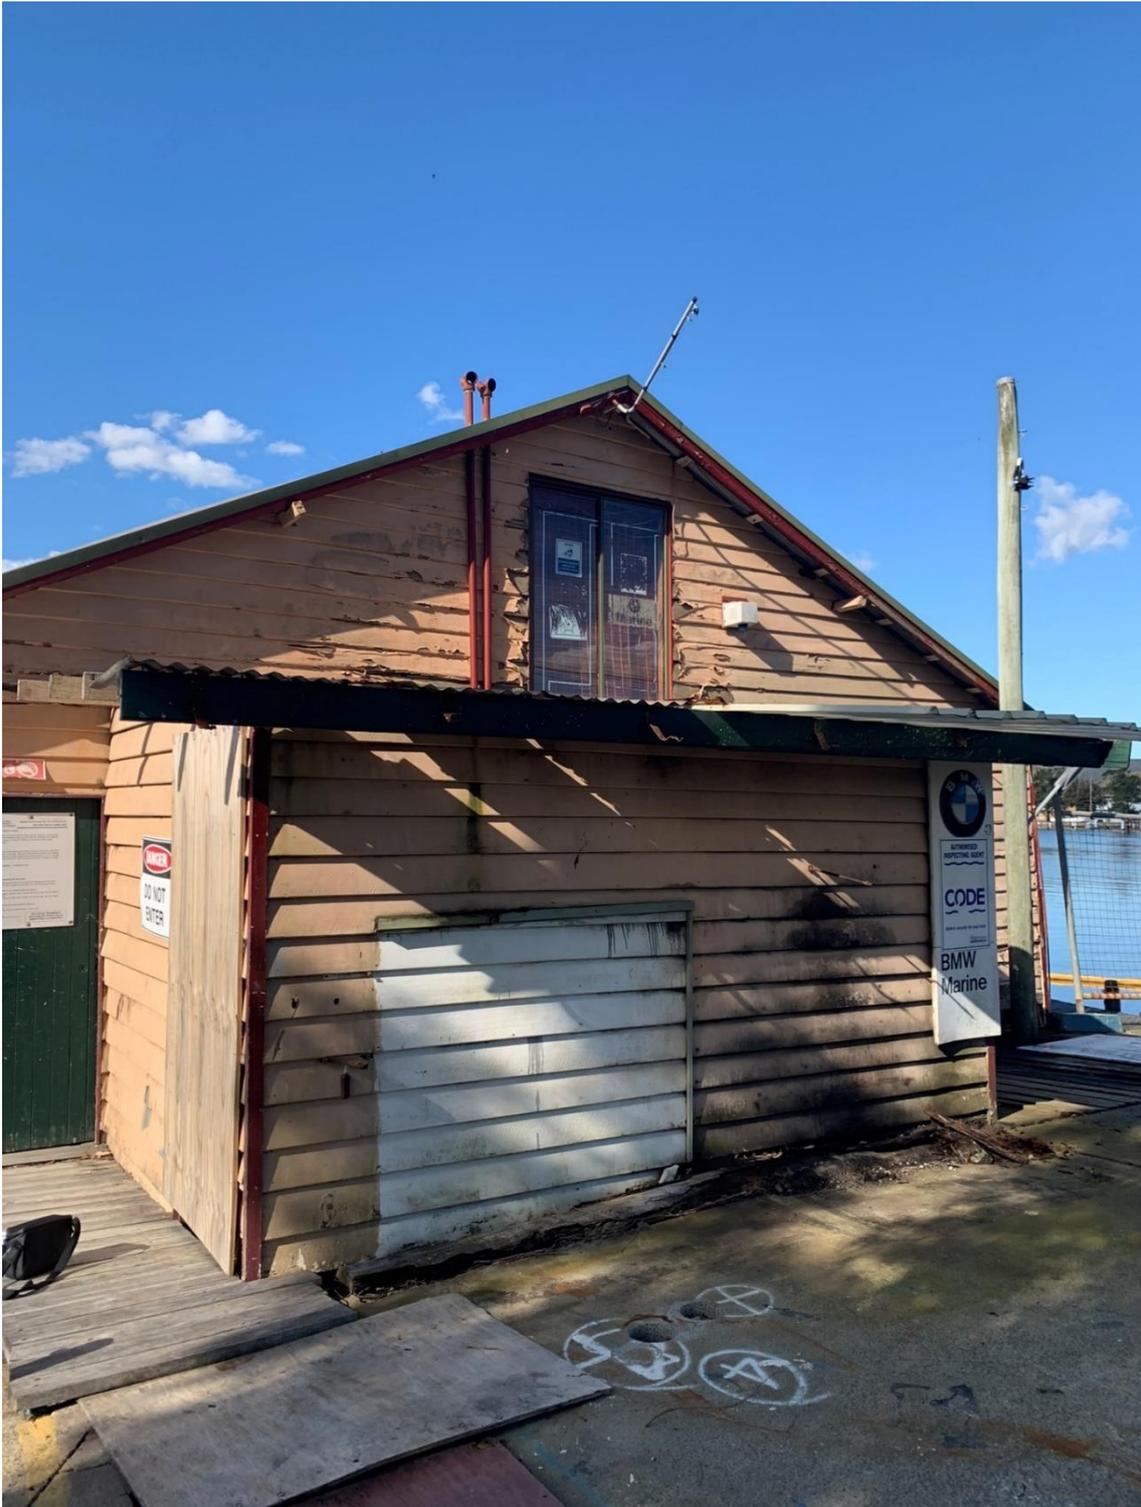
Figure 40 - Western elevation of boatshed. Note staining to oil sump area. Slab in foreground over underground tanks.

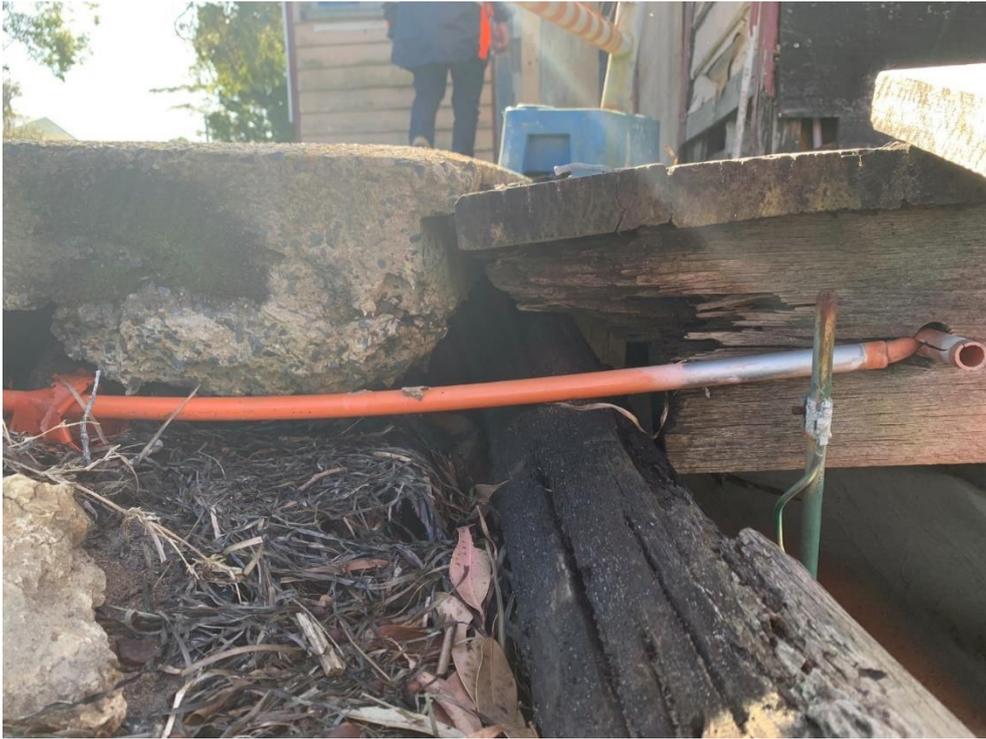
Figure 41 - Junction between hardstand and suspended deck showing deteriorated, unsupported timbers

The junction between the hardstand and the suspended floor structure (Figure 41) shows the slab having been undermined as supporting soils have been displaced.

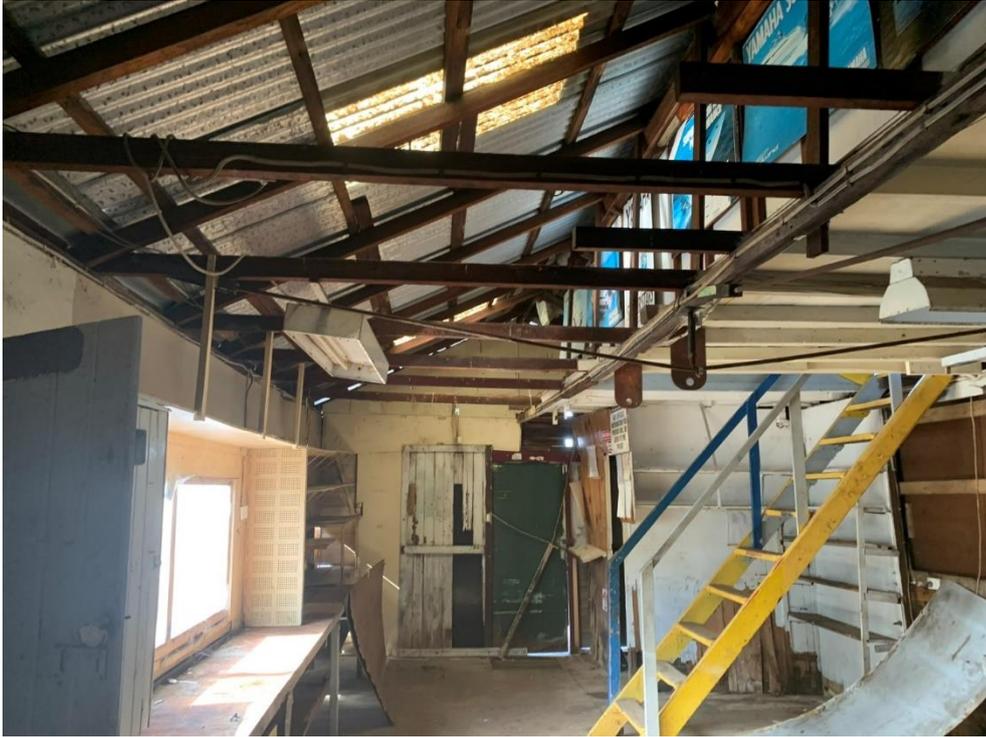
Figure 45 - Internal showing structural arrangement of mezzanine support

The structural members supporting the mezzanine appeared grossly inadequate in size to support mezzanine floor loads. Linings to the mezzanine prevented visual inspection of the underlying structure, including inspection for termite damage.

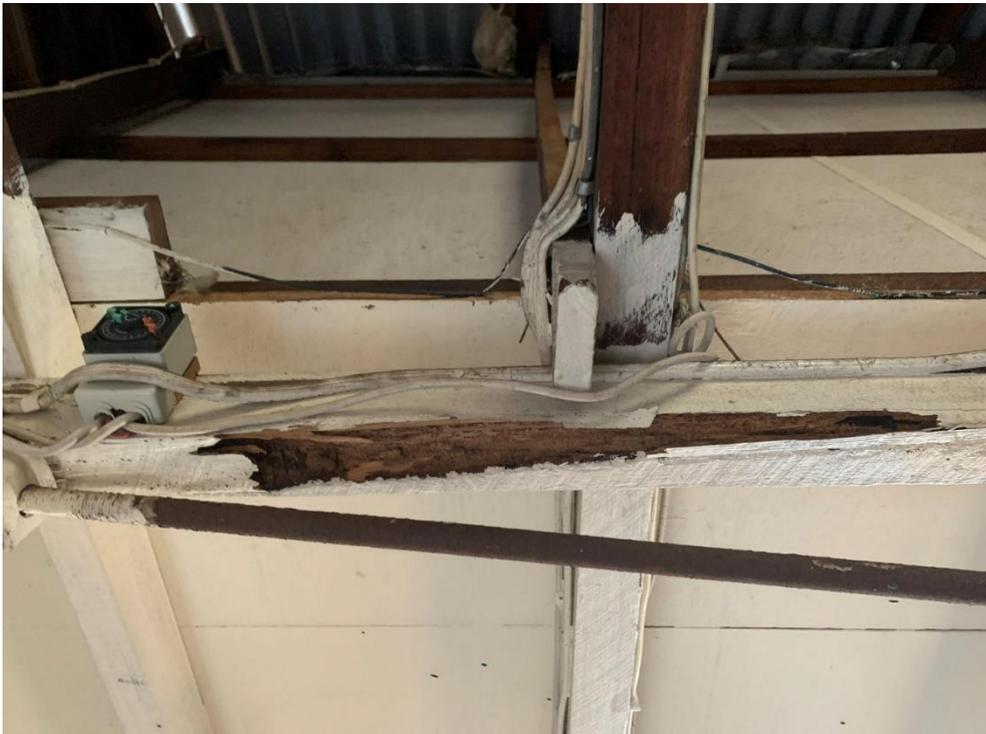
Figure 46 - Termite damage (internal boatshed), noting section loss

Termite damage was noted to 2 areas (refer Figures 46 and 47) although the extent of damage was unable to be verified due to the presence of wall linings.

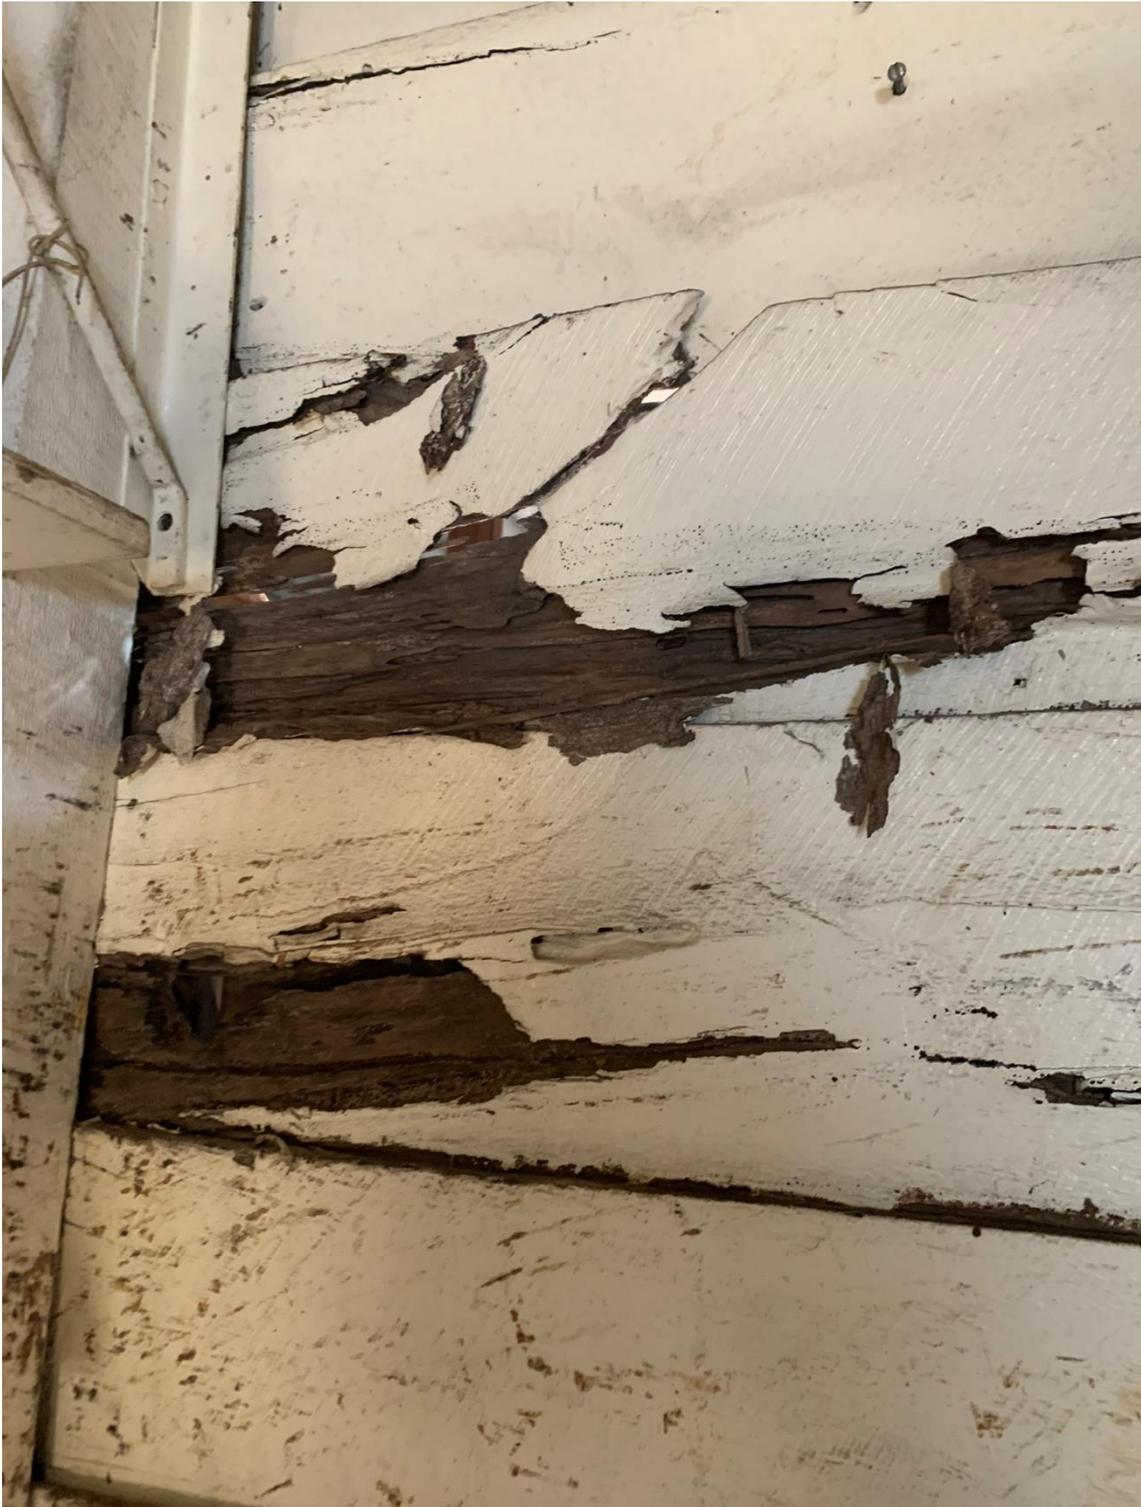
Figure 47 - Termite damage to lining boards (internal boatshed)

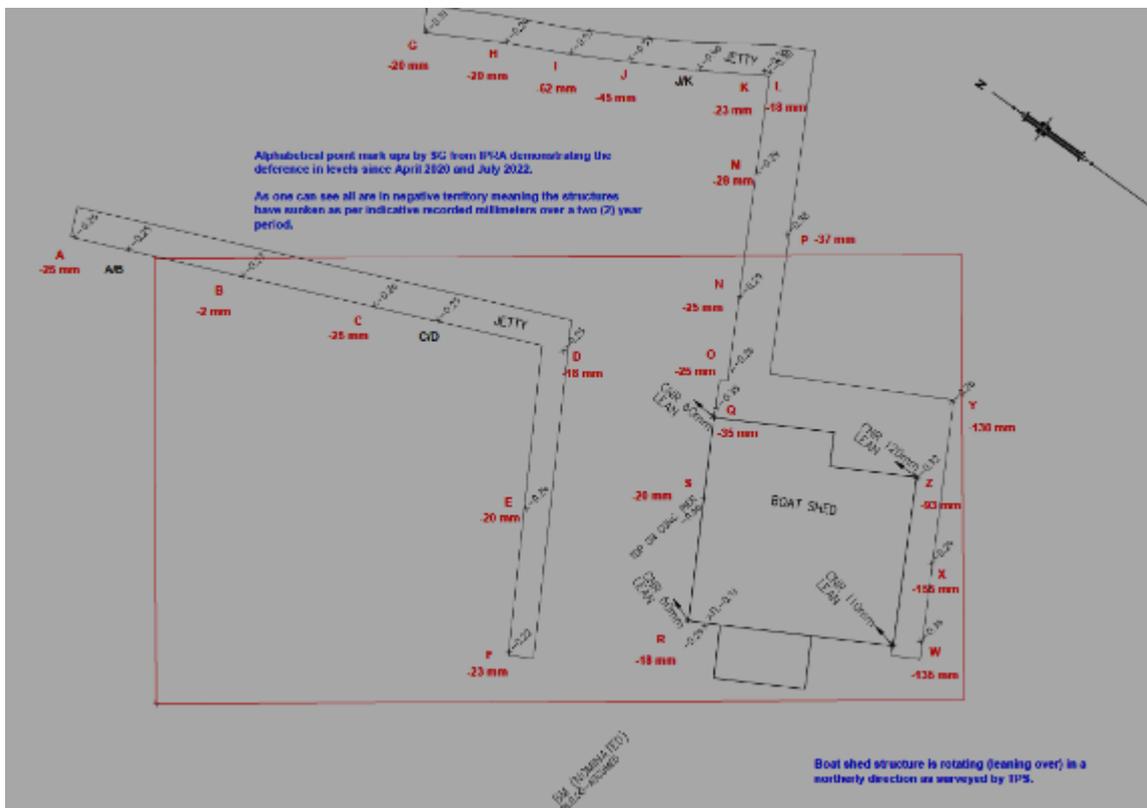
The attached jetty is shown in Figures 2, 3 and 6-10. The jetty showed evidence of settlement/displacement of timber piles. The length of jetty parallel to the shoreline was in a highly dilapidated state with floorboards missing and horizontal displacement of the piles. Timber piles also showed a reduction in cross-sectional area just below water level (refer Figures 8 and 9). Timber pile softening was noted to the inside face of the pile as shown in Figure 6 where timber was easily removed by hand. Figure 48 below shows the measured change in levels of the structures between 2020 and 2022. Note that the jetty has been largely unused during this time and as such has been subject to minimal imposed loads apart from wave action and tidal effects. Even so, the jetty has experienced between 18mm and 62mm of vertical displacement which, in my opinion, suggests inadequate pile bearing materials or failure of the pile itself.

Figure 48 - Level changes recorded between 2020 to 2022 (IPRA report 25.07.22)
