**Hazardous Building Materials (HAZMAT)
Report, 17 Denison Street, Gloucester NSW**

**Prepared for Department of Planning,
Housing and Infrastructure**

Project 228674.00

5 July 2024

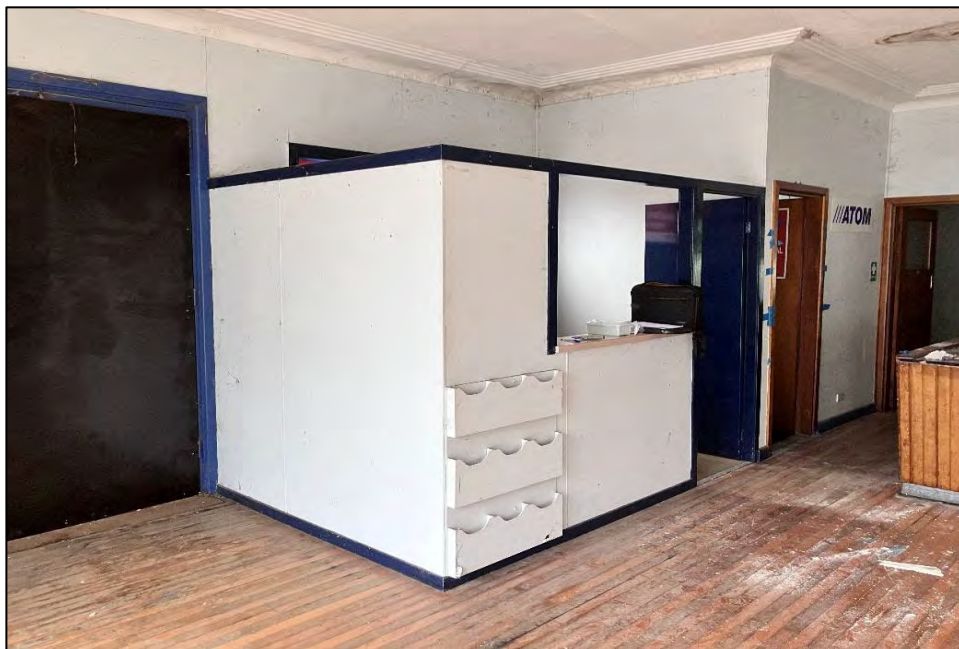
Photograph 1: Eastern building, main retail area, eastern office cubicle, dividing wall, exterior side, fibre cement sheeting, no asbestos detected by analysis.

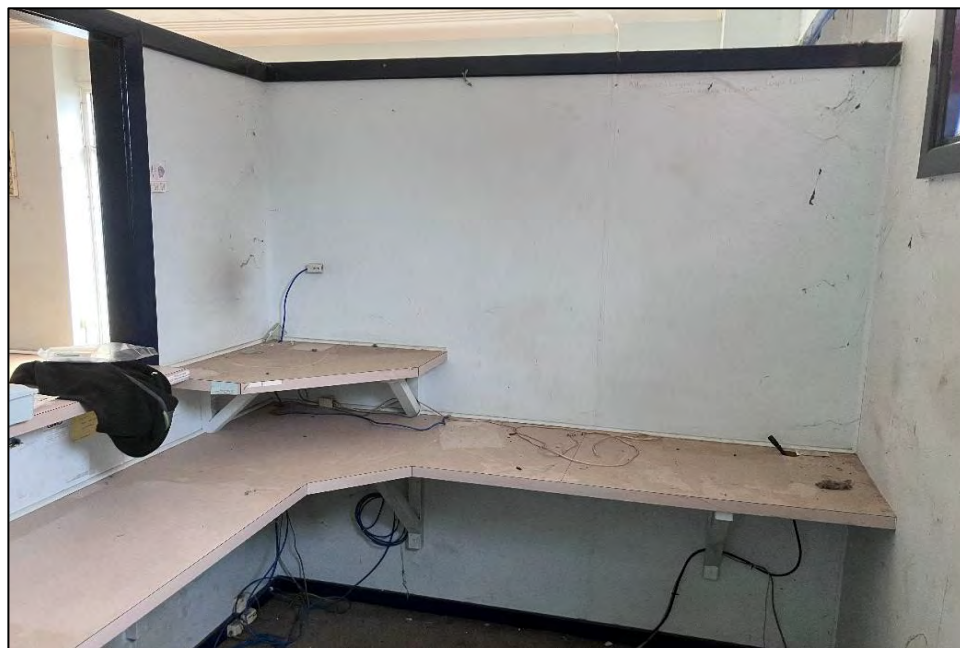
Photograph 2: Eastern building, main retail area, eastern office cubicle, dividing wall, interior side, fibre cement sheeting, suspected non-asbestos.

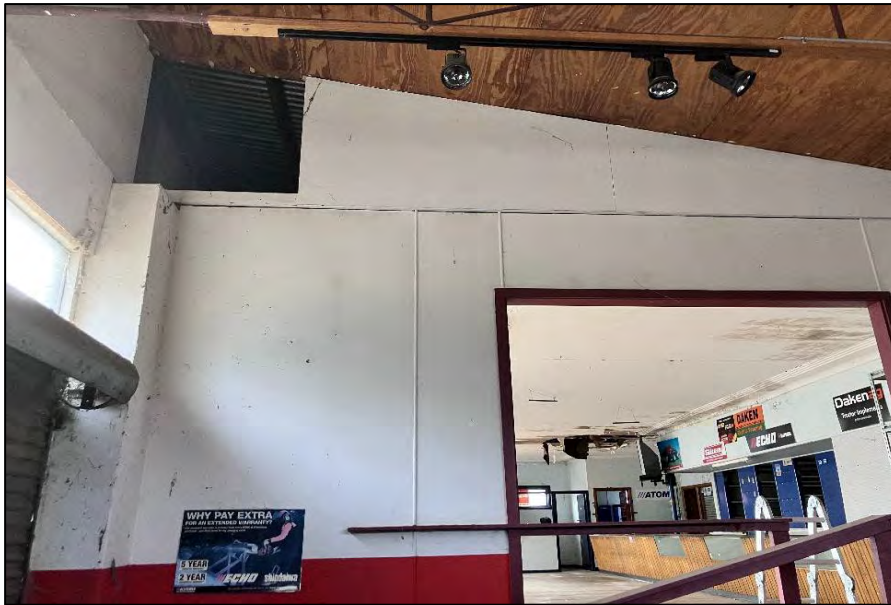
Photograph 3: Eastern building, northwestern garage, eastern wall, upper section (to ceiling void), fibre cement sheeting, no asbestos detected by analysis.

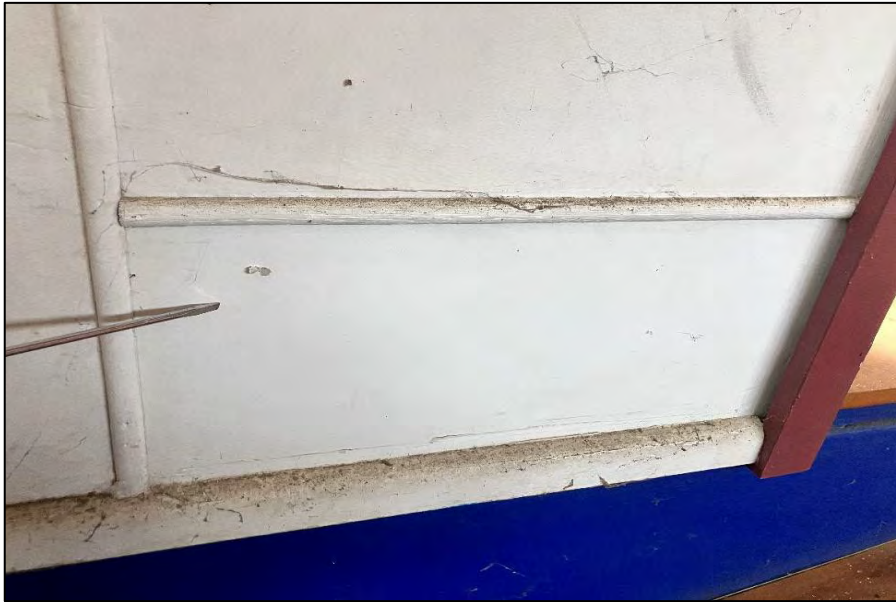
Photograph 4: Eastern building, northwestern garage, eastern wall, portion of lower lining, fibre cement sheeting, no asbestos detected by analysis.

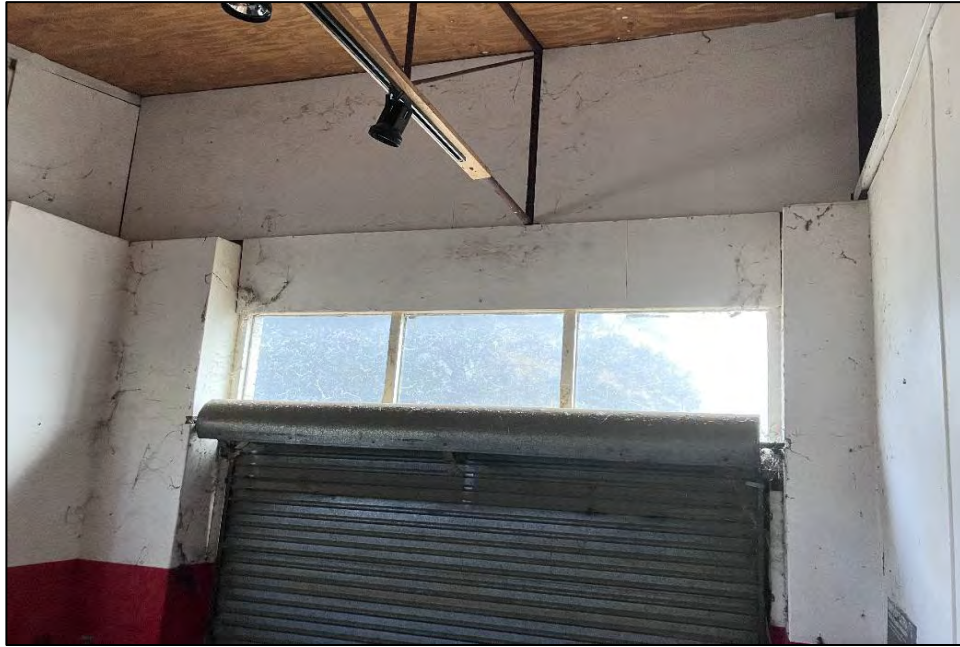
Photograph 5: Eastern building, northwestern garage, northern wall, strip ling above roller door, fibre cement sheeting, no asbestos detected by analysis (SMF detected).

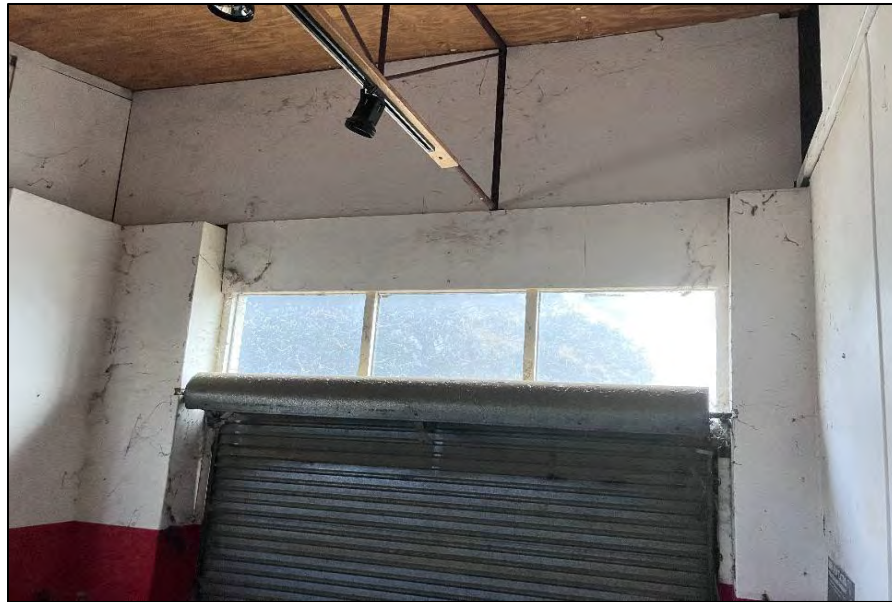
Photograph 6: Eastern building, northwestern garage, northern wall, uppermost wall linings, suspected fibre cement sheeting, suspected asbestos.

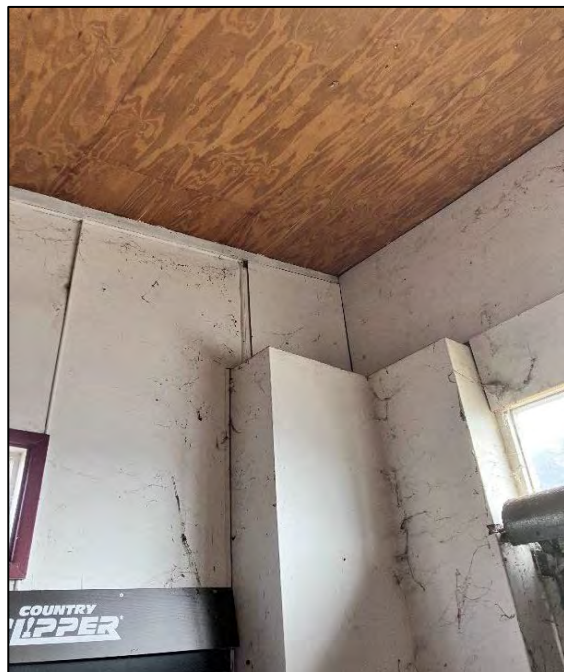
Photograph 7: Eastern building, northwestern garage, western wall, infill above brick column, suspected fibre cement sheeting, suspected asbestos.

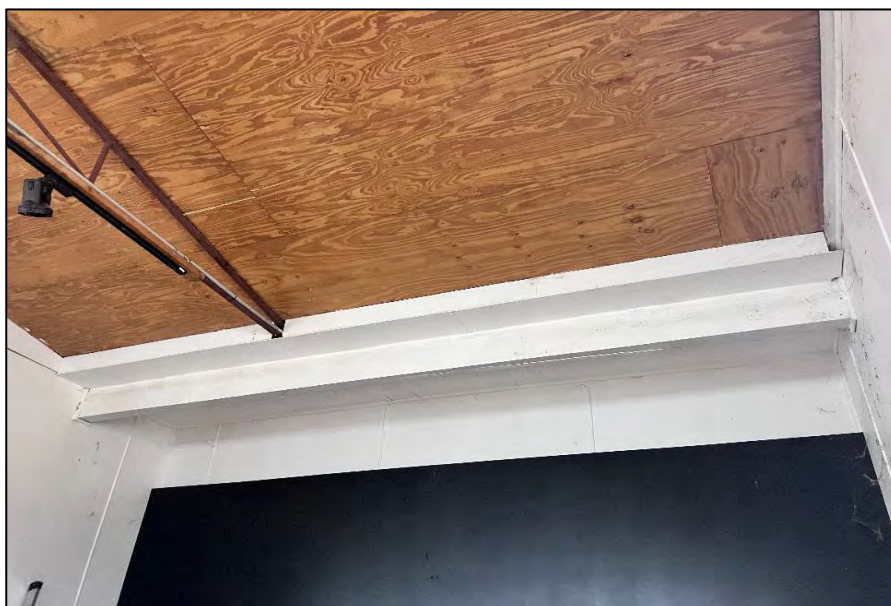
Photograph 8: Eastern building, northwestern garage, southern end, strip lining adjoining south side of timber rafter, fibre cement sheeting, no asbestos detected by analysis.

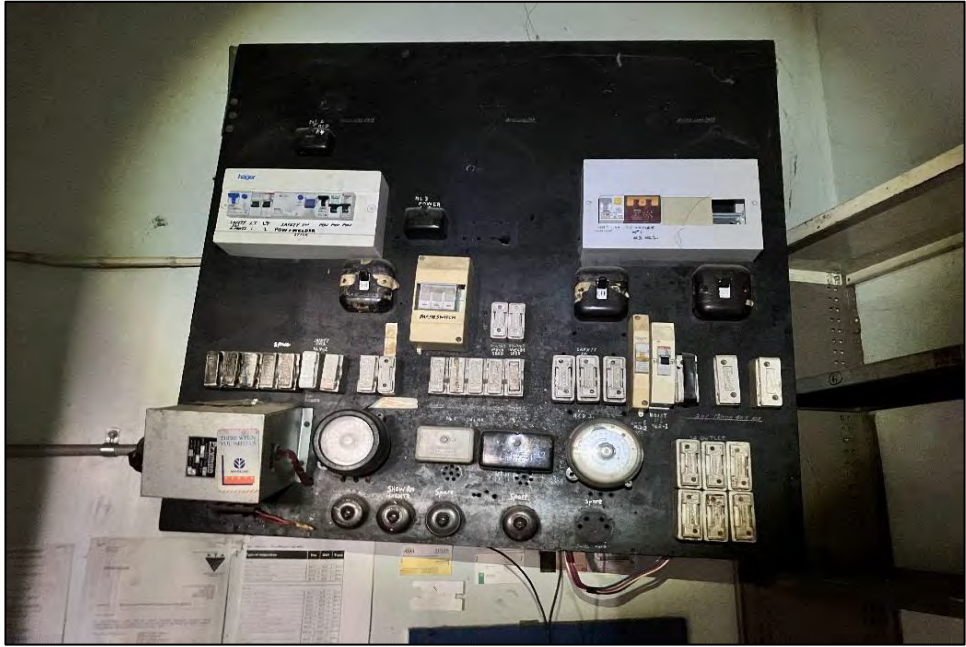
Photograph 9: Eastern building, electrical room, main electrical panel, resinous board, suspected asbestos.

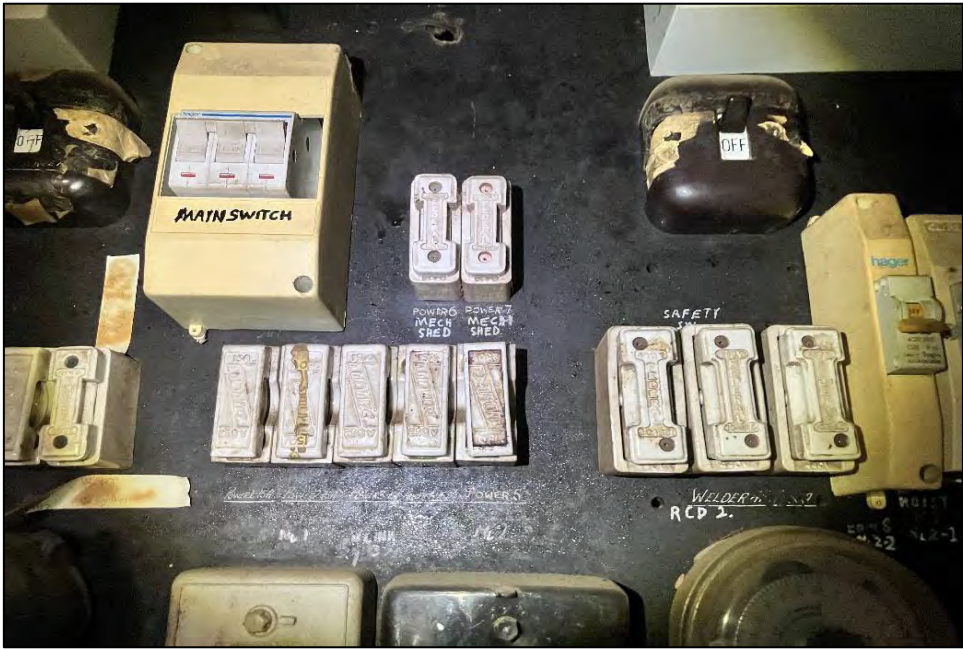
Photograph 10: Eastern building, electrical room, main electrical panel, ceramic fuses generally, internal insulation, suspected asbestos.

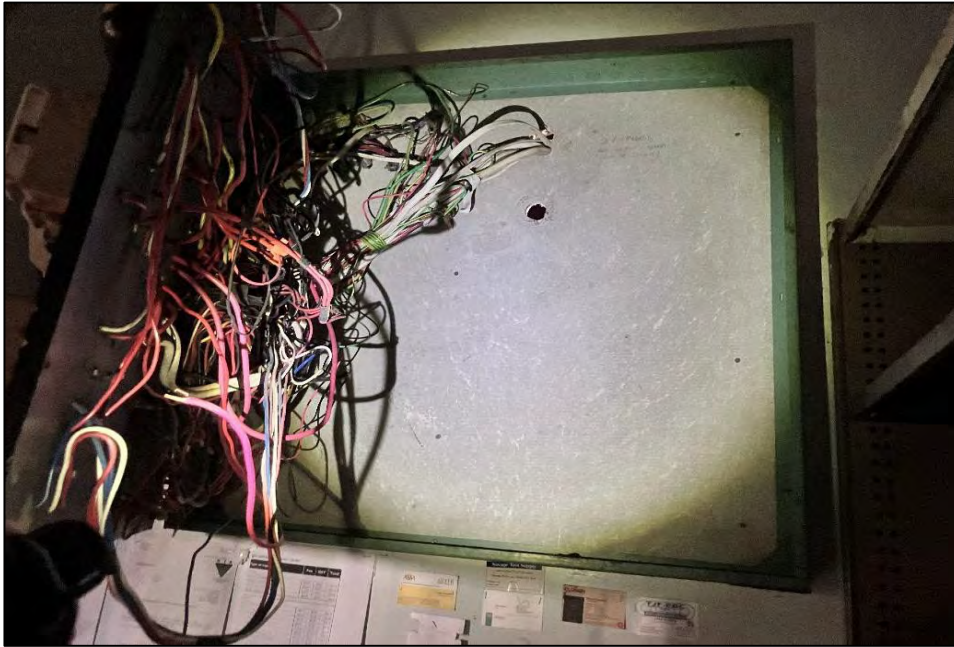
Photograph 11: Eastern building, electrical room, wall at rear of main electrical panel, fibre cement sheeting, suspected asbestos.

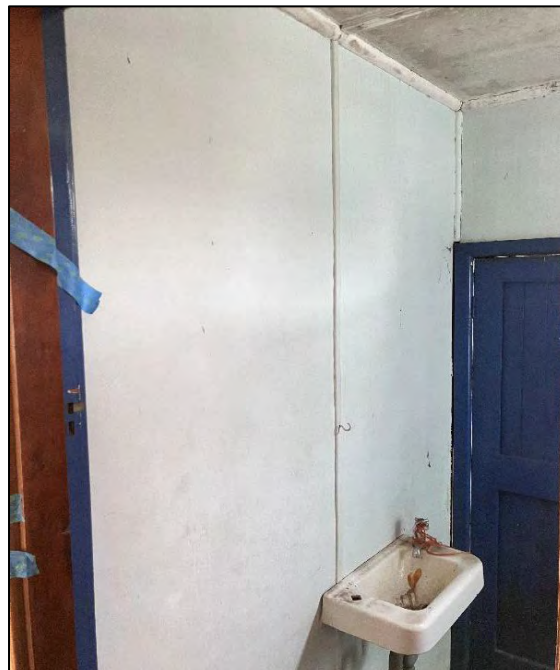
Photograph 12: Eastern building, main retail area, eastern toilets, wall linings generally, fibre cement sheeting, asbestos detected by analysis.

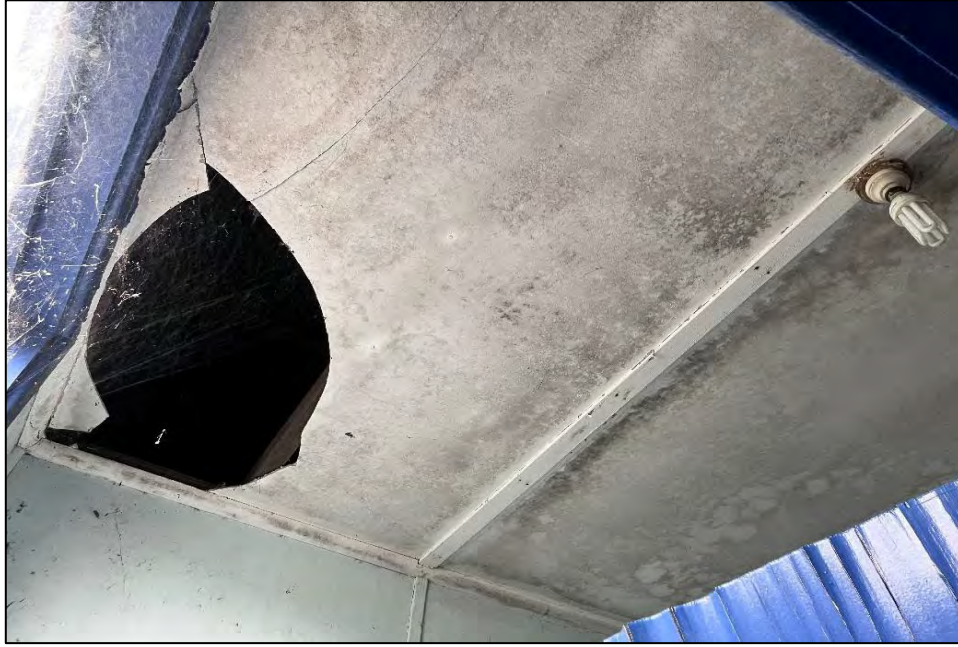
Photograph 13: Eastern building, main retail area, eastern toilets, ceiling, fibre cement sheeting, asbestos detected by analysis.

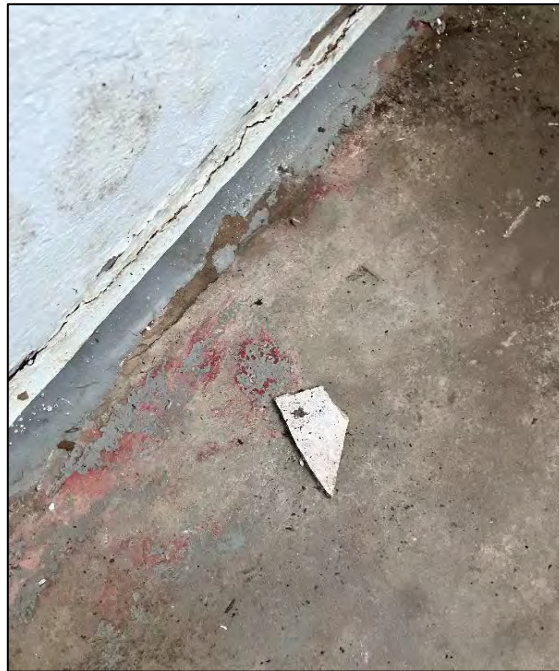
Photograph 14: Eastern building, main retail area, eastern toilets, floor, fibre cement fragment(s), suspected asbestos.

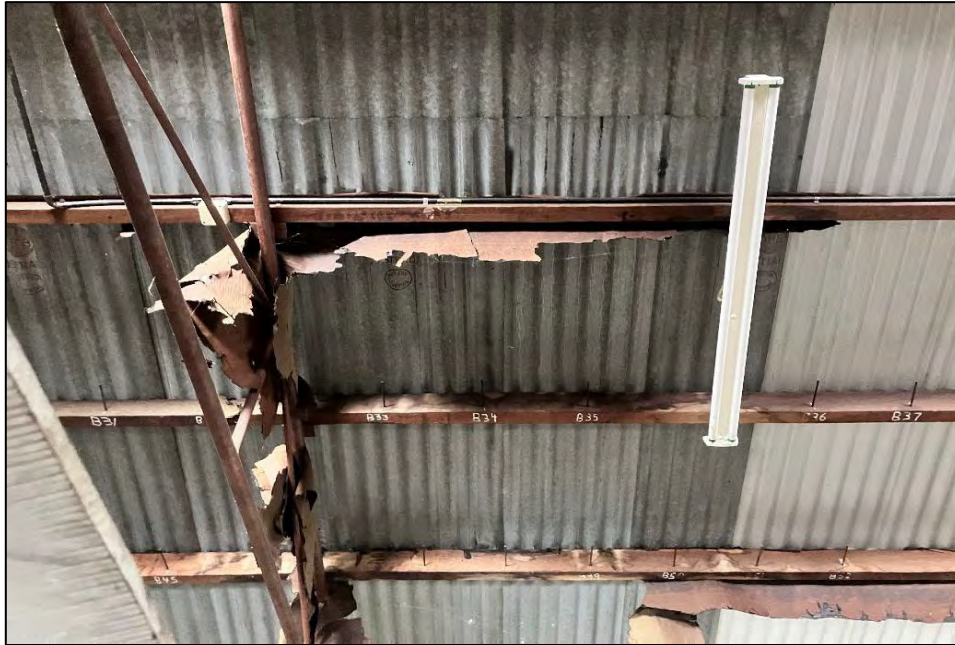
Photograph 15: Eastern building, tool store, underside of roof, bituminous lining, no asbestos detected by analysis.

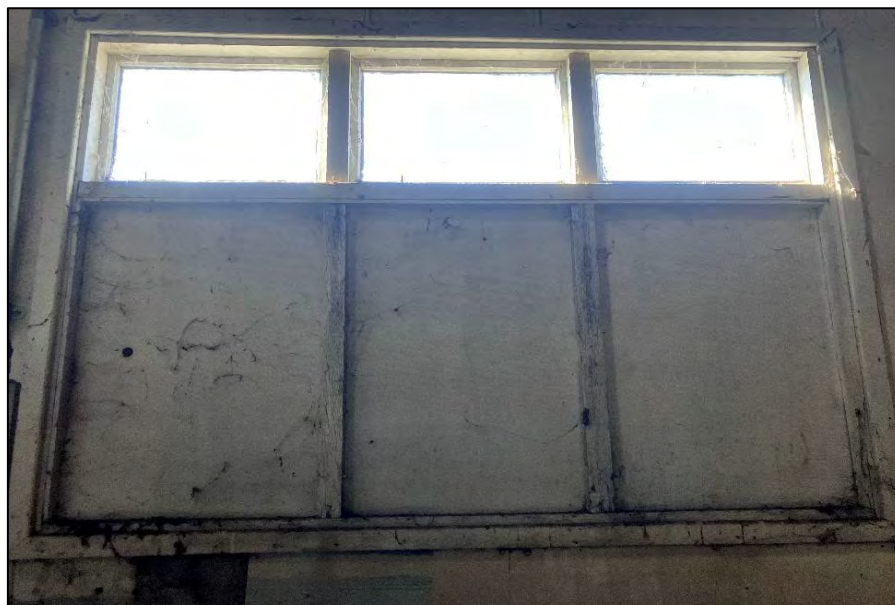
Photograph 16: Eastern building, main warehouse area, eastern wall, window infill, fibre cement sheeting, asbestos detected by analysis.

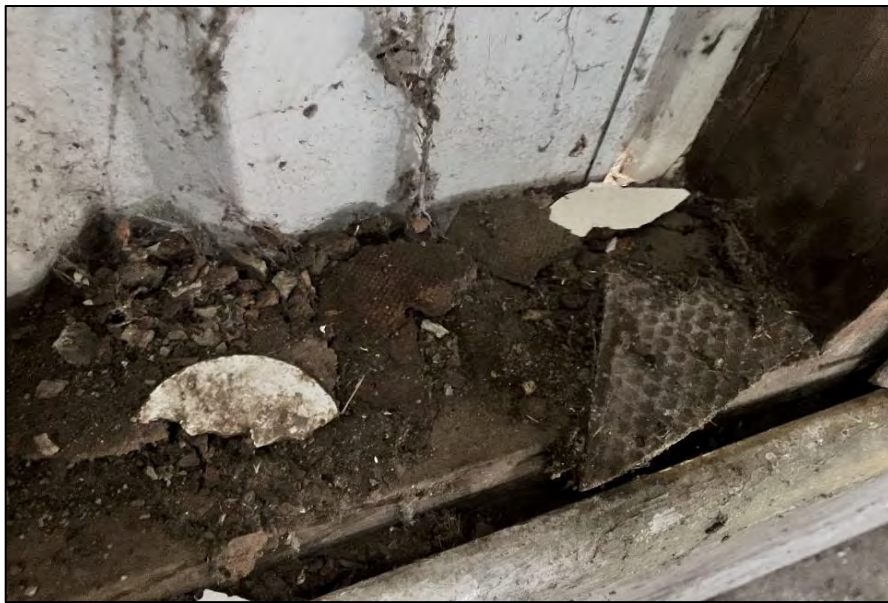
Photograph 17: Eastern building, main warehouse area, eastern wall, timber framework, fibre cement fragment(s), asbestos detected by analysis.

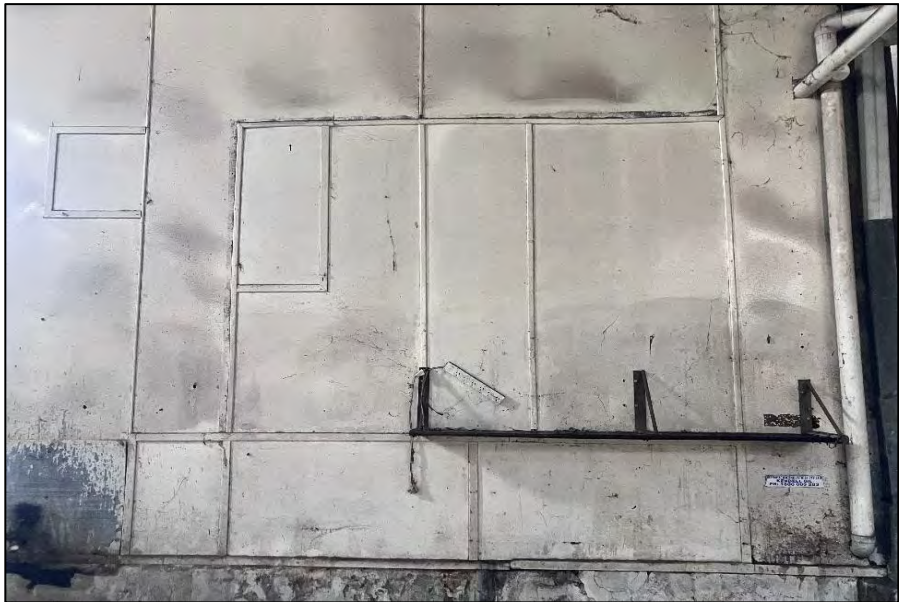
Photograph 18: Eastern building, main warehouse area, eastern wall, framed section(s), fibre cement sheeting, asbestos detected by analysis.

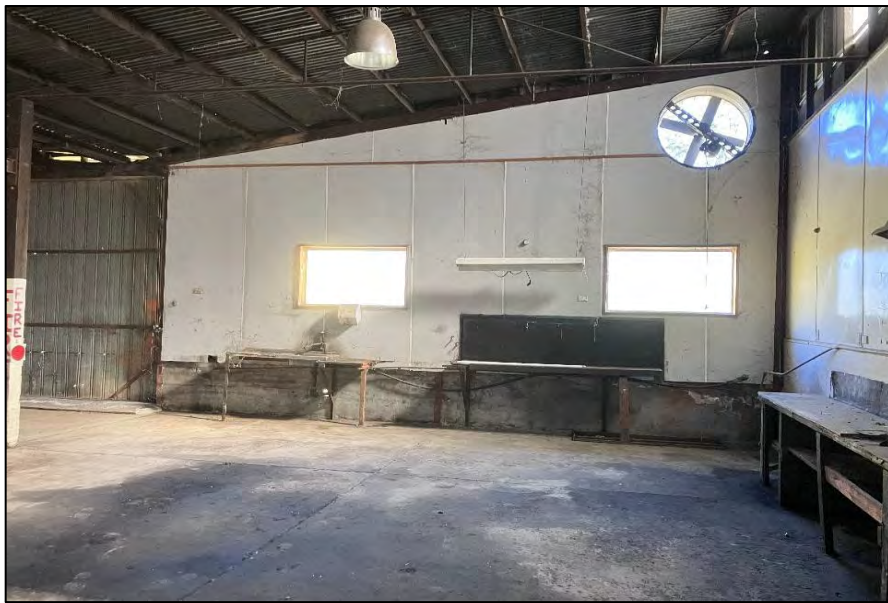
Photograph 19: Eastern building, main warehouse area, western wall linings generally, fibre cement sheeting, no asbestos detected by analysis.

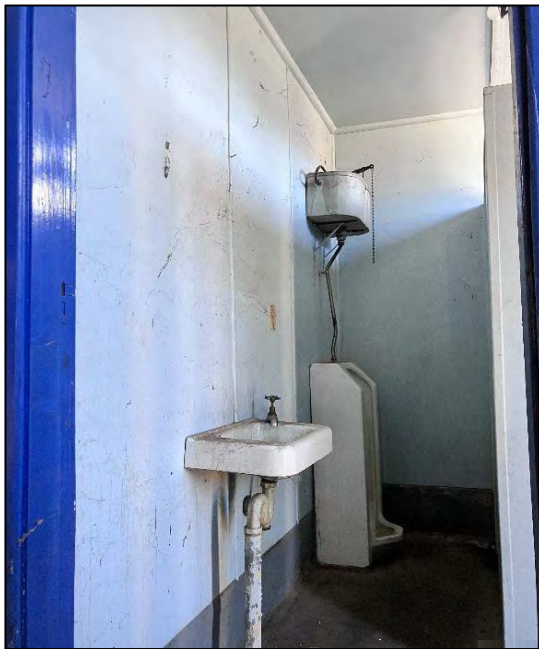
Photograph 20: Eastern building, main warehouse area, northeastern toilets, wall linings generally, fibre cement sheeting, suspected asbestos.

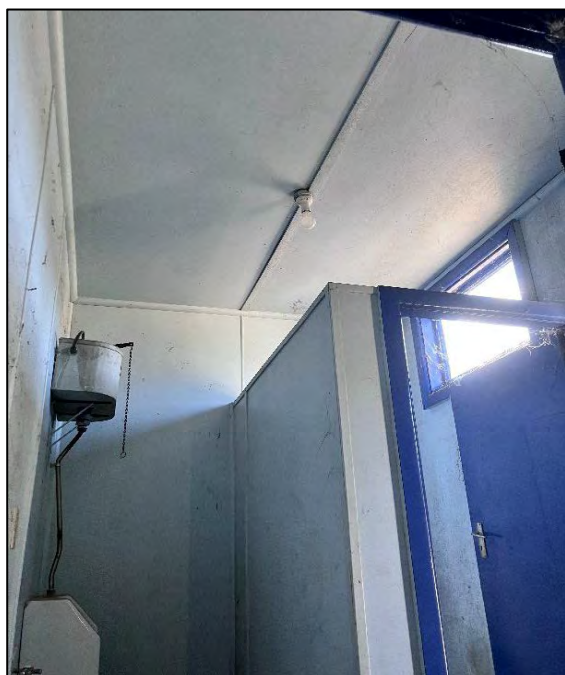
Photograph 21: Eastern building, main warehouse area, northeastern toilets, ceiling lining, fibre cement sheeting, suspected asbestos.

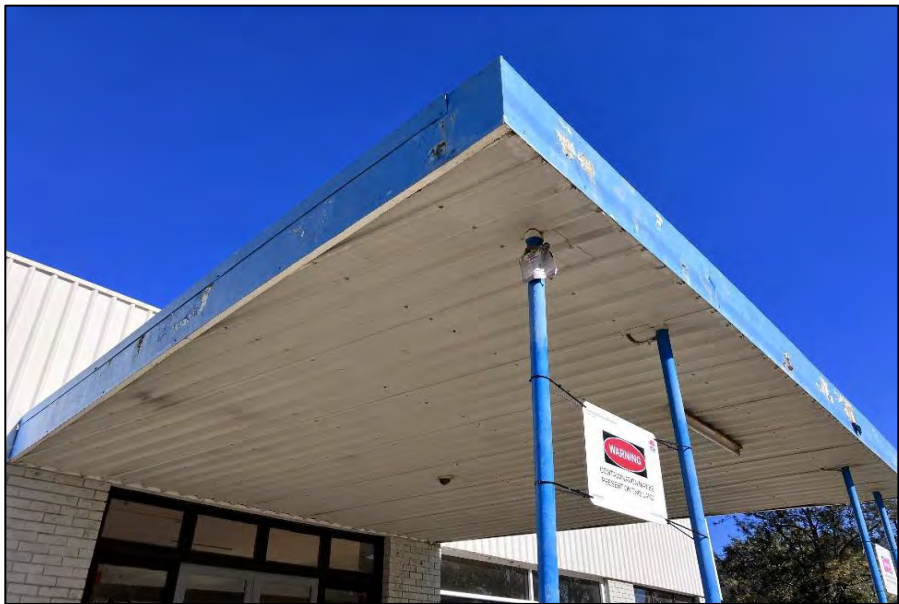
Photograph 22: Eastern building, exterior, northern façade, awning fascia, possible fibre cement sheeting, suspected non-asbestos.

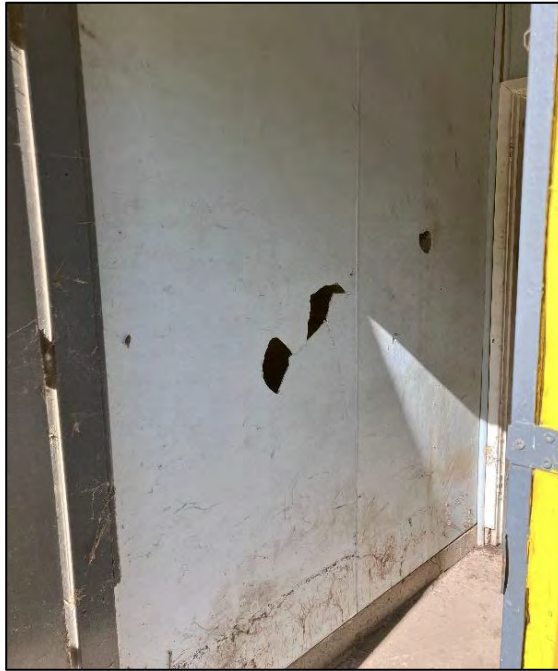
Photograph 23: Western building (Dunlop Tyres), entry vestibule, wall linings generally, fibre cement sheeting, asbestos detected by analysis.

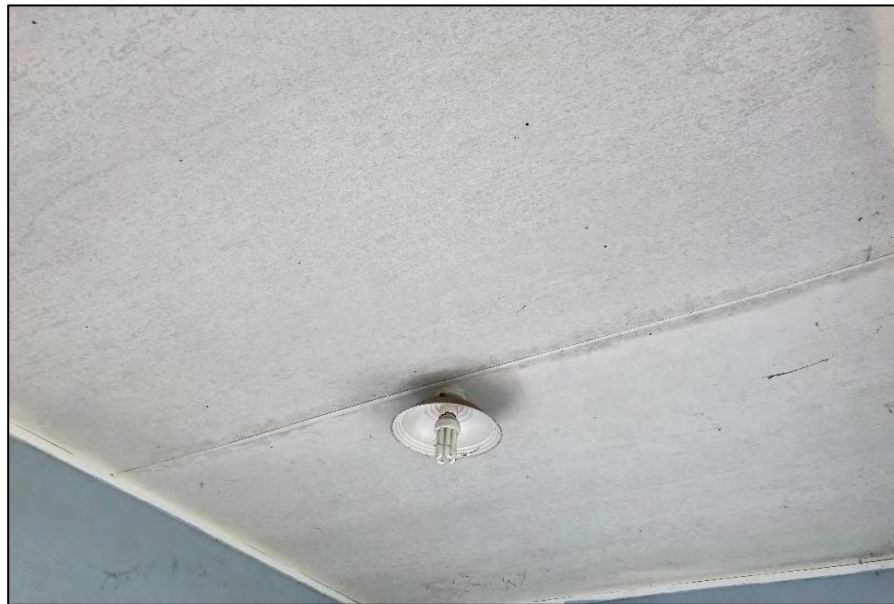
Photograph 24: Western building (Dunlop Tyres), entry vestibule, ceiling, fibre cement sheeting, suspected asbestos.

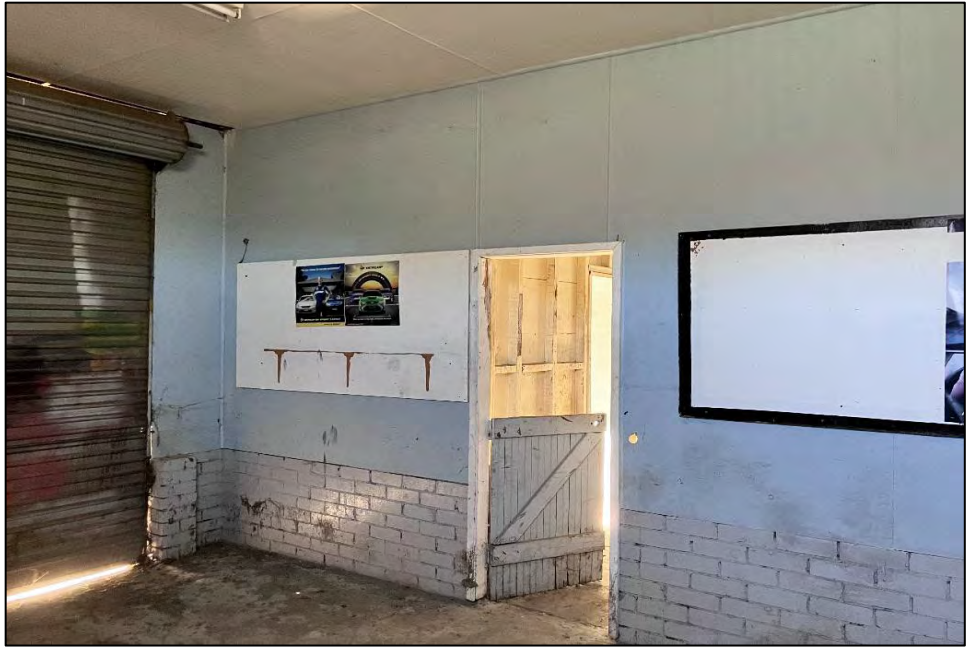
Photograph 25: Western building (Dunlop Tyres), western garage and store room, wall linings generally, fibre cement sheeting, asbestos detected by analysis.

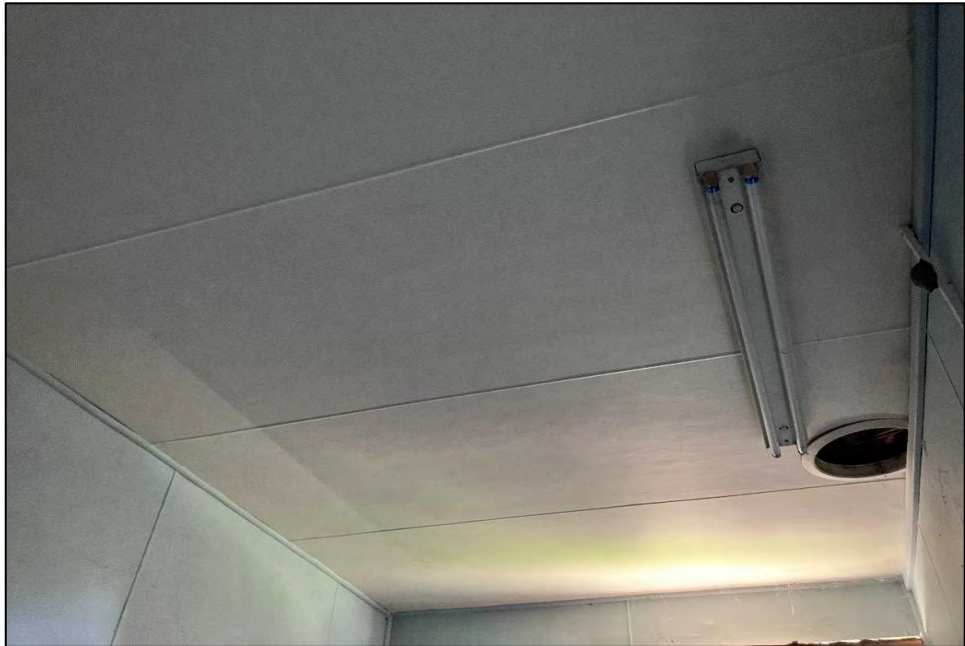
Photograph 26: Western building (Dunlop Tyres), western garage and store room, ceiling linings generally, fibre cement sheeting, suspected asbestos.

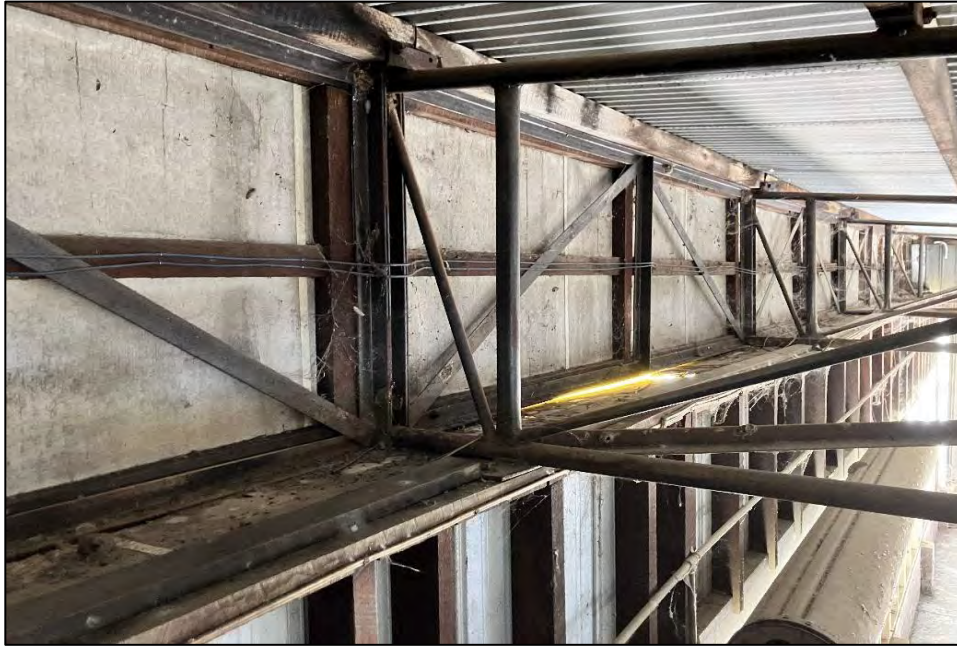
Photograph 27: Western building (Dunlop Tyres), northern façade, fascia, fibre cement sheeting, asbestos detected by analysis.

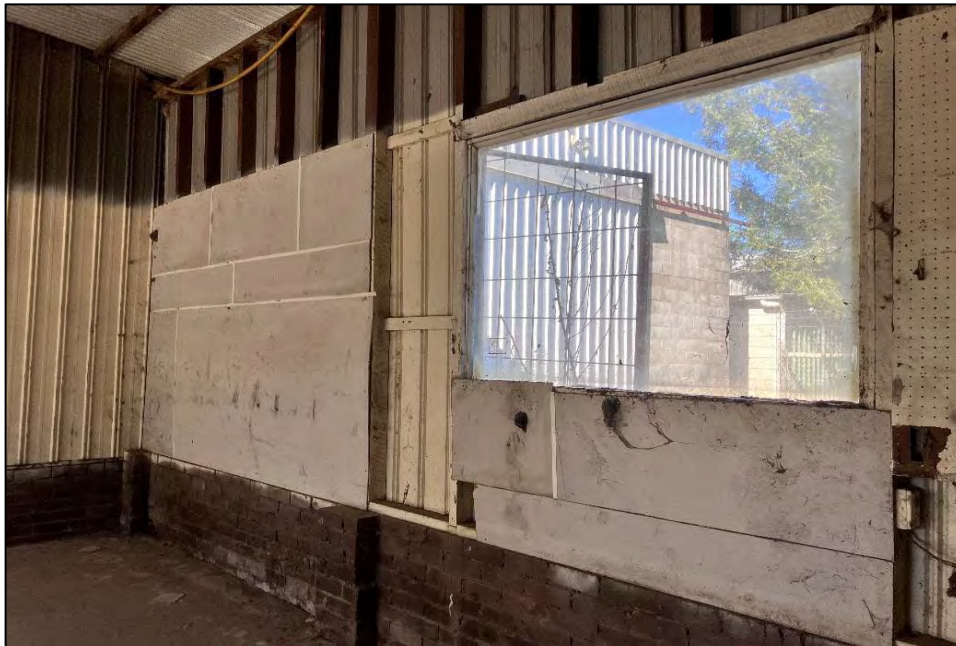
Photograph 28: Western building (Dunlop Tyres), interior, southern side, wall lining(s) inc. to support ledge, fibre cement sheeting, no asbestos detected by analysis.

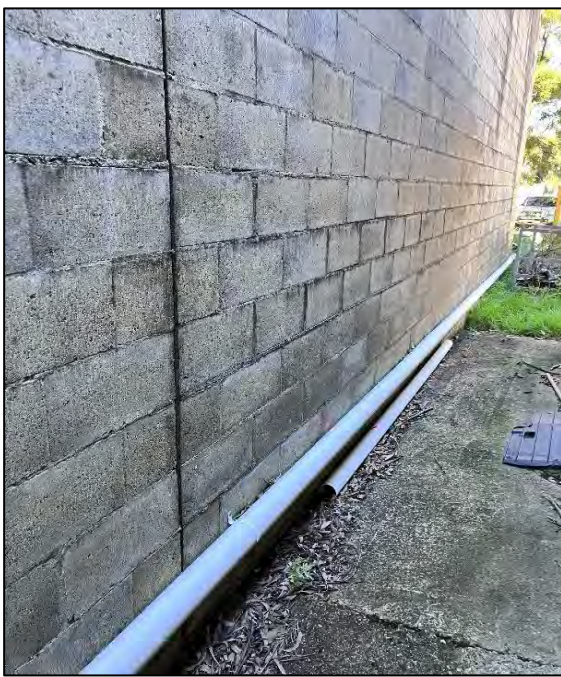
Photograph 29: Western building (Dunlop Tyres), exterior, southern façade, wall, expansion gap, lining, no asbestos detected by analysis.

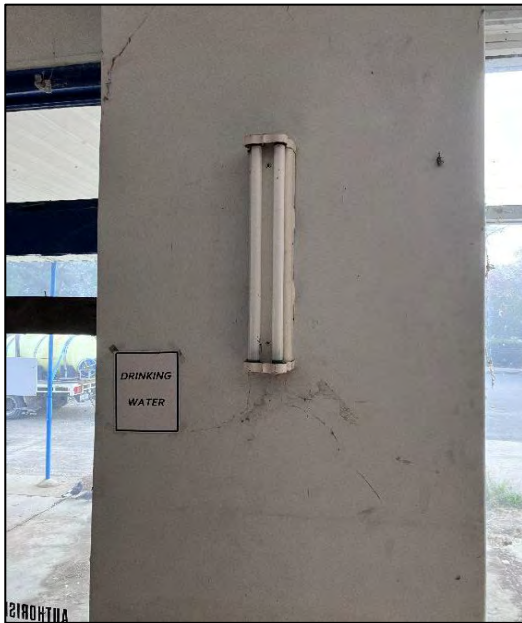
Photograph 30: Eastern building, main retail area, concrete column at main entrance, pale blue paint, lead paint detected.

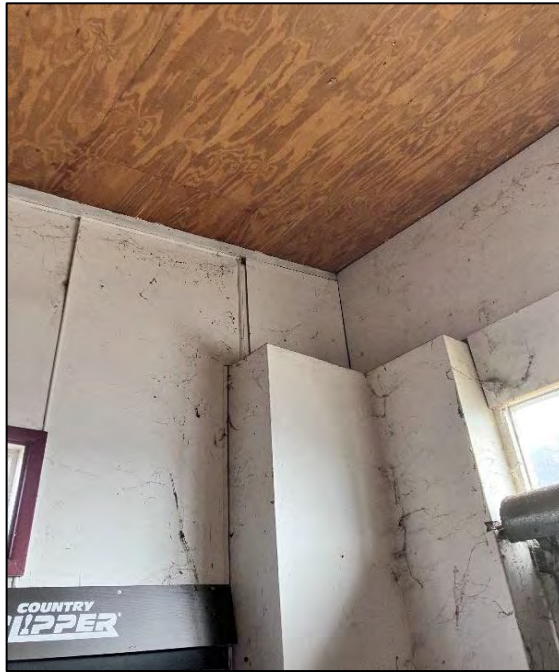
Photograph 31: Eastern building, northwestern garage, masonry column, white paint, lead paint detected.

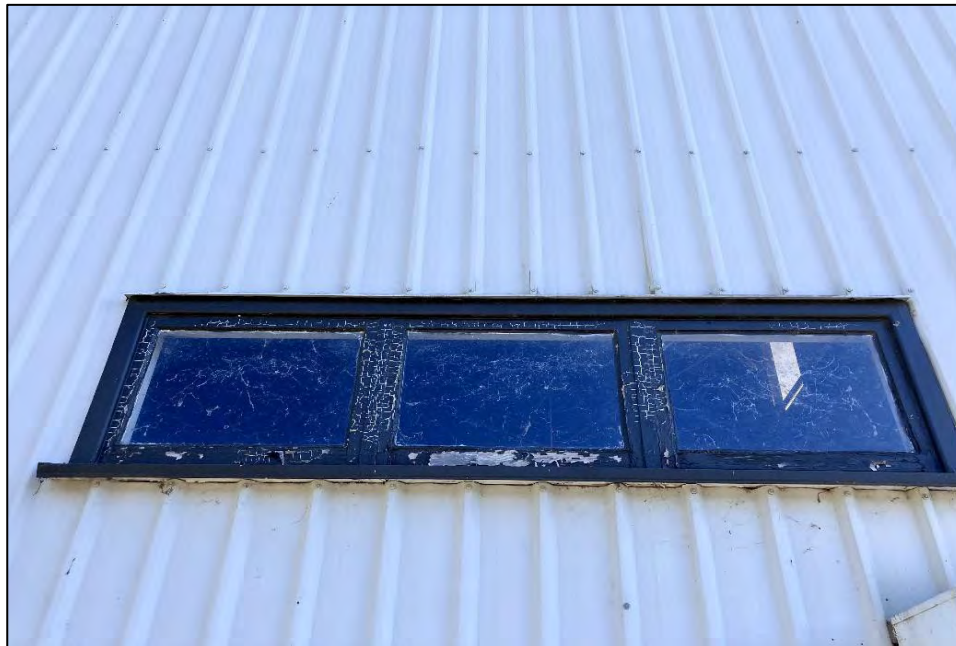
Photograph 32: Eastern building, exterior, eastern façade, window frame, grey paint, lead paint detected.

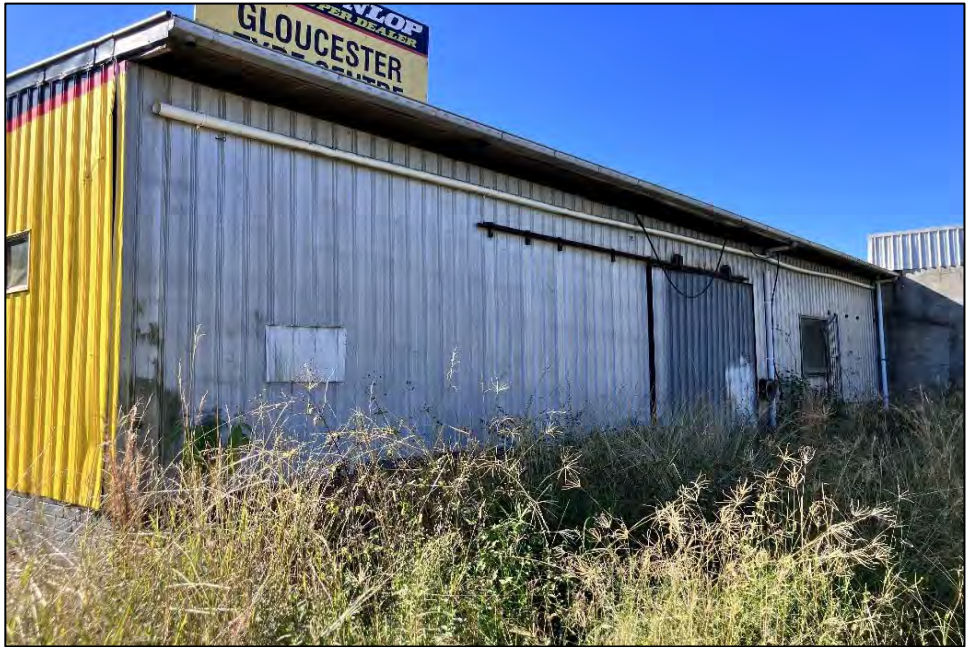
Photograph 33: Western building (Dunlop Tyres), southern façade, sliding door, cream and underlying blue paint, lead paint detected.

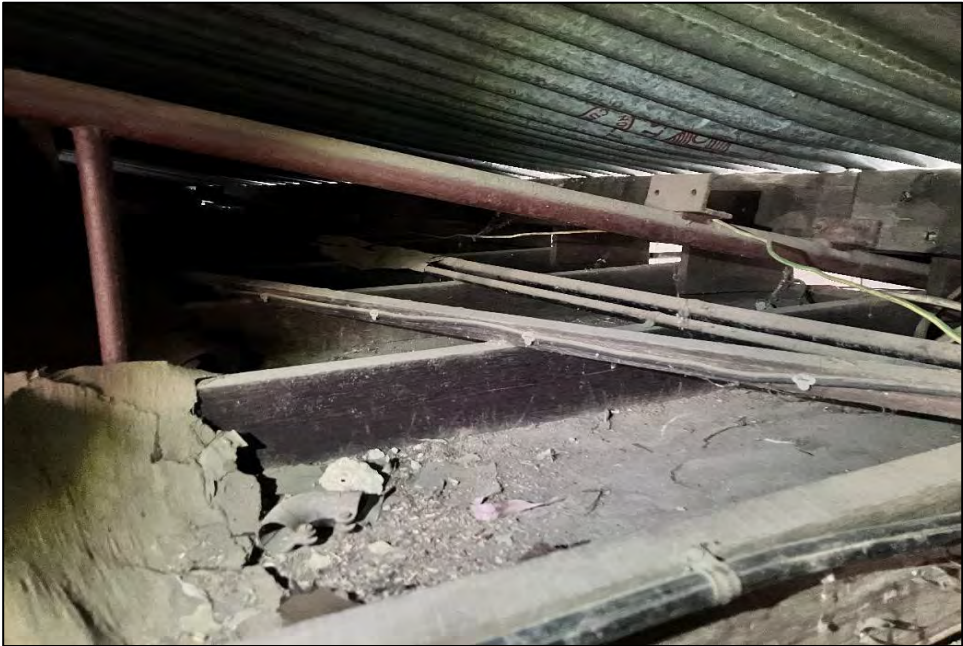
Photograph 34: Eastern building, tool store, eastern end, ceiling cavity, settled dust / debris, lead detected.

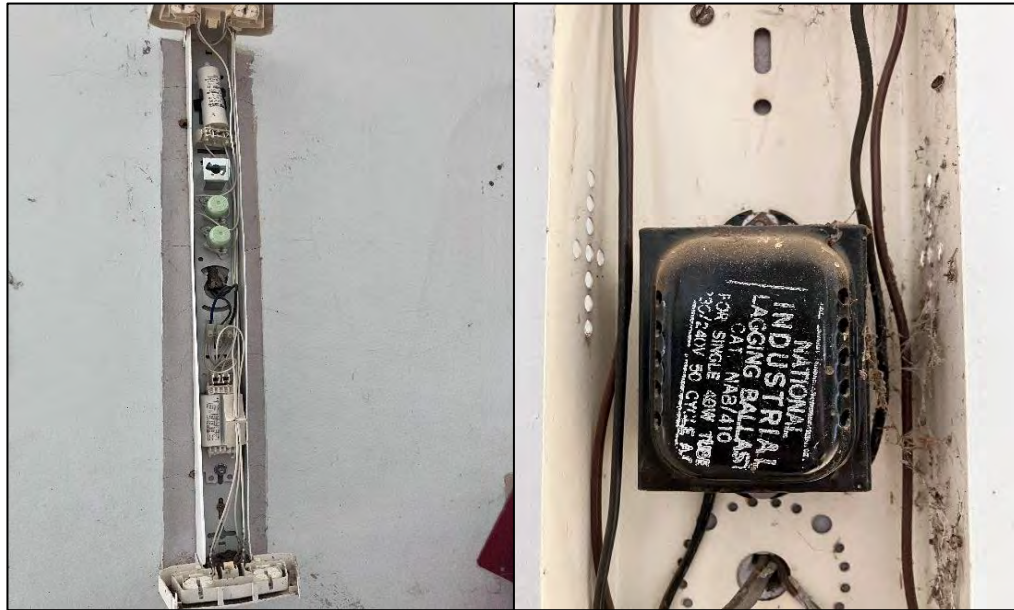
Photograph 35: Eastern building, main retail area, wall(s), fluorescent light fittings generally, internal components (e.g., capacitors, ballasts), PCB (suspected).

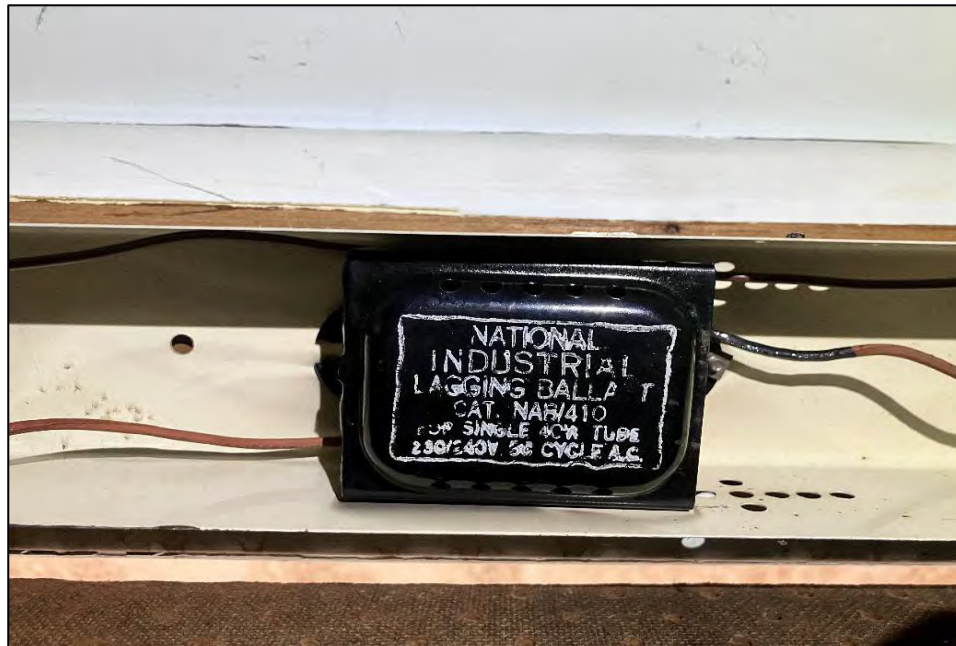
Photograph 36: Eastern building, service counter and tool store, fluorescent light fitting(s), internal components (e.g., capacitors, ballasts), PCB (suspected).

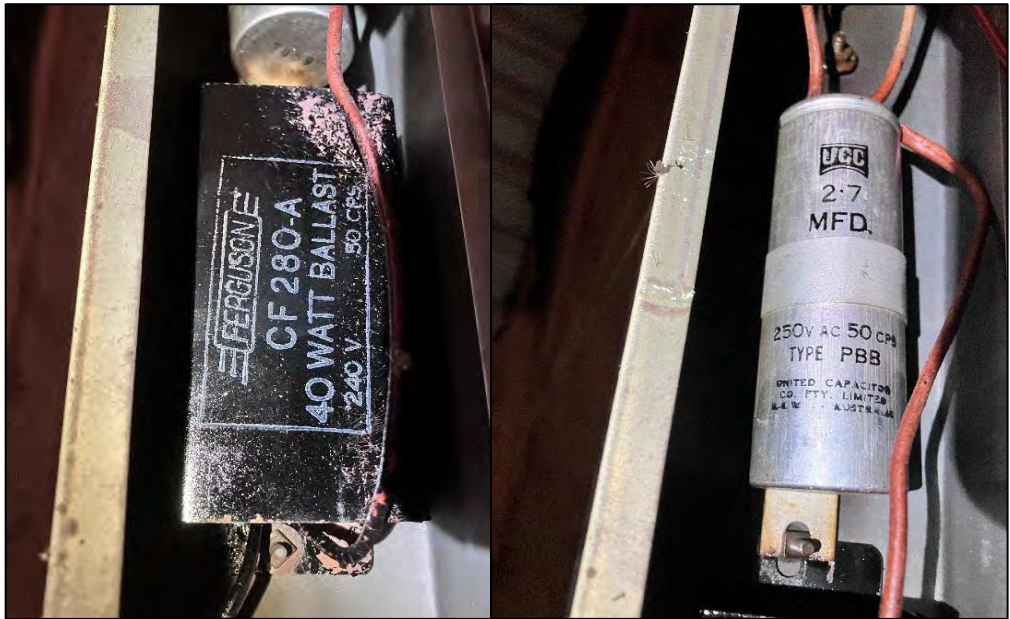
Photograph 37: Eastern building, tool store, fluorescent light fitting(s), internal components (e.g., capacitors, ballasts), PCB (suspected).

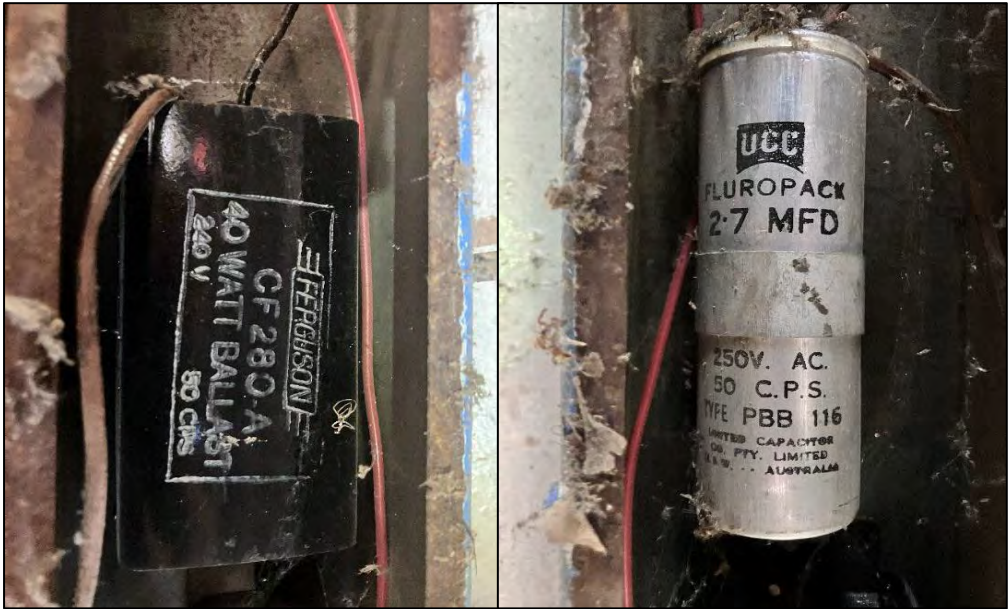
Photograph 38: Eastern building, main warehouse area, northern wall, fluorescent light fittings generally, internal components (e.g., capacitors, ballasts), PCB (suspected).

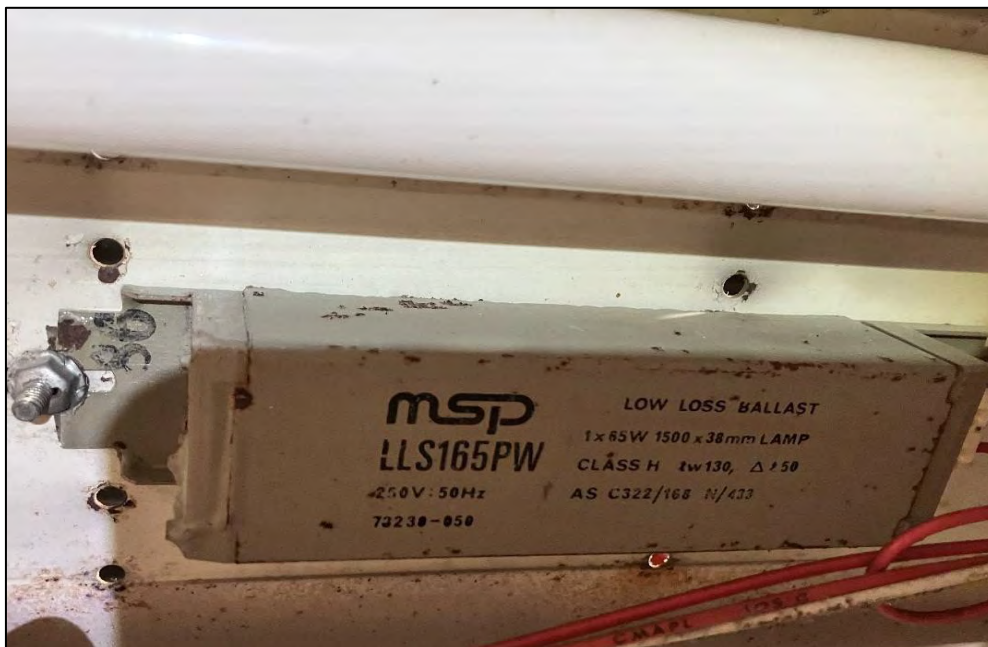
Photograph 39: Eastern building, main warehouse area, suspended fluorescent light fittings generally, internal components (e.g., capacitors, ballasts), PCB (suspected).
