**Hazardous Building Materials (HAZMAT)
Report, 17 Denison Street, Gloucester NSW**

**Prepared for Department of Planning,
Housing and Infrastructure**

Project 228674.00

5 July 2024

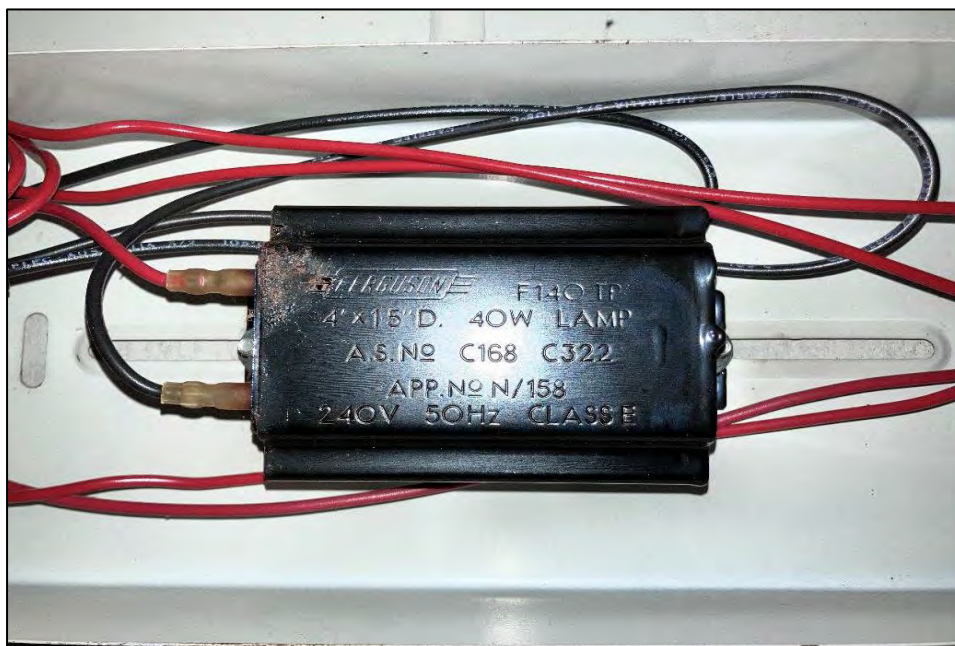
Photograph 40: Western building, western garage and store room, fluorescent light fittings generally, internal components (e.g., capacitors, ballasts), .

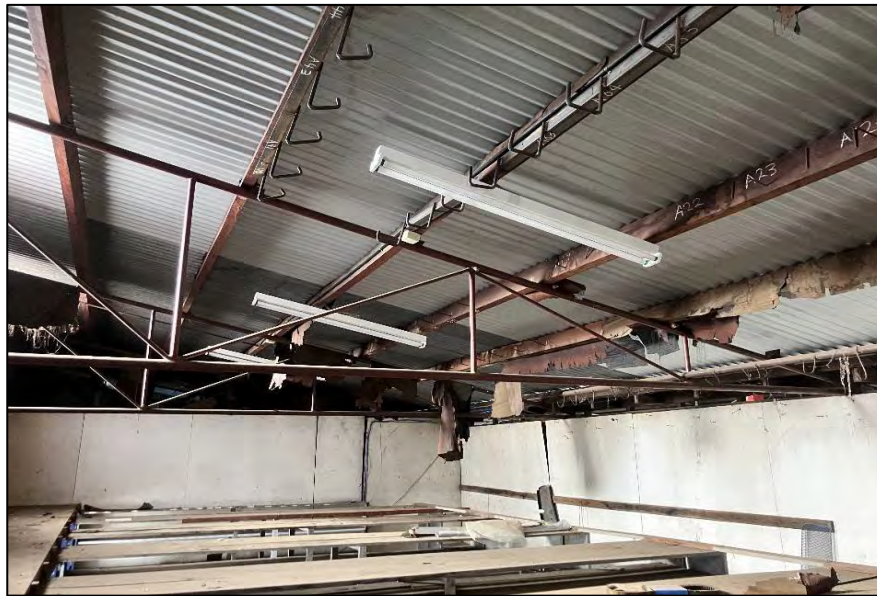
Photograph 41: Building in general, rooms and areas in general, fluorescent light fittings generally, internal components (e.g., capacitors, ballasts), PCB (suspected).

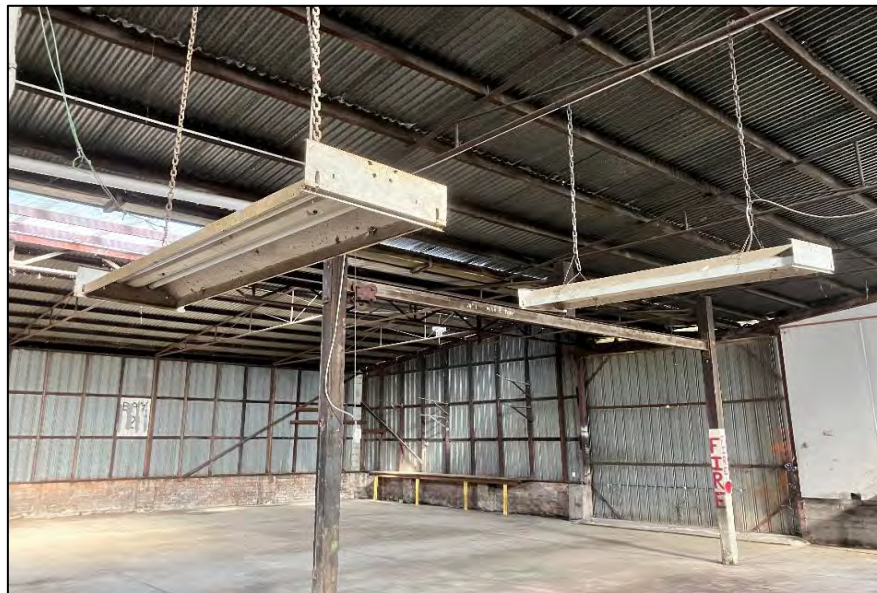
Photograph 42 Building in general, rooms and areas in general, fluorescent light fittings generally, internal components (e.g., capacitors, ballasts), PCB (suspected).

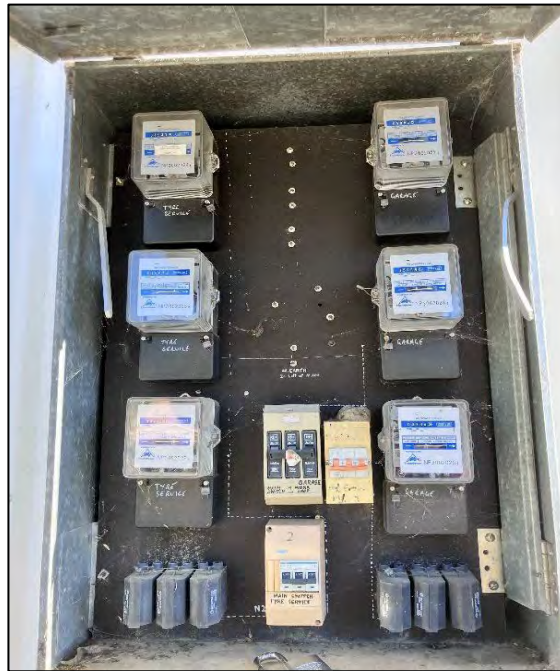
Photograph 43: Eastern building, exterior, eastern façade, electrical panel, backing board, suspected non-asbestos.

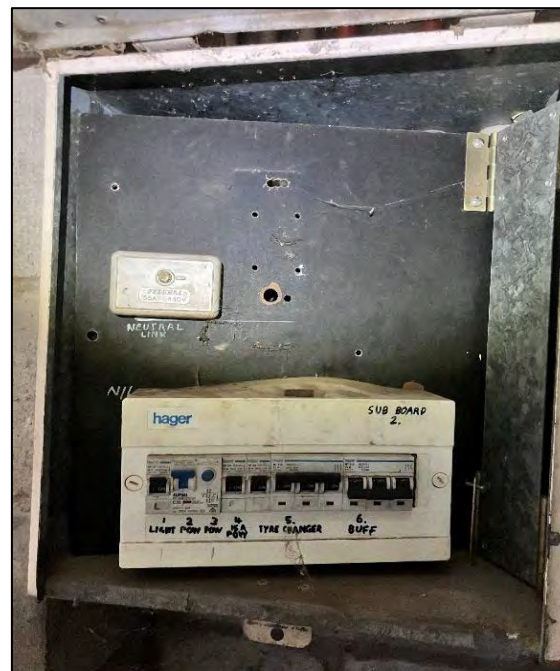
Photograph 44: Southern building, interior, eastern side, electrical panel, backing board, suspected non-asbestos.

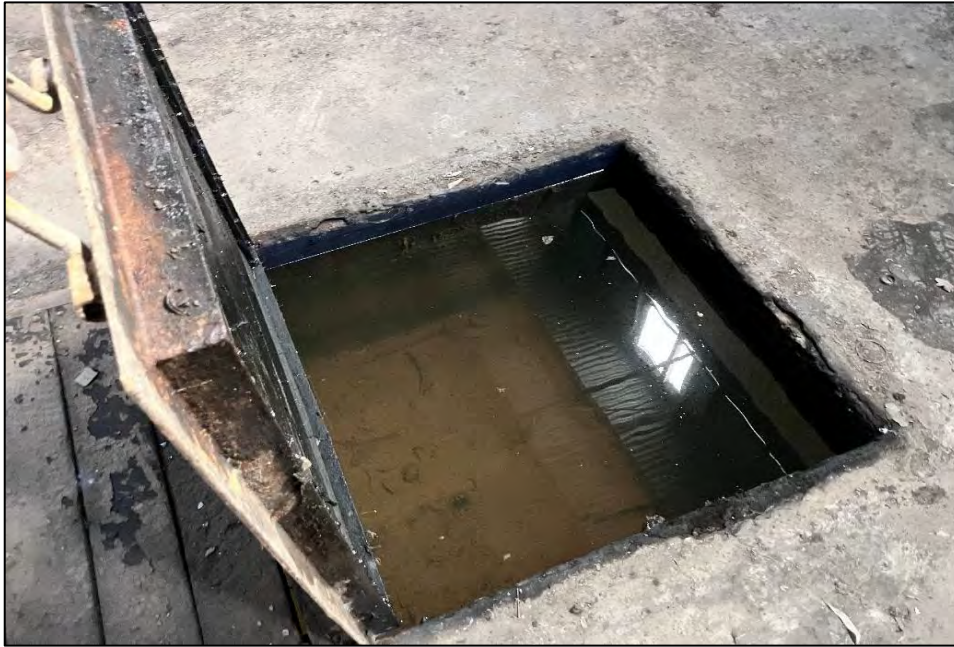
Photograph 45: Eastern building, main warehouse area, several pits in floor, materials in general, inaccessible (confined space, liquids etc.).

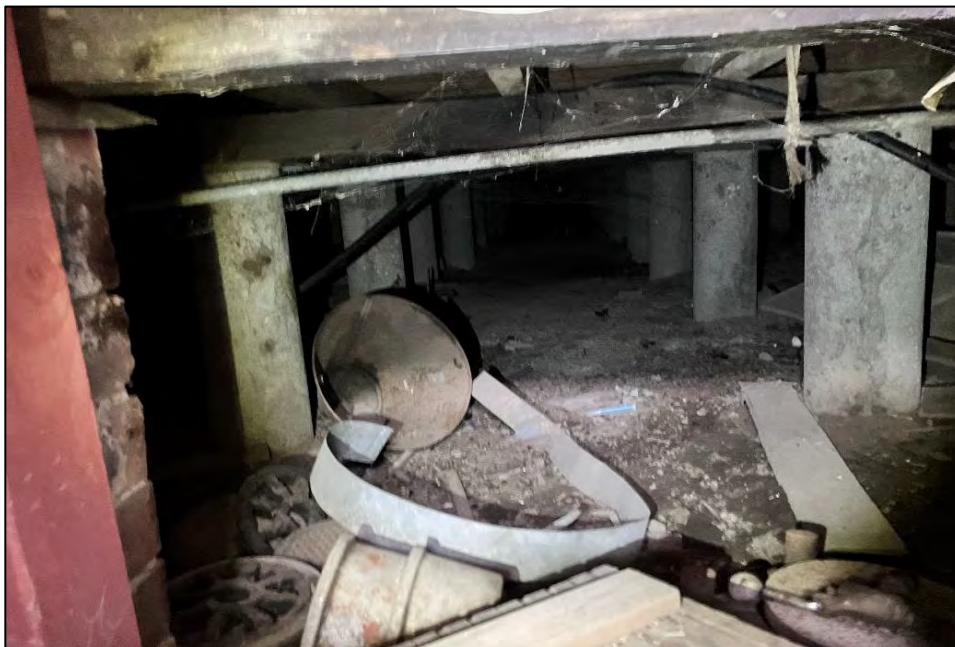
Photograph 46: Eastern building, rooms and areas in general, subfloor, materials in general, inaccessible (crawl space).
