Catherine Hill Bay Jetty

Prepared for The Department of Planning and Environment

July 2023
Project Number N23028
Version 001

Report No. 1 – History and Locality

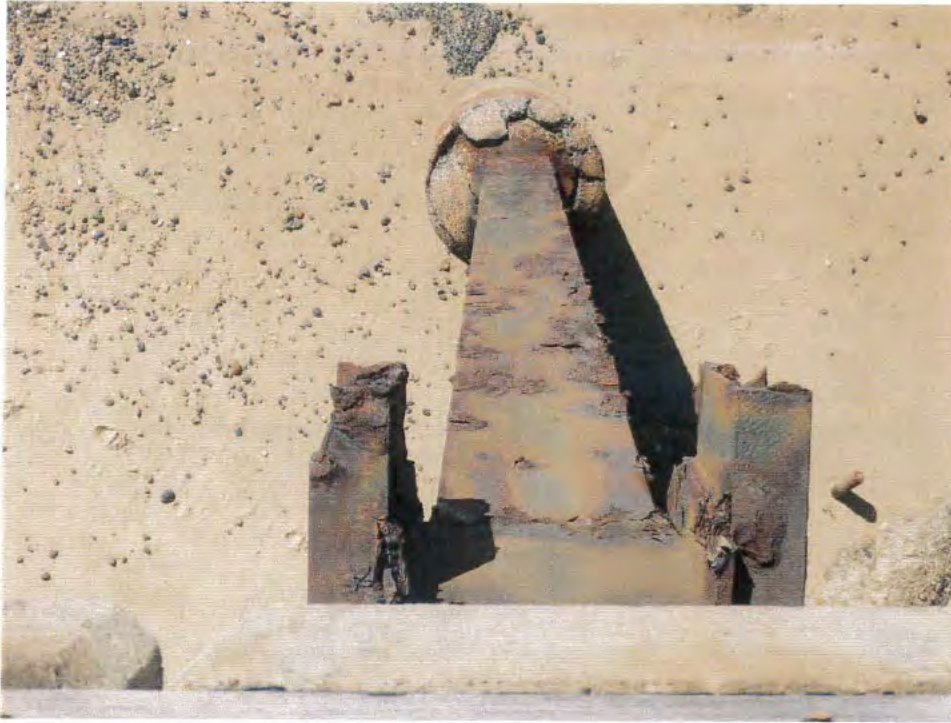
3. Bent 28. The primary columns have significant corrosion to both the webs and flanges. The diagonal braces had corrosion holes at the connections with the legs and along their length. The twin members across the head of the columns, immediately under the primary deck support beams, were badly corroded, missing flange and web. The connections between the twin members and the columns were badly corroded and swollen. Refer to Photo's 1, 2,15,16,17 and 18.

12. The base of the legs of the bents were encased in concrete. Gaps between the concrete and the legs were visible. Given the observable corrosion in the legs above the encasement it is reasonable to assume that the legs were corroded below the encasement where conditions for corrosion would be excellent. Refer to Photo's 1, 4, 7,8,19 and 32.

Photo 1. A view down the outer leg of a Bent. Note the overall corrosion and the corrosion damage to the interconnecting PFC's and their welded connections.

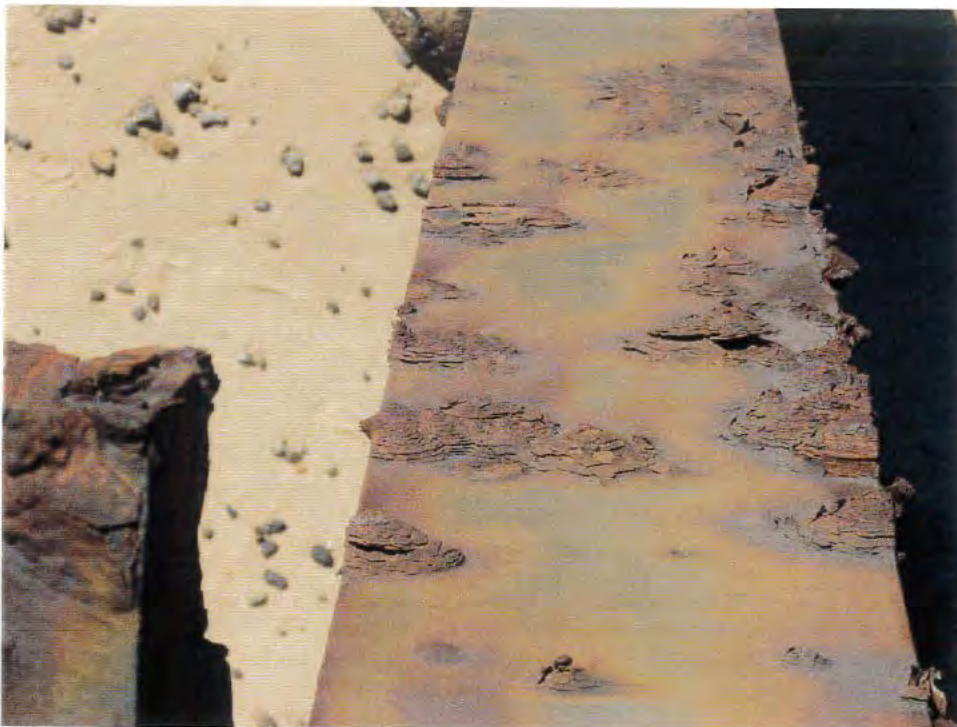
Photo 2. A detailed view of corrosion on the face of a column Bent shown in Photo 1.

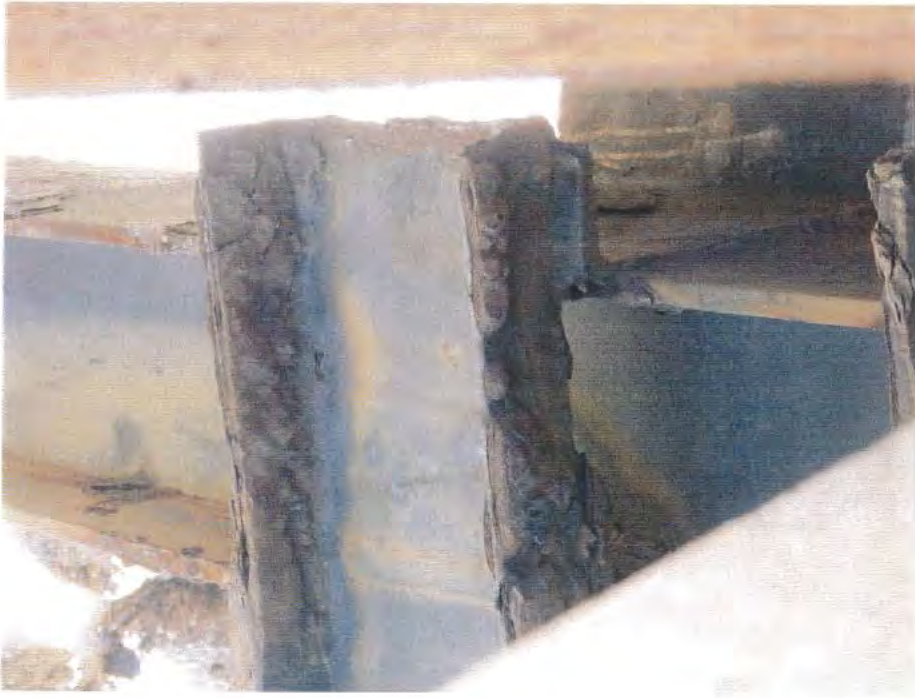
5. Bent 25. The primary columns have significant corrosion to both the webs and flanges. The flanges had corroded with the thickness reduced to 12mm. The webs had localise but significant deep corrosion. The diagonal braces had corrosion holes at the connections with the legs and along their length. The twin members across the head of the columns, immediately under the primary deck support beams were badly corroded, missing flange and web. The connections between the twin members and the columns were badly corroded and had failed on one side with the member only restrained by the suspect welds on the opposite column. Refer to Photo's 3,4,5,7,8,10,25,26,27,28,29,30 and 31

Photo 3. A detailed view of corrosion damage to the top of a Bent column.

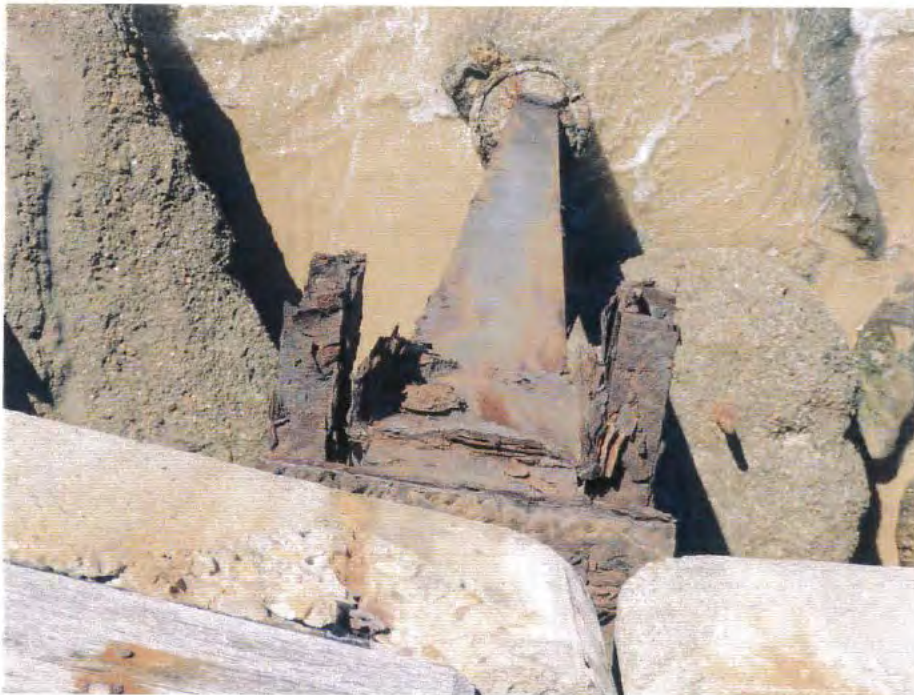
Photo 4. A detailed view of severe corrosion at the top of a Bent.

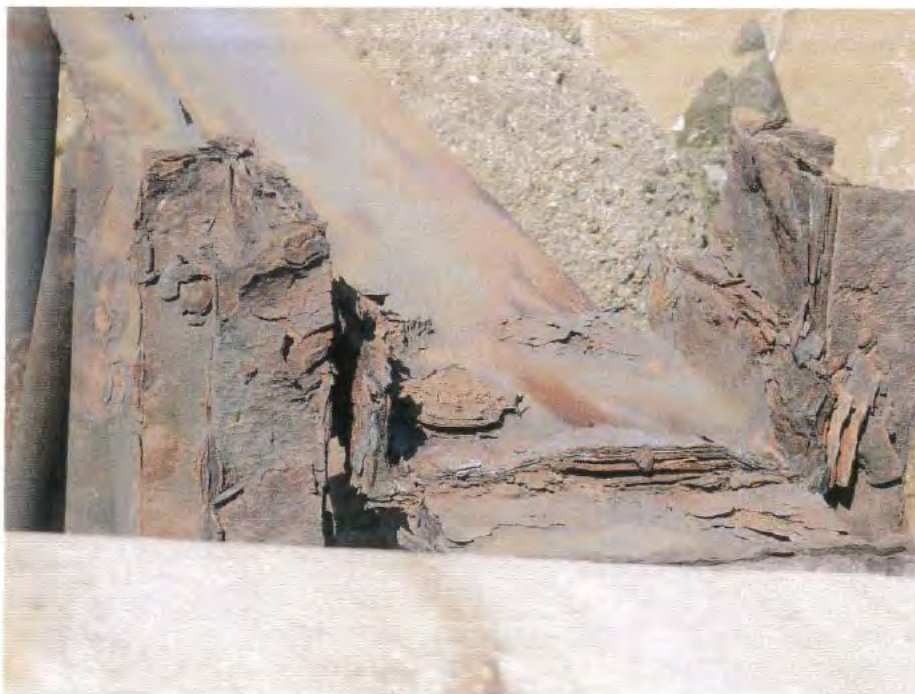
Photo 5. A detailed view of corrosion damage to the top of a Bent leg and the interconnecting PFC's shown in Photo 4. Note the failure of the welds between the PFC's and the leg.

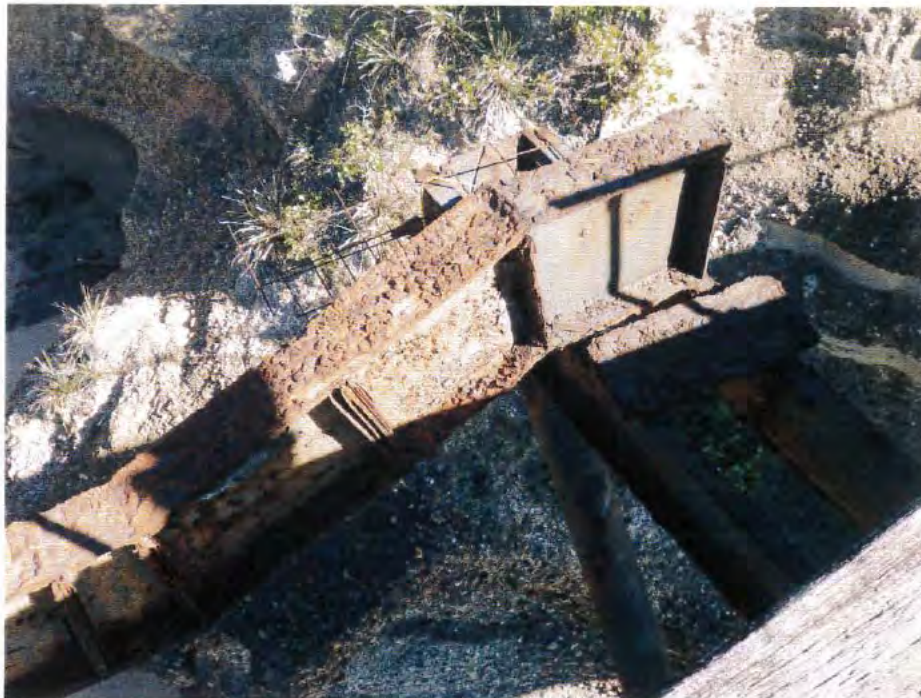
8. Reinforcing corrosion was visible on the soffit of the deck with exposed steel and there were corrosion related cracks on the sides of the slab.
9. Ancillary structure between the deck and the cliff face was badly corroded. Between bents 23 and 25 the corrosion was so severe that hinges in the supported structure may form and collapse without warning. This structure was also supported on twin members that span between the columns which had significant corrosion between the twin members and the columns. Refer to Photo 6.

Photo 6. A detailed view of corrosion damage to ancilliary structure connected to Bent 24.

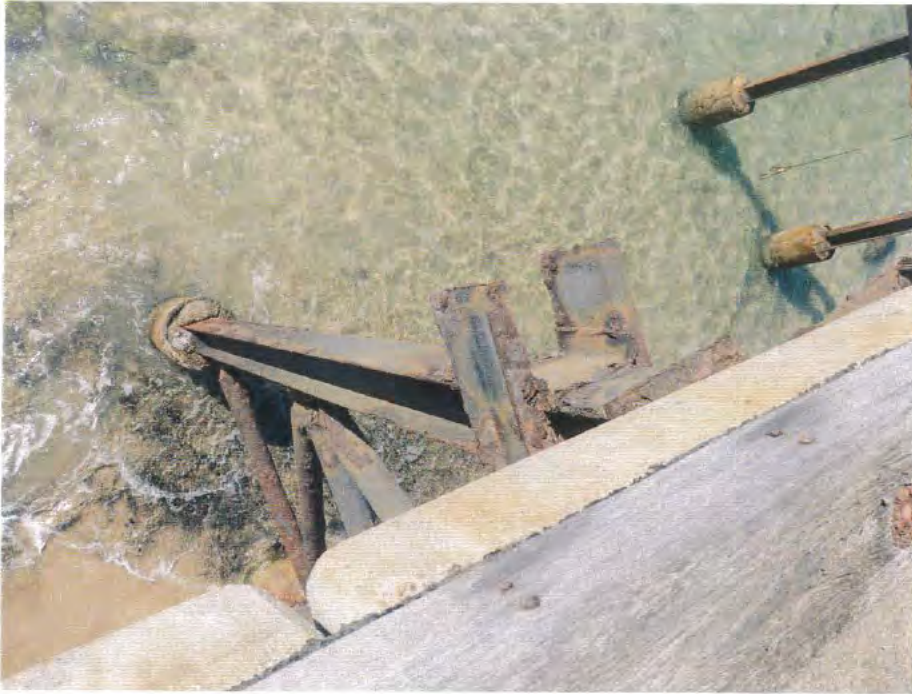
Photo 7. A detailed view down the length of a Bent leg. Note the damage to the concrete encasement and the PFC ties that run between the legs of the bent.

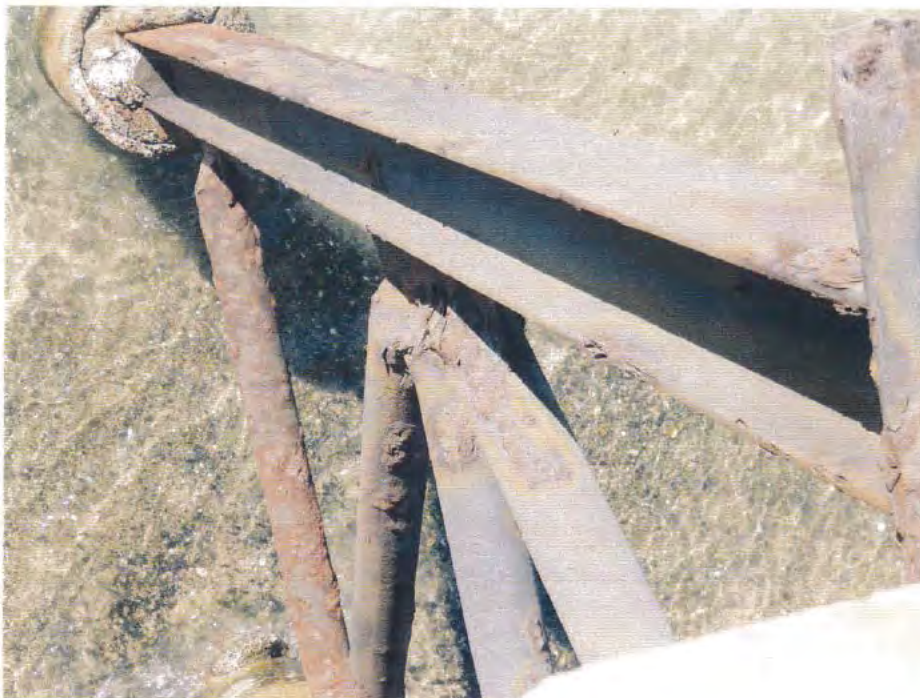
Photo 8. A detailed view of corrosion damage to the bracing members for the Bent shown in Photo 7.

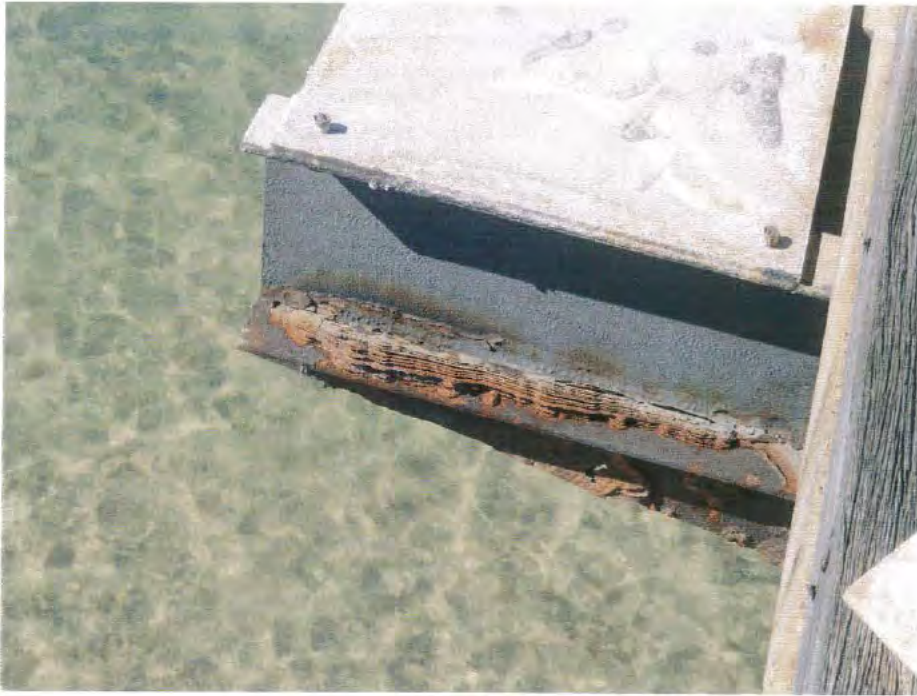
16. The primary support beams for the newer section were corroded but not as badly as the original beams. The corrosion was also around the location of the ancillary structure. Refer to Photo 9.

Photo 9. A detailed view of corrosion to the bottom flanges of PFC tie members that connect the Bent legs immediately under the primary deck beams.

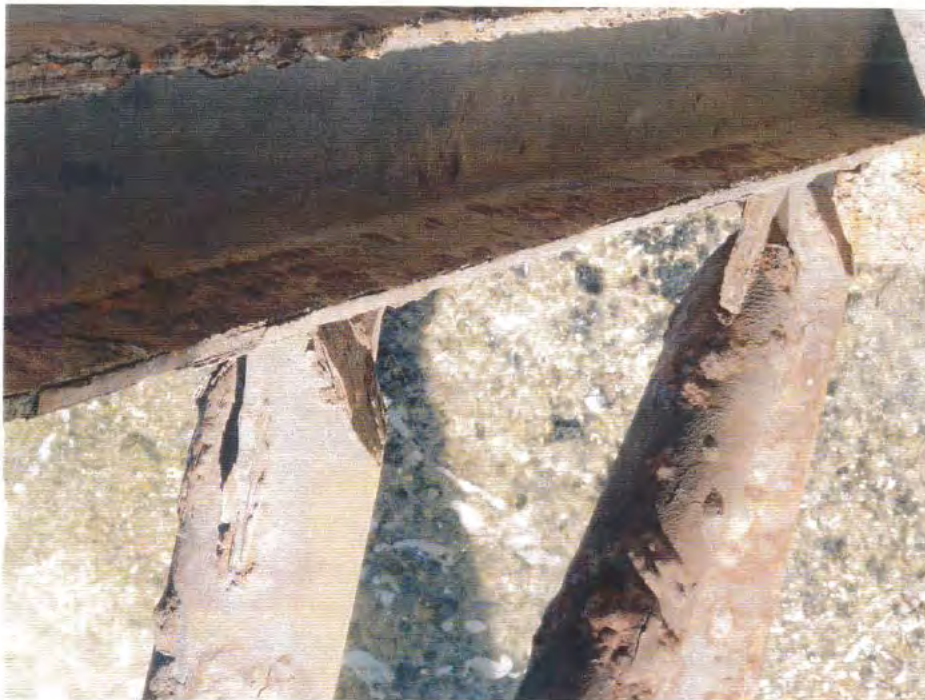
Photo 10. A detailed view of corrosion in the brace elements of a Bent frame.

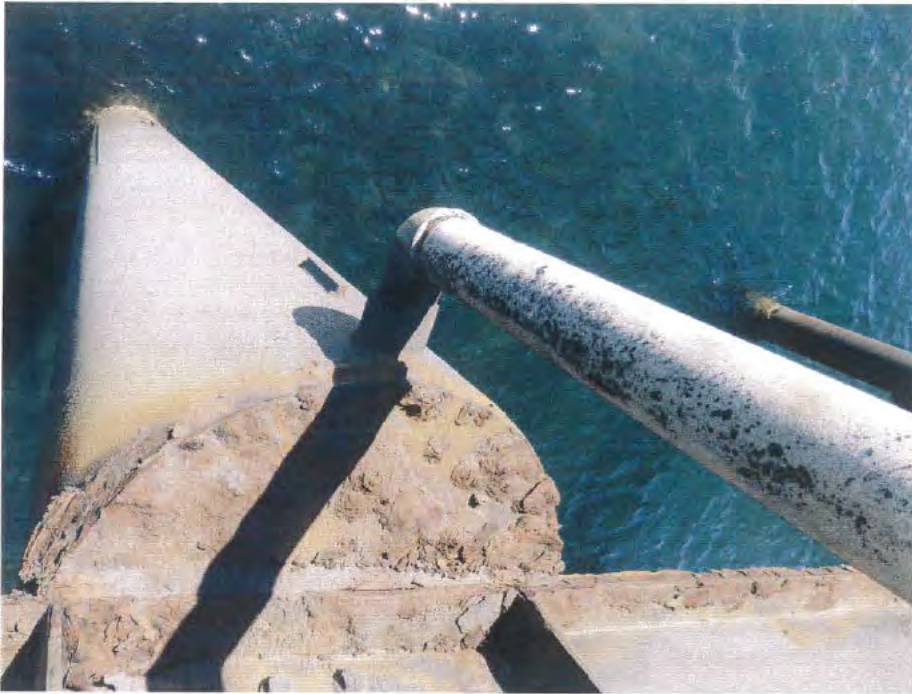
14. The caps of the new columns were corroded and the bottom flanges of the primary beams were also corroded over the cap plates. Refer to Photo 11.
15. The heads spanning between the columns had localised corrosion mainly at the weld sites. Due to access limitations the degree of corrosion was not determined.

Photo 11. A typical view of corrosion on the CHS Bent leg cap plate. Note the corrosion of the primary beam flange.

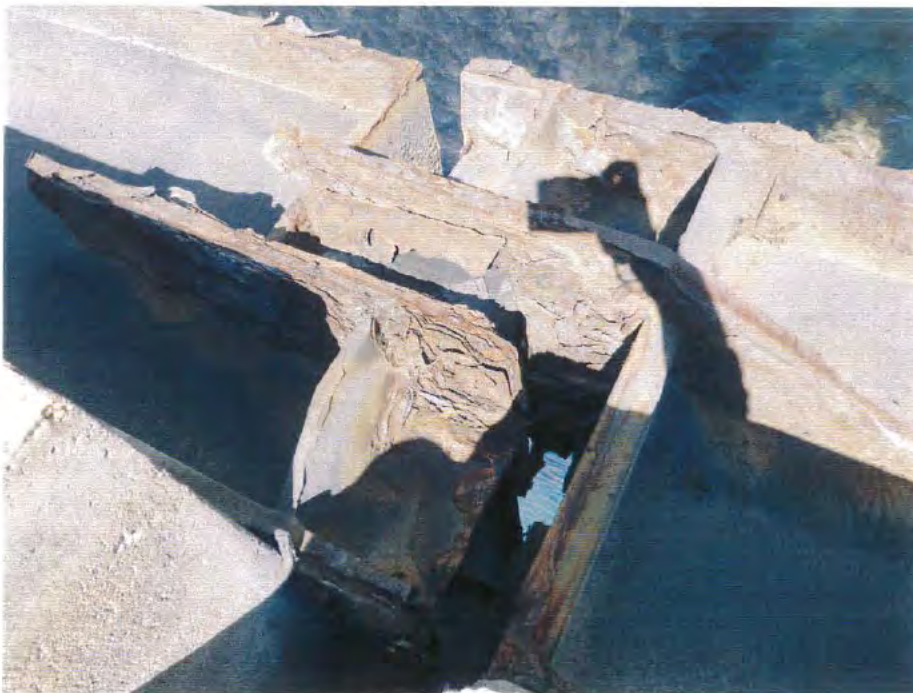
17. The primary support beams for the newer section were badly corroded at the location of beam splices. Refer to Photo 12.
18. The soffit of the concrete deck on the newer section appeared to be in a better condition than the original deck.

Photo 12. A detailed view of corrosion at a primary beam splice for the newer section of the jetty. Note: the degree of corrosion around the heavily welded sections.

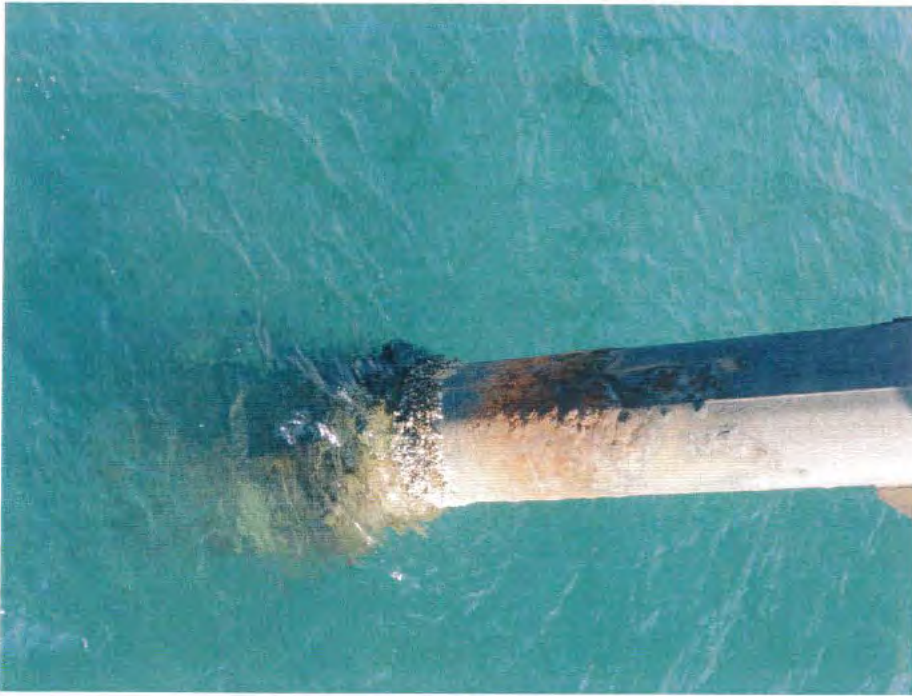
13. The columns for the Bents 1-17 were corroded, mainly at the weld sites, but the corrosion did not appear as bad as the damage observed on the older sections. These columns were hollow and filled with sea water. The original method of corrosion protection was to fill the column void with an anti-corrosion oil that floated on the surface of the water and coated the inside of the column with a skin of oil with the rise and fall of the tide. In addition the columns had sacrificial anodes fixed in place. Bubbling corrosion was noted on the side of the columns above high water mark. Refer to Photo 13.

Photo 13. A typical view of corrosion at the base of a CHS Bent.

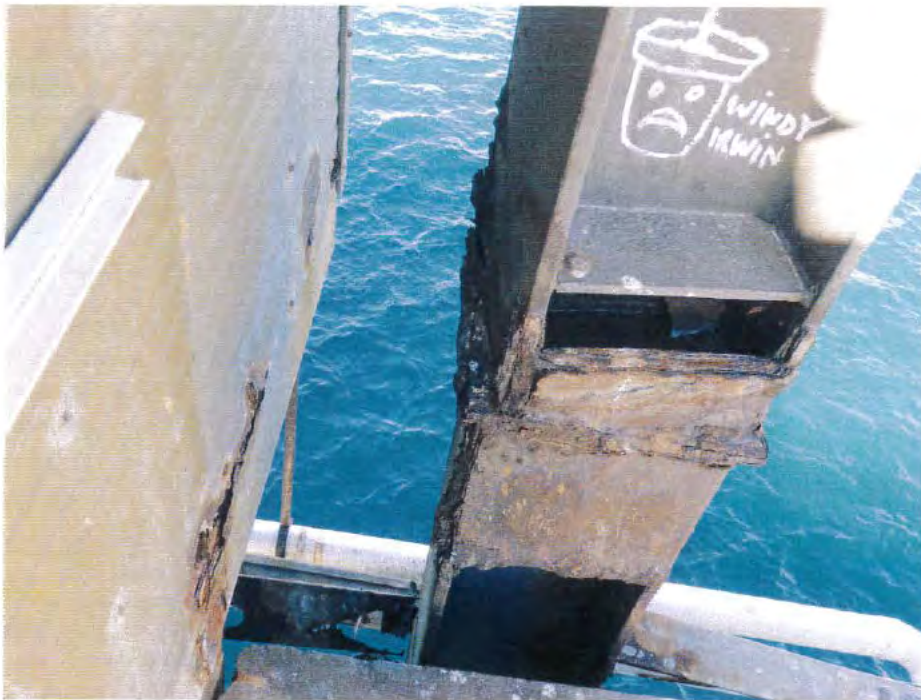
- The steel davit crane near bent 5 was severely corroded and is unsafe.
- The removal of the timber deck may have had a negative effect on the lateral stability of the superstructure, being unsure of the capacity of the raking pile sets.

21. A steel crane associated with the deck above was badly corroded and in danger of toppling. Refer to Photo 14.
22. The manholes were covered with steel plates. The plates were sufficient for pedestrian traffic only.

Photo 14. A detailed view of corrosion damage to a derrick near bent 4. Note: the concentration of rust around the heavily welded sections.

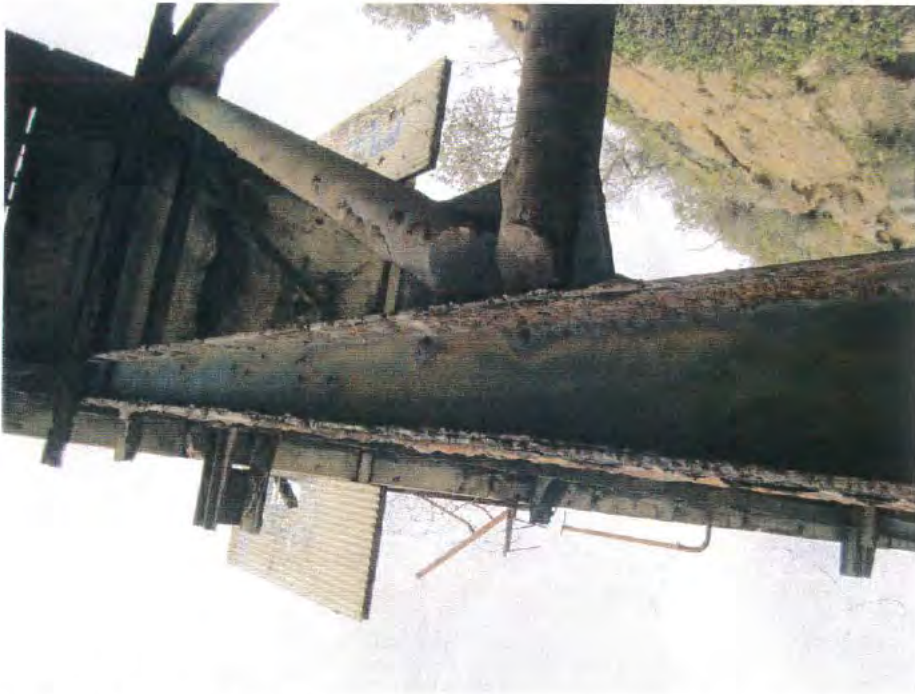
11. The horizontal bracing ties and struts were corroded. Due to access the degree of corrosion was not ascertainable. Refer to Photo's 15, 23, 26,27,28,30 and 31.

Photo 15. A detailed view of the outer leg of a Bent. Note the corrosion damage to the leg and brace members.

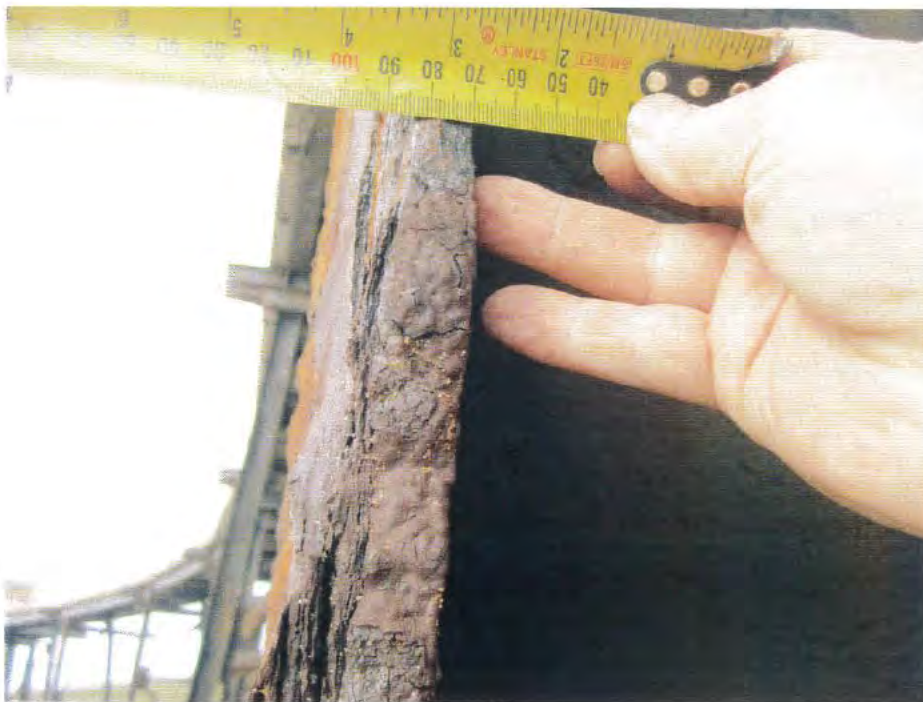
Photo 16. A detailed view of a corrosion reduced Bent leg flange. Note: the flange thickness was originally 18.5mm.

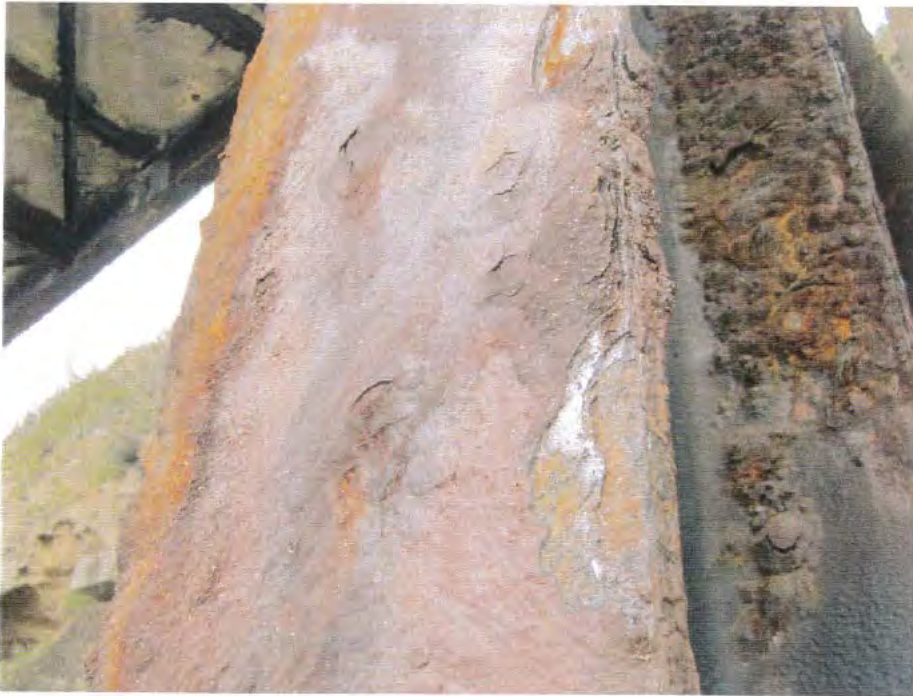
Photo 17. A detailed view of corrosion damage to both the inner and outer faces of a Bent leg.

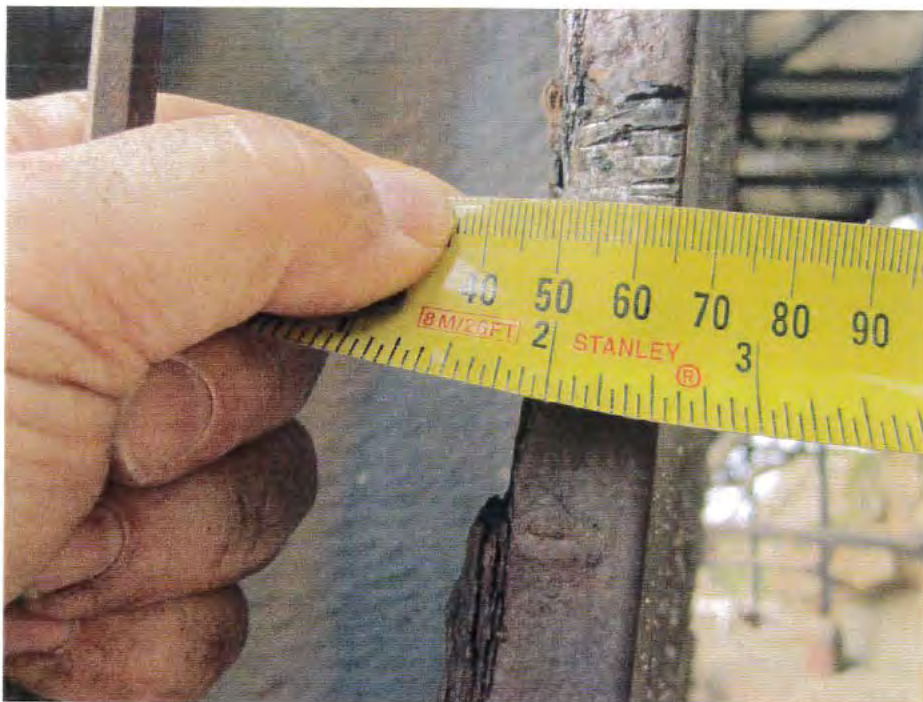
Photo 18. A detailed view of a corrosion reduced Bent leg. Note the flange thickness was originally 18.5mm.

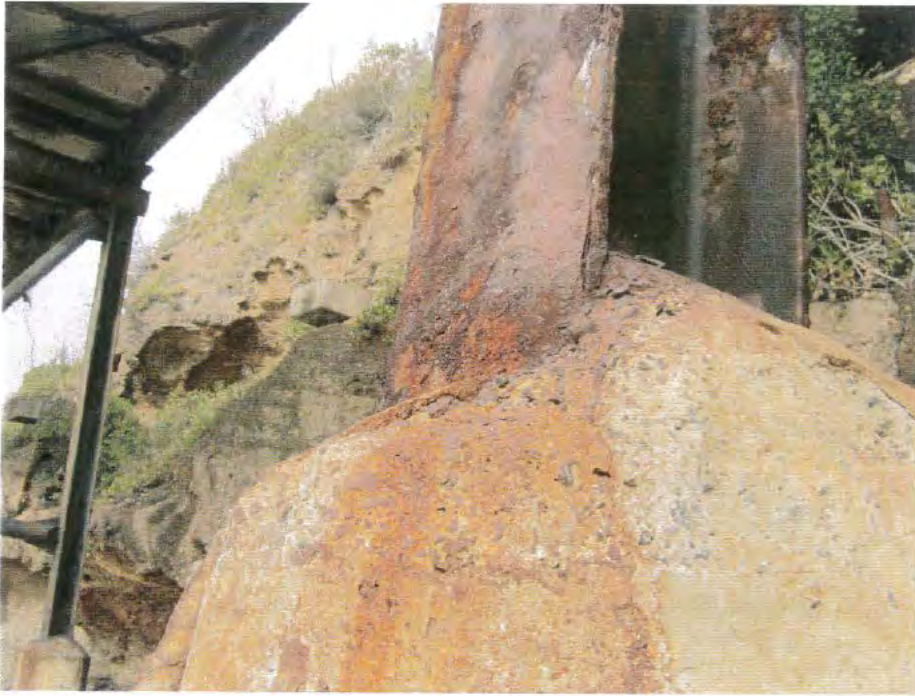
4. Bent 27. The primary columns have significant corrosion to both the webs and flanges. The diagonal braces had corrosion holes at the connections with the legs and along their length. The twin members across the head of the columns, immediately under the primary deck support beams were badly corroded, missing flange and web. The connections between the twin members and the columns were badly corroded and swollen. Refer to Photo's 19, 20,21,22,23 and 24

Photo 19. A detailed view of the base of a Bent leg. Note the rust staining and the swelling of the flanges.

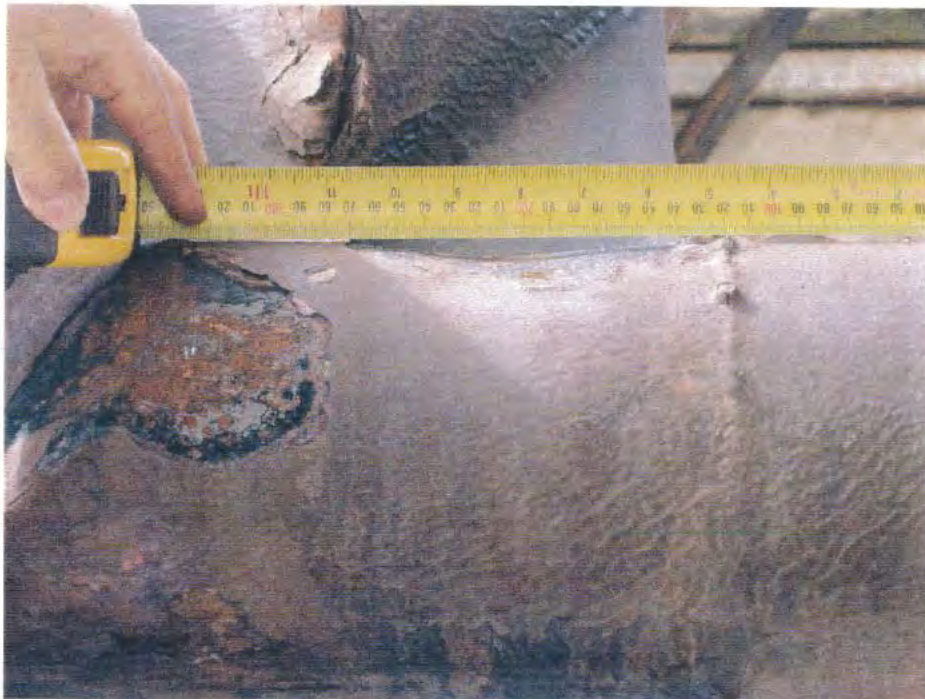
Photo 20. A detailed view of corrosion damage to a Bent brace member. Note the dent in the top of the member.

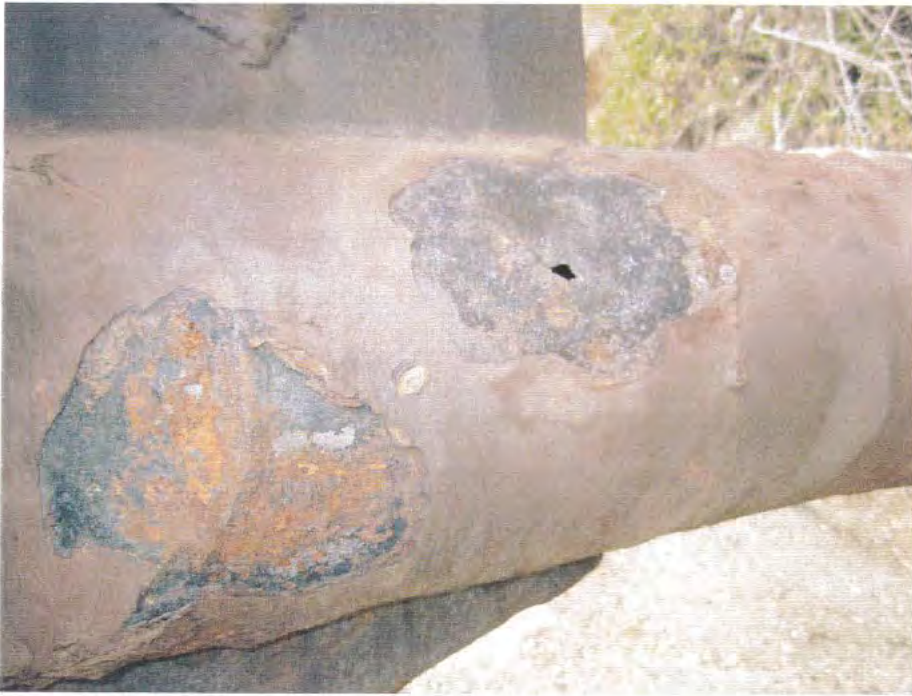
Photo 21. A detailed view of corrosion damage Bent brace member.

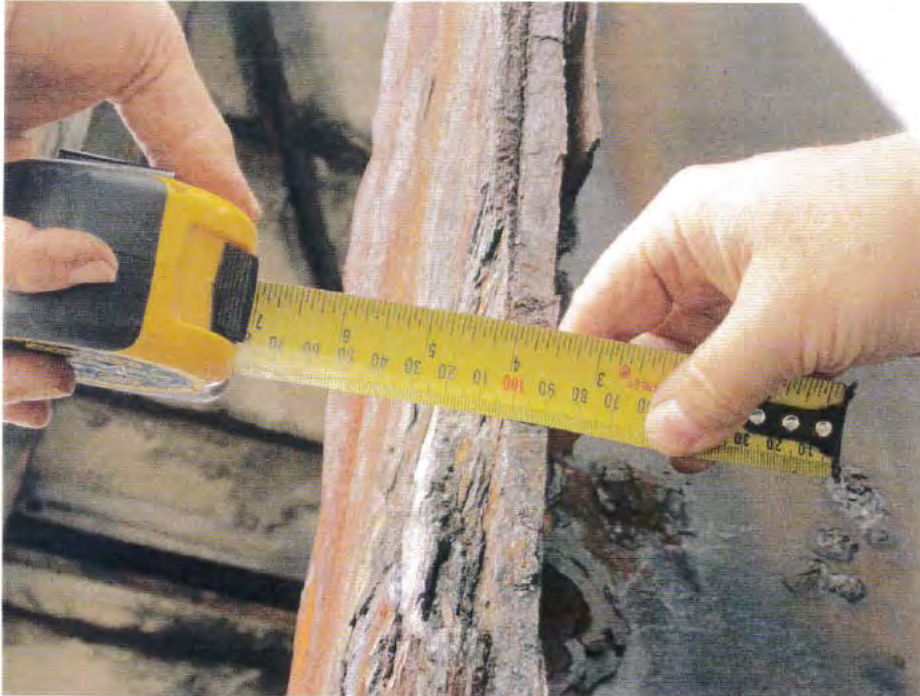
Photo 22. A detailed view of a corrosion reduced flange.

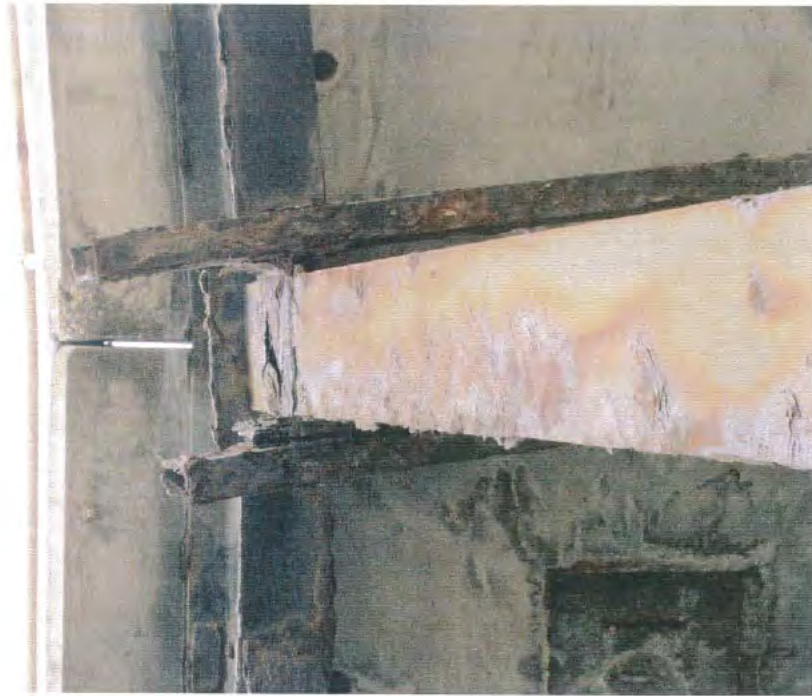
Photo 23. A detailed view of corrosion damage to the interconnecting PFC members. Note the failed welded connections between the PFC's and the leg.

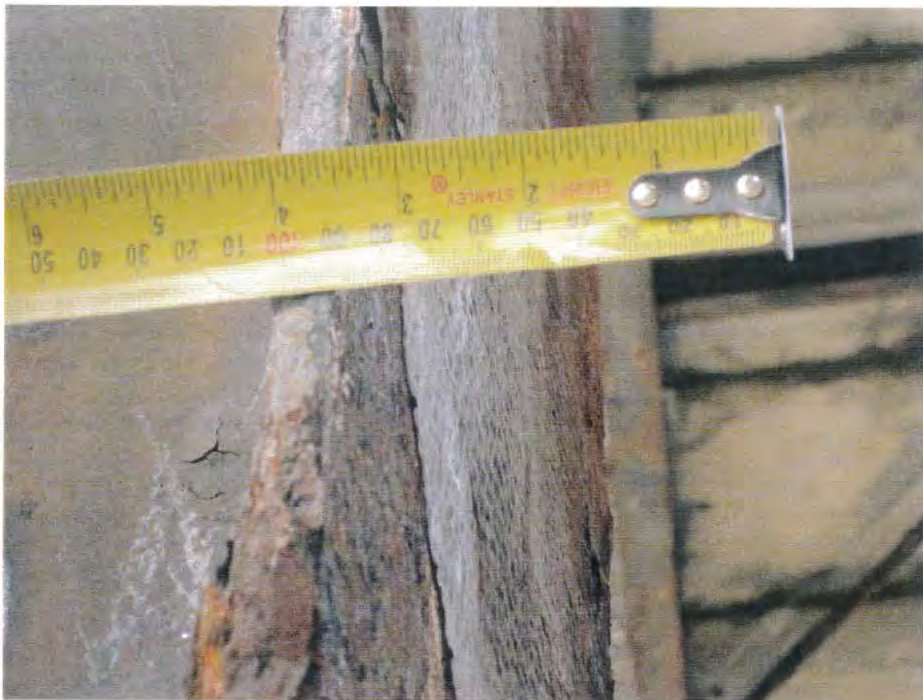
Photo 24. A view of corrosion reduced flange thickness. The original thickness was 18.5mm and is now 12mm.

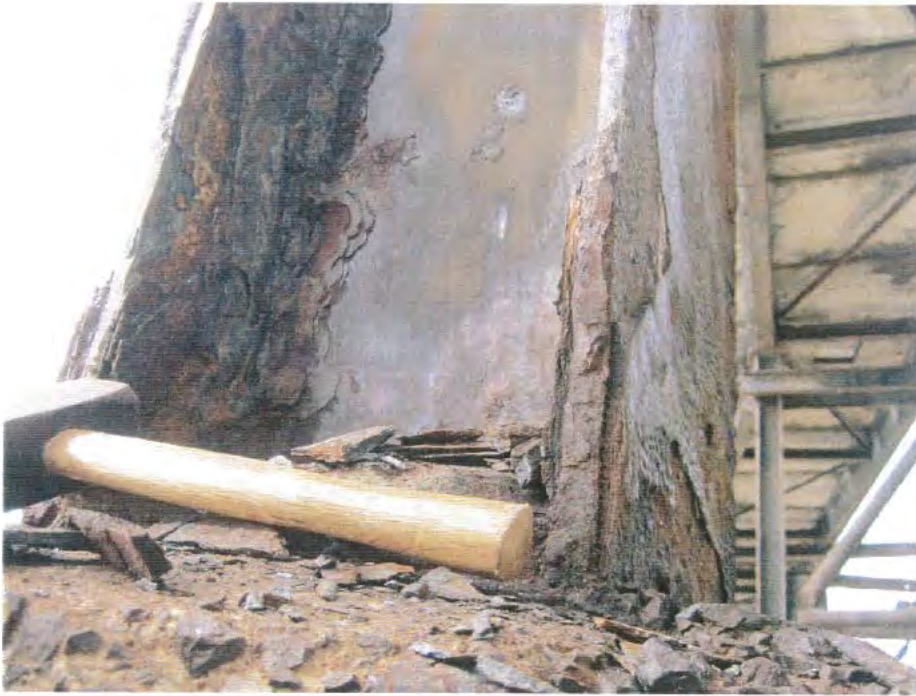
Photo 25. A detailed view of corrosion at the base of a Bent leg. Note the amount of rust scale.

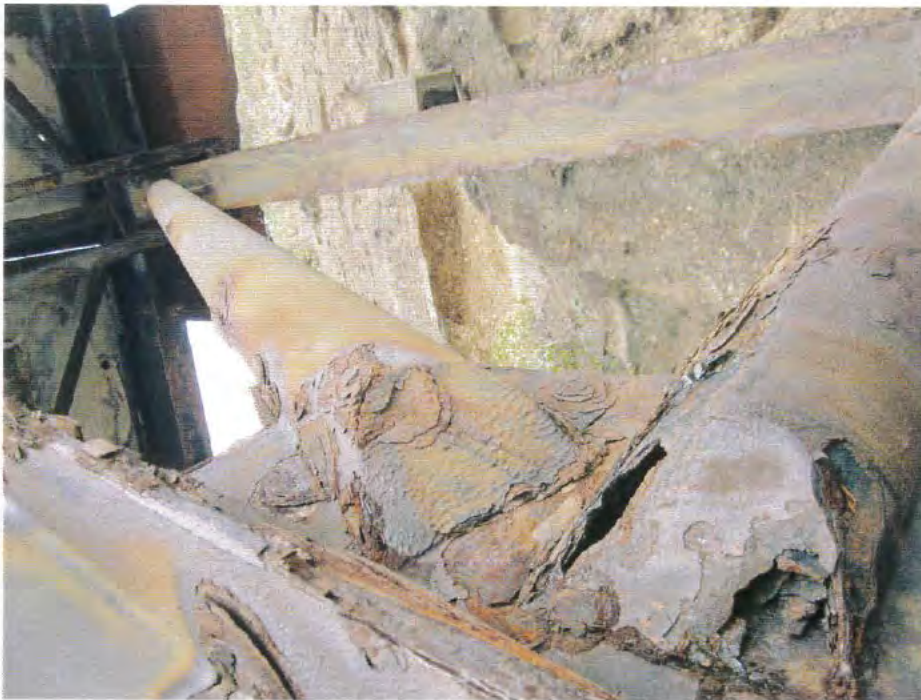
Photo 26. A detailed view of a corroded Bent bracing connection.

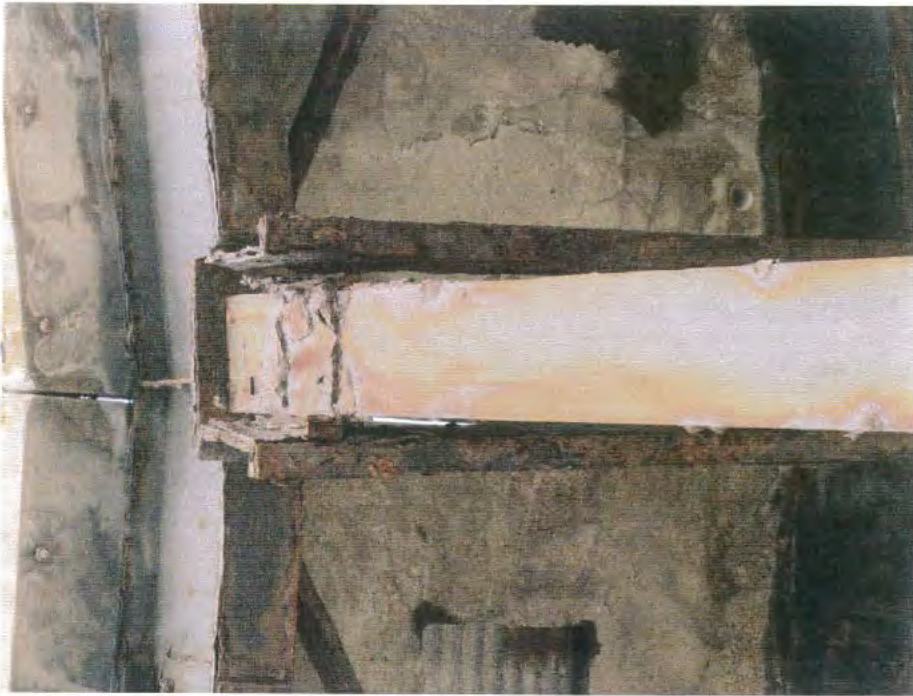
Photo 27. A detailed view of failed welded connections between the Bent legs and interconnecting PFC's.

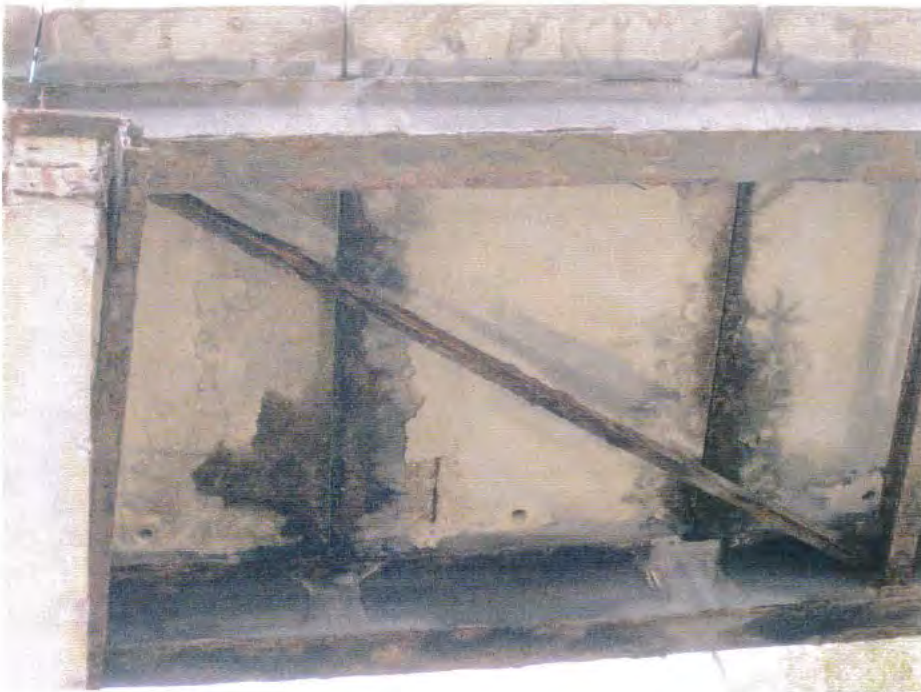
Photo 28. A detailed view of the soffit of a deck section. Note the corrosion to the reinforcing, deck brace, primary beam flanges, inter-leg PFC and the failed weld connection between the PFC and leg.

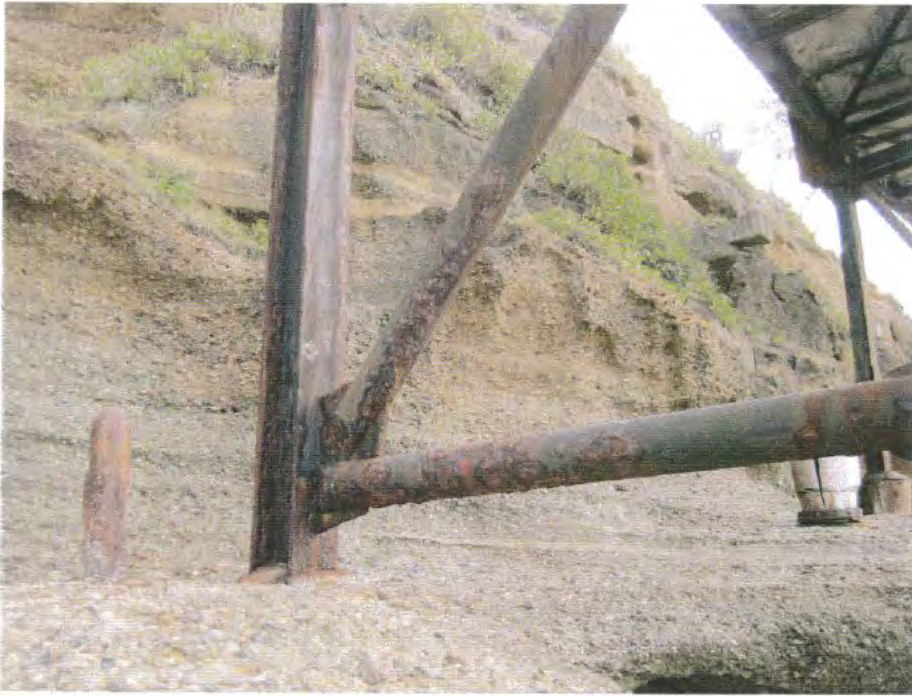
Photo 29. A detailed view of corrosion damage to the base of a Bent. Note the damage to the connection plate.

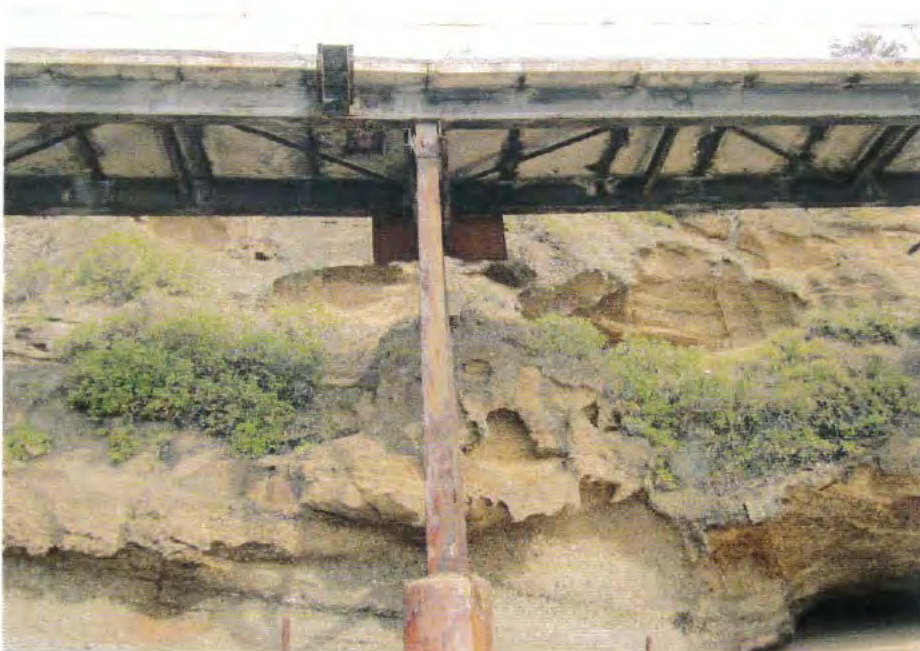
10. The primary beams spanning between the bents had corroded to the top and bottom flanges with the corrosion noted primarily over the bents and at the location of welding associated with the location of ancillary structure. Refer to Photo's 30 and 31.

Photo 30. A view of the outer leg of the Bent shown in Photo 29. Note the rust staining on the concrete encasement.

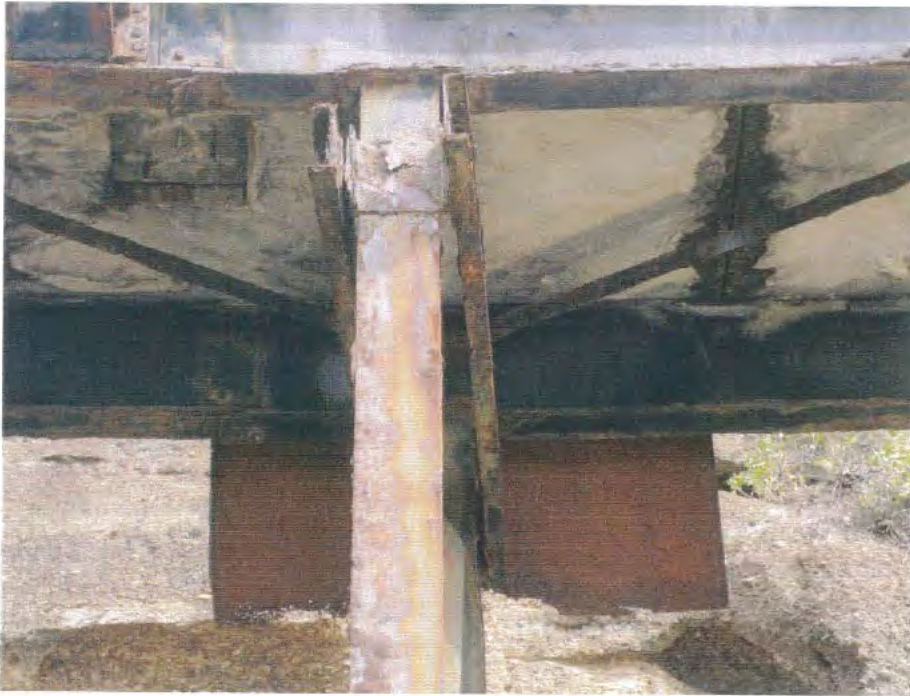
Photo 31. A detailed view of the top of Photo 30. Note the corrosion damage to the steelwork and in particular the separation of the left hand PFC from the leg due to weld failure from corrosion.

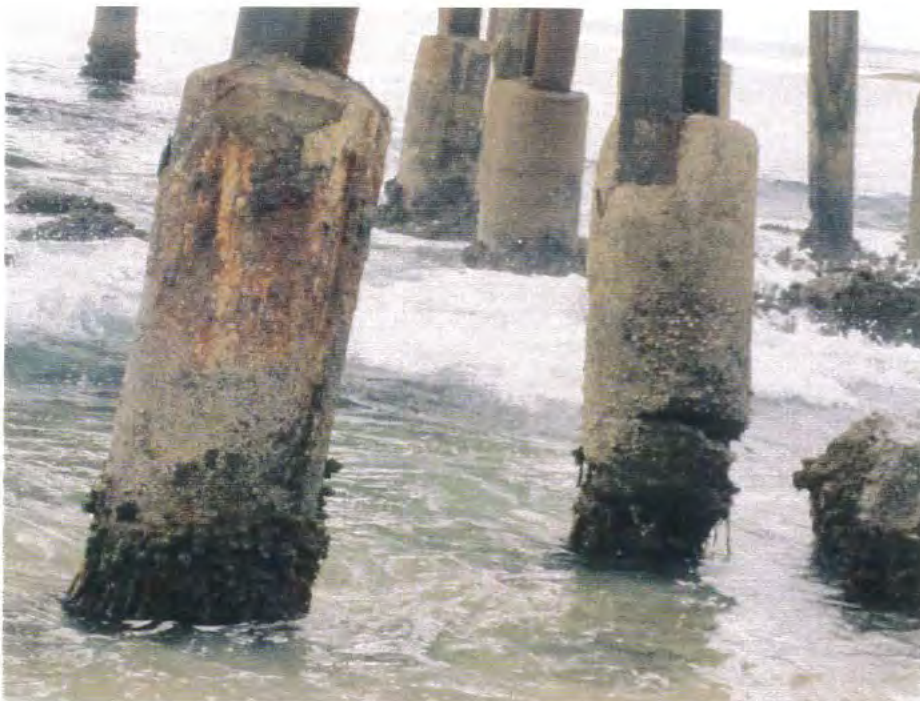
Photo 32. A detailed view of the base of a steel leg. Note the leg is supported on a timber pile with a connection that appears to be a damaged concrete encasement.
