Catherine Hill Bay Jetty

Prepared for The Department of Planning and Environment

September 2023
Project Number N23028
Version 002

Report No. 2 – Materials Engineering & Durability

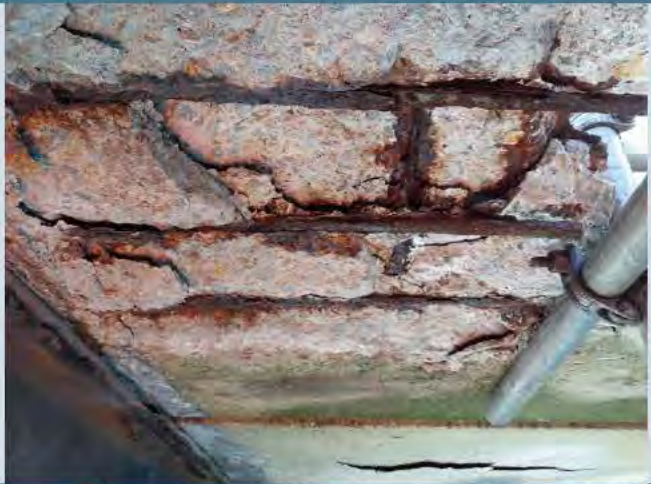
Description and Comment	Photo
<p>Exposed reinforcement in the soffit.</p> <p>Several instances of spalled concrete because of corroding/expanding reinforcement were observed. It is likely the chloride ions have penetrated to the depth of reinforcement and initiated corrosion.</p>

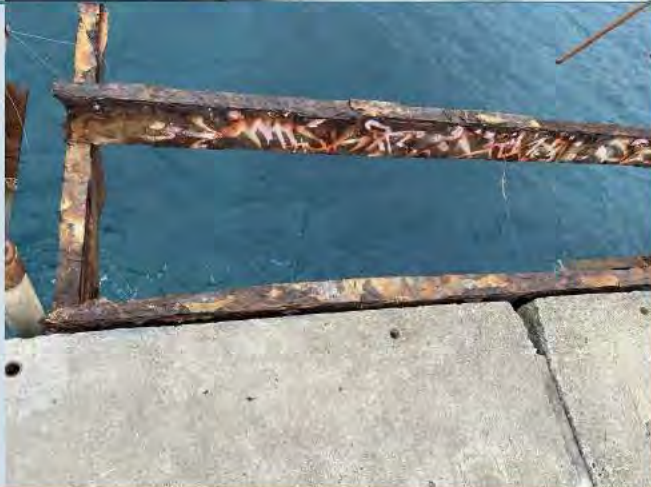
<p>Minor edge spalling.</p> <p>Most of the panels exhibited some form of corner or edge spalling. This is likely a result of general wear and tear over time.</p>

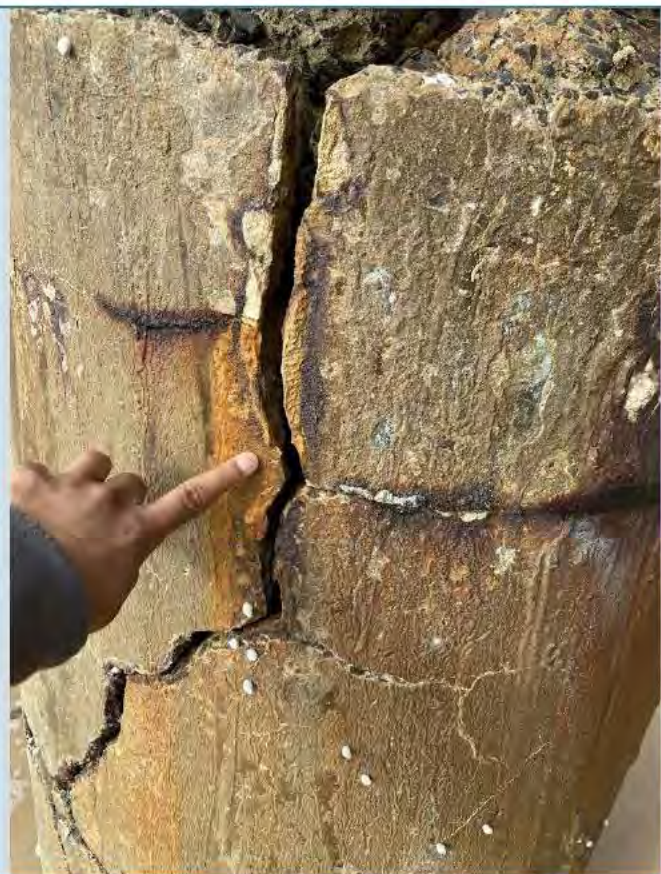
The concrete encasements are no longer fit for purpose. Large cracks, voids, and significant spalls were observed.

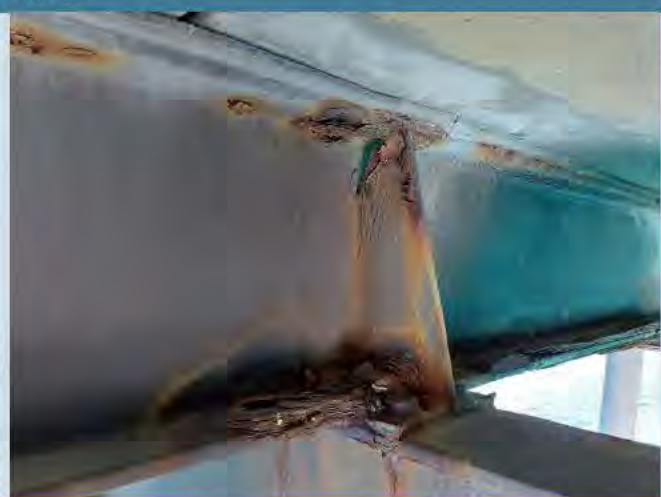
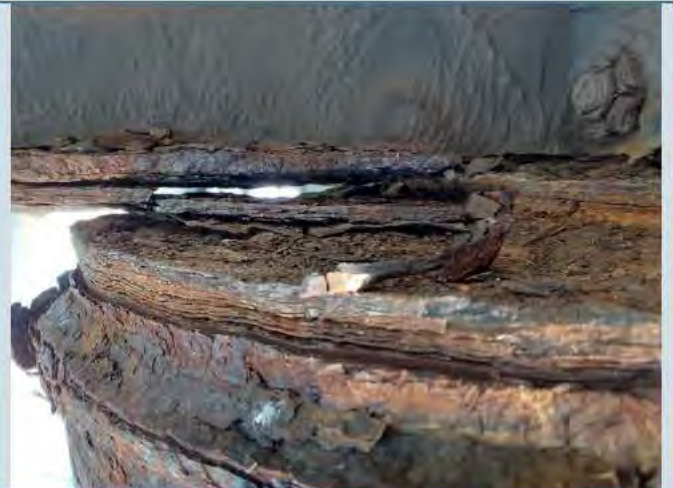
Description and Comment	Photo
The primary beams along their extent, away from connections, are generally in good condition.

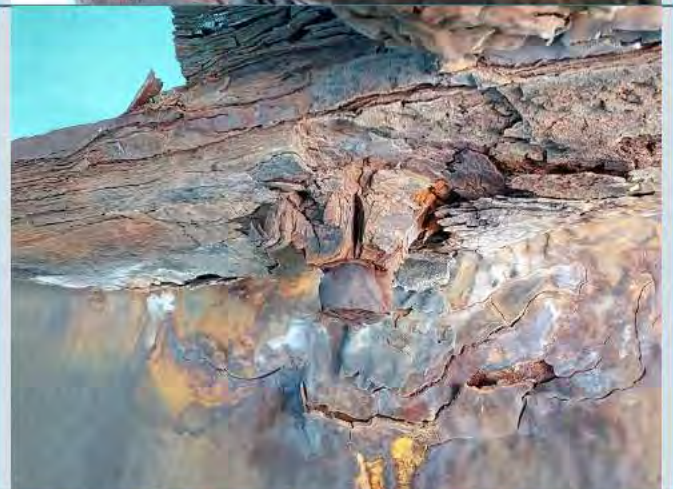
<p>Typically, nut and bolt connections are no longer fit for purpose with significant corrosion and section loss observed.</p>

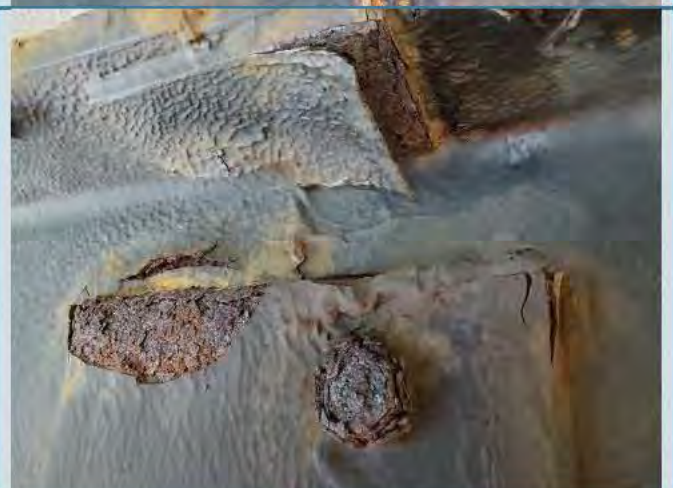
<p>Splice connections were observed to be corroding between primary beams. Coating deterioration was also observed.</p>

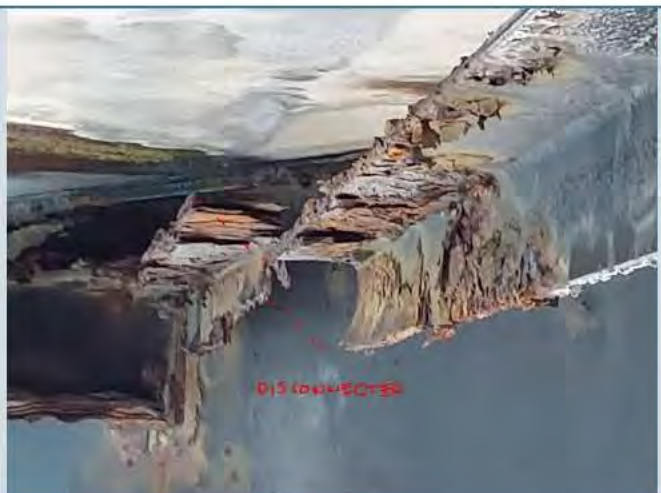
In most instances the diagonal bracing had completed corroded, failed, or fallen from the structure.

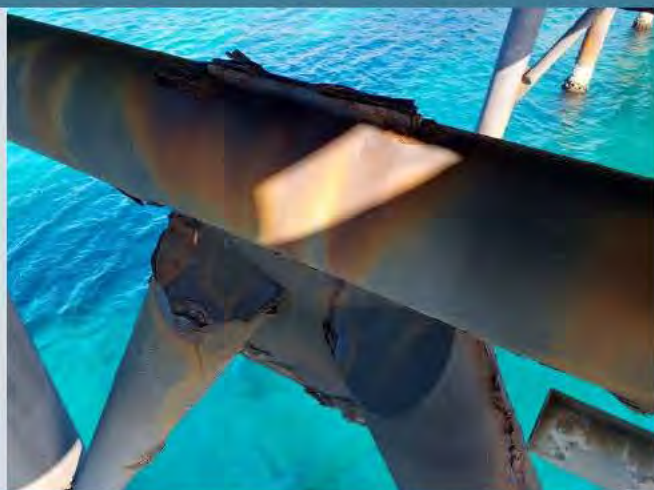
Typically, the external surface of the CHS bracing exhibited coating loss, blistering, corrosion initiation, and deterioration at the connections.

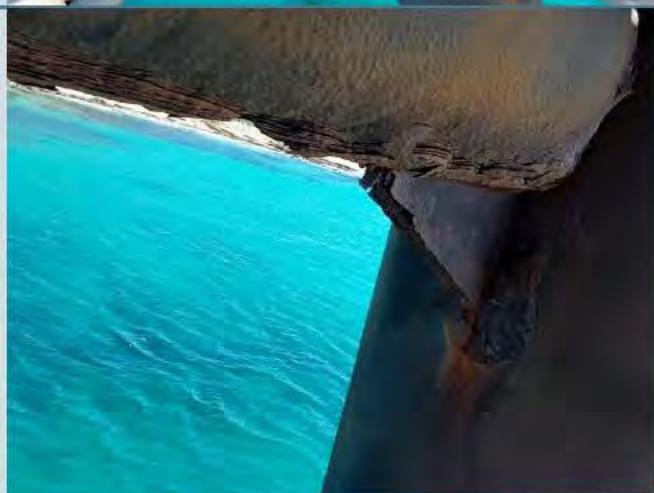
The bottom of the CHS bracing elements exhibited lamination and stiffener plates were also corroded with notable section loss.

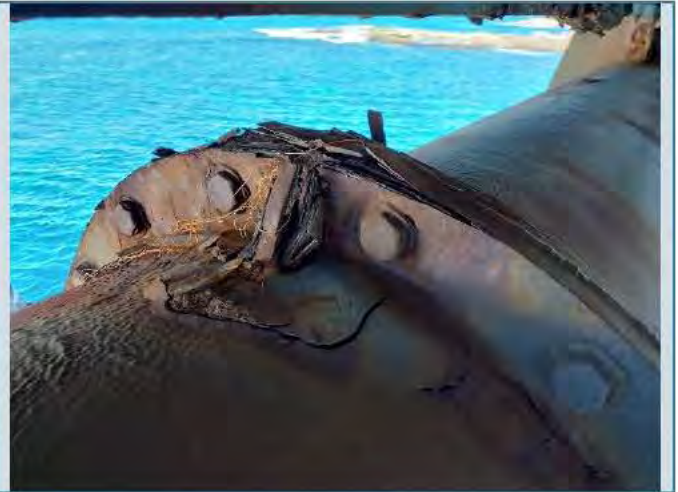
The splice connections between CHS braces exhibited corrosion between the circular plates, at stiffeners, and on the nuts.

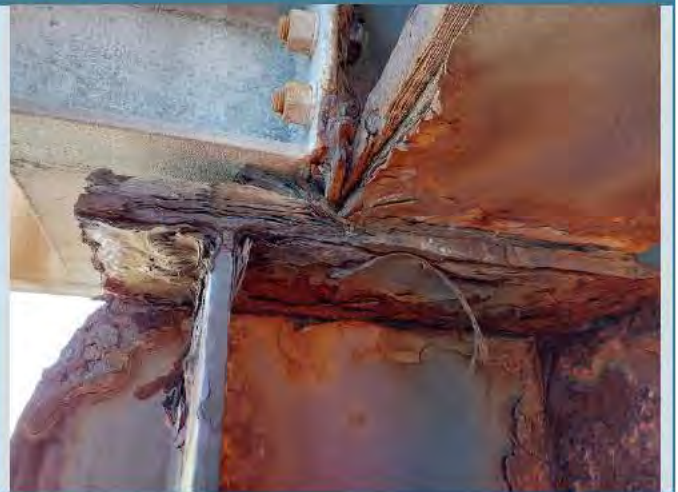
Large bearing plates and platforms are welded to the top of the CHS piles to support primary beams. These exhibited significant corrosion and lamination.

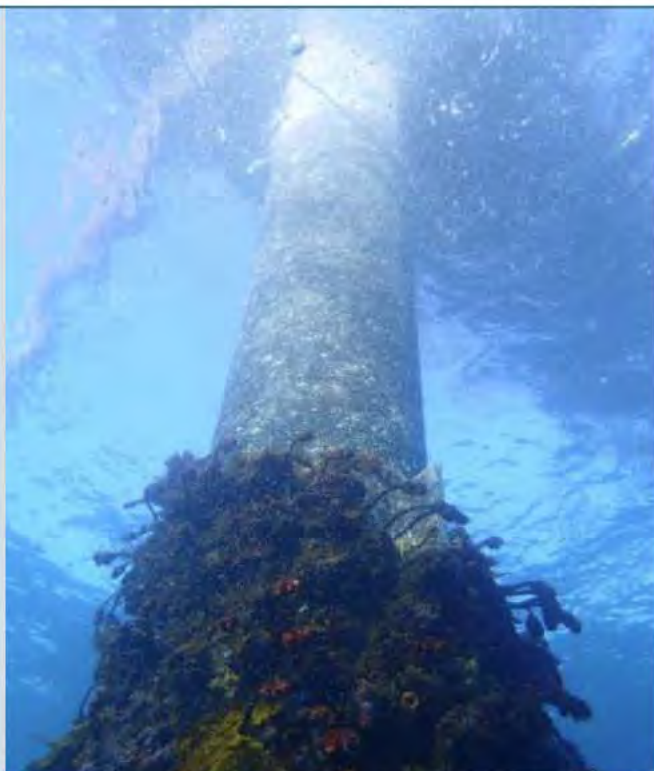
Piles below the water level had extensive marine growth.

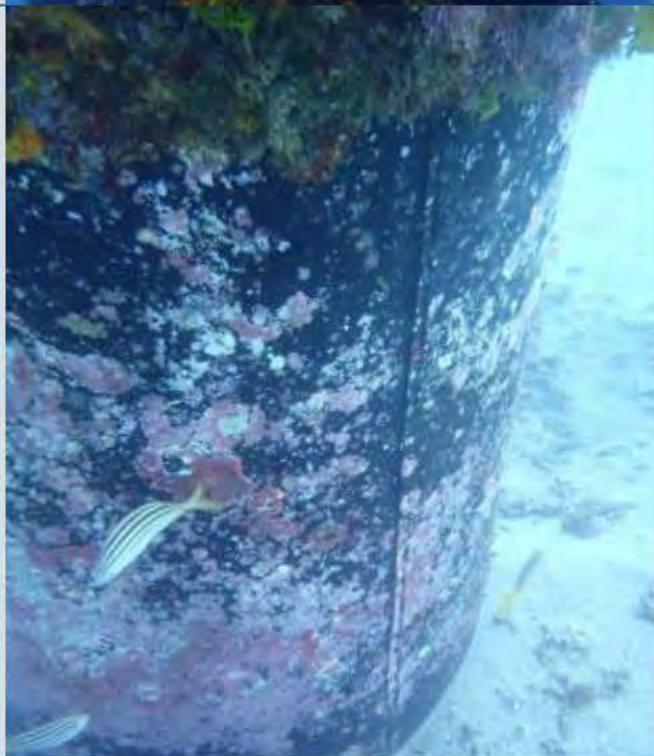
Once cleaned, the pile outer surface showed evidence of local blistering and coating deterioration.

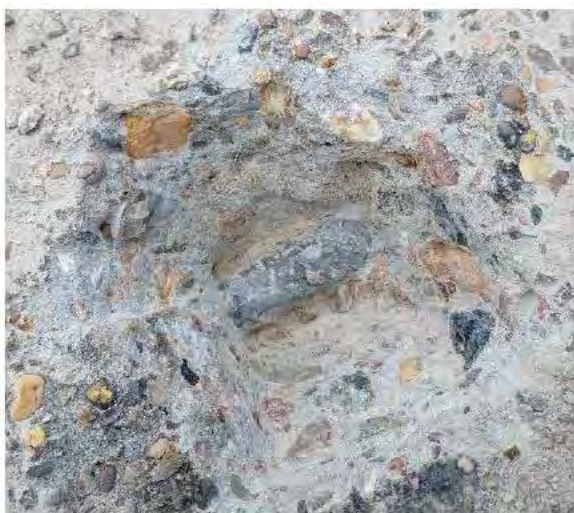
Figure 1: Reinforcement breakout

In all breakouts, the reinforcement bars were in good condition and did not have any signs of corrosion, as observed in Figure 1. In addition, we note that reinforcement bars that were exposed from atmospheric condition or concrete deterioration were also measured, with the condition of the bars being moderately corroded, as observed in Figure 2. The reinforcement bar diameter was measured between 19-20mm.
