Catherine Hill Bay Jetty - Structural Condition Report

Prepared for NSW Department of Planning and Environment

July 2023
Project Number: N23028
Version: Rev A

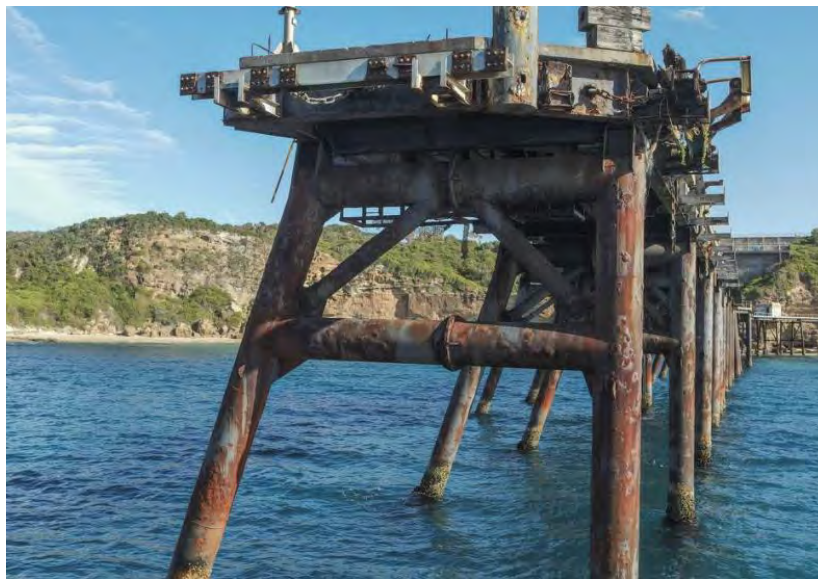
Figure 13 – Bent 1 Drone Captured Image

The fender piles indicated on the northern side of the jetty in the original drawings have already been removed. The main 760CHS support columns typically have patches of local corrosion blistering, where the coating has failed, of a typical size of around 100mm x 100mm, distributed fairly evenly across the surface of the steel casing. Typically, based on site observations the damage would be classified as Condition State 2 or 3. The following figure is an image captured using a drone and shows the deterioration looking from the water at Bent 1.

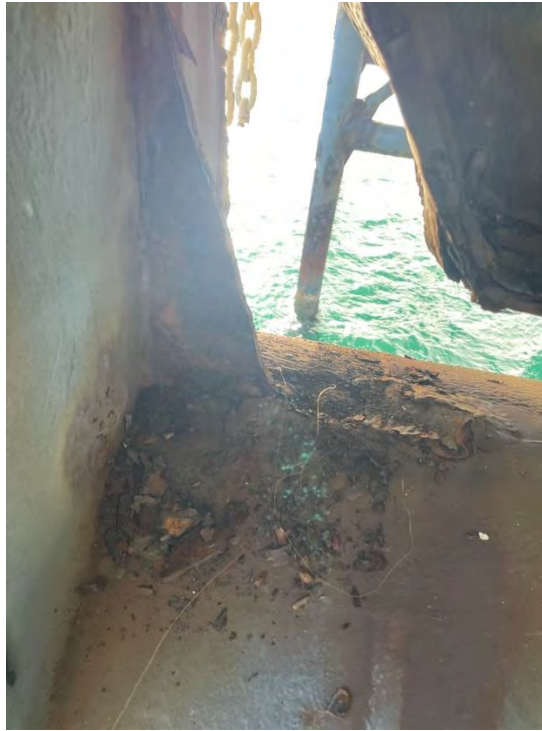
Figure 14 – CHS Tie Brace to CHS Column Connection

Corrosion was more severe at the connection point of the horizontal and vertical bracing. The welded plate connection was often heavily corroded and would correlate to condition state 4.

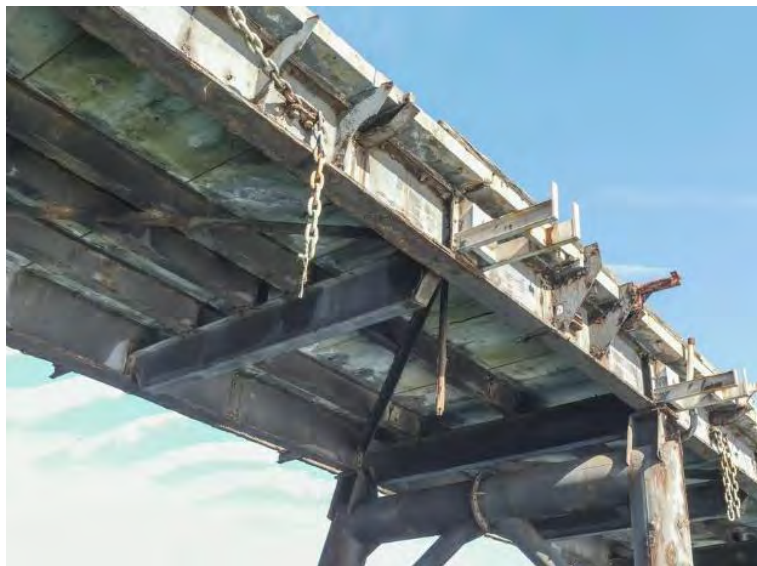
Figure 15 – Typical Layout of Deck Types DA1 and DA2

Moderate blistering and lamination were observed in primary, secondary, and tertiary beams, and was typically more severe on the lower flange. In this instance, these were generally assigned condition stage 2, rising to condition state 4 in more severe areas. Generally, the loss of section appears to be relatively minor (less than 20%) but this will need to be ascertained in a subsequent investigation and the beams downgraded accordingly. This would require extensive cleaning and removal of corroded material to ascertain. BG&E were only able to spot clean corroded areas.

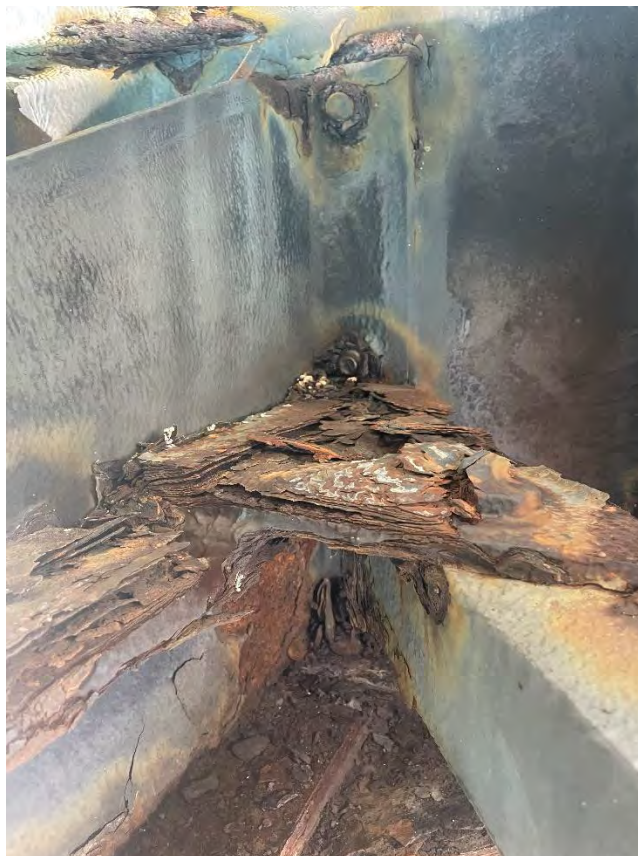
Figure 16 – Connection Between Plan Bracing, Secondary Beam and Primary Beam, Deck Type DB

Moderate corrosion was almost always present where the plan bracing connects with the secondary beams, and was frequently present where transverse beams crossed primary beams, i.e., at steel connections and contact points. The plan bracing tended to be more severely affected by corrosion due to its smaller size and thinner plate sections, and most of the plan braces would be considered condition state 3 with many rising to condition state 4.

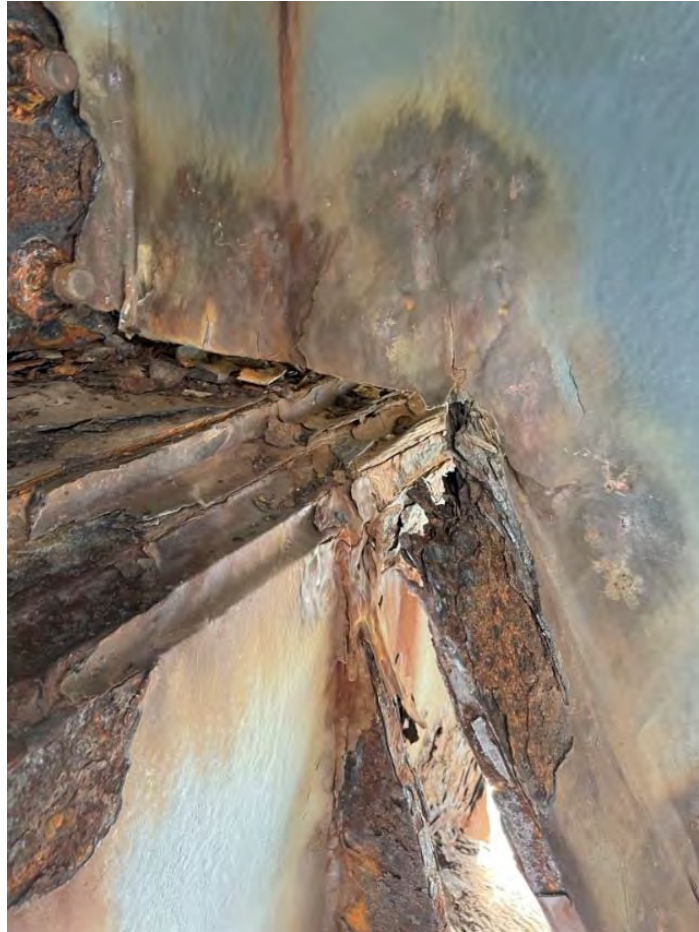
Figure 17 – Connection Between Secondary Beam and Primary Beam, Deck Type DA1

The connection between tertiary beams and secondary beams appeared to be significantly corroded in almost all cases. This would generally be classified as condition state 4, dropping down to 3 in some instances. The connections between secondary beams and primary beams were also noted to be heavily corroded. It was noted that one of the

secondary beams had completely rusted through and lost its bottom flange at the connection point. Fatigue caused by high localised concentrations of stress applied cyclically by wind, waves, boat forces and mechanical actions such as the conveyor and ship loader forces can cause fatigue corrosion which can increase the rate of environmental corrosion. Also, the different grades of plate steel compared with the hot-rolled sections may be more prone to corrosion initiating, causing trapped seawater in the pitting lamination that may affect adjacent materials. All similar connections would need to be analysed further to determine if it was a common trend or localised incident.

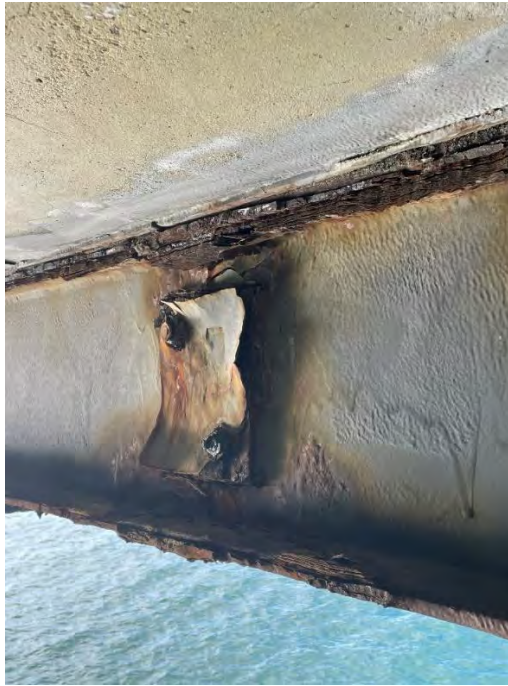
Figure 20 – Primary Beam Splice, Deck Type DB

Beam splices were also more heavily corroded than the rest of the members. These splices will need to be assessed after cleaning to better analyse the remaining thickness of the metal and the butt weld connection. The level of deterioration looks to be high in the bolts, but it is thought that these bolts were installed for the temporary state and the beams were then full butt weld. It is noted that welds are more prone to fatigue failure than plain metal, and in the presence of higher corrosion should be subject to greater ongoing scrutiny.

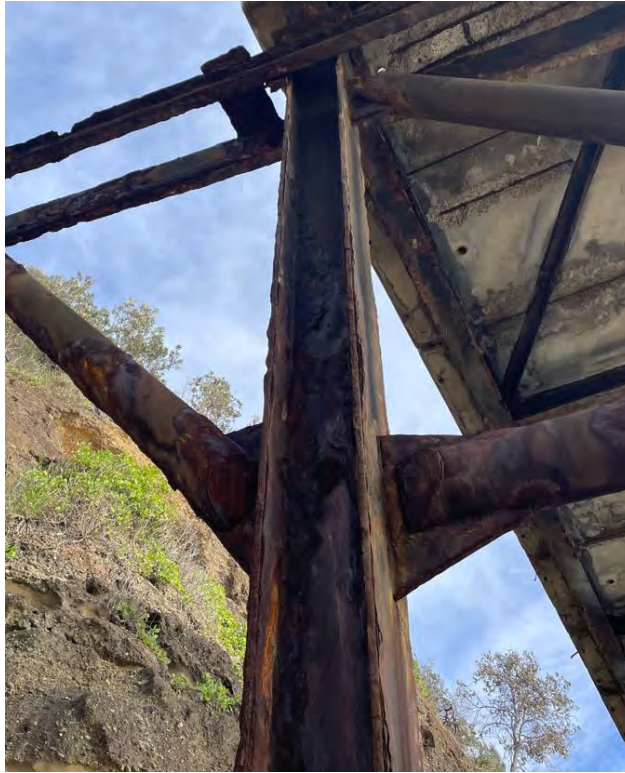
Figure 21 - 310 UC Column, Typical of Bents 18-28

Corrosion was generally more severe for steelwork within the tidal and splash zone, which included all the columns between Bents 18 and 27. Apart from the known tendency for corrosion to be most severe in the intertidal zones due to presence of oxygen and chloride ions, this could be caused by abrasion of the steel's coating by suspended sand within the turbulent water leaving the steel unprotected, as well as abrasion of the steel itself. Wind blowing sand and salt would also rise as it reaches the shoreline and cliff result in more significant corrosion. The columns in this area generally exhibit widespread corrosion pitting and flange lamination, causing significant section loss. Most of the columns in this area display signs of section loss would be classified as condition state 4. These columns will need to be cleaned and assessed further to better determine the remaining thickness of the metal. However, based on what we can observe it appears that material loss exists in the web and flanges and elsewhere the base metal thickness would be greatly reduced on a widespread scale. It is unlikely that these columns could be strengthened and reused. BG&E did not witness any significant failure in the universal columns such as cracking, deformation, or splitting.

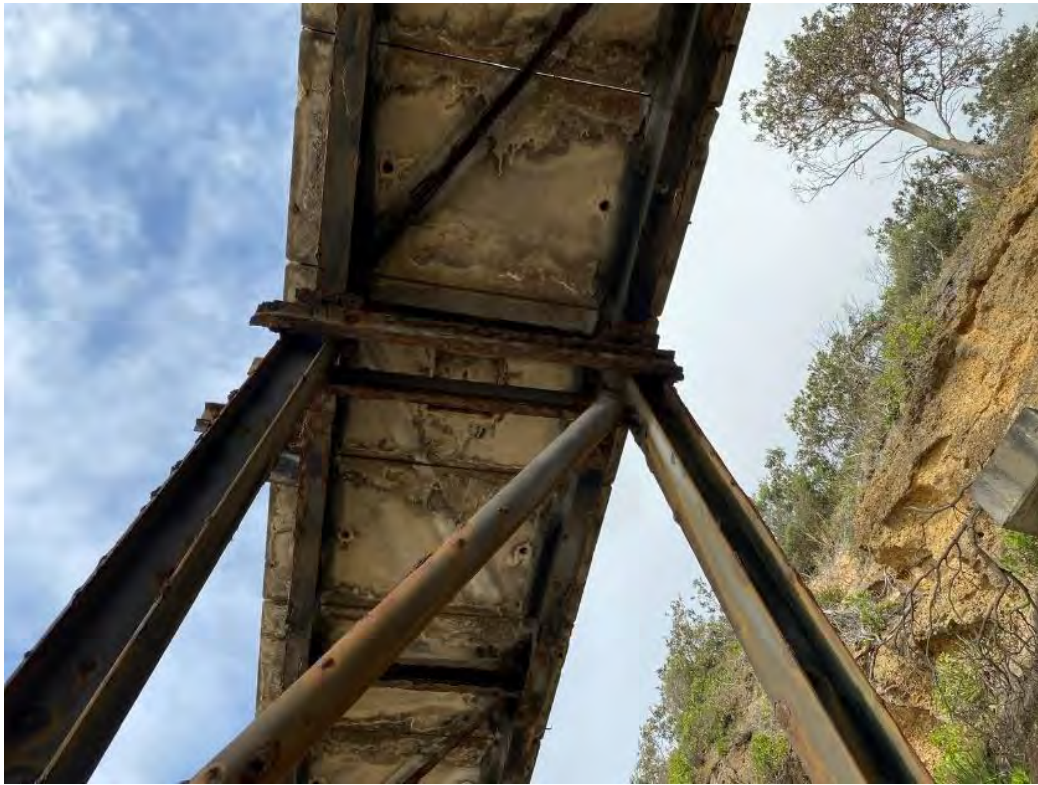
Figure 23 – Plan Bracing Missing Beneath Typical Deck Type DC

Plan bracing has been heavily corroded in many places and in some areas, it is no longer present at all. It is not known if the bracing has been removed to avoid safety risks or if it fell off on its own accord. The report produced by BG&E in 2017 recommended certain sections be removed due to safety concerns. All sections would be classed as condition state 4 and many are now in a dangerous condition. This has been highlighted as an immediate safety concern for pedestrian traffic below the jetty. Again, the corrosion was particularly evident at the connection plates. These angles and beams provide stiffness in plan against lateral forces such as wind and wave action, and provide resistance to lateral torsional buckling of the primary beams under vertical loading. The poor condition of these braces therefore significantly weakens the lateral-torsional buckling capacity of the beams, and hence their loadbearing capacity. These plan braces would need to be replaced prior to significant loads being applied to this part of the jetty.

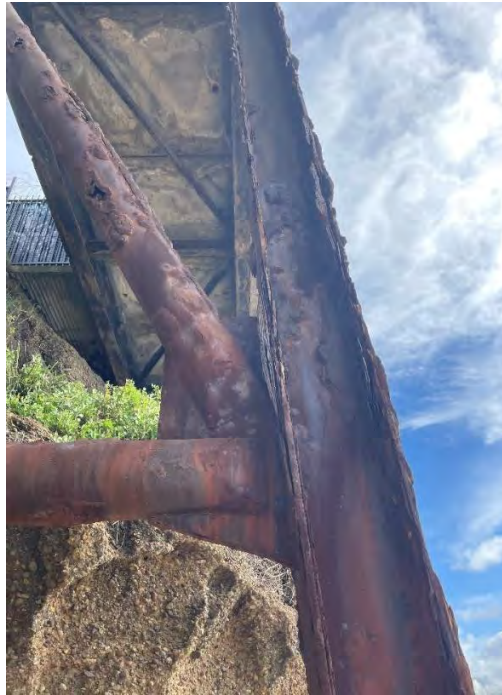
Figure 24 – CHS Vertical Bracing with Heavy Corrosion, Typical of Bents 18-28

The vertical bracing between columns varied from condition state 2 and 4. These members varied greatly in their degree of deterioration, with several sections exhibiting material loss and displaying almost complete section loss. Other sections showed relatively minor section loss. These members again would need to be cleaned and the thicknesses measured to better understand their integrity. The bracings poor condition would significantly decrease the lateral capacity of the frame as a whole and it would need to be rectified or replaced before any significant loads are applied to the structure.

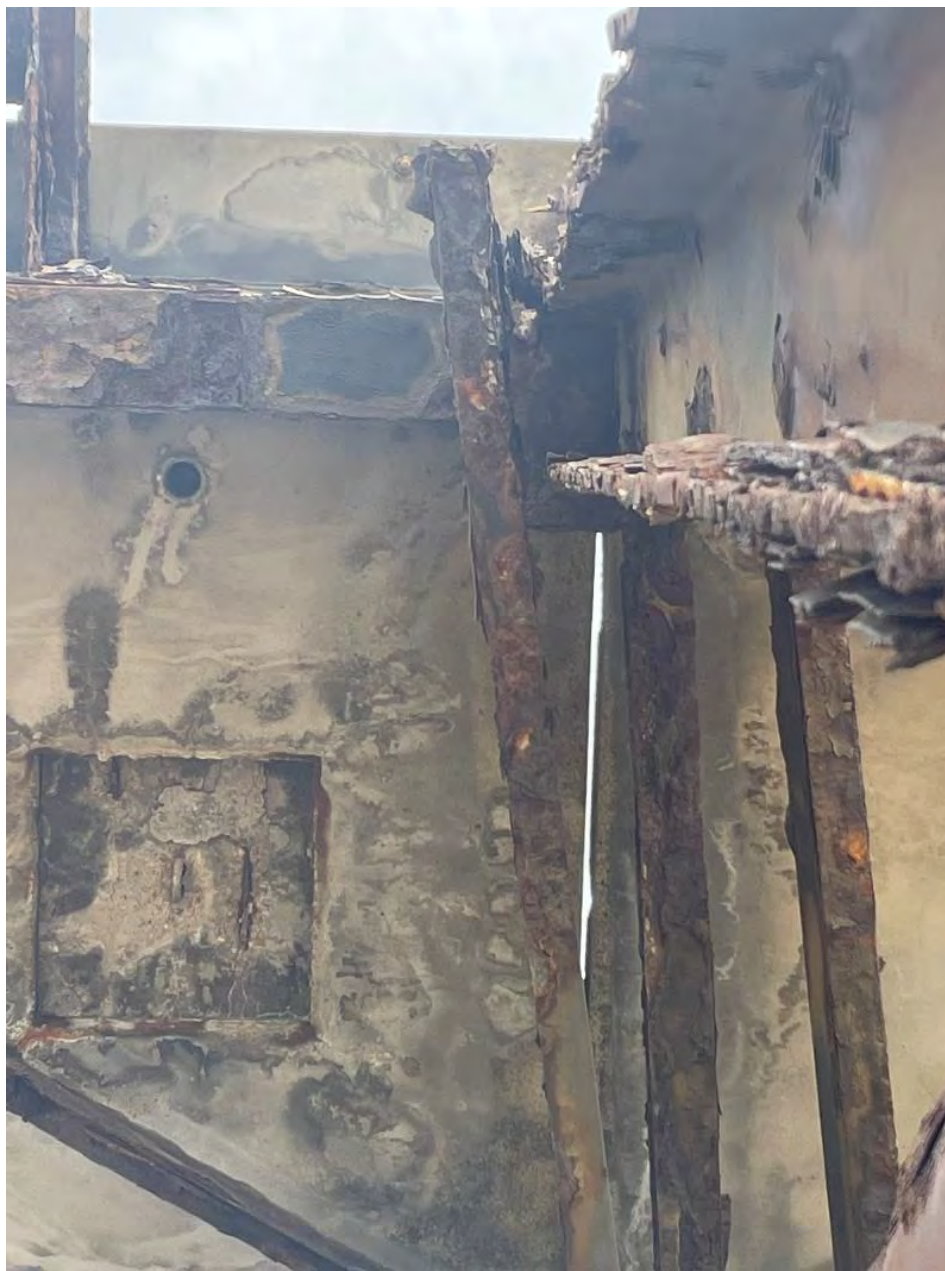
Figure 26 – Back-to-Back PFC, Visibly Detached from UC Columns, Typical of Bents 18-28

The back-to-back PFC members present near the top of bents 19 to 26 were observed to be heavily corroded and, in some areas, appear to have completely peeled away from the columns. This again is an immediate risk of falling on pedestrians. It appears that these were previously part of a cantilever supporting a side platform. The corrosion states of these channels were condition state 4. As they now appear to be redundant, they should be removed entirely.

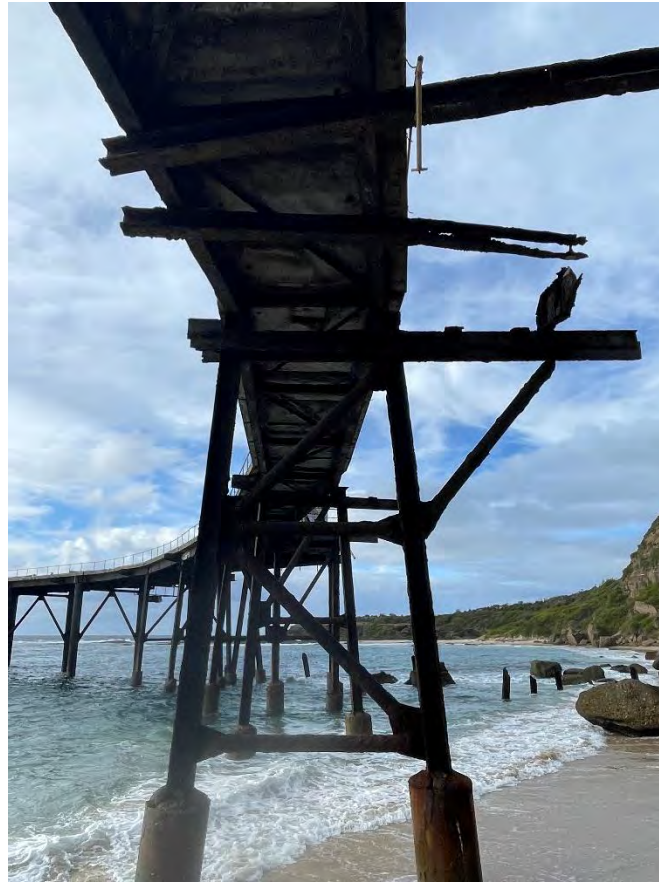
Figure 27 – Cantilever Beams to be Removed

Members cantilevering near bent 20 are present. These were retained elements that once supported a Bondek slab that is discussed in our 2017 report (N17009-REP-001) but has since been removed. These members show significant corrosion and connections in some places have corroded through completely. These members are all condition state 4 and should be removed for the safety of pedestrians walking under the jetty.

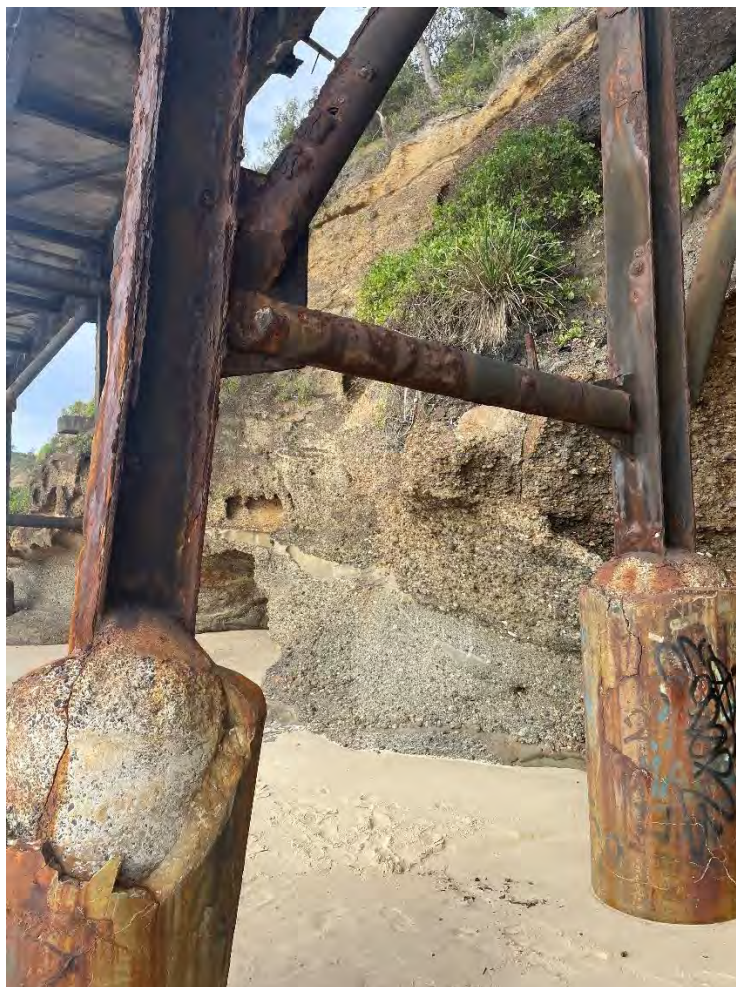
Figure 28 – Concrete Encasement for Corrosion Protection around UC Columns, Typical of Bents 18-28

Support columns for Bents 18-28 appear to have been installed in unreinforced mass concrete piers embedded to rock, as is evident by hand excavation to the side of the concrete encasement beside Bent 26. Concrete encasement of the support columns appears to be constructed through a 750mm diameter concrete pipe and in-filled after installation with reinforced concrete. This concrete 'pot' installation is the likely reason for the sleeve appearance of the concrete encasement, where the external concrete layers have cracked and broken away from the concrete infill. The uppermost sections of the concrete infill also appear to be progressively spalling away from the exposed steel columns. The loss of concrete section suggests these encasements are condition state 4. It is believed that these concrete encasements are to protect the steel from corrosion and to achieve a sufficiently large bearing sleeve/base in the founding material. Therefore, the loss of concrete to-date does not appear to be critical but should at least be made-good to fulfill its original purpose of protecting the steel column. Given that we advise the demolition of the steel columns, new piers to rock would likely need to be constructed. Alternatively, the existing piers/columns could be demolished down to a level where steel corrosion is acceptable and new columns spliced to it. This would need further breakouts to investigate.

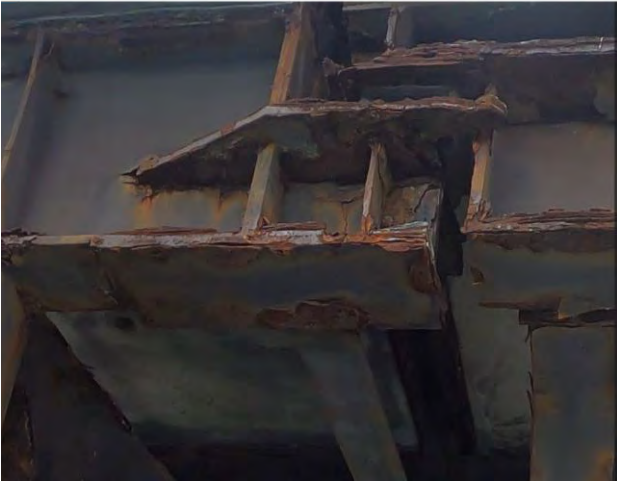
Figure 40 - Bent 17 Movement Joint

A visual inspection of the movement joint on both primary beams on Bent 17 show large corrosion and section losses that requires complete replacement of the sections, stiffeners and bearings.

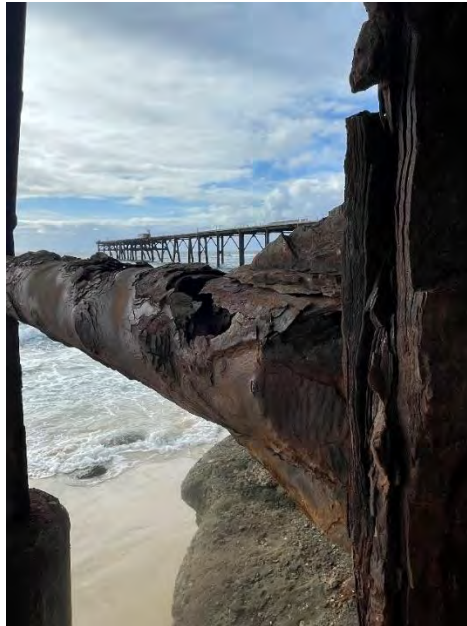
Figure 42 – CHS Tie Bracing Member, Typical of Bents 18-28

All bracing members, 230 CHS and 200PFCs are heavily corroded with section losses.

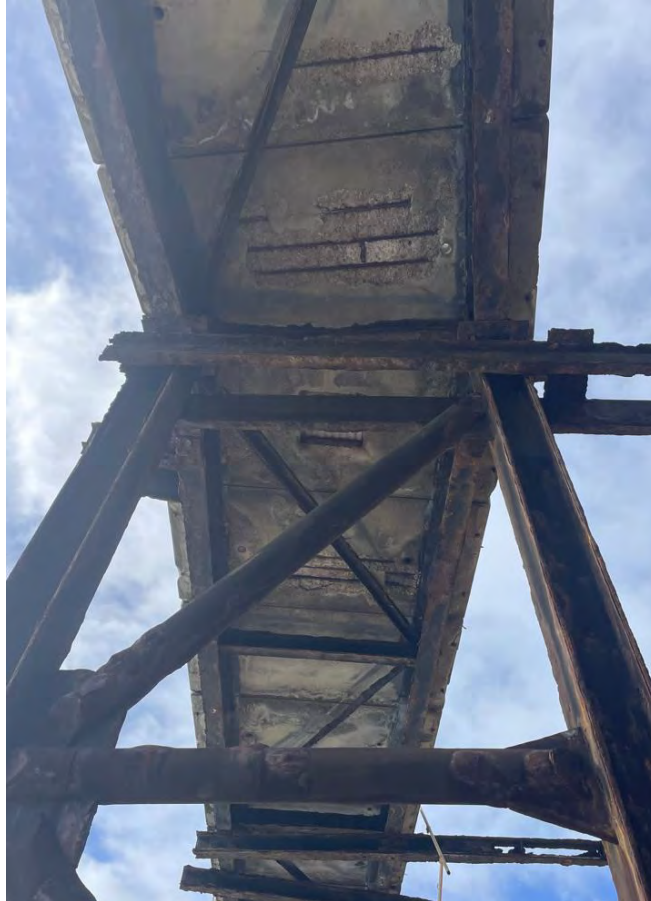
Figure 44 - Precast Panels Showing Deterioration with Reinforcement Exposed, Deck Type DC

We estimate that a significant number of planks (in the order of 20-30% across the whole Jetty) are to be either replaced or strengthened with carbon fiber reinforcement grooved-in steel reinforcement or alternative methods.

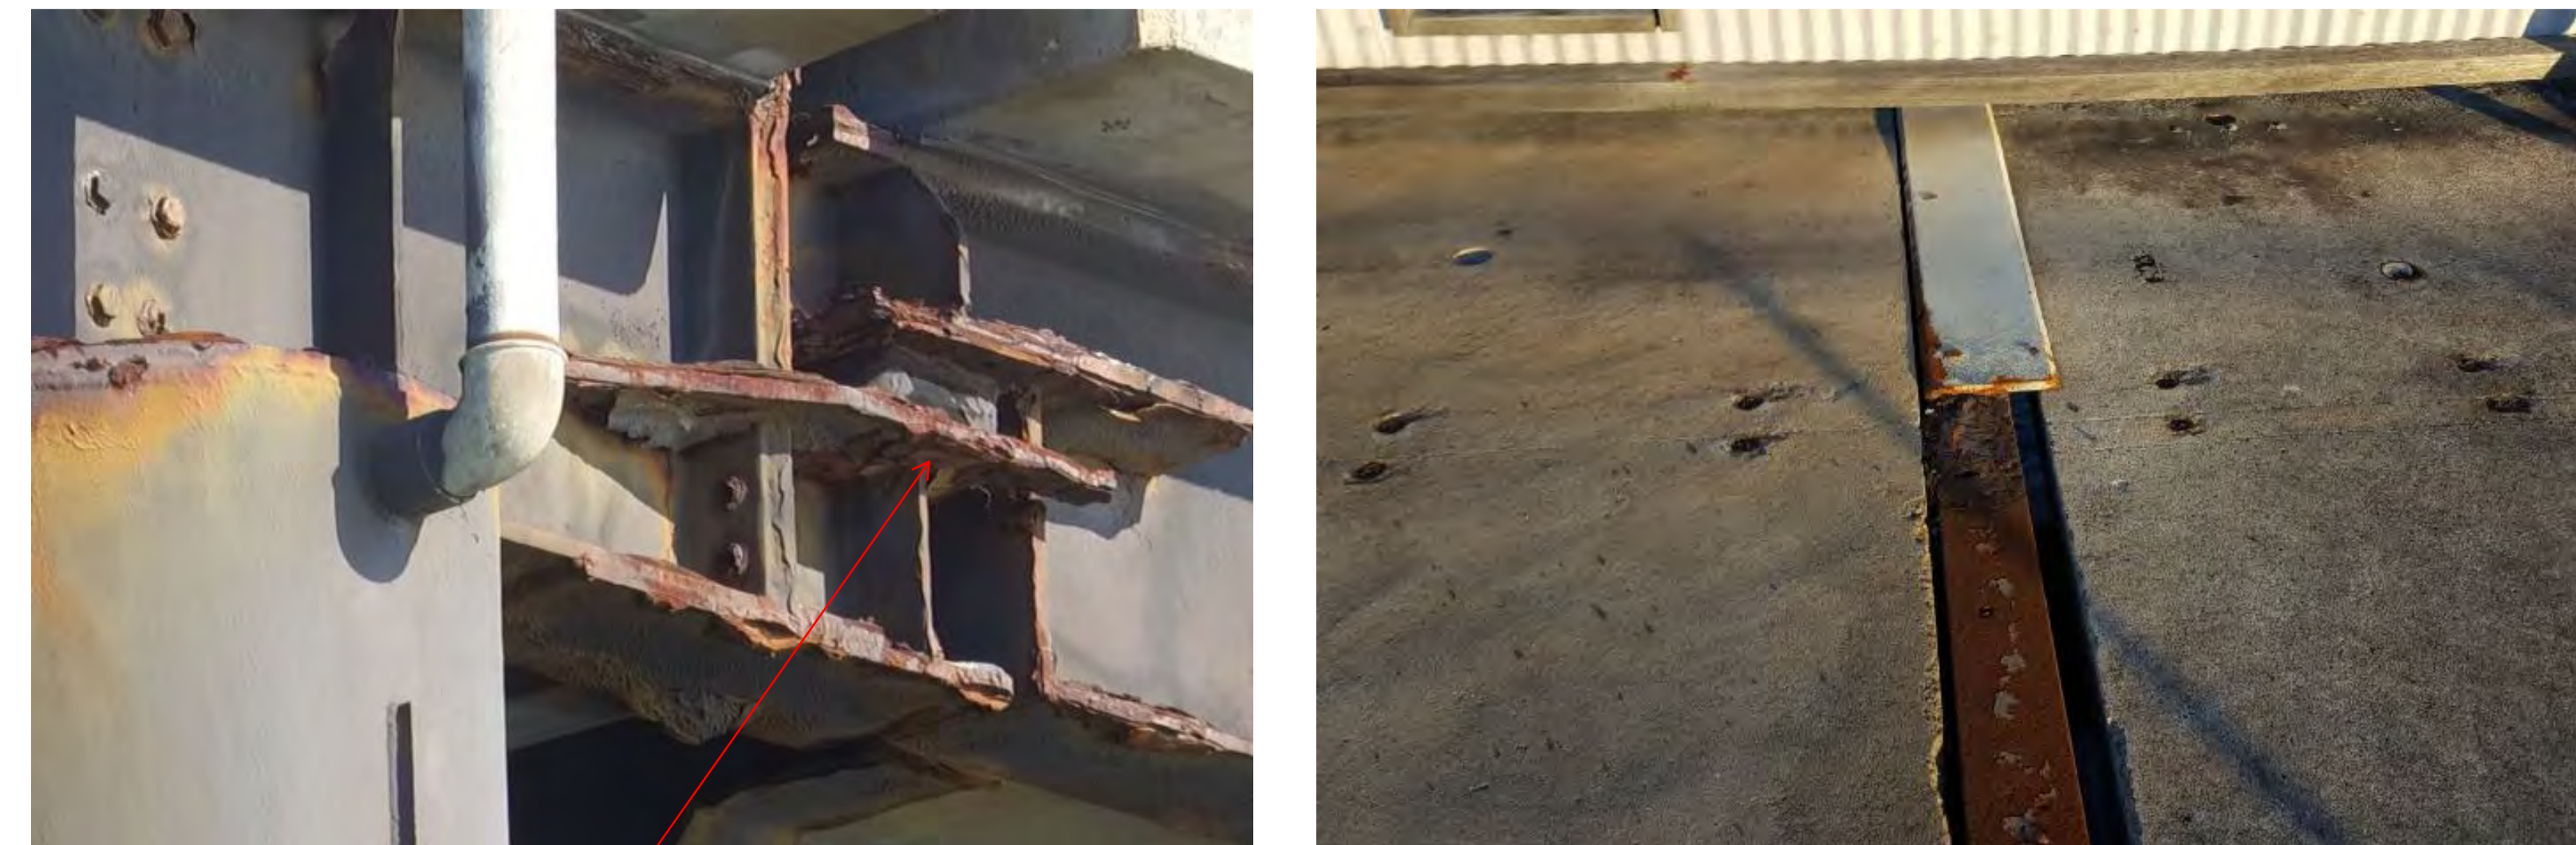
DELAMINATION AND RUST OF PLATES

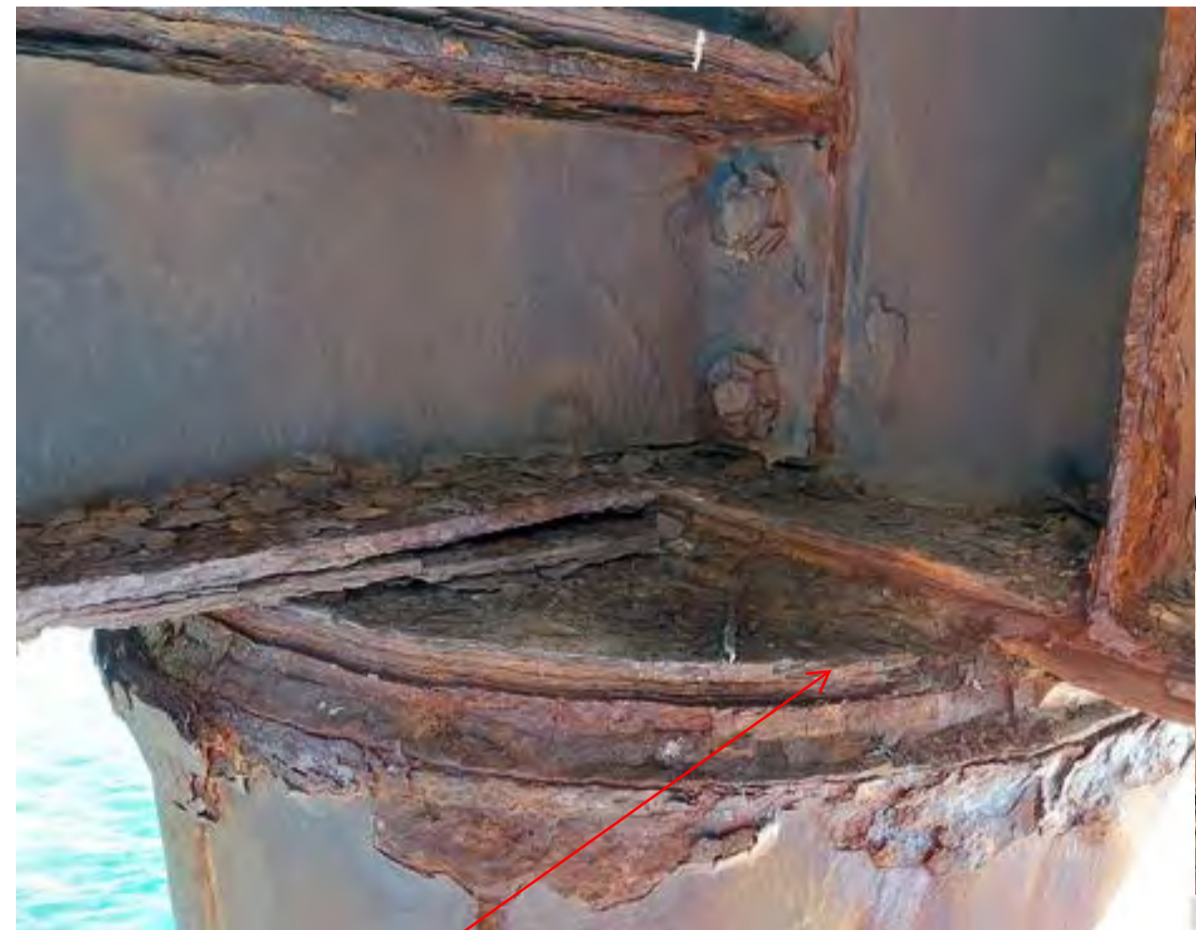
CONNECTION DETAIL - PRIMARY BEAM TO BENT

END RUSTED. SOME LOSS OF SECTION AT CONNECTION TO CHS

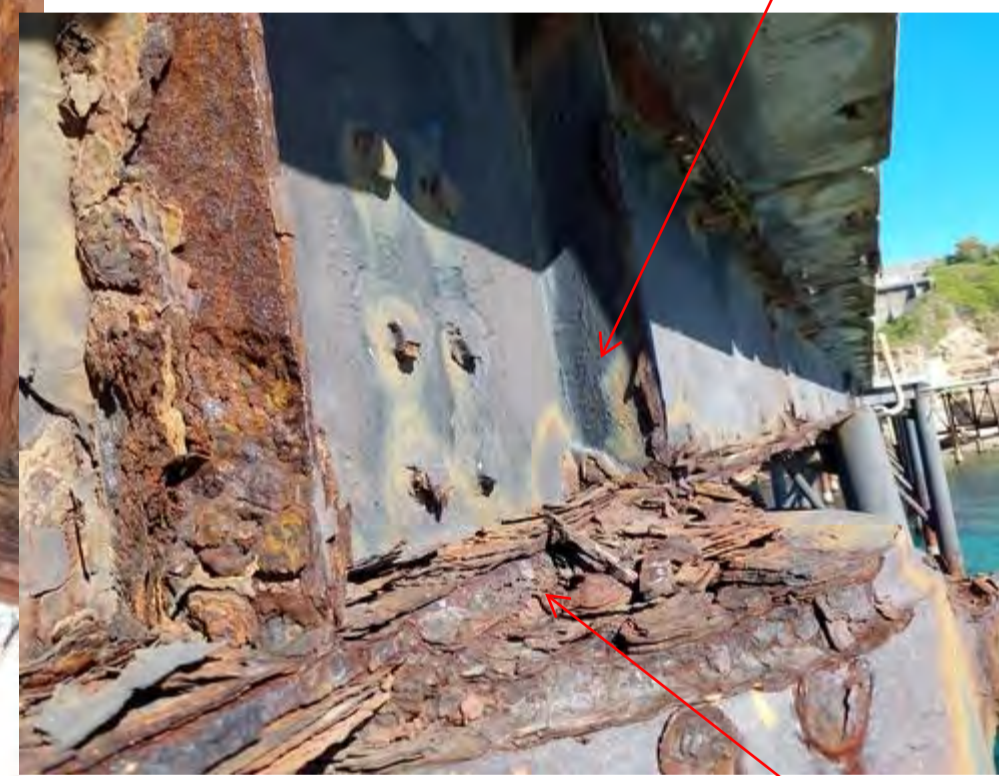
DUE TO THE SEVERE DELAMINATION OF THE BTM FLANGE IT IS NOT POSSIBLE TO DETERMINE IF THE PRIMARY BEAMS ARE BOLTED/WELDED OR SITTING ON A BEARING TO THE BENTS

PRIMARY BEAM BTM FLANGE SHOWS SEVERE DELAMINATION

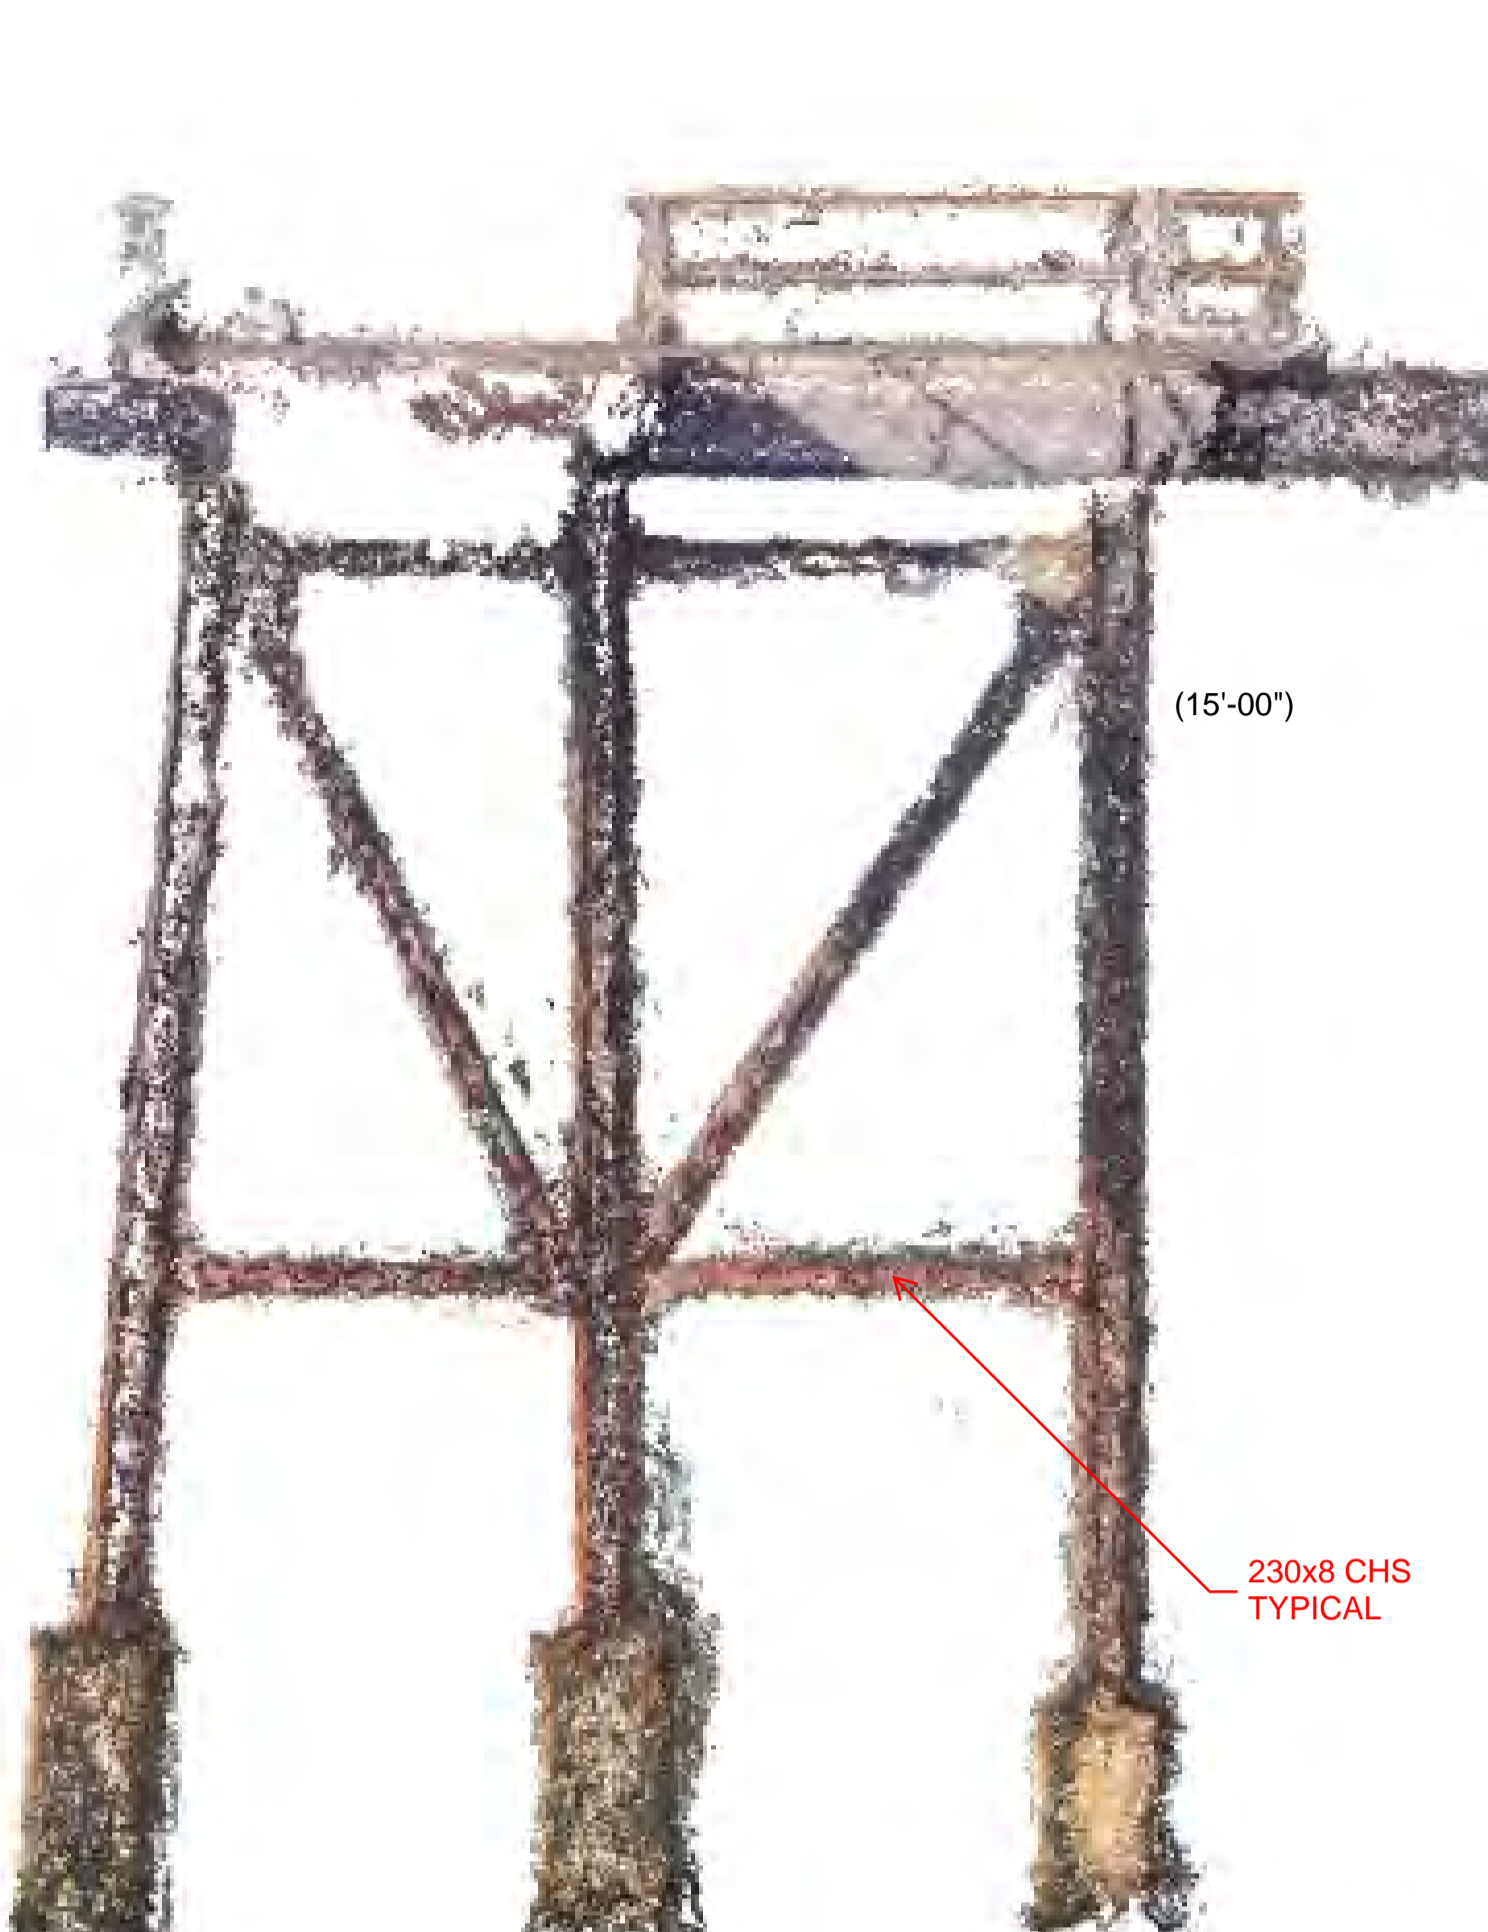
BENT 20 - POINTCLOUD

ALL COLUMNS ARE 310UC18 IN BAD CONDITIONS WITH LOSS OF SECTION IN THE FLANGE
