External Memo – Catherine Hill Bay Jetty – Summary Report

Project Number N23146
Client Department of Planning and Environment
Date 7 December 2023
Document Number 002
Revision A
Prepared By [REDACTED]
Reviewed By [REDACTED]
Approved By [REDACTED]

1 Introduction

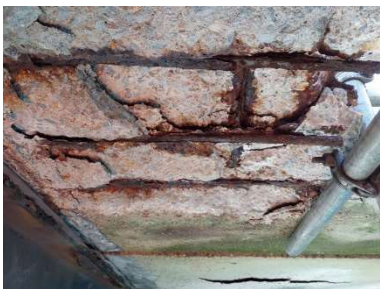
<p><u>Exposed reinforcement in the soffit.</u></p>

<p>Photo 4 Several instances of spalled concrete because of corroding/expanding reinforcement were observed. It is likely the chloride ions have penetrated to the depth of reinforcement and initiated corrosion.</p>	<p><u>Concrete encasement of steel columns.</u></p>

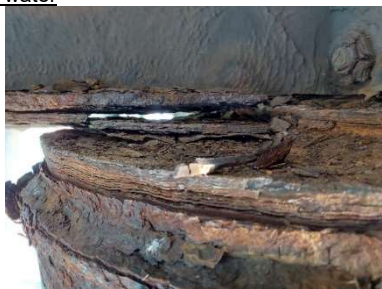
<p>Photo 6 Where primary beams connect to other elements i.e., columns, base plates, secondary beams etc, corrosion has initiated and section loss occurring.</p>
<p><u>Nut and bolt connections</u></p>

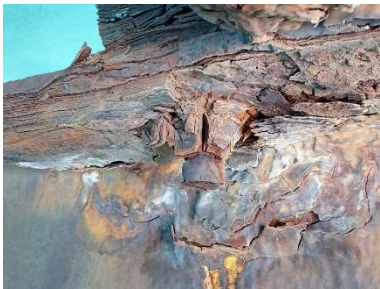
<p>Photo 7 Typically, nut and bolt connections are no longer fit for purpose with significant corrosion and section loss observed.</p>	<p><u>Bracing</u></p>

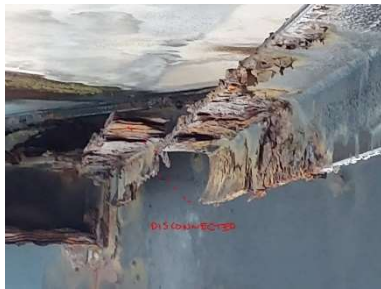
<p>Photo 8 In most instances the diagonal bracing had completed corroded, failed, or fallen from the structure.</p>	<p><u>Circular hollow section columns in water</u></p>

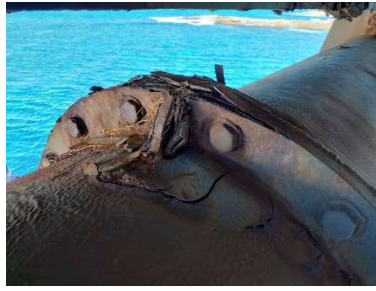
Photo 11

The connections between circular hollow section braces exhibited corrosion between the circular plates, at stiffeners, and on the nuts.

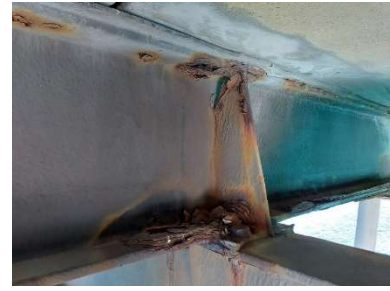
Photo 12

The primary beams along their extent, away from connections, are generally in good condition.
