# ex-HMAS Adelaide - Structural Condition Report (PROC12925)

Prepared for Department of Planning, Housing, and Infrastructure – Crown Lands

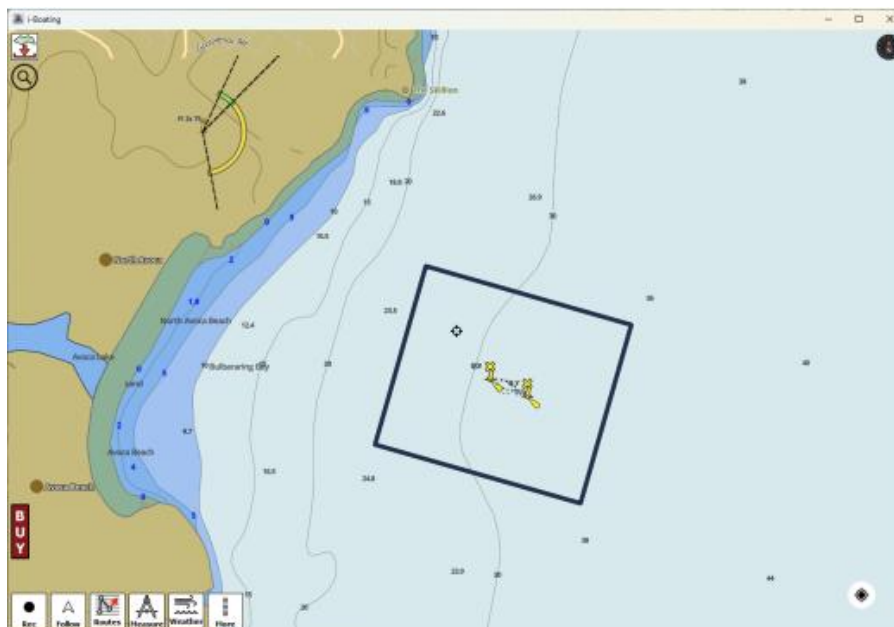
Figure 1 - Survey Area

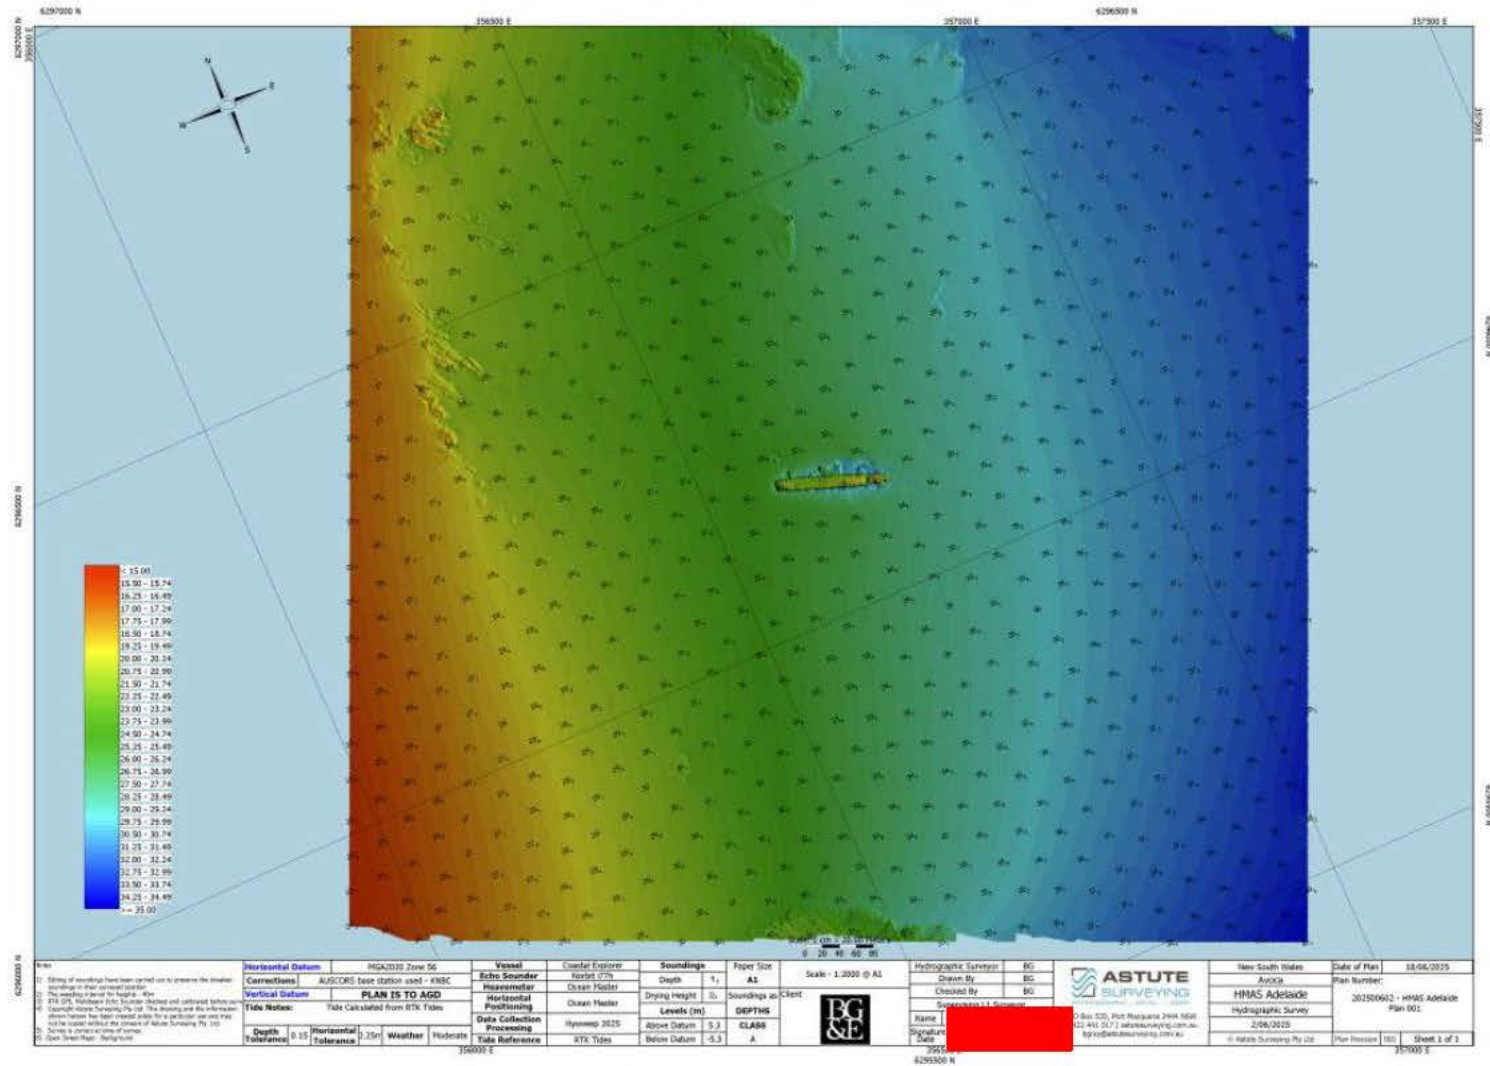
Figure 3 - Survey Plan

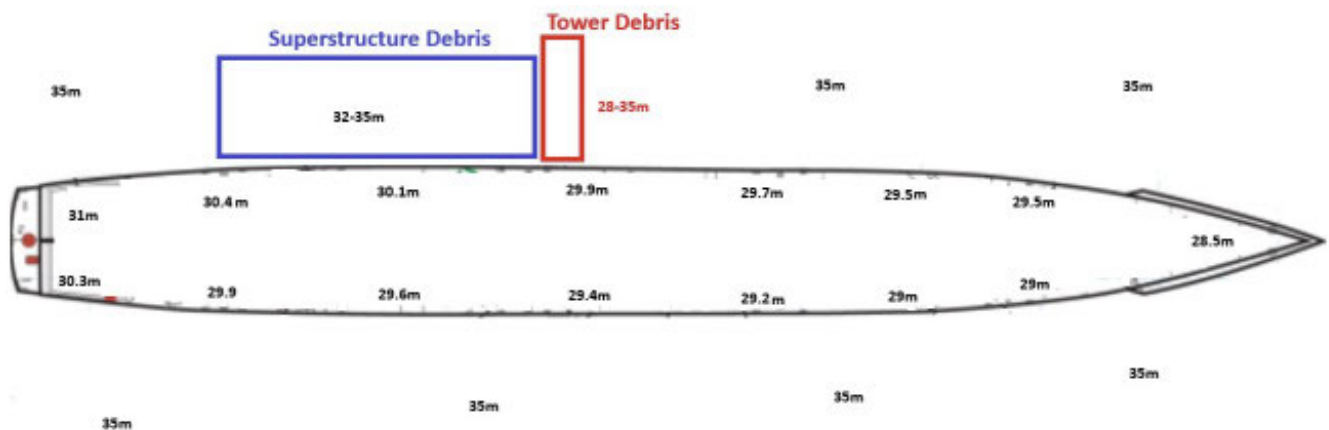
Figure 12 - Depth Profiles

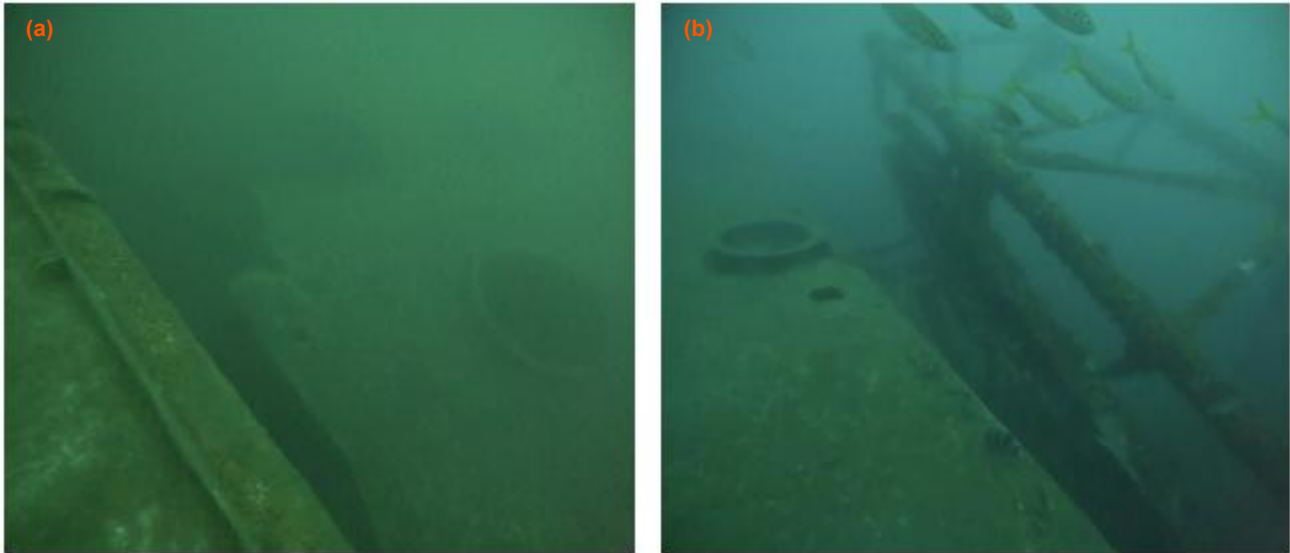
Figure 13 – Two Major Areas of Debris being Part of the Superstructure (a) and the Tower (b)

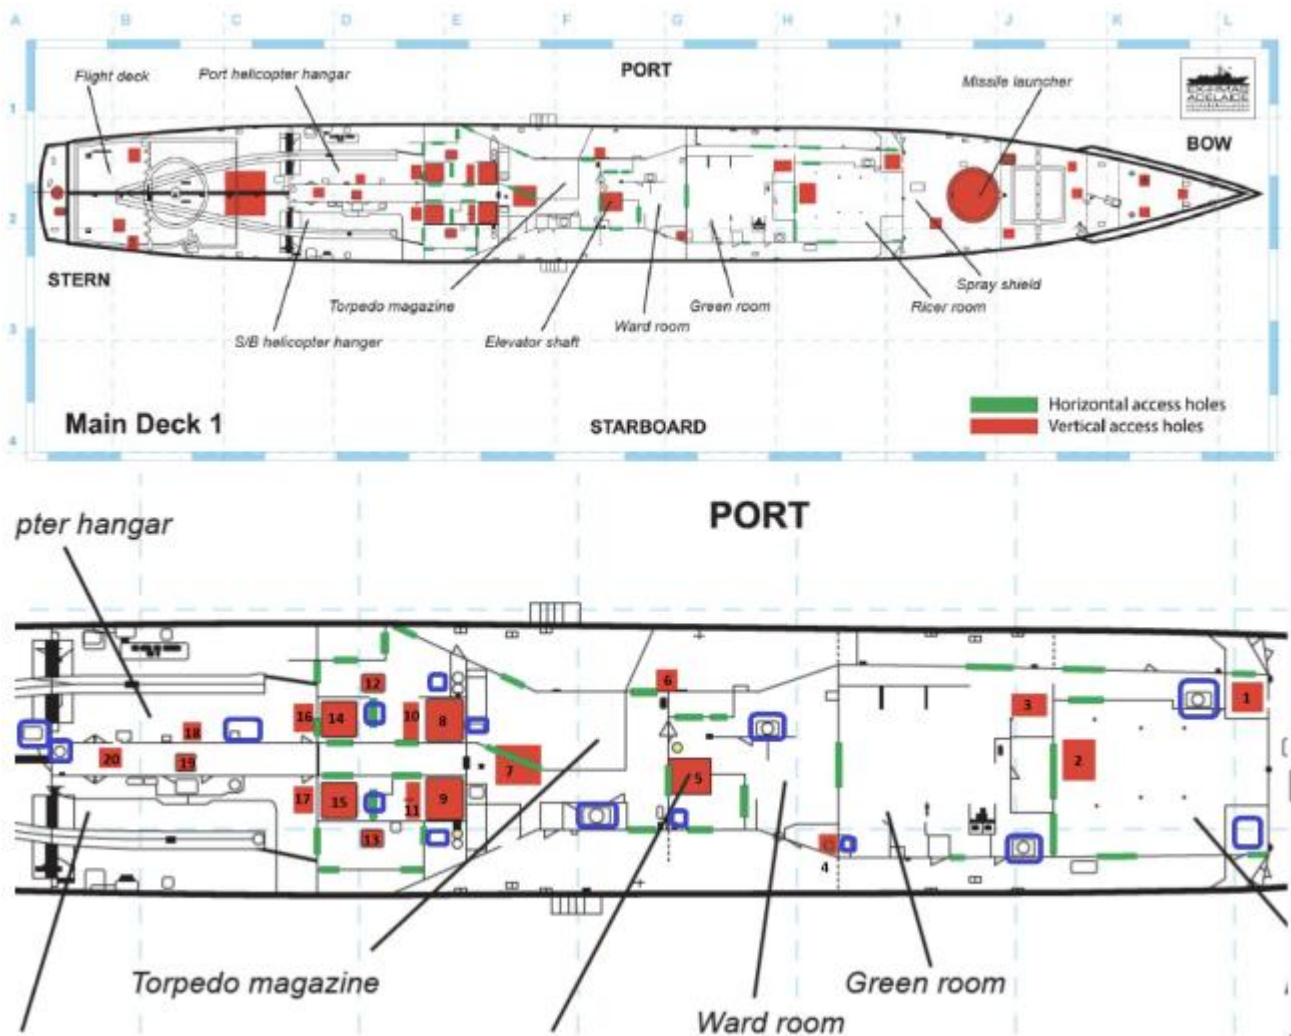
Figure 15 - New Penetrations Map

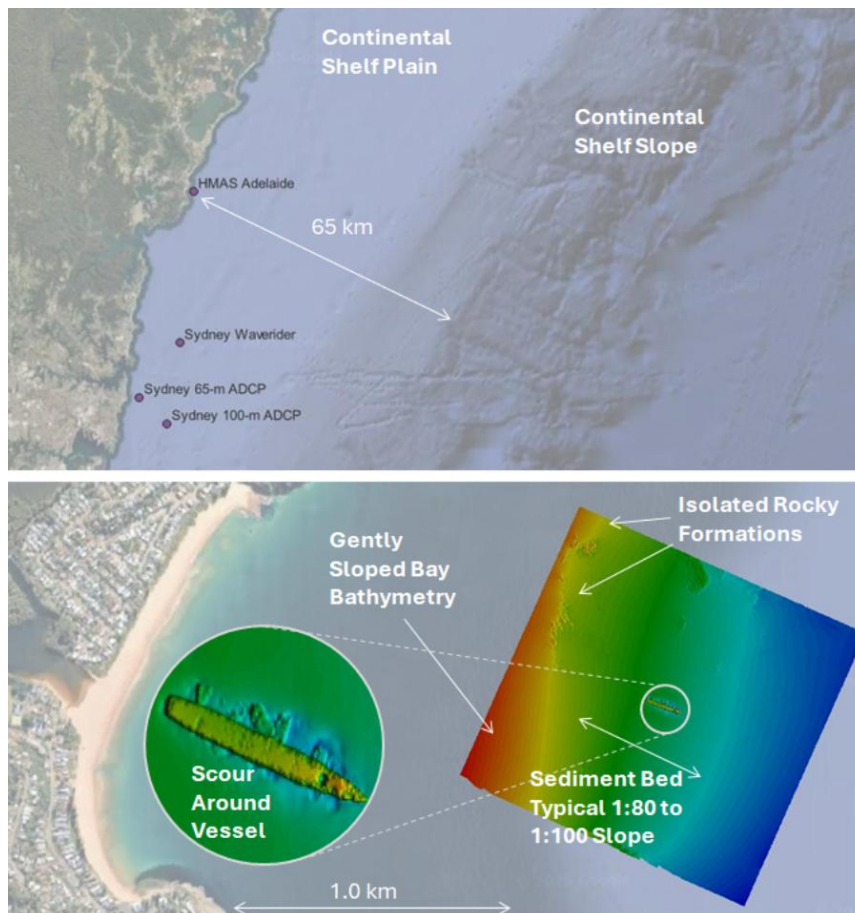
Figure 19 - Wreck Position on Shelf and Coastal Slope

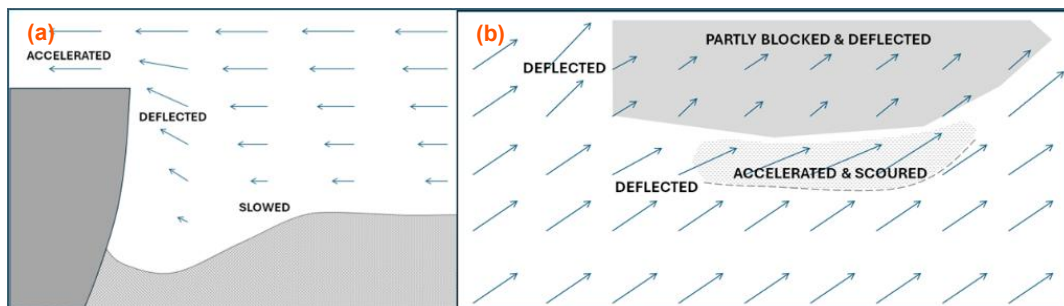
**Figure 20 - Schematic Illustration of Flow Interactions**

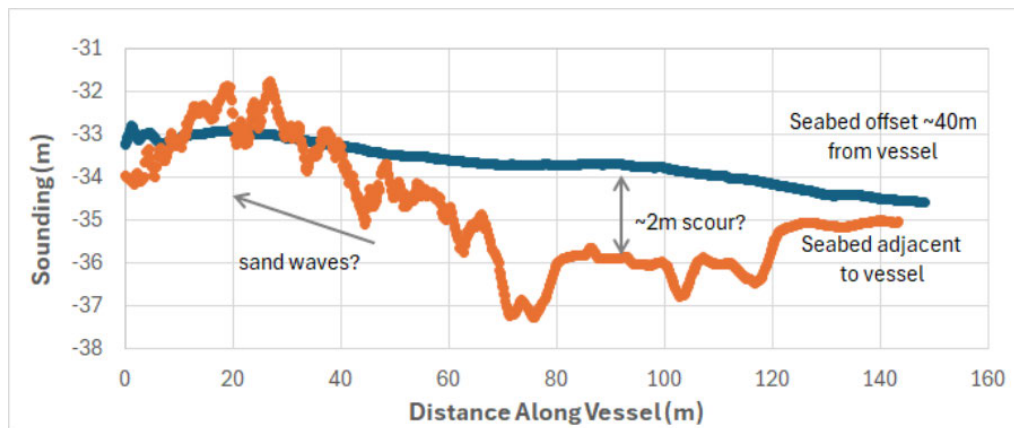
Figure 21 - Indication of Seabed Change Next to Vessel
