## **Ex-HMAS ADELAIDE Artificial Reef**

### **Reef Community and Sediment Movement Surveys**

301020-03410 – FINAL

29 June 2011

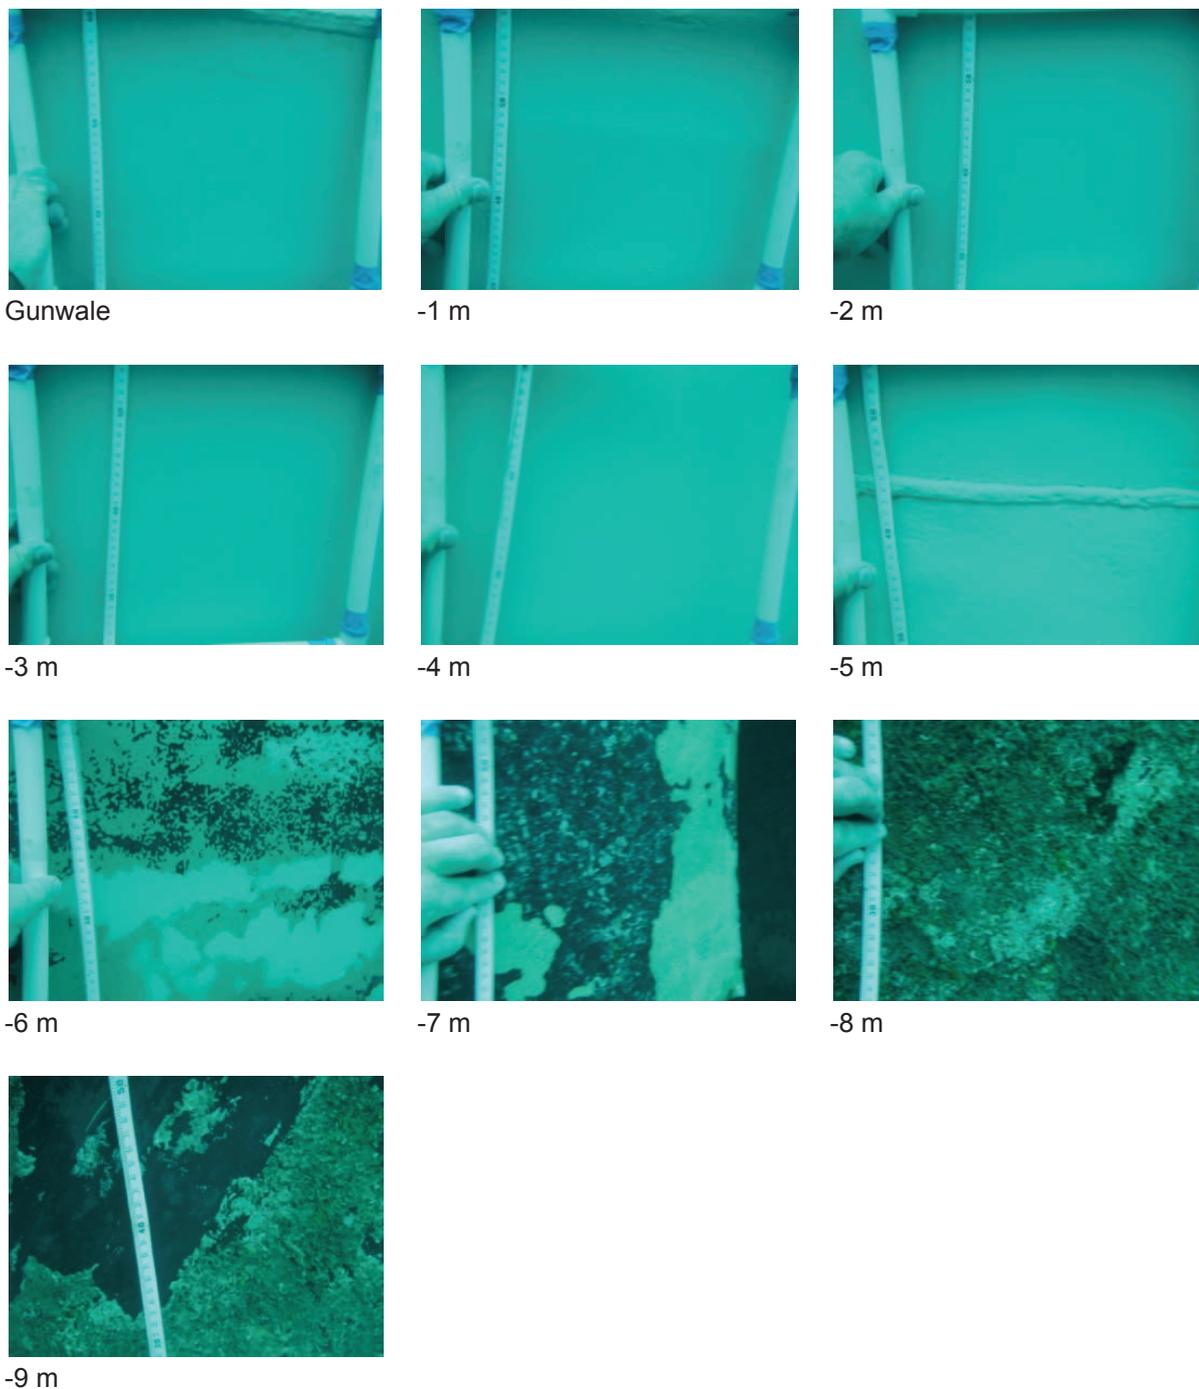
**Figure 3.1 Vertical photo quadrats down the hull of the bow port side (showing depth relative to uppermost quadrat at the gunwale).**

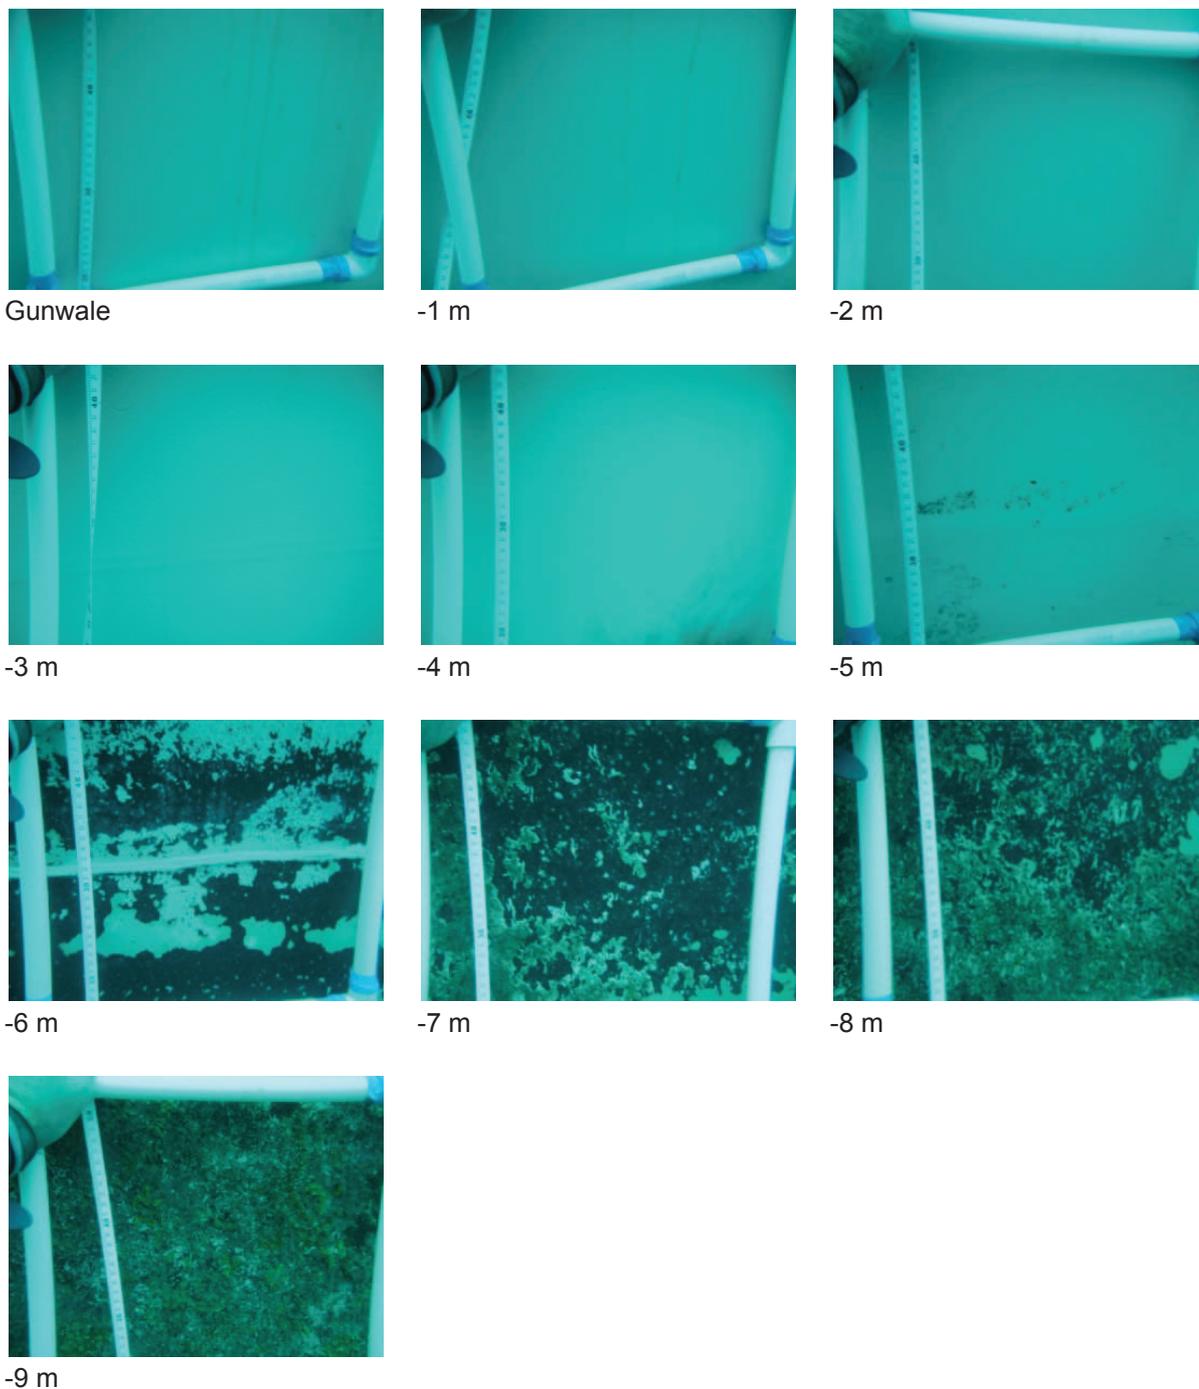
CPC analysis of photo quadrats down the hull on the bow starboard side showed no obvious marine growth until the -7 m quadrat, where serpulid worm casings covered 40% of the hull. At -8 m, serpulid casings covered a slightly smaller proportion, with green algae also covering 30%. At -9 m below the gunwale, the cover of serpulid casings increased to 80% and green algae covered 20% of the hull. Bare metal was found at -6 m from the gunwale (see **Table 3.2** and **Figure 3.2**).

**Figure 3.2 Vertical photo quadrats down the hull of the bow starboard side (showing depth relative to uppermost quadrat at the gunwale).**

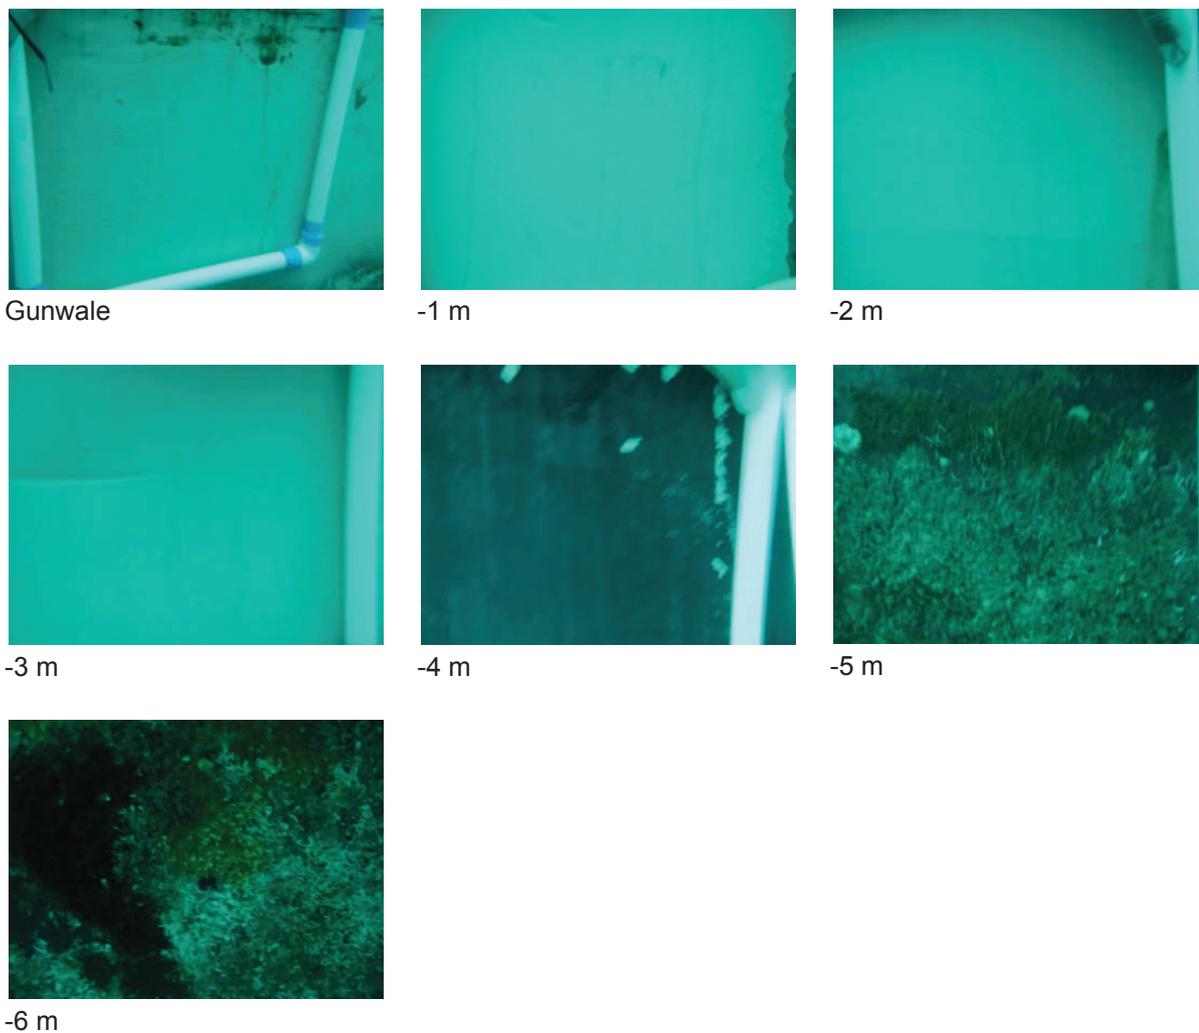
**Figure 3.3 Vertical photo quadrats down the hull of the stern port side (showing depth relative to uppermost quadrat at the gunwale).**

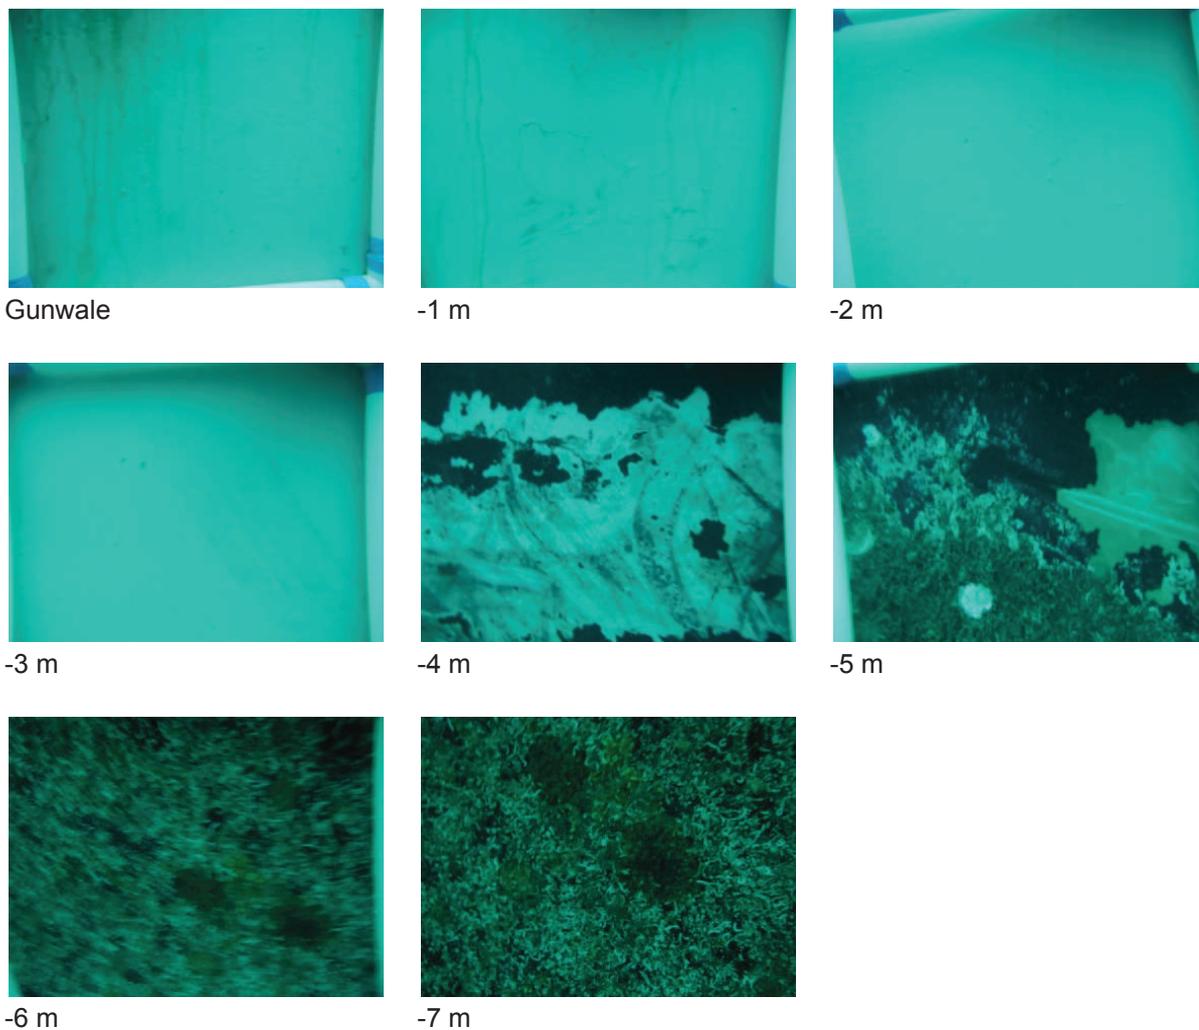
CPC analysis on the vertical transect of the stern starboard side of the hull showed no marine growth until 5 m from the gunwale. There was 50% cover of serpulid worm casings at -5 m, after which serpulid casings dominated the hull (85% at -6 m and 80% at -7 m) with smaller proportions of green algae (15% at -6 m and 20% at -7 m). Bare metal was observed at 4 m from the gunwale (**Figure 3.4** and **Table 3.4**).

**Figure 3.4 Vertical photo quadrats down the hull of the stern starboard side (showing depth relative to uppermost quadrat at the gunwale).**

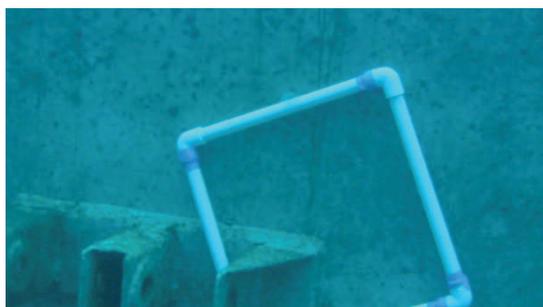
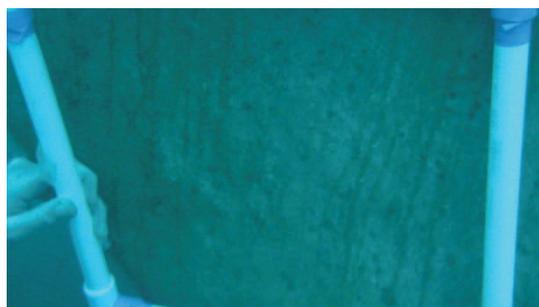
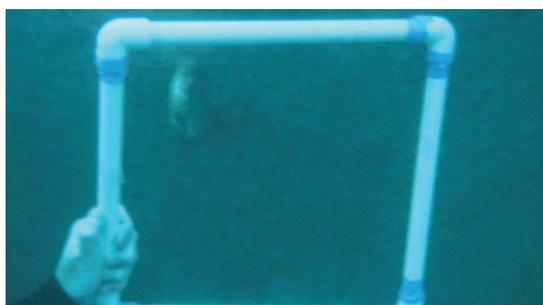
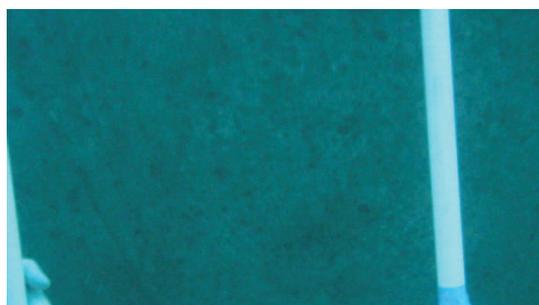
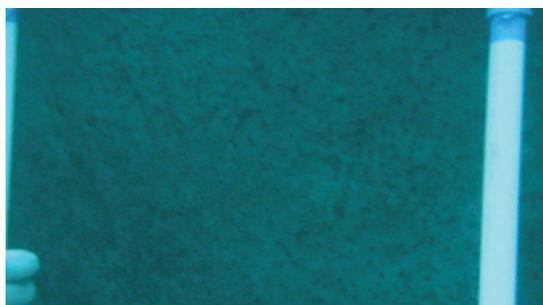
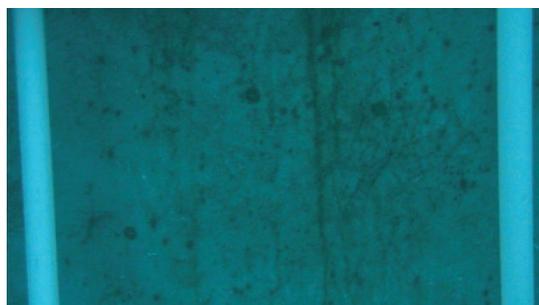
The port side transect taken along the hull in the horizontal plane, taken immediately below the gunwale, was undertaken along a depth gradient of 28 m. A light coating of marine algae all over the vessel at this depth was observed in all still images taken on the hull as shown in **Figure 3.5**.

**Figure 3.5** Still images taken along the port side horizontal plane under the gunwale.

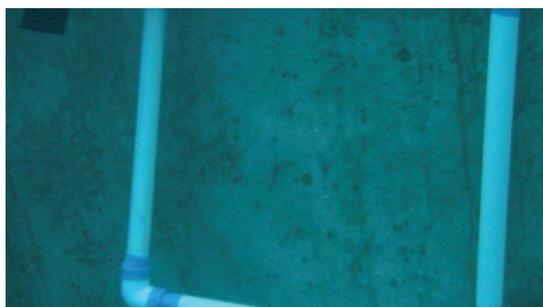
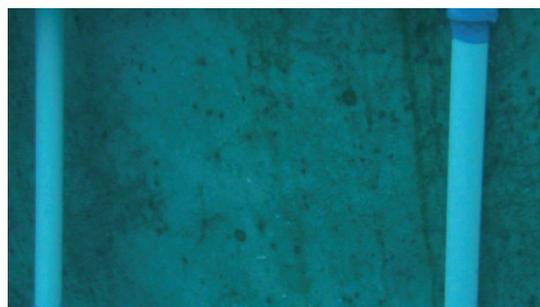
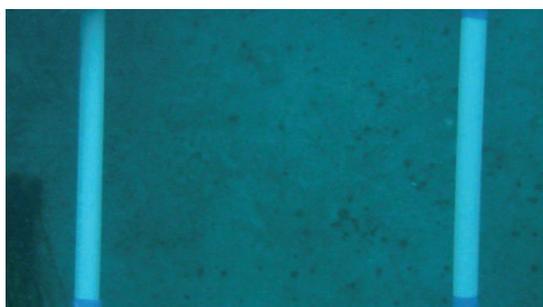
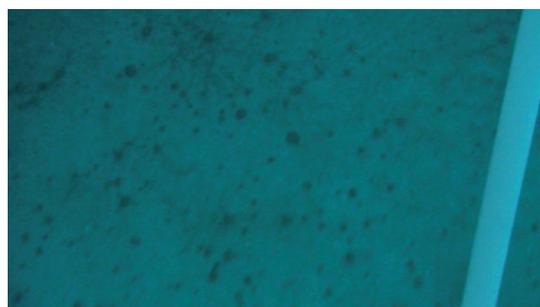
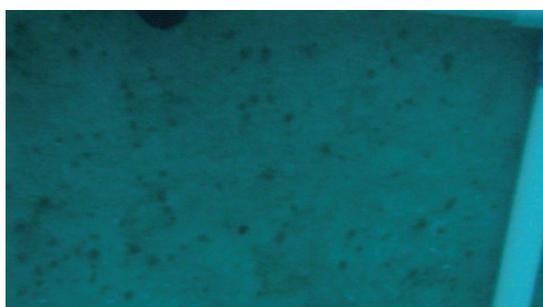
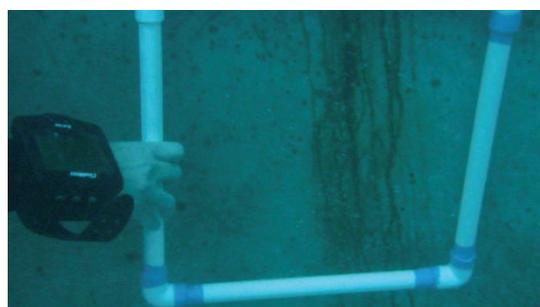
The port side transect taken along the hull in the horizontal plane, taken 1 m below the gunwale, was undertaken along a depth gradient of 29 m. A light coating of marine algae was observed on the hull in all still images taken as shown in **Figure 3.6**.

**Figure 3.6 Still images taken along the port side horizontal plane 1 m below the gunwale.**

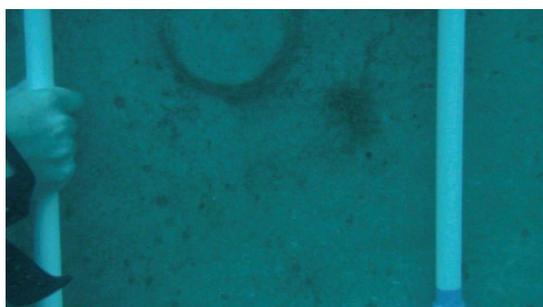
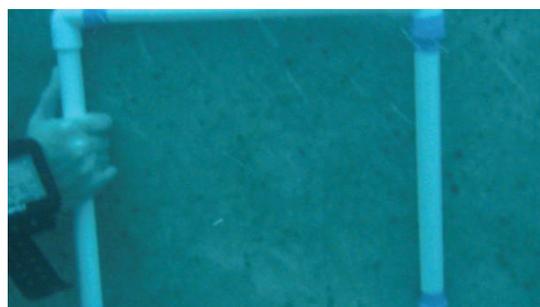
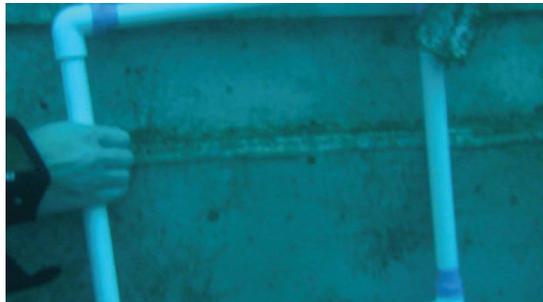
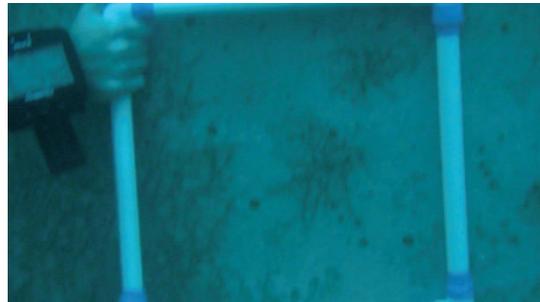
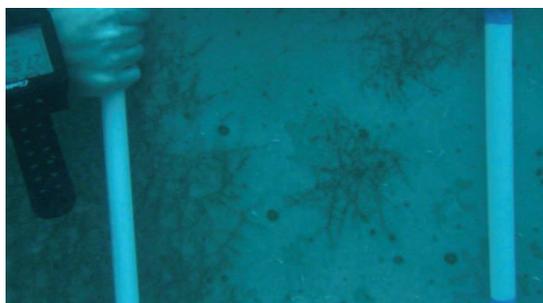
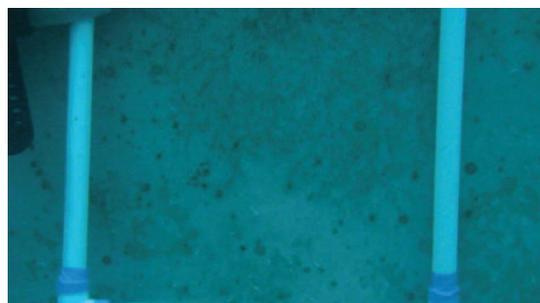
The port side transect taken along the hull in the horizontal plane, taken 2 m below the gunwale, was undertaken along a depth gradient of 30 m. A light coating of algae was observed on the hull in all still images. Stolonate ctenostome (soft) bryozoans were also recorded in quadrats 3, 4 and 5 (see **Figure 3.7**).

**Figure 3.7 Still images taken along the port side horizontal plane 2 m below the gunwale.**

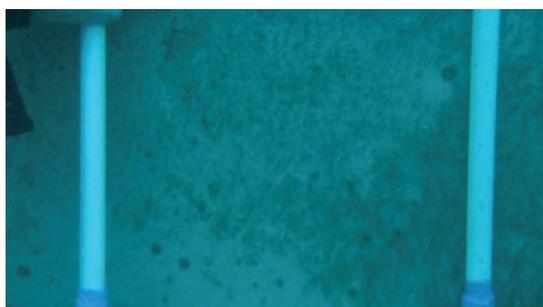
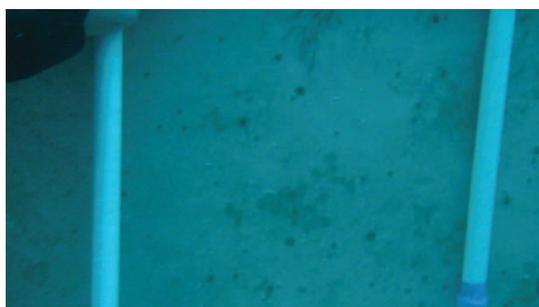
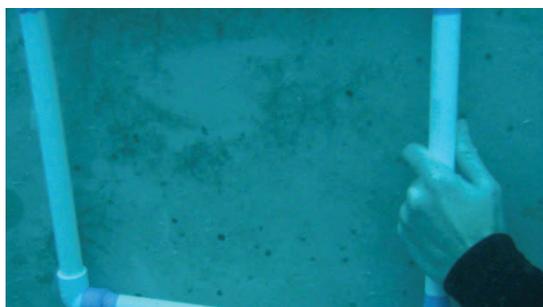
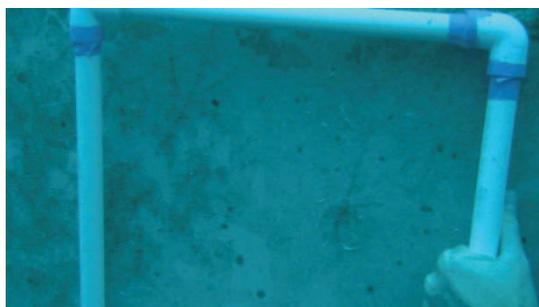
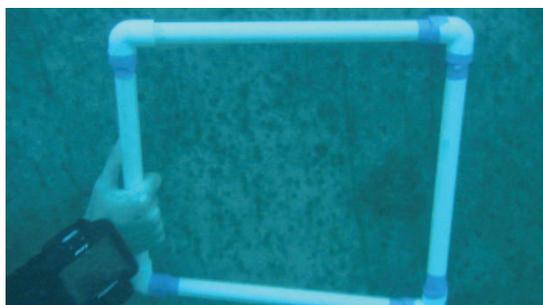
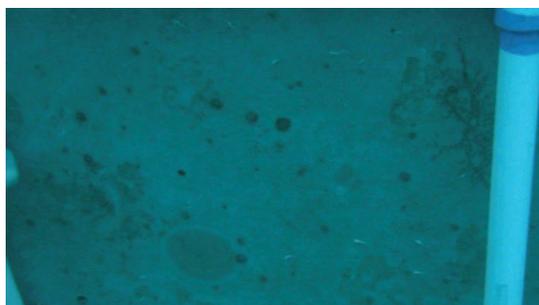
The starboard side transect taken along the hull in the horizontal plane, taken immediately below the gunwale, was undertaken along a depth gradient of 28 m. A light coating of marine algae was present on the hull in all still images taken as shown in **Figure 3.8**. Stolonate ctenostome bryozoans were also observed in a number of quadrats (i.e. 2, 4 and 6).

**Figure 3.8** Still images taken along the starboard side horizontal plane below the gunwale.

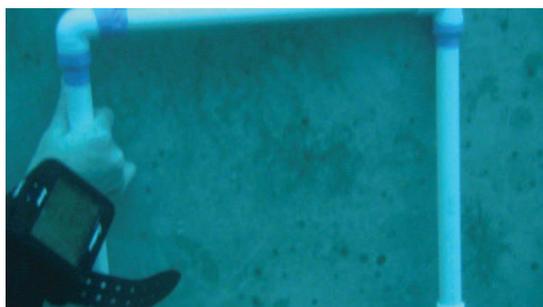
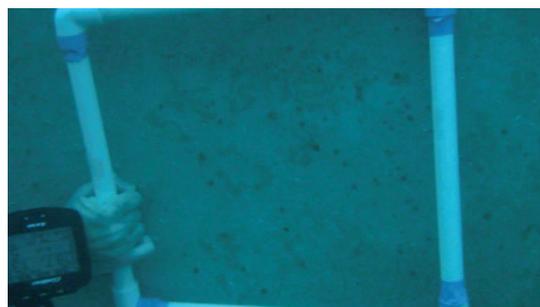
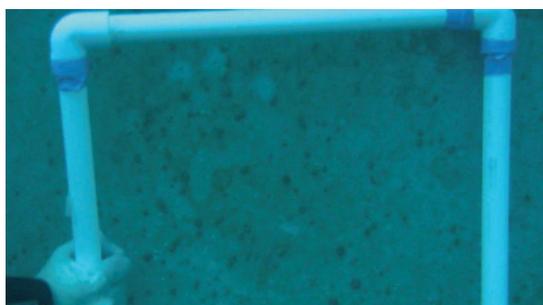
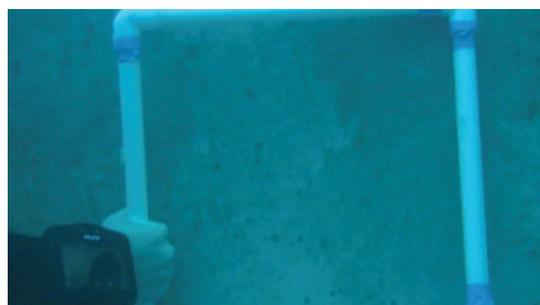
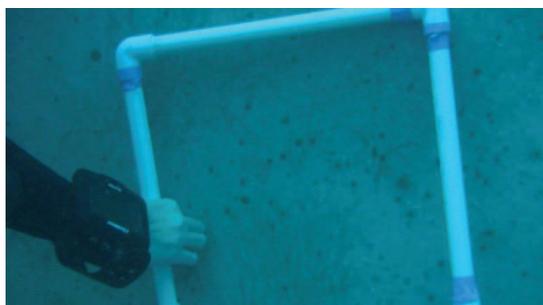
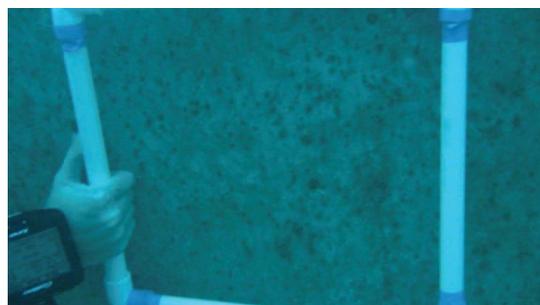
The starboard side transect taken along the hull in the horizontal plane, taken 1 m below the gunwale, was undertaken along a depth gradient of 29 m. As with all other quadrats a light coating of algae was present over the hull in all still images taken (see **Figure 3.9**).

**Figure 3.9 Still images taken along the starboard side horizontal plane 1 m below the gunwale.**

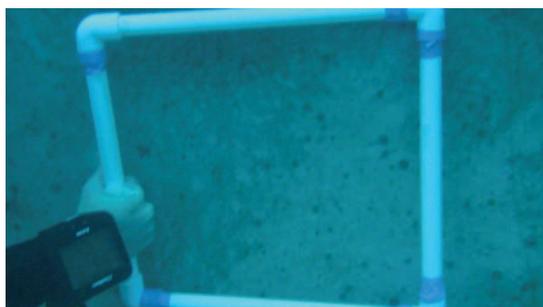
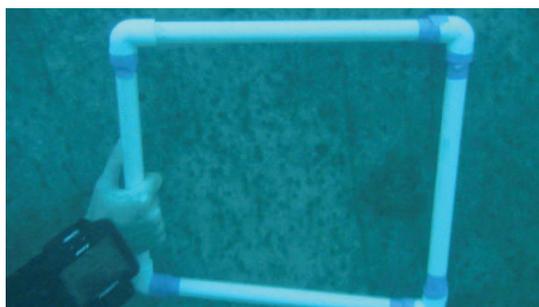
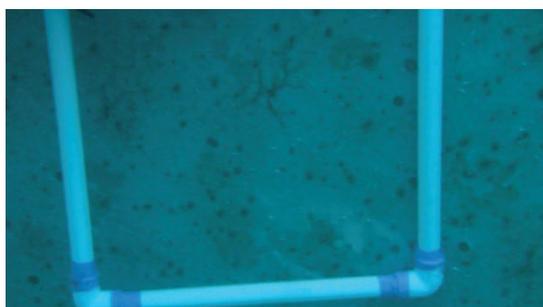
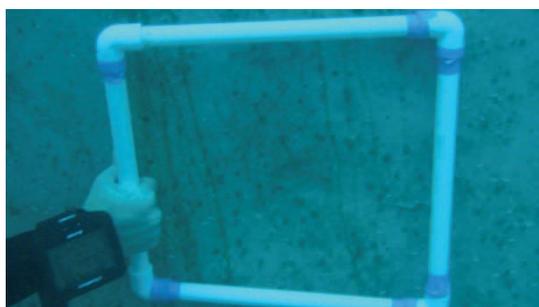
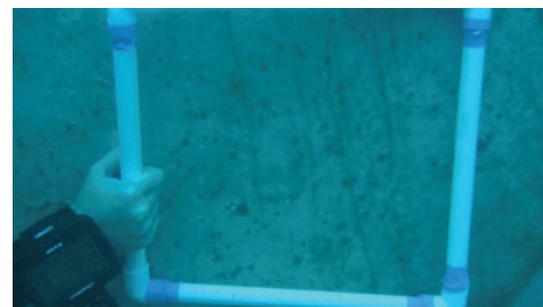
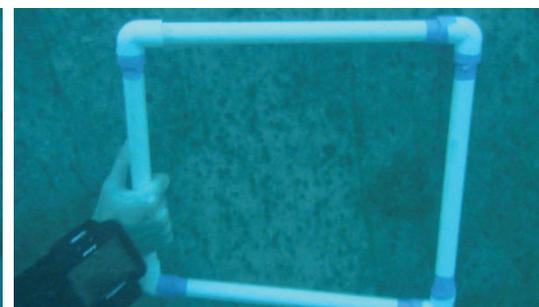
The starboard side transect taken along the hull in the horizontal plane, taken 2 m below the gunwale, was undertaken along a depth gradient of 30 m. A light covering of algae was found to cover the hull in all quadrats as shown in **Figure 3.10**.

**Figure 3.10** Still images taken along the starboard side horizontal plane 2 m below the gunwale.

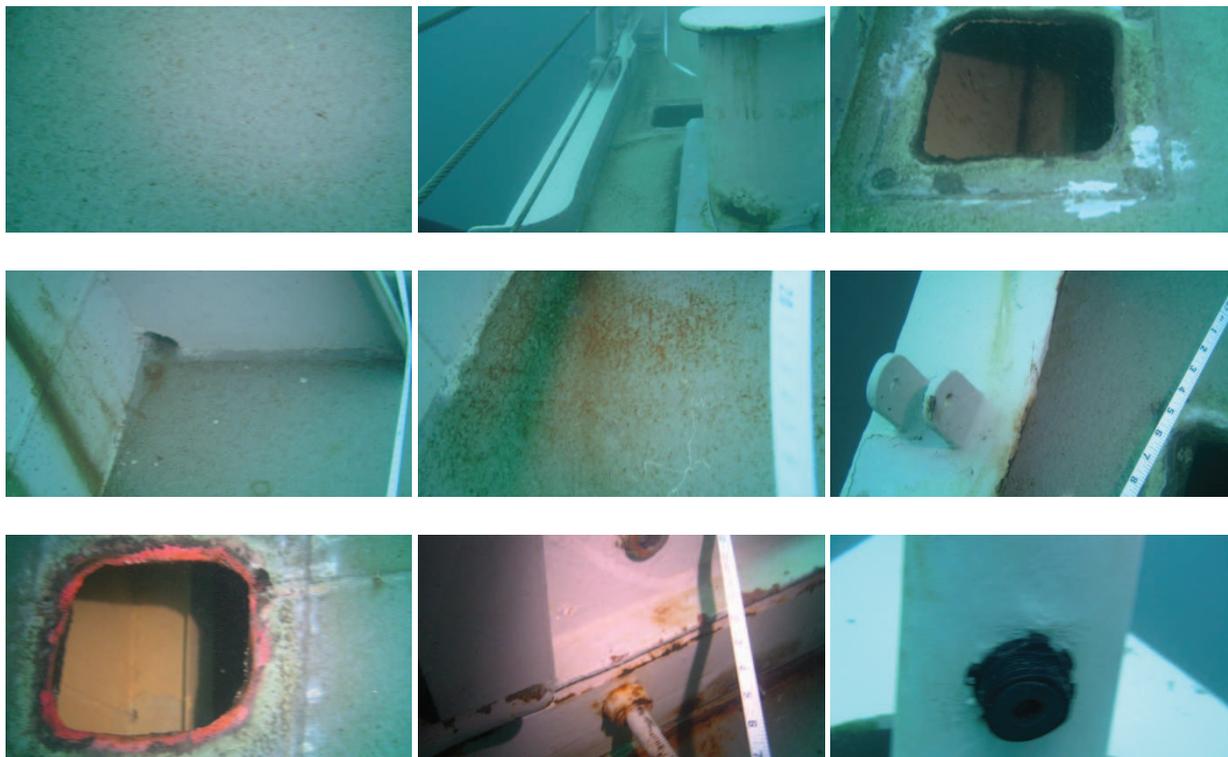
No obvious marine growth was present on the bow port side horizontal transect (see **Figure 3.11**).

**Figure 3.11** Still images captured on the bow port side transect.

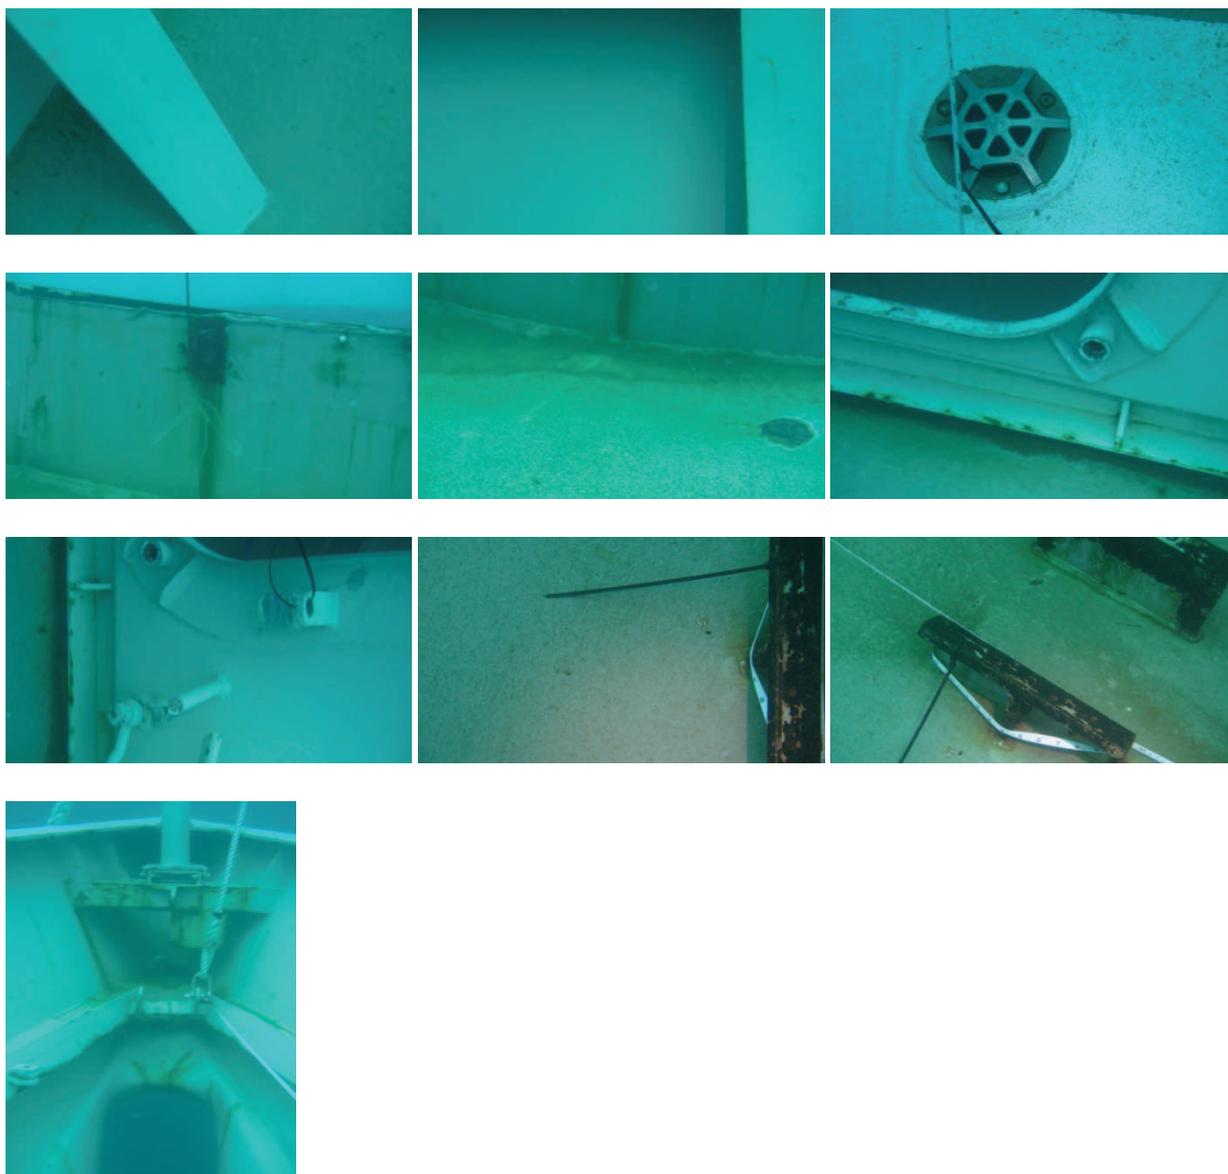
No obvious marine growth was present on the bow starboard side transect as shown in **Figure 3.12** below.

**Figure 3.12** Still images captured on the bow starboard side transect.

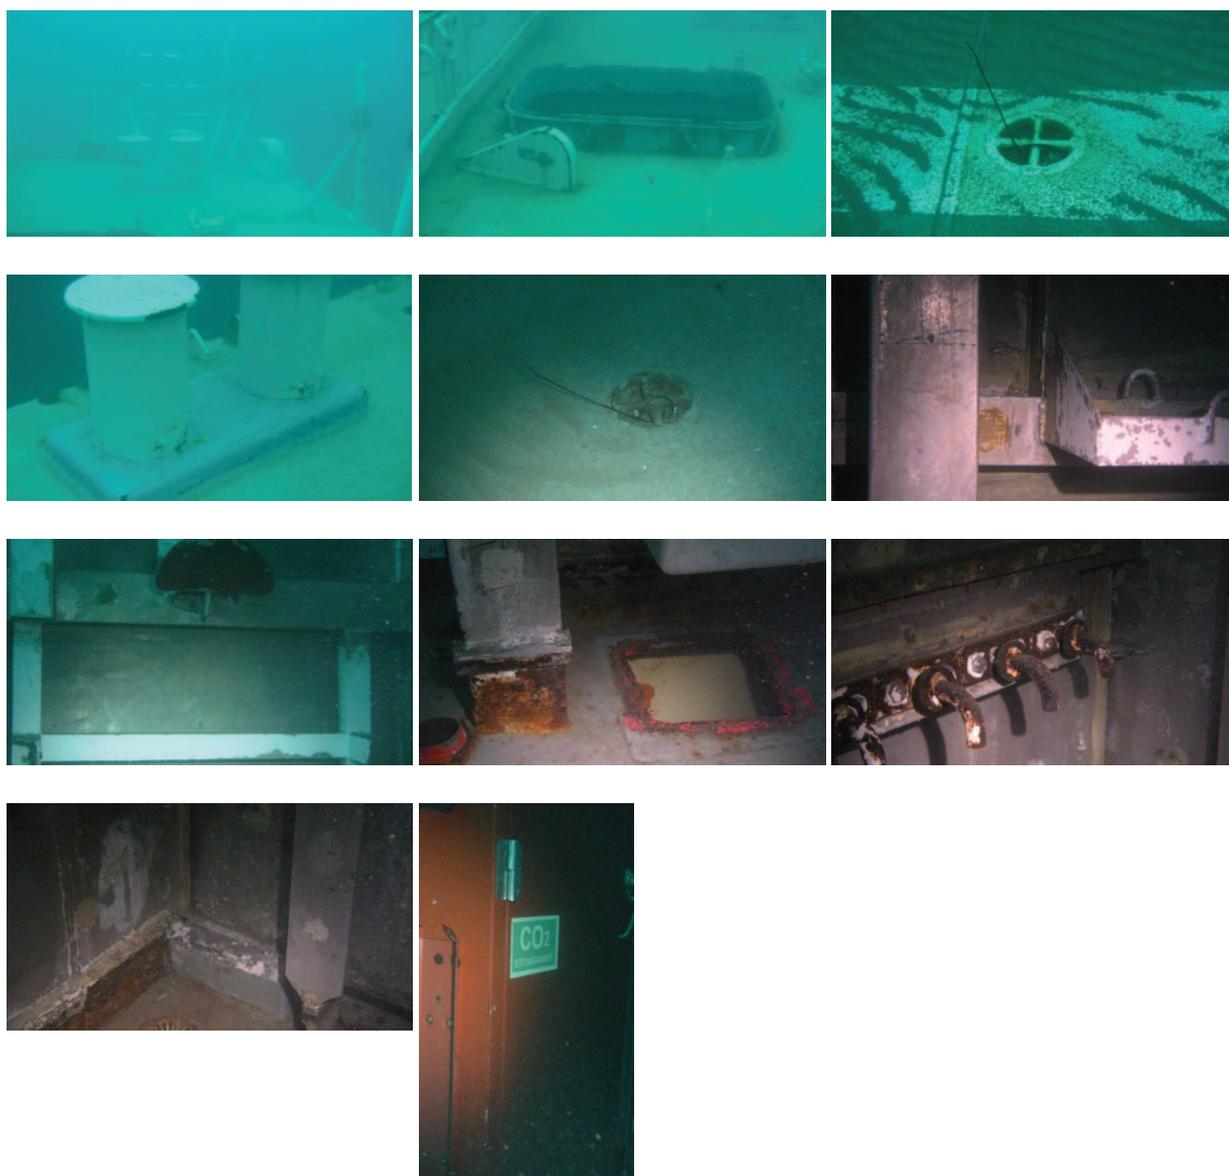
No obvious marine growth was present on the stern port side horizontal transect as shown in Figure 3.13.

Figure 3.13 Still images captured on the stern port side transect.

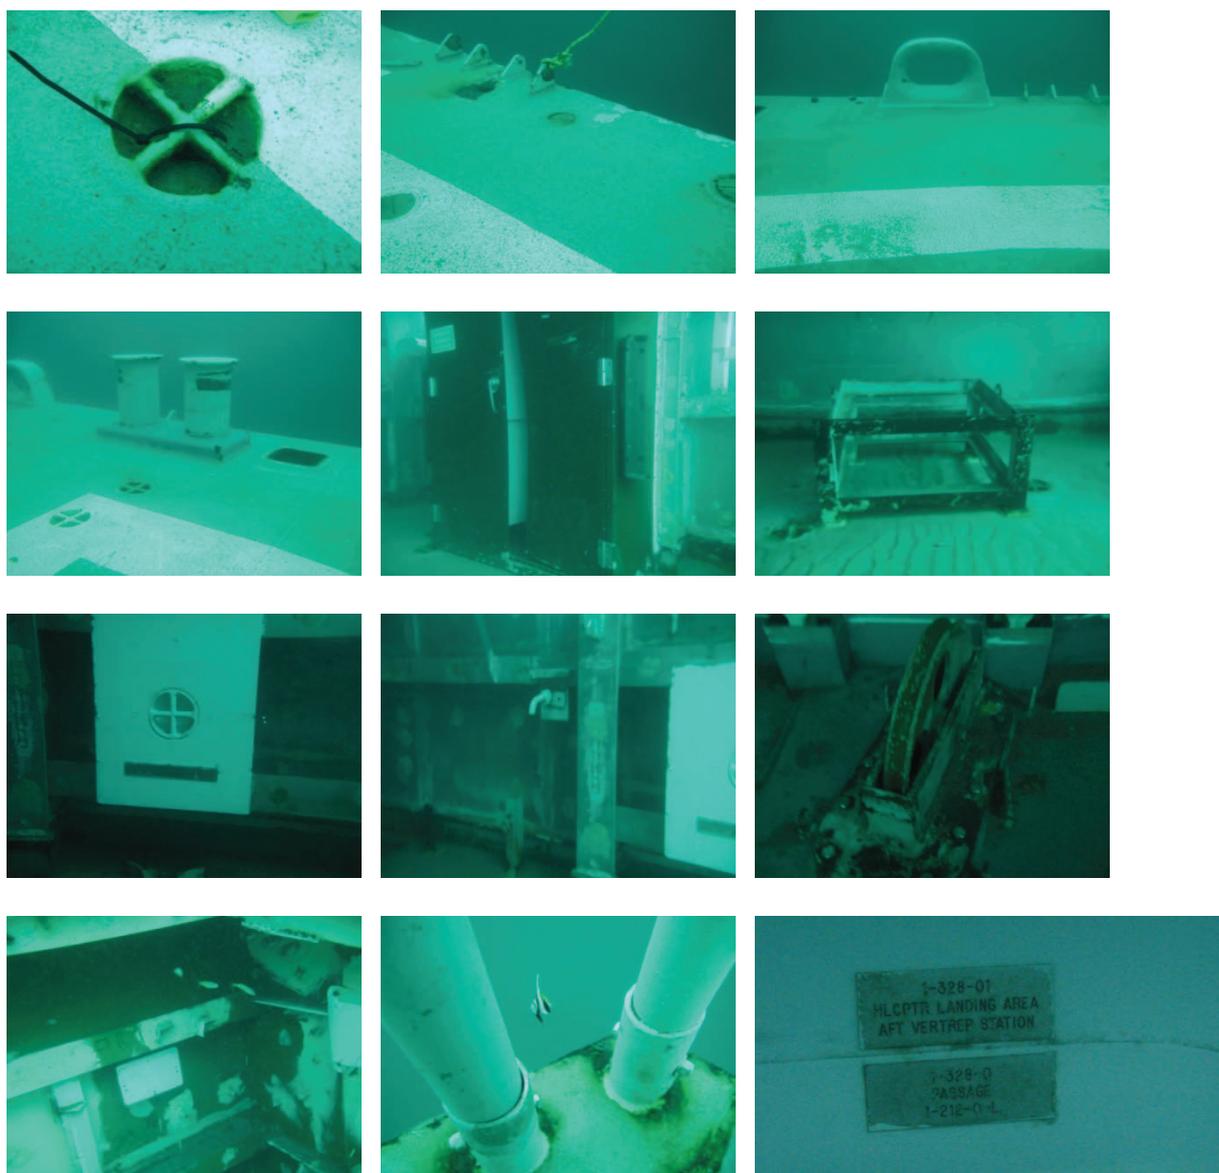
No obvious marine growth was present on the stern starboard side transect as shown in **Figure 3.14** below.

**Figure 3.14** Still images captured on the stern starboard side transect.

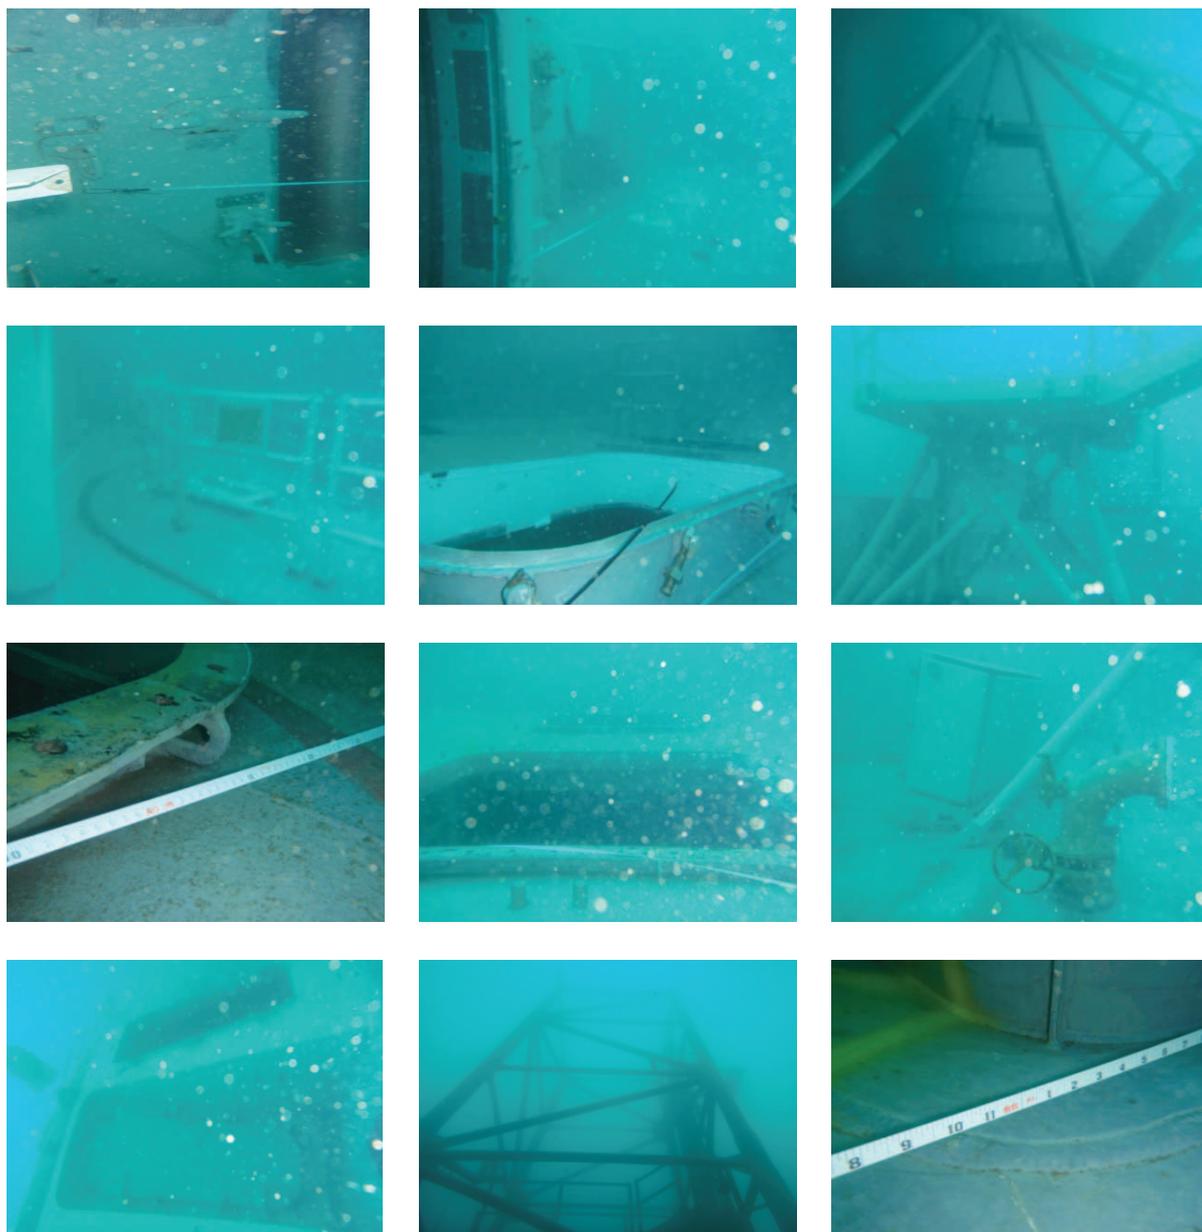
No obvious marine growth was present on the mid ship port side transect as shown in **Figure 3.15**.

**Figure 3.15** Still images captured on the mid ship port side transect.

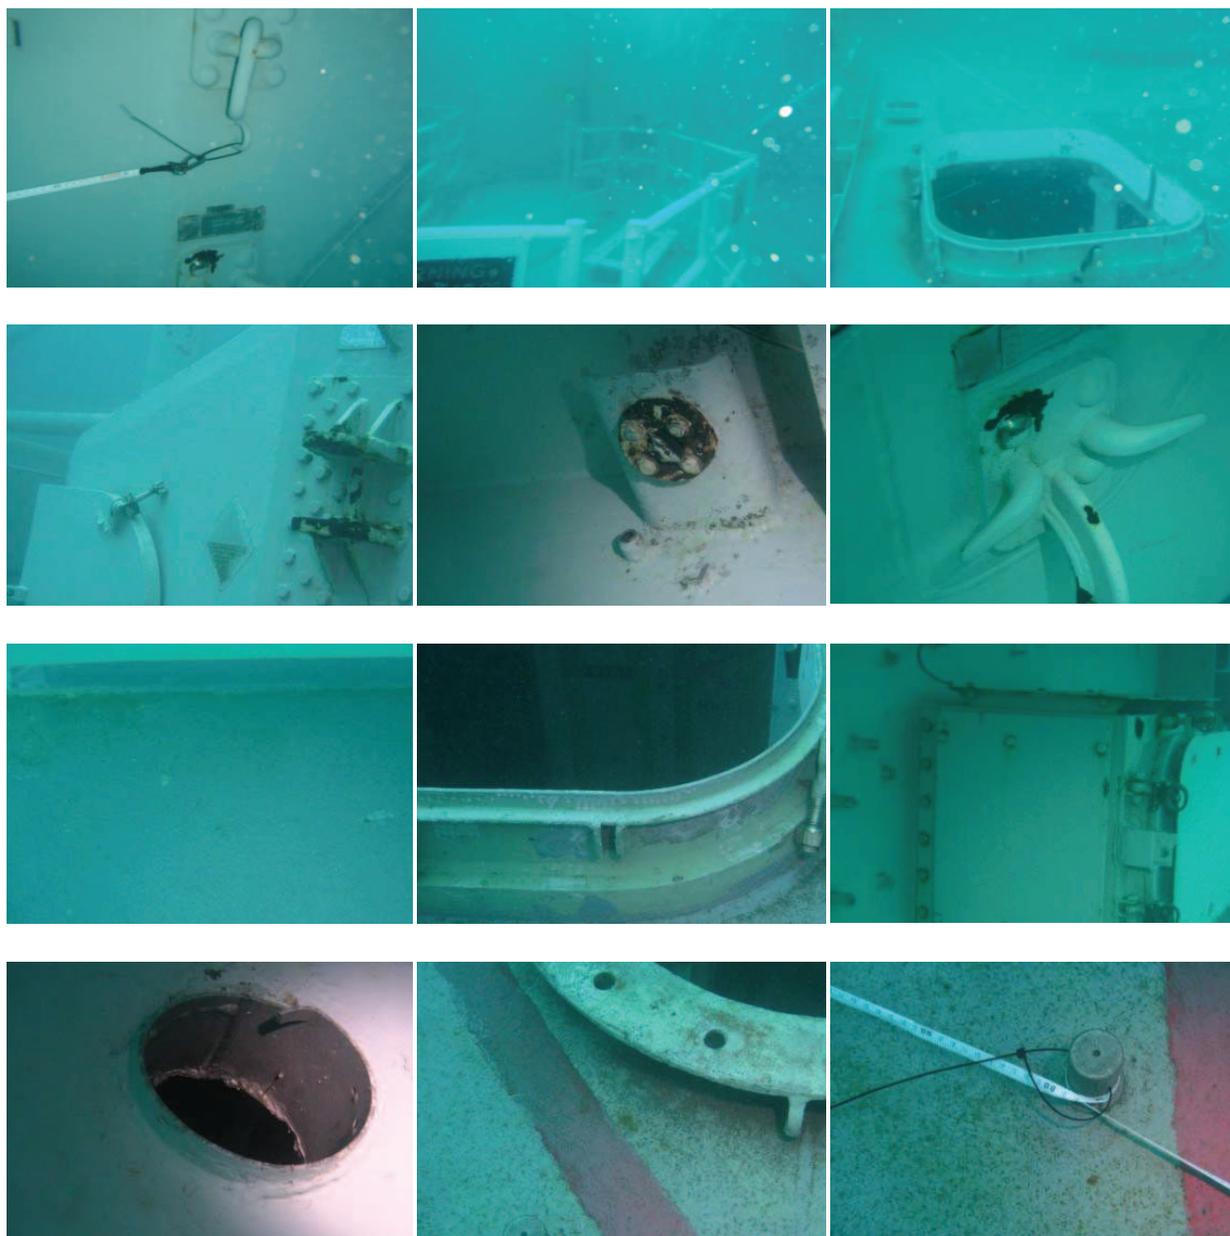
No obvious marine growth was present on the mid ship starboard side transect as shown in **Figure 3.16**.

**Figure 3.16** Still images captured on the mid ship starboard side transect.

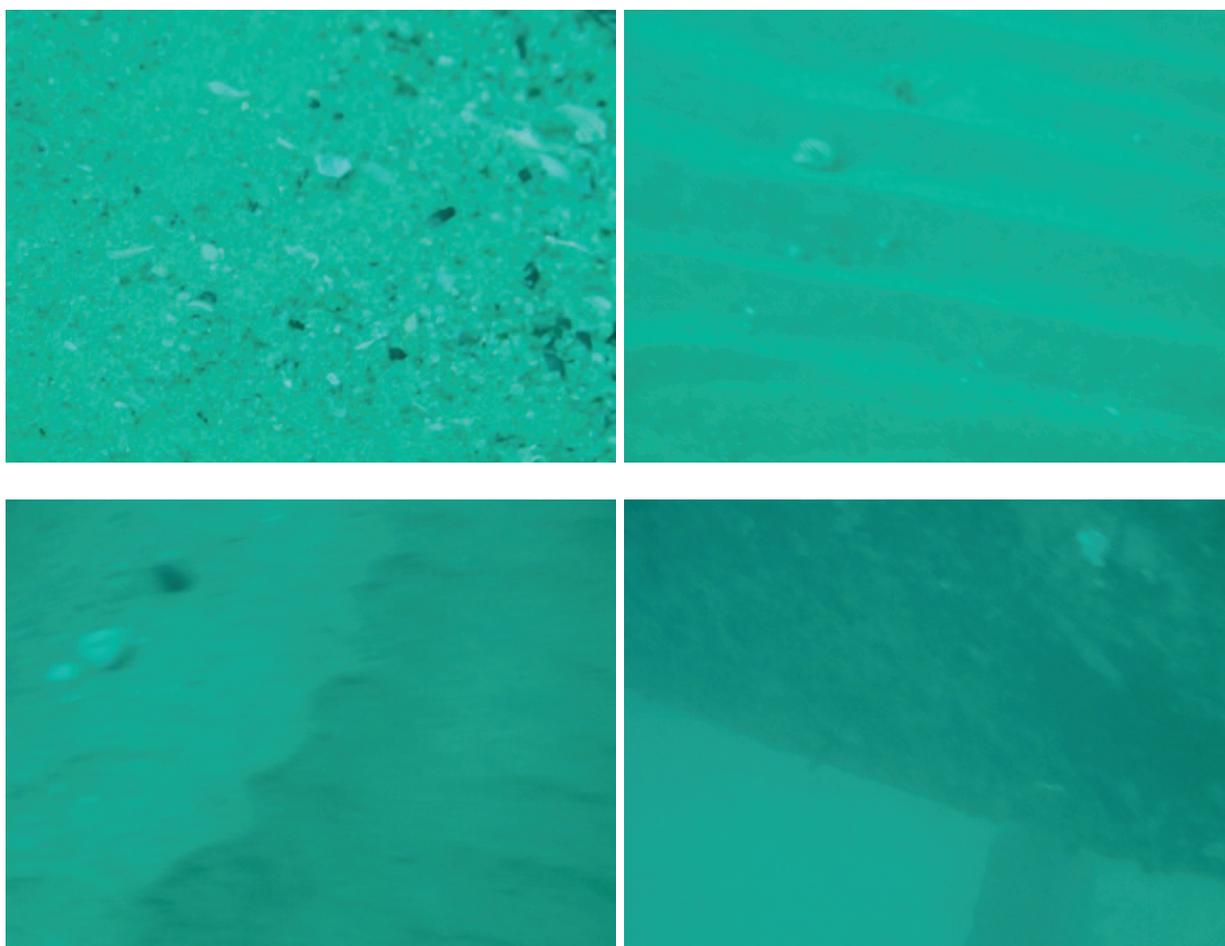
The seafloor sediments around the bow of the ship consisted of fine sands with a high degree of shell rubble in some areas. Sand ripples were evident with increasing distance from the ship's hull and there was also evidence of sand displacement / scouring where the ship has settled on the seabed. Dense marine growth was present underneath the hull of the ship, but for safety reasons this growth was not assessed (**Figure 3.17**).

**Figure 3.17** Images of the seabed and hull at the bow of the ship.
