## **Ex-HMAS ADELAIDE Artificial Reef**

### **Reef Community and Sediment Movement Surveys**

301020-03410 – FINAL

29 June 2011

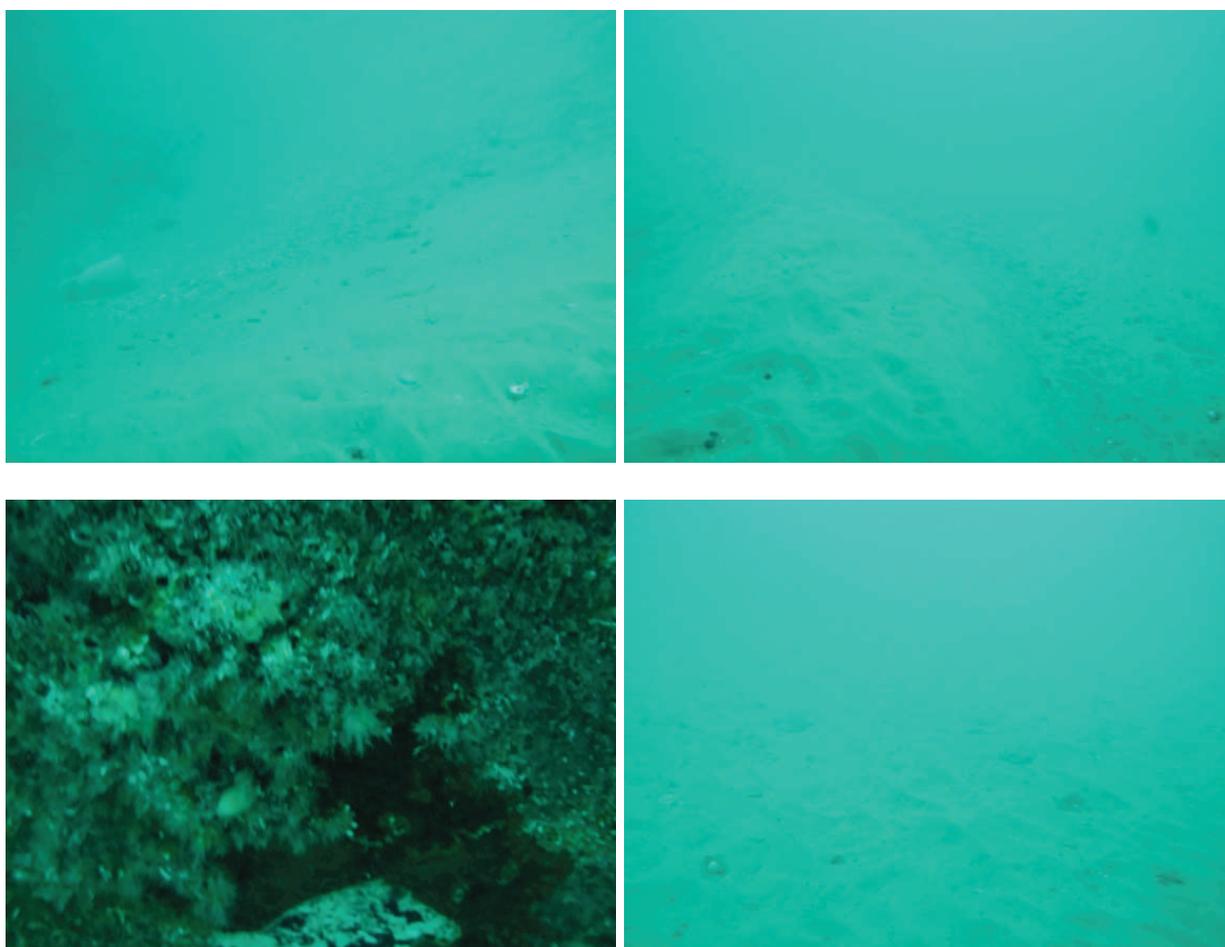
Seafloor sediments at the port side of the stern of the ship consisted of fine sands with a high degree of shell rubble. A significant area of sand displacement / scouring was present approximately 3 m from the vessel. This was around 1.5 m deep and 6 m in diameter. Marine growth was present underneath the hull of the vessel at the stern however this was not assessed due to safety reasons (see **Figure 3.18**).

**Figure 3.18** Images of the seafloor and hull at the stern of the ship port side.

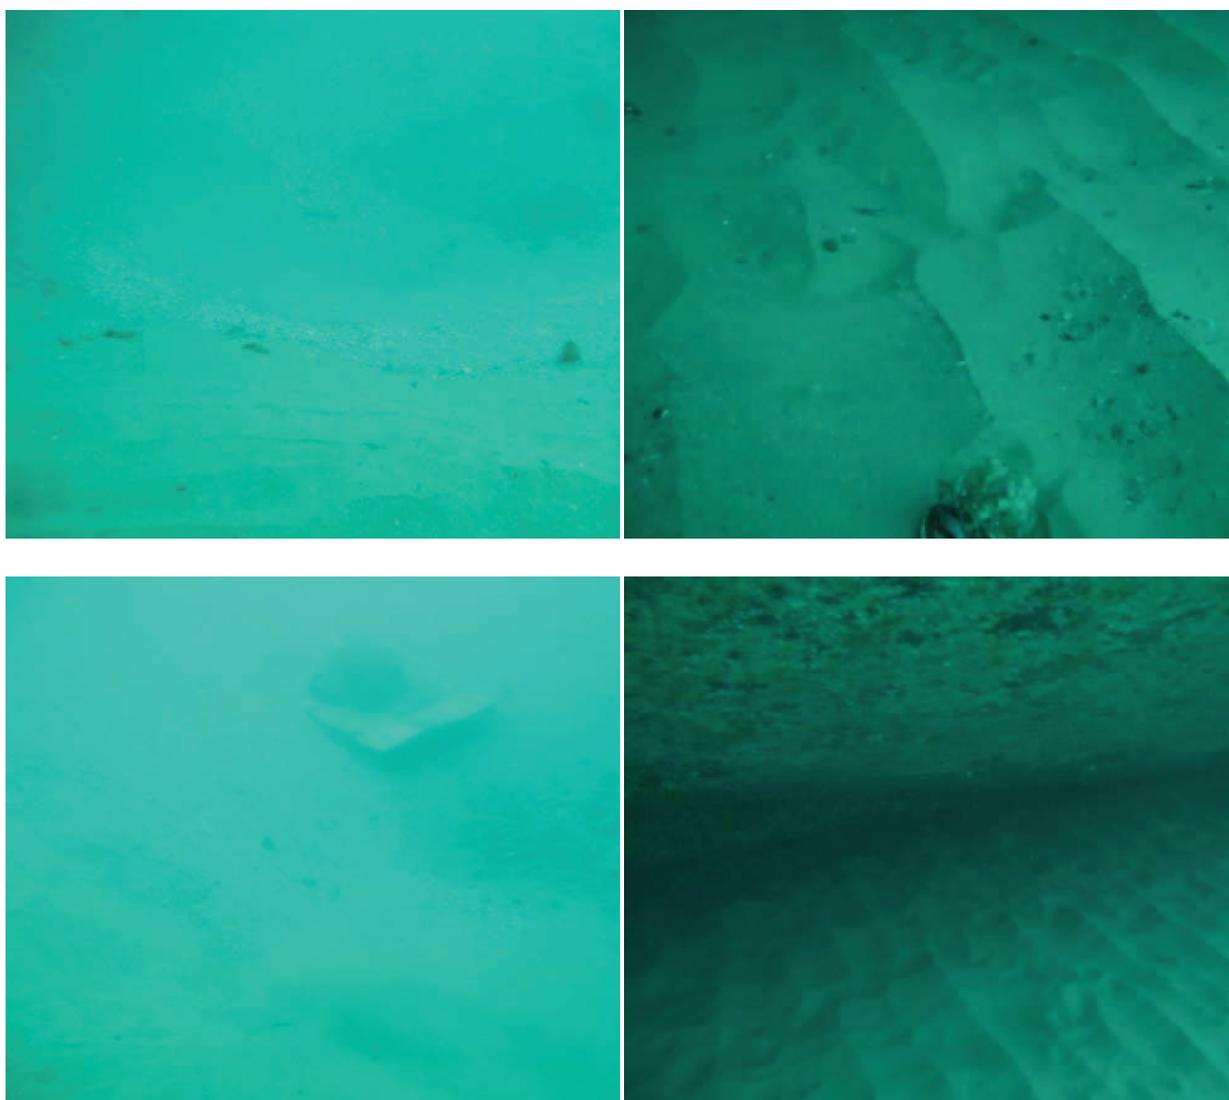
Seafloor sediments at the starboard side of the stern of the ship also consisted of fine sands with a high degree of shell rubble. As with the port side of the vessel a significant area of sand displacement / scouring was present approximately 3 m from the vessel, approximately 1.5 m deep and 6 m in diameter. Marine growth was present underneath the hull of the vessel at the stern however this was not assessed due to safety reasons (see **Figure 3.19**).

**Figure 3.19** Images of the seafloor and hull at the stern of the ship starboard side.
