## ex-HMAS Adelaide - Structural Condition Report

Prepared for Department of Planning, Housing, and Infrastructure

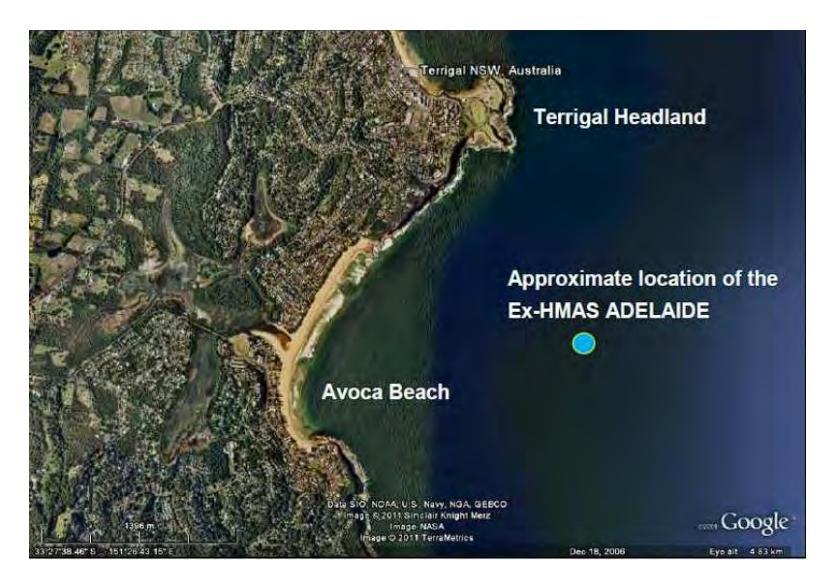
Figure 1 Approximate Location of the ex-HMAS Adelaide

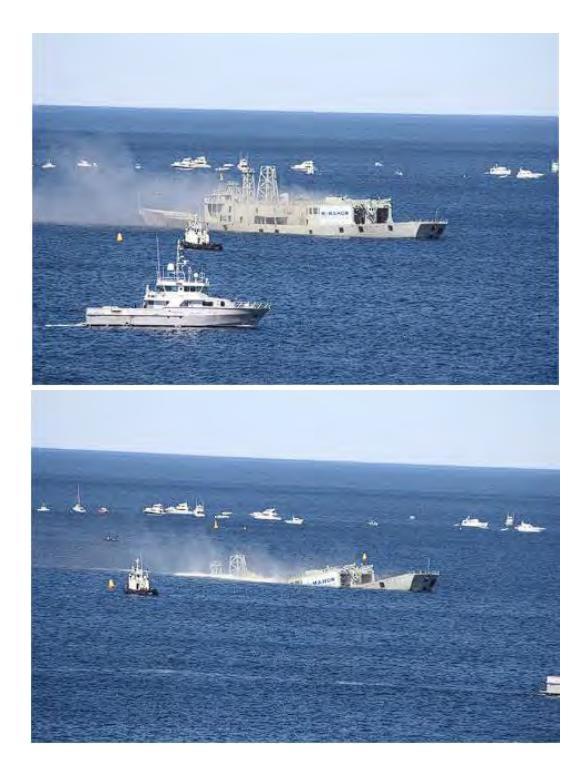
During the clearance dive it was noted that all charges detonated correctly and that only minor cracks on 02 Deck were observed. The inclination of the ship measured 2.5-3 degrees to port.

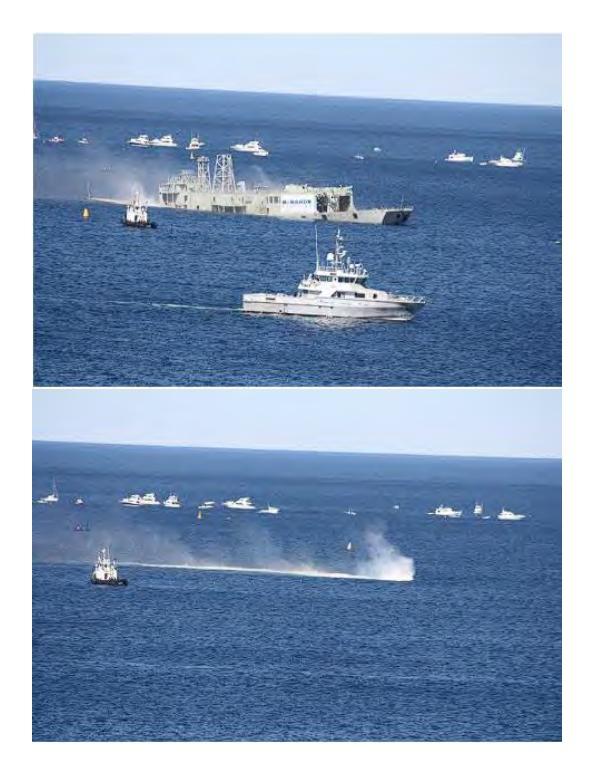
Figure 2 Sequence of Scuttling Photos

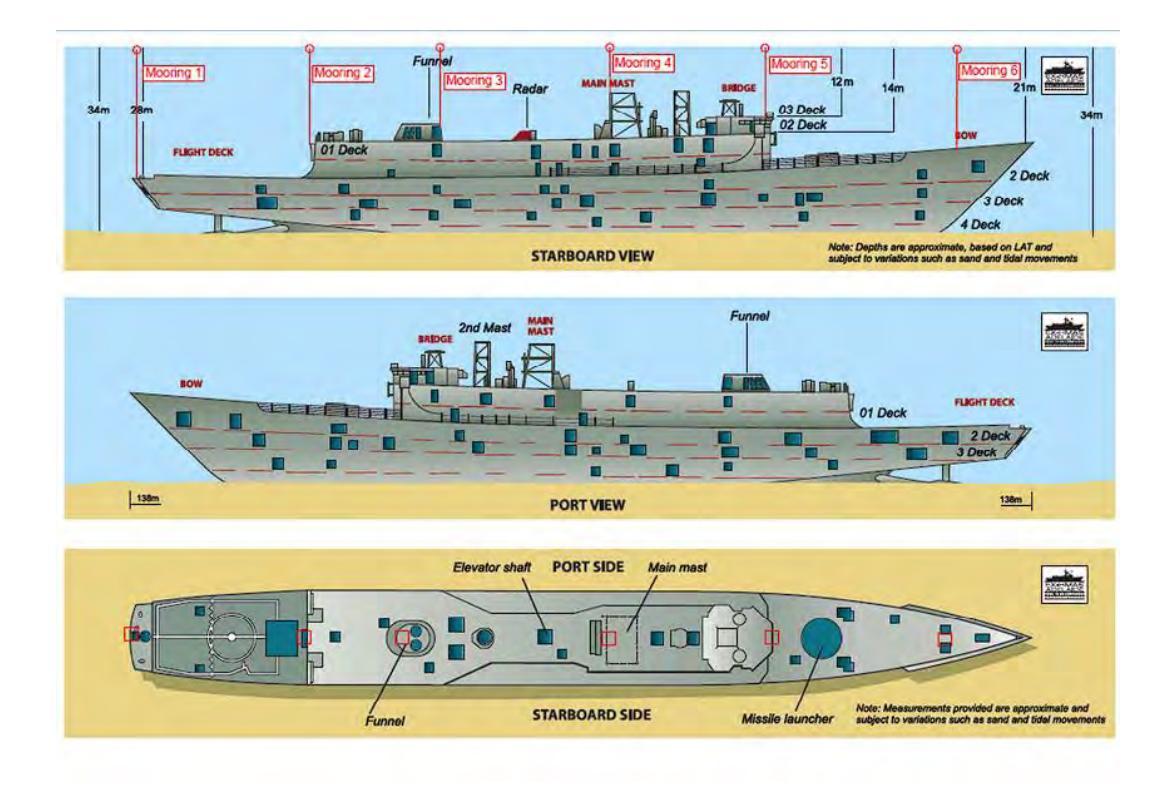
Figure 4 General Arrangement of the ex-HMAS Adelaide

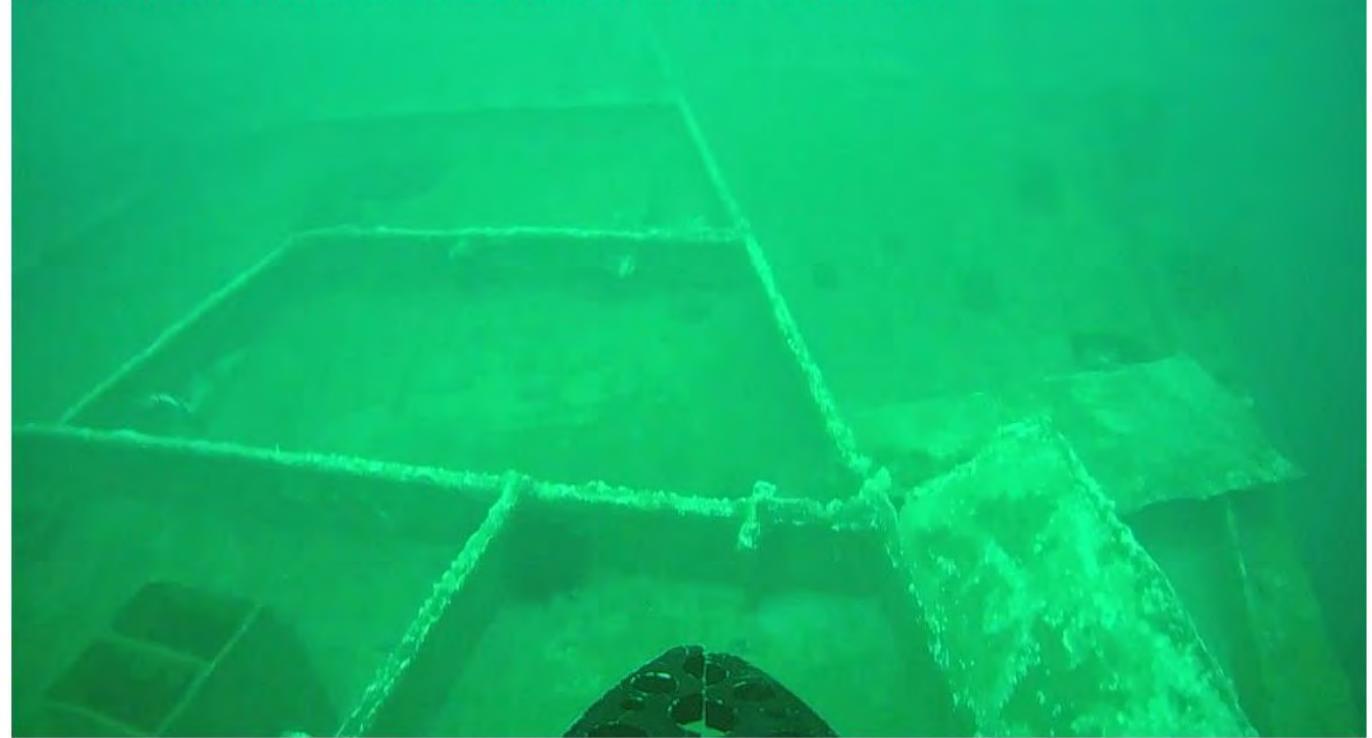
#### Figure 5 Photo from 25th of July Dive Report

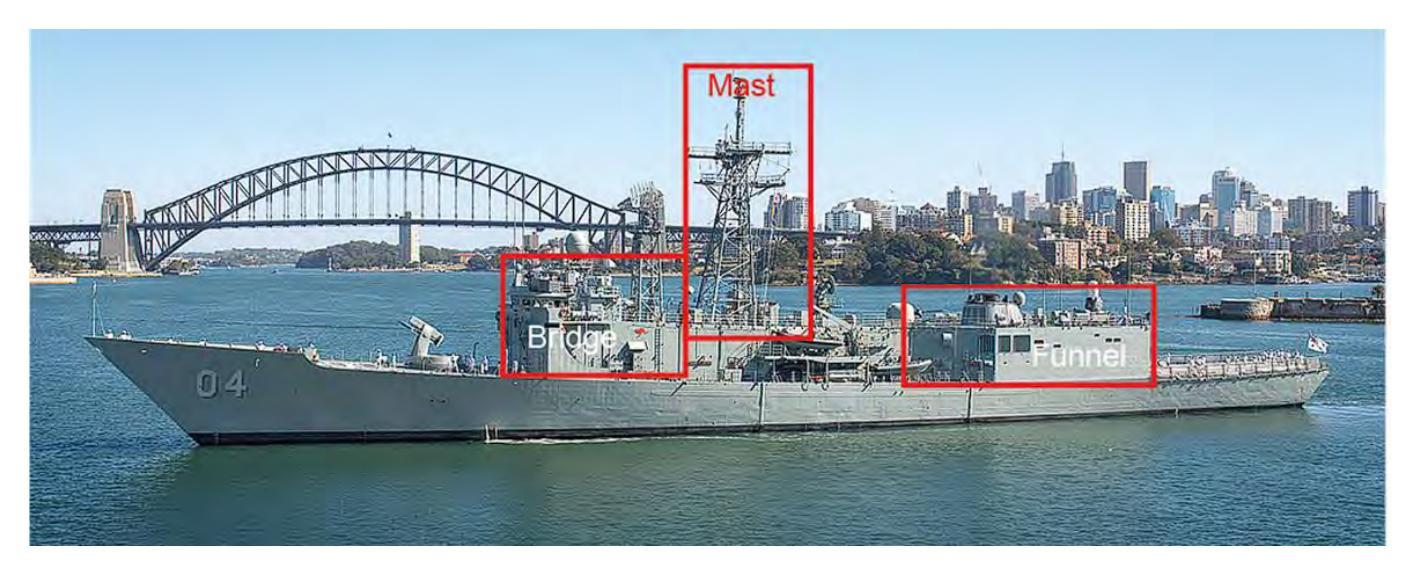
Figure 6 Photo from 25th of September Dive Report
