Statement of Heritage Impact

Proposed Demolition

**Empire Bay Boat Shed
Sorrento Road
EMPIRE BAY, NSW**

Prepared for
Department of Planning & Environment
Crown Land
by **Eureka Heritage**
Project No 230202

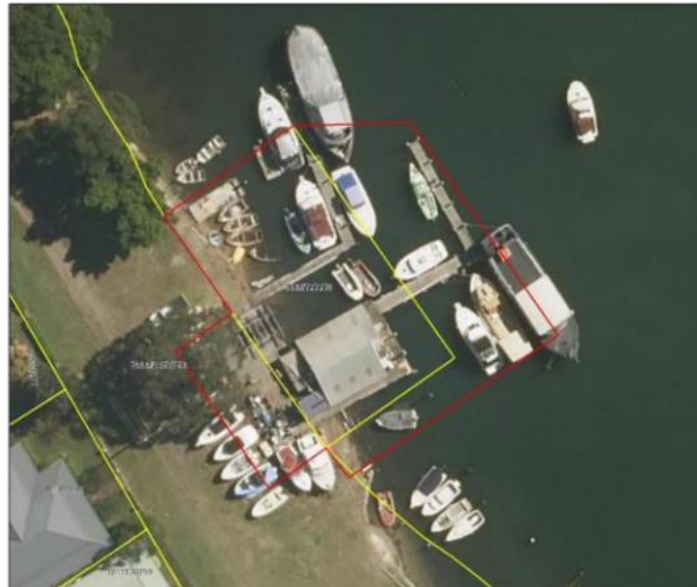
Figure 1.5 – Aerial view of the study site in 2020 while still operating as a commercial marina.

The boat shed has been operating as a commercial marina, Empire Bay Marina, since the 1970s with an ever-expanding footprint including a slipway and jetties used for mooring large vessels (**Figure 1.5**).

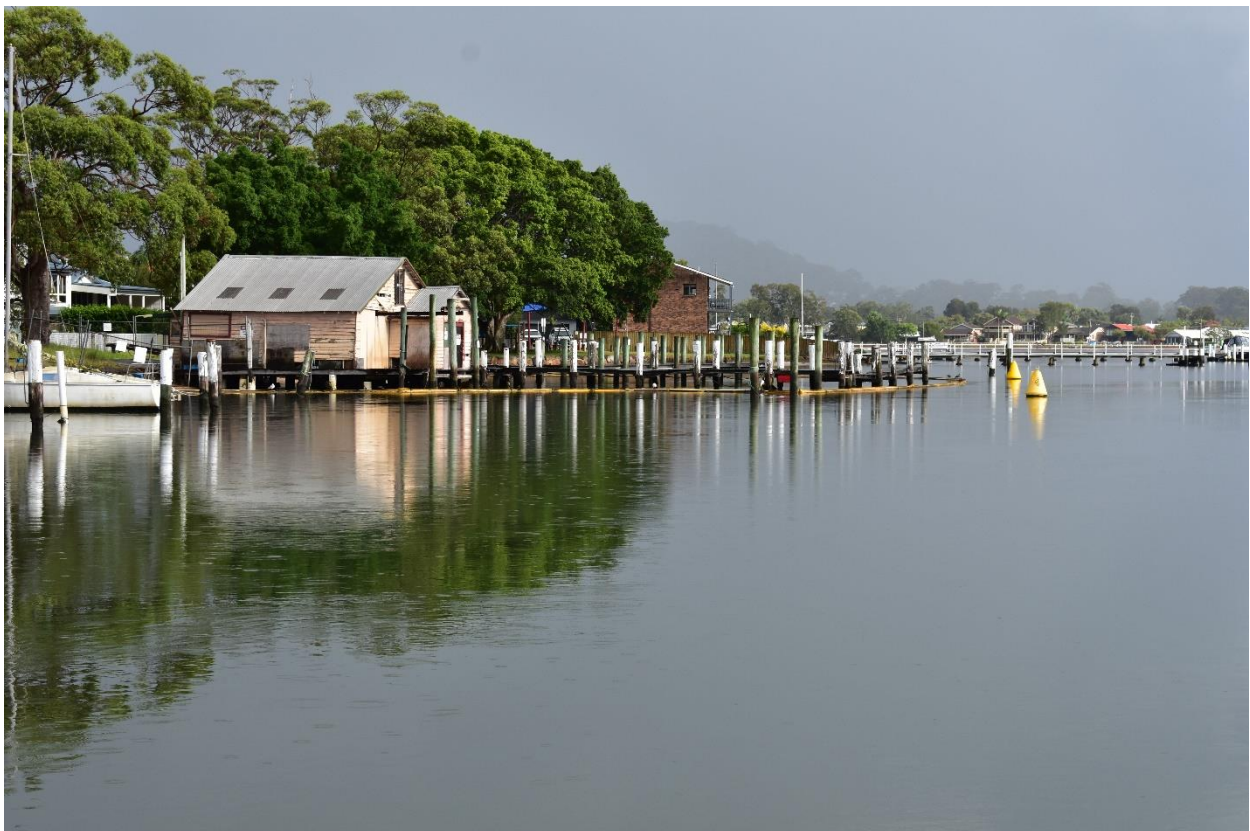
Figure 1.8 – Looking north to the Empire Bay Boat Shed showing jetties and floating silt curtain installed by Crown Land to contain debris.

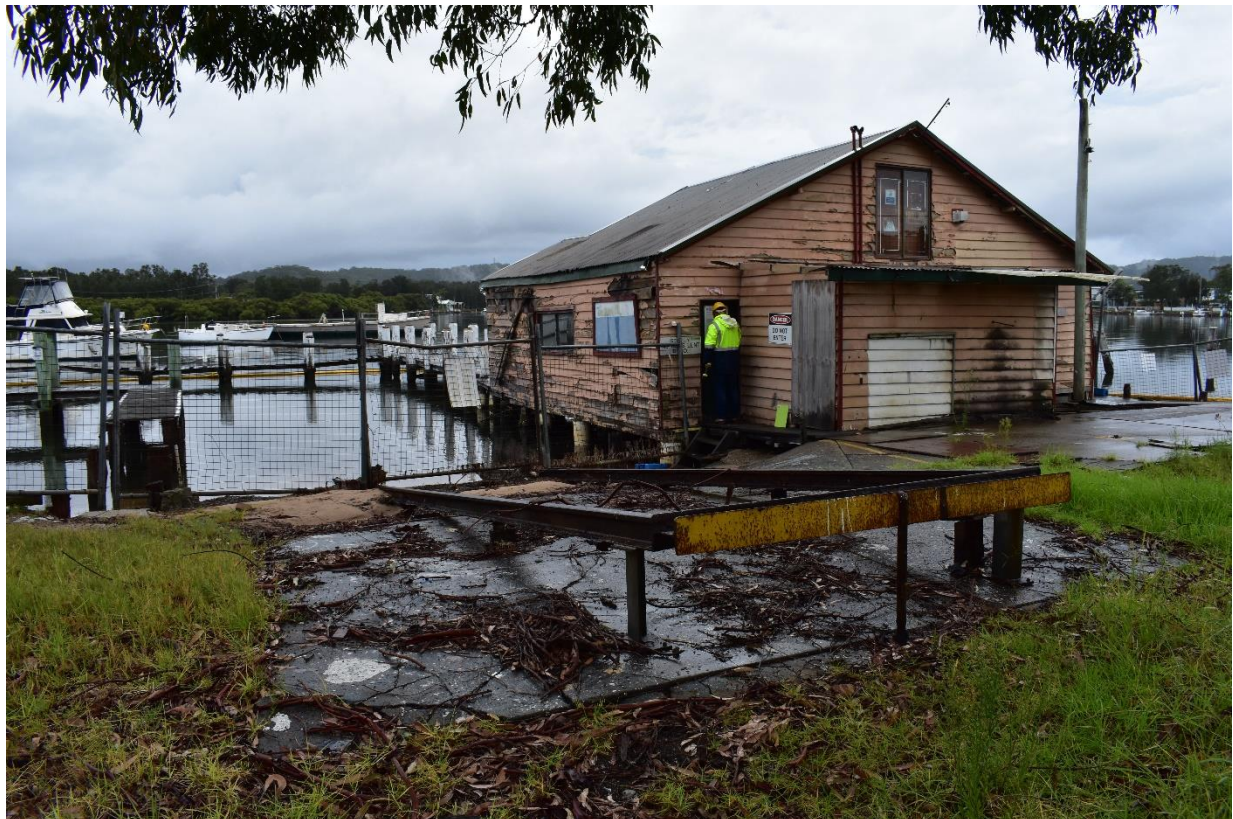
- Slip way rails were located adjacent to the shed to the north with a failing concrete slab beneath. No evidence of a slipway cradle remained.
- Evidence of what appeared to be an earlier slipway, consisting of remnants of timber piers, was observed between the existing rails and the northern elevation of the shed.

Figure 1.9 –Northern and western elevations with slipway rails in foreground.

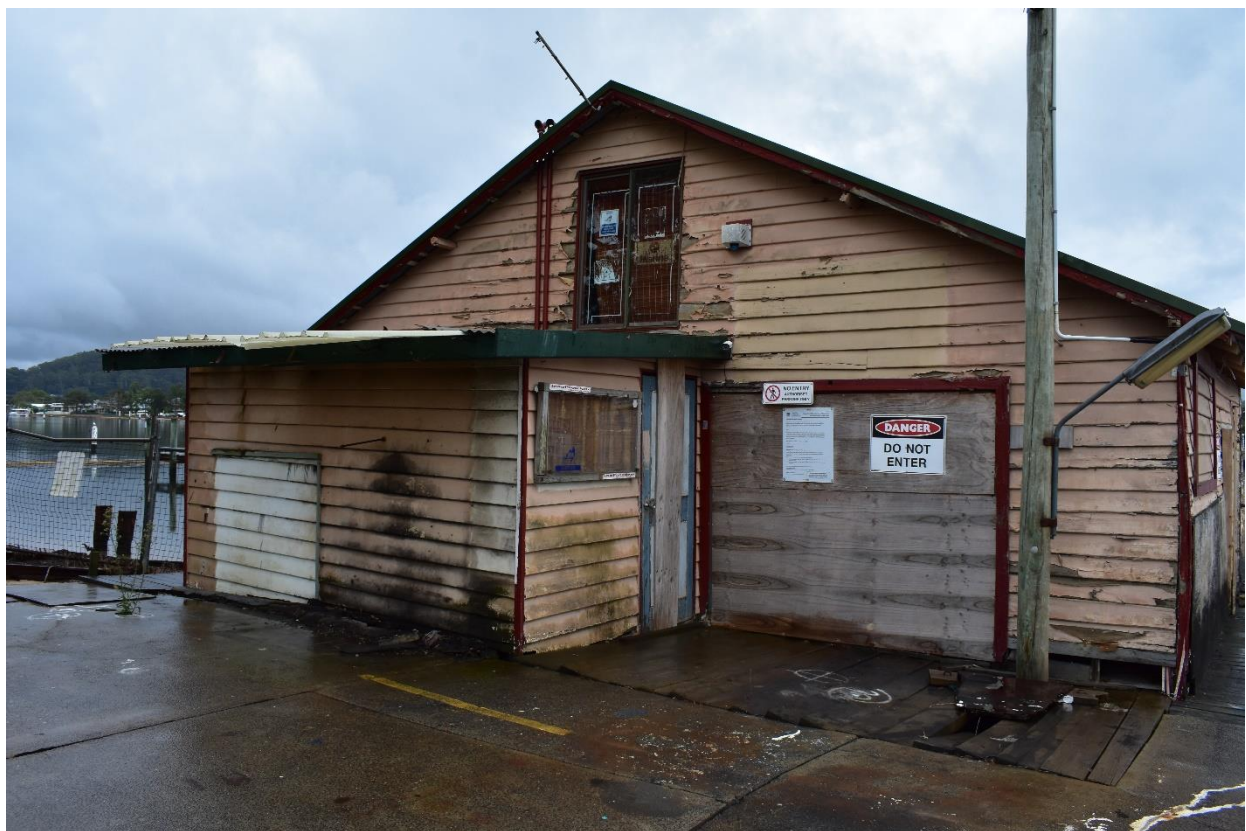
- Underground fuel tanks were noted, present beneath a concrete slab to the west of the shed.
- A motor room has been tacked to the western elevation of the boat shed to house the motors used to lift vessels up the slipway. (Not inspected internally).

Figure 1.10 – Western elevation of the boat shed showing former doorway, now sealed and obscured, and c1980s addition housing motors for pulley system used to raise boats on slipway.

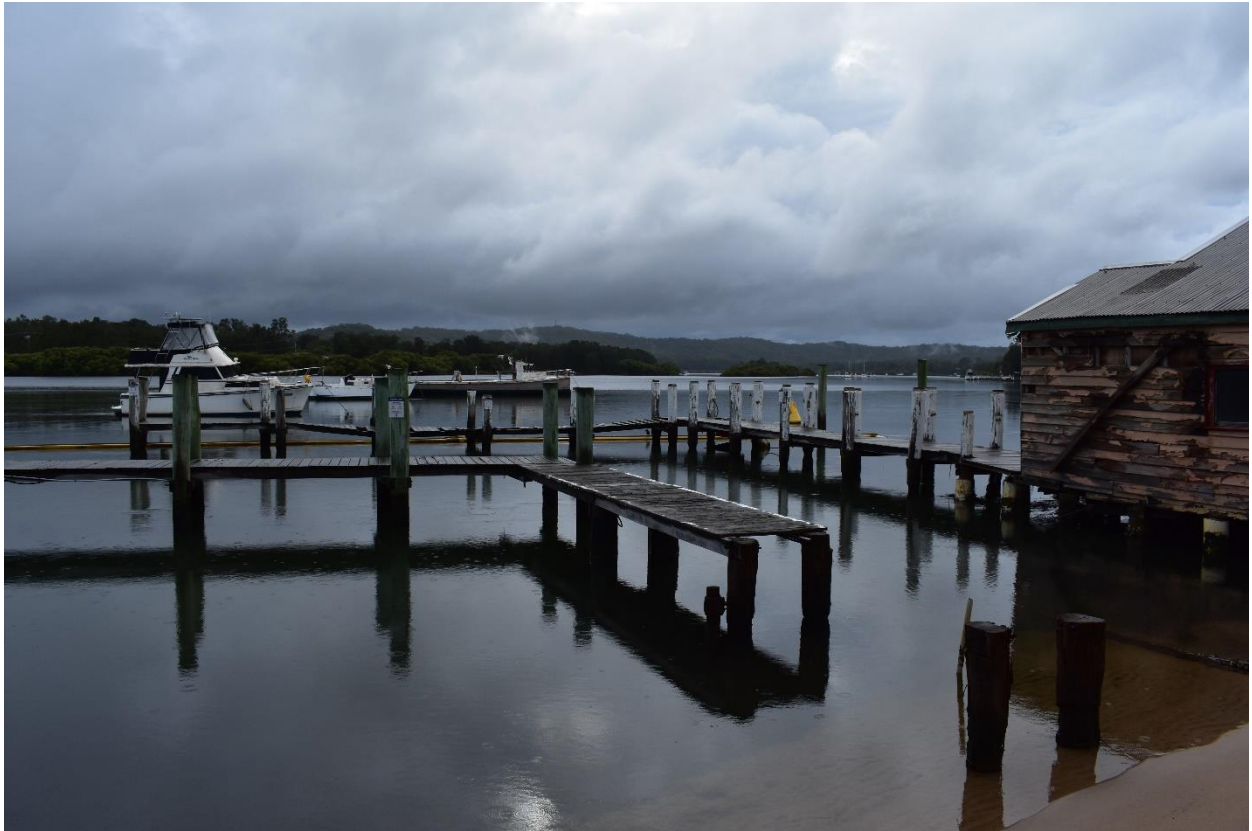
- Fencing has been installed to restrict public access.
- Landings and jetties were in extremely poor condition, again in an obvious state of degradation to the point of being dangerous. To make safe, jetty boards had been removed and access restricted.

Figure 1.11 – Jetties on the northern elevation of the boat shed.

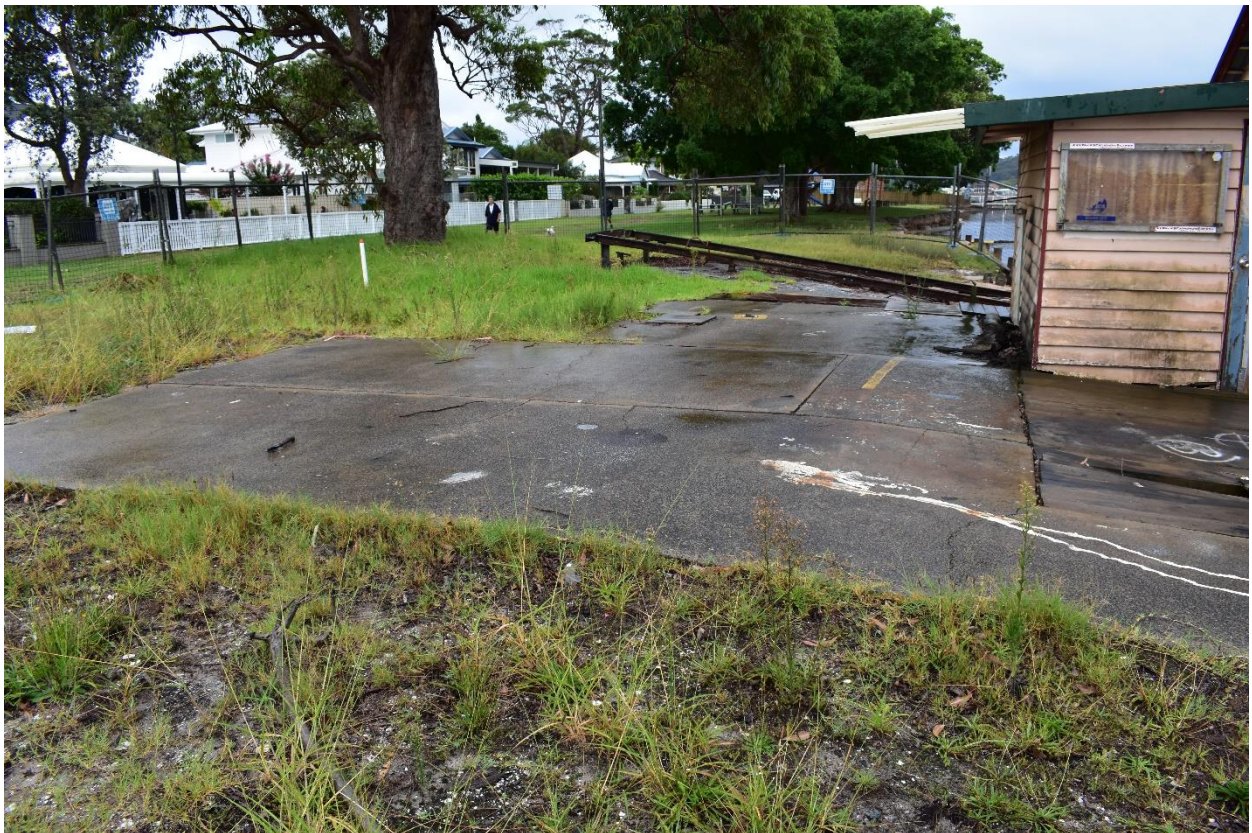
Figure 1.12 – Concrete installed over the underground fuel tanks, looking north along reserve.

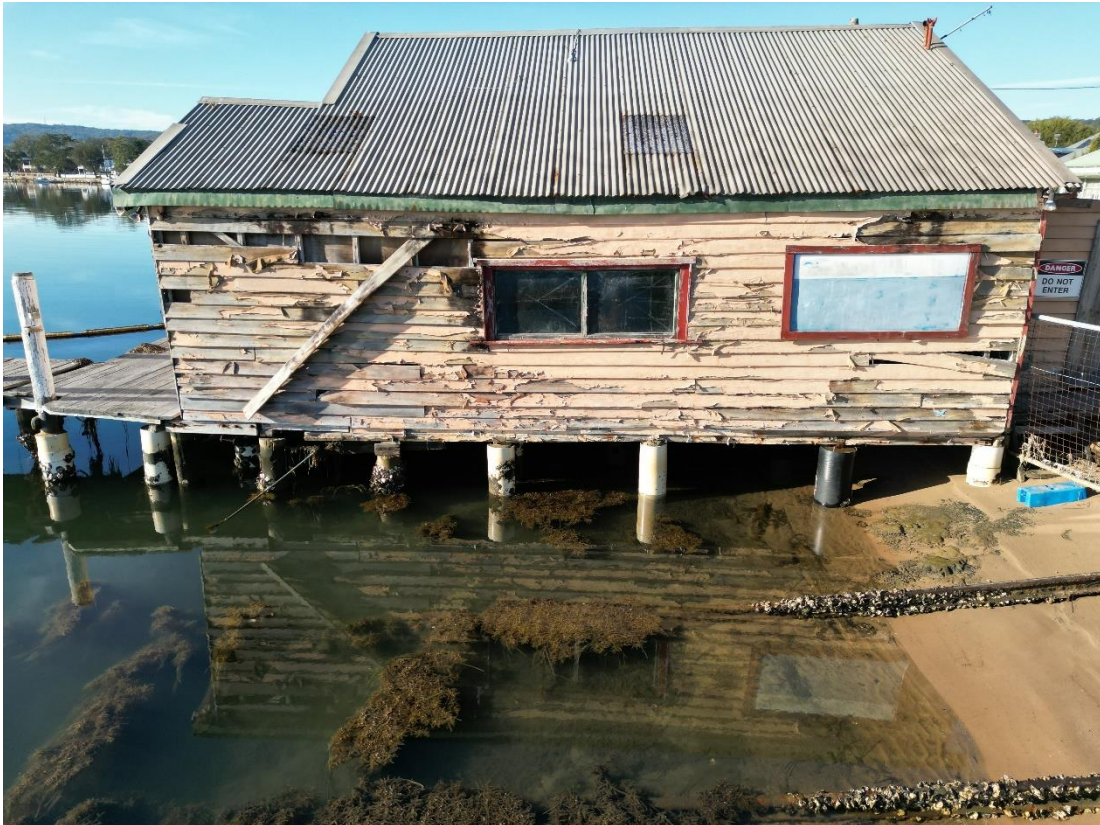
Figure 1.13 – Detail of the northern elevation of the boat shed showing deterioration of timber cladding and slipway rails below HWM.
Image by Catalyst Consulting.

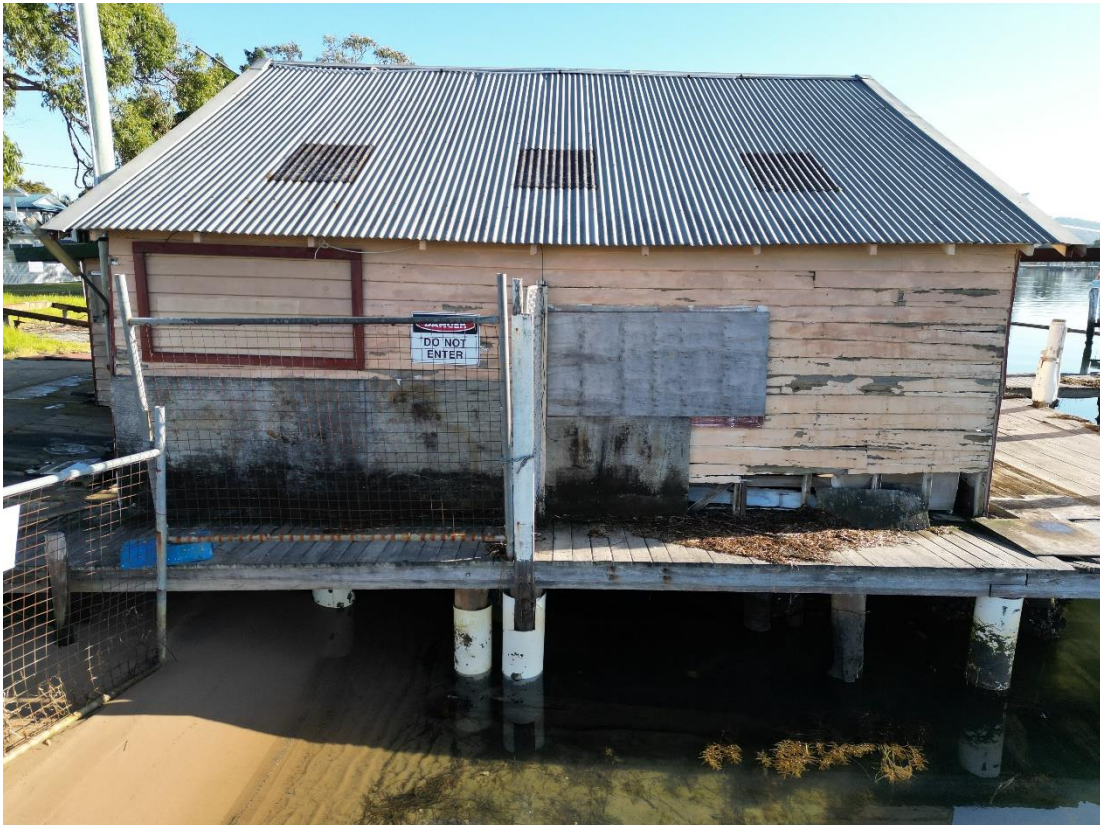
Figure 1.14 – Southern elevation of boat shed with timber walkway to rear landing.
Image by Catalyst Consulting.

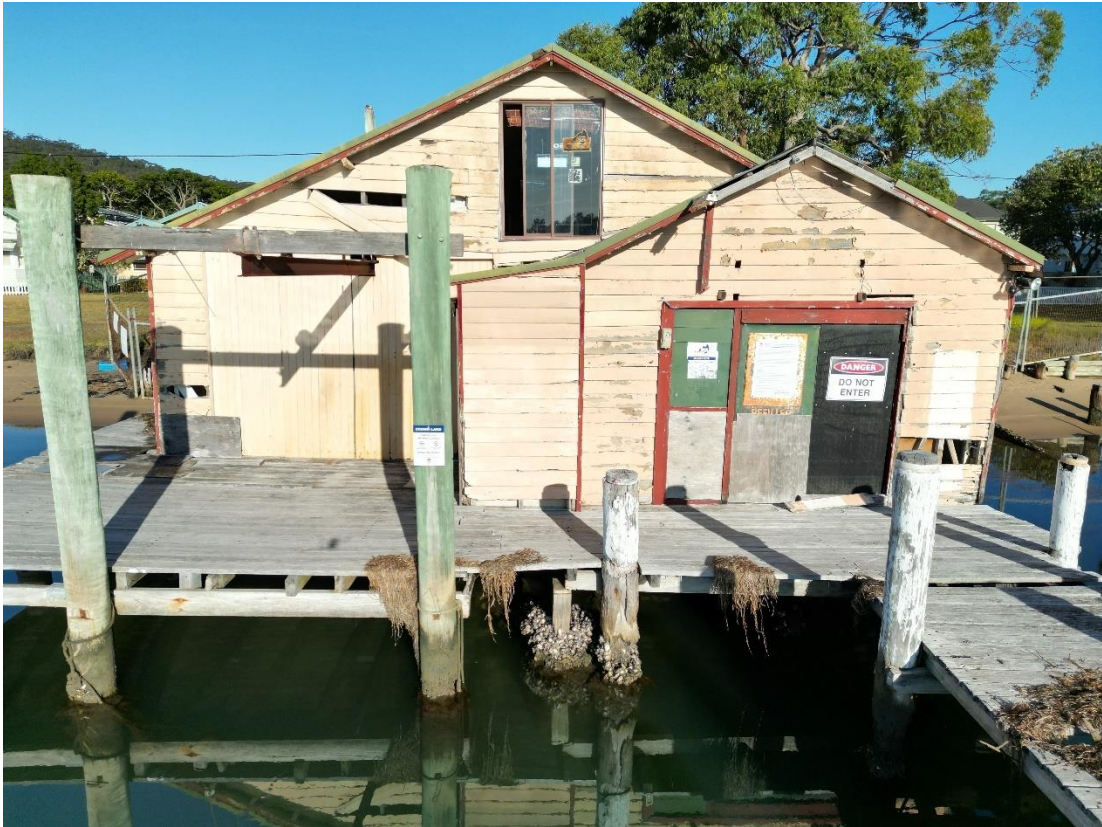
Figure 1.15 – Eastern elevation of the boat shed as seen from Cockle Creek.
Image by Catalyst Consulting.

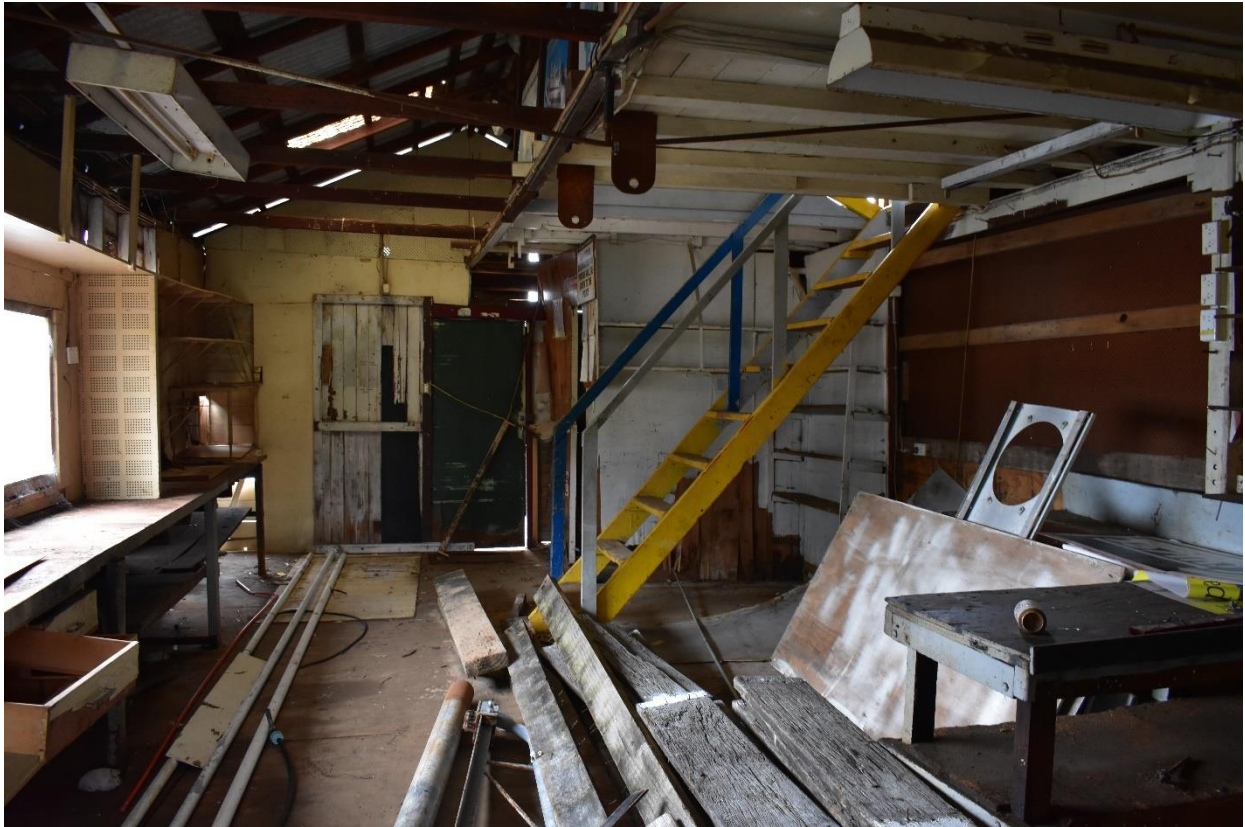
Figure 1.19 – Internal view with northern elevation at left of view. Stairs to mezzanine level are shown with salvaged jetty timbers stored on the floor, with salvaged external signage and aerials.

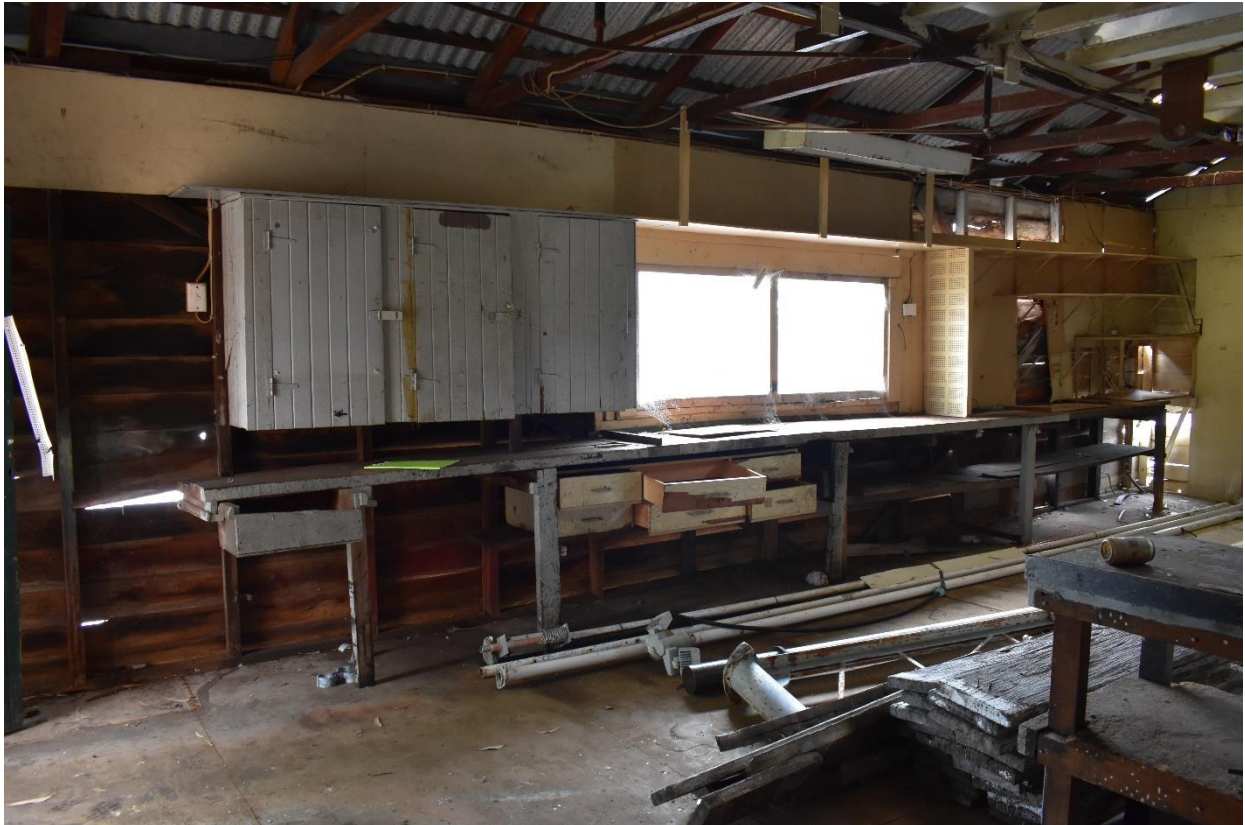
- A fixed timber window was observed on the northern elevations. Framework of a former window was also observed on the southern elevation but obscured by external boards.

Figure 1.20 – Internal view of the northern elevation with fixed timber window.

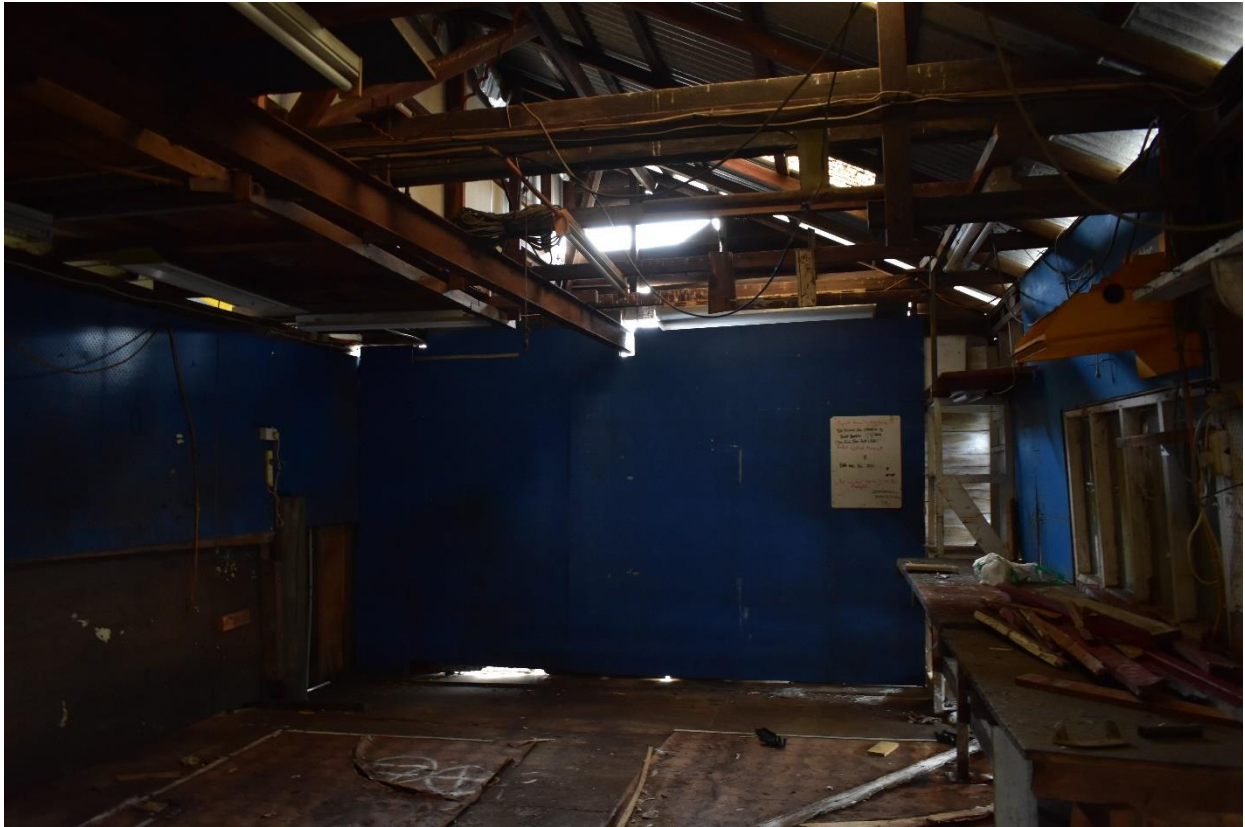
Figure 1.21 – Internal eastern elevation of the boat shed showing roof framing and I beam installed for gantry crane. Sheeting obscured the double doors to the landing.

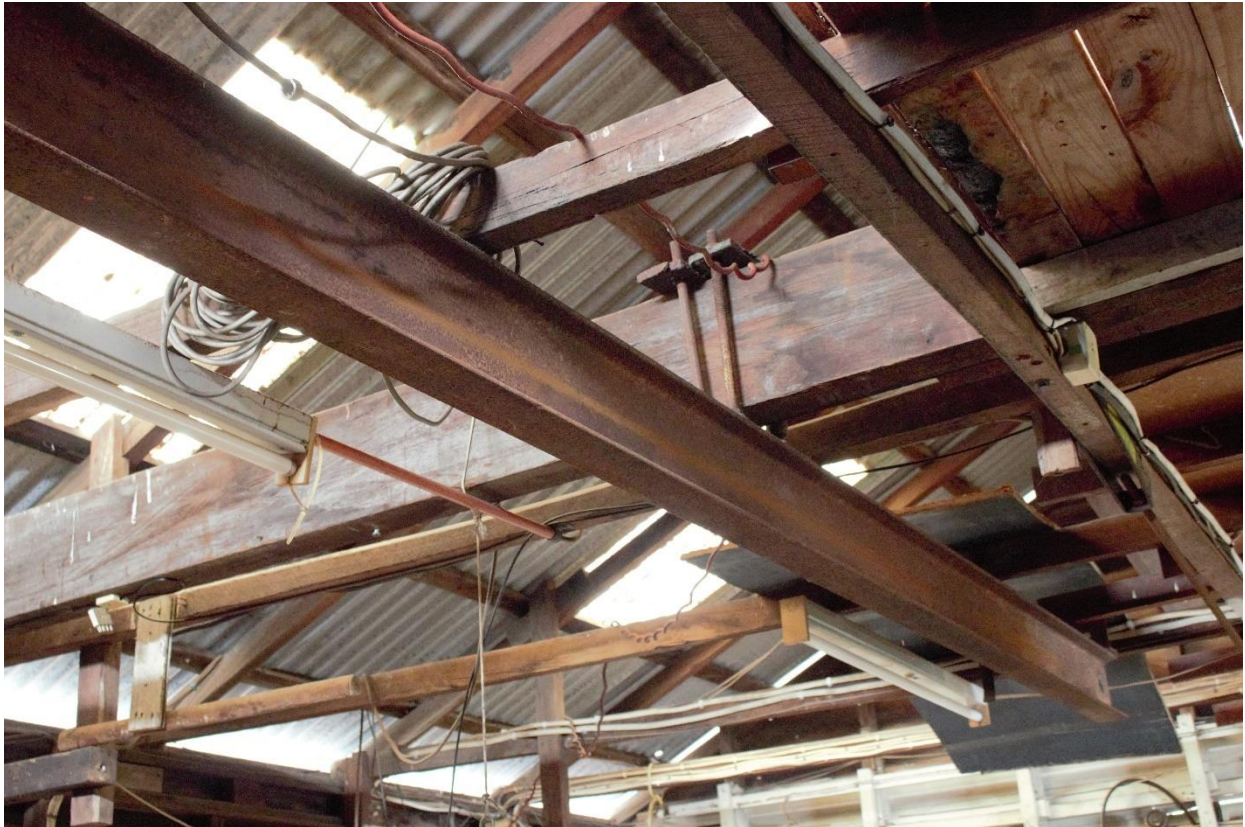
Figure 1.22 – Detail of I beam gantry and roofing framework.

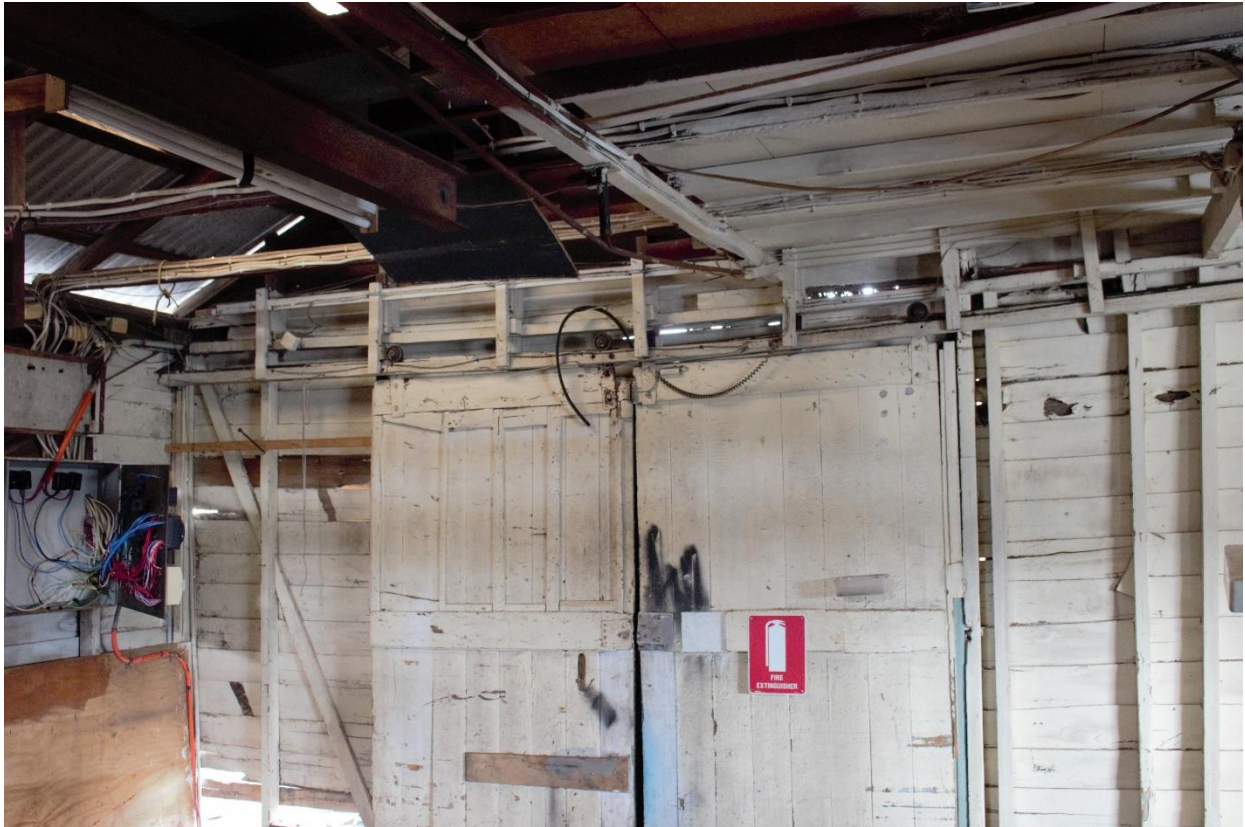
**Figure 1.23 – Timber barn style sliding doors – possibly original to 1925.
These doors were obscured from view externally.**

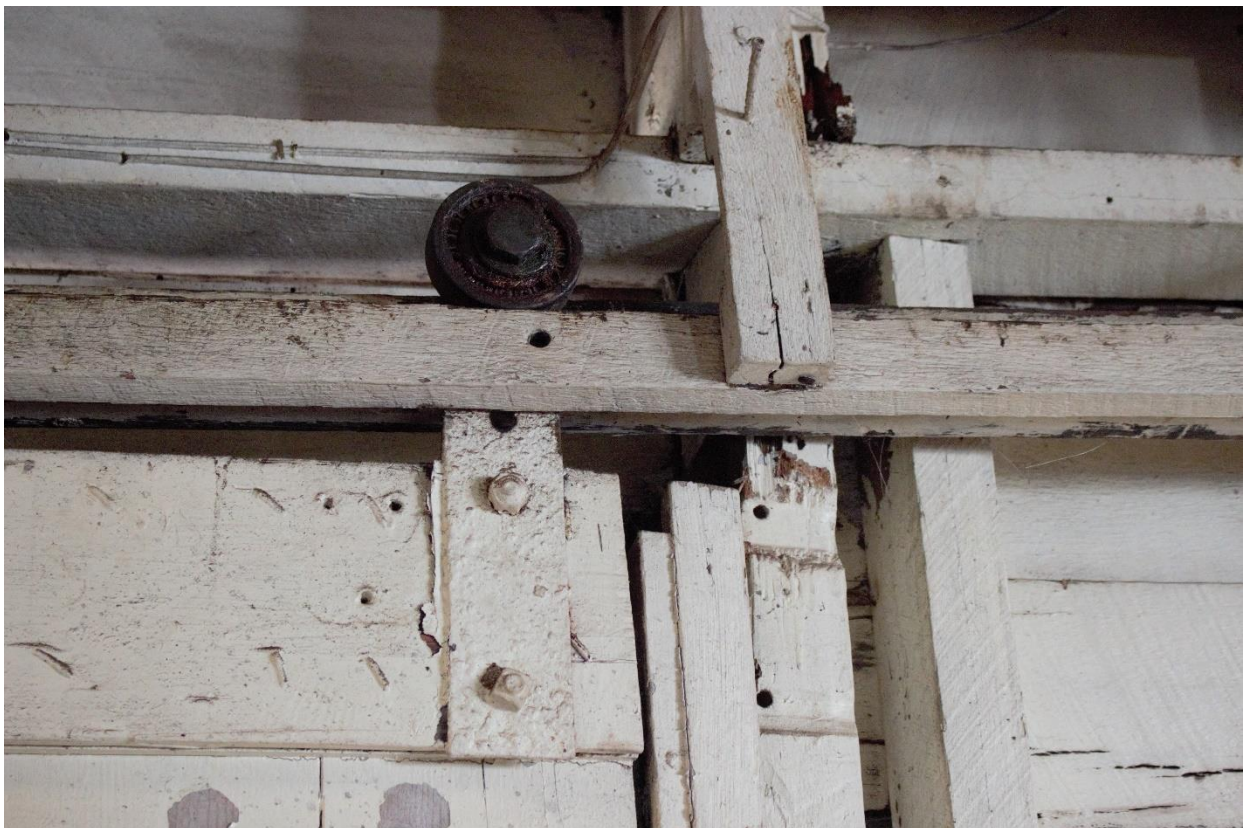
Figure 1.24 – Detail of roller mechanism on western sliding doors.

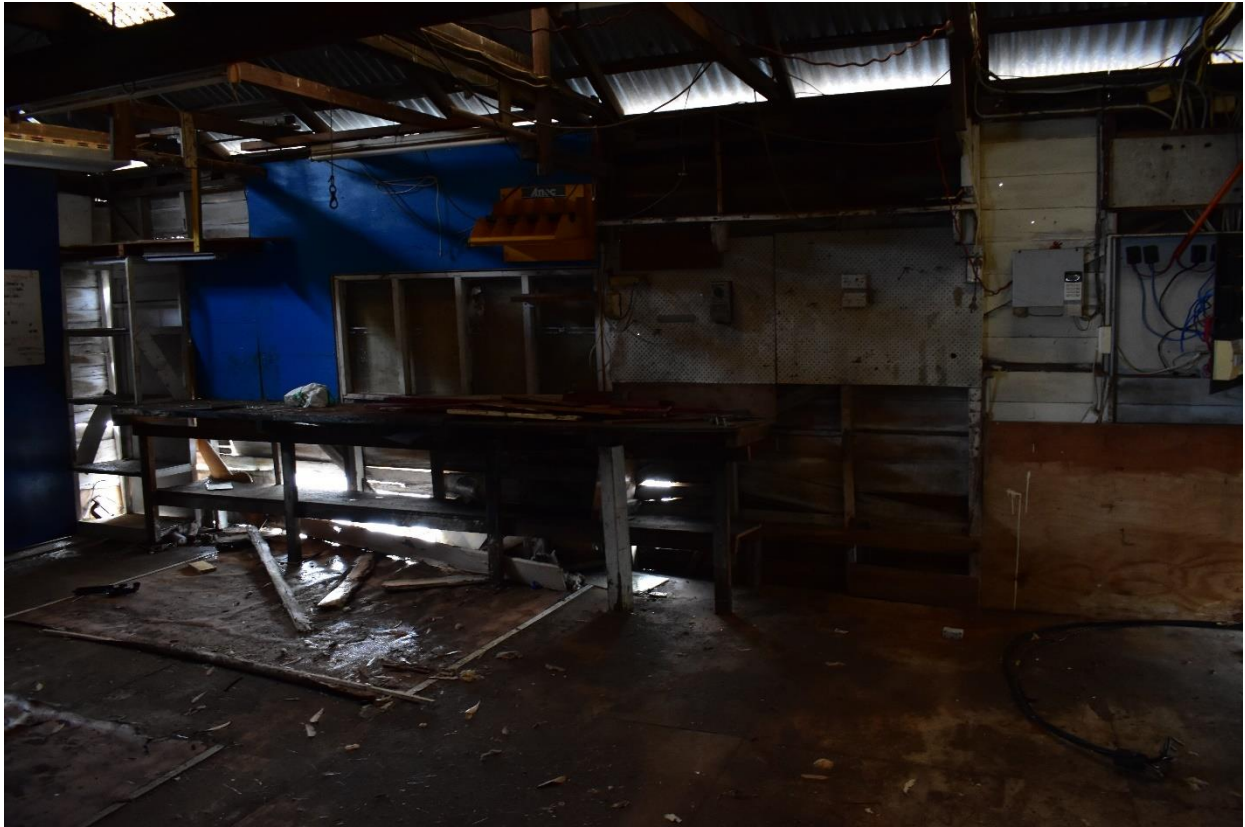
Figure 1.25 – Internal view of southern elevation showing the window glass now removed and remnants of workbenches.

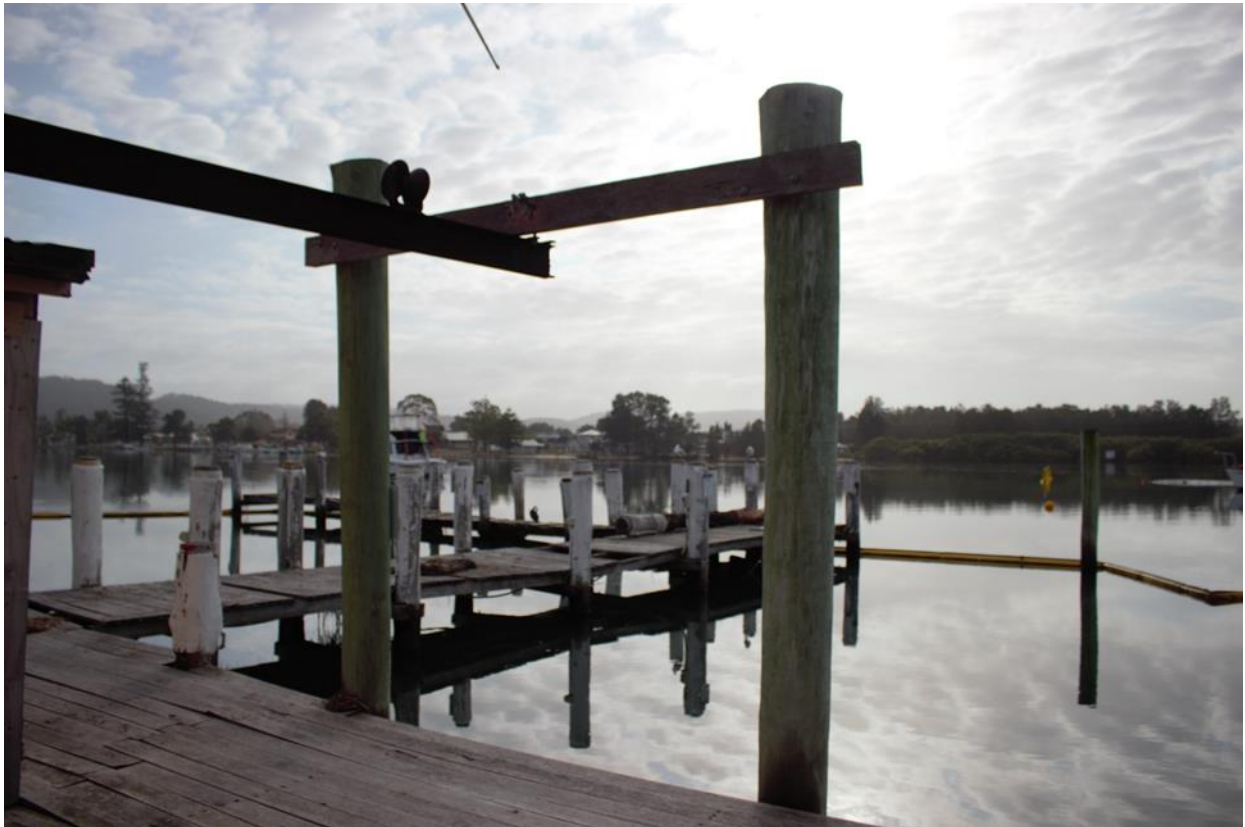
Figure 1.26 – Landing on eastern elevation of boat shed with uprights to support gantry – a modification dating to the 1980s. Beyond are jetties dating to the 1980s.

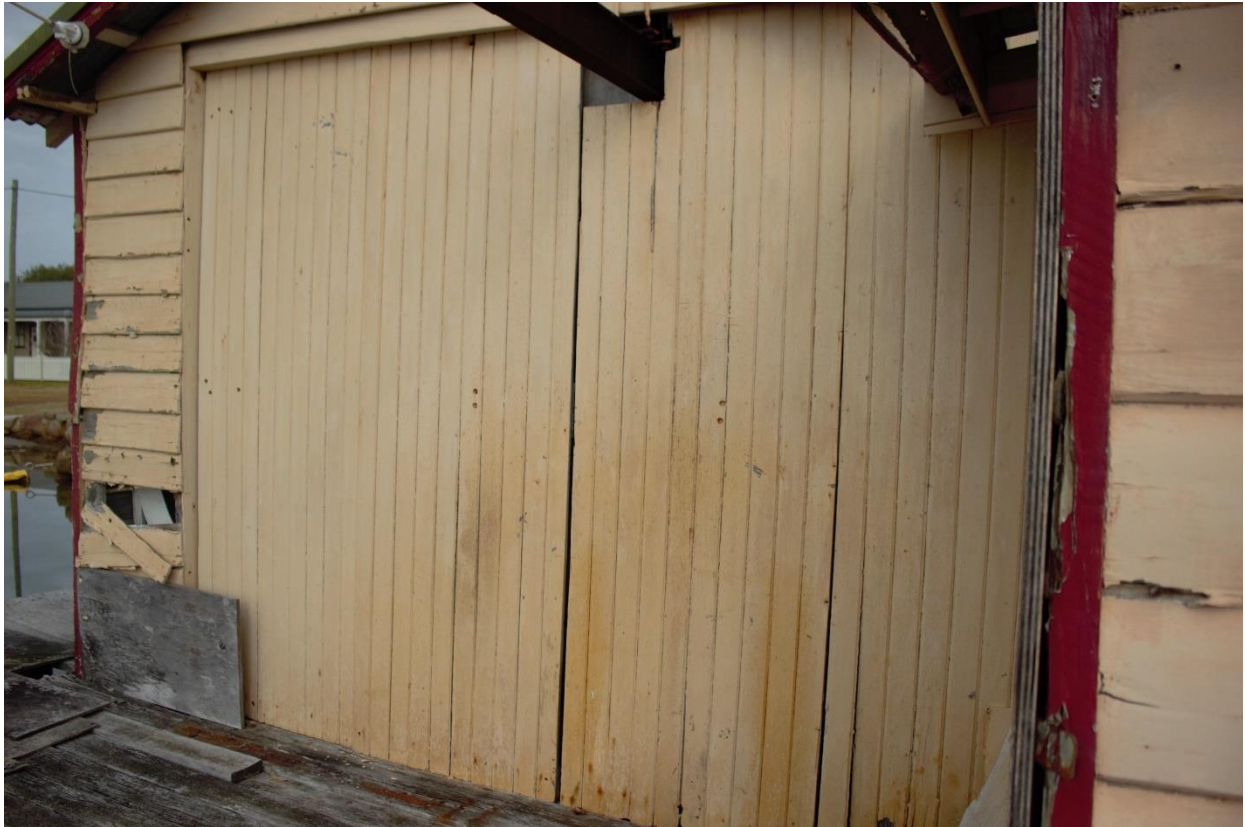
Figure 1.27 – Timber doors on eastern elevation of the boat shed which appear to be original fabric although modified for gantry structure.

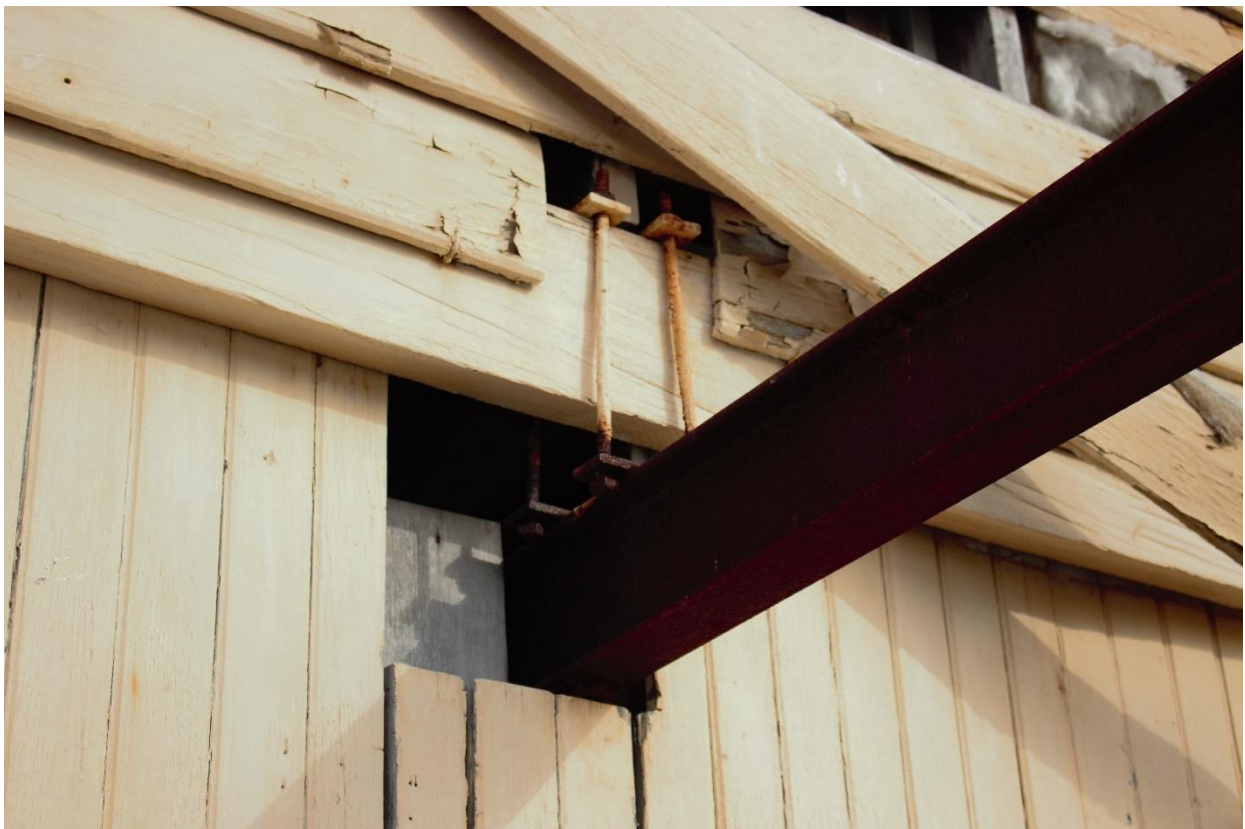
Figure 1.28 – Detail of modification of door for installation of I beam for gantry.

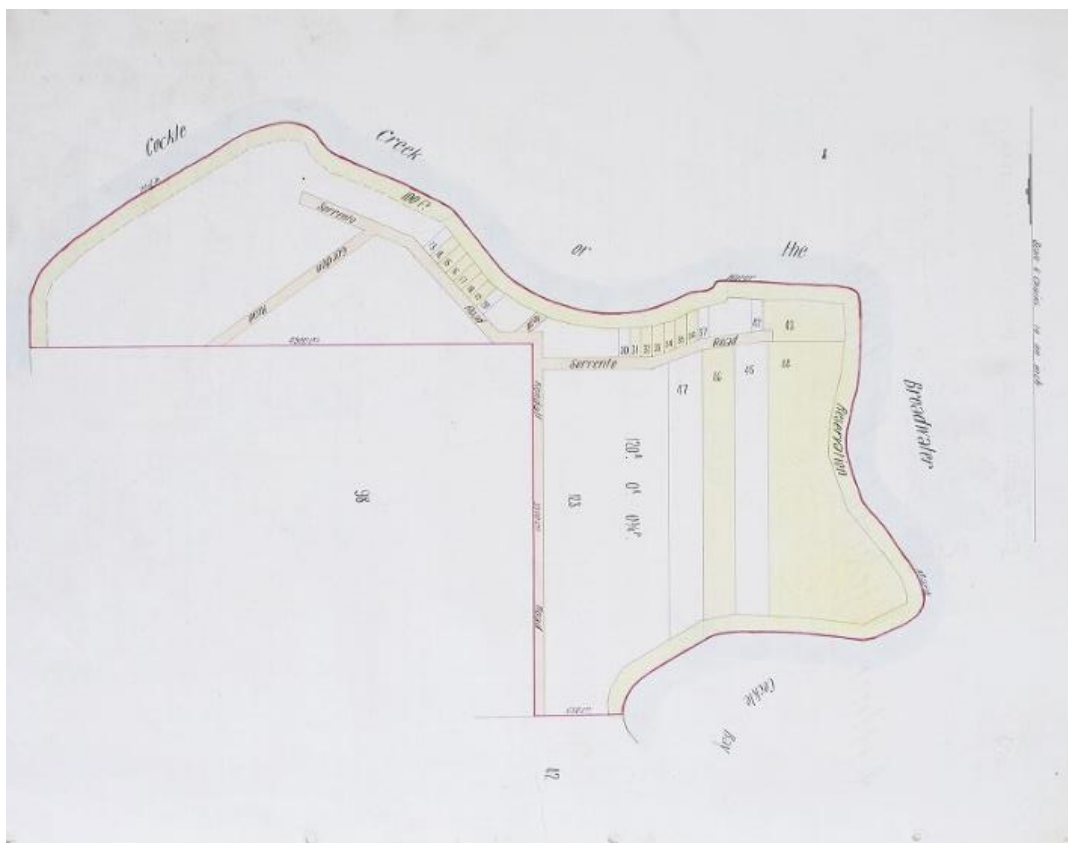
Figure 2.4 – Empire Bay DP 4707 showing Rickards’s early subdivision allotments and roadways within former Portion 123, and showing the extent of the 100ft foreshore reserve.

This notification describes the creation of the 100-foot reservation along the Sorrento Street foreshore that exists today (**Figure 2.4**). This reservation covered an area of 4 and one-quarter acres. This change in the reservation corresponds to the purchase of the land and by Rickard and the subsequent subdivisions and land sales he brokered¹⁹ (refer **Figure 2.5 to Figure 2.8**).

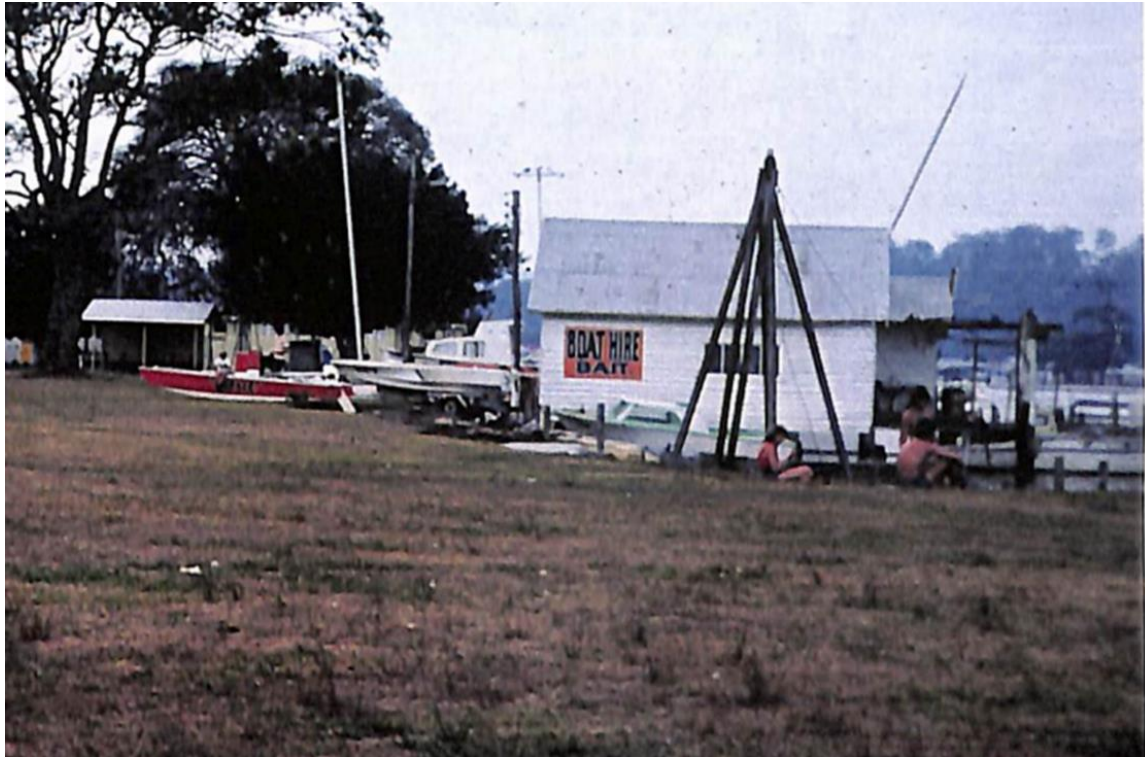
Figure 2.21 – The boat shed in 1978 showing the gantry structure had been installed.
Source: Gwen Dundon

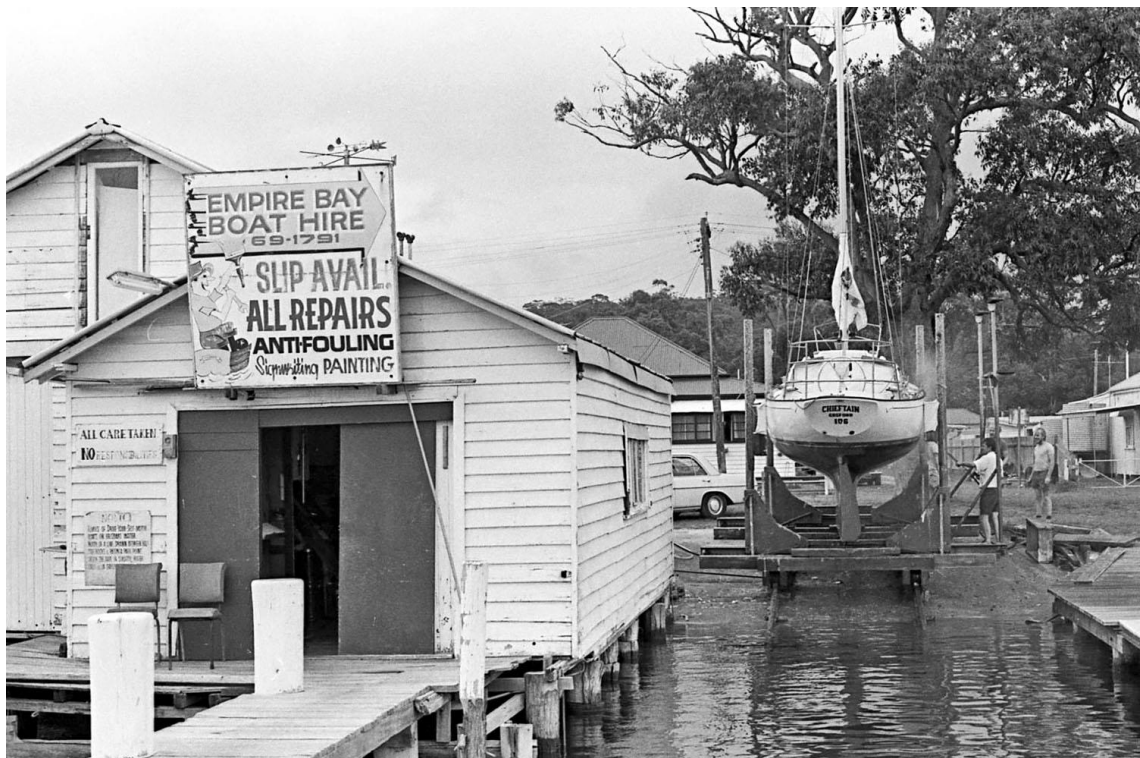
Figure 2.22 – 1981 showing the boat shed and the slip way in use.
Source: Gwen Dundon – image by Jeff Pickering

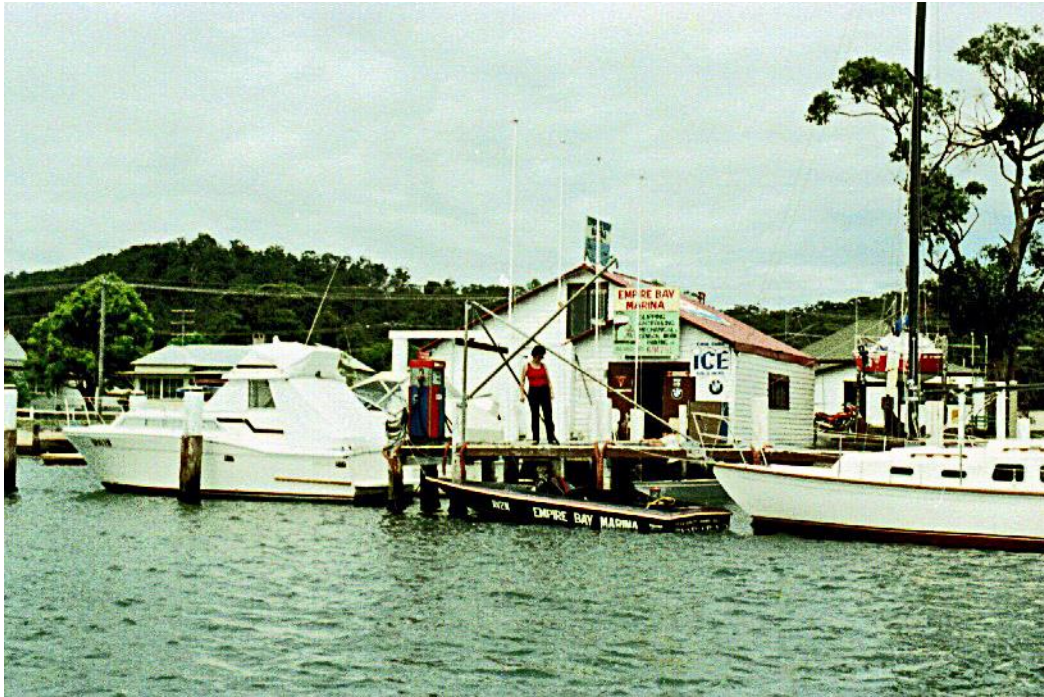
Figure 2.23 – 1983 showing the boat shed painted white with yacht on slipway and petrol bowser on landing. The gantry can be seen behind bowser.
 Source: Gwen Dundon – image by Graeme Andrews
