Statement of Heritage Impact

Proposed Demolition

**Empire Bay Boat Shed
Sorrento Road
EMPIRE BAY, NSW**

Prepared for
Department of Planning & Environment
Crown Land
by **Eureka Heritage**
Project No 230202

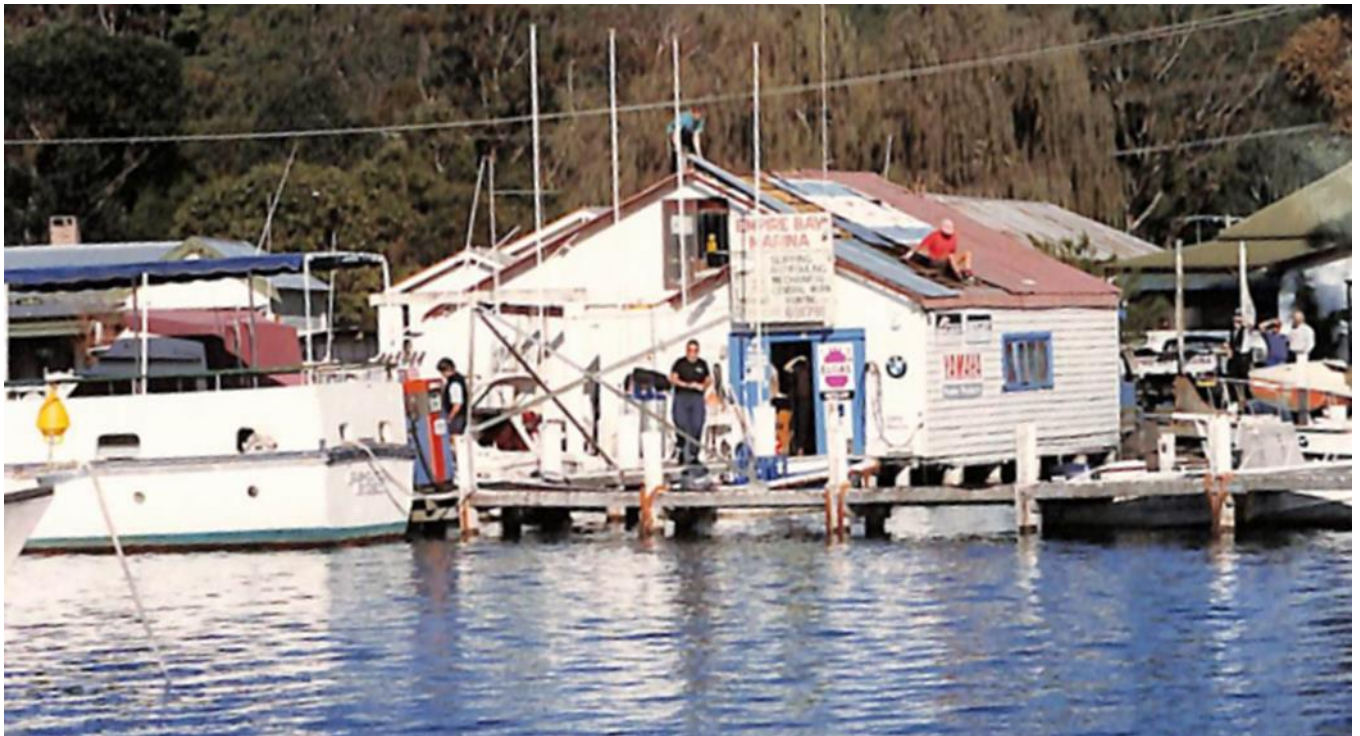
Figure 2.26 – The eastern elevation during the roof replacement.
Source: Empire Bay Progress Association.

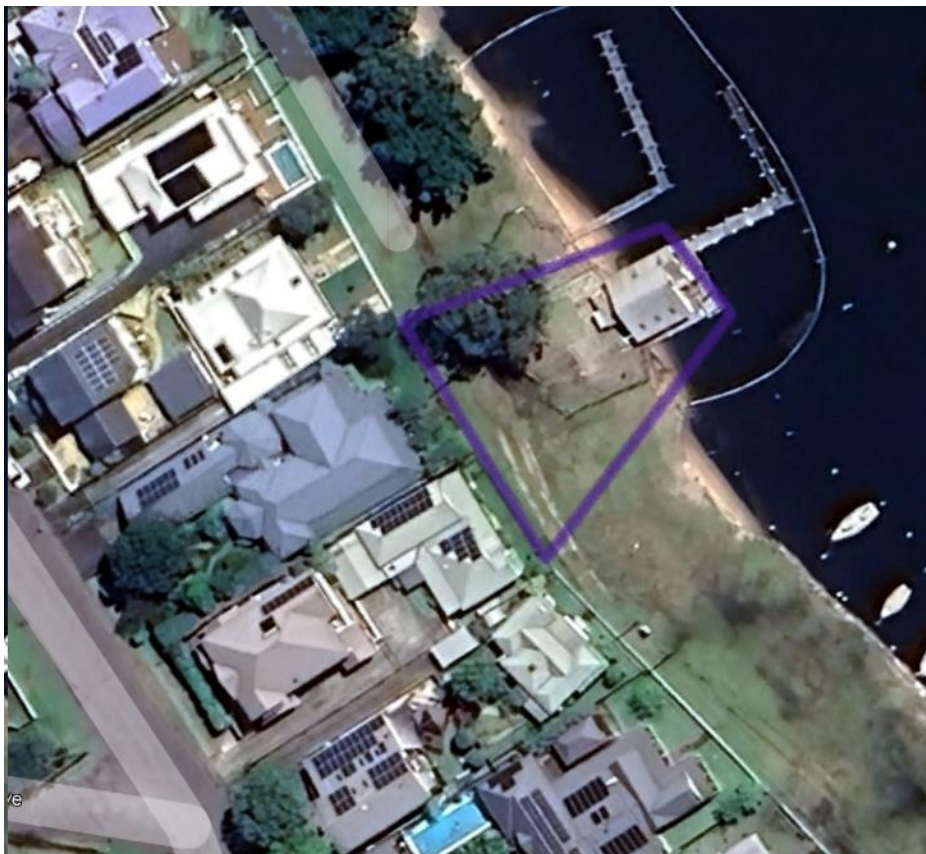
Figure 3.3 – Curtilage of the Empire Bay Boat Shed.

As the boat shed was constructed within the foreshore landscape and has a substantiated association with the Empire Bay General Store, located opposite, and the Davis dwellings either side of the store, it might be reasonable to include a portion of the reserve land between the two as part of the curtilage. **Figure 3.2** below provides a graphic representation of the reasoned curtilage of the site. As can be seen, the proposed curtilage excludes the jetties on the basis they are associated with the c1970s use of the site and/or don't contribute substantially to an understanding of the 1925-1968 history of the site.

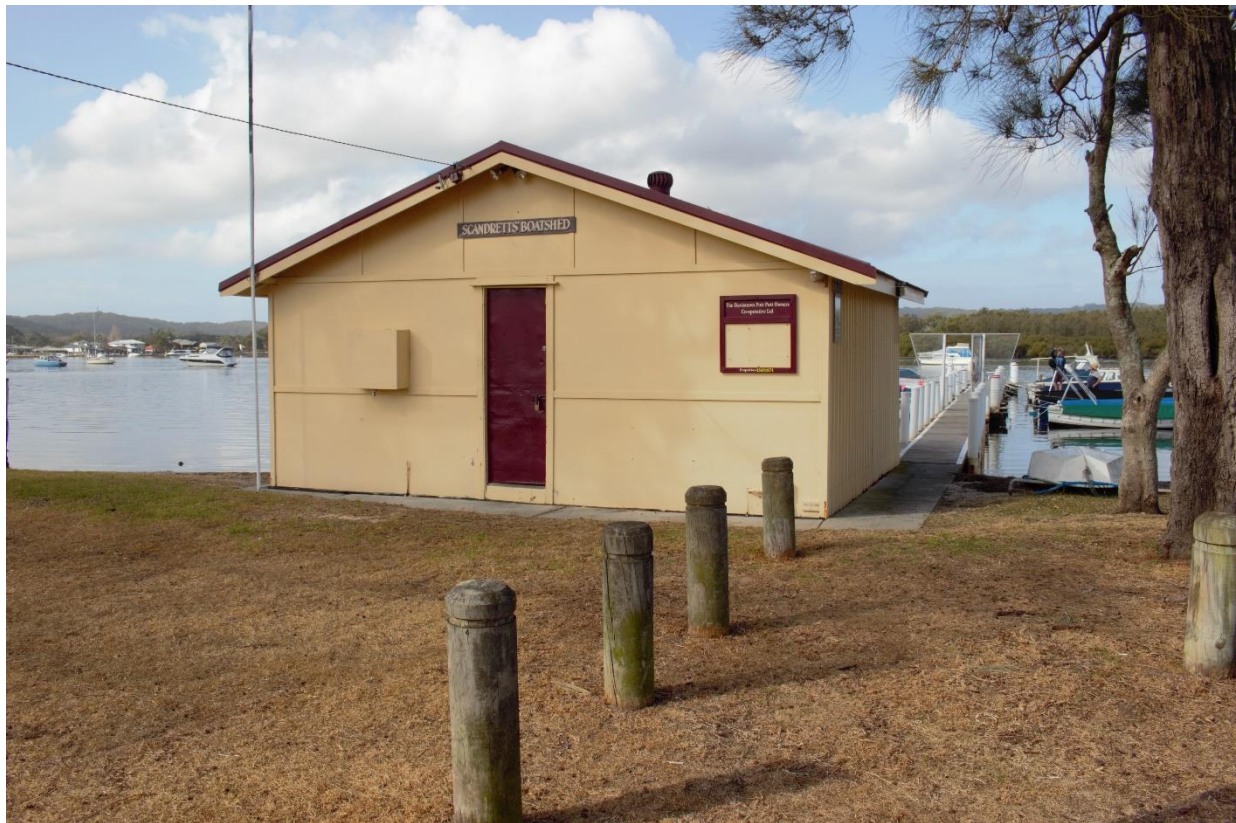
Figure 3.5 – Western elevation of Scandrett's Boat Shed.

The simple gable design and form of the Scandrett’s boat shed, with wharf and slipway, is similar to that of the Empire Bay Boat Shed but it is noted that none of the building fabric of the original 1880 structure remains, supporting the notion that buildings of this type have a limited lifespan. It is assumed from the information of the SHI that the building was replaced during the inter-war years (although this has not been substantiated and details such as whether footings or piers were replaced are not known). Little specific historical context has been provided within the SHI such that further comparative analysis, other than physical comparison, has not been possible.

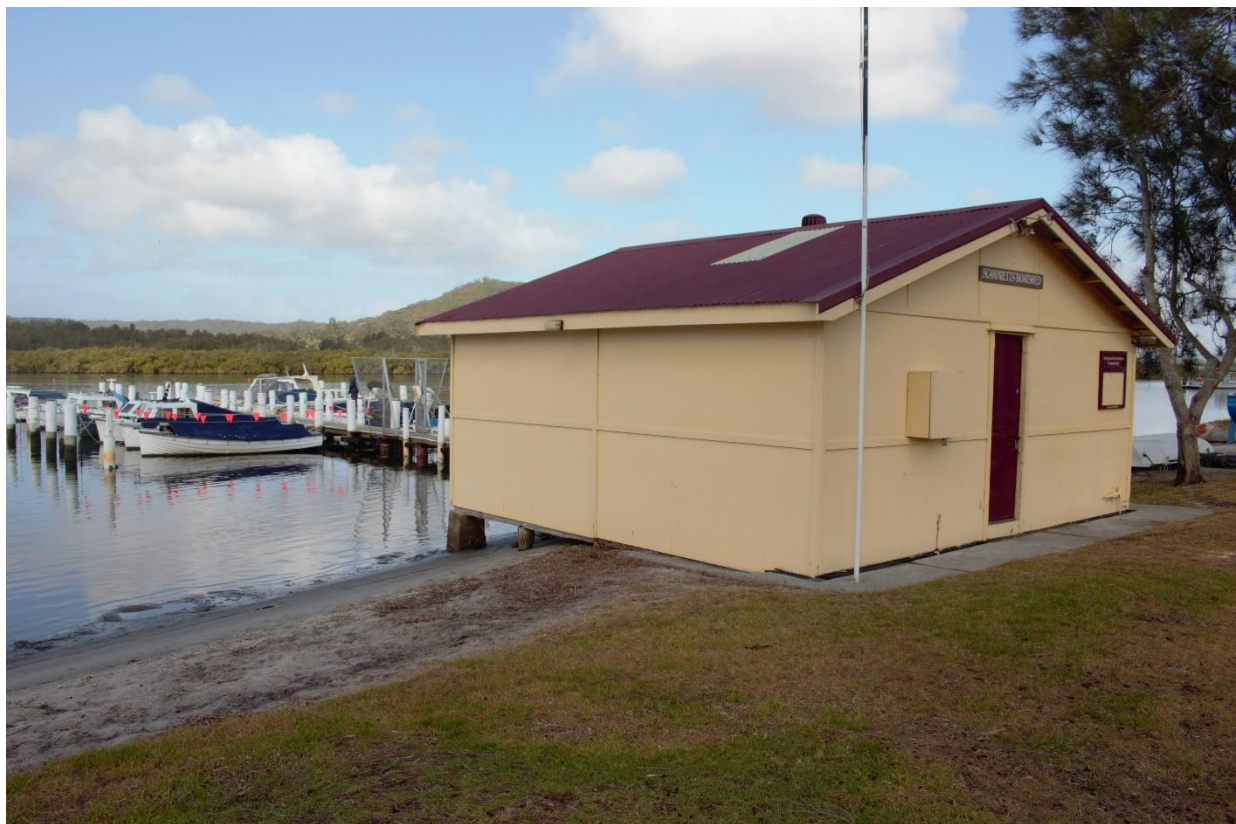
Figure 3.6 – Southern and eastern elevations of Scandrett's Boat Shed.

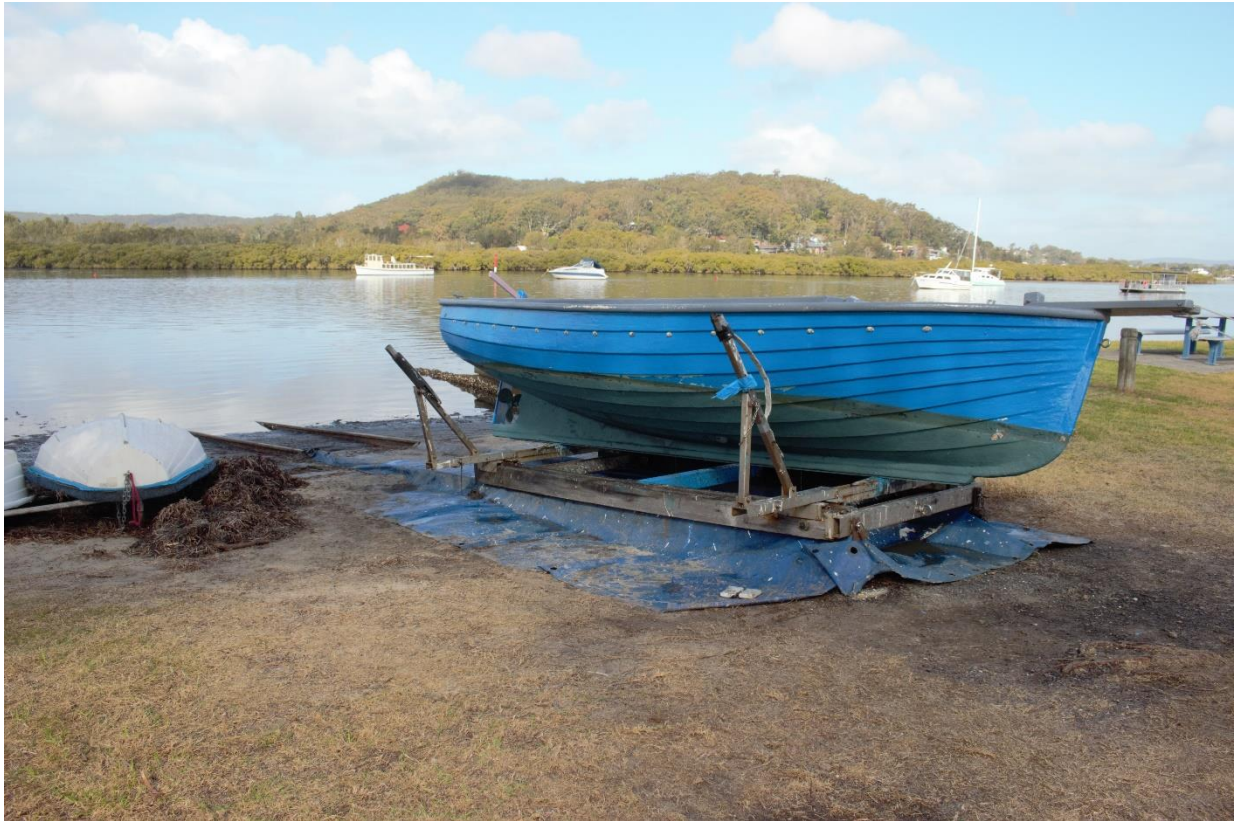
Figure 3.7 – Slipway and cradle for Putt Putt boats likely very similar to the early slipway at the Empire Bay boat shed.
