Assessment of geomorphic changes, hydraulics and potential foreshore stabilisation options at Windang, Lake Illawarra

WRL TR 2023/08, December 2023

By T A Tucker, I R Coghlan and J T Carley

UNSW
Water Research
Laboratory

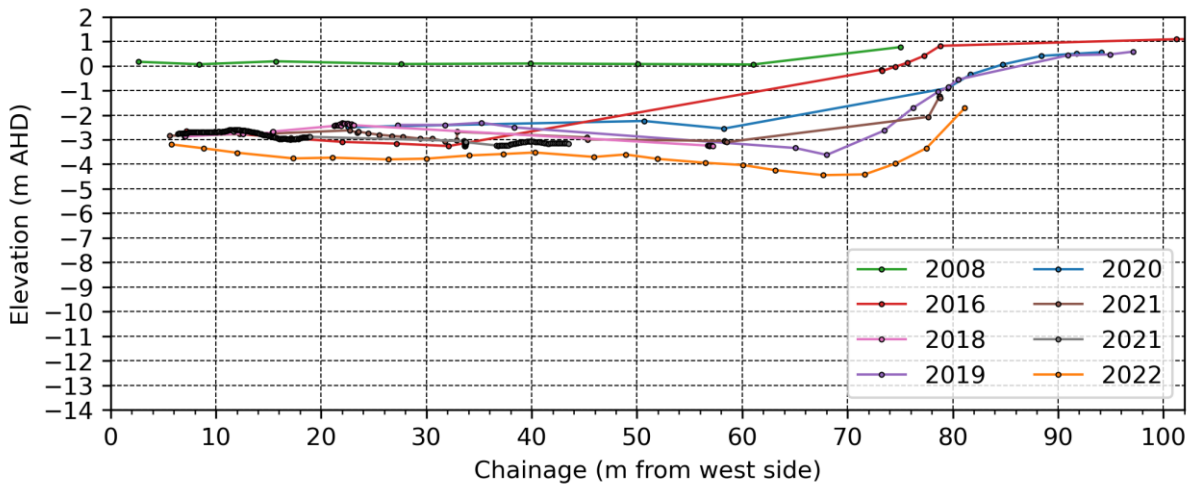
Figure 3.6 Change in bathymetry at cross-section 3 (Figure 3.2) to the south of the study area

Comparison of bathymetric data clearly shows the erosion of a hole in front of the groyne located within the study area. In Figure 3.3, the hole clearly forms between 2007 and 2018. Between 2008 and 2022 the hole caused by erosion has developed to be ~12 m deeper. Figure 3.4 shows that erosion of sand at the toe of the groyne is still continuing despite having some variability. Indeed, this is the case at each of the cross-sections identified (see Figure 3.5 and Figure 3.6).

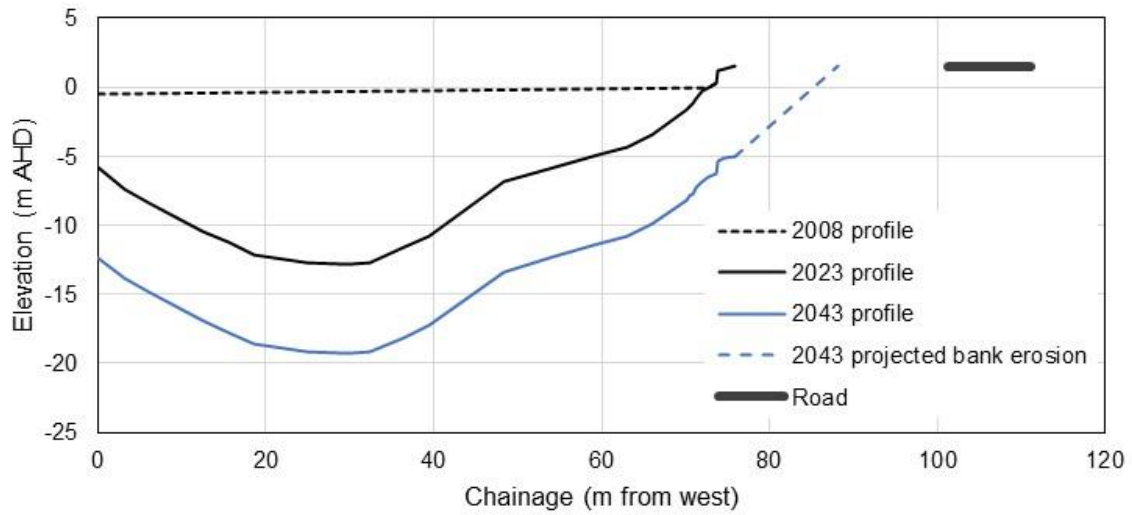
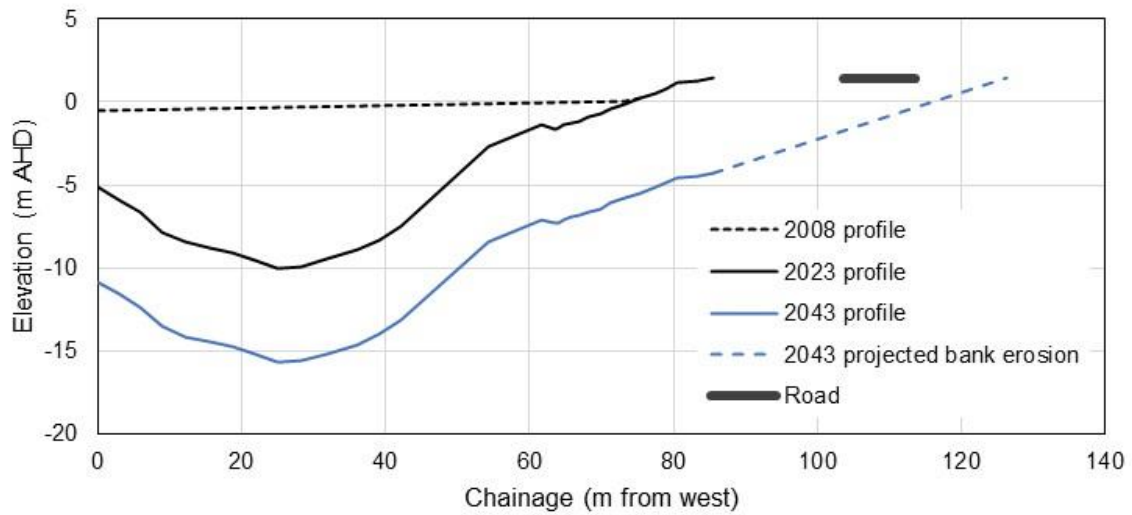
Figure 3.12 Indicative future erosion prediction at cross-section F1

Figure 3.13 Indicative future erosion prediction at cross-section F2

Figure 3.14 Indicative future erosion prediction at cross-section F3

Figure 3.15 Indicative future erosion prediction at cross-section F4

Figure 3.16 Indicative future erosion prediction at cross-section F5

Figure 3.17 Indicative future erosion prediction at cross-section F6

Figure 3.18 Indicative future erosion prediction at cross-section F7

Figure 3.19 Indicative future erosion prediction at cross-section F8

Review of the projected cross-sections shows that, in the future, existing assets located along the Windang foreshore are likely to be at risk from erosion. This includes the existing roadway which provides access to Windang Surf Life Saving Club as well as park facilities such as tables, shelters and the playground. Note, the actual slope angle of the foreshore will depend upon factors such as the forces leading to erosion and sediment type/size. Indicative erosion profiles presented here are approximations only and the actual slope angles may vary. Slope angles measured from existing data at the Windang foreshore ranged from 1 Vertical (V) : 2 Horizontal (H) (typical for sandy clays) to flatter than 1V:5H (typical for fine sands) (Bray, 1979). Sediment samples collected in the channel adjacent to the foreshore and presented by Tucker et al. (2023) found that the D₅₀ sediment size was between 0.5 and 0.25 mm. Sediment of this size is classified as medium to coarse sand on the Wentworth scale and would be expected to have a stable slope of approximately 1V:4H.
