Ex-HMAS Adelaide Artificial Reef Reef Community Monitoring Survey 12

**Prepared for: Department of Primary Industries –
Land and Natural Resources**

May 2015

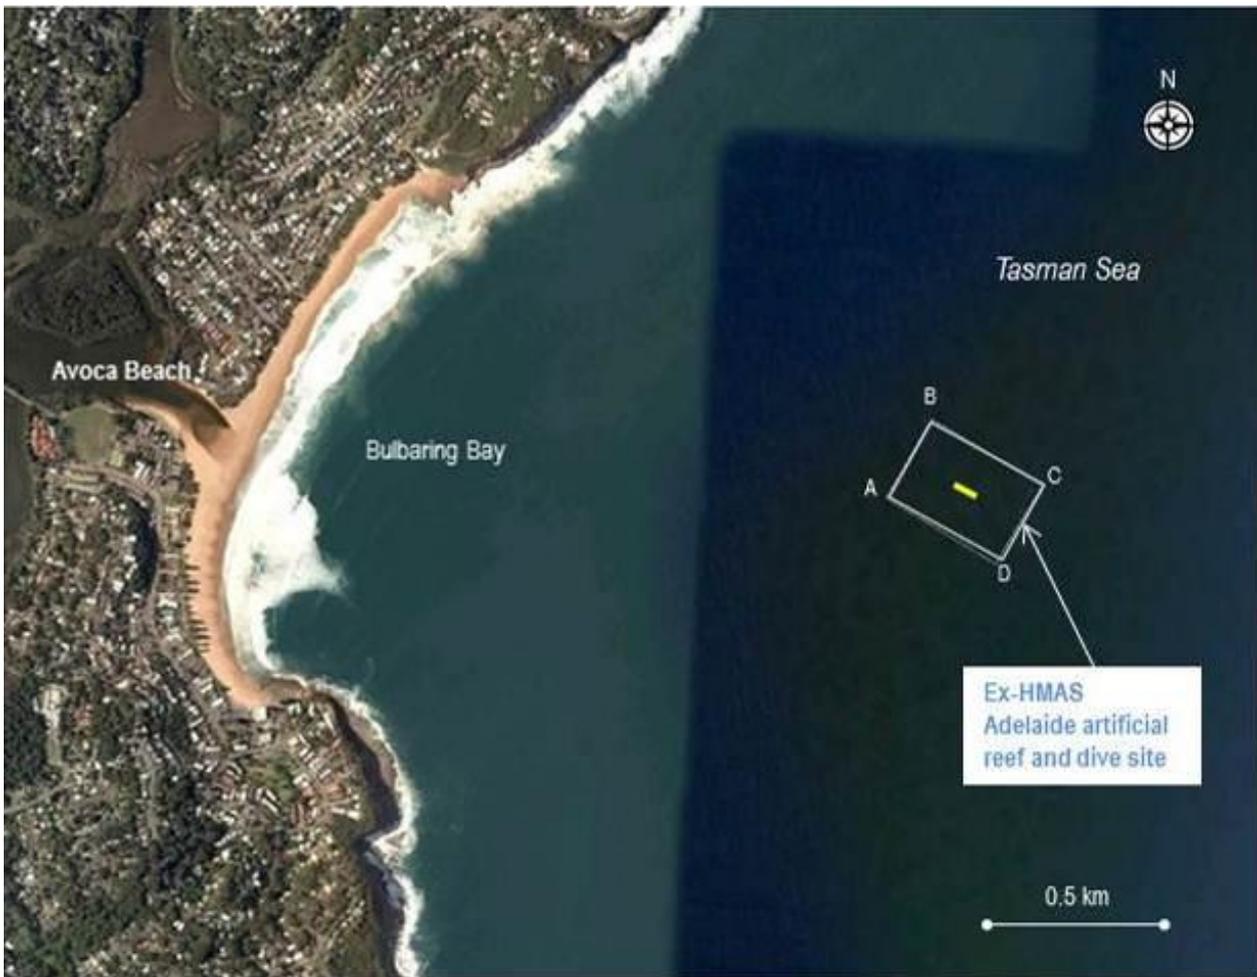
Boundary of Dive Site	Easting (MGA 94)	Northing (MGA 94)
A	356428.713	6296117.693
B	356538.438	6296341.142
C	356850.615	6296188.618
D	356742.410	6295963.310

Figure 1: Location of Ex-HMAS Adelaide Artificial Reef and Dive Site. The approximate location and orientation of the ship is indicated by the yellow line.
