# **Ex-HMAS Adelaide Artificial Reef Reef Community Monitoring Survey 13**

**Job Number: 59916176**

**Prepared for: NSW Department of Primary Industries - Lands  
June 2016**

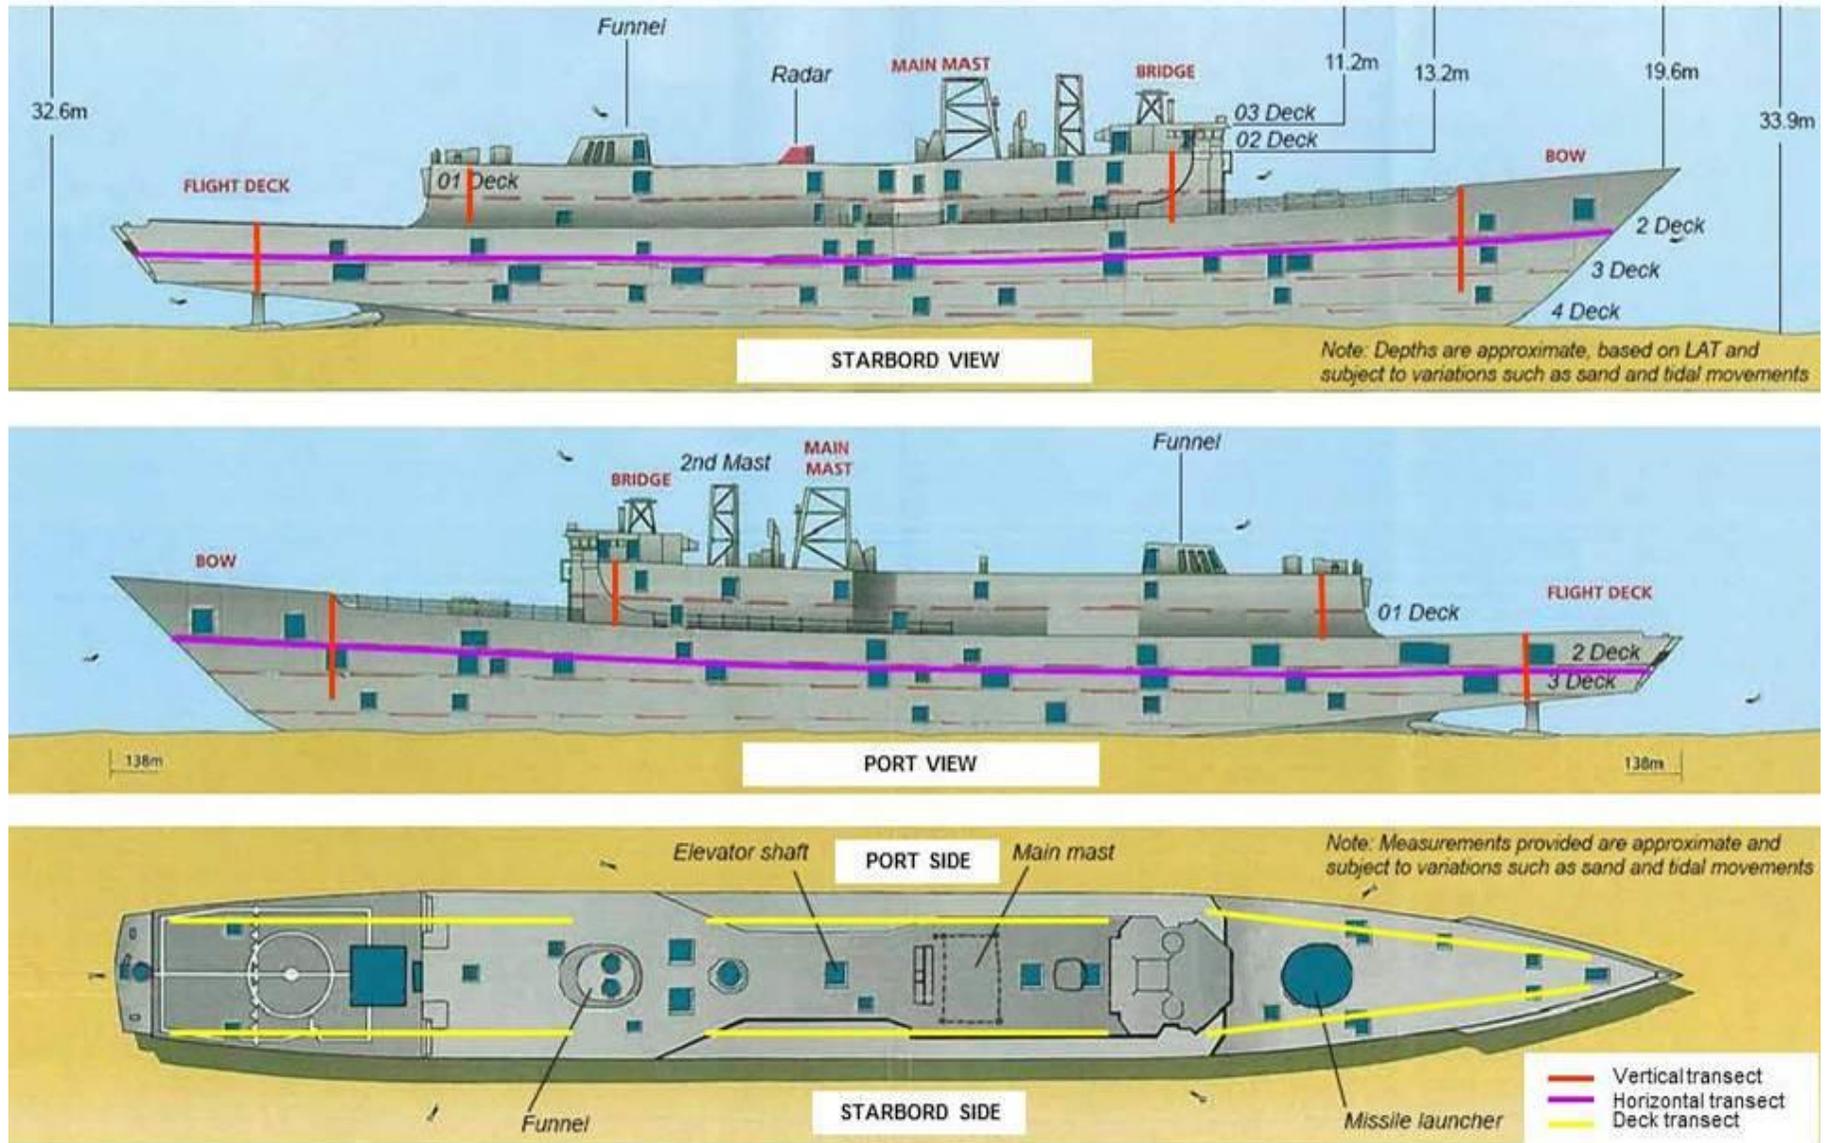
Figure 2: Plans of the Ex-HMAS Adelaide and positions of the reef assemblage survey sampling Transects.

- x 6 Transects in total (2 x 50 m Transects at the bow, 2 x mid ship and 2 x stern on port and starboard aspects).
- x 30 photoquadrats in total (x 5 per transect).

Photoquadrats were acquired at regular intervals along each transect. For the vertical Transects this was approximately every 0.5 m. This was originally every metre, however, the 30 m depth limit for divers meant the number of replicate photoquadrats was restricted, therefore photoquadrats were taken every 0.5 m.

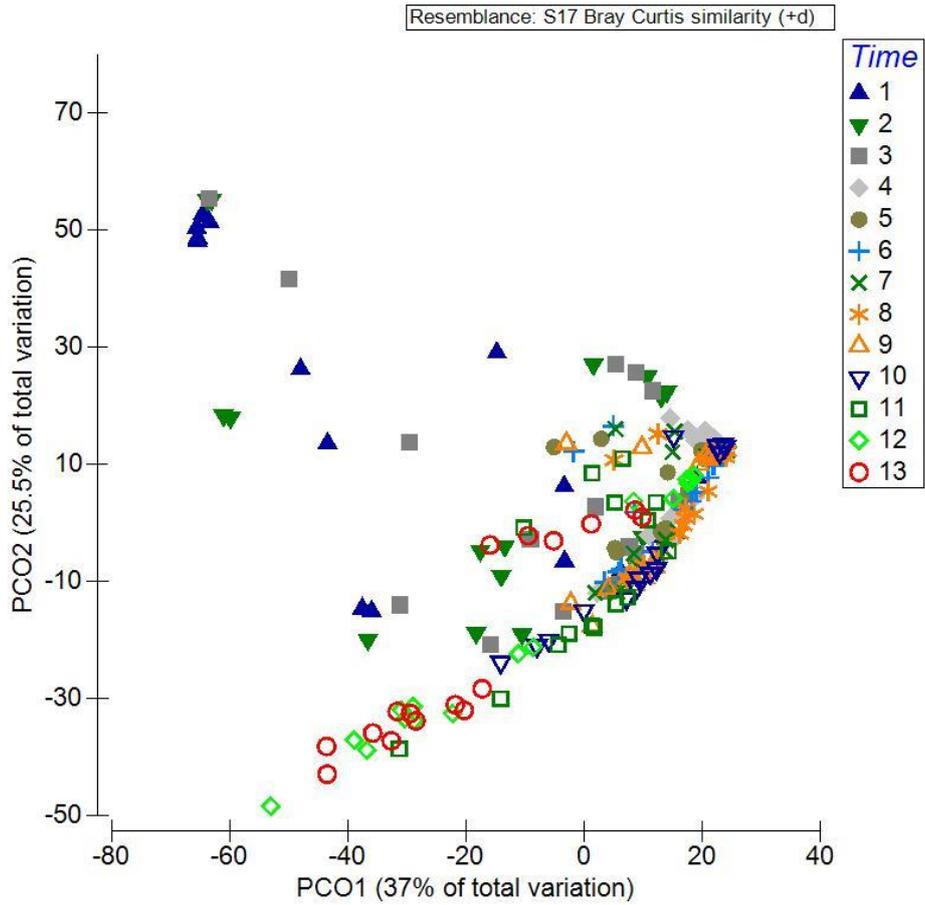
Figure 4: Principal Coordinates Analyses (PCoA) of Percent Cover of Encrusting assemblages from Transects Taken at all Positions on the Ex-HMAS Adelaide for Surveys 1 to 13

- Overall, no significant difference in the structure of encrusting assemblages was detected between Survey 12 and Survey 13. Differences were detected between surveys at a local scale (i.e. at the scale of Orientations (i.e. deck and hull), Positions on the deck (bow, mid-ship and stern) and individual Transects);

There was no evidence of an overall change in the ship-wide assemblage structure between Surveys 12 and 13. In most recent previous surveys, ship-wide differences have been detected. Results of Survey 12 showed significant changes in the composition of the sessile reef assemblage over the previous six months following Survey 11 (September 2014); this was similar to previous consecutive surveys (10 and 11) which also differed in assemblage structure. Differences between surveys may partly be due to successional changes as well as seasonal conditions which would potentially influence current patterns and recruitment, all of which would be expected to influence the abundance and composition of encrusting assemblages. It is possible that the absence of a detectable difference in the ship-wide assemblage between the most two most recent surveys may be indicative of a slowing in the rate of successional change. However, differences between surveys were still apparent at different surfaces on the ship, which suggests that changes are still occurring.

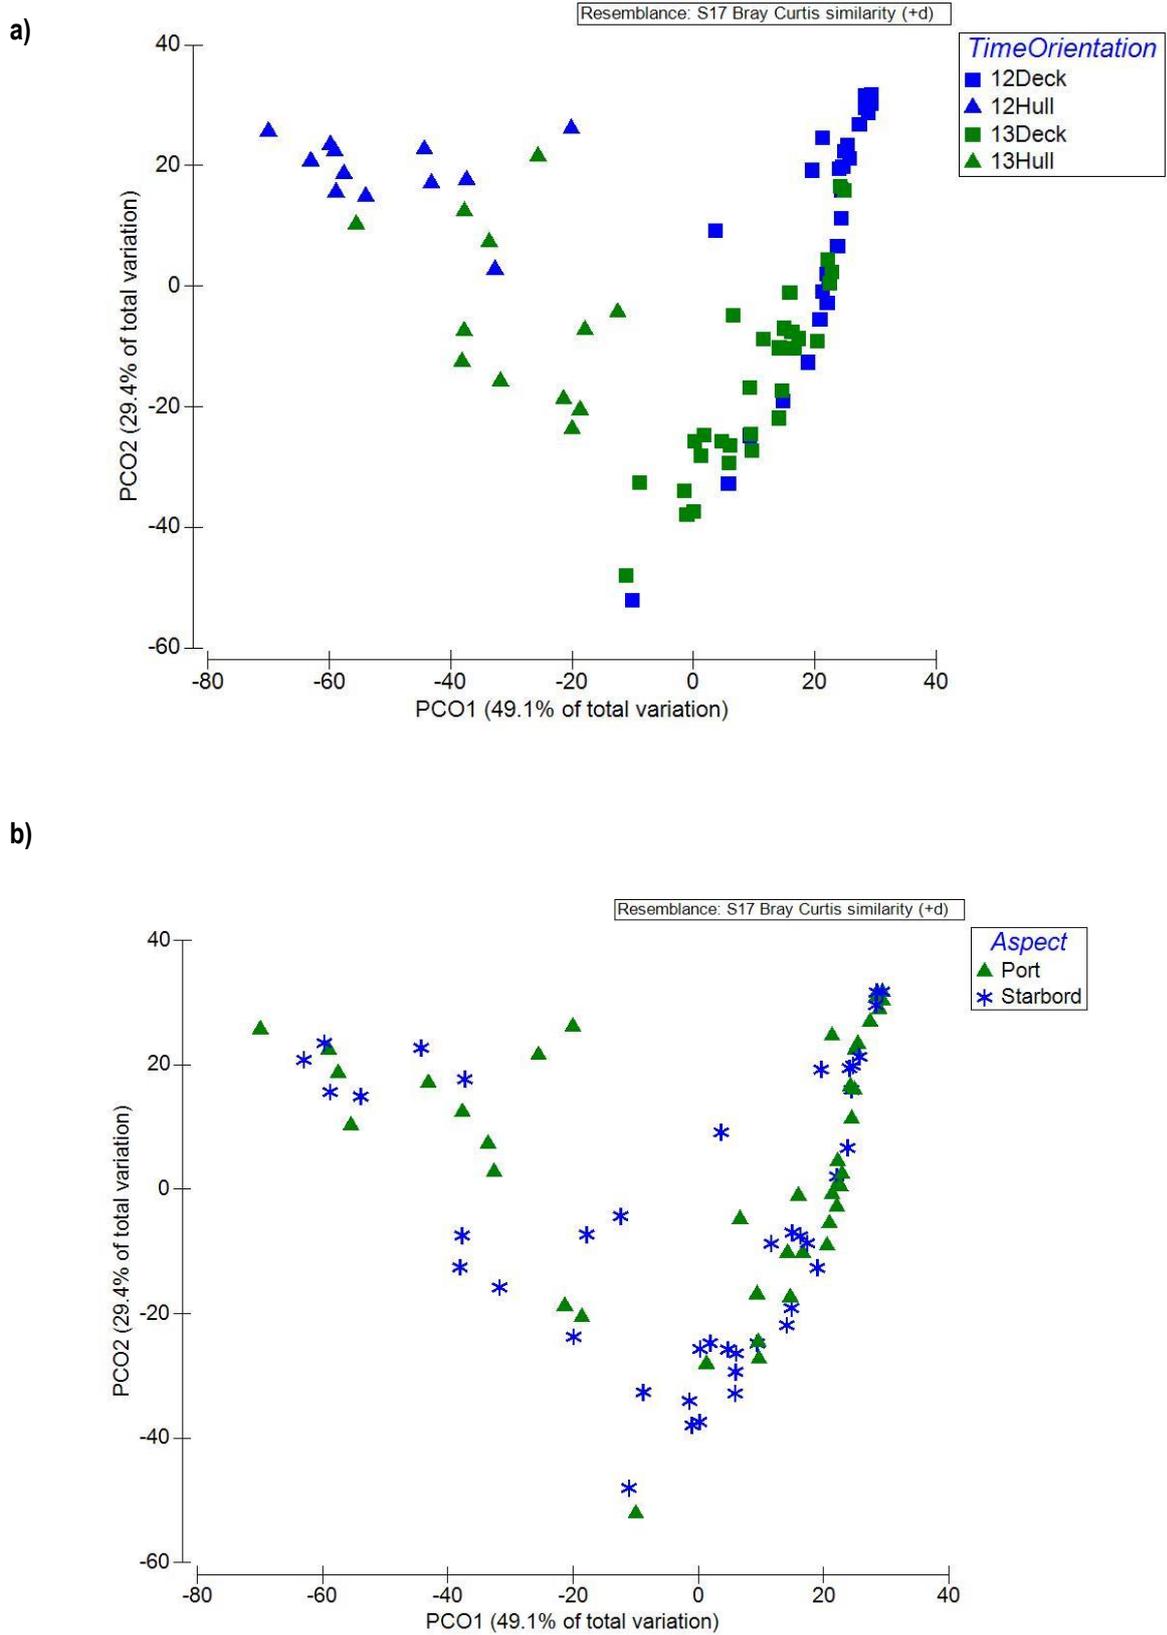
Figure 5: Principal Coordinates Analyses (PCoA) of Percent Cover Encrusting assemblages from Transects a) Taken on Hull and Deck Surfaces and b) on different Aspects of the Ex-HMAS Adelaide for Surveys 12 and 13

- There were significant differences in the structure of assemblages between the horizontal deck and the vertical hull, in Surveys 12 and 13 (i.e. an effect of Orientation);
- No significant difference in the structure of assemblages was detected between shallow and deep vertical Transects (i.e. no effect of Depth);
- There was a significant difference in the structure of assemblages between the bow and the mid-ship Positions during Survey 12 and during Survey 13 (i.e. an effect of Position); and
- There was a significant difference in the structure of assemblages between the port and starboard Aspects, averaged across all other factors, for each of the analyses undertaken (i.e. a main effect of Aspect).

Differences between surveys were detected at a more local scale at different surfaces on the ship (i.e. Orientation - horizontal deck Transects and vertical hull Transects, Position – bow, mid-ship and stern and Transect). Also, as has often been the case in previous surveys, significant differences in assemblage structure were detected between Orientations (i.e. horizontal deck vs. vertical hull) during Surveys 12 and 13. As discussed previously, it is likely that suspension / filter feeders such as ascidians and anemones (particularly *Corynactis* sp., which was often found to contribute to a relatively large proportion of the dissimilarity between assemblages) tend to proliferate on more shaded (i.e. vertical) portions of the ship (for example, where competition for space from algae would be expected to be lower) or possibly where there is more current which would be expected to improve feeding efficiency. There is also some evidence to suggest a substantial, overall increase in the abundance of this taxon in recent surveys, however, there was also some evidence to suggest a reduction in the cover of this taxon between Surveys 12 and 13 at some individual Transects. *Corynactis* sp. form colonies joined to a common 'sheet like' base, with several colonies joining one another. Bright purple and pink forms of the anemone have also been observed on the ship but in much lower densities. On natural reefs the anemone is often found in the entrances to sea caves and prefer shaded conditions (Edgar 2003), hence they are generally observed in association with the vertical (more shaded) parts of the ship. Algae would be expected to be more abundant on upper horizontal surfaces where light availability is optimal.

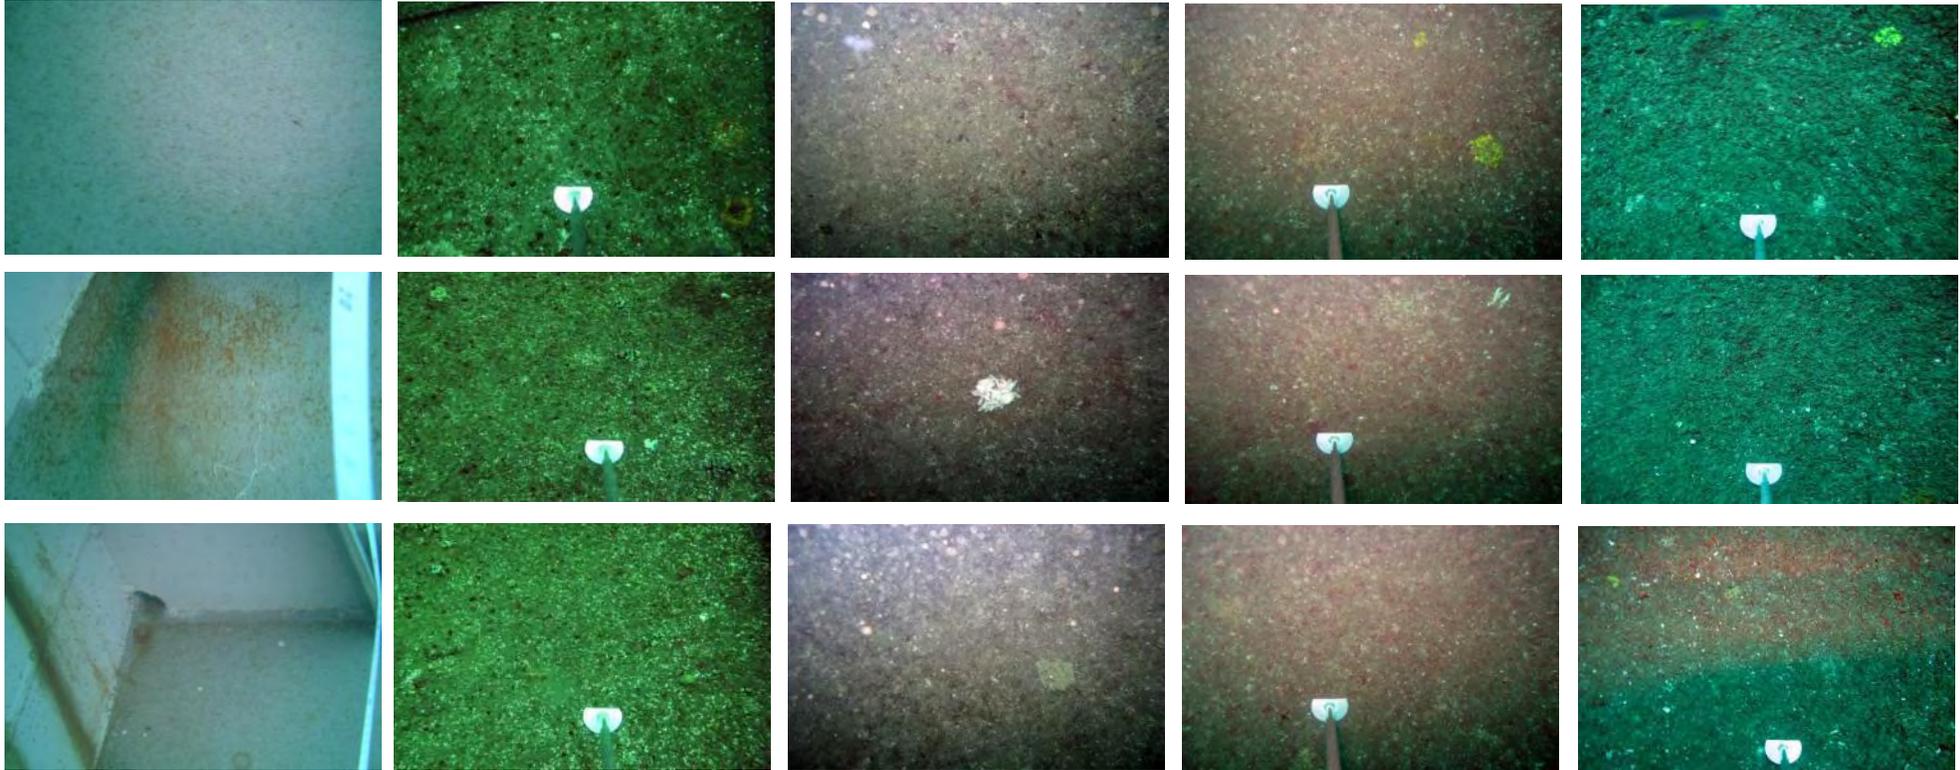
**Plate 1:** Deck port bow

Position	Description of Assemblage
Deck Port Bow	The deck surface was encrusted with a uniform assemblage of small barnacles, serpulid tubes and fine filamentous algae. Tubular solitary sponges, white papillate encrusting sponges and yellow encrusting sponge were also conspicuous. Tarwhine ( <i>Rhabdosargus sarba</i> ), eastern hulafish ( <i>Trachinops taeniatus</i> ) and sweep ( <i>Scorpius lineolatus</i> ) were all observed.
Deck Port Mid	Unlike some previous surveys no kelp ( <i>Ecklonia radiata</i> ) was observed in this area. The majority of the deck was otherwise heavily encrusted with barnacles, serpulid tubes, encrusting red algae and fine filamentous algae. Patches of encrusting yellow/orange and white sponge was observed on the deck as were many small bare patches. Tarwhine were common and rock cale ( <i>Crinodus lophodon</i> ) were abundant on the deck.
Deck Port Stern	The deck was predominantly covered in serpulid tubes, barnacles and fine filamentous algae. Large tubular and papillate sponges were conspicuous on the deck surface.

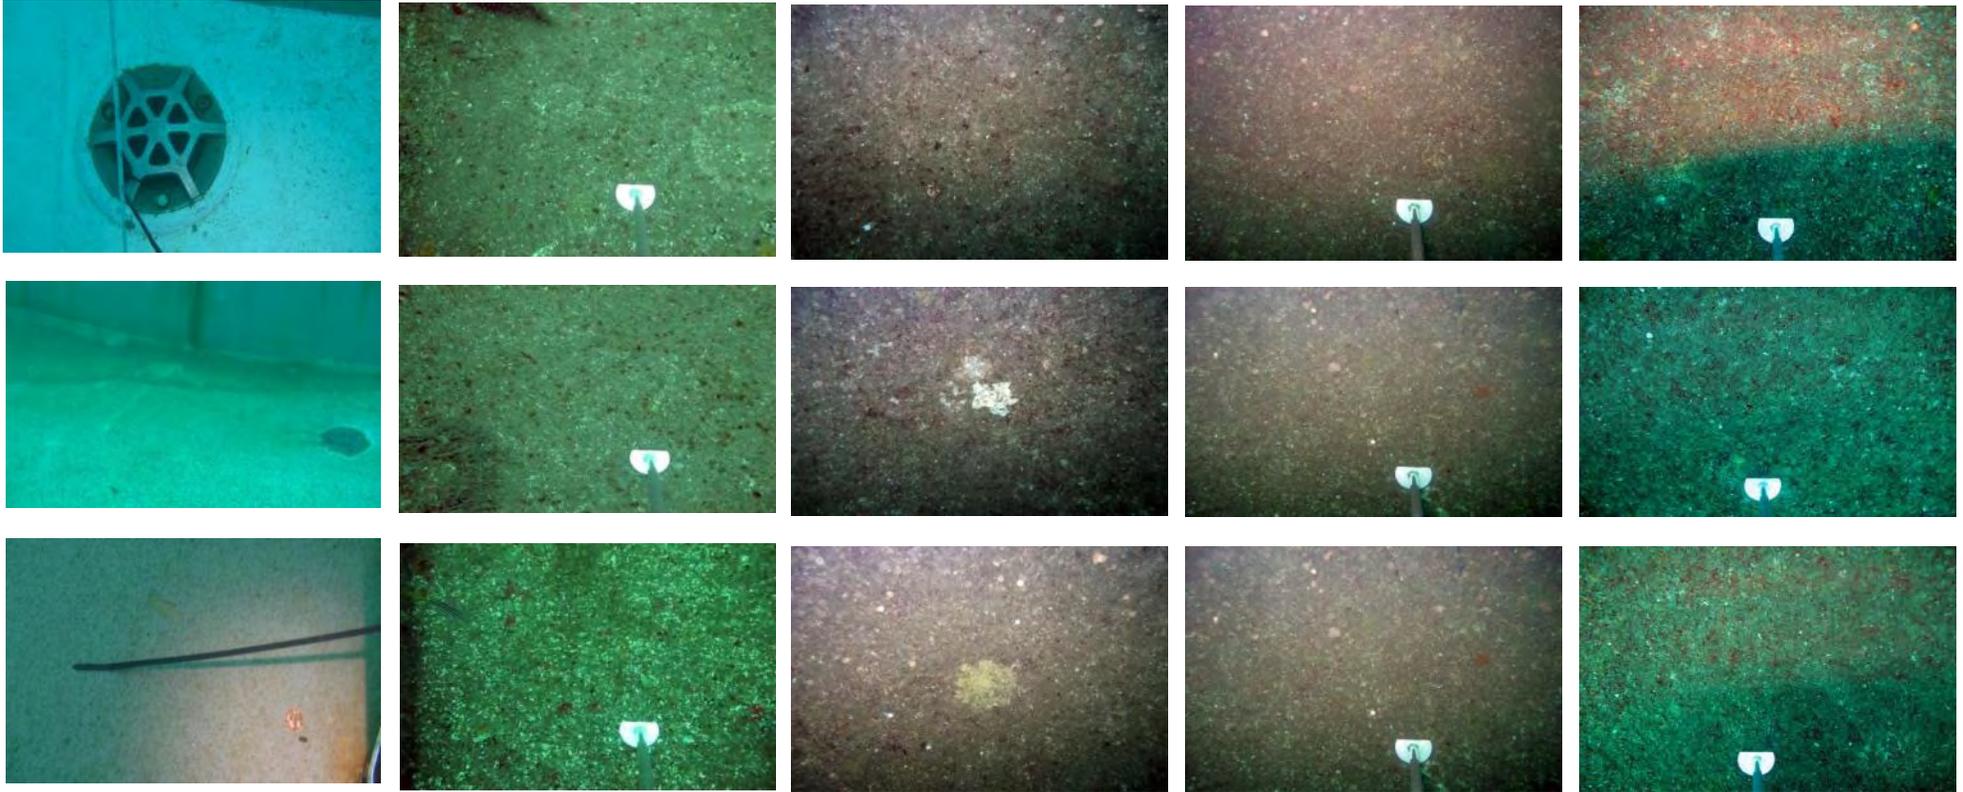
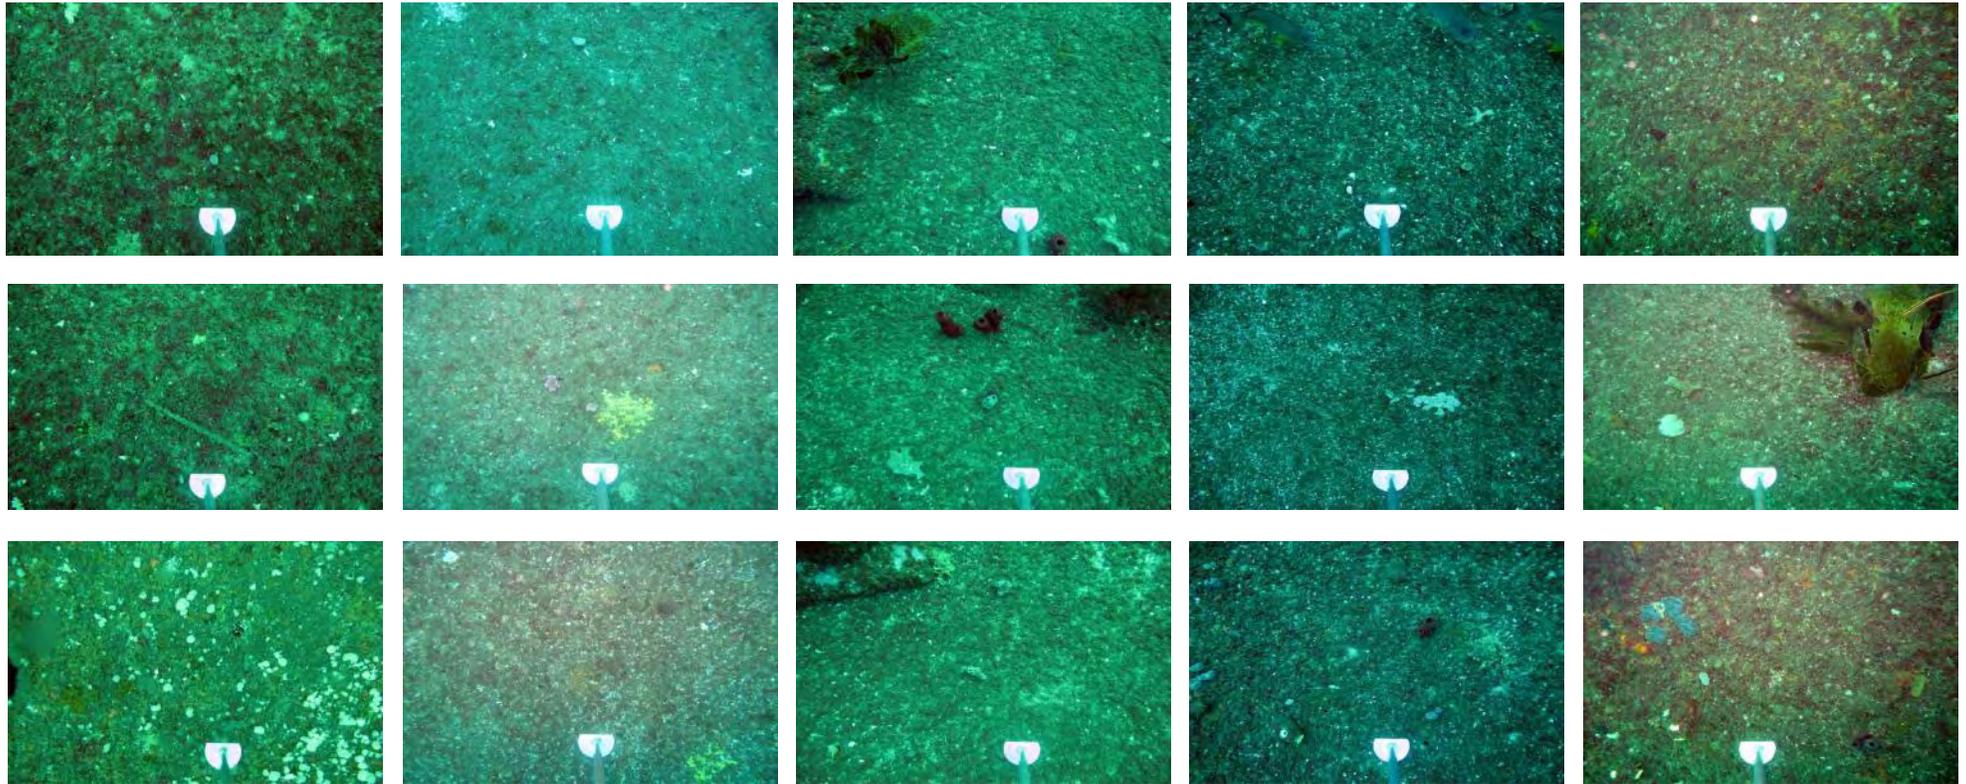
**Plate 4:** Deck Starbord Bow

Deck Starboard Bow	As with previous surveys, encrusting growth included barnacles, serpulid tubes and tufting algae with patches of tubular, papillate and encrusting sponges. Solitary, tubular, red, pink and white sponges were observed on the deck. Schools of eastern hulafish and sweep were observed as well as some banded parma ( <i>Parma polylepis</i> ) and white ear ( <i>Parma microlepis</i> ).
Deck Starboard Mid	As per previous surveys, the majority of the deck was encrusted with barnacles, encrusting algae, and fine red filamentous algae. Tubular solitary sponges, white papillate and orange encrusting sponges and serpulid tubes were conspicuous on the deck surface. Unlike some previous surveys no kelp ( <i>Ecklonia radiata</i> ) was observed. Fish observed included schools of one-spot puller ( <i>Chromis hypsilepis</i> ), eastern hulafish and mado ( <i>Atypichthys strigatus</i> ) as well as tarwhine, sweep, wirrah ( <i>Acanthistius ocellatus</i> ), snapper ( <i>Pagrus auratus</i> ), rock cale and girdled parma.

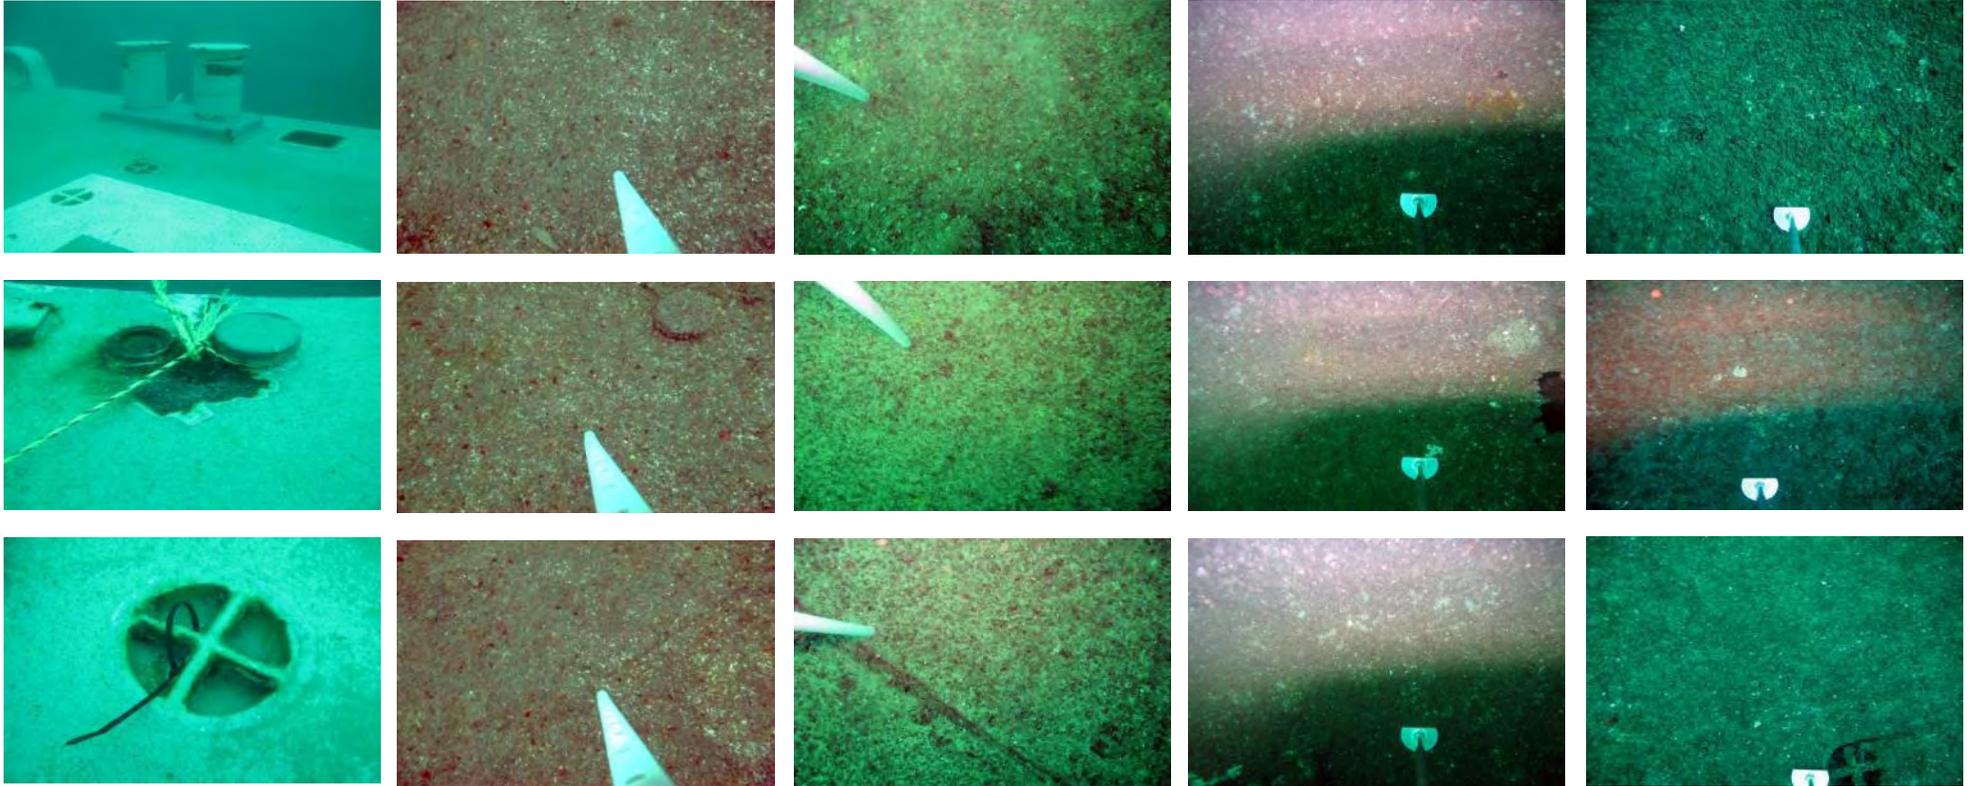
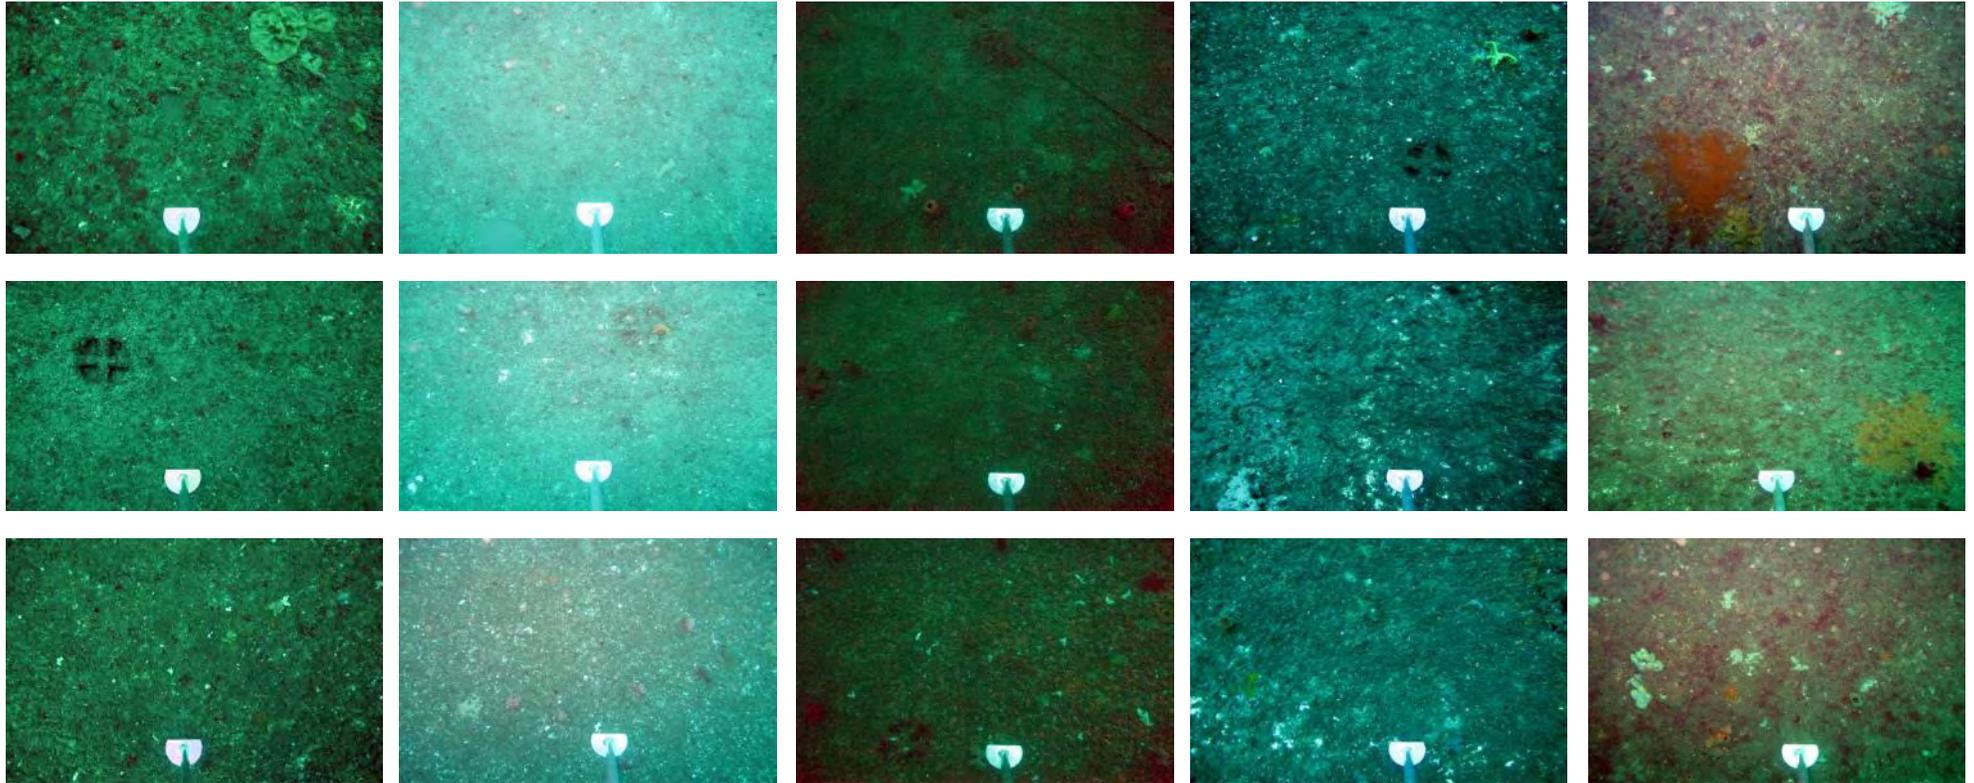
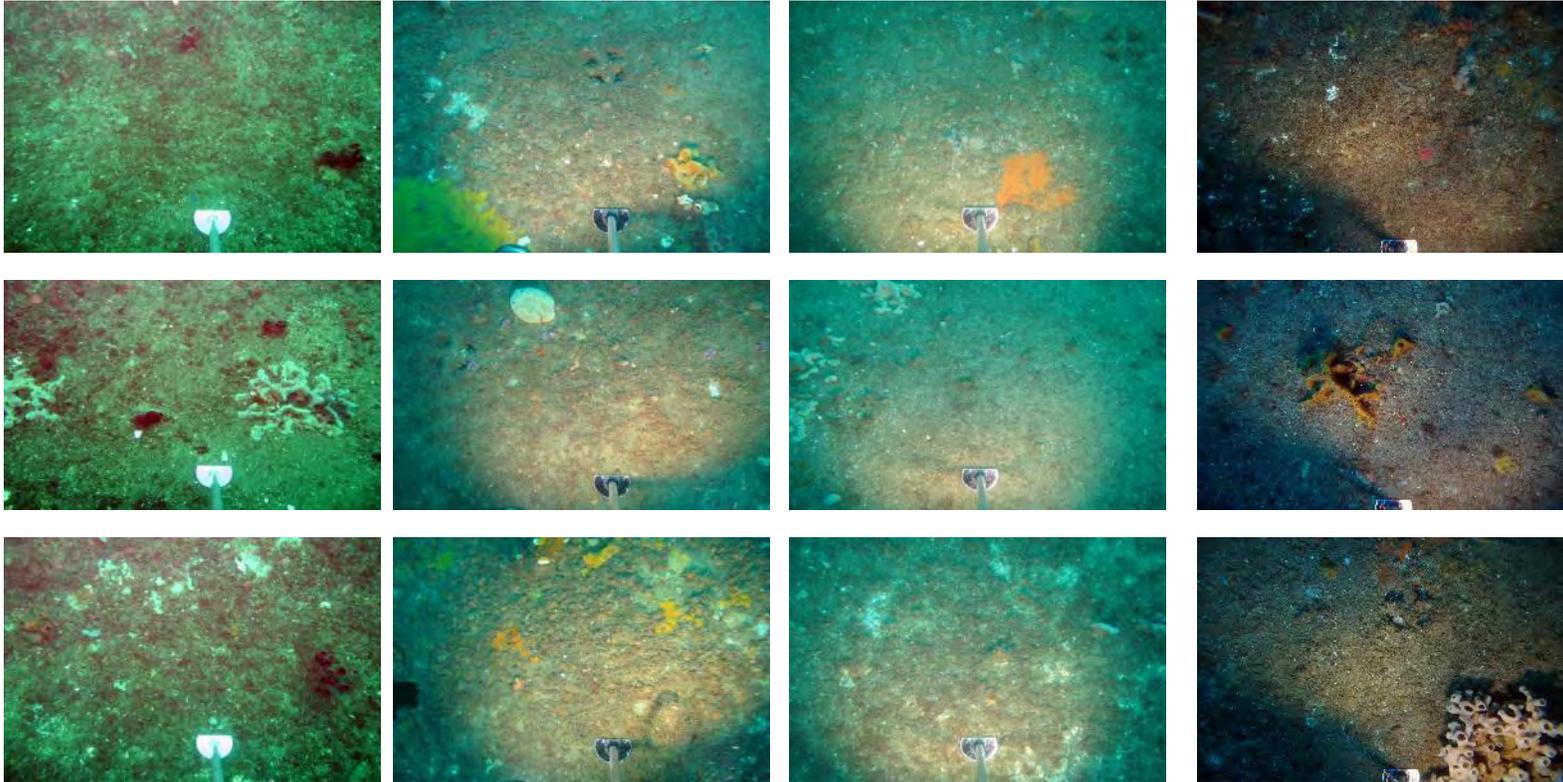
**Plate 6:** Deck Starbord Stern

Deck Starboard Stern	The deck was predominantly covered in serpulid tubes, barnacles and fine filamentous algae. Large tubular and papillate sponges were conspicuous on the deck surface. Fish observed included, tarwhine, one-spot puller and eastern red scorpioncod ( <i>Scorpaena cardinalis</i> ).
Horizontal Hull Port and Starboard	Similar to the previous survey, the hull, particularly the upper rim, remains densely colonised by sessile invertebrates, particularly large ascidians, on both the port and starboard sides of the ship. As with previous surveys, these included various ascidians such as <i>Herdmania momus</i> and a red unidentified species, large barnacles and encrusting sponges and bryozoans. Tiny orange and pink jewel anemones ( <i>Corynactis</i>

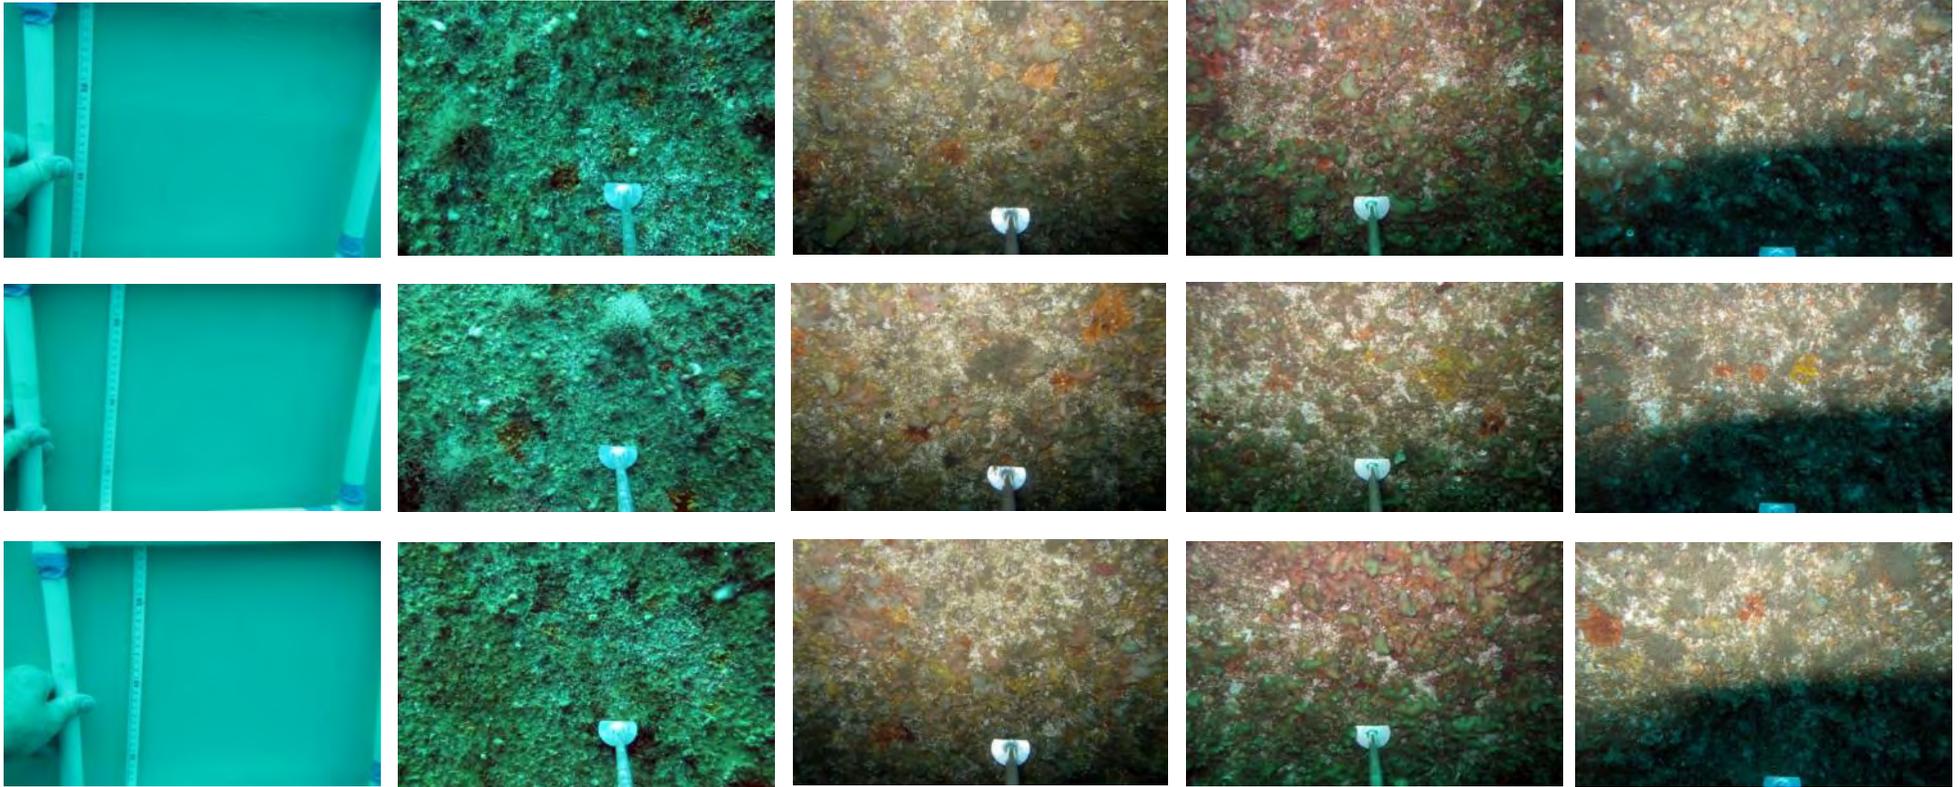
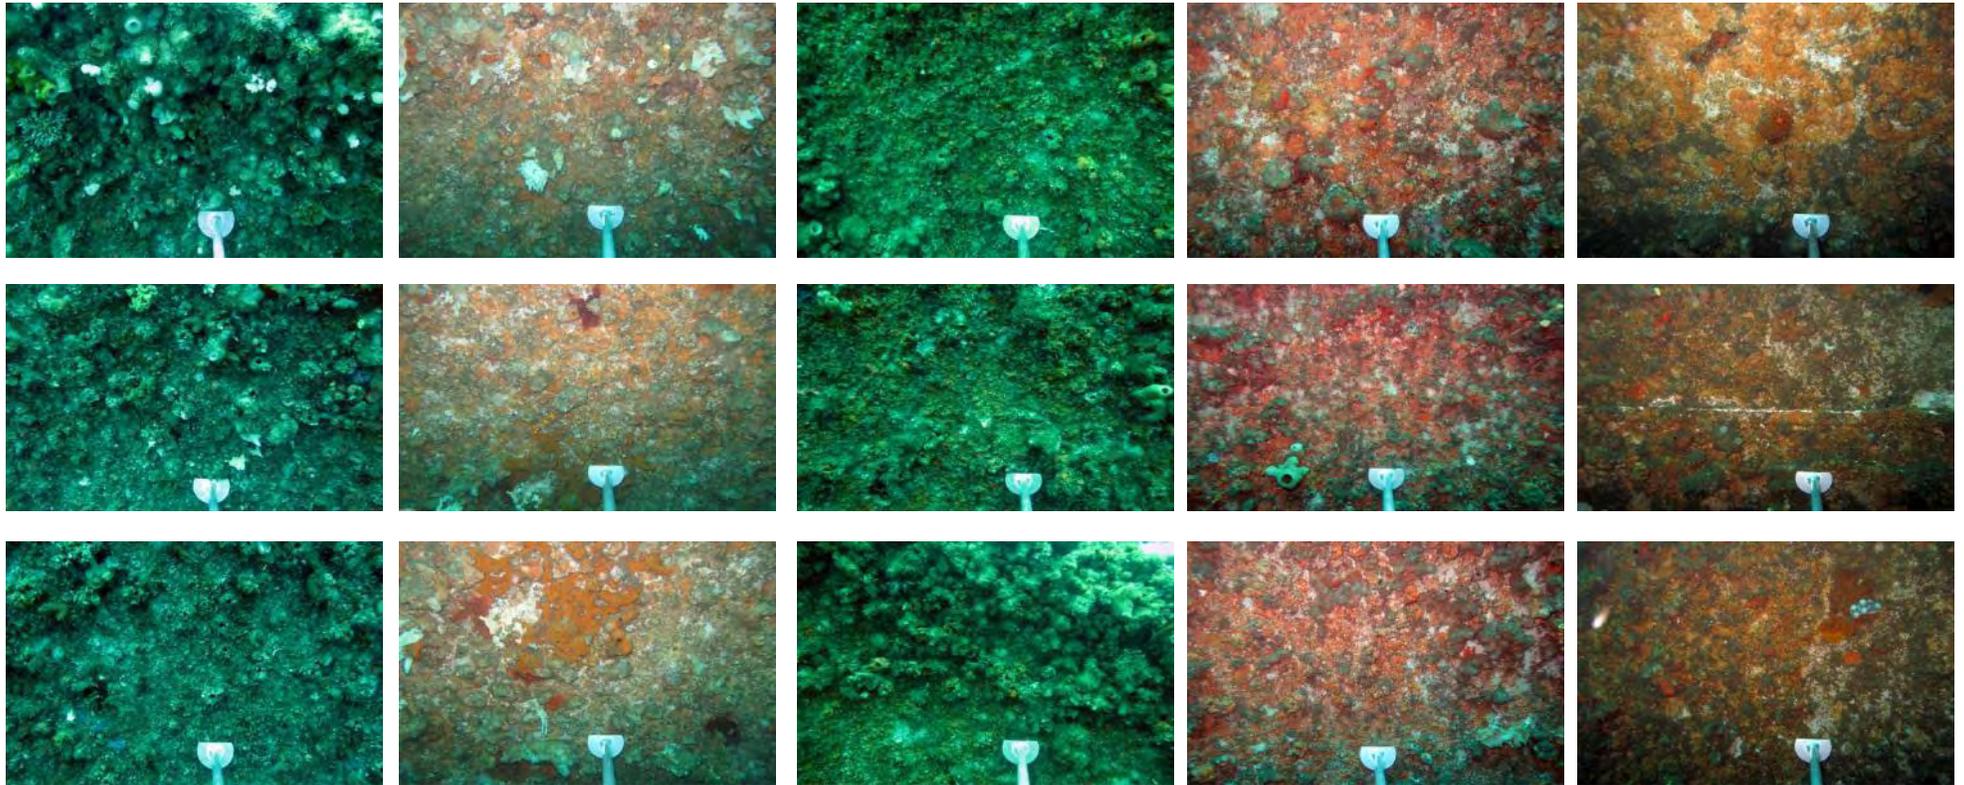
**Plate 9:** Vertical Hull Port Bow

Large ascidians such as *Herdmania momus*, barnacles and tiny orange and bright purple jewel anemones (*Corynactis* sp.) were the most prevalent encrusting biota on the vertical bow of the ship. As for the horizontal hull areas, the upper rim of the vertical bow areas had the thickest cover of invertebrates. Various encrusting and papillate sponges and bryozoans were also observed with brown filamentous algae overgrowing many of the large ascidians and barnacles. Hula fish were abundant around the bow area.
