Ex-HMAS Adelaide Artificial Reef Reef Community Monitoring Survey 3

Job Number: EL1112024E

**Prepared for: Department of Primary Industries – Catchments
and Lands**

May 2012

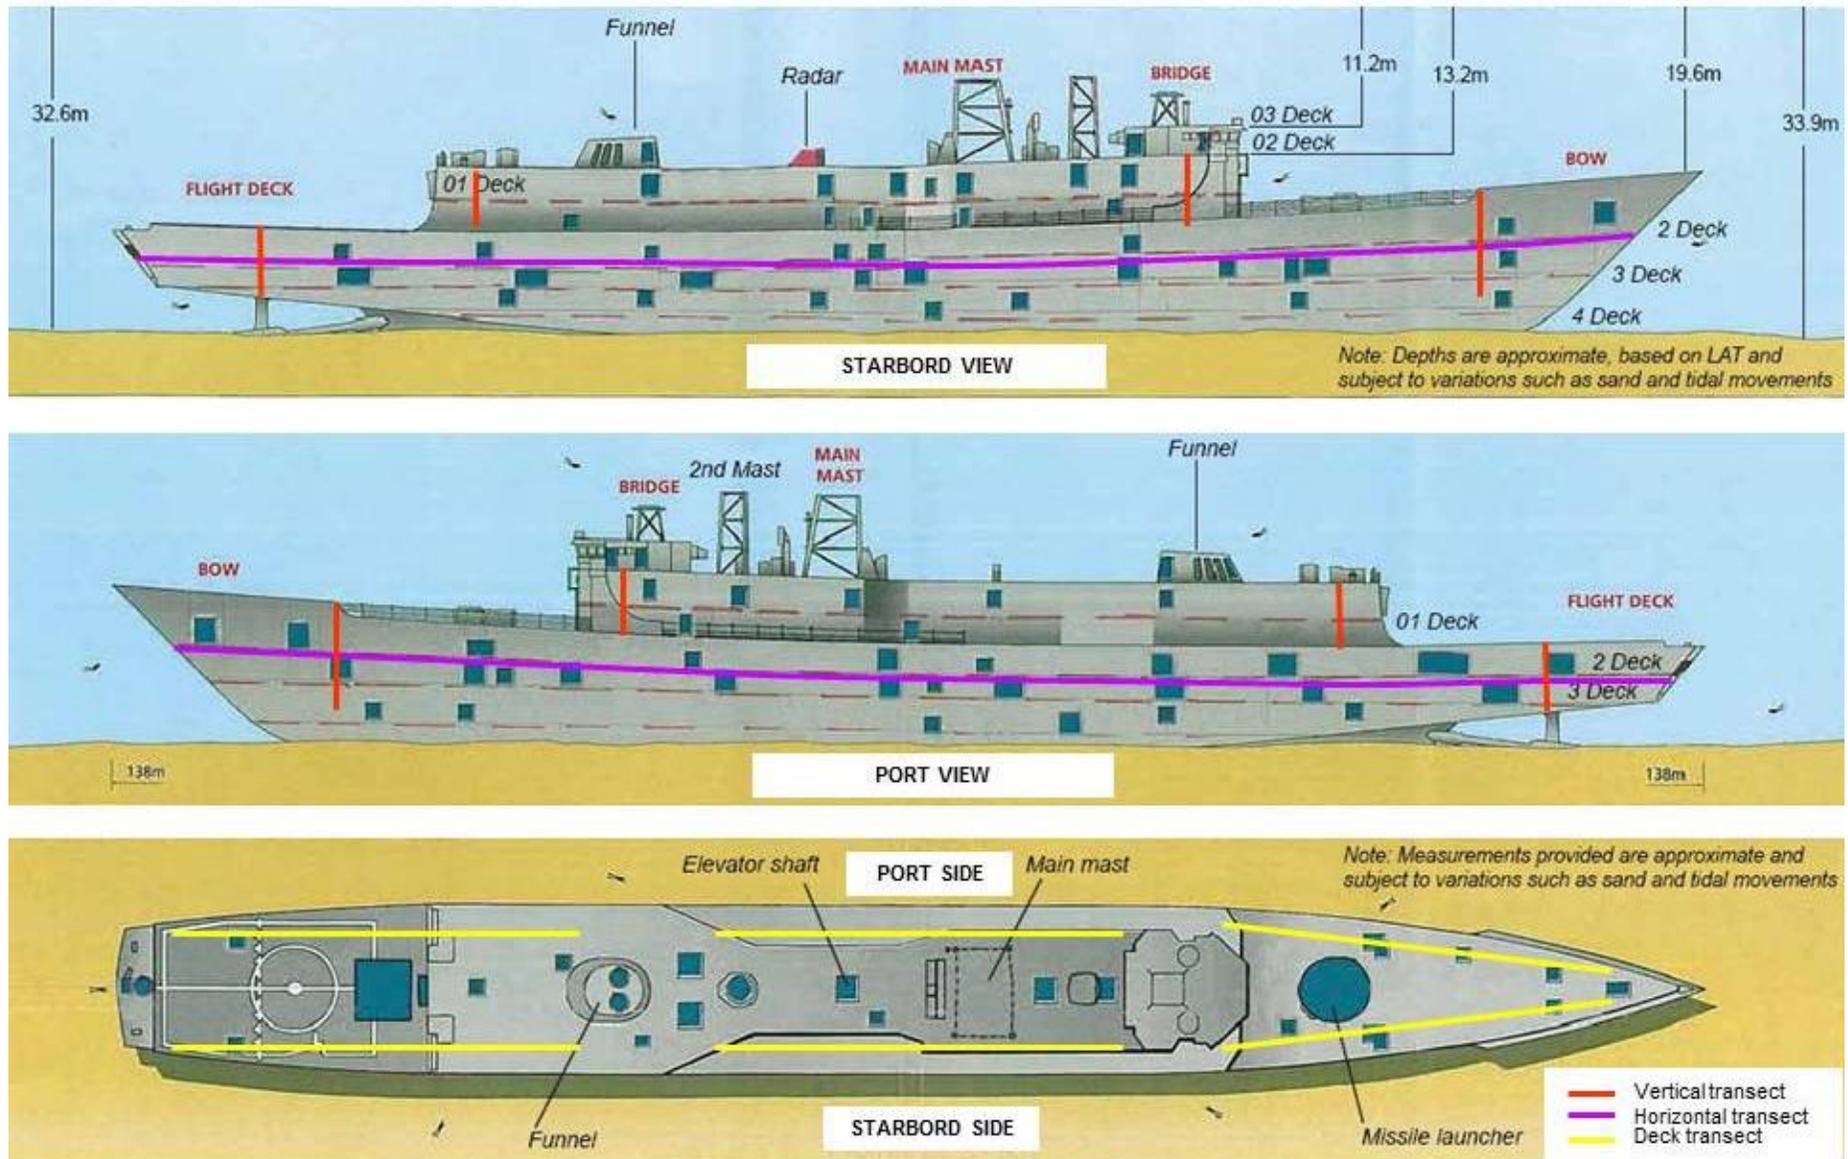
Figure 2: Plans of the Ex-HMAS Adelaide and Positions of the Reef Community Survey Sampling Transects.

The approximate locations of all transects are indicated on **Figure 2**.

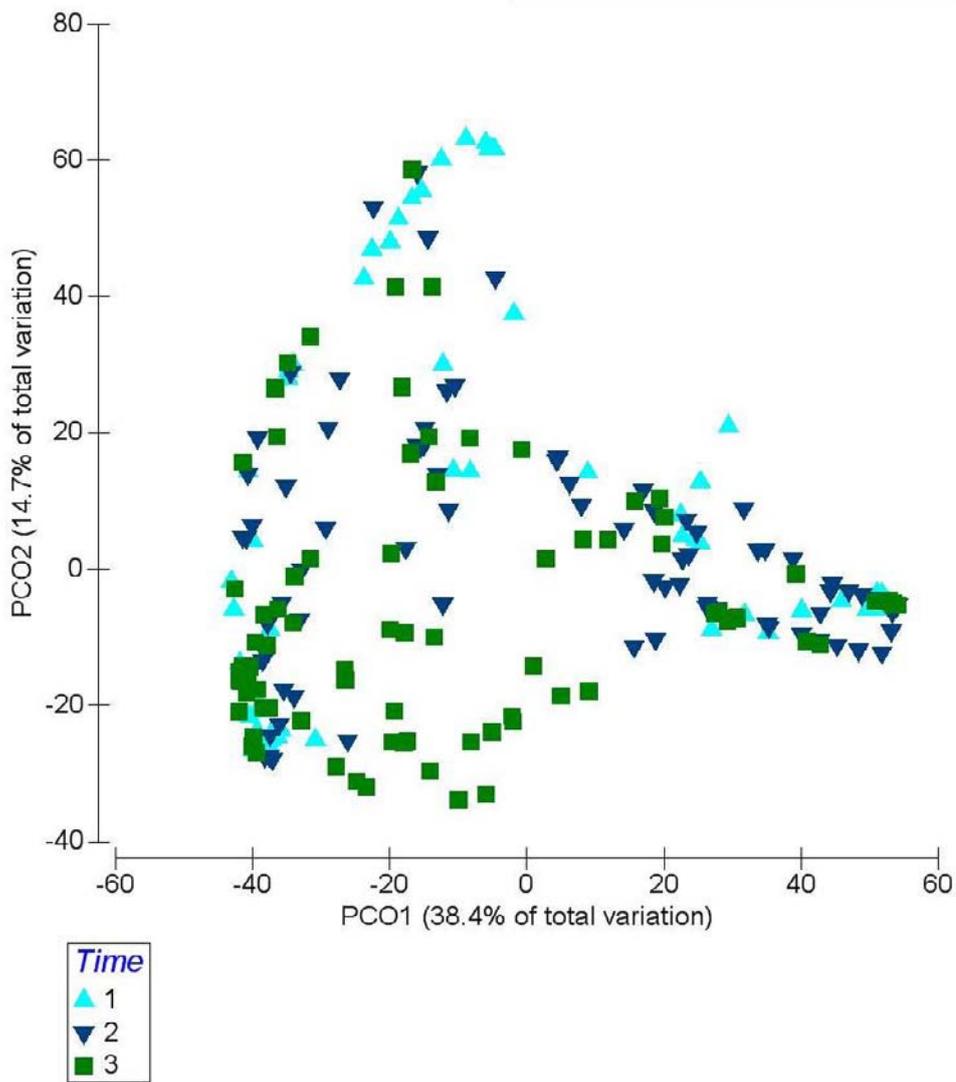
Figure 4: Principal Coordinates Analyses (PCoA) of Percent Cover of Encrusting Assemblages from Transects Taken at all Positions on the Ex-HMAS Adelaide for Surveys 1, 2 and 3.

Neither time nor position (depth and/or aspect) independently caused significant differences to assemblages associated with the ship. However, there was a significant interaction between time and transect (**Appendix C**), which indicated that the effect of time on assemblages was dependent on the location of the transect (i.e. deep or shallow, port or starboard). Pair-wise tests indicated that assemblages sampled from the deep starboard side

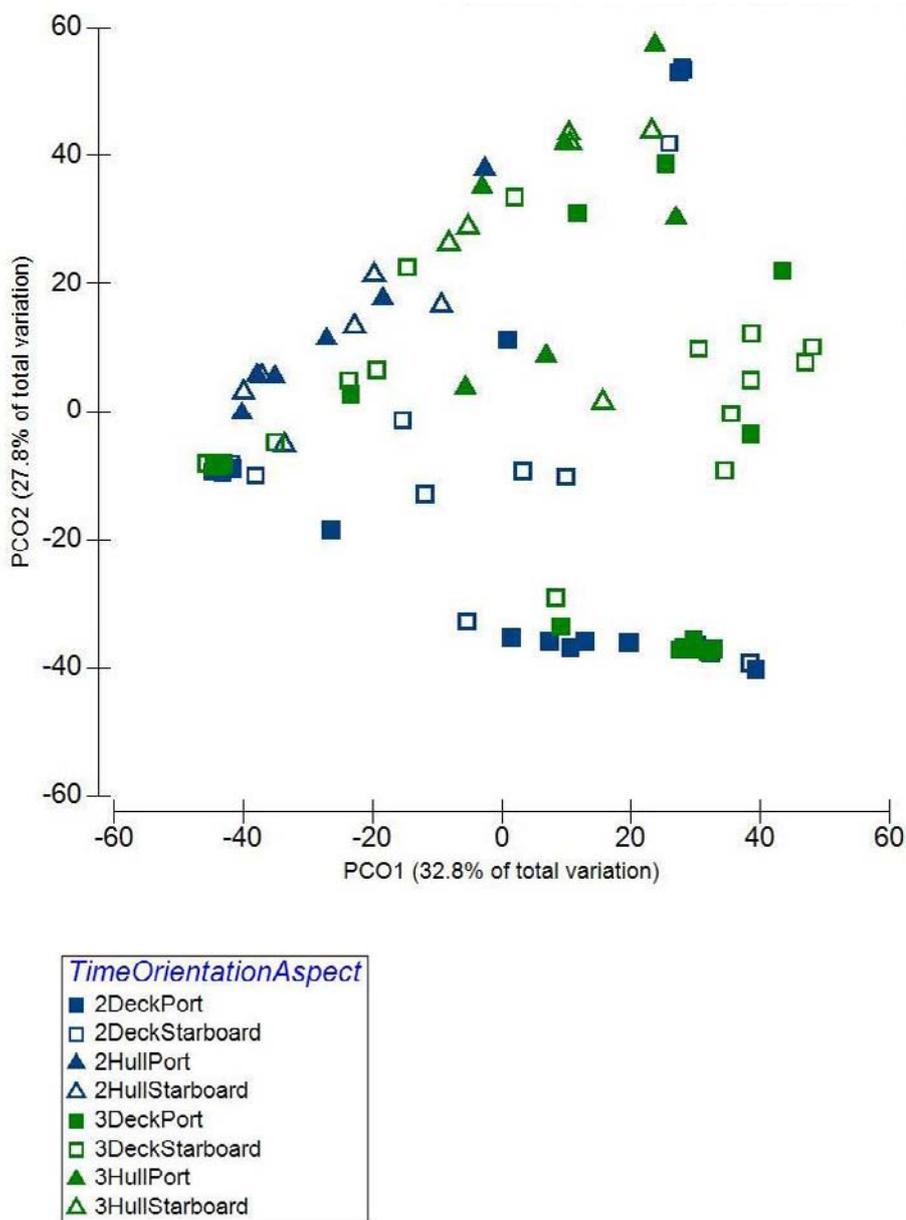
Figure 5: Principal Coordinates Analyses (PCoA) of Percent Cover of Encrusting Assemblages from Transects Taken on Hull and Deck Surfaces of the Ex-HMAS Adelaide for Surveys 2 and 3.

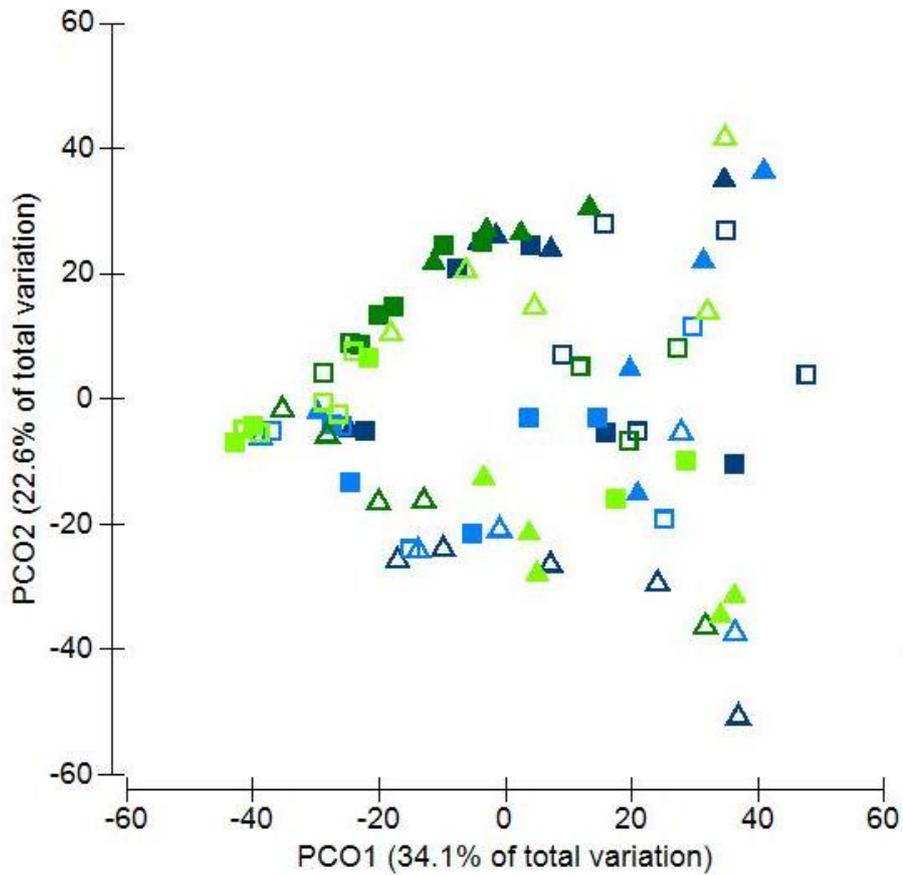
Figure 6: Principal Coordinates Analyses (PCoA) of Percent Cover of Encrusting Assemblages from Transects at Different Depths and Aspect on the Ex-HMAS Adelaide for Surveys 2 and 3.

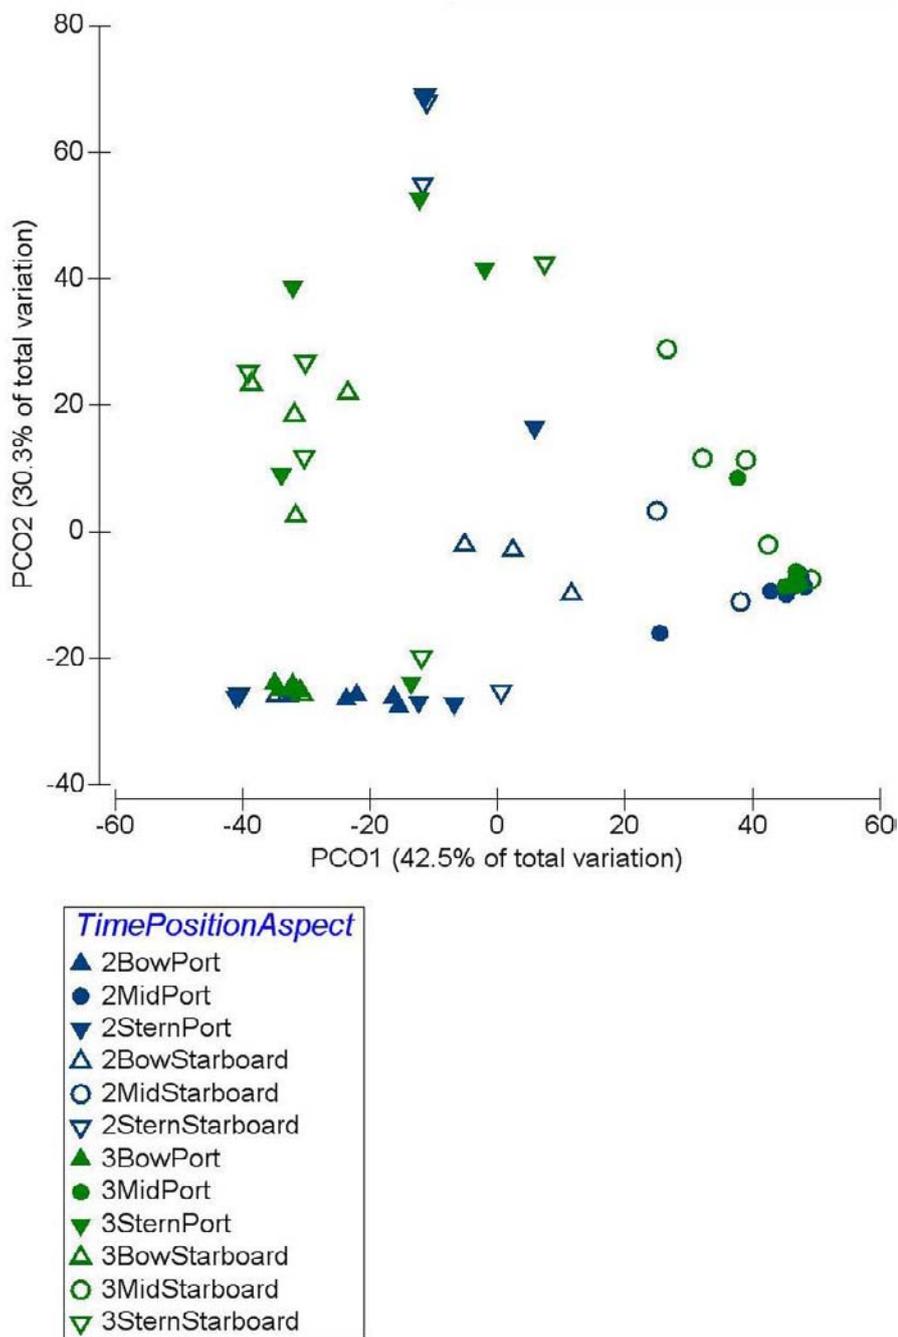
Figure 7: Principal Coordinates Analyses (PCoA) of Percent Cover of Encrusting Assemblages from Transects Taken at Different Positions on the Deck Ex-HMAS Adelaide for Surveys 2 and 3.

Species assemblages on the deck surfaces of the ship varied significantly between Surveys 2 and 3, regardless of their position (bow, mid, stern) or aspect (port or starboard side). Assemblages also varied significantly among the different positions on the ship (bow, mid, stern) and these differences were consistent for both Surveys 2 and 3 and both sides of the ship (i.e. port or starboard). Likewise, the assemblages sampled on either side of the ship (port or starboard) differed significantly, irrespective of time or position (**Appendix C**). These patterns are evident within the PCoA (**Figure 7**). Pair-wise tests for the factor 'position' showed significant differences occurred between all levels (i.e. bow, mid and stern) (**Appendix D**). Temporal differences were generally due to the increased sedimentation and growth of turfing brown algae with the already present serpulid matrix (**Appendix E**). Barnacles and encrusting algae also increased in cover from Survey 2 to Survey 3. Differences between assemblages sampled from the bow compared to those sampled from the mid and stern positions were generally due to a greater cover of turfing brown algae, sediment and serpulid worms on the bow of the ship. Differences between assemblages sampled from the mid and stern positions of the ship were due to a greater cover of serpulid worms on the mid-section of the ship. Assemblages from the stern were generally much greater in cover of turfing brown and encrusting algae, sediment, barnacles and serpulid worms compared to assemblages sampled from the mid-section. It also appeared from SIMPER analyses that the starboard side of the ship generally had a greater cover of serpulid worms and serpulids associated with turfing brown algae and sediment (**Appendix E**). The variation among samples observed at the time of Survey 3 was not significantly different from that measured during Survey 2 (**Appendix F**).

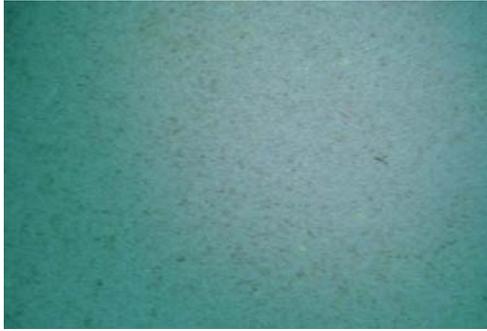
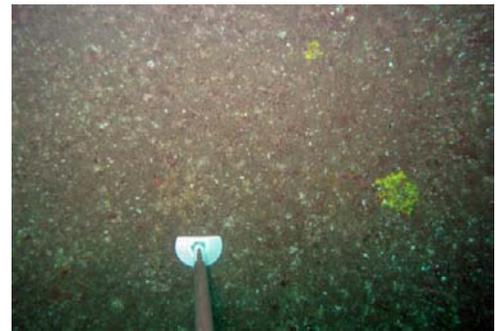
Plate 1: Deck port bow

Position	Description of Assemblage
Deck Port Bow	The railings had become heavily colonised with ascidians and brown algae with some sponges and branching red algae noted. Encrusting growth of turfing brown algae covered the flat areas of the deck while sessile invertebrates were absent on the majority of the deck. Mado (<i>Atypichthys strigatus</i>) were abundant, while leatherjackets (family Monacanthidae) and tarwhine (<i>Rhabdosargus sarba</i>) were also common.
Deck Port Mid	Turfing brown algae covered the deck while Kelp (<i>Ecklonia radiata</i>) and branching red algae formed conspicuous patches. An unknown bright white encrusting substance (observed in previous survey) remained present. The superstructure and areas of railing had become heavily colonised with ascidians and turfing brown algae. Schools of mado and tarwhine were common.
Deck Port Stern	The deck was predominantly covered in brown turfing algae and serpulid polychaete tubes with some sand although the reef assemblage on this part of the ship was relatively sparse compared to the midship deck. Silver trevally (<i>Pseudocaranx dentex</i>) was observed schooling around the deck.

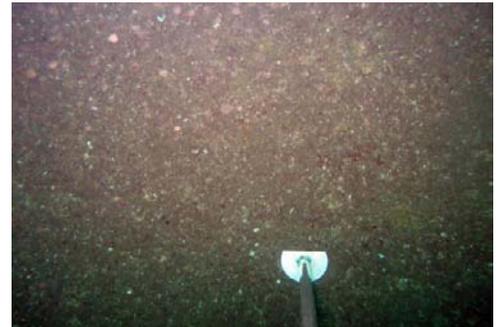
Plate 4: Deck Starbord Bow

Deck Starbord Bow	Encrusting growth of predominantly brown turfing/filamentous algae was abundant on the flat areas of the deck with patches of encrusting sponges. A school of silver trevally was observed. Tarwhine was observed feeding on the deck.
Deck Starbord Mid	Turfing/filamentous brown algae was abundant on the deck while Kelp (<i>Ecklonia radiata</i>) has now become established. Branching red algae and encrusting yellow sponges were also observed on the deck. The rails and other vertical / complex structure on the deck were heavily colonised by sessile invertebrates. Mado were abundant amongst complex structures and kelp patches. Patches of a bright white encrusting substance were again present.
Deck Starbord Stern	Encrusting growth of predominantly brown turfing/filamentous algae dominated the flat areas of the deck. Schools of tarwhine and silver sweep (<i>Scorpiis lineolata</i>) were observed.

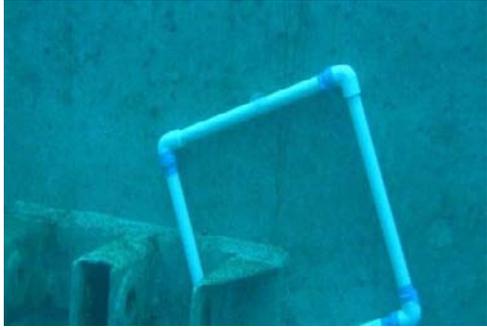
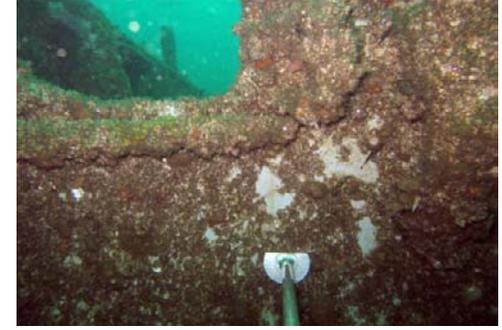
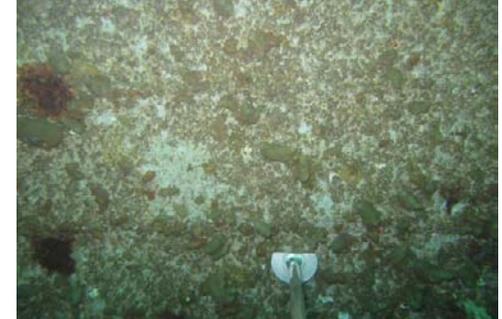
Plate 7: Horizontal Hull Port

Horizontal Hull Port and Starbord	The hull has become colonised by sessile invertebrates on both the port and starbord aspects of the ship. These include ascidians (predominantly consisting of <i>Herdmania momus</i>) and a range of encrusting sponges. Eastern blue groper (<i>Achoerodus viridis</i>) and red morwong (<i>Cheilodactylus fuscus</i>) were observed swimming alongside the hull.

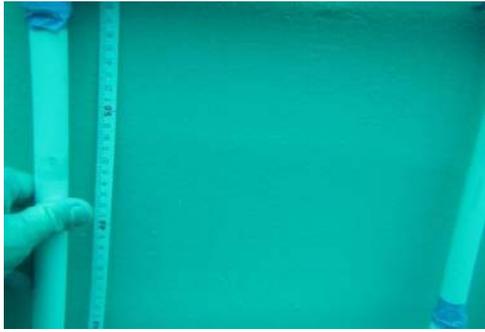
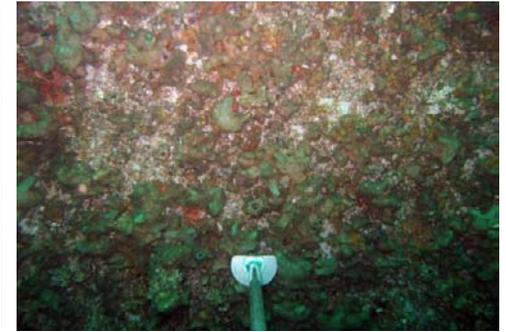
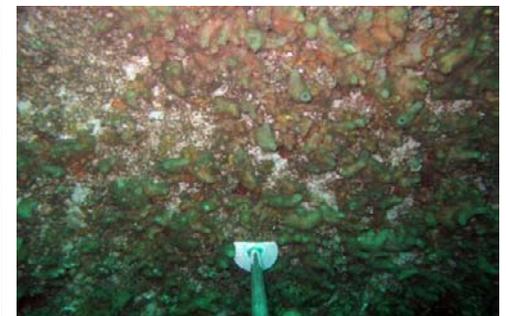
Plate 9: Vertical Hull Port Bow

Vertical Hull Bow	Ascidians were prevalent on the hull of the ship, while barnacles, various encrusting and papillate sponges were also observed.
Vertical Hull Stern	The cover consisted of predominantly of ascidians, sponges and barnacles.
Vertical Hull Superstructure	The cover consisted of predominantly a combination of ascidians, sponges and barnacles.
