# **Ex HMAS Adelaide Artificial Reef Sediment Quality Monitoring Survey 1**

**Job Number: EL1112024**

**Prepared for Department of Primary Industries –  
Catchments and Lands**

**December 2011**

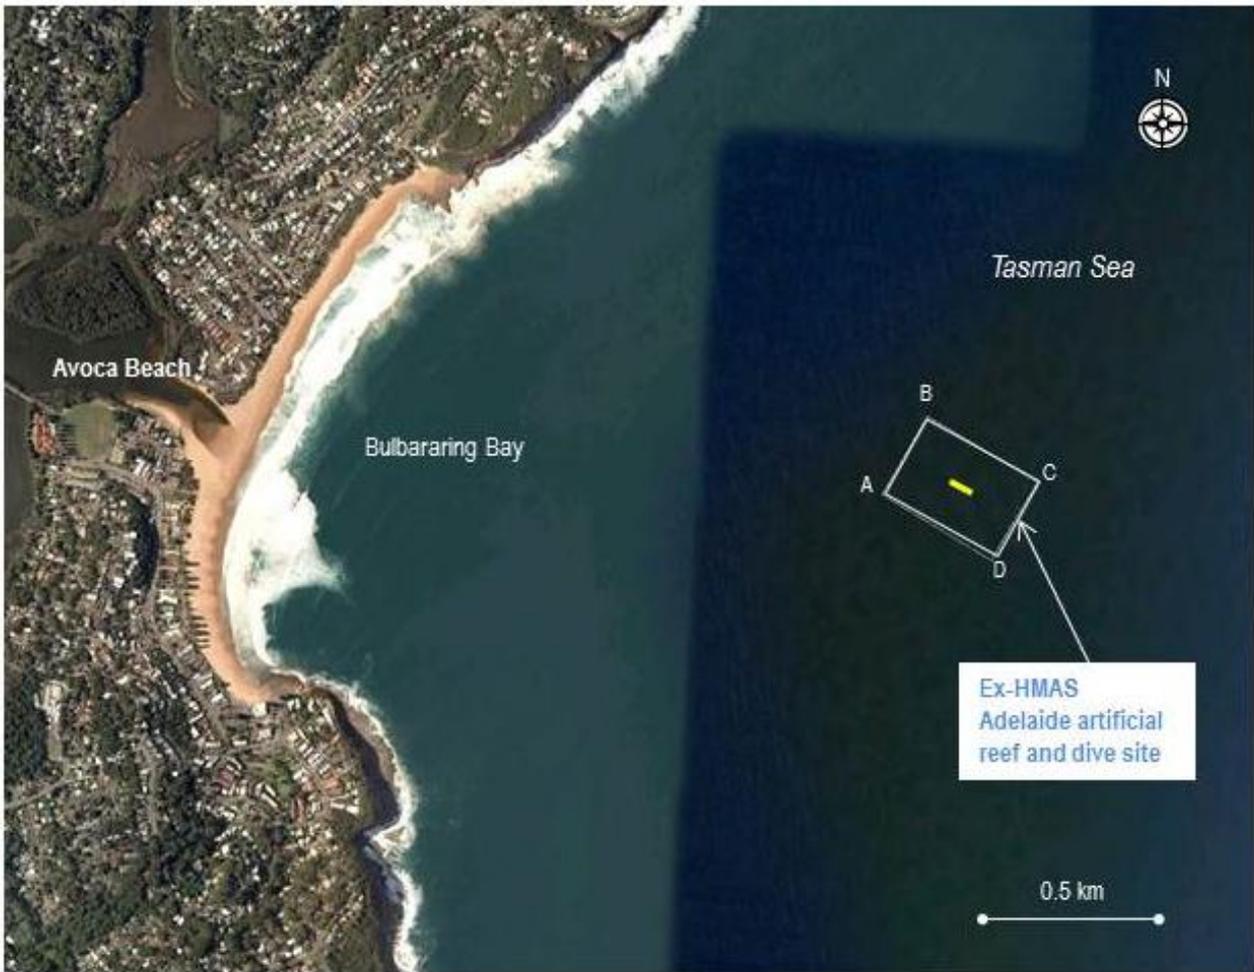
Boundary of Dive Site	Easting (MGA 94)	Northing (MGA 94)
A	356428.713	6296117.693
B	356538.438	6296341.142
C	356850.615	6296188.618
D	356742.410	6295963.310

**Figure 1: Location of Ex-HMAS Adelaide Artificial Reef and Dive Site.** The approximate location and orientation of the ship is indicated by the yellow line.

The Ex-HMAS Adelaide artificial reef and dive site is located within Bulbararing Bay, approximately 1.87 km offshore from Avoca Beach. The ship lies at a depth of approximately 32 m to 34 m of water at Lowest Astronomical Tide (LAT) on top of a relatively flat, sandy substratum. There is a minimum of 6 m of sand overlying bedrock. The vessel is orientated with the bow facing into the prevailing ESE swell direction (**Figure 1**).

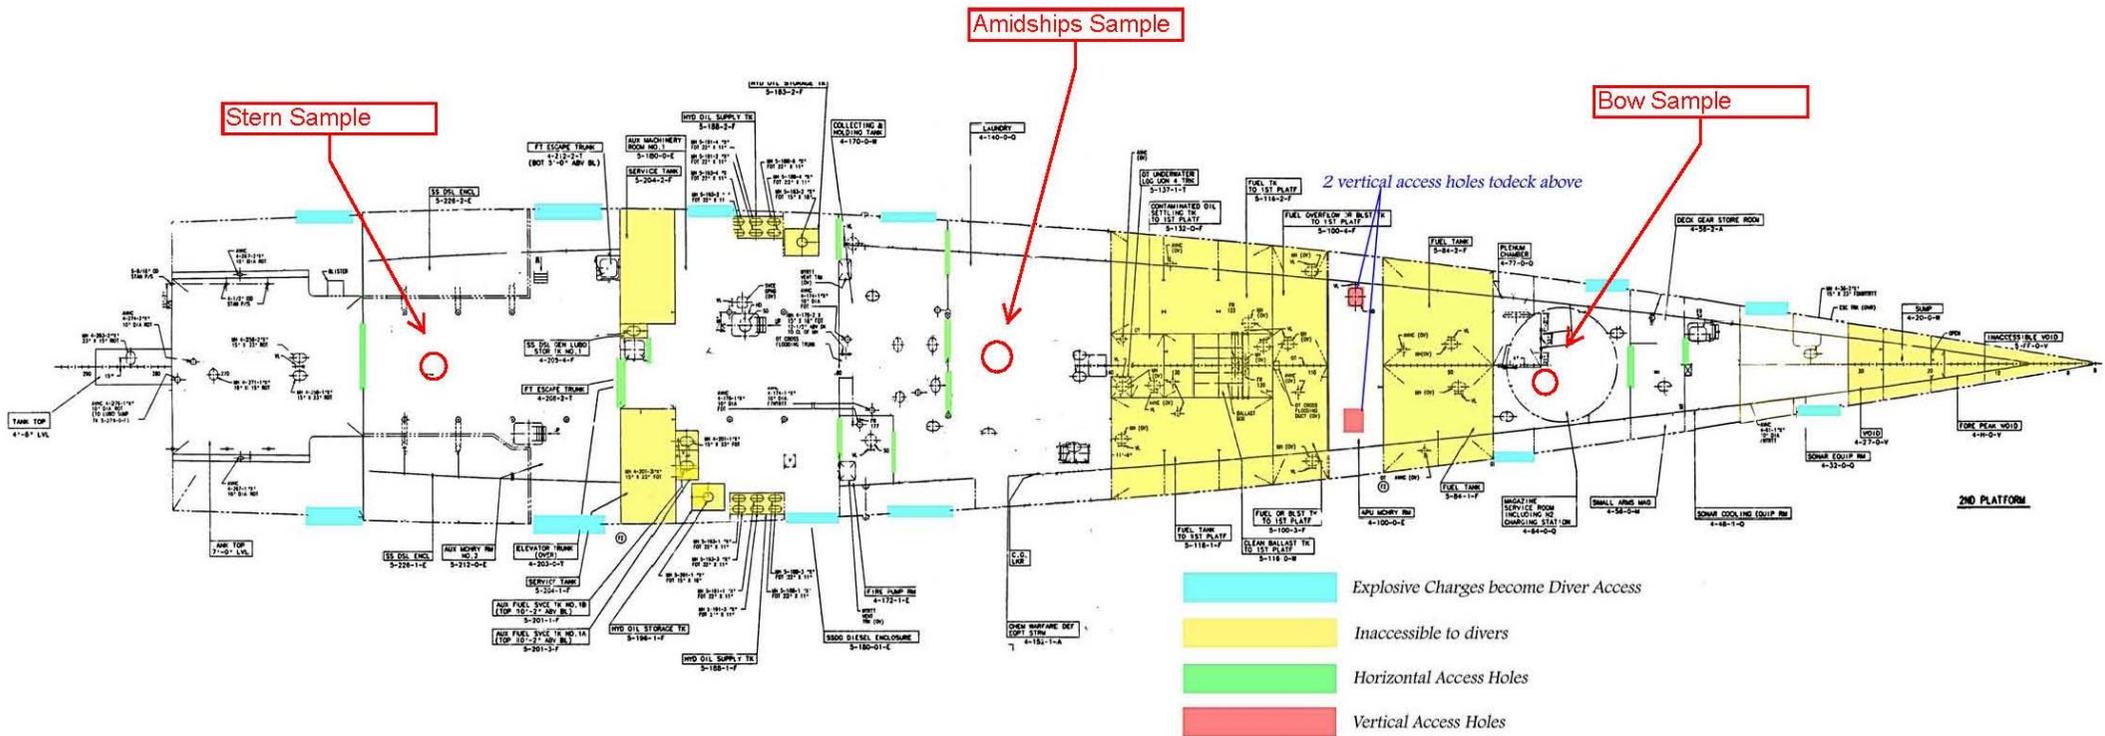
Figure 3: Locations of Sediment Sampling Sites within the Hull of the Ex-HMAS Adelaide. Samples were collected by divers from McClelland's Diving Services on 06 October 2011.

Samples were collected by commercially qualified (ADAS Part 3) divers and sealed into zip-lock polyurethane bags, placed inside a second bag and then placed in an esky. Samples were refrigerated at 4°C overnight, then sent by courier to ALS laboratories, Sydney (an NATA accredited laboratory) for processing the following day. These samples were analysed for lead concentration only, as per the requirements of the LTMMP.

Sediments from within the ship's hull were collected on 5 October 2011 by a team of commercially qualified (ADAS Part 3) divers supplied by McClelland Diving Services. Sea conditions were calm and fine with a light offshore (NNW) breeze (BOM 2011). The tide was low in the morning (0.6 m) pushing to a high of 1.5 m in the afternoon (16:05). Lead concentrations found in all three samples were less than 5 mg/kg which was well below the lower ISQG trigger value of 50 mg/kg.
