Ex HMAS Adelaide Artificial Reef Sediment Quality Monitoring Survey 2

Job Number: EL1112024

**Prepared for Department of Primary Industries –
Catchments and Lands**

January 2013

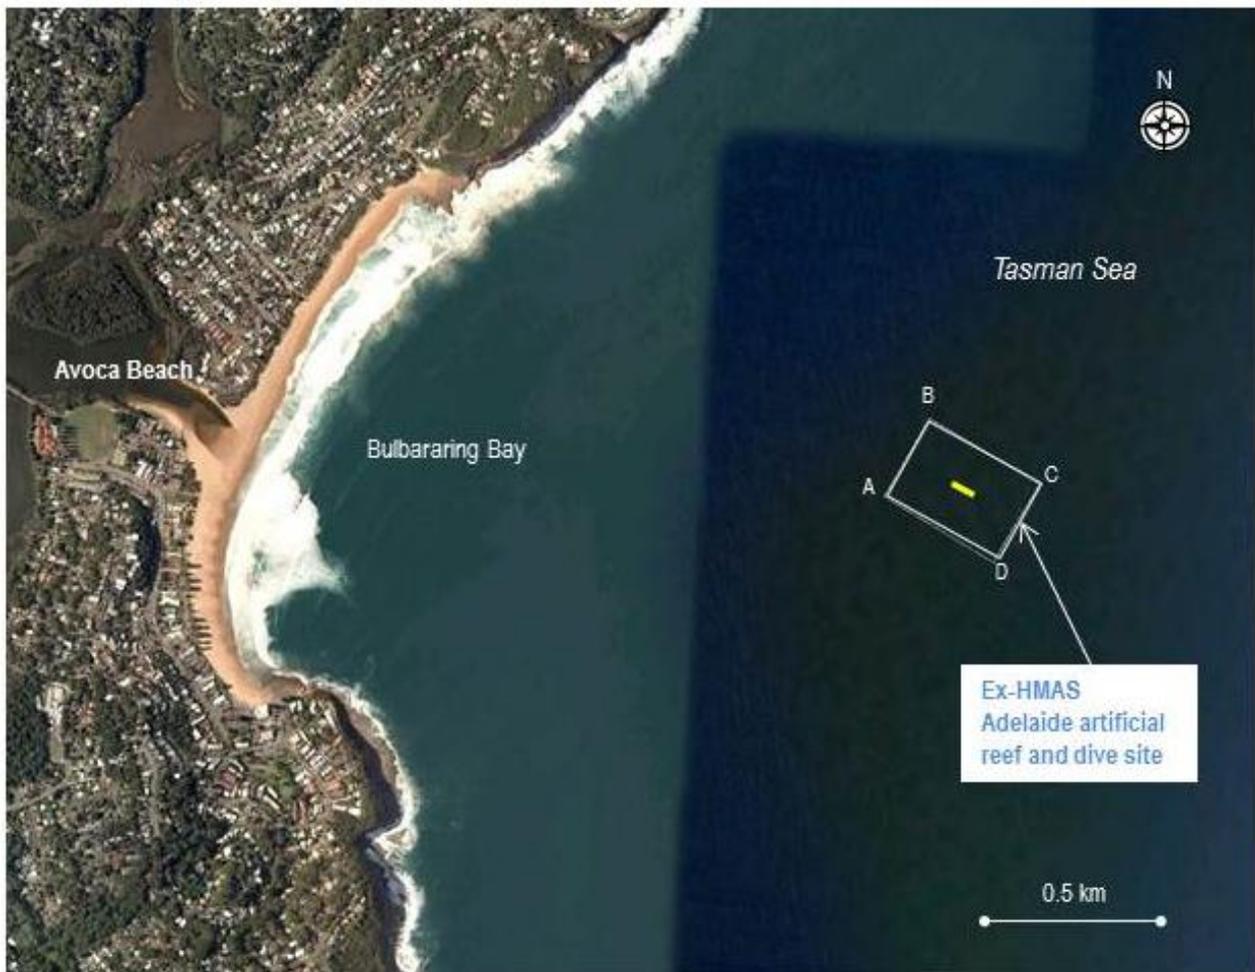
Boundary of Dive Site	Easting (MGA 94)	Northing (MGA 94)
A	356428.713	6296117.693
B	356538.438	6296341.142
C	356850.615	6296188.618
D	356742.410	6295963.310

Figure 1: Location of Ex-HMAS Adelaide Artificial Reef and Dive Site. The approximate location and orientation of the ship is indicated by the yellow line.

The Ex-HMAS Adelaide artificial reef and dive site is located within Bulbararing Bay, approximately 1.87 km offshore from Avoca Beach. The ship lies at a depth of approximately 32 m to 34 m of water at Lowest Astronomical Tide (LAT) on top of a relatively flat, sandy substratum. There is a minimum of 6 m of sand overlying bedrock. The vessel is orientated with the bow facing into the prevailing ESE swell direction (**Figure 1**).

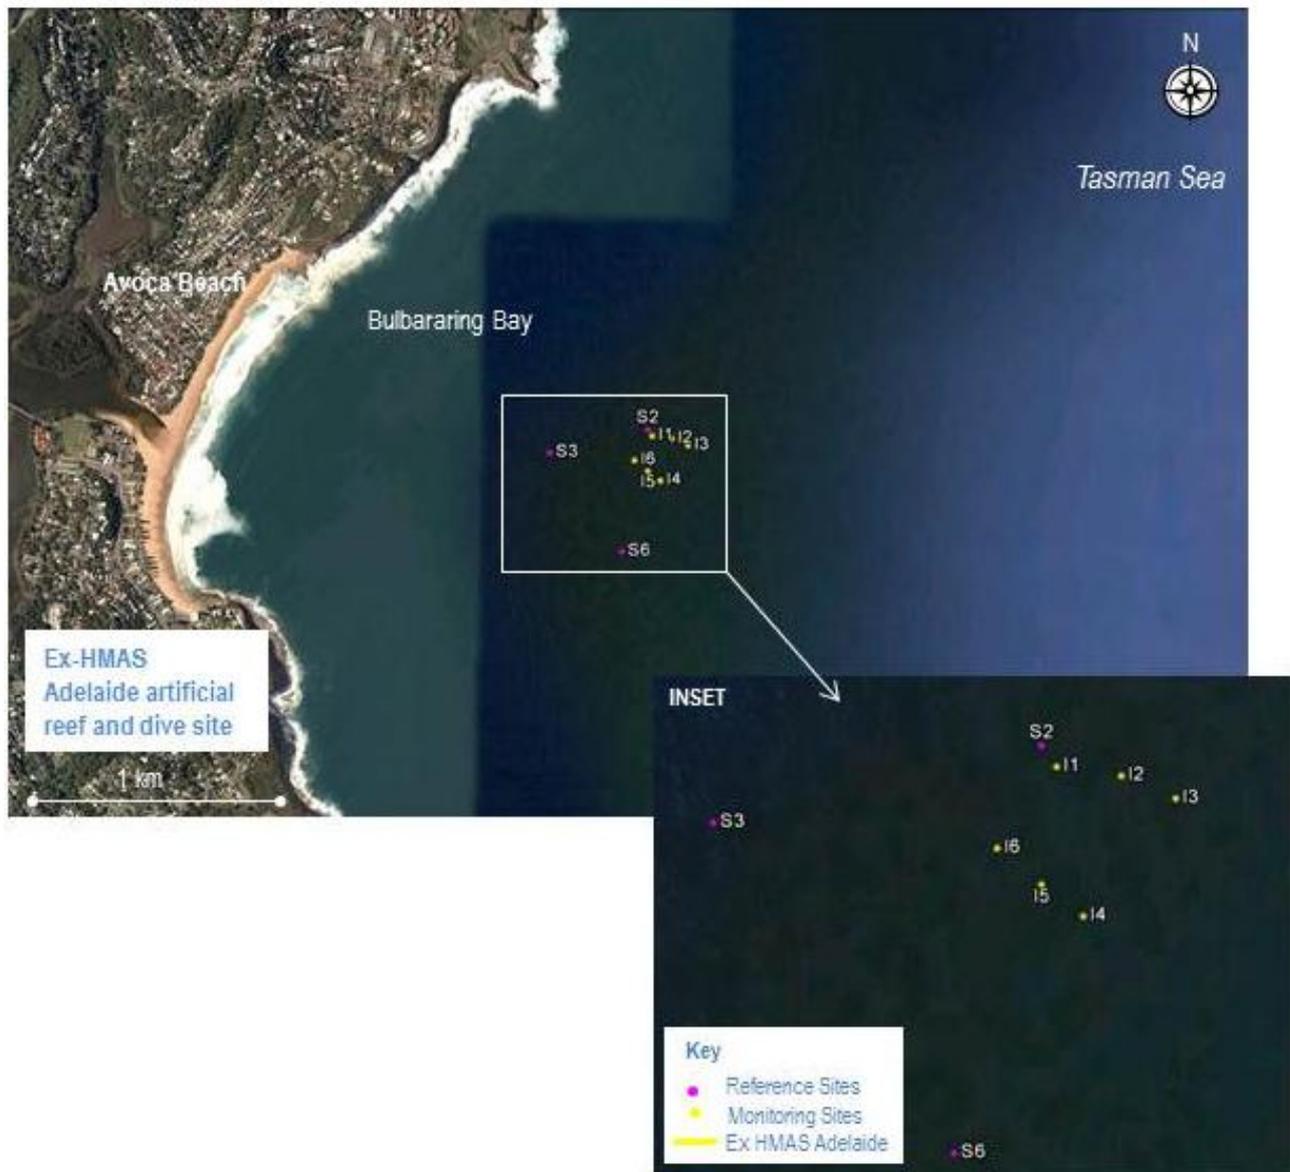
Figure 2: Locations of Marine Sediment Quality Sampling Sites.

Samples were collected from the same sites as those pre-determined by Worley Parsons in the earlier (one month post-scuttling survey) and subsequent monitoring surveys. These included a total of nine samples with three reference locations (S2, S3 and S6) and six monitoring locations (I1, I2, I3, I4, I5 and I6). For continuity, the same location ID's as previous surveys were used. Locations and GPS positions of the nine sampling locations are given in Table 1 and Figure 2.

Table 1: GPS Positions of Marine Sediment Quality Sampling Sites (Coordinates are in MGA 94).

Sample Point	Latitude (S)	Longitude (E)
Control Site - S2	33°27.829'	151°27.416'
Control Site - S3	33°27.880'	151°27.157'
Control Site - S6	33°28.099'	151°27.347'
Monitoring Site - I1	33°27.843'	151°27.428'
Monitoring Site- I2	33°27.849'	151°27.479'
Monitoring Site - I3	33°27.864'	151°27.522'
Monitoring Site - I4	33°27.942'	151°27.449'
Monitoring Site - I5	33°27.921'	151°27.416'
Monitoring Site - I6	33°27.897'	151°27.381'
