Fact sheet | Urunga Wetlands

The Urunga Wetlands site is now a valuable community space following a \$10 million program of extensive remediation and parkland work. It has been transformed from a once barren wasteland to a lively wetland habitat.

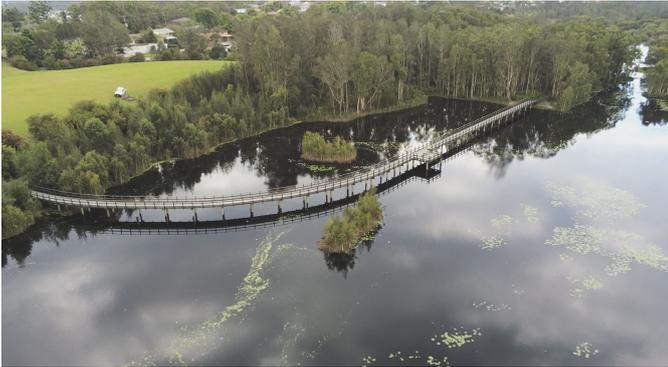
Timber boardwalk over Urunga Wetlands

A great destination for locals and visitors to the region, the site has a 150 metre boardwalk allowing people to walk over the wetland and a 450 metre walking track surrounding the park.

The validation for public open space was successful and allowed the site to be developed into parkland with infrastructure that includes a 450 metre sealed footpath and 150 metre boardwalk out over the wetland.

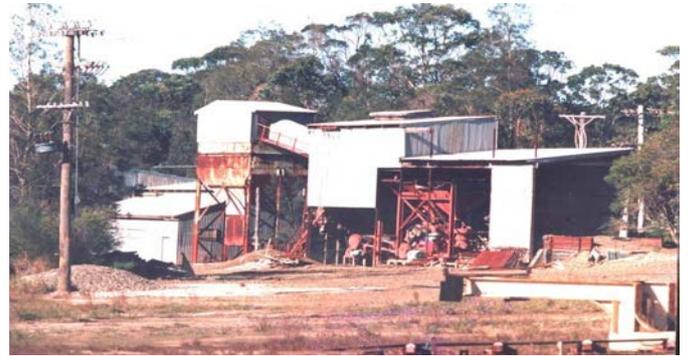
The old antimony processing plant (circa 1980)

The processing plant was used for extracting heavy metal antimony from its ore, stibnite.

After the ore was delivered to the site, it was crushed and the antimony removed using complex chemical reagents and equipment.

The antimony processing required large volumes of water, which was released after use onto the adjoining wetland foreshore.

These waste tailings were rich in heavy metals including antimony, arsenic, lead and reagent residues of cyanide and cresylic acid.

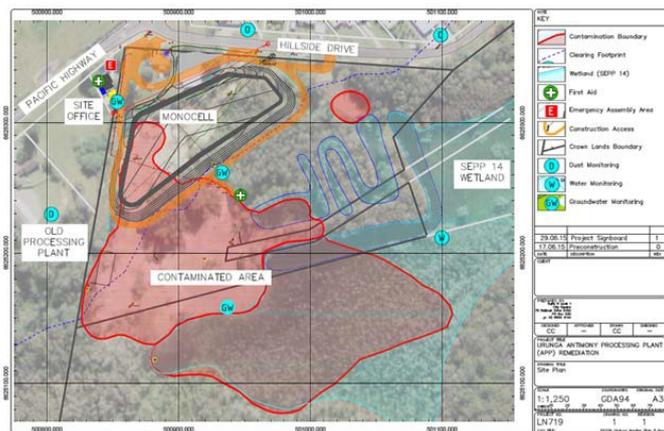
Site plan showing the contaminated area

A two year investigation was undertaken with the assistance of GHD Pty Ltd. The investigation was required to understand the type of contamination affecting the site so that the best remediation options could be developed.

The recommended option approved by the Environmental Protection Authority involved excavating the site, treating the contaminated material and then placing it in a specially engineered containment cell that was to be covered and revegetated.

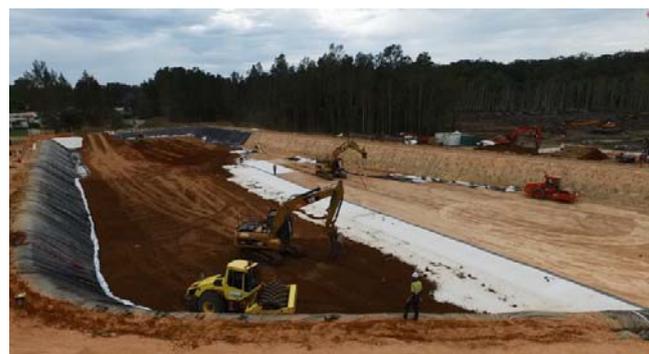
The base of the containment cell during construction (2016)

Only a grassy mound now indicates where the containment cell is located, but beneath that surface is an engineered structure with 15 different layers.

The containment cell was designed for a 100 year life. It functions by separating the treated waste from all water streams, including surface waters and groundwater.

The structure is fitted with a leachate collection layer. It has an access pipe to facilitate monitoring and sampling and also allows for leachate removal if required.

This material was stockpiled and then treated with chemicals to stabilise the waste before disposing of it in an engineered containment cell constructed on-site.

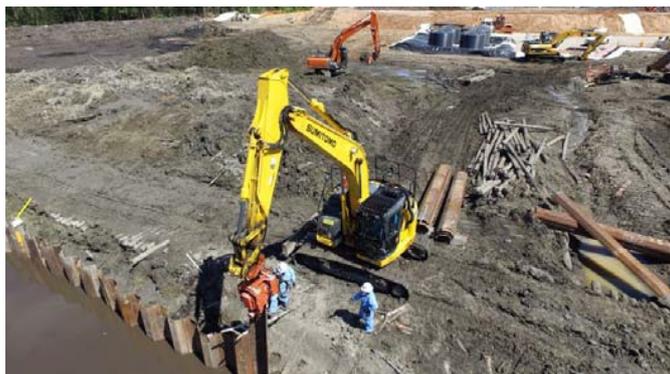
Installing a sheet pile wall to hold back the wetland water

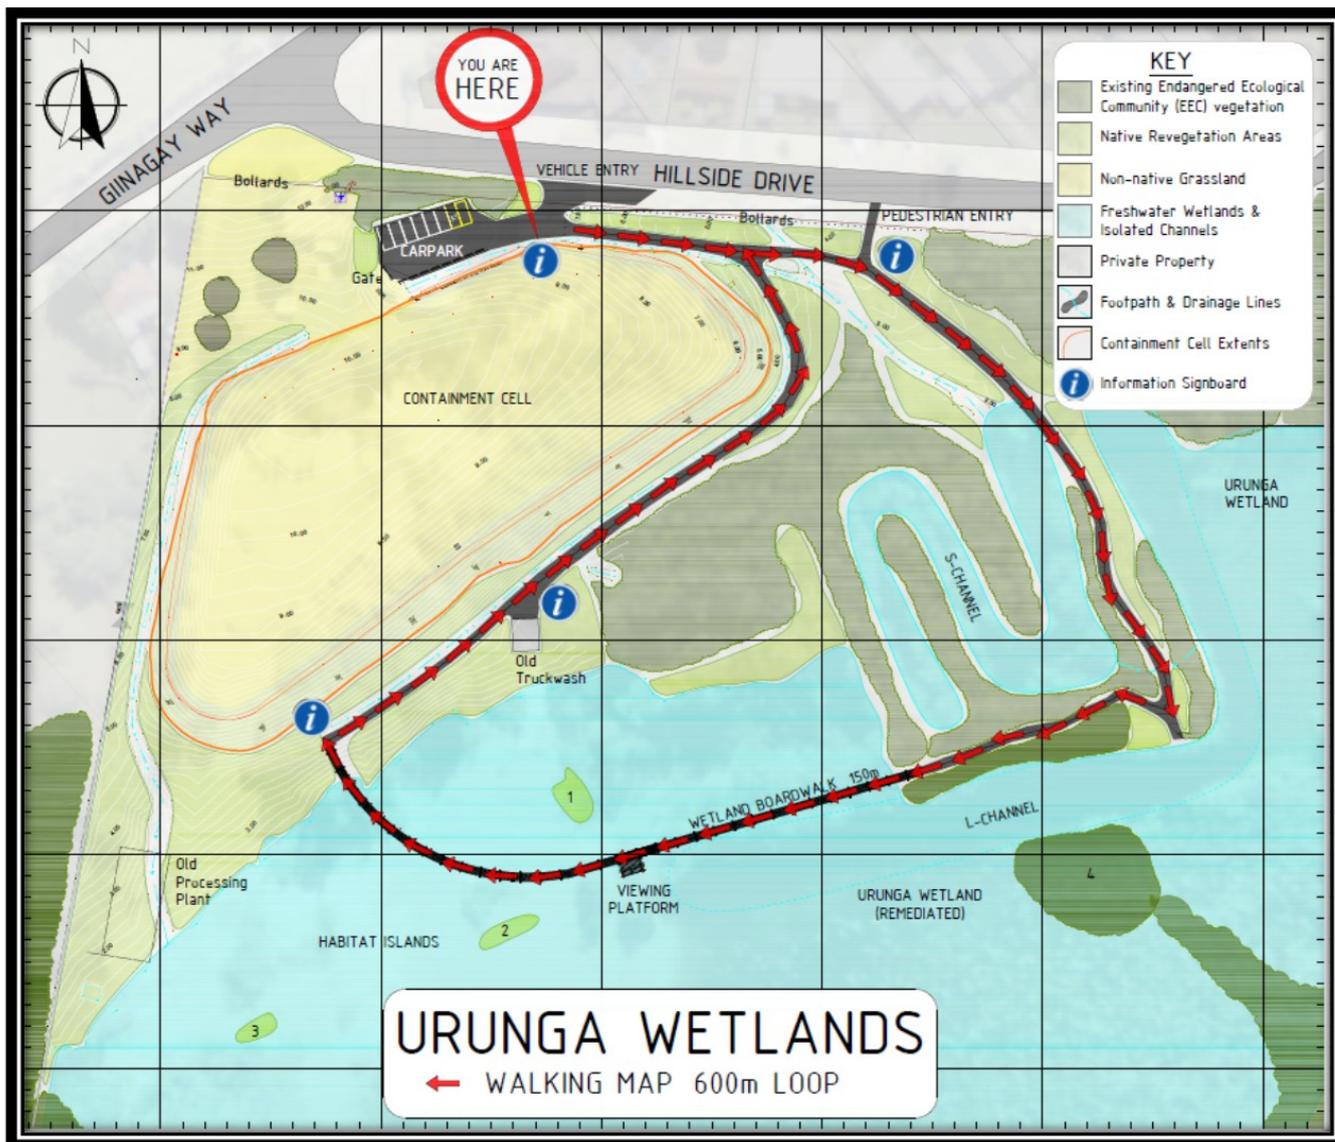
Walking trail around Urunga Wetlands

The walking trail around Urunga Wetlands takes you in a 600 metre circuit from the carpark, down to the water’s edge and across the boardwalk back up past the containment cell, which looks like a grassy mound.
