Stage 1 & 2 Site Contamination Assessment

Proposed Visitor Information Centre

17 Denison Street, Gloucester

Report No. RGS02423.1-AB

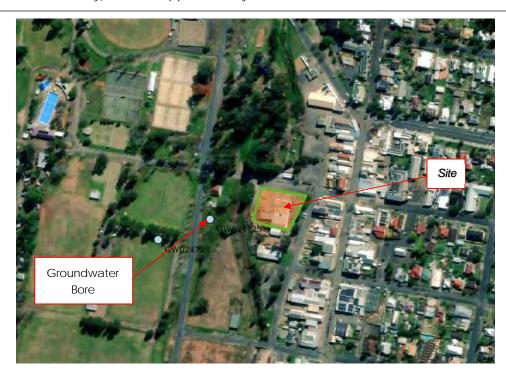
Plate 2: Approximate site boundary outlined in green. Nearest off-site licensed groundwater bore is located approximately 900m to the west of the site.

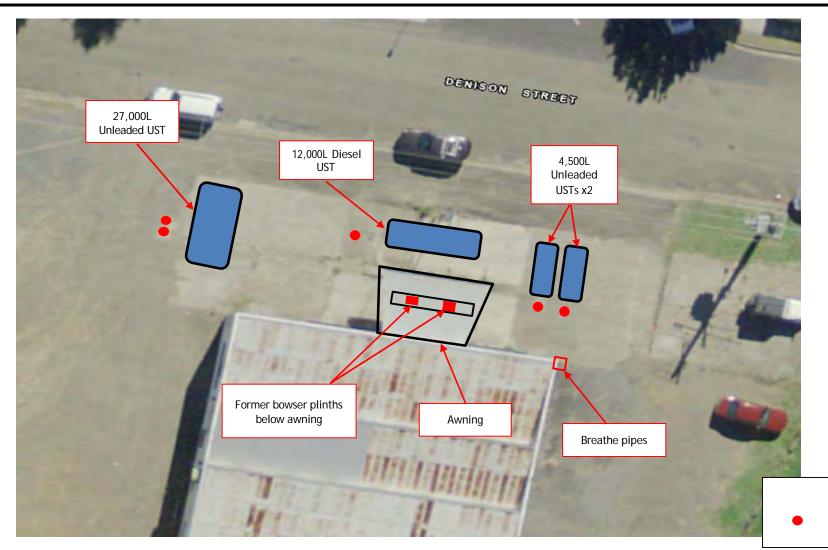
Client:	Midcoast Council	Job No.	RGS02423.1
Project:	Drawaged Visitor Information Contra	Drawn By:	APH
	Proposed Visitor Information Centre	Scale:	As Shown
	17 Denison Street, Gloucester	Date:	25-Jan-22
Title:	Former Fuel Services Layout Plan	Drawing No.	Figure 2

- Anecdotal and land title information suggests that the site has previously been used as a service station, machinery shop and a tyre service centre;
- Site observations indicate that the USTs are still in-situ in the layout as shown on site plans included in the search of the hazardous chemicals on premises database;

It is recommended that a contractor experienced in the removal of USTs be engaged to facilitate the removal of the USTs and associated fuel infrastructure. The removal should be supervised by a suitably qualified environmental consultant and should involve PID screening of the remedial excavations followed by validation sampling in accordance with the specifications outlined in the RAP. Validation sampling of the floors and walls of the remedial excavations is required to assess the efficacy of the removal of the hydrocarbon impacted soils surrounding the USTs.
