## **Updated Remediation Action Plan**

### **Proposed Visitor Information Centre**

**17 Denison Street, Gloucester NSW**

**Project 228674.02**

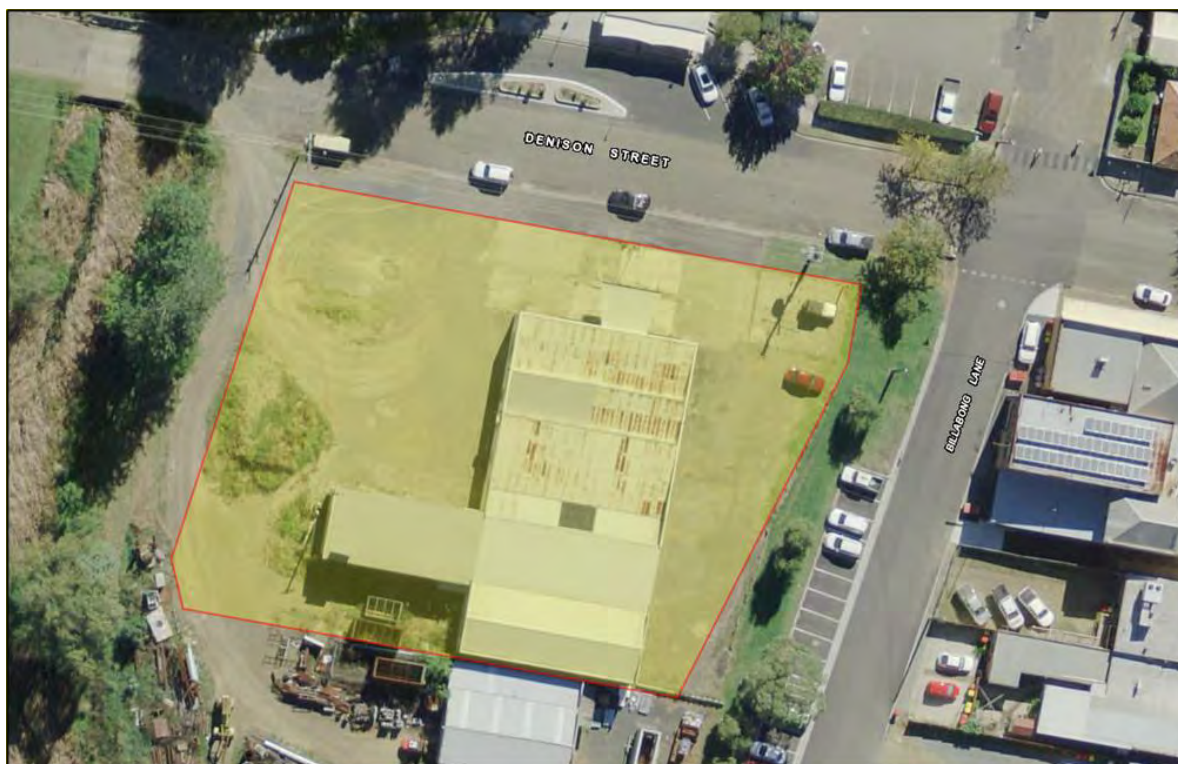
**Figure 1: Overview of the site area in yellow (Source: SixMaps, image dated 24/06/2024)**

The site boundary is shown on Figure 1.

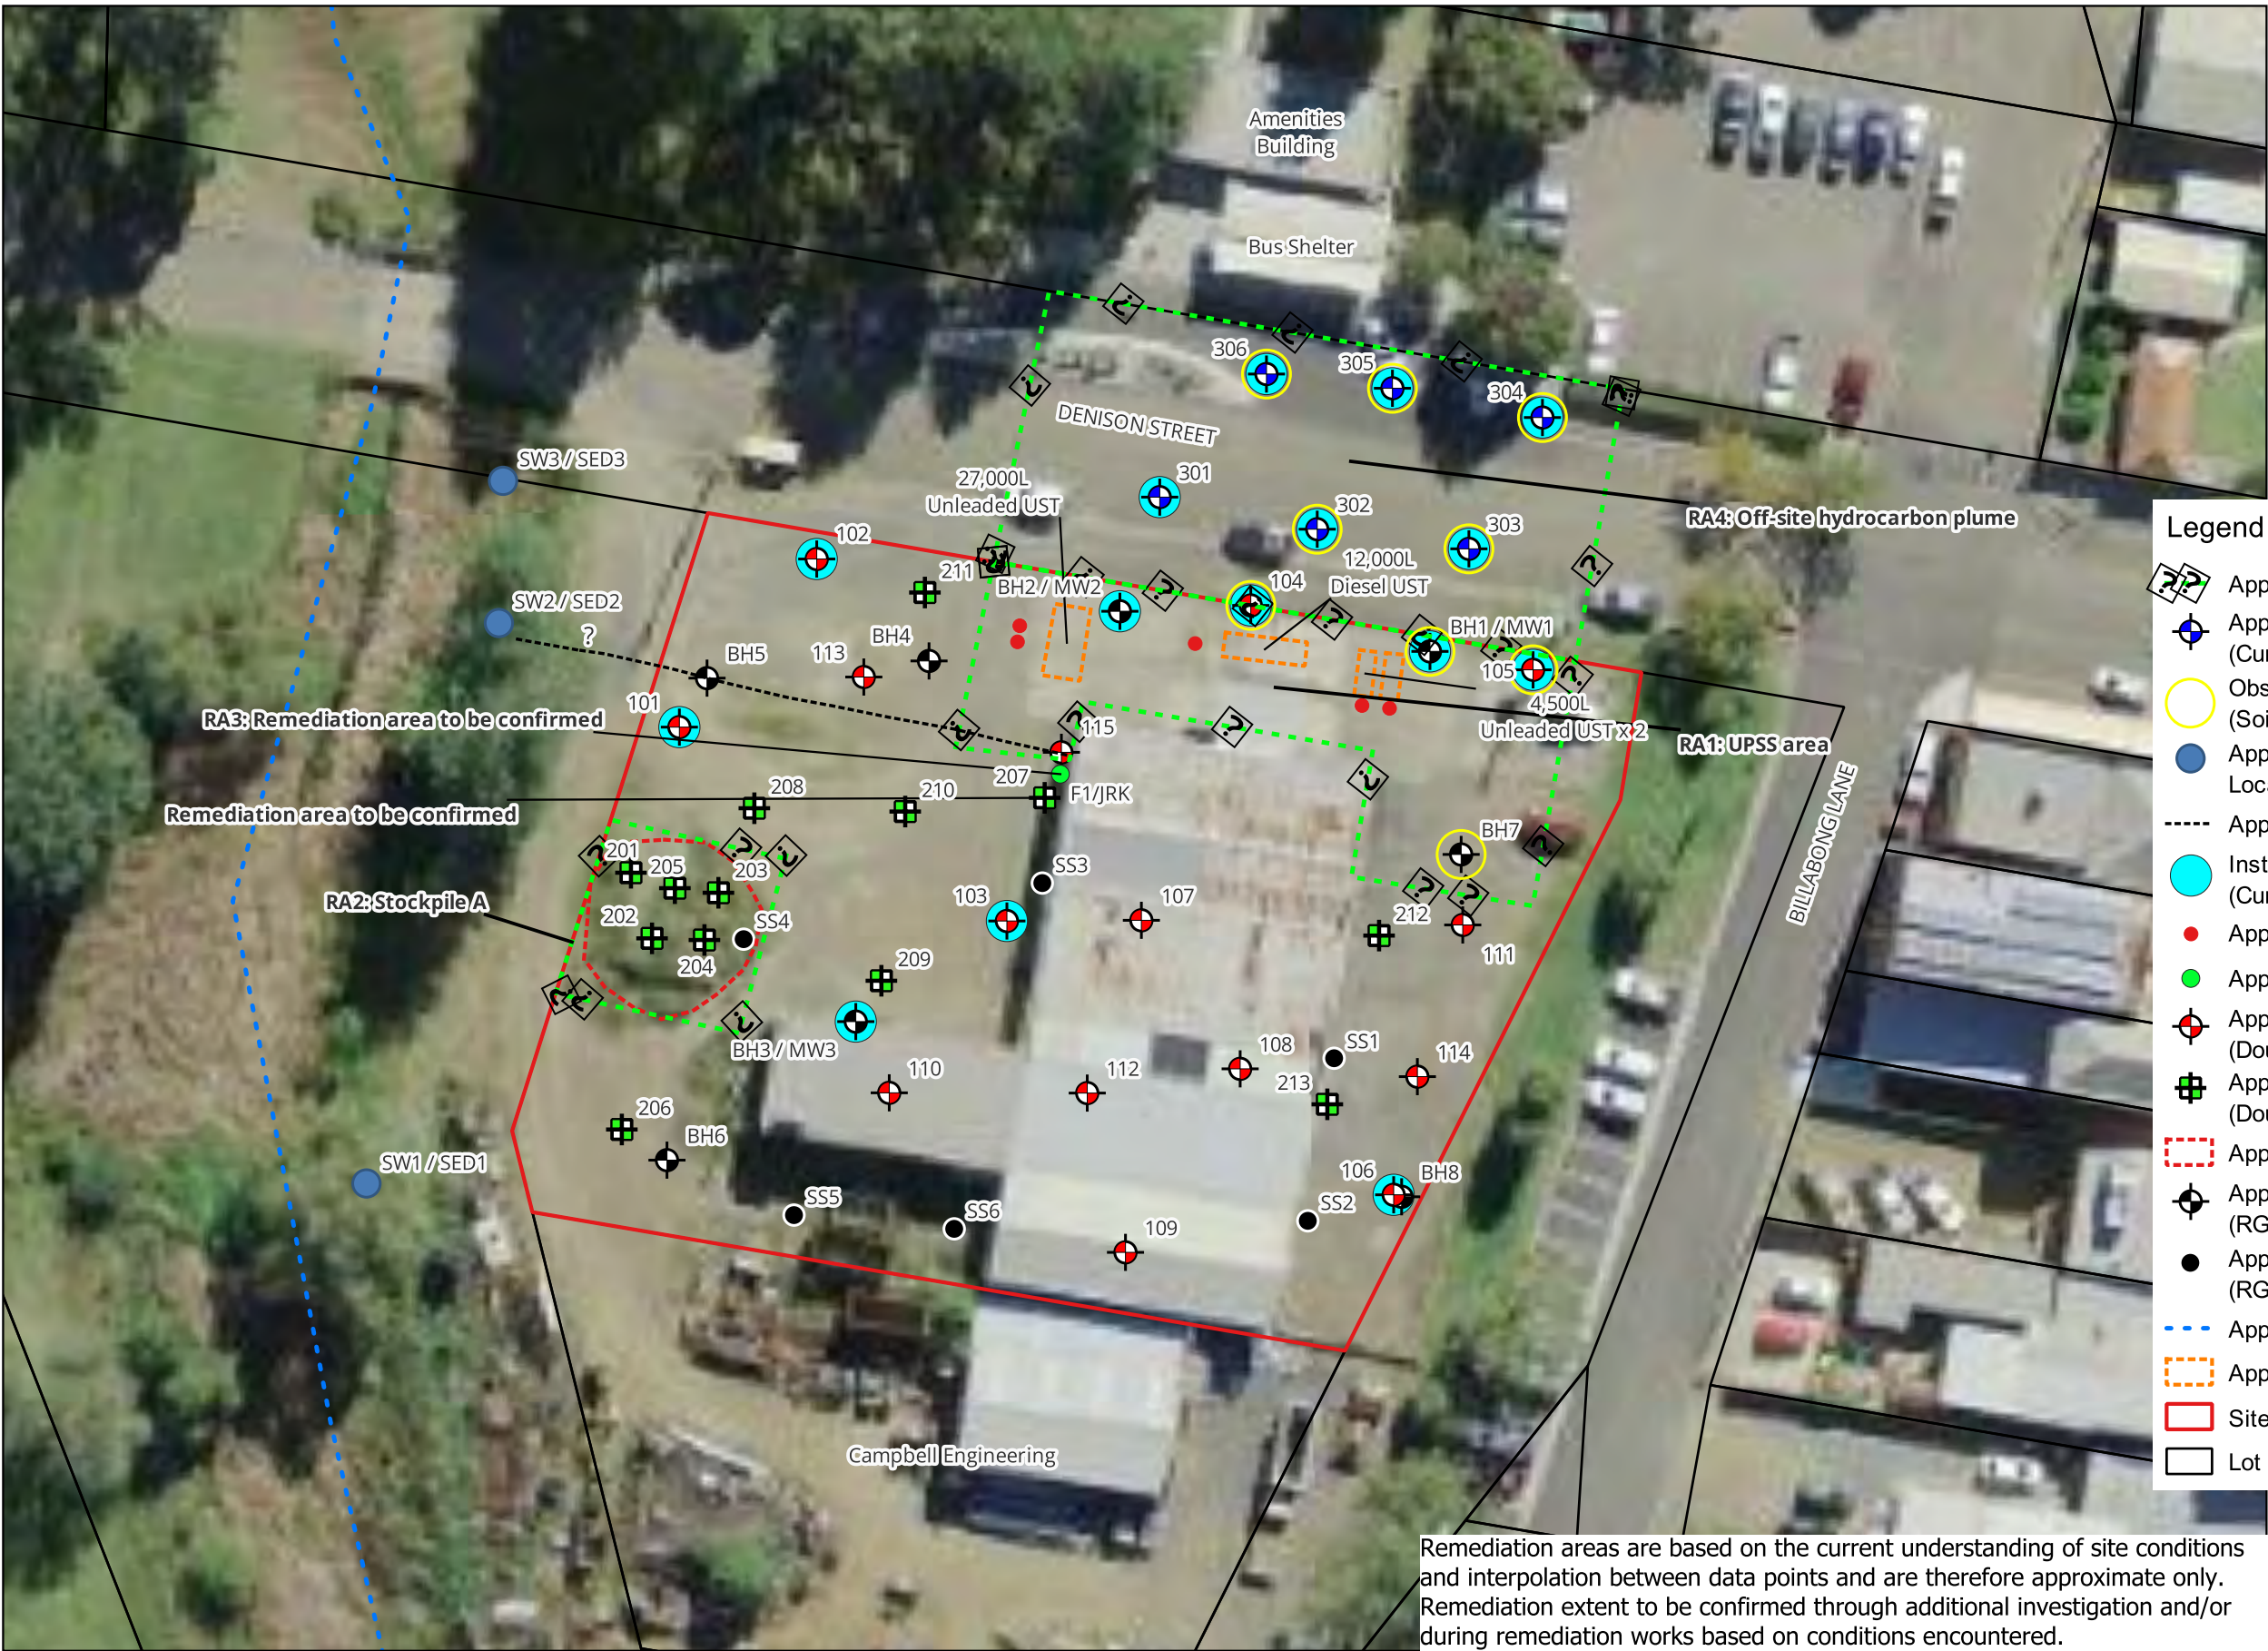
- Legend**
- Approximate Remediation Area
  - Approximate Borehole Locations (Current Investigation)
  - Observed Hydrocarbon Impacts (Soil and Groundwater)
  - Approximate Surface Water & Sediment Locations (Current Investigation)
  - Approximate Drainage Line
  - Installed Groundwater Wells (Current and Previous Investigations)
  - Approximate UST Fill Points
  - Approximate Fibro Fragment
  - Approximate Bore Locations (Douglas, 2024)
  - Approximate Test Pit Locations (Douglas, 2024)
  - Approximate Stockpile A Extent
  - Approximate Borehole Location (RGS, 2022)
  - Approximate Surface Sample Location (RGS, 2022)
  - Approximate Creek Alignment
  - Approximate UST Locations
  - Site Boundary
  - Lot Boundary

Remediation areas are based on the current understanding of site conditions and interpolation between data points and are therefore approximate only. Remediation extent to be confirmed through additional investigation and/or during remediation works based on conditions encountered.

Reference should be made to Drawing 5, Appendix A for approximate remediation areas. It is noted that remediation areas are based on current understanding of site conditions and interpolation between data points and are therefore approximate only. Remediation extent is to

be confirmed through additional investigation and/or during remediation works based on conditions encountered.

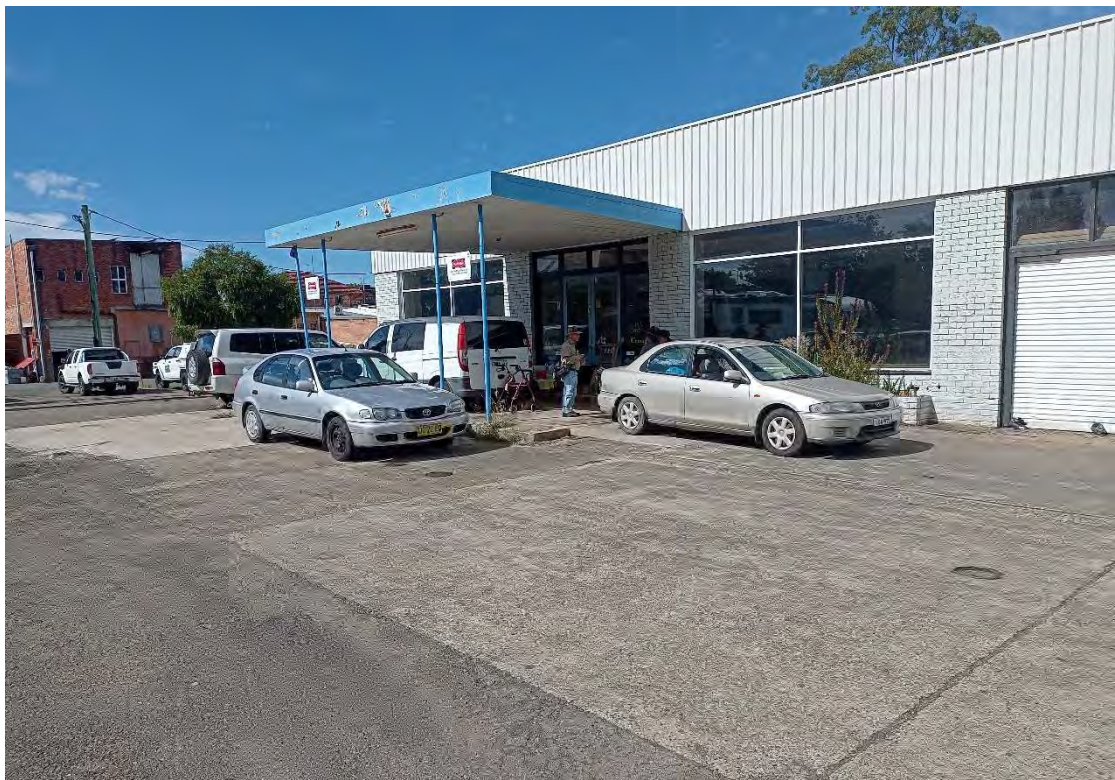
Photo 2: Looking across tank farm area in northern portion of the site (18 April 2024)

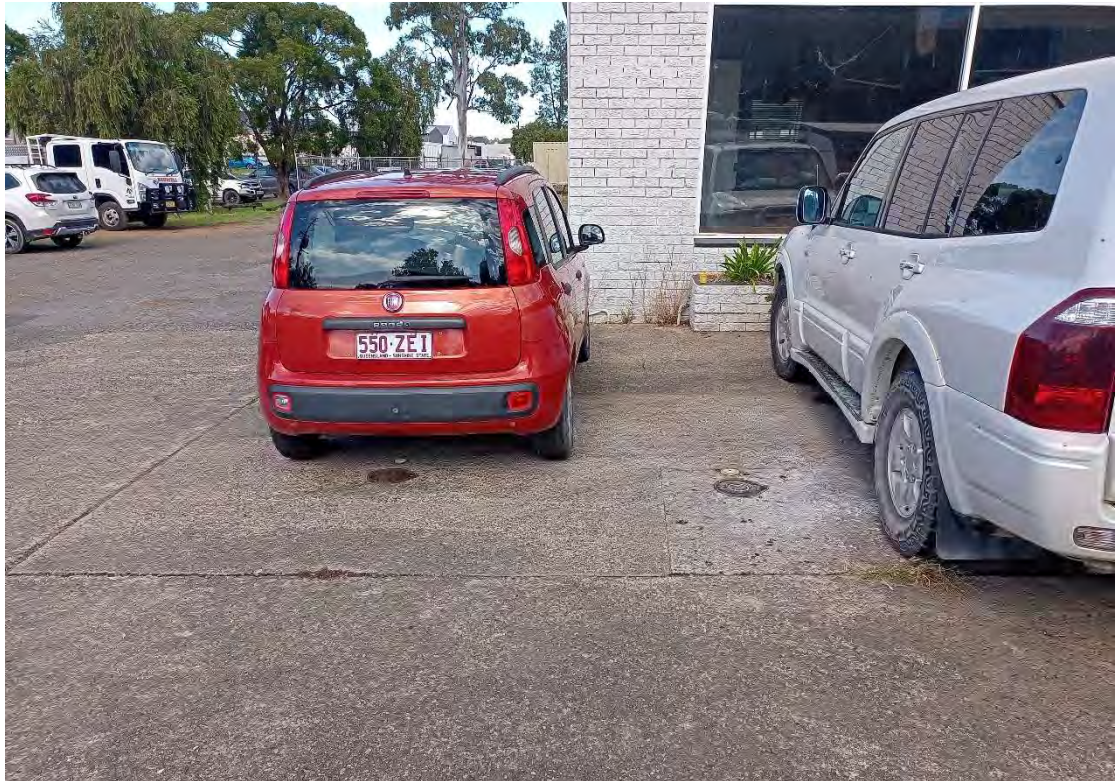
Photo 3: Fill points for two 4,500L unleaded USTs in north eastern portion of the site (18 April 2024)

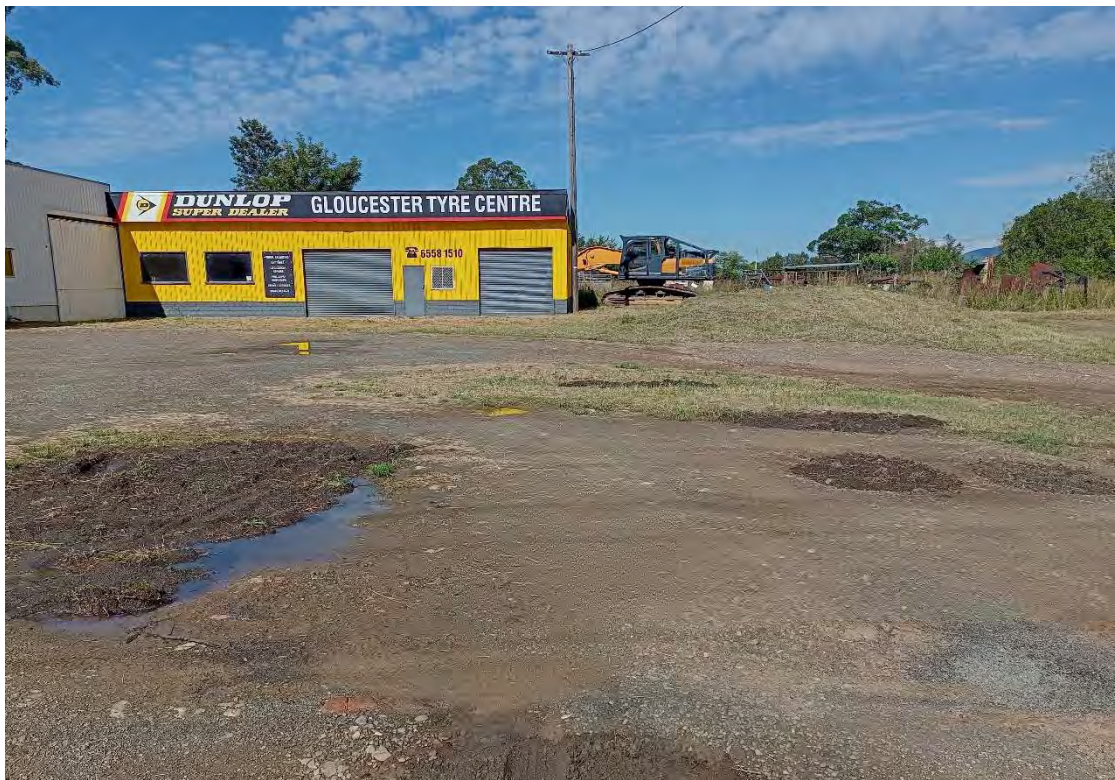
Photo 4: Looking across the western portion of the site. Fill materials observed (18 April 2024)

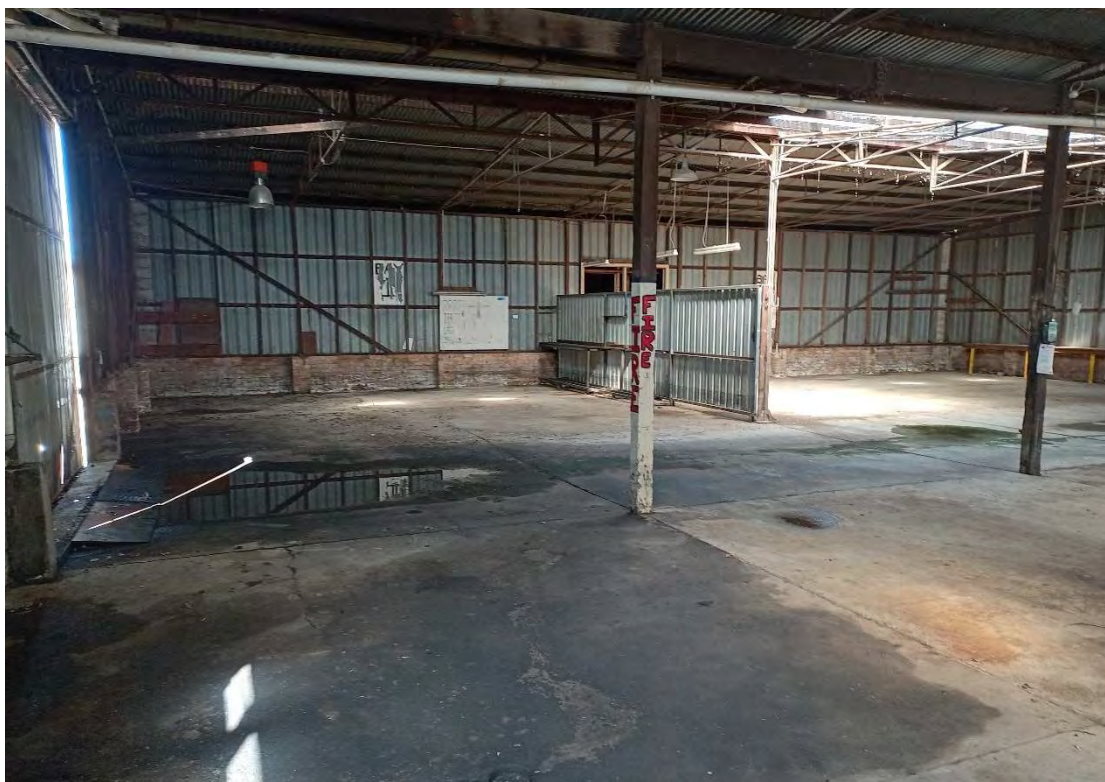
Photo 5: Former workshop area in eastern portion of the site. Hydrocarbon staining observed at surface

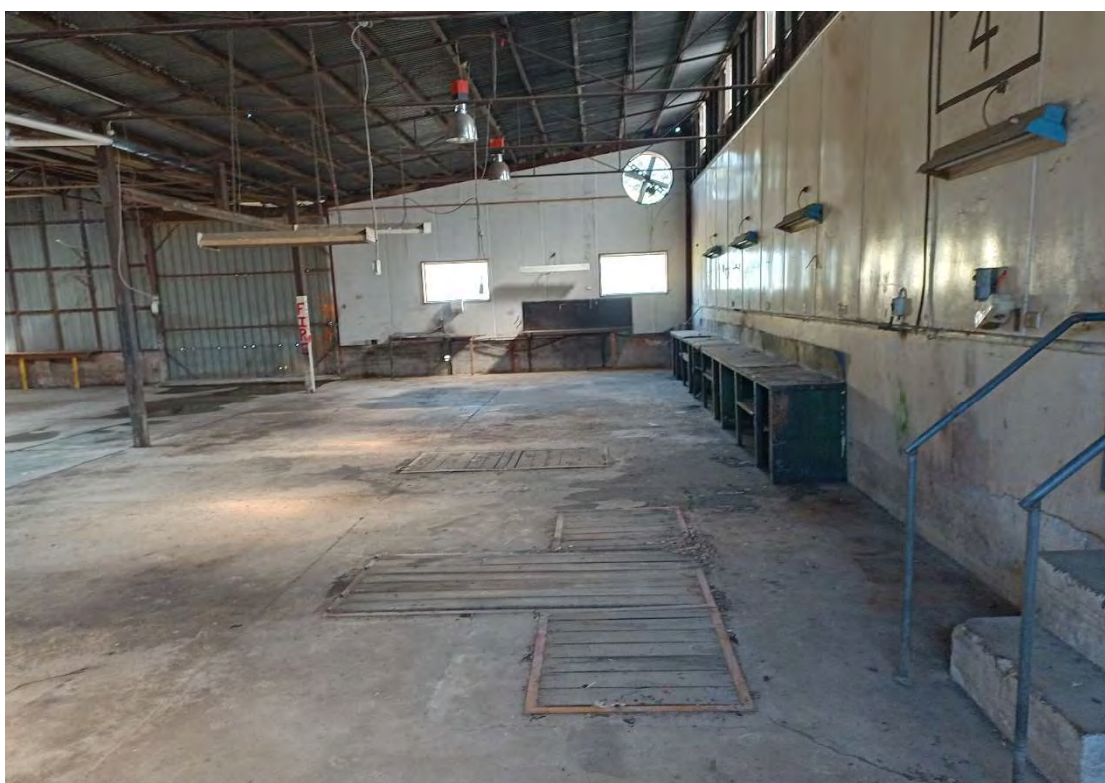
Photo 6: Looking east across former workshop. Possible inspection pits observed (18 April 2024)

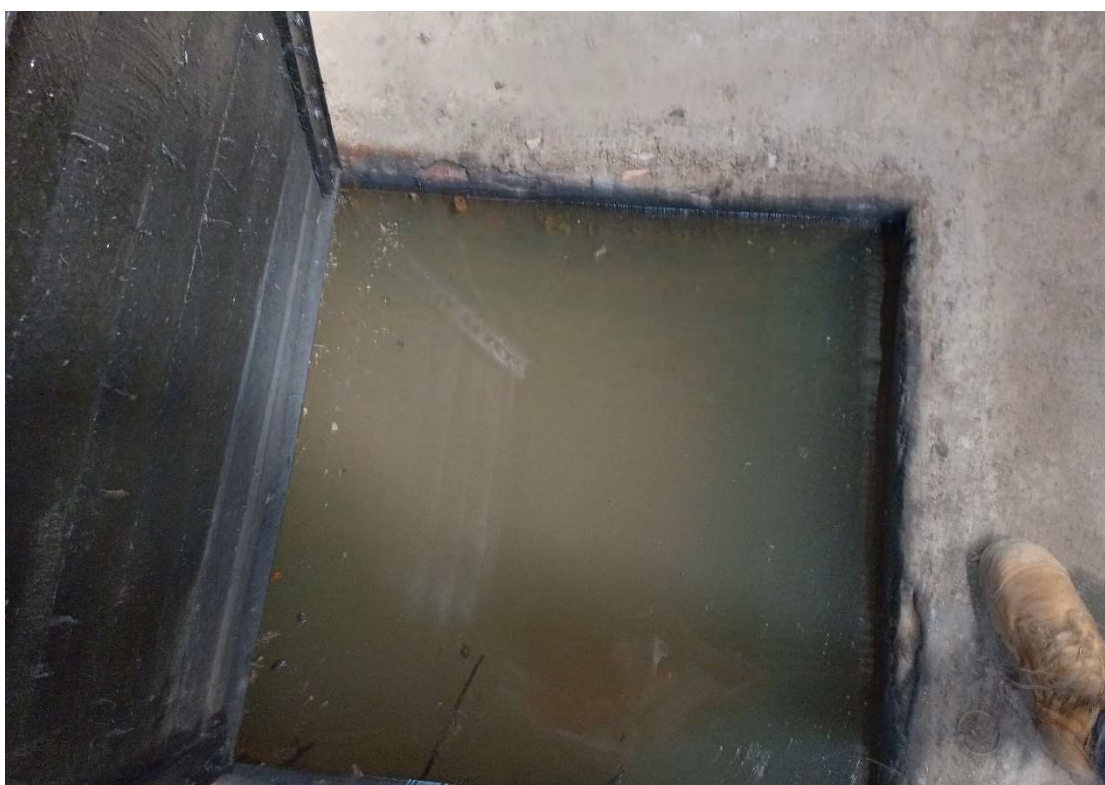
Photo 8: Inspection pit filled with water at the time of the initial inspection (18 April 2024)

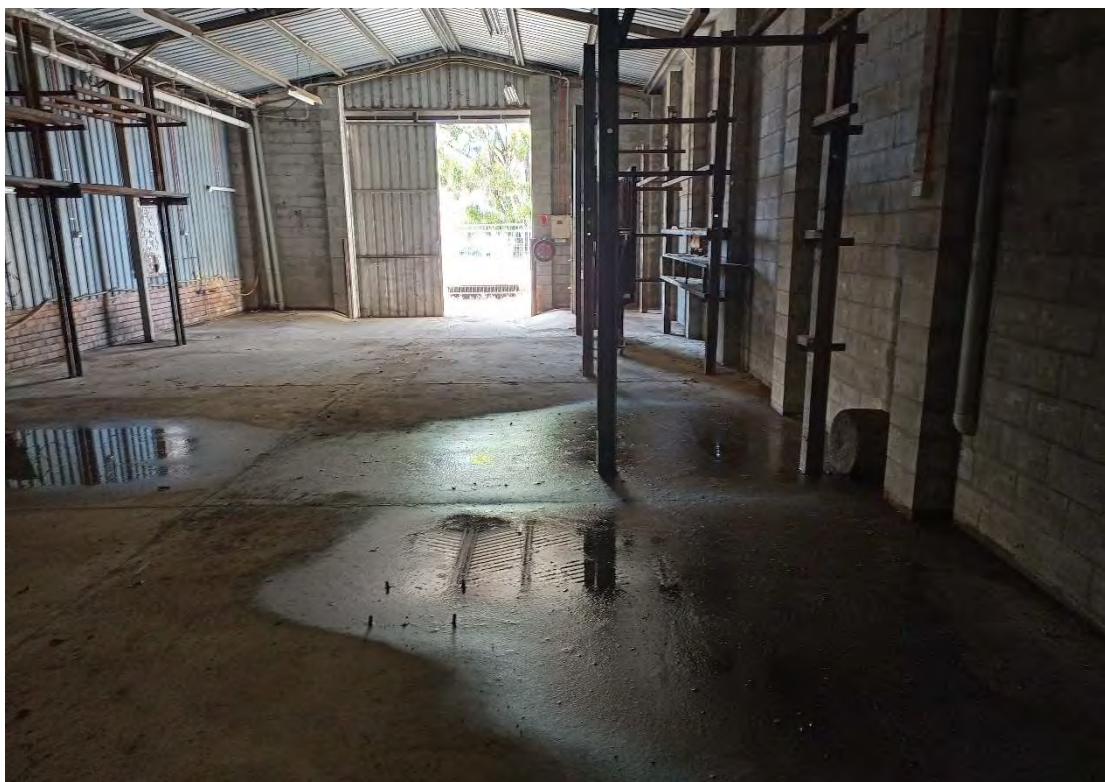
Photo 11: Shed in south eastern corner of the site. Hydrocarbon staining observed at surface (18 April 2024)

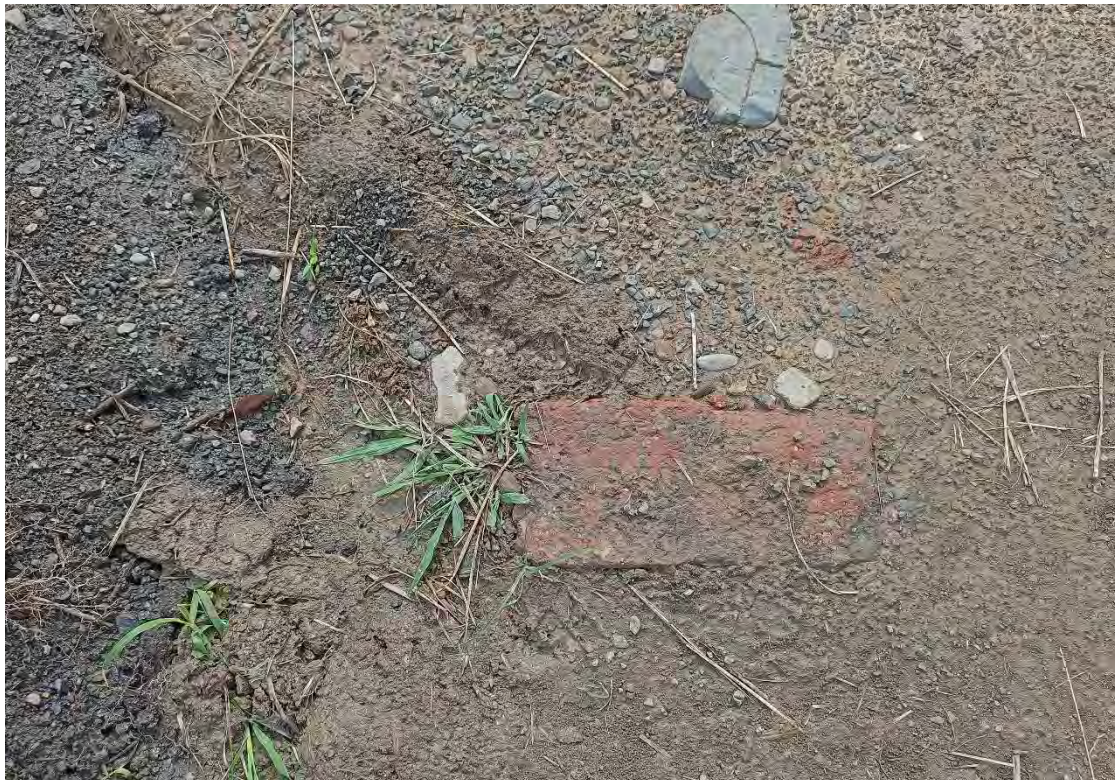
Photo 14: Bricks observed within fill materials observed at the surface across the western portion of the site

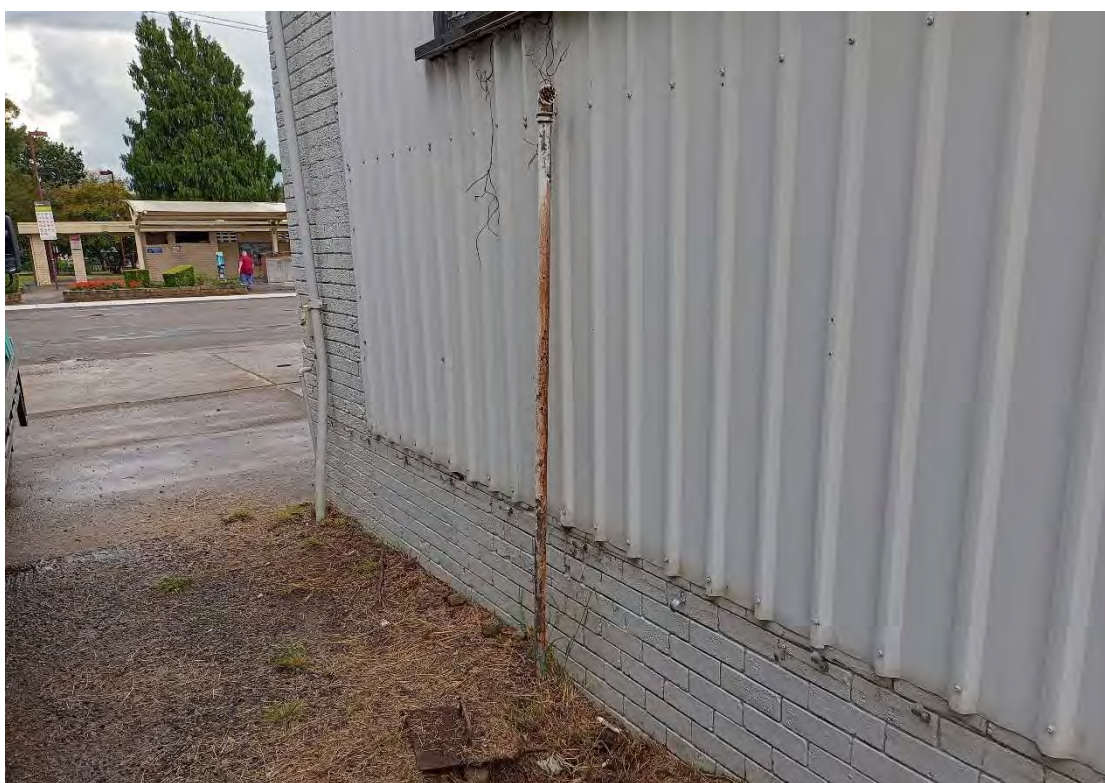
Photo 16: Waste sump and possible breath point for USTs in the northern portion of the site (18 April 2024)

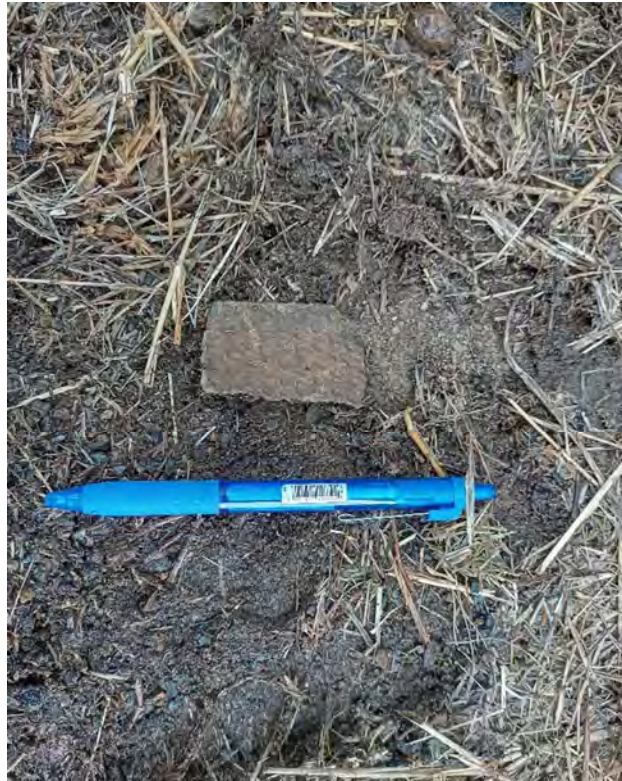
Photo 17: Fibro fragment F1/JRK observed at the surface in the central portion of the site (18 April 2024)

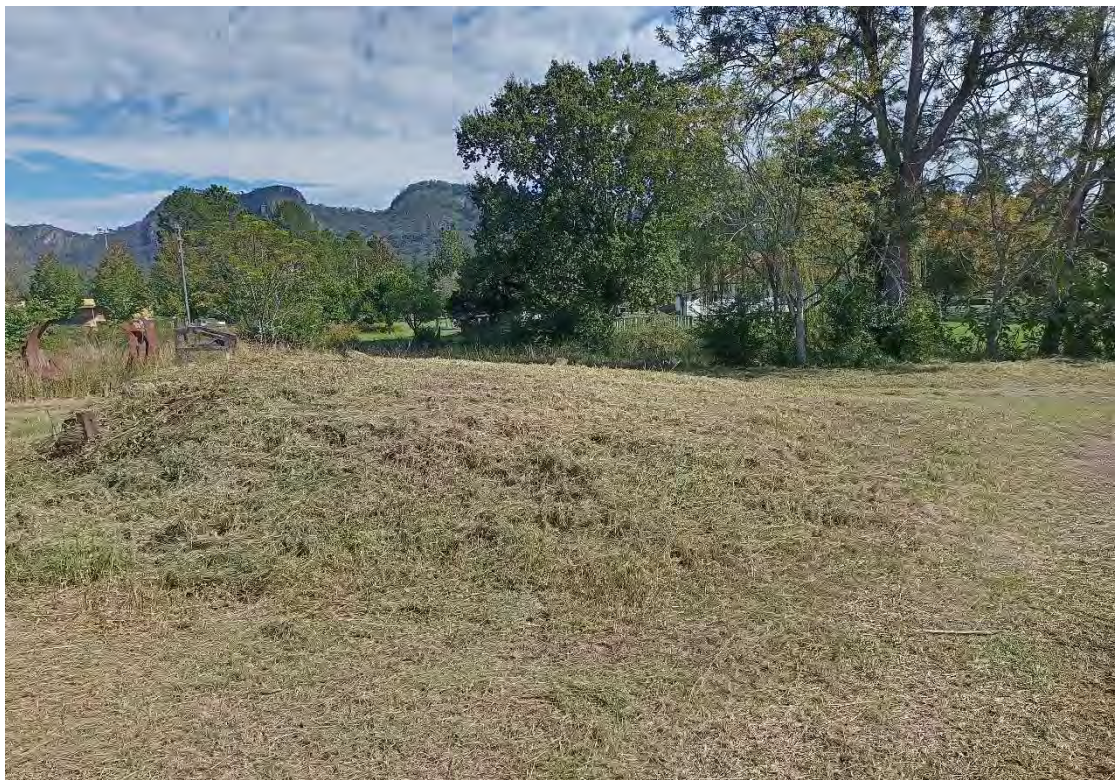
Photo 20: Stockpile A in the western portion of the site (18 April 2024)

Stockpile A materials were classified in the Douglas (2024) DSI as 'General Solid Waste (non-putrescible) (CTI and TCLP1/SCC1) – Special Waste (Asbestos)'. The materials are proposed to be excavated and disposed directly to a licensed landfill. Due to the presence of building rubble and minor asbestos materials, asbestos air monitoring is recommended during stockpile excavation, handling and disposal. Handling and disposal of the materials should be conducted in accordance with statutory and regulatory requirements.

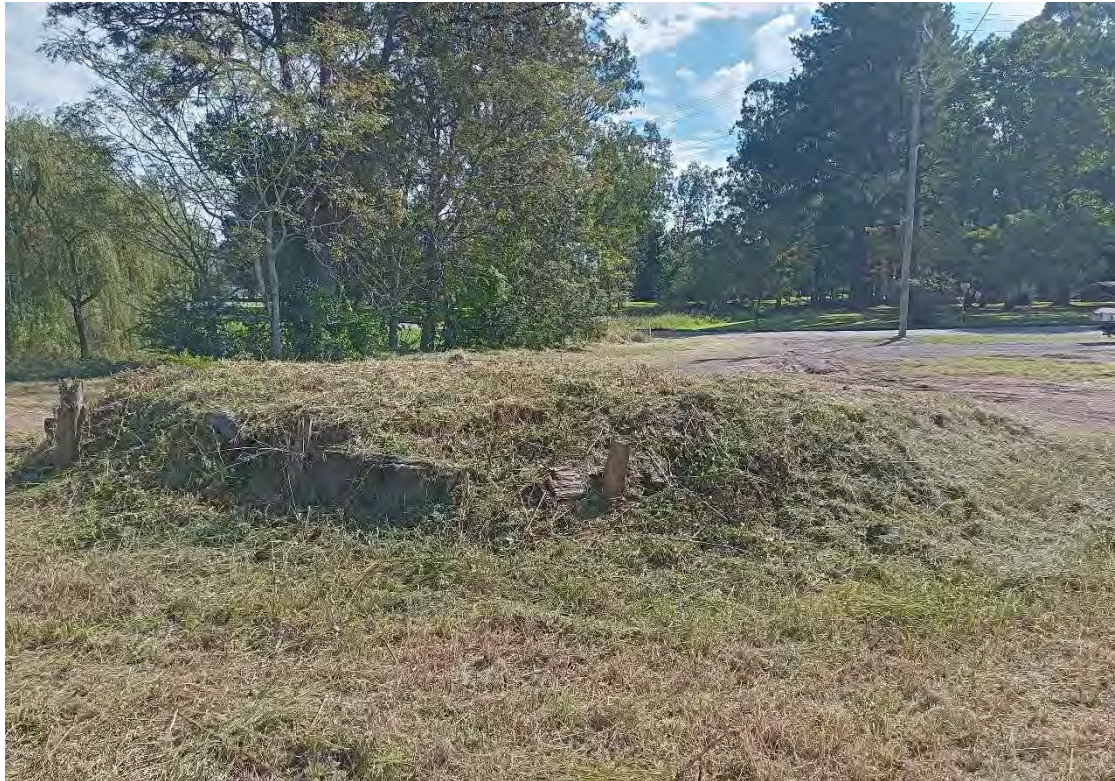
Photo 21: Looking north west at Stockpile A. Timber and concrete observed (18 April 2024)

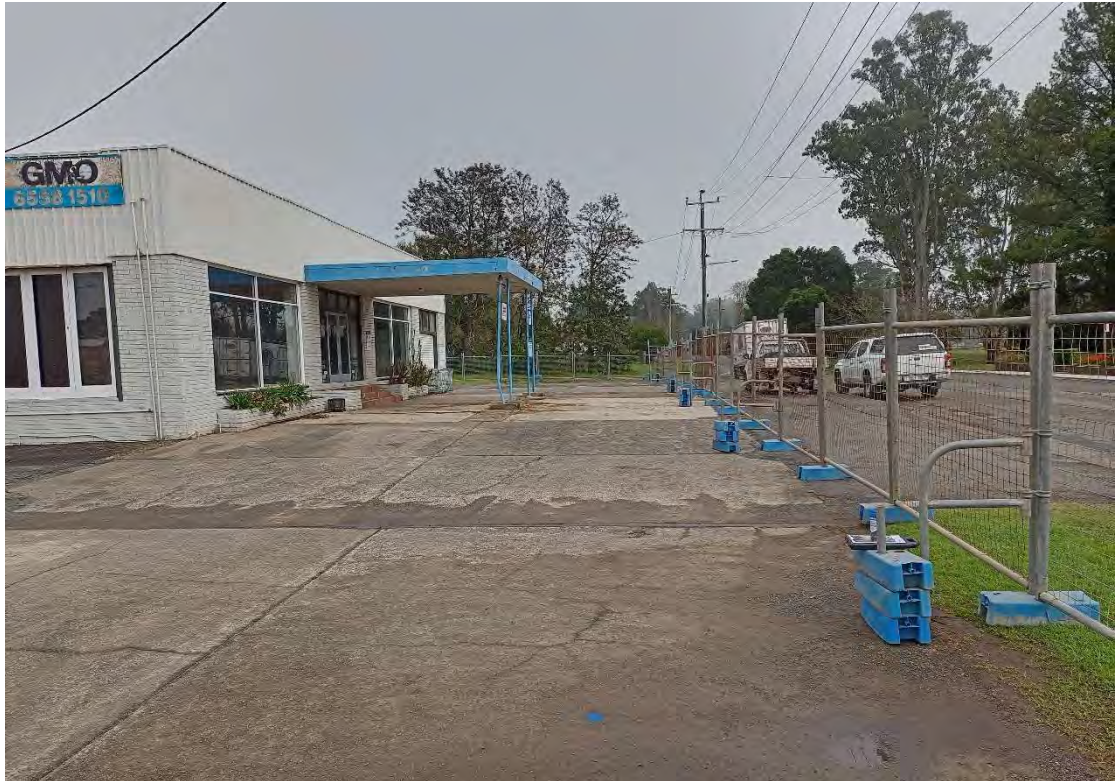
Photo 23: Looking along the northern boundary of the site at tank farm (6 June 2024)

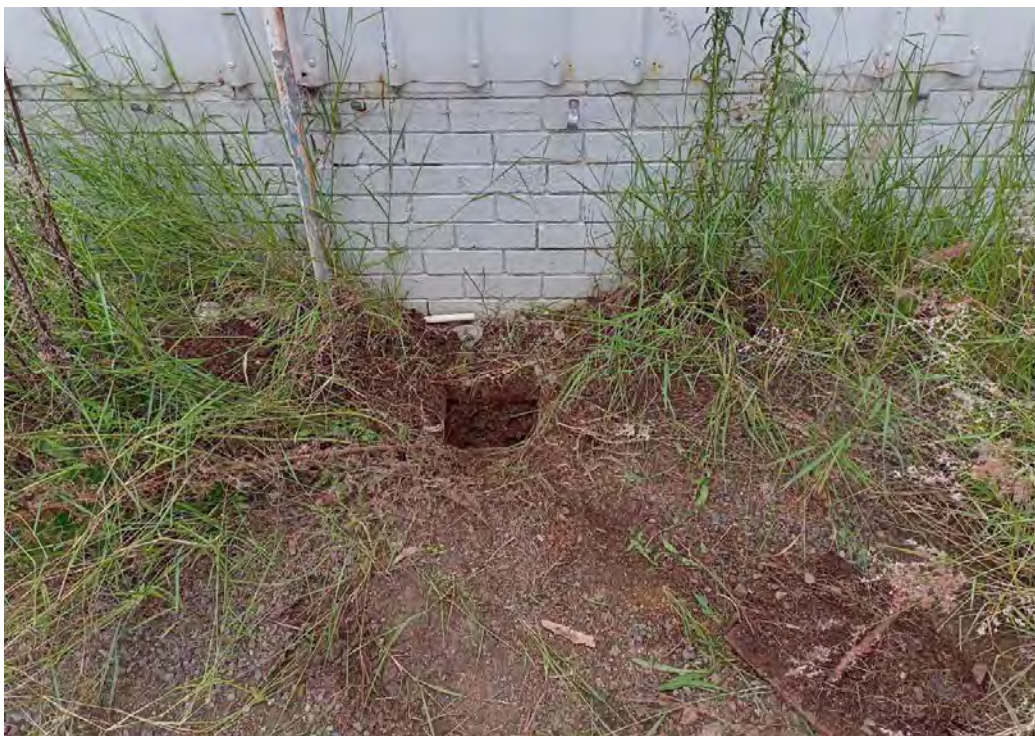
Photo 5: Former sump located adjacent workshop building at the site (31 March 2025)

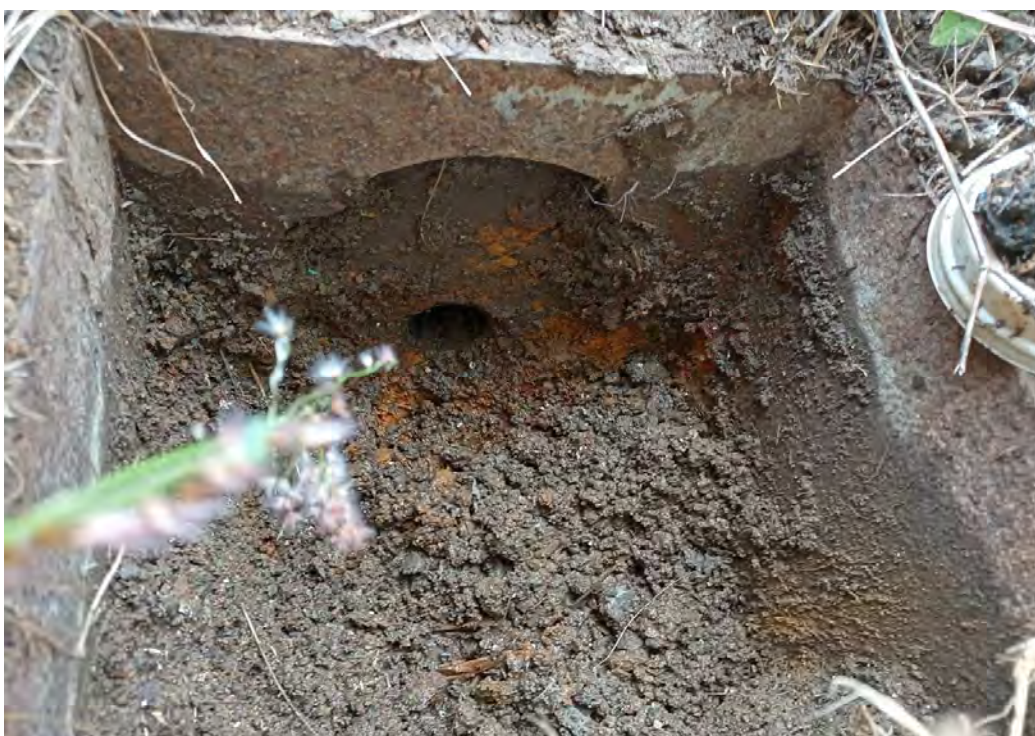
Photo 6: Drainage pipe within sump leading towards the creek adjacent the site (31 March 2025)

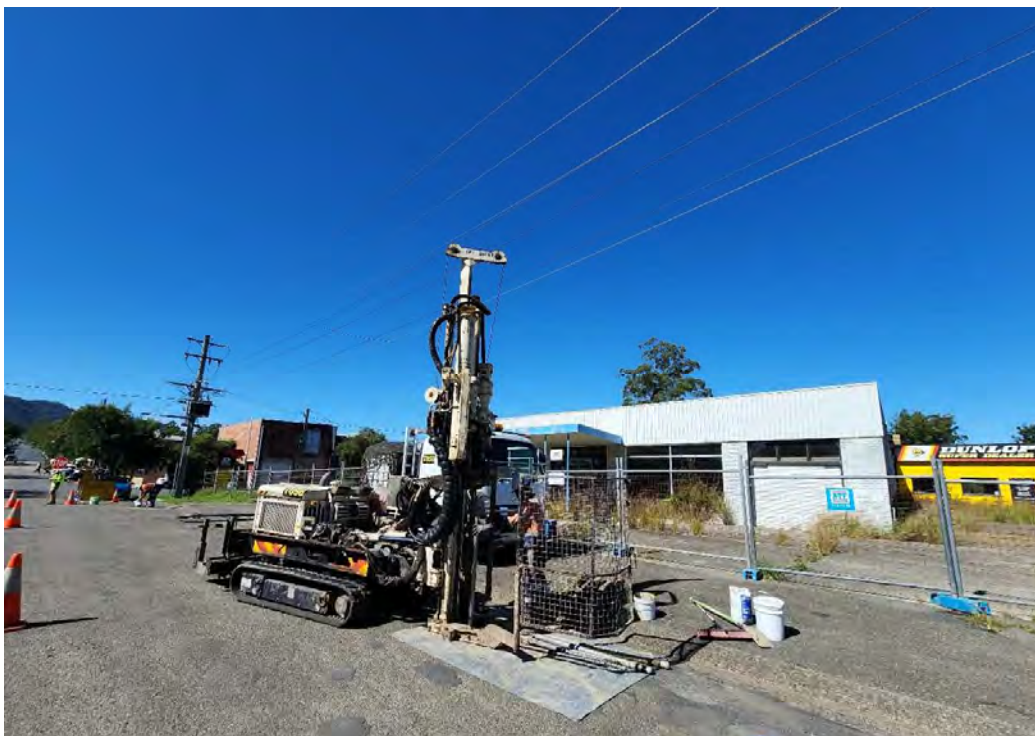
Photo 7: Drilling Bore 301 in the road along Denison Street (14 April 2025)

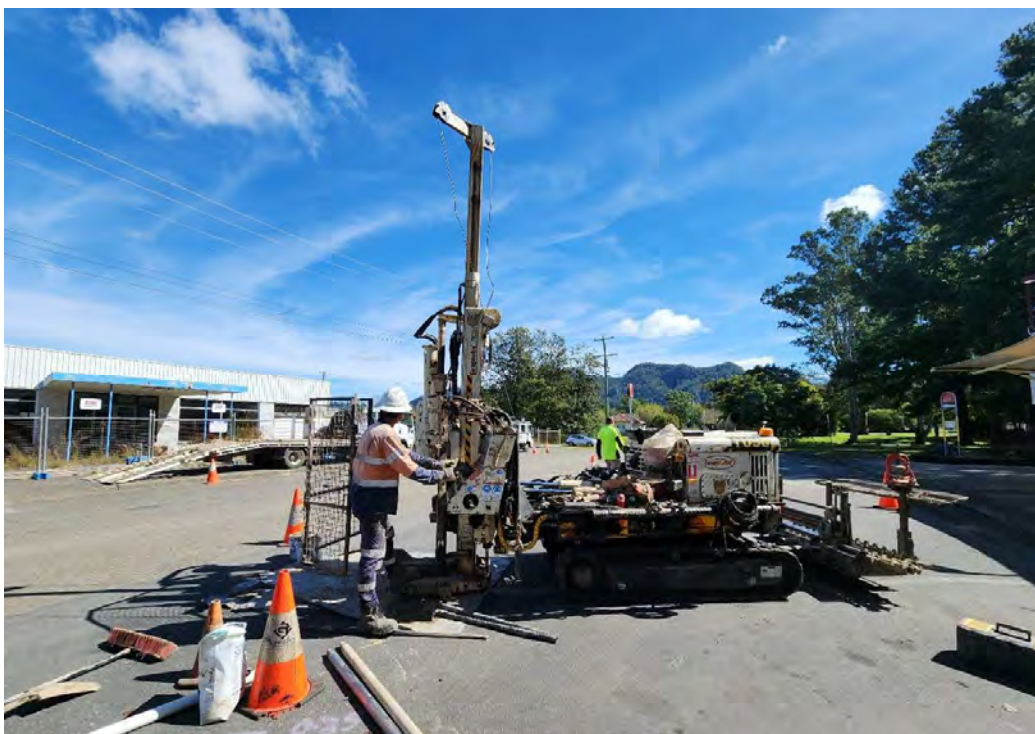
Photo 8: Drilling Bore 305 on northern side of Denison Street (14 April 2025)

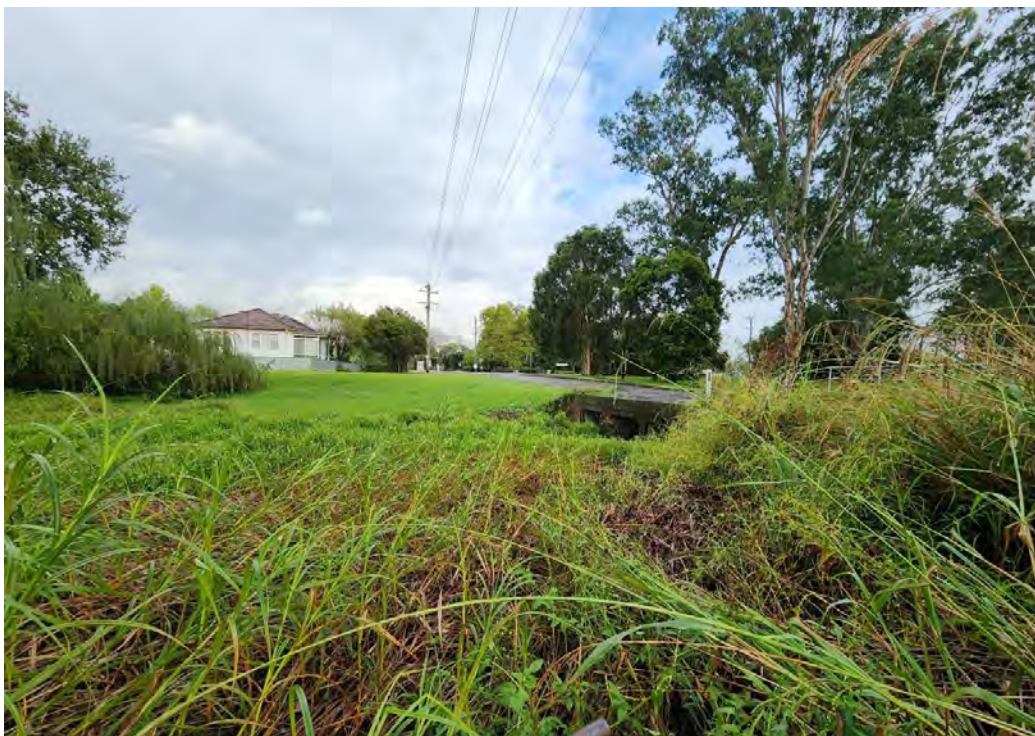
Photo 9: Vegetation observed at sediment/surface water location 3 – looking north west (15 April 2025)

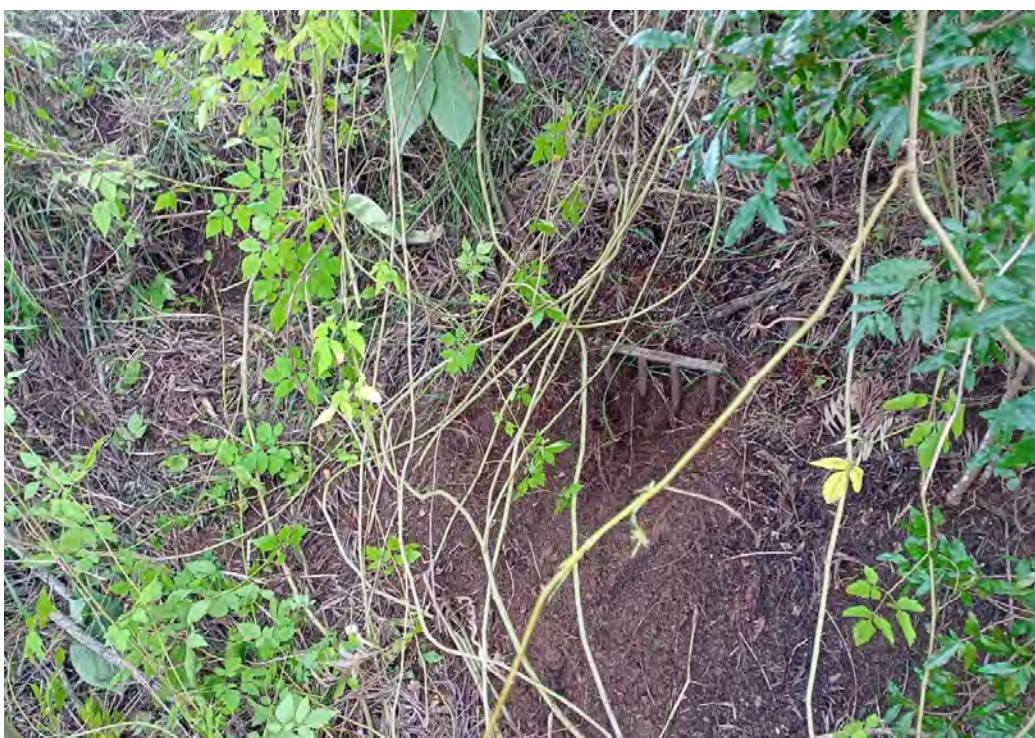
Photo 12: Waste metal and fill materials observed in area of pipe outlet in embankment (31 March 2025)
