Project Number: N23028

Catherine Hill Bay Wharf – High-risks, Rectification/Partial Demolition Options

Catherine Hill Bay Wharf

93 Flowers Drive, Catherine Hill Bay, New South Wales
N23028

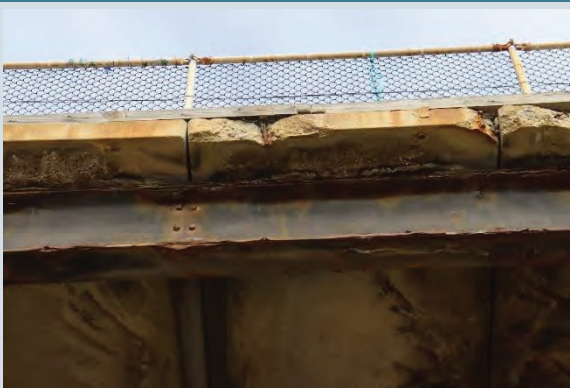
Observation, Risk, and Comment	Photo
<p>Concrete spalling on the edge of the precast decking.</p> <p>Quantity: Approx 10 sq.m</p> <p>Risk: Potential fall hazard from spalling concrete onto pedestrians walking underneath.</p> <p>Recommendation: Remove deleterious material over the trafficable zone and patch with a suitable, high-strength cementitious material to temporarily protect embedded reinforcement.</p>

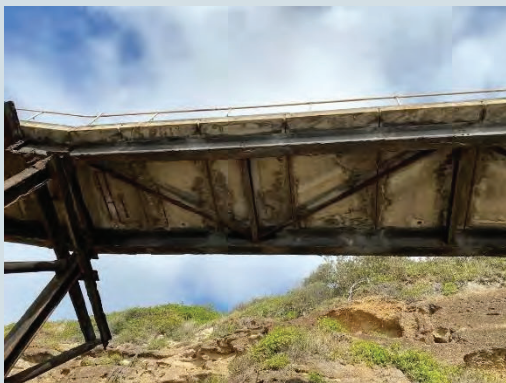
<p>Photo 2</p>

<p>Photo 1</p>
<p>Concrete spalling and exposed reinforcement on the underside of the precast decking.</p> <p>Quantity: Approx 15 sq.m</p> <p>Risk: Potential fall hazard from spalling concrete onto pedestrians waking underneath.</p> <p>Recommendation: Remove deleterious material over the trafficable zone and patch with a suitable, high-strength cementitious material to temporarily protect embedded reinforcement.</p>

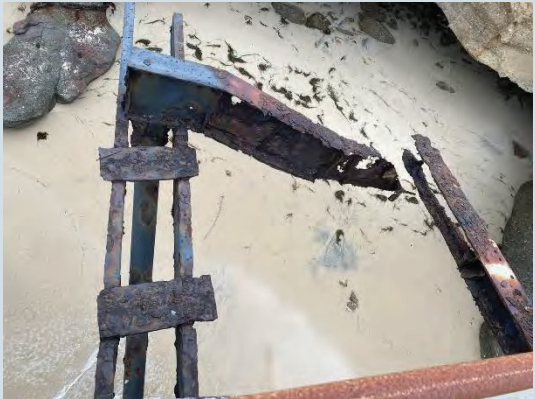
<p>Photo 4</p>

Observation, Risk, and Comment	Photo
<p>Corroded steel elements.</p> <p>Location:</p> <p>Quantity: Approx 2 m</p> <p>Risk: Potential fall hazard from corroded steel elements falling onto pedestrians walking underneath.</p> <p>Recommendation: Remove corroded element over the trafficable zone.</p>

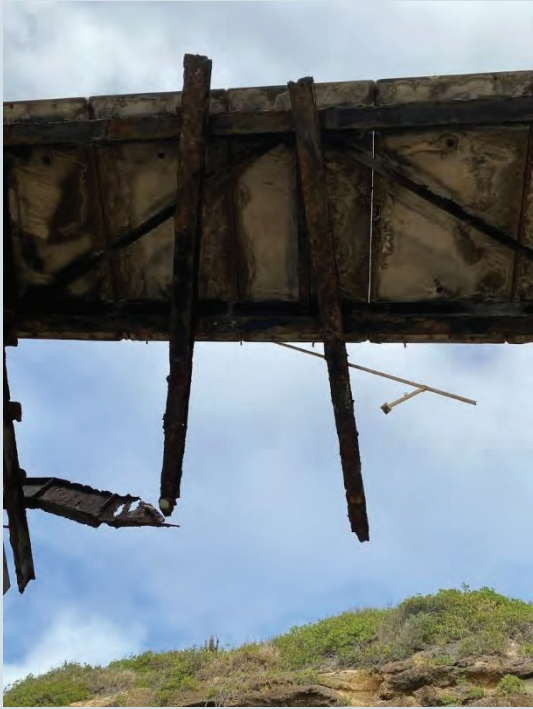
Observation, Risk, and Comment	Photo
<p>Corroded secondary beam steel elements.</p> <p>Location:</p> <p>Quantity: Approx 15 m</p> <p>Risk: Potential fall hazard from corroded steel elements falling onto pedestrians walking underneath.</p> <p>Recommendation: Remove corroded element over the trafficable zone.</p>

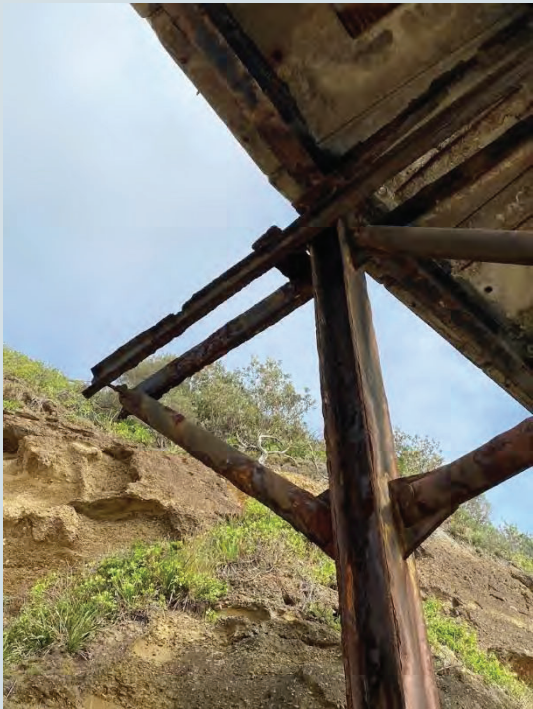
<p>Photo 6</p>

<p>Photo 5</p>
<p>Corroded secondary beam and diagonal circular hollow section brace steel elements.</p> <p>Location:</p> <p>Quantity: Approx 15 m</p> <p>Risk: Potential fall hazard from corroded steel elements falling onto pedestrians walking underneath.</p> <p>Recommendation: Remove corroded element over the trafficable zone.</p>

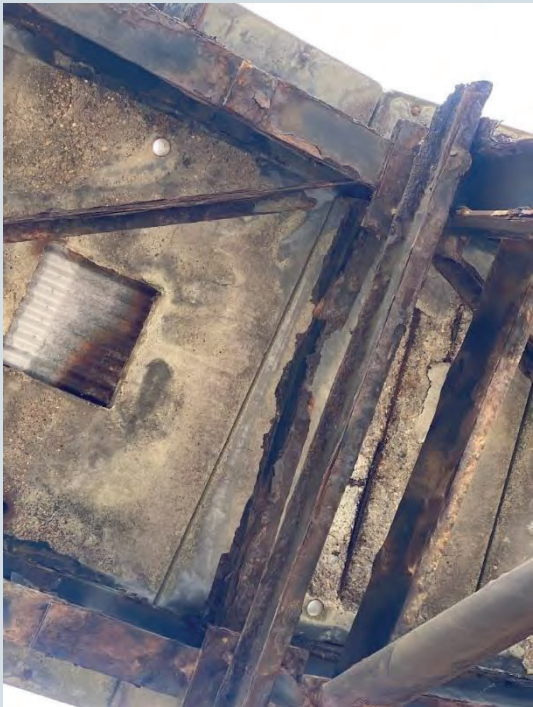
<p>Photo 7</p>
<p>Corroded diagonal bracing steel elements. Location: Quantity: Approx 10 m Risk: Potential fall hazard from corroded steel elements falling onto pedestrians walking underneath. Recommendation: Remove corroded element over the trafficable zone.</p>

Observation, Risk, and Comment	Photo
<p>Corroded secondary beam steel elements. Location: Quantity: Approx 5 m Risk: Potential fall hazard from corroded steel elements falling onto pedestrians walking underneath. Recommendation: Remove corroded element over the trafficable zone.</p>

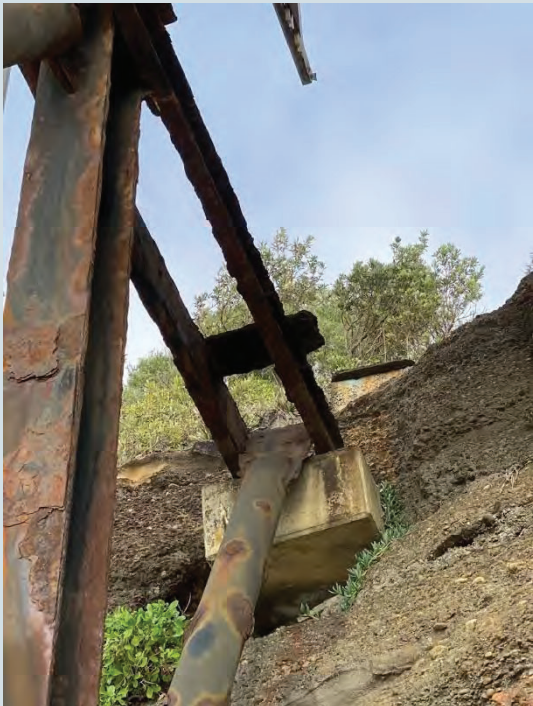
<p data-bbox="853 1037 938 1059">Photo 9</p>
<p>Corroded diagonal bracing steel elements. Location: Quantity: Approx 10 m Risk: Potential fall hazard from corroded steel elements falling onto pedestrians walking underneath. Recommendation: Remove corroded element over the trafficable zone.</p>

Observation, Risk, and Comment	Photo
<p>Corroded secondary beam steel elements. Location: Quantity: Approx 20 m Risk: Potential fall hazard from corroded steel elements falling onto pedestrians walking underneath. Recommendation: Remove corroded element over the trafficable zone.</p>

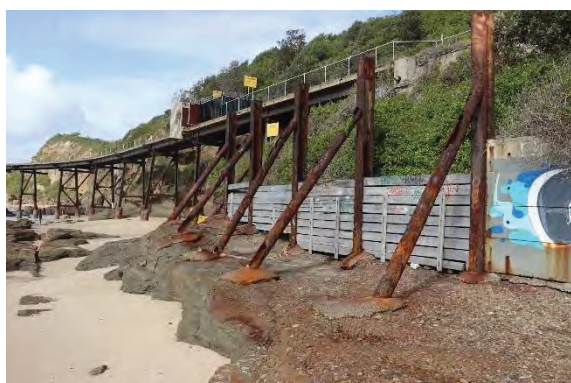
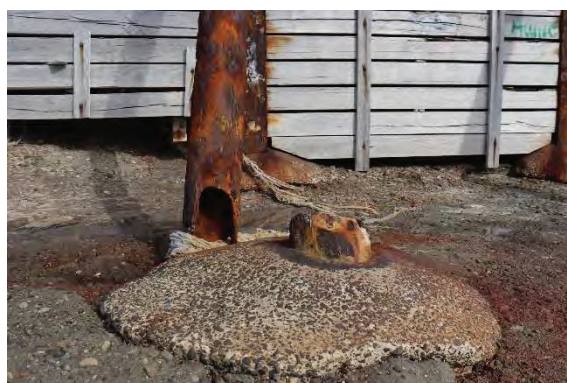
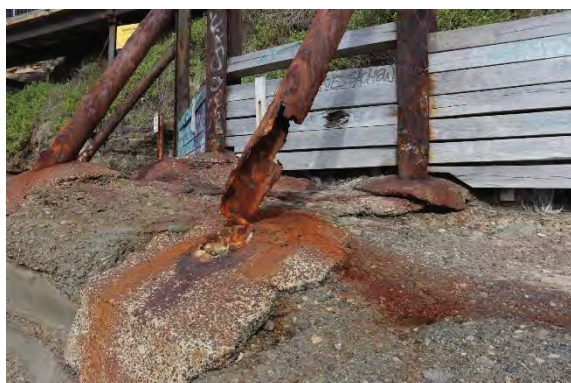
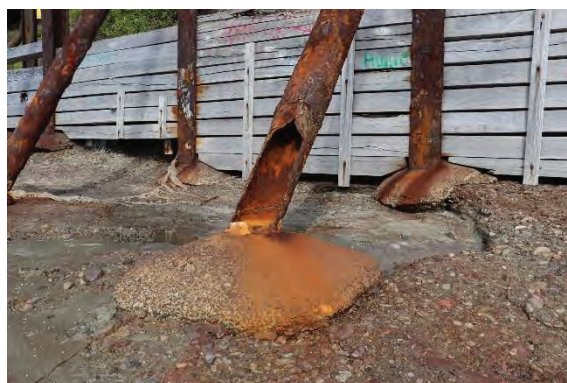
Just north of bent 28 sits a dilapidated retaining wall comprised of timber walers, steel piles, and angular circular hollow section bracing. The bracing is severely corroded and, in most cases, no longer offering support. It is BG&E's opinion that this retaining wall, whilst likely originally designed to support much higher earth loads, is no longer functional. The erosion of the ground behind this wall has exposed the concrete abutment at bent 28. We would recommend demolishing this wall.

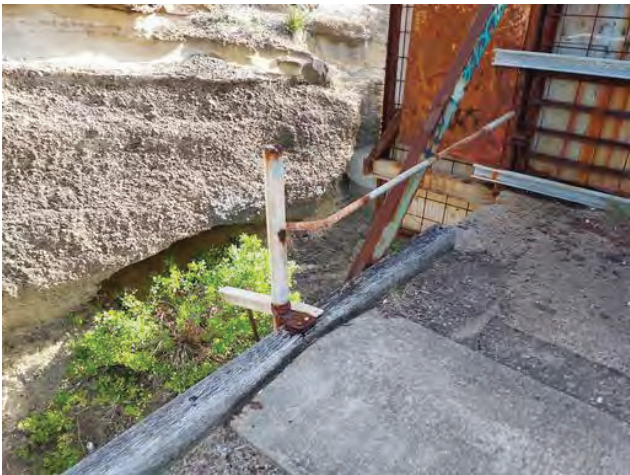
Missing and Deteriorated Handrail

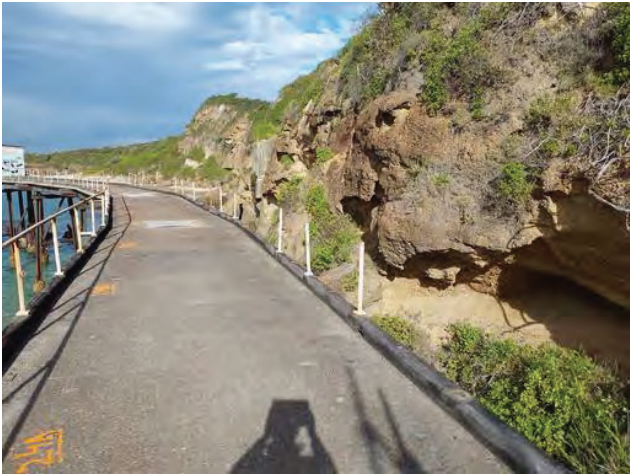
Missing Handrail

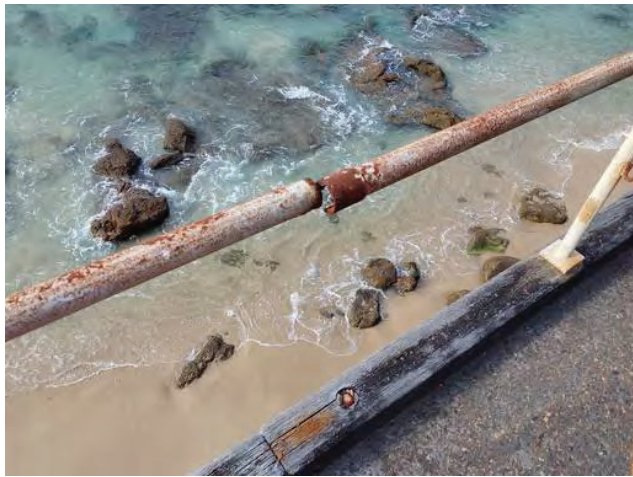
Handrail Connection Corroded

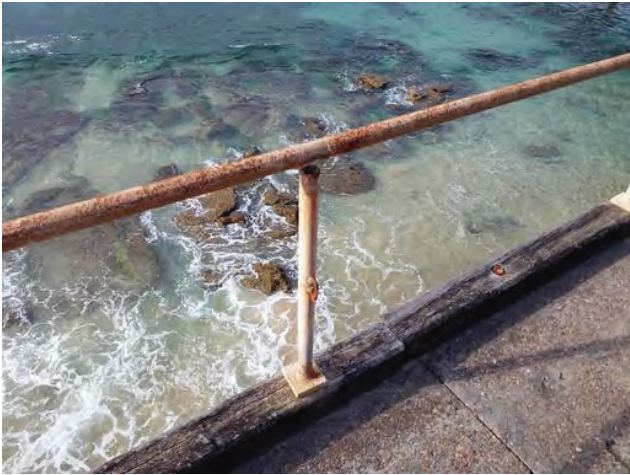
Handrail Connection Corroded

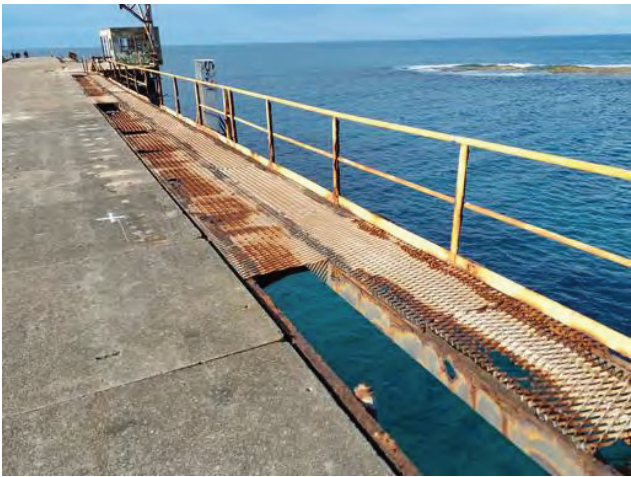
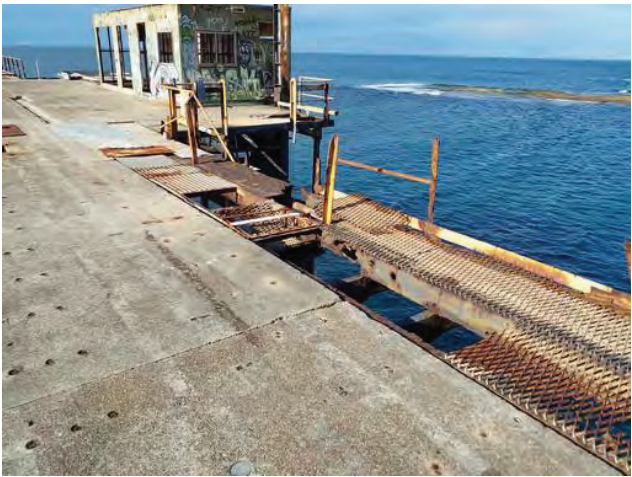
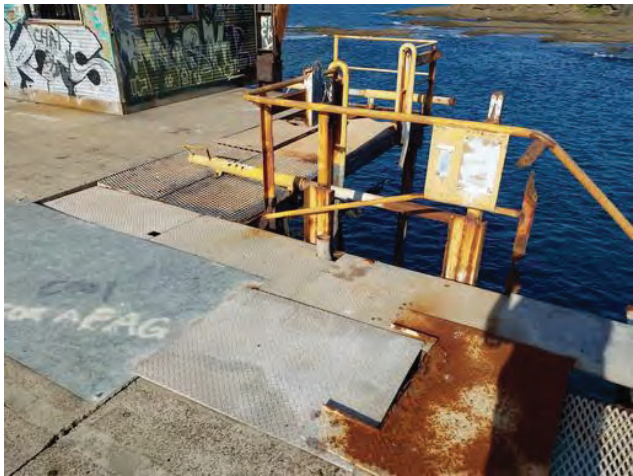
Corroded Catwalk

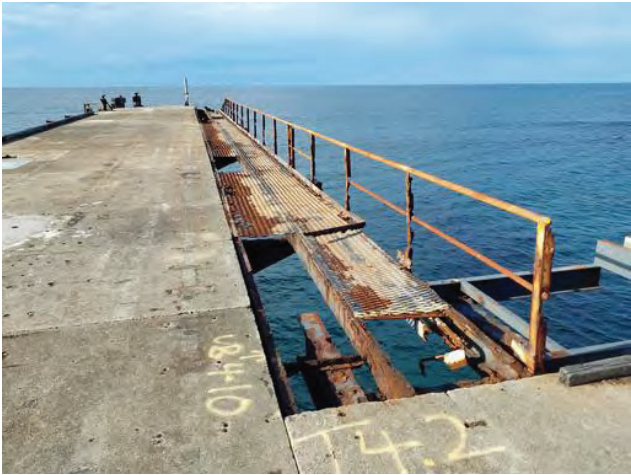
Corroded Catwalk

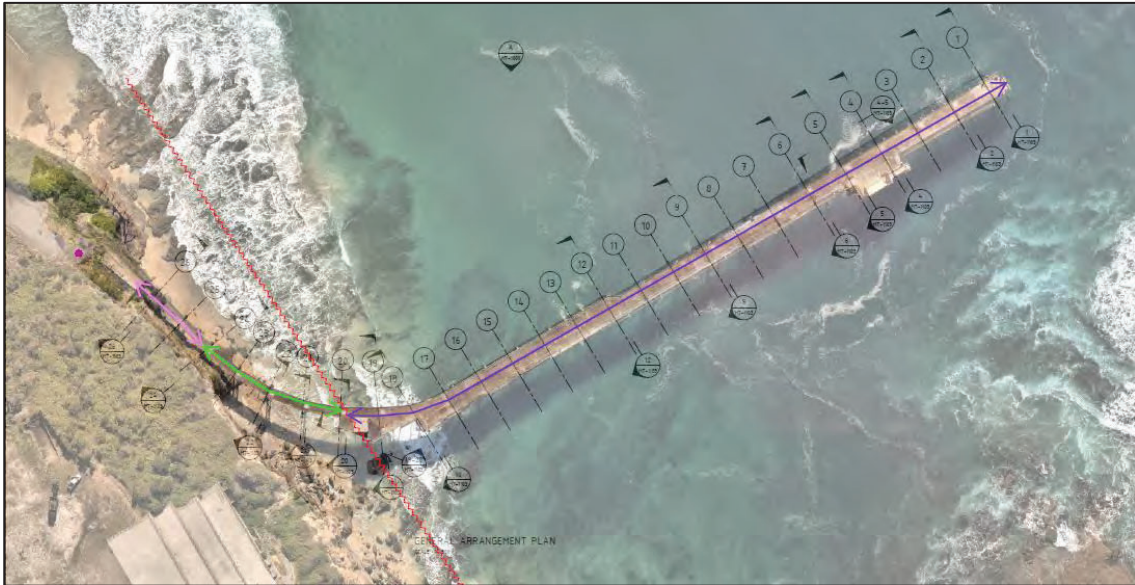
Figure 1 – Wharf Plan

The site locality is within the City of Lake Macquarie Local Government Area. Figure 1 below provides an insight in the size and location of the structure, and confirms that both landside and marine plant will be required during repair and demolition works.
