# Brunswick Heads Caravan Parks

## Preliminary concept designs for shoreline remediation and small boat access and storage

Prepared for: Byron Shire Holiday Parks Reserve Trust  
Project Manager: Charlie Hewitt  
Ref: 0910859  
Date: April 2007  
© GeoLINK, 2007

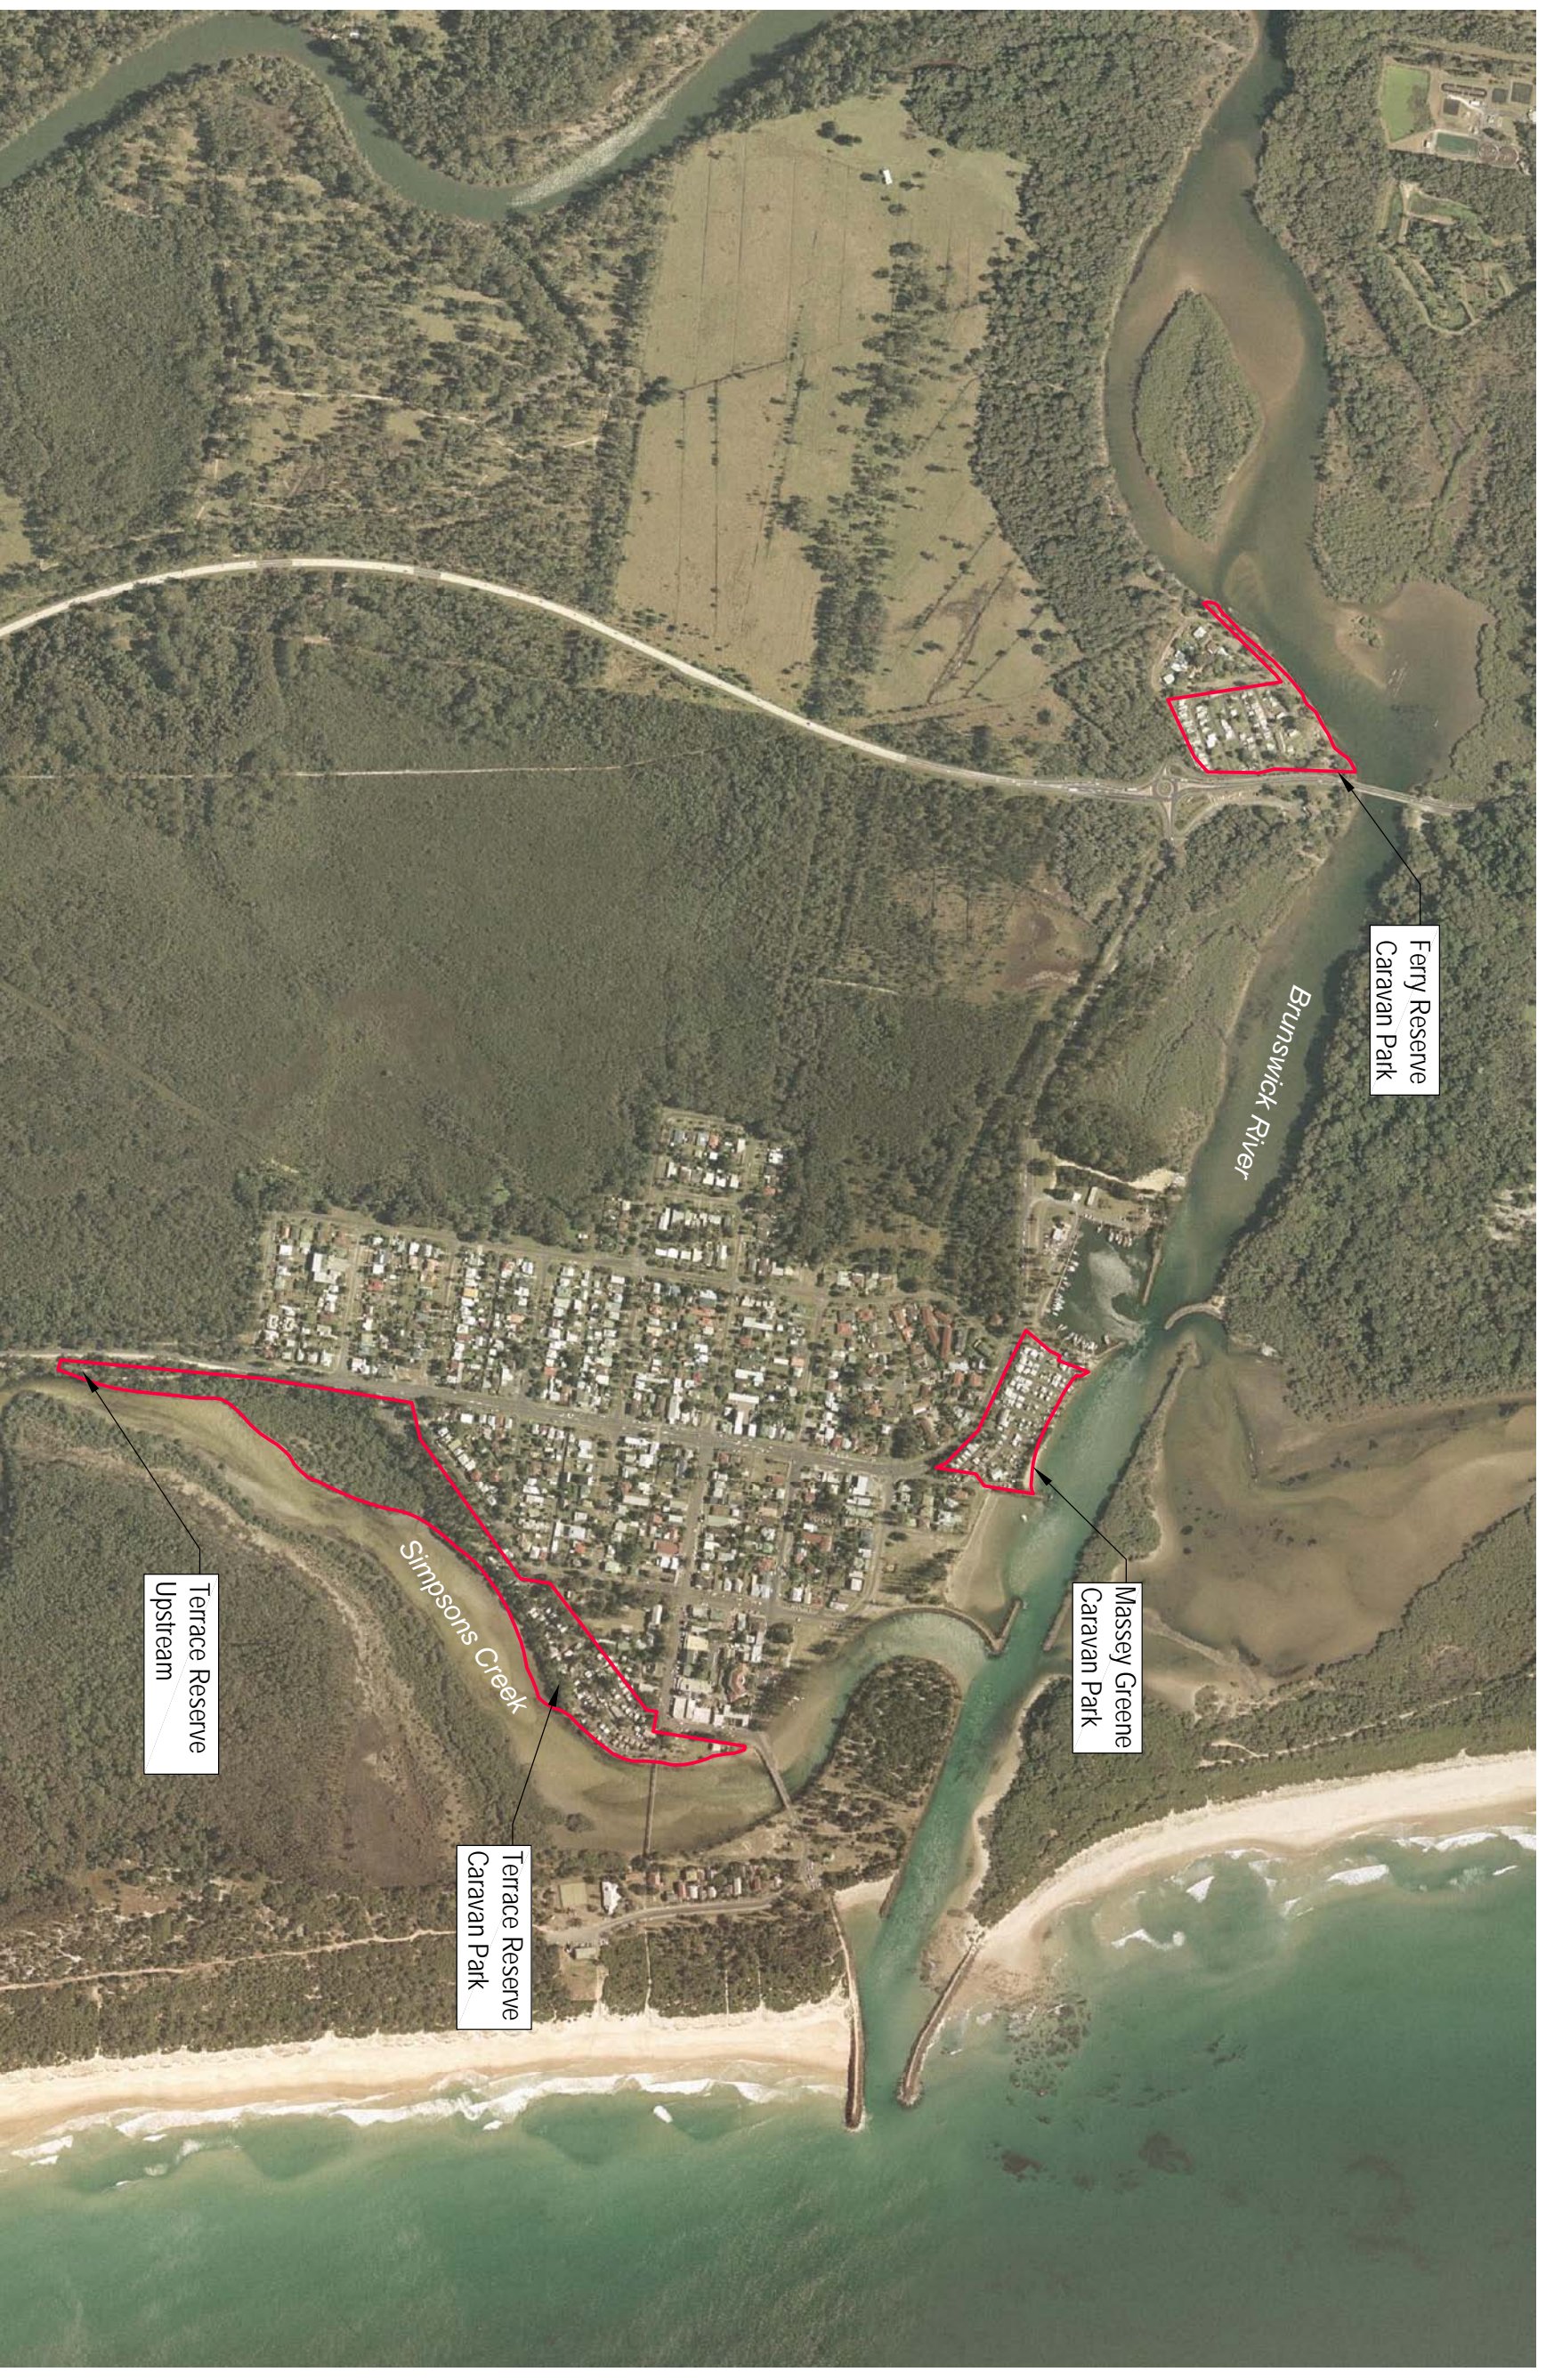
**Plate 1.1**      **A typical view of relatively undisturbed shoreline areas on Simpsons Creek**

A typical view of the natural shoreline on these reaches of the river system is shown in **Plate 1.1**, taken looking downstream at the 'Terrace Reserve Upstream' site (see Section 2.4). Note that the higher steeper bank on the left is on the outside of a bend – a normal characteristic of meandering rivers which generally follow a natural process of accretion on the inside of bends and erosion on the outside of bends. An elevated bank is a feature of the shoreline of Terrace Reserve Caravan Park in particular.

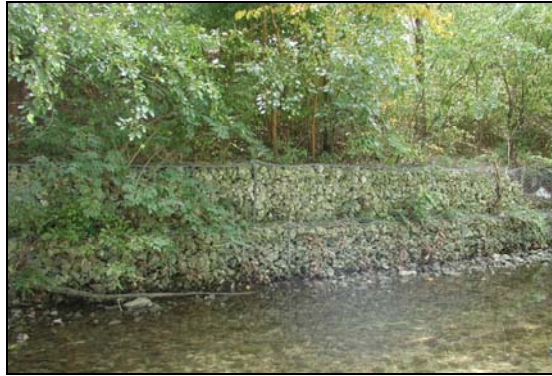
Plate 2.3 Example of a gabion wall (CEES, 2007)

**Gabion wall:** 'Gabions' are blocks made of wire mesh and filled with rocks at the site of construction allowing flexibility in the size of the blocks and laying of the mesh on uneven slopes. They are often supported on a 'reno mattress' which is a series of interlinked flatter gabions less than 0.5 m thick.
