EX HMAS ADELAIDE ARTIFICIAL REEF AND DIVE SITE

POST SCUTTLING REPORT

19 April 2011

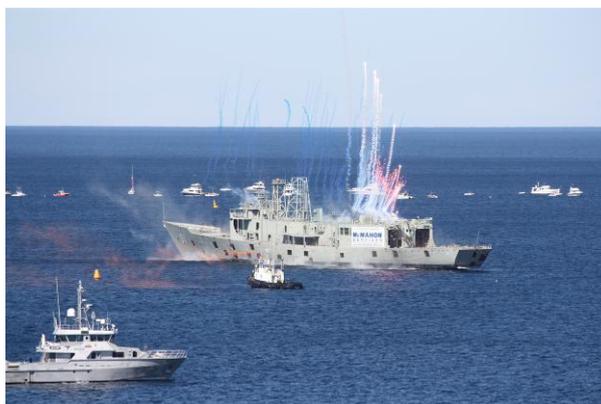
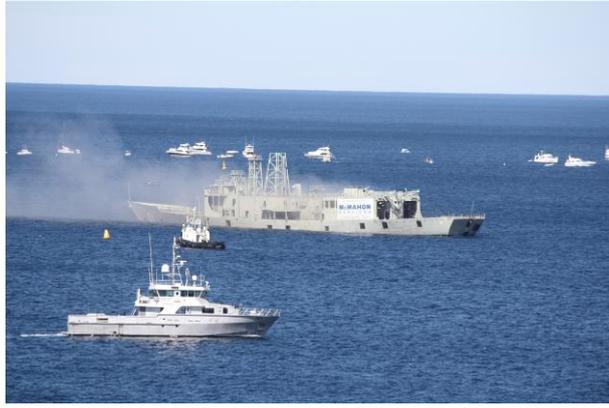
11:48am:

Ex-HMAS Adelaide was scuttled on 13 April 2011, with the detonation of cutting charges occurring at approximately 11:48am and the vessel submerged at approximately 11:50am as shown in the following sequence of photos.

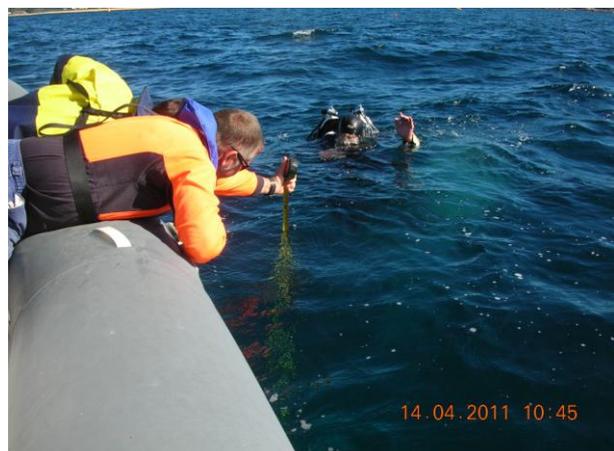
As approved by DSEWPC on 8 April 2011, NSW Maritime provided an independent observer (Ray Moss) to verify the measurement of the highest point of the vessel on 14 April 2011. NSW Maritime also converted the raw reading to give the result of 8.02m at LAT. A copy of correspondence from NSW Maritime regarding the verification is attached at Annexure 1.
