Catherine Hill Bay Jetty

Prepared for The Department of Planning and Environment

September 2023
Project Number N23028
Version 002

Report No. 2 – Materials Engineering & Durability

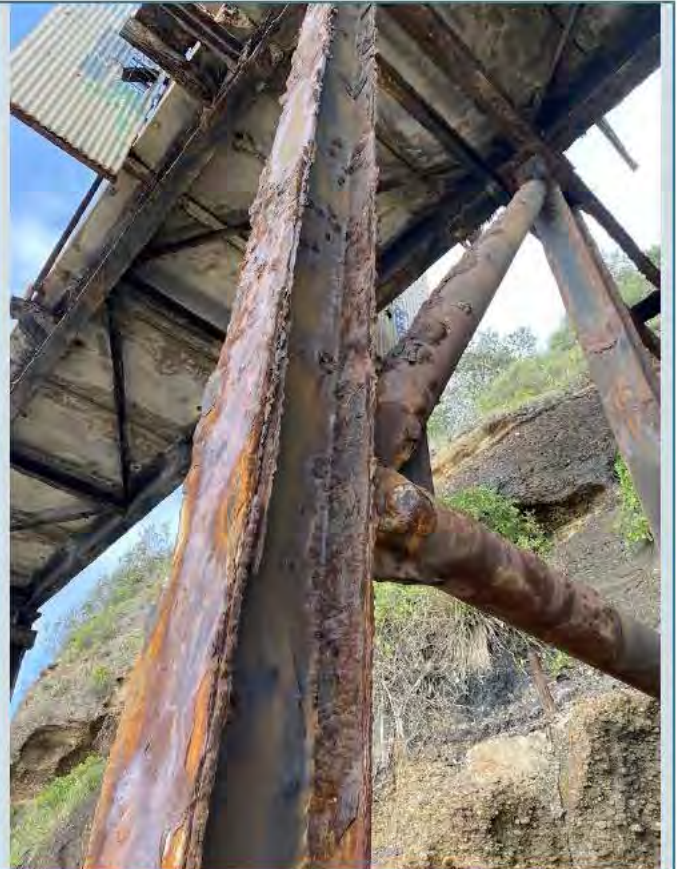
2.2.7 Universal Columns

Connections of CHS bracing to UC's were also heavily corroded. Stiffener plates were showing section loss and CHS braces also had visible section loss.

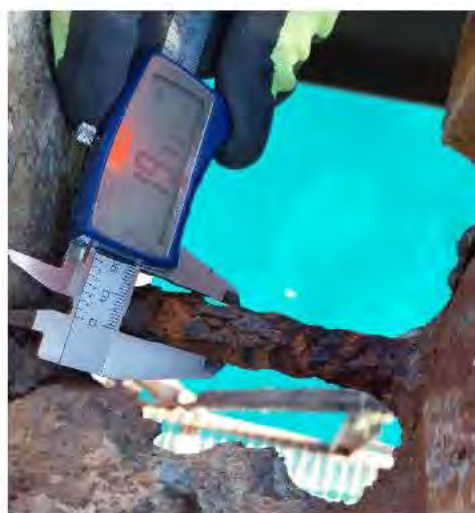
Figure 2: Exposed reinforcement

In all breakouts, the reinforcement bars were in good condition and did not have any signs of corrosion, as observed in Figure 1. In addition, we note that reinforcement bars that were exposed from atmospheric condition or concrete deterioration were also measured, with the condition of the bars being moderately corroded, as observed in Figure 2. The reinforcement bar diameter was measured between 19-20mm.

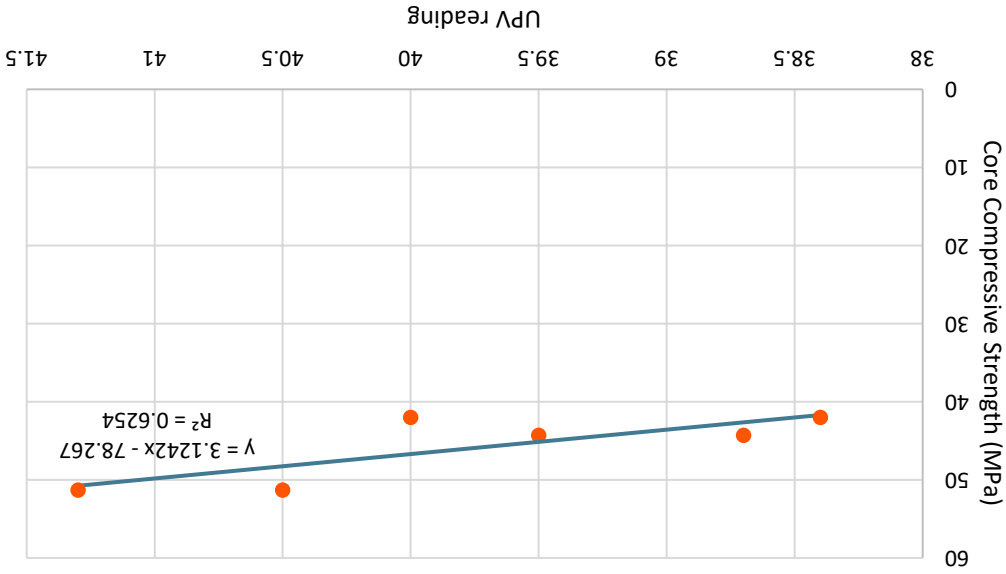
Figure 4: Correlation between UPV reading and core compressive strength

In addition, a correlation between UPV readings to the compressive strength of the extracted cores were made in Figure 3. Taking into consideration of the R-squared value (0.6254) being more than 0.5 illustrates that the correlation is statistically significant. As a result, a correlation between UPV readings to the compressive strength of the extracted cores can be made.

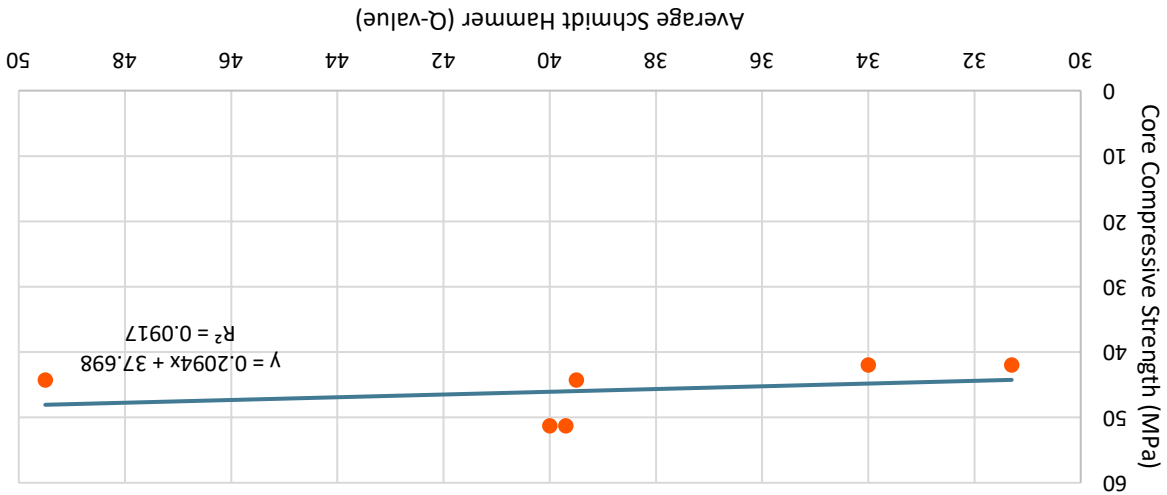
Figure 3: Correlation between Schmidt hammer and core compressive strength

A correlation between Schmidt Hammer readings to the compressive strength of the extracted cores were made in attempt to extrapolate the compressive strength of the concrete slabs where coring was not completed, as observed in Figure 3. Taking into consideration of the R-squared value (0.0917) being less than 0.5 illustrates that the correlation is not statistically significant. As a result, a correlation between Schmidt Hammer readings to the compressive strength of the extracted cores cannot be made.

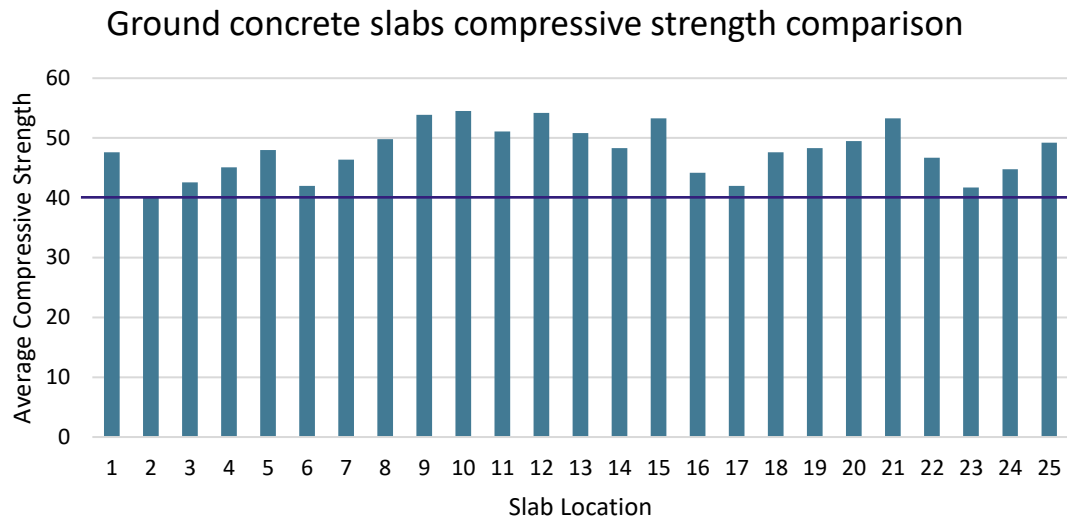
Figure 5: Comparison between compressive strength of ground slabs to in-situ characteristic strength

The in-situ characteristic compressive strength values have been derived using the method outlined in BS EN 13791:2019, and the relationship developed between the UPV reading and core compressive strength data shown in Figure 4. The in-situ characteristic compressive strength of the ground slabs was calculated to be 40 MPa. A comparison to the in-situ characteristic compressive strength of the ground slabs to the respective average compressive strength was graphed in Figure 5.

The characteristic in-situ compressive strength was calculated as 40 MPa. With reference to Figure 5, all slab locations are above the characteristic in-situ strength. As a result, it is recommended the characteristic in-situ strength can be adopted in designs for structural analysis and testing.

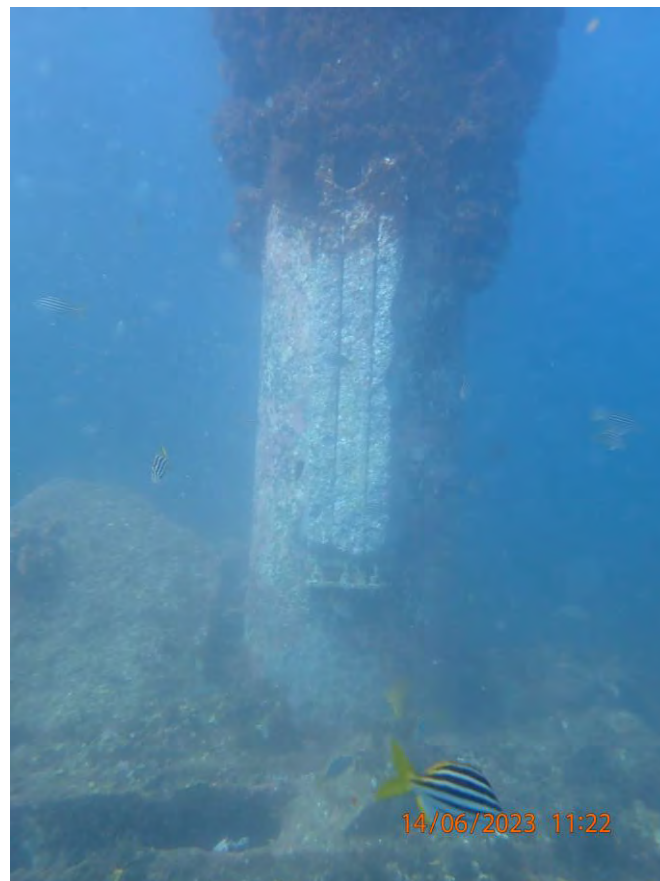
Photo 13: Pile 2 Anode

- At the base of the pile, one large anode is fitted to tabs, welded on the pile. See **Photo 13**

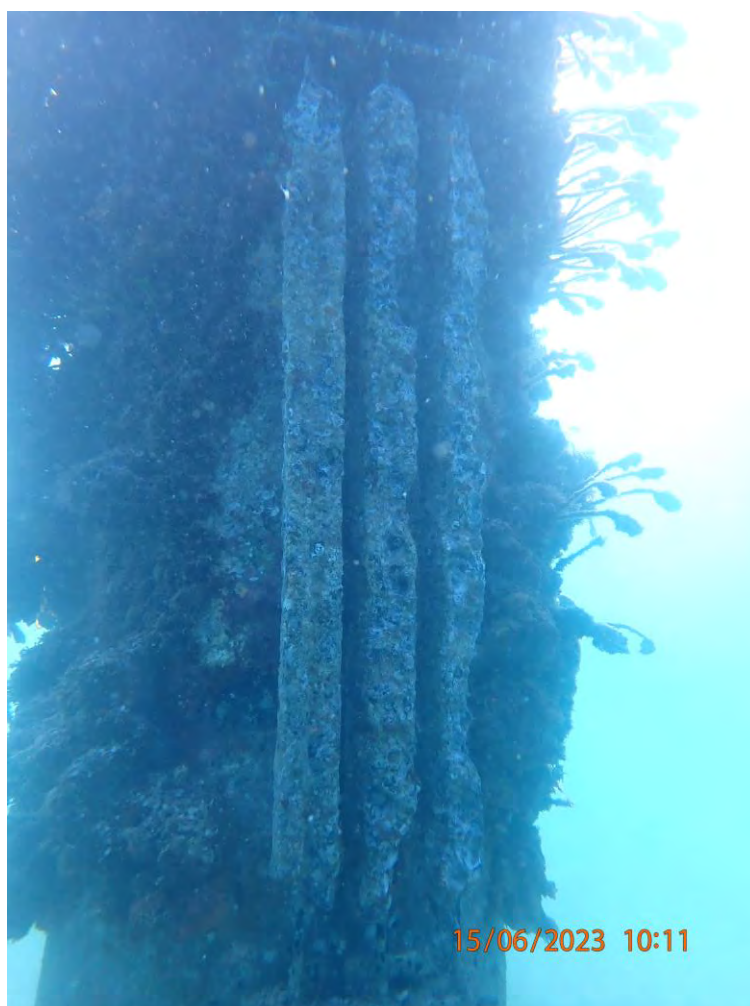
Photo 18. Pile 3. Anode

- At the base of the pile, one large anode is fitted to tabs, welded on the pile. See **Photo 18**

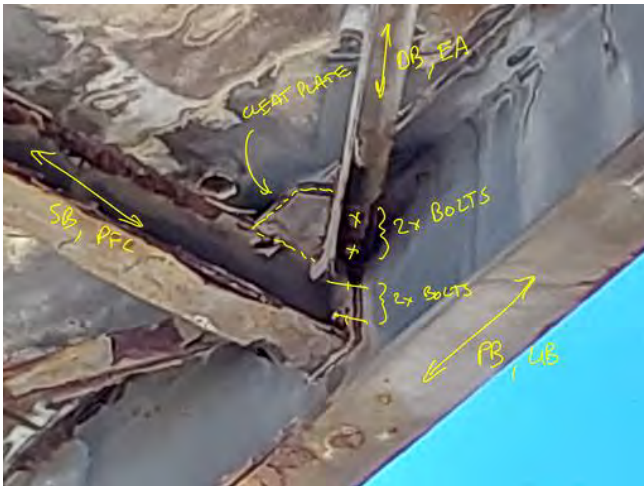
20230614_012348_photo

Not every PB connection has a stiffener

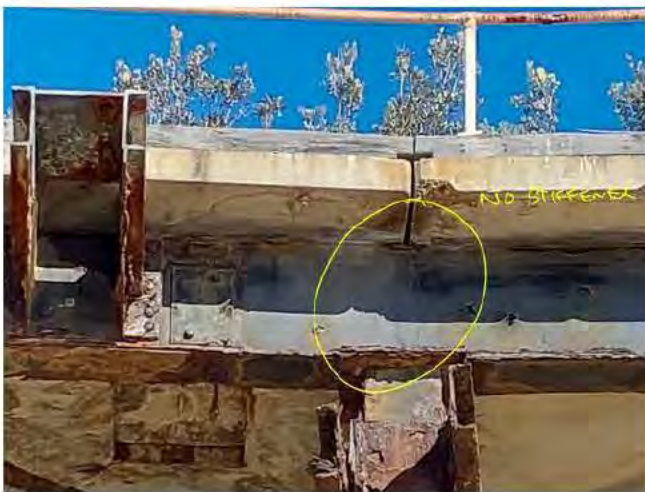
20230614_011207_photo

Simply Supported
