Catherine Hill Bay Jetty - Structural Condition Report

Prepared for NSW Department of Planning and Environment

July 2023
Project Number: N23028
Version: Rev A

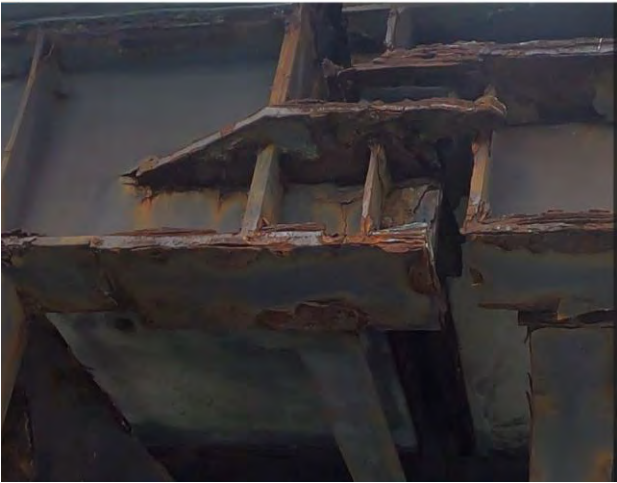
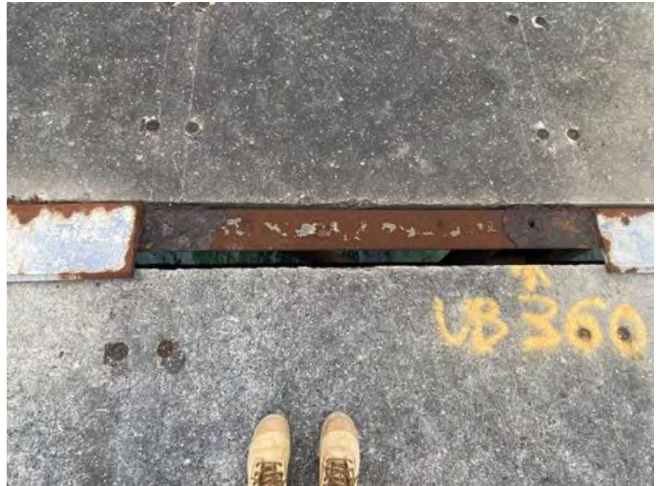
Figure 7 - Bent 17 Movement Joint

There is a movement joint at Bent 17, including a steel corbel in the primary beams.

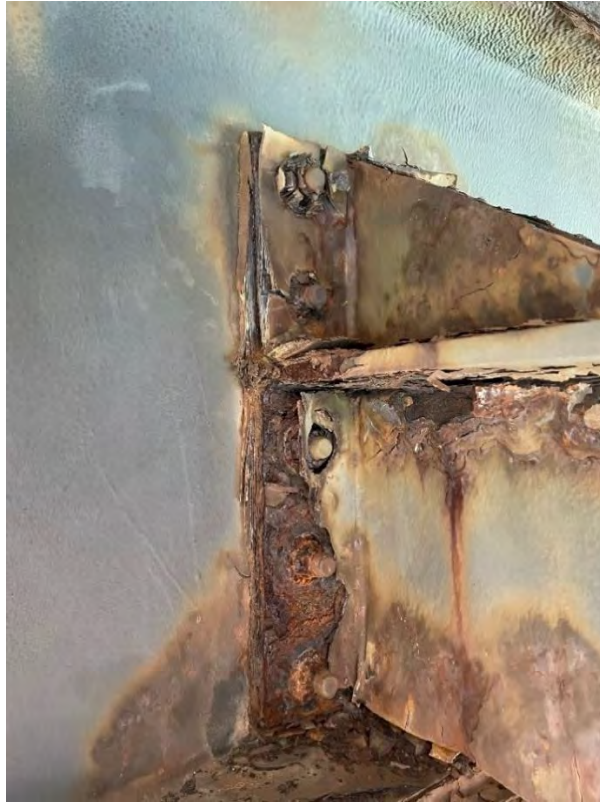
Figure 18 - Connection Between Secondary Beam and Primary Beam, Deck Type DA1

The connection between tertiary beams and secondary beams appeared to be significantly corroded in almost all cases. This would generally be classified as condition state 4, dropping down to 3 in some instances. The connections between secondary beams and primary beams were also noted to be heavily corroded. It was noted that one of the

secondary beams had completely rusted through and lost its bottom flange at the connection point. Fatigue caused by high localised concentrations of stress applied cyclically by wind, waves, boat forces and mechanical actions such as the conveyor and ship loader forces can cause fatigue corrosion which can increase the rate of environmental corrosion. Also, the different grades of plate steel compared with the hot-rolled sections may be more prone to corrosion initiating, causing trapped seawater in the pitting lamination that may affect adjacent materials. All similar connections would need to be analysed further to determine if it was a common trend or localised incident.

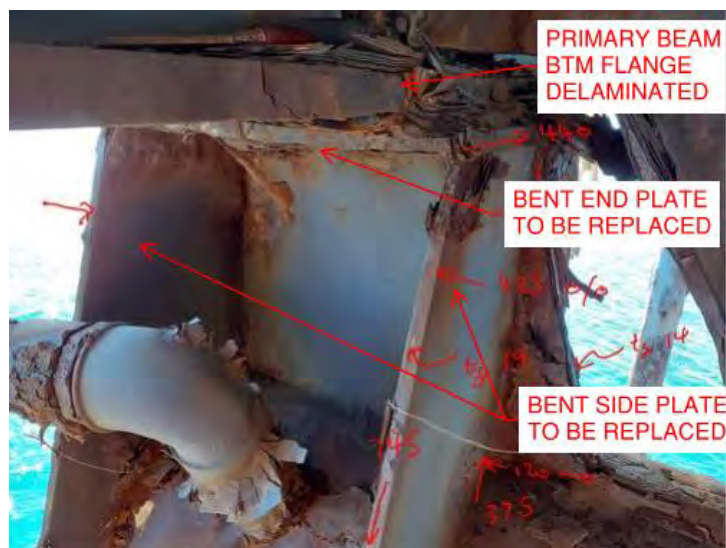
Figure 31 – Primary Beam to Bent Connection, Deck Type DA1

This is typical on all primary member to bent connections.

- Flanges: 2 x 150w x 1500Lx 32thk Plates
- Connection: 2 x 500w x 500h x 20thk Side Plates
1 x 600w x 600l x 32thk End Plate

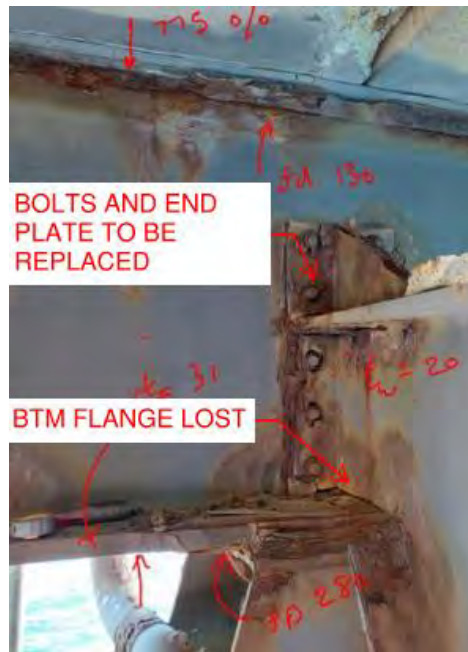
Figure 32 – Secondary Beam to Primary Beam Connection, Deck Type DA1

- Flanges: 2 x 100w x 1000Lx 15thk Plates
- End connection: 1 x 300w x 600h x 20thk Plate
- Bolts: 10M20 Bolts

This is typical on all secondary to primary member connections.

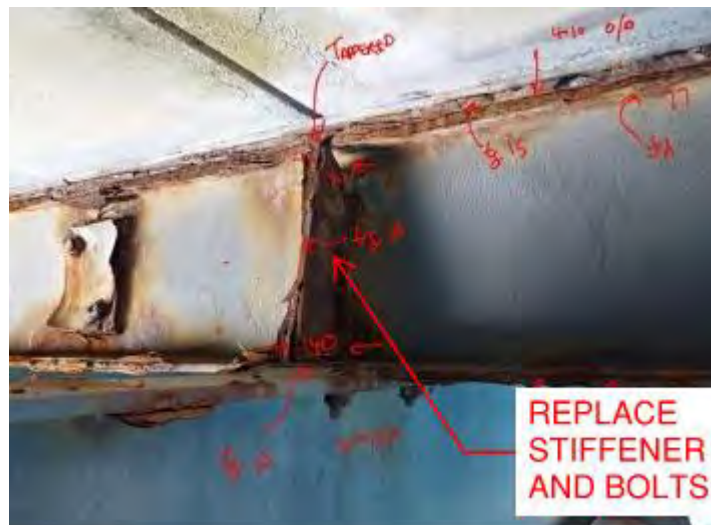
Figure 33 – Tertiary Beam to Secondary Beam Connection, Typical of Deck Type DA1

- Stiffener: 2 x 150w x 400h x 15thk Plates
- Bolts: 4M20 Bolts

This appear to be typical across all tertiaries to secondary member connections.

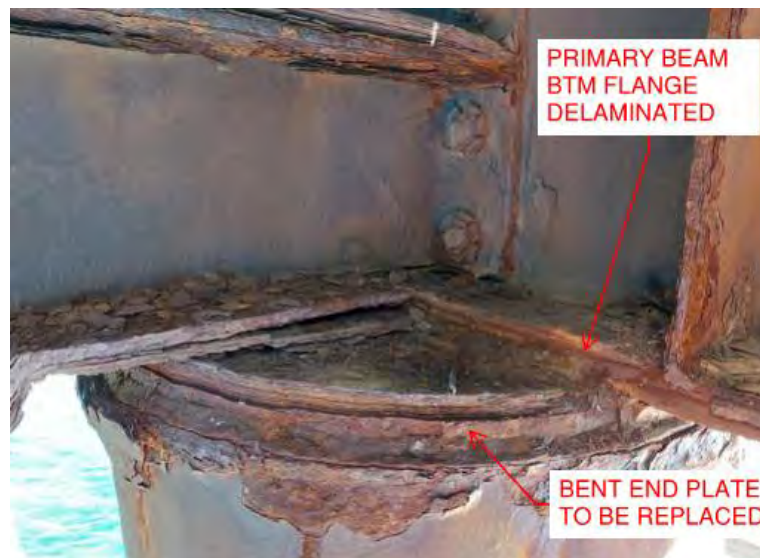
Figure 34 - Primary Beam to Bent Connection, Deck Type DA2

This is typical on all primary member to bent connections.

- Flanges: 2 x 100w x 1500Lx 20thk Plates
- Connection: 1 x 600w x 600l x 32thk End Plate

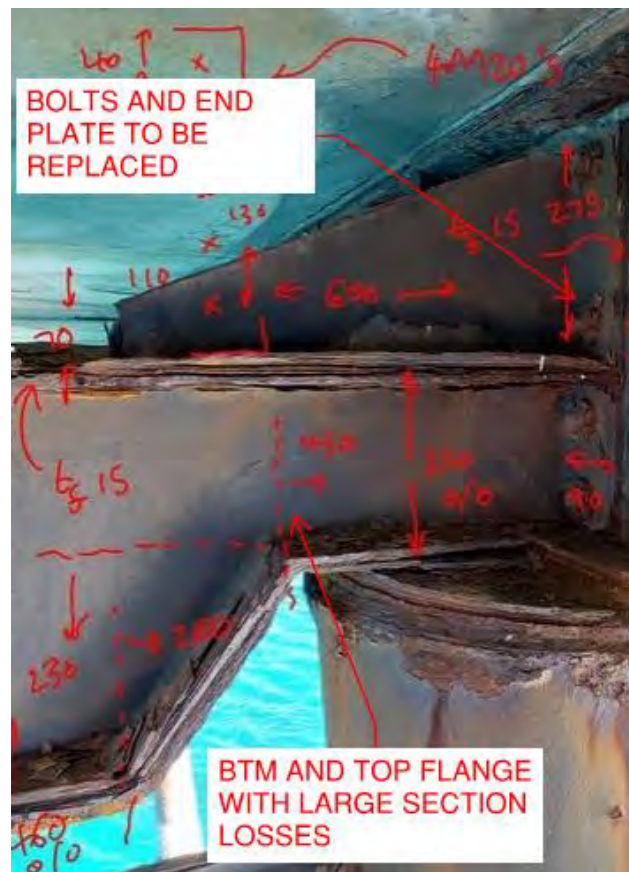
Figure 35 - Secondary Beam to Primary Beam Connection, Deck Type DA2

- Flanges: 2 x 100w x 1000Lx 15thk Plates
- End connection: 1 x 300w x 500h x 20thk Plate
- Bolts: 8M20 Bolts

This is typical on all secondary to primary member connections.

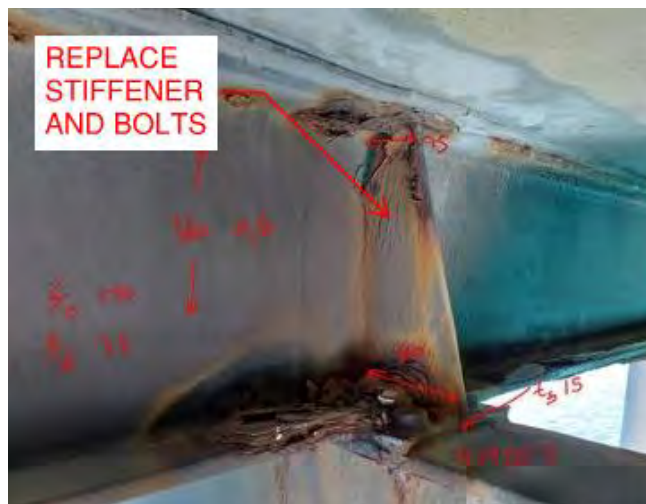
Figure 36 - Tertiary Beam to Secondary Beam Connection, Typical of Deck Type DA2

- Stiffener: 2 x 100w x 350h x 12thk Plates
- Bolts: 4M20 Bolts

This appear to be typical across all tertiaries to secondary member connections.

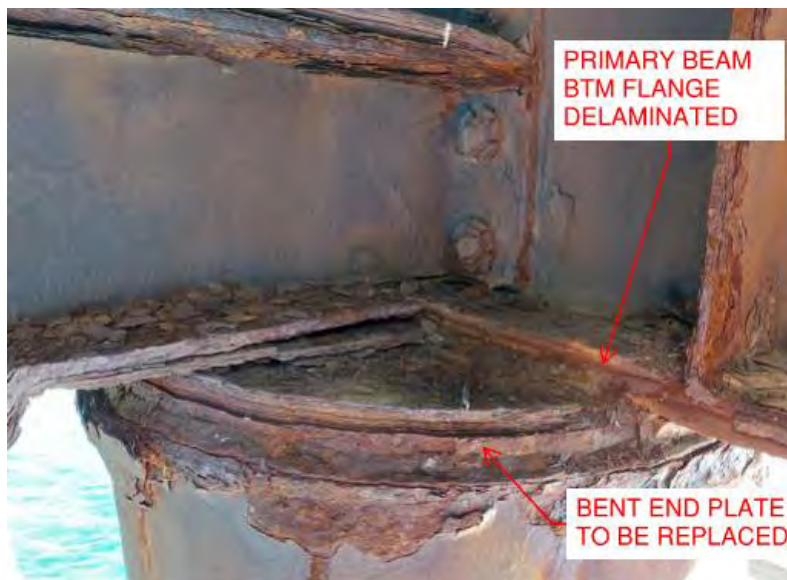
Figure 37 - Primary Beam to Bent Connection, Deck Type DB

This is typical on all primary member to bent connections.

- Flanges: 2 x 100w x 1500L x 25hk Plates
- Connection: 1 x 600w x 600l x 40hk End Plate

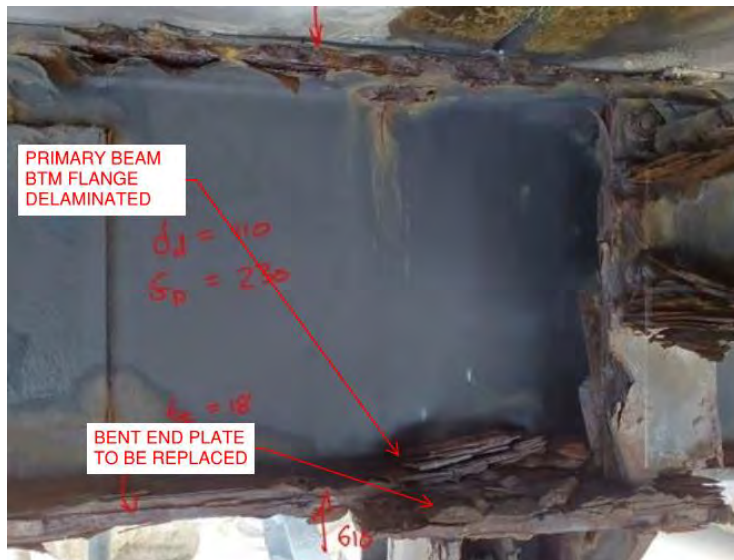
Figure 39 - Primary Beam to Bent Connection, Deck Type DC

Site inspection show some corrosion at the bottom and top flanges. Considering a 20% loss of the flanges, the section does have sufficient capacity.

There are large section losses to the beam bottom flange at the connection to the bents. The bottom flange of the beam needs to be replaced and the following strengthening plates are required on each connection.

This is typical on all primary member to bent connections.

- Flanges: 2 x 100w x 1500Lx 20thk Plates
- Connection: 1 x 400w x 400l x 25hk End Plate

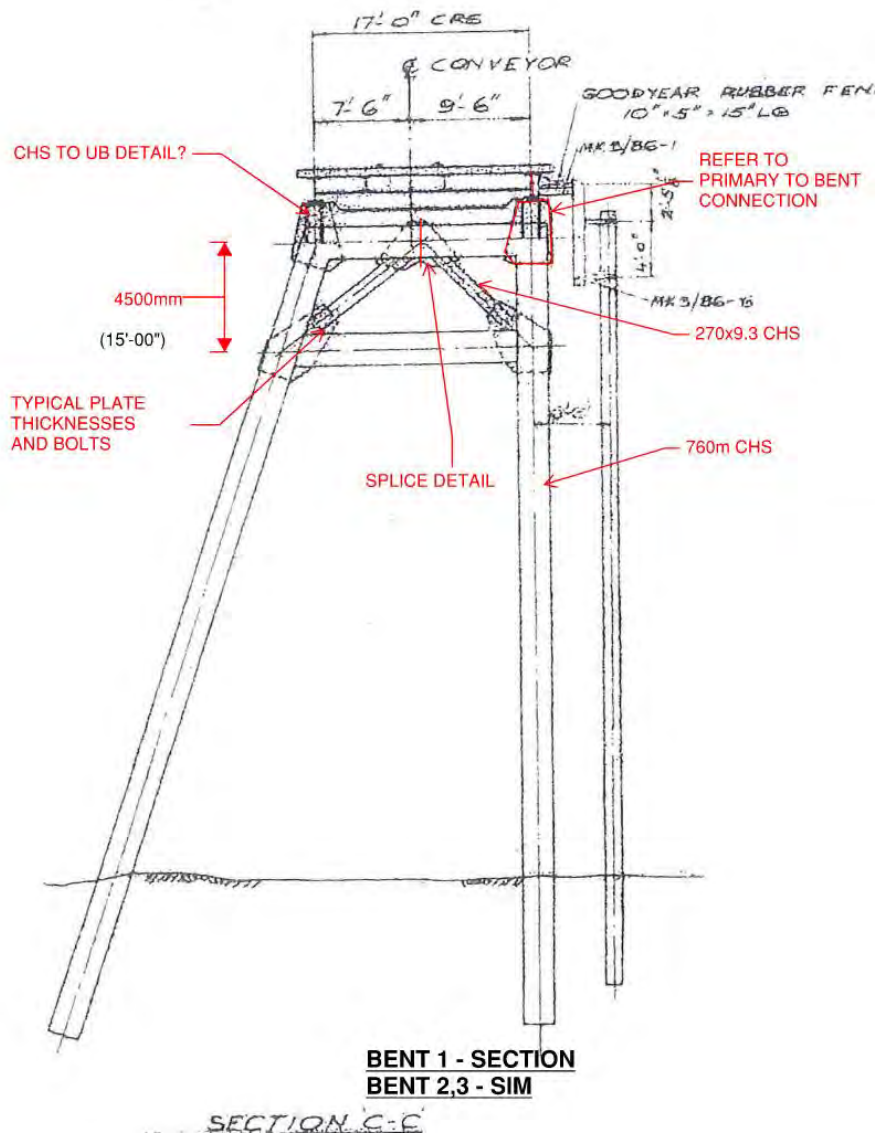
5.6.1 Structural arrangement

The bent main member 760CHS has sufficient capacity to carry the proposed loads. Assessing the capacity of the founding sand and rock is outside the scope of this report in the absence of geotechnical data. Based on site inspection minor rectification works to the structural bracing are required. Additionally, allowance must be made for bearing replacement on each connection of primary beam to bent.

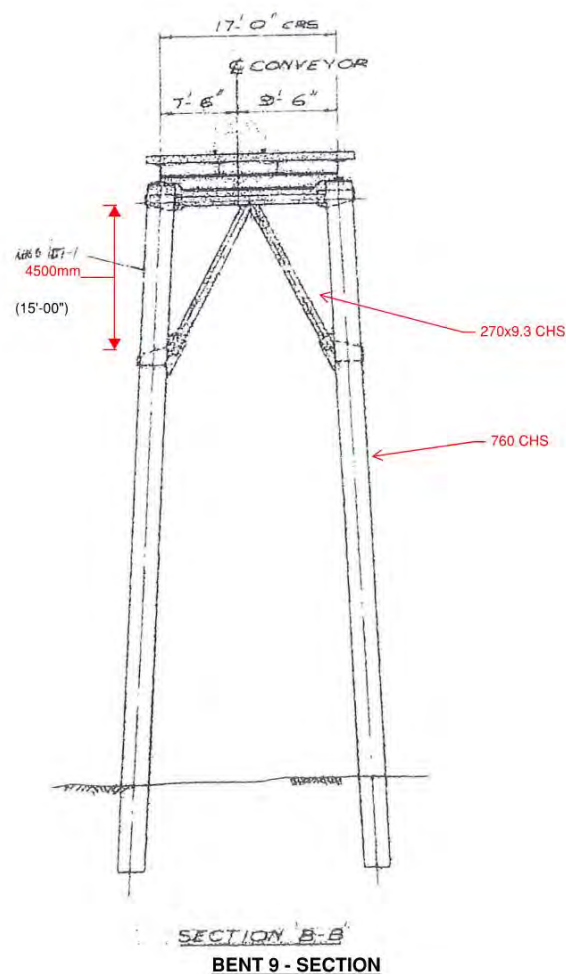
5.7.1 Structural arrangement

The bent main member 760CHS has sufficient capacity to carry the proposed loads. Assessing the capacity of the founding sand and rock is outside the scope of this report in the absence of geotechnical data. Based on site inspection minor rectification works to the structural bracing are required. Additionally, allowance must be made for bearing replacement on each connection of primary beam to bent.

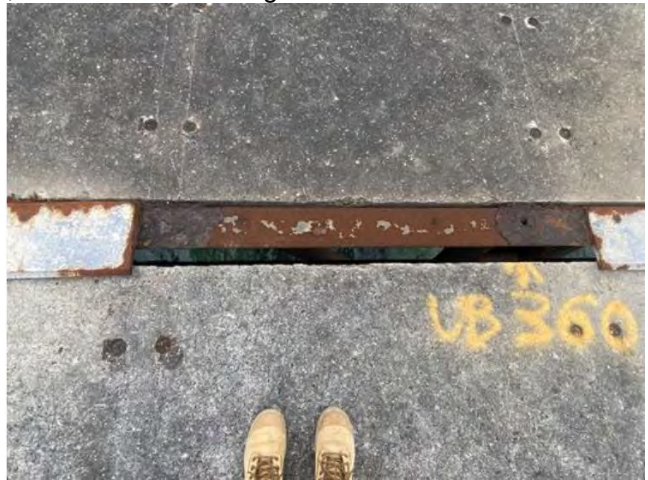
Figure 41 - Bent 17 movement joint

A visual inspection of the movement joint on both primary beams on Bent 17 show large corrosion and section losses that requires complete replacement of the sections, stiffeners and bearings.

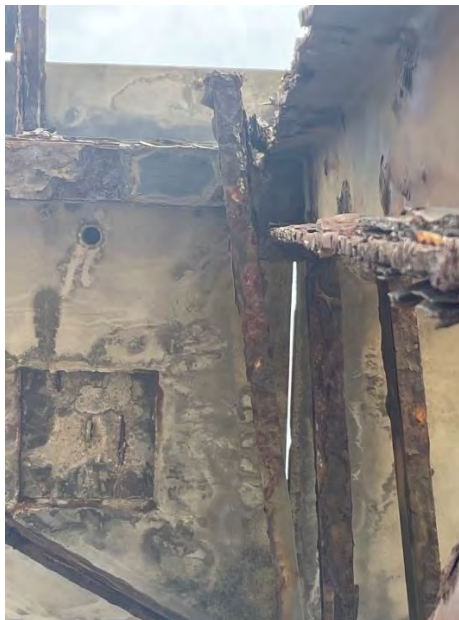
All structural members that comprise bents 18 to 28 are to be replaced due to heavy corrosion and section loss.

All bracing members, 230 CHS and 200PFCs are heavily corroded with section losses.

Figure 43 – Back-to-Back PFC, Visibly Detached from UC Columns, Typical of Bents 18-28

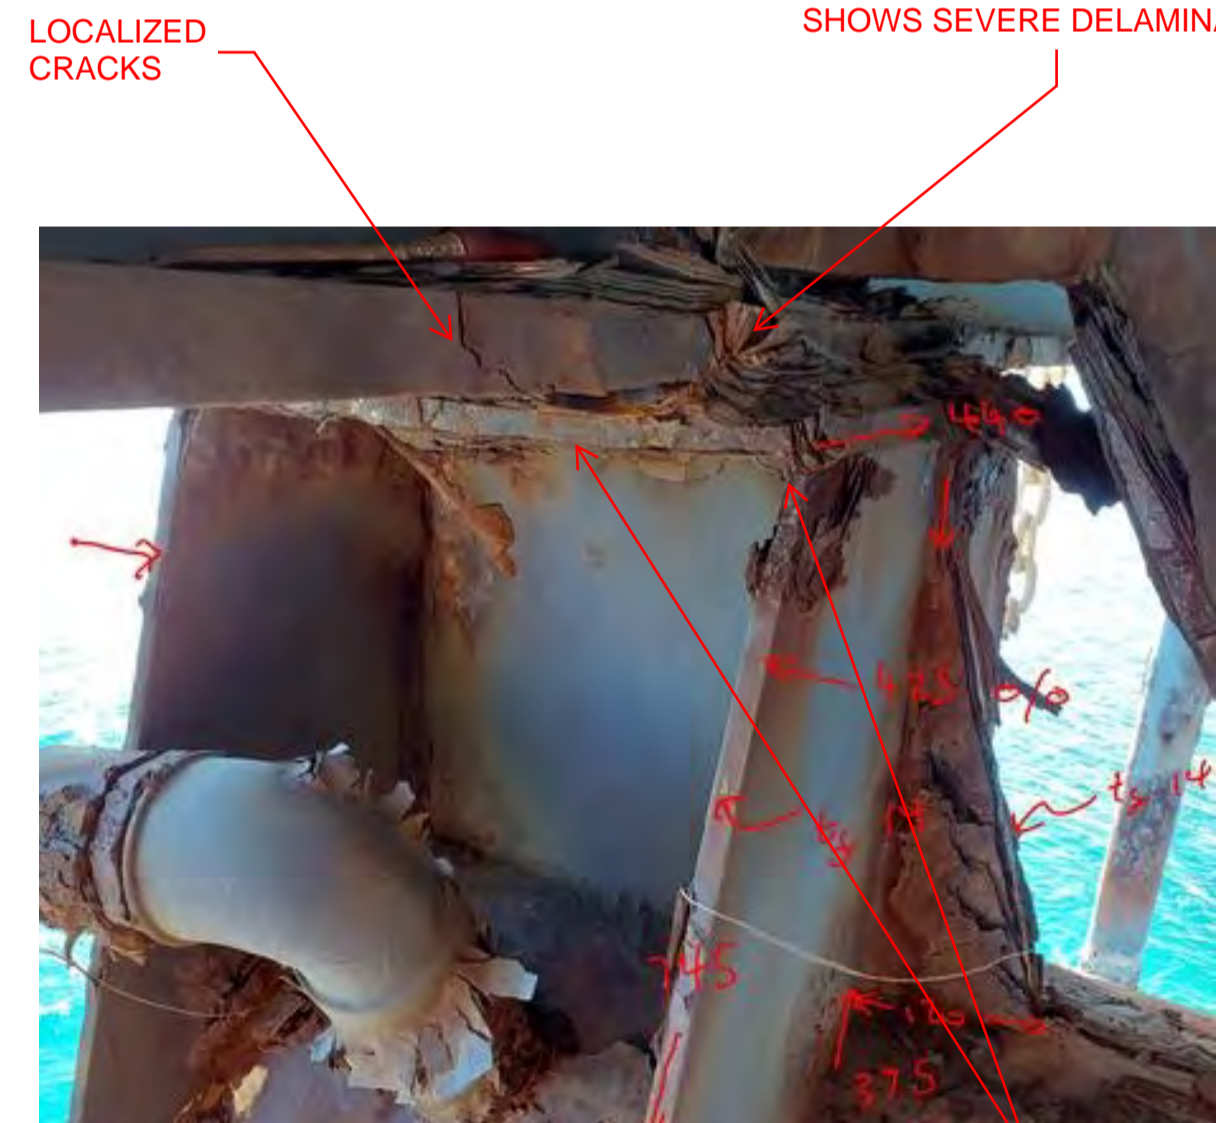
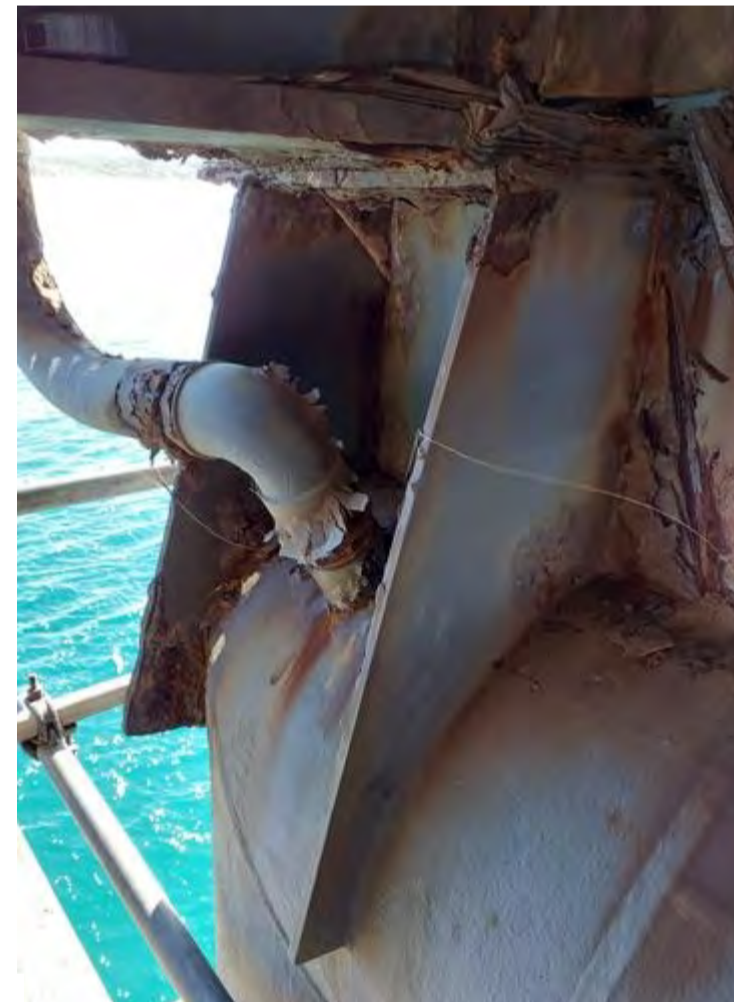
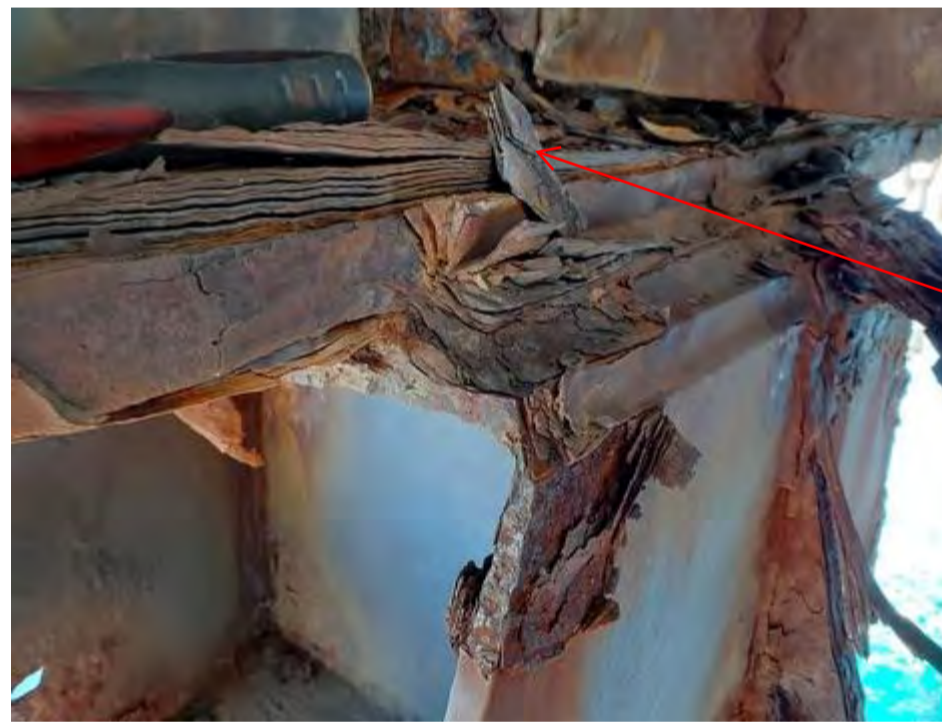
**BENT 1 - SECTION
BENT 2,3 - SIM**

DUE TO THE SEVERE DELAMINATION OF THE BTM FLANGE IT IS NOT POSSIBLE TO DETERMINE IF THE PRIMARY BEAMS ARE BOLTED/WELDED OR SITTING ON A BEARING TO THE BENTS

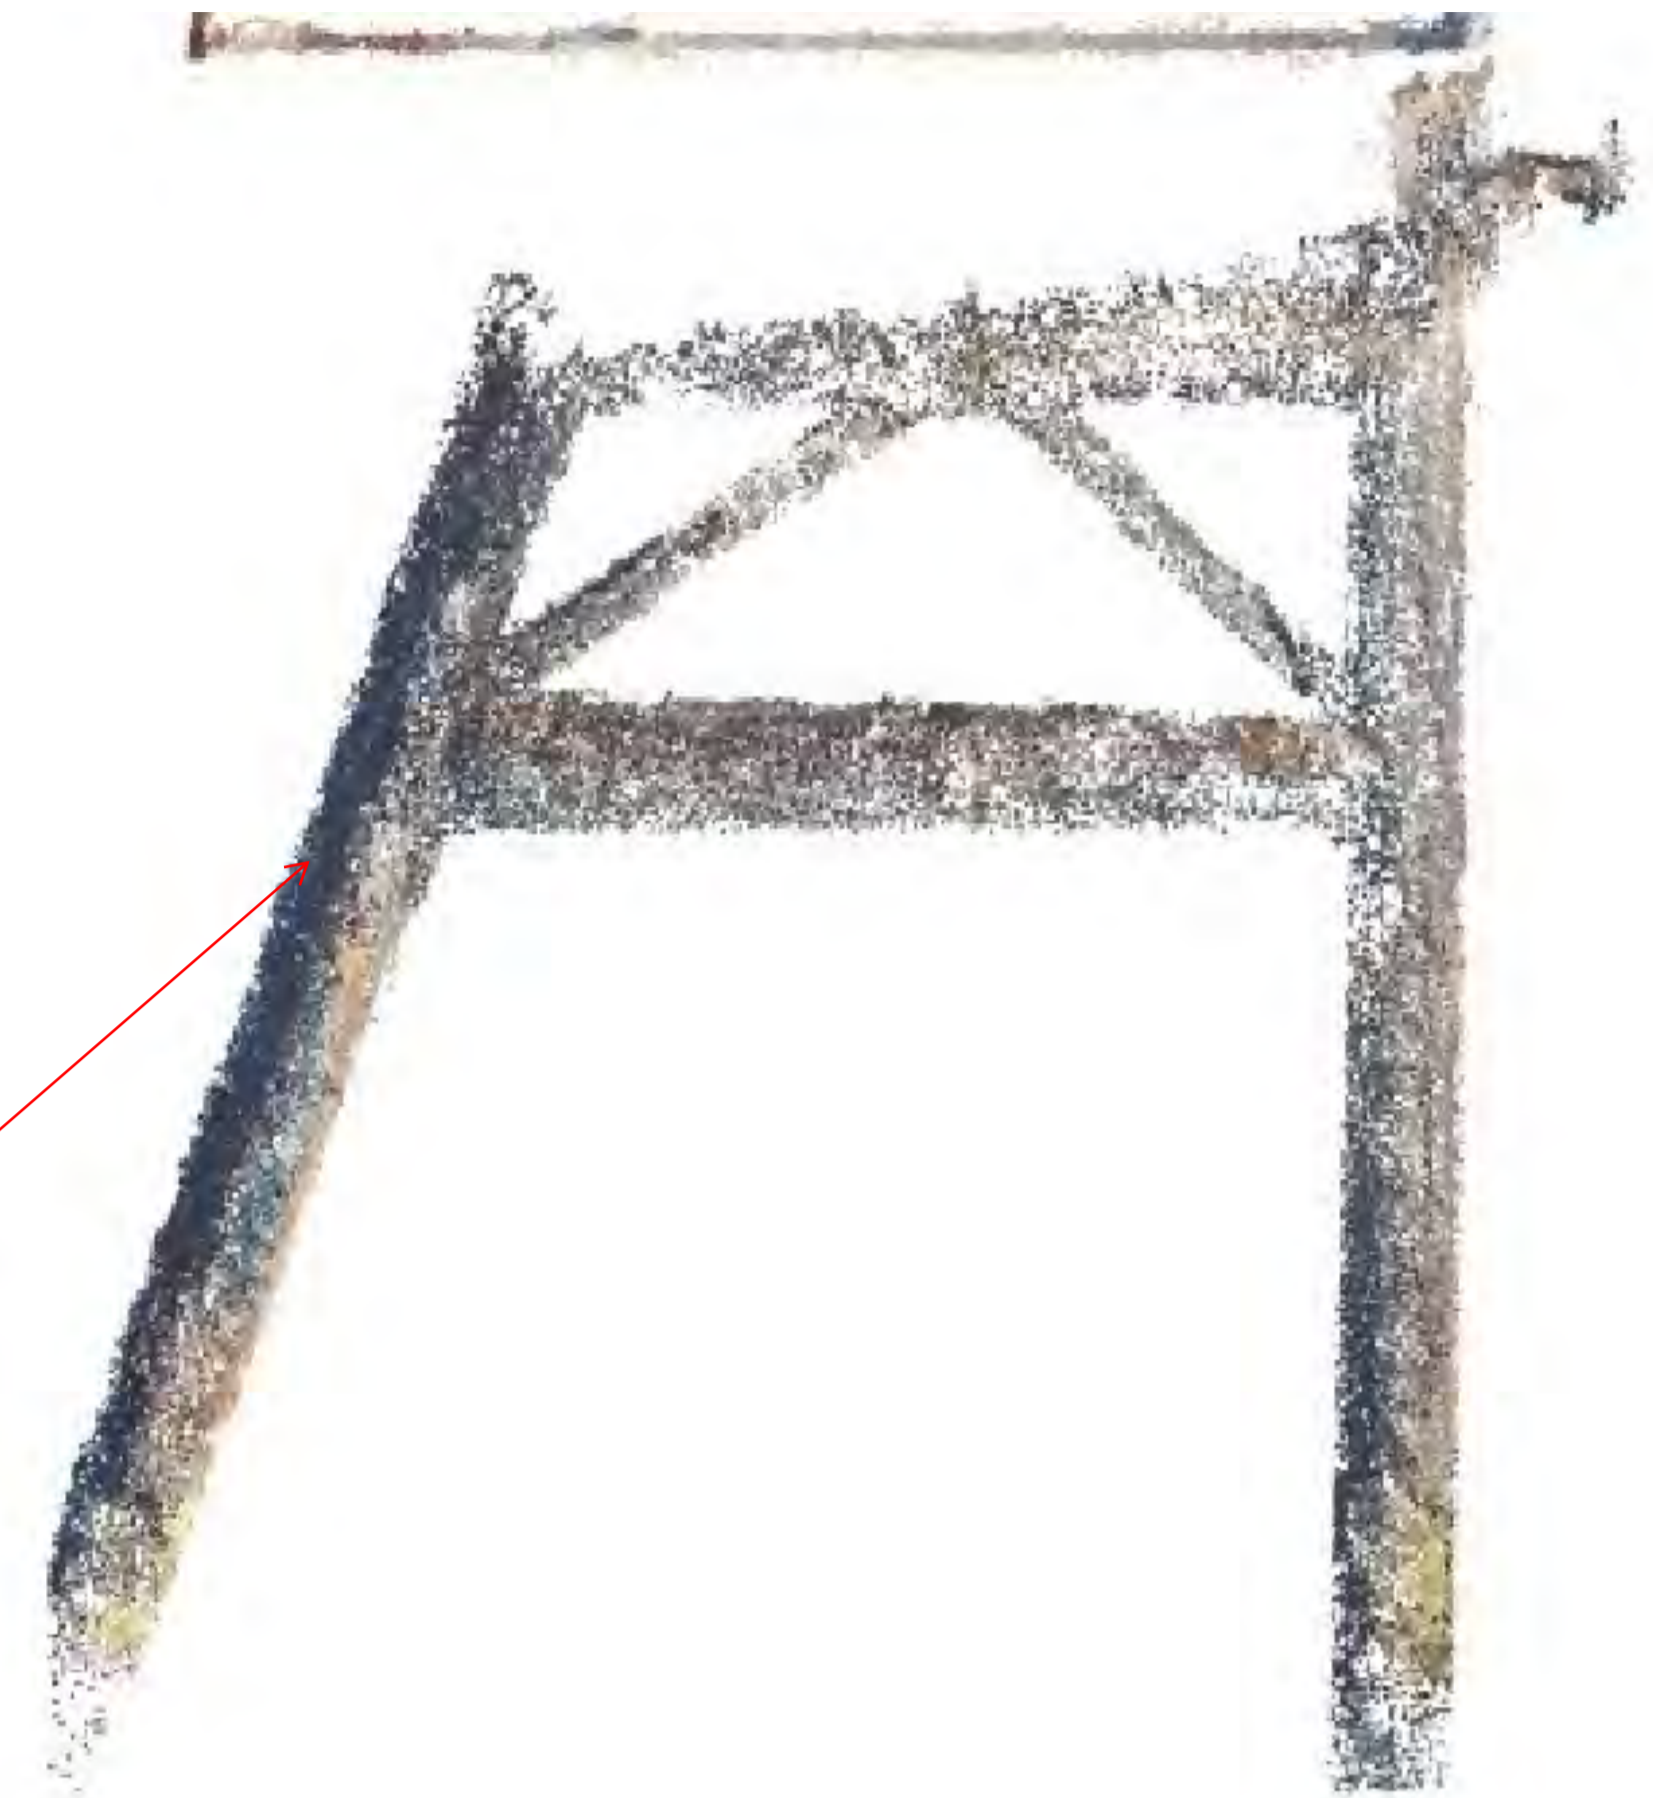
BENT 6 - POINTCLOUD
BENT 7,8 - SIM

INFORMATION FROM POINT
CLOUD, ASSUMED SIMILAR
SECTIONS AND CONDITIONS
TO BENT 1

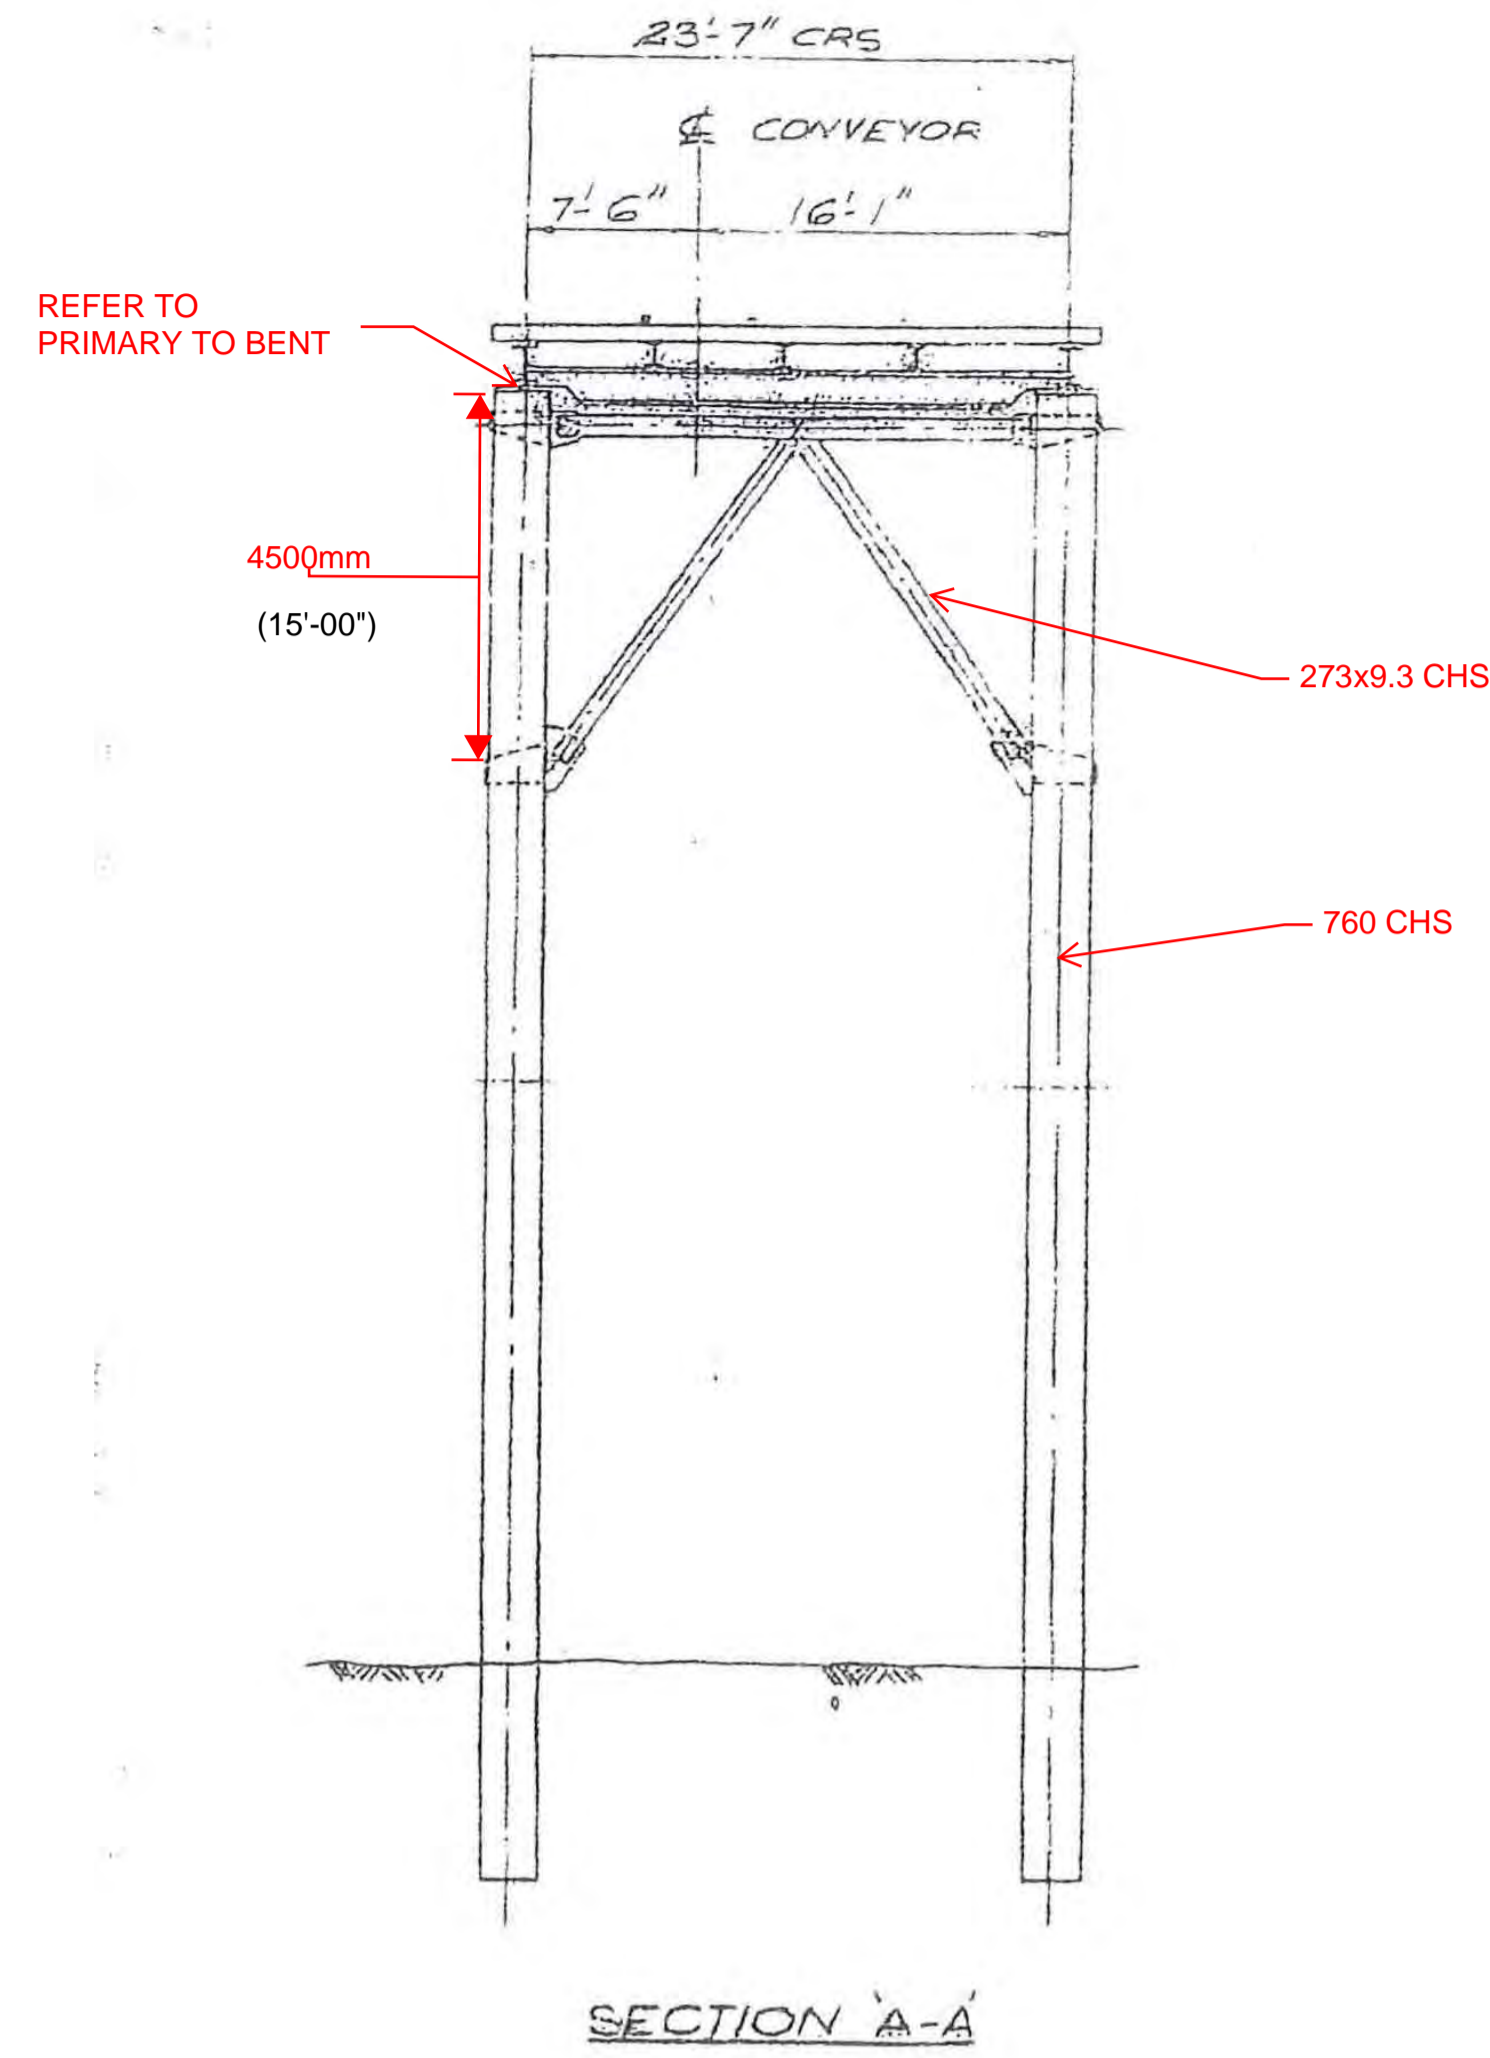
BENT 12 - POINTCLOUD
BENT 13,14,15,16,17 - SIM

DUE TO THE SEVERE DELAMINATION OF THE BTM FLANGE IT IS NOT POSSIBLE TO DETERMINE IF THE PRIMARY BEAMS ARE BOLTED/WELDED OR SITTING ON A BEARING TO THE BENTS

END RUSTED. SOME LOSS OF SECTION AT CONNECTION TO CHS

PRIMARY BEAM BTM FLANGE SHOWS SEVERE DELAMINATION

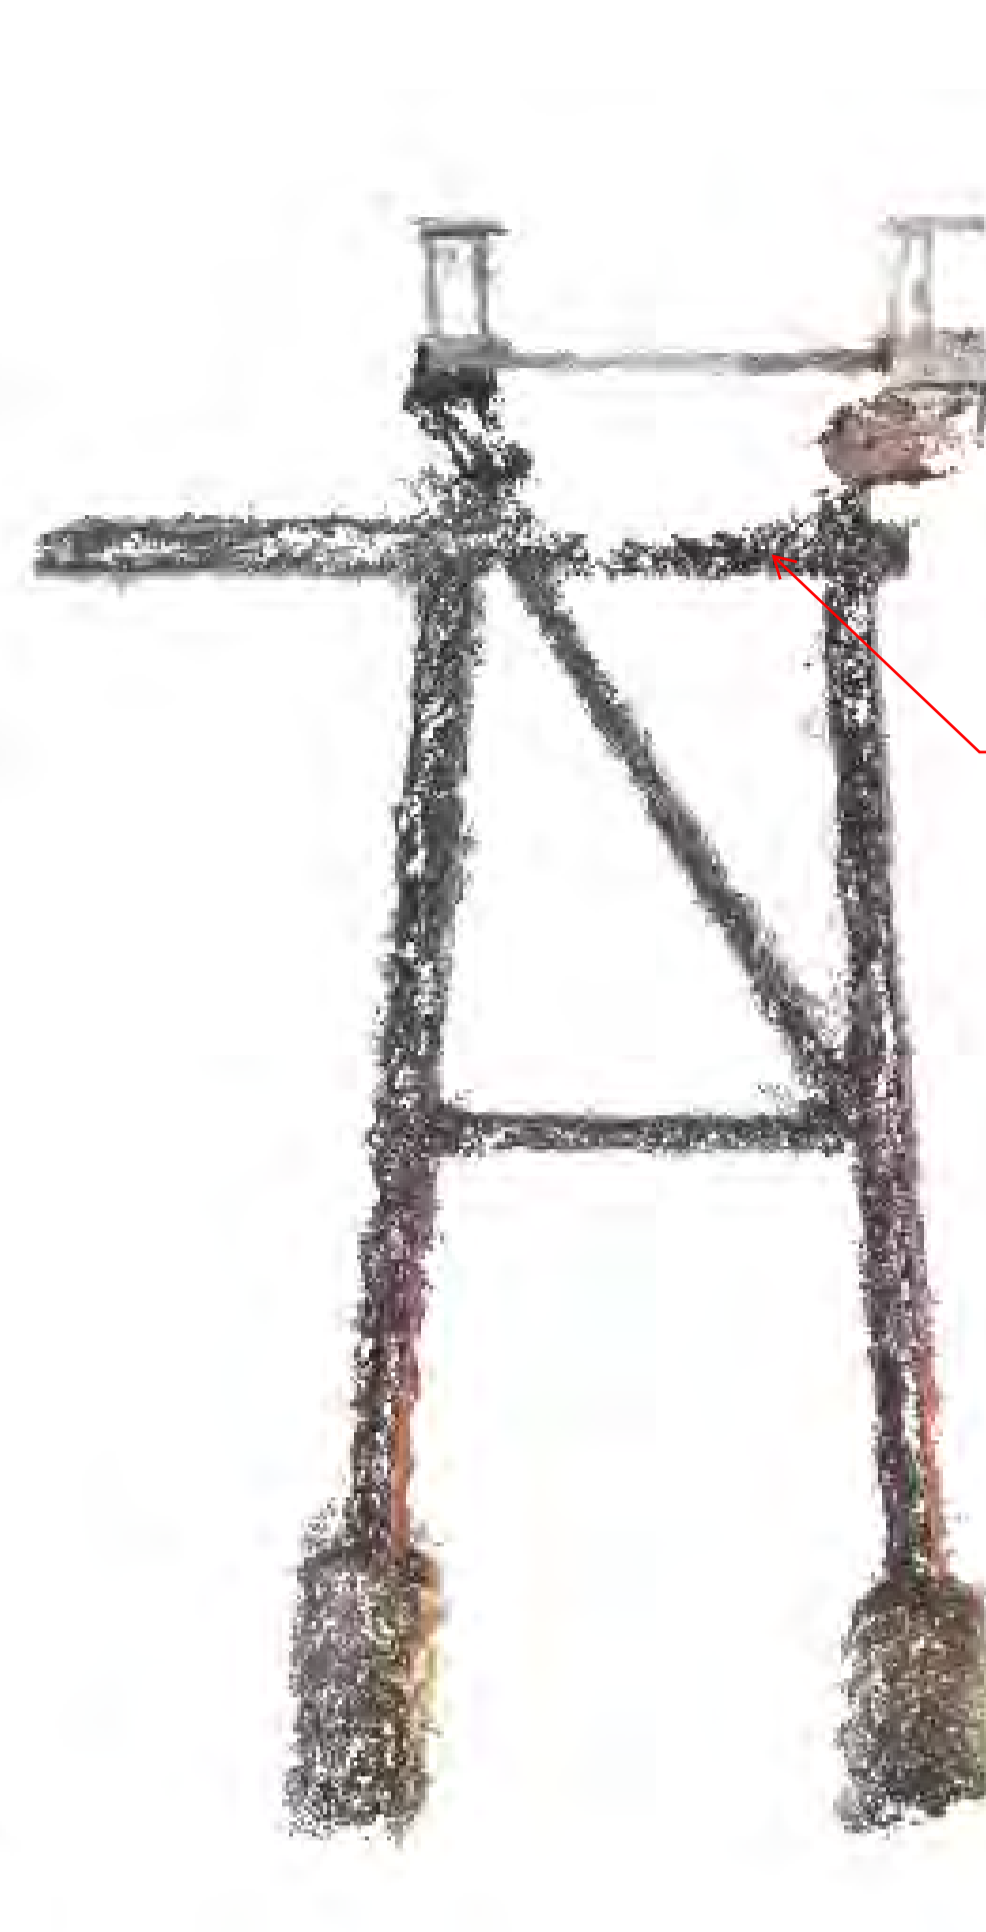
BENT 21 - POINTCLOUD

ALL COLUMNS ARE 310UC18 IN BAD CONDITIONS WITH LOSS OF SECTION IN THE FLANGE

The UC Columns were observed to be in very poor condition and show high levels of corrosion and section loss. Due to their height, the section loss and lack of bracing/restraint, these members have limited capacity to carry axial loads and are susceptible to buckle in their weak axis. The location of the columns in the tidal and splash zones mean that the rates of corrosion are faster, and it can be seen when analysing the past reports that since maintenance has ceased the rates of corrosion have increased even further. Due to the visible delamination and generally poor condition of these members they are most likely going to have to be replaced completely. There are 22 columns in this section that would need replacing or significant work to clean and remediated.

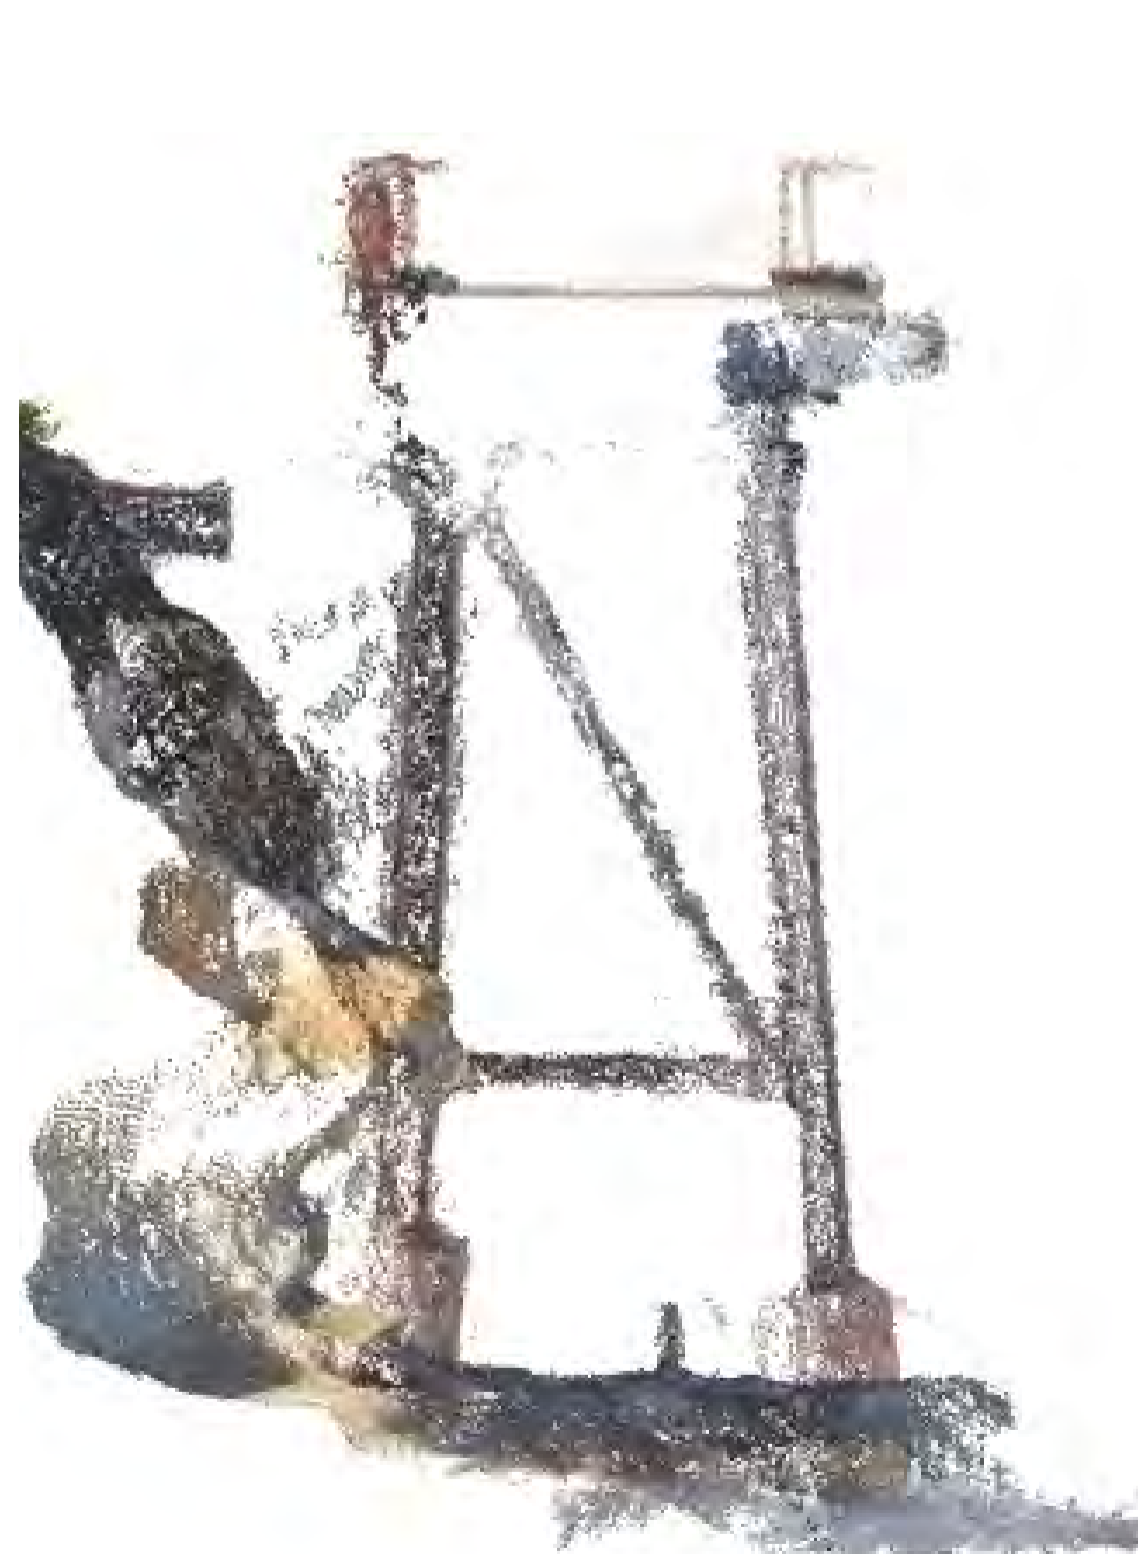
BENT 24 AND 25 - POINTCLOUD

ALL BRACING HAVE LOSS OF SECTIONS (HOLES) AND SEVERELY DAMAGED

The vertical bracing and tie beams in this section of the jetty are also all very highly corroded with several of the CHS members being corroded to the point of holes forming. It has been estimated that only about 20% of these members have the potential to be reused. The members that have potential to be reused will need to be cleaned and reanalysed to determine the resulting section capacity. Any members that are to be reused will need to have a corrosion inhibitor

applied and a maintenance schedule developed. With approximately 30 bracing members, it has been approximated that 24 members will need to be replaced.

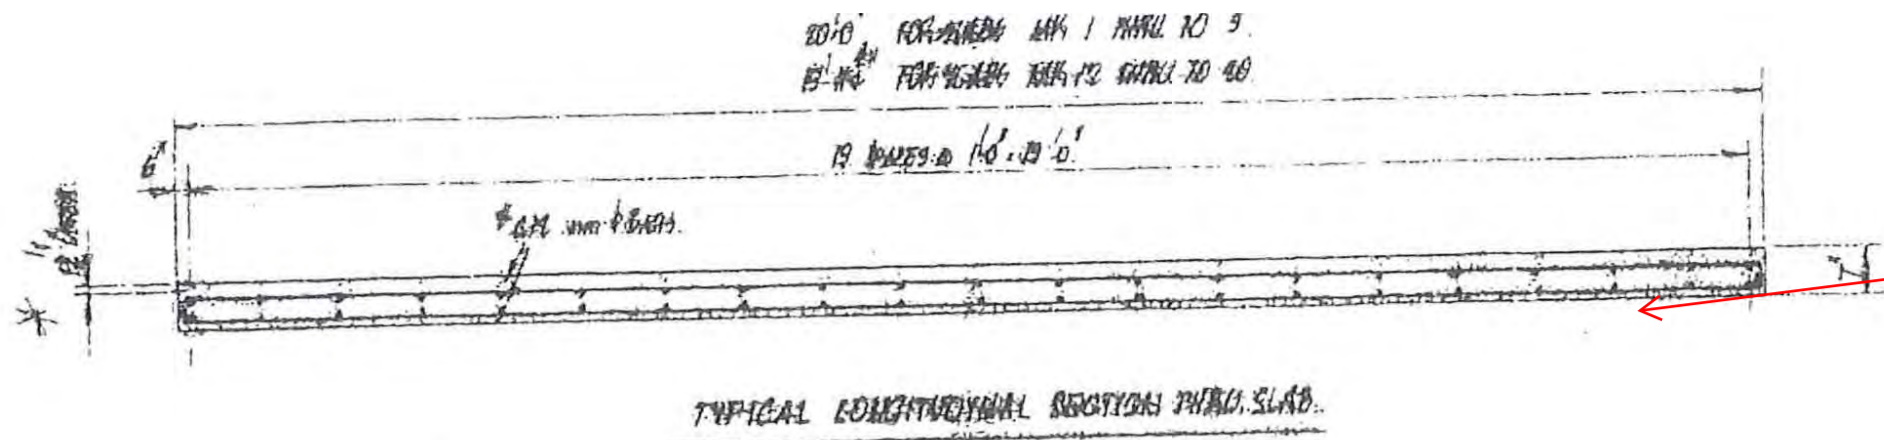
178thk PRECAST PLANK
CONFIRM THICKNES, REO AND
f_c=30MPAa
BTM REO IS EXPOSED IN SOME AREAS

Observations and testing conducted on the precast panels suggest that many panels were in adequate condition to maintain. Due to access below the deck being limited to five locations it was difficult to accurately enumerate the precast panels that were deteriorated to sufficiently warrant being repaired or replaced. From observations it has been estimated that at least 15% of the precast panels will require reparation and possibly be replaced. With the Jetty extending approximately 342 metres, and the precast panels being 1.82 metres wide, it has been estimated that there is a total of 188 precast concrete panels along the Jetty. This equates to roughly 28 panels that are likely to need replacement or reparation.
