External Memo – Catherine Hill Bay Jetty – Summary Report

Project Number N23146
Client Department of Planning and Environment
Date 7 December 2023
Document Number 002
Revision A
Prepared By [REDACTED]
Reviewed By [REDACTED]
Approved By [REDACTED]

1 Introduction

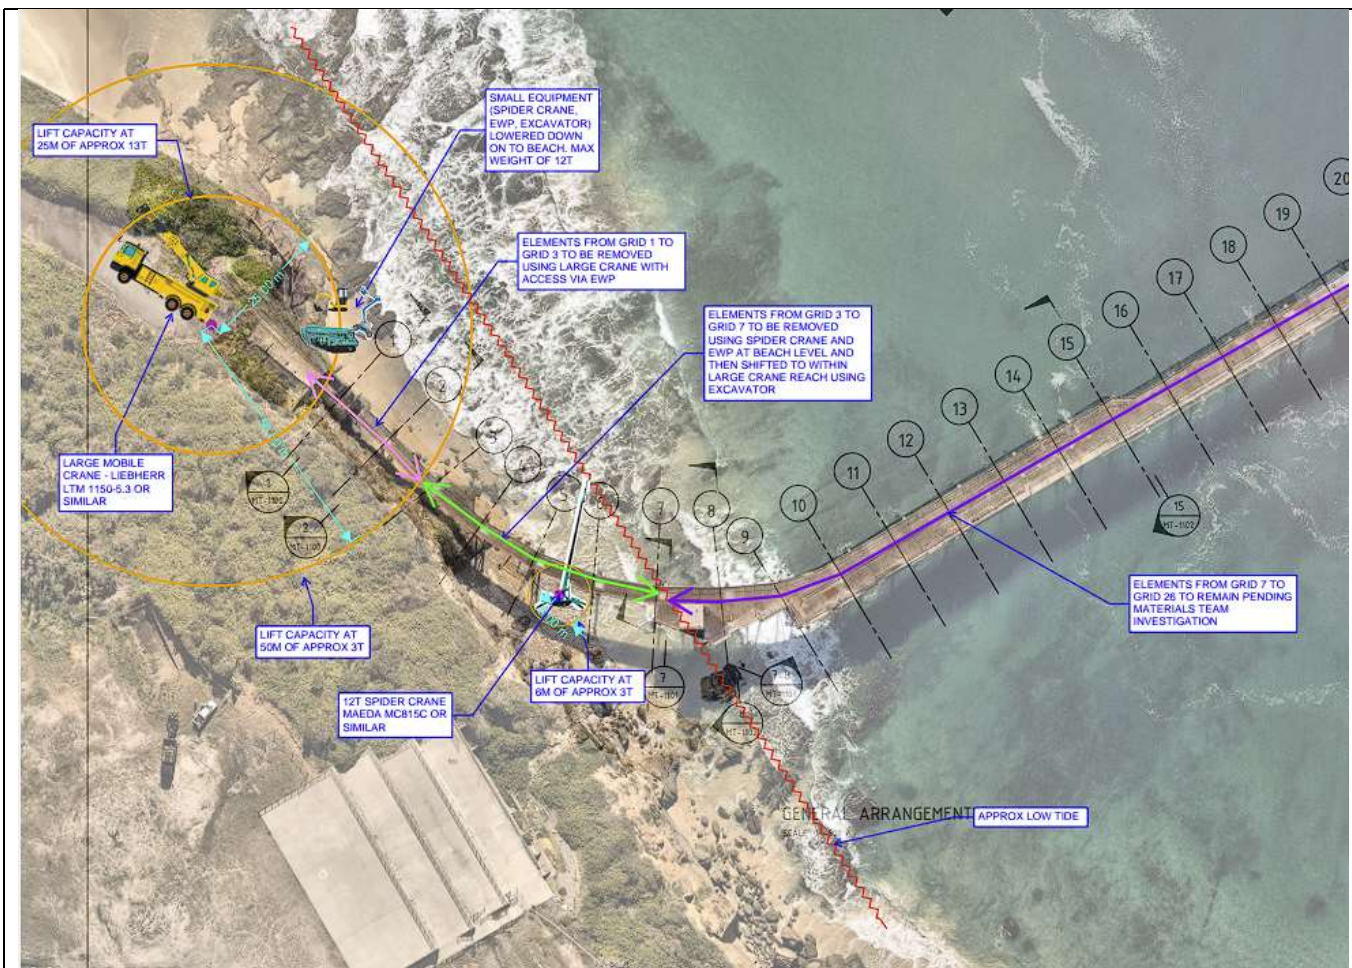
Photo 13 - Extract of the Partial Demolition Concept

This concept involves removing one or multiple spans of the jetty so that it is no longer connected to land at the access road. This would further restrict access to the retained portion of the jetty and remove the section of the jetty that is in the poorest condition.

A large reach mobile crane would be stationed at the location shown on the extract to the right. This crane would be used to lift off as many of the precast deck planks as could be reached. The precast planks have a mass of approximately 2,500kg each. The remaining planks that could not be reached from the large crane could be lifted down and moved to within reach of the large crane using a 12-tonne spider crane, EWP, and excavator.

Once all the precast deck planks had been removed, steel members could be cut and removed with the use of the two cranes and EWP.
