# Ex-HMAS Adelaide Artificial Dive Reef

Revised Long Term Monitoring and Management Plan -  
2017-2026

301015-03845 – Final V2

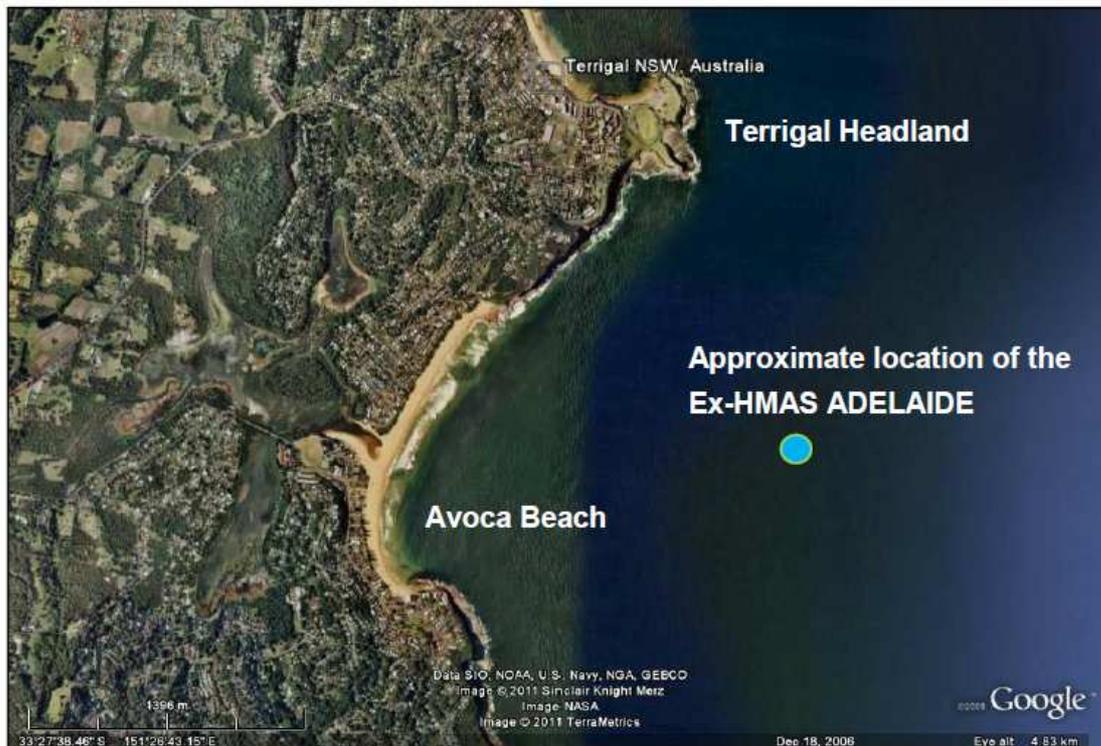
Figure 1-1 Location of the Ex-HMAS Adelaide dive reef.

On 13<sup>th</sup> April 2011, the Ex-HMAS Adelaide was scuttled in front of an estimated 18,000 people. The final location of the vessel is approximately 1.4 km from Terrigal Headland and 1.9 km from Avoca Beach (Figure 1-1). Table 1-1 provides the scuttling co-ordinates for the ship.

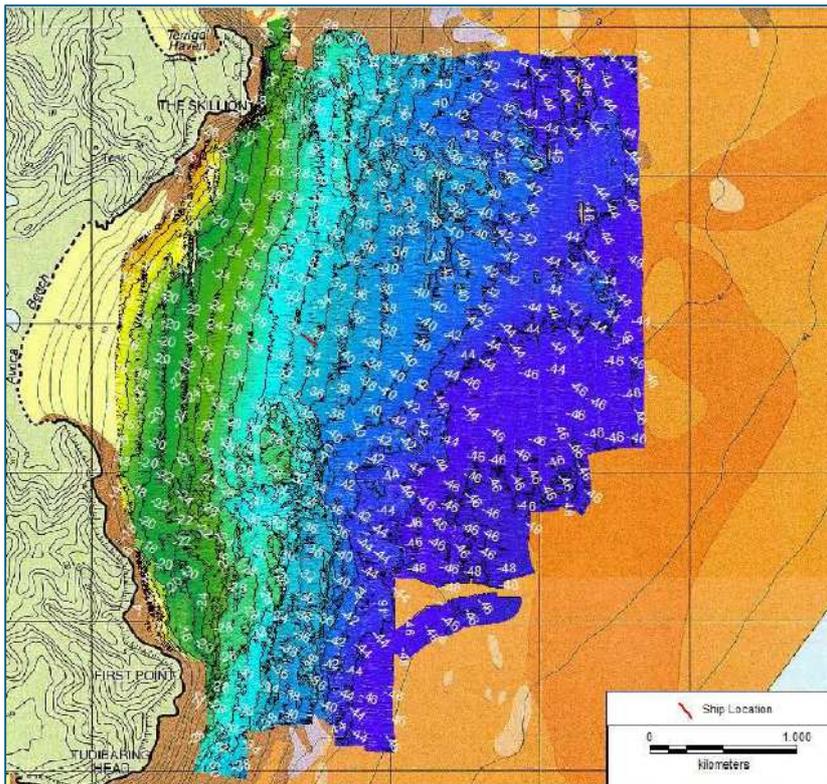
Figure 1-2 Bathymetry in the vicinity of the scuttling site.

Note: depths relative to Australian Height Datum (AHD) (approximately 0.93m above LAT). Source: multibeam hydrographic survey data (DECC 2008) overlain on digitised NSW Public Works Department (PWD) survey (1m contours) (1984-1989).

The final scuttling site is in 32 m of water at Lowest Astronomical Tide (LAT) and after scuttling, the depth of water over the main mast is 8.02 m LAT (personal communication with DoI Crown Lands and Water in 2011). The substrate on which the Ex-HMAS Adelaide rests is reasonably flat and sandy, with at least 6 m of sand overlaying bedrock as anticipated (Figure 1-2). Approximate depths to various levels on the ship are shown in Figure 1-3.

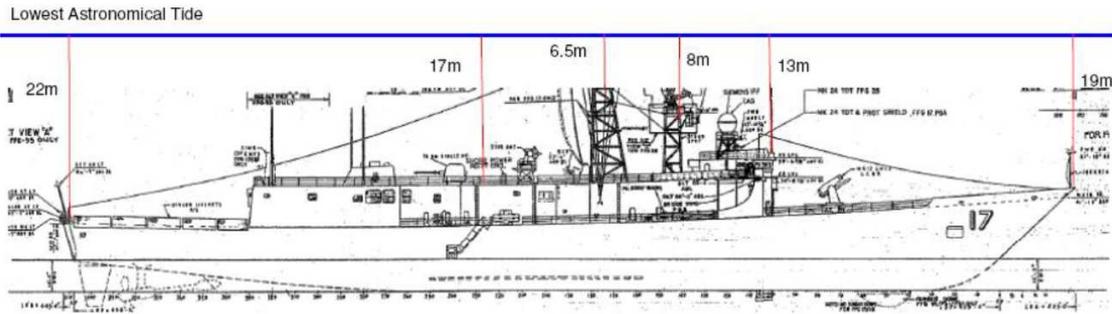
Figure 1-3 Approximate depth to the Ex-HMAS Adelaide dive reef.

Note: depths in relation to Lowest Astronomical Tide (LAT) do not take into account settlement which is expected to be 0.5 m initially and approximately 2 m in the longer term.

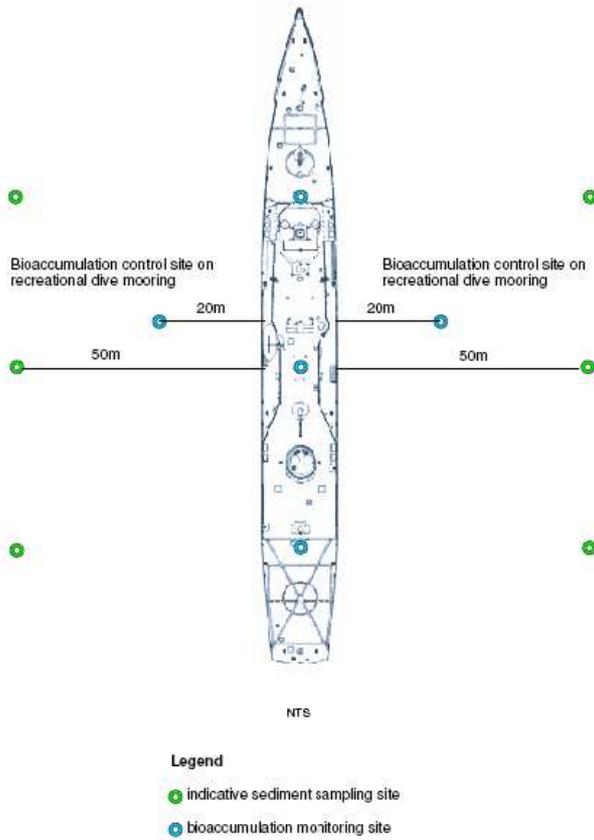
Figure 2-1 Location of sediment and bioaccumulation monitoring sites.

The locations of sediment quality (and bioaccumulation) sampling sites are shown in Figure 2-1 and Figure 2-2. Samples are collected from three control locations (S2, S3 and S6) and six impact locations (I1, I2, I3, I4, I5 and I6) for all survey times.

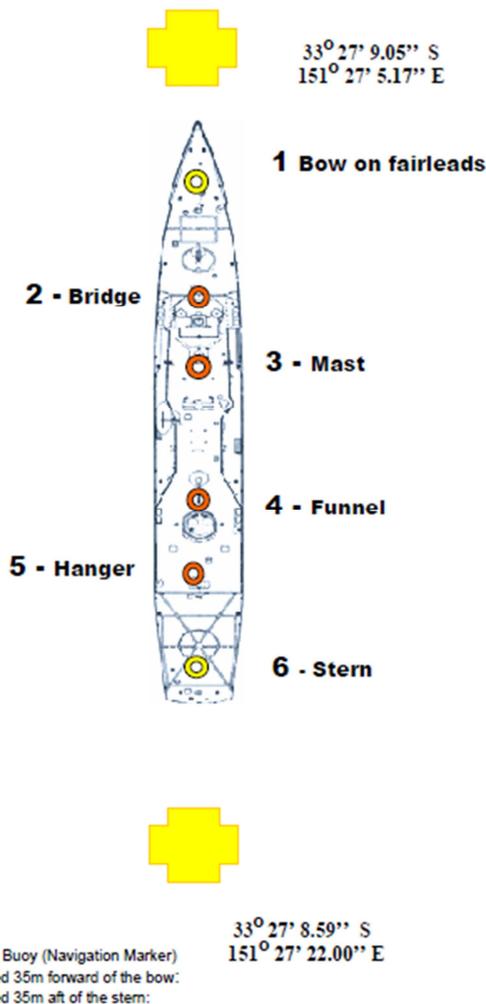
Figure 5-1 Location of all originally installed moorings and special markers around the Ex-HMAS Adelaide dive wreck. Note that the special marker buoys are now ~ 100 m off the bow and stern rather than the 35 m indicated here.

Currently there are only four moorings physically available for use on the Reserve and one in Terrigal Haven. These moorings have adequately met diver demand to date (without considering visitor numbers generated by unauthorised access). Figure 5-1 and Figure 5-2 show the location of these moorings. These moorings are attached directly to the ship.

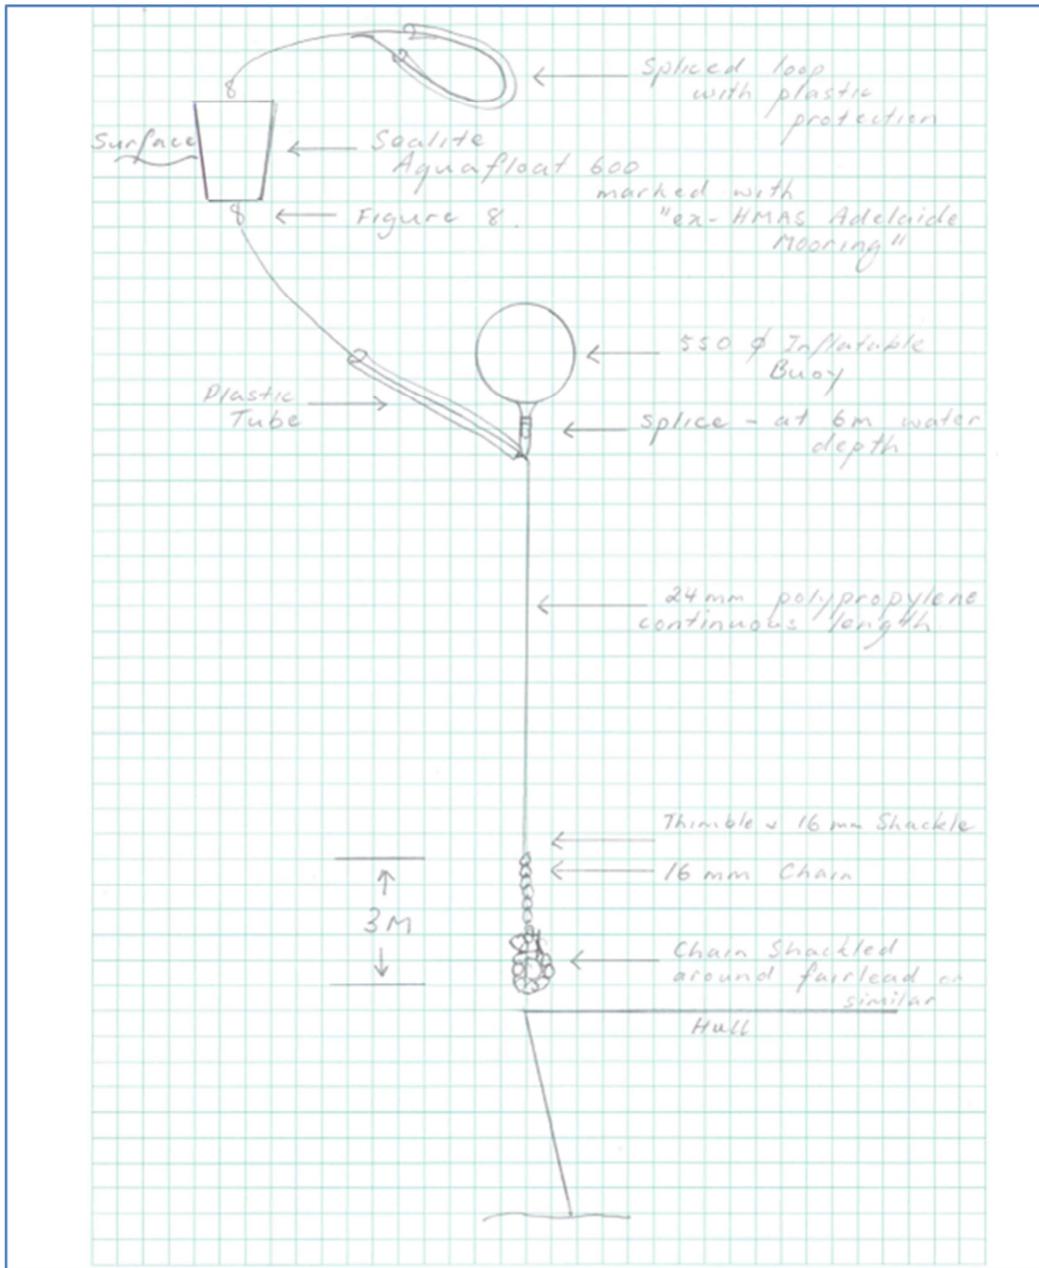
Figure 5-3 Design specifications for the mooring buoys on the Ex-HMAS Adelaide.

There are six mooring sites on the Ex-HMAS Adelaide Reserve and one in Terrigal Haven that are authorised under commercial mooring Licence CL6353 (issued by Roads and Maritime Services). The design specifications for these moorings is shown in Figure 5-3.

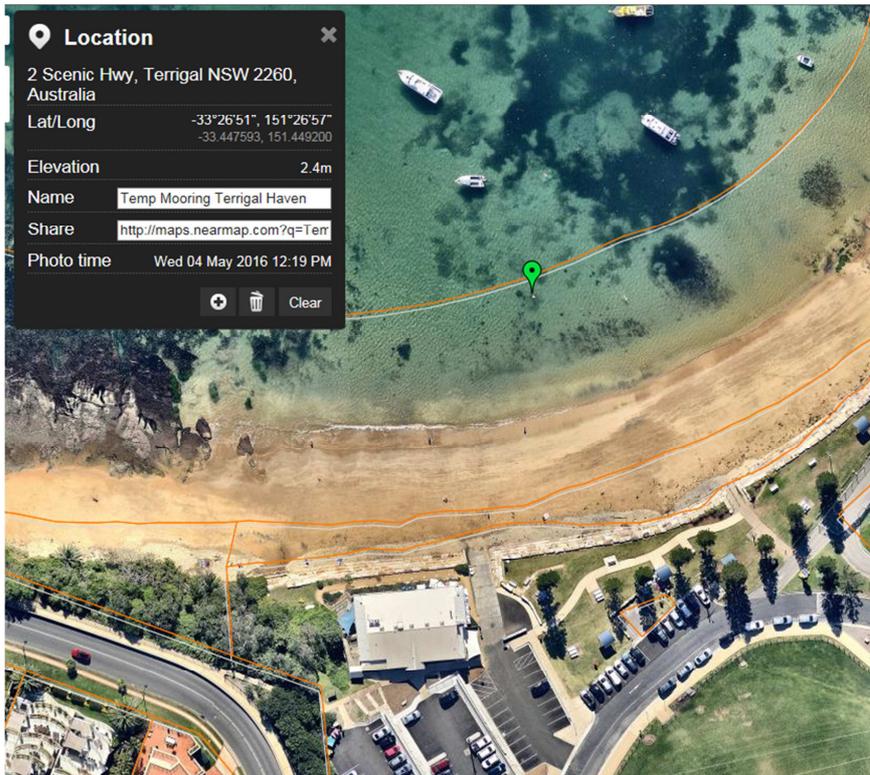
Figure 5-4 Location of the mooring buoy in Terrigal Haven.

The Terrigal Haven mooring buoy is used by diving vessels when transferring divers and equipment to and from the shore. The approximate location of this buoy is shown in Figure 5-4.
