## BUILDING CONDITION REPORT

| Subject property address: | Empire Bay Marina<br>16B Sorrento Rd, Empire Bay NSW 2257 |
| Date of inspection: | 2 <sup>nd</sup> April 2020 |
| Inspection purpose: | Inspect and assess the condition of the structures comprising the Empire Bay Marina. The subject site is shown on Figure 1 |

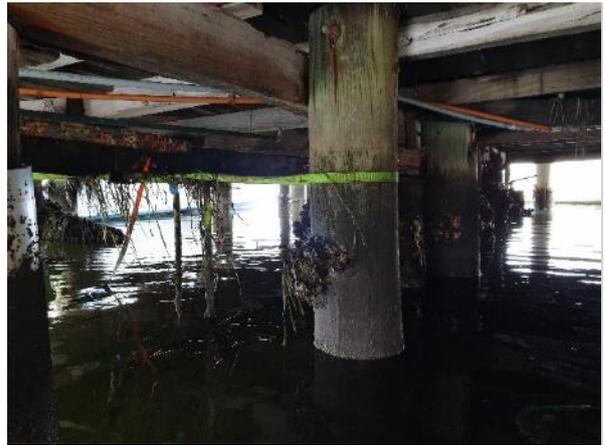
Photograph 2 shows an example of ratchet straps providing some form of support / tie-down / tension bracing to prevent separation in subfloor framing members.

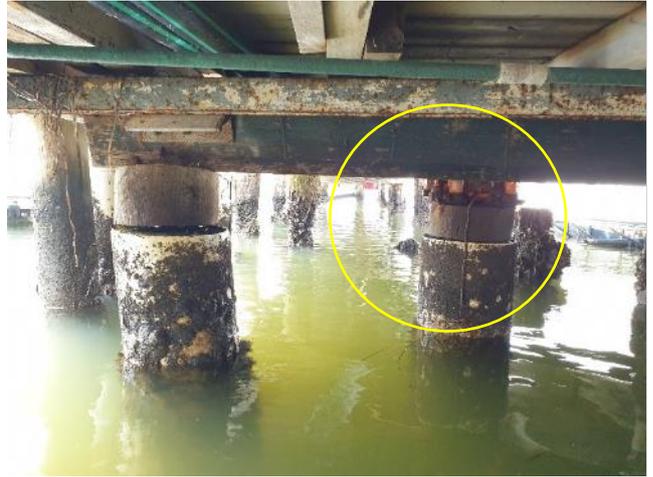
Photograph 8 shows another view point of where packing blocks are being placed upon piers.

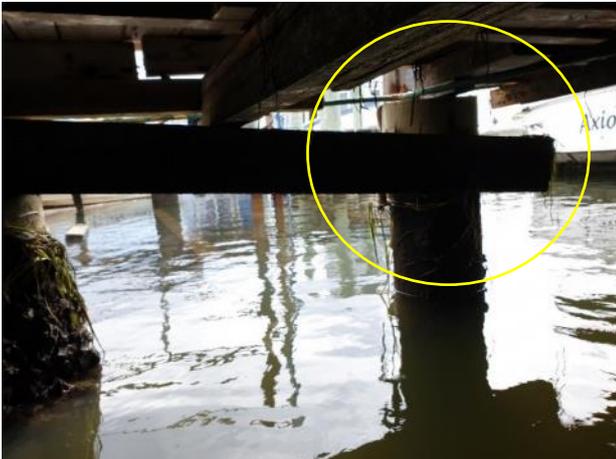
Photograph 9 shows where a bearer is now 'unsupported'.

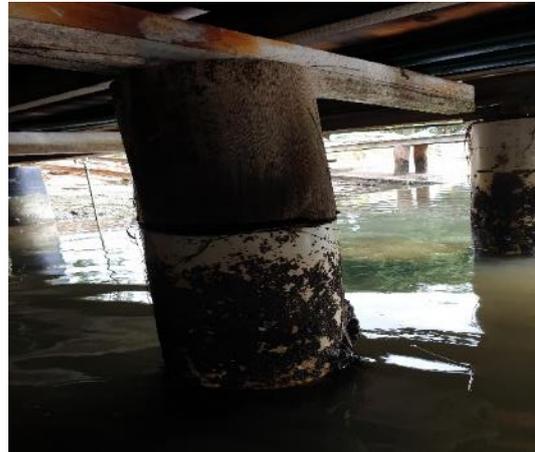
Photograph 10 shows another example of where a large section of timber has been placed on top of existing pier/ pile with no means of adequate strapping or hold down connecting that pier to bearer.

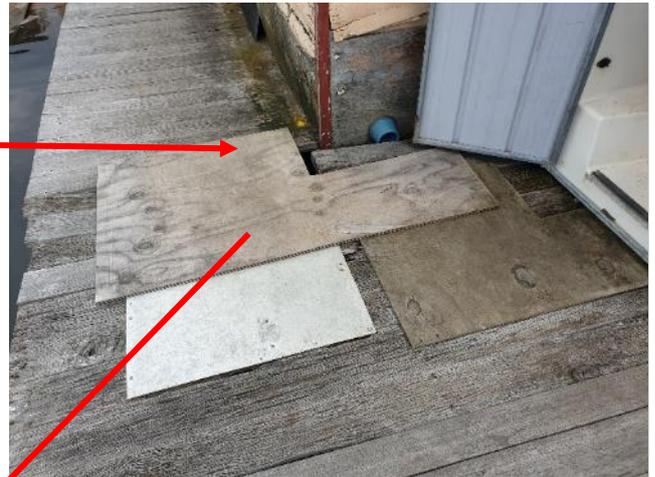
Photograph 15 shows plywood sheeting placed above that location.

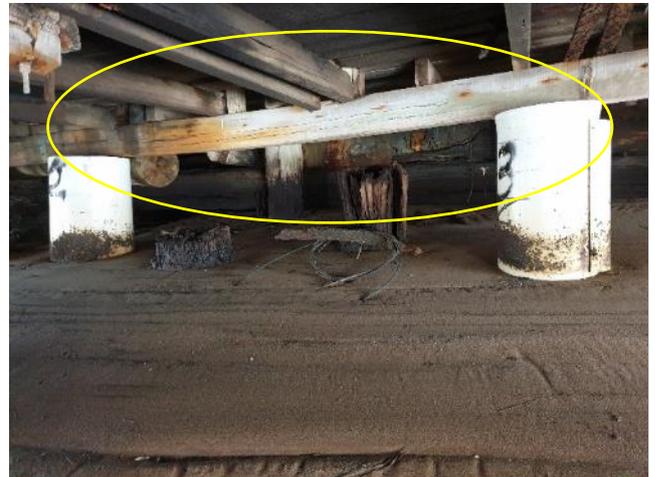
Photograph 23 shows timber joist has slipped off the bearer.

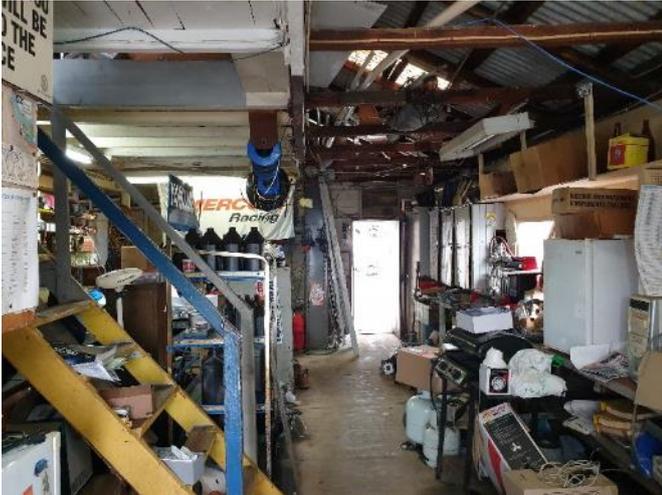
Photograph 26 shows an example of the obstructions that limited the viewing of wall framing.

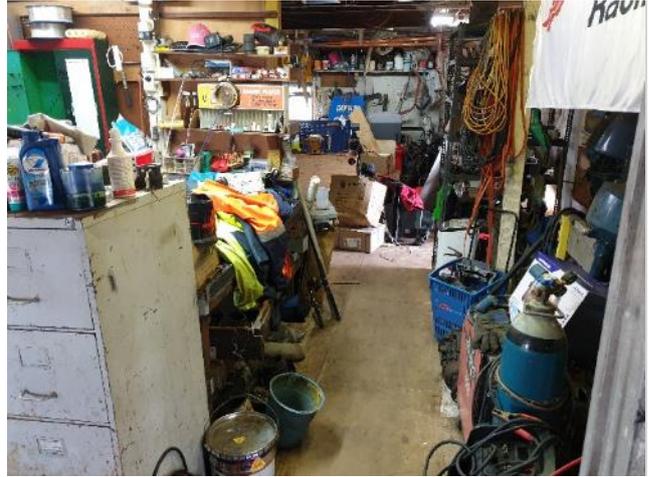
Photograph 27 shows an example of the obstructions that limited the viewing of wall framing.

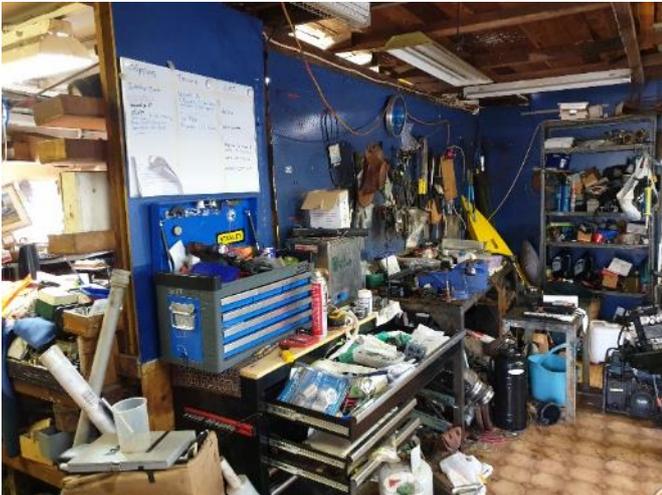
Photograph 28 shows an example of the obstructions that limited the viewing of wall framing.

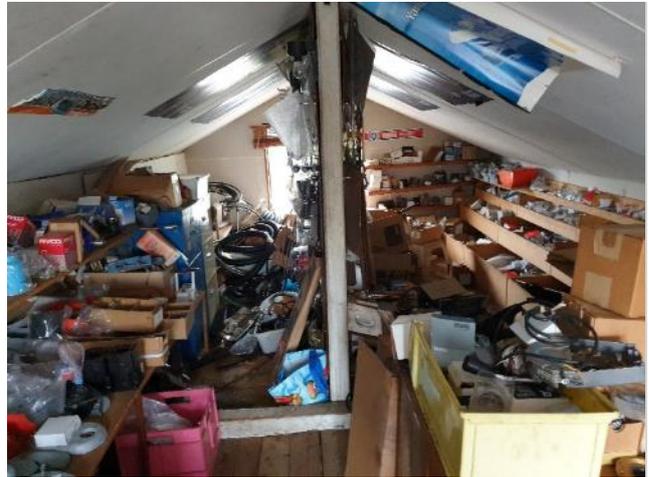
Photograph 29 shows an example of the obstructions that limited the viewing of wall framing.

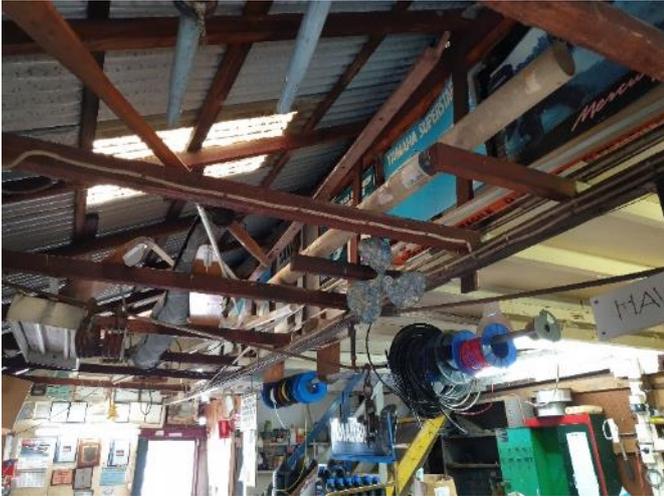
Photograph 32 shows an overview of timber ceiling / roof frame.

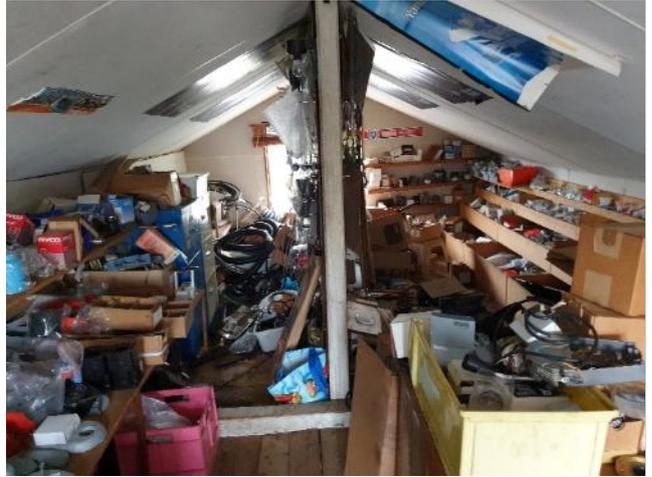
Photograph 33 shows an overview of the mezzanine area with stored items.

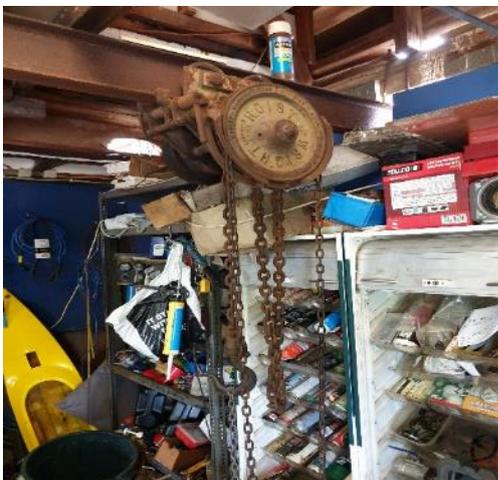
Photograph 36 shows the chain block that appears to still be in use.

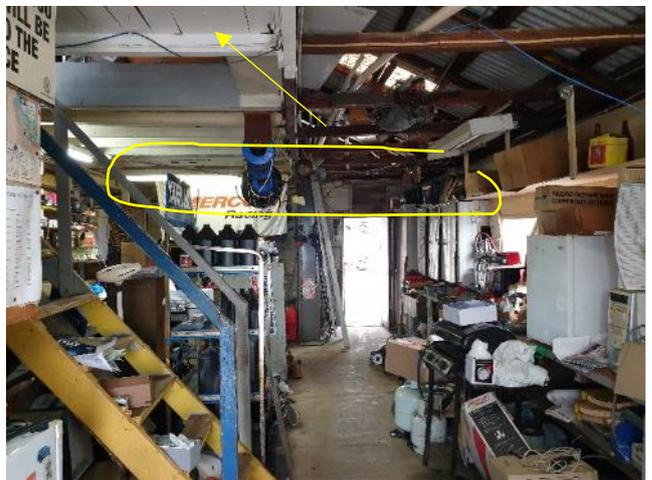
Photograph 37 shows another view point of mezzanine loading and another steel tension brace.

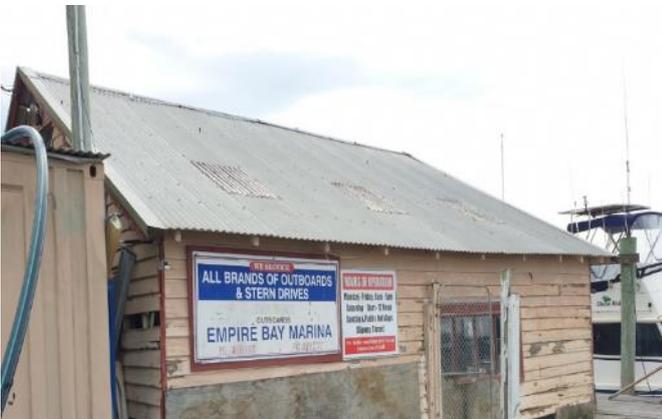
Photograph 47 shows the roof cladding above boat shed appears satisfactory.

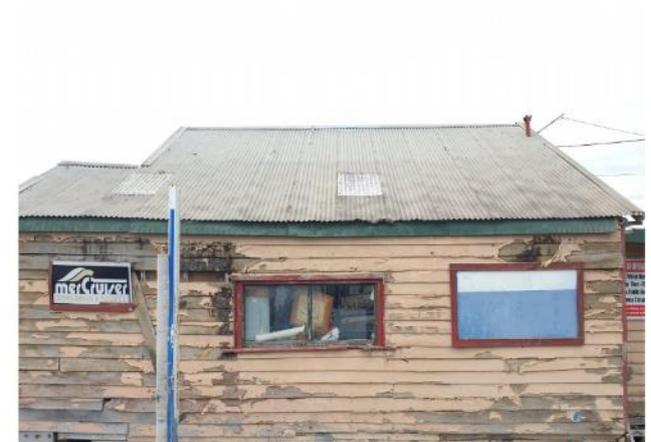
Photograph 48 shows the roof cladding above boat shed appears satisfactory.

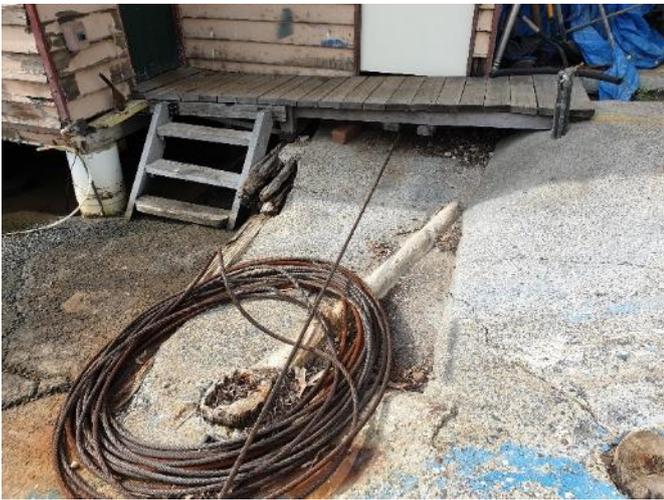
Photograph 51 shows stored defunct steel rope.

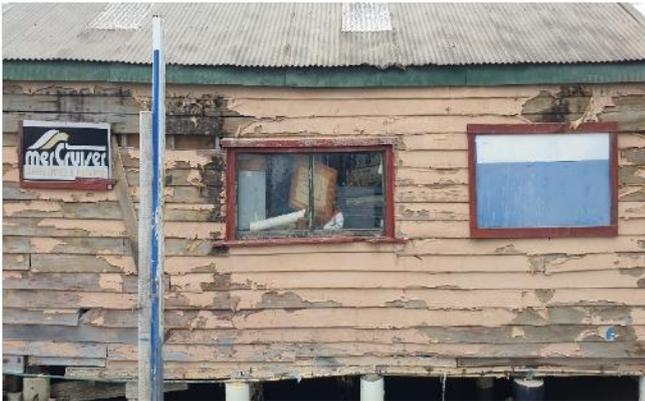
Photograph 61 shows an example where 2x windows have been covered over, along with centre window in a 'weathered' state.

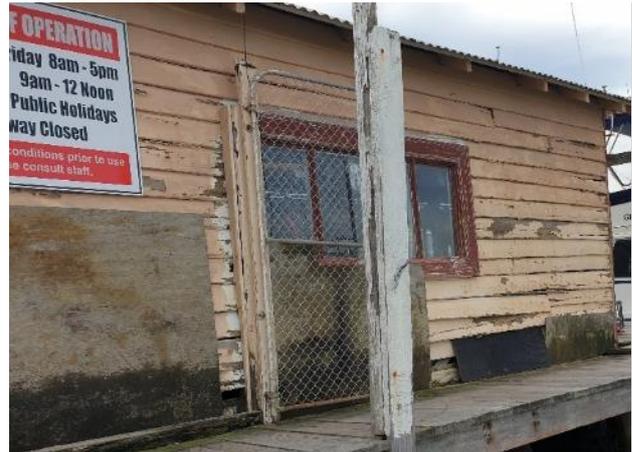
Photograph 62 shows another weathered window.

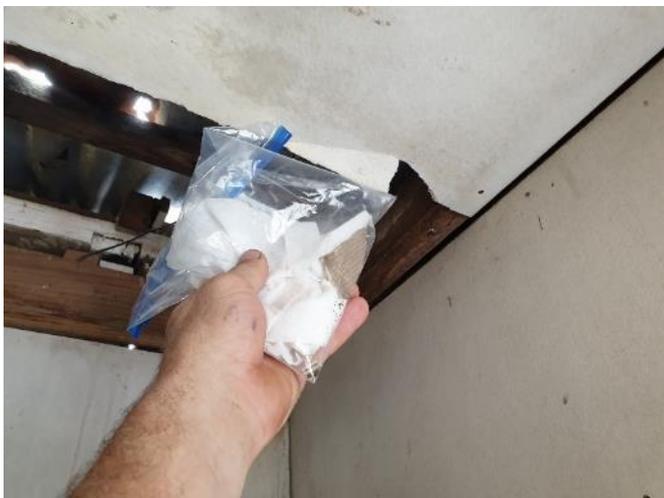
Photograph 65 shows FC sample taken from outdoor shower ceiling.

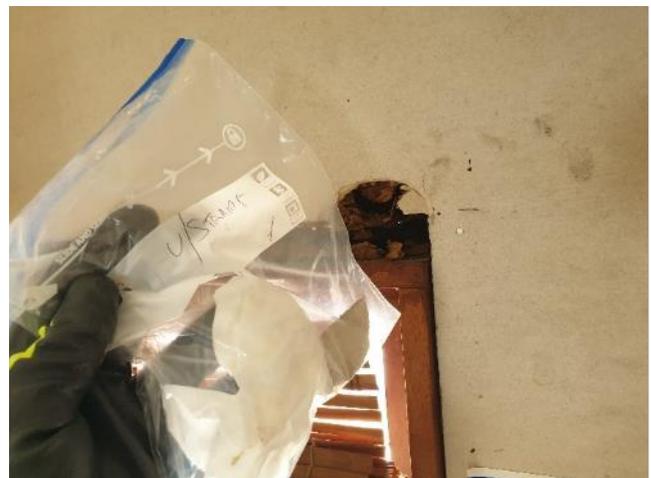
Photograph 66 shows sample taken from FC wall lining to loft / mezzanine level.

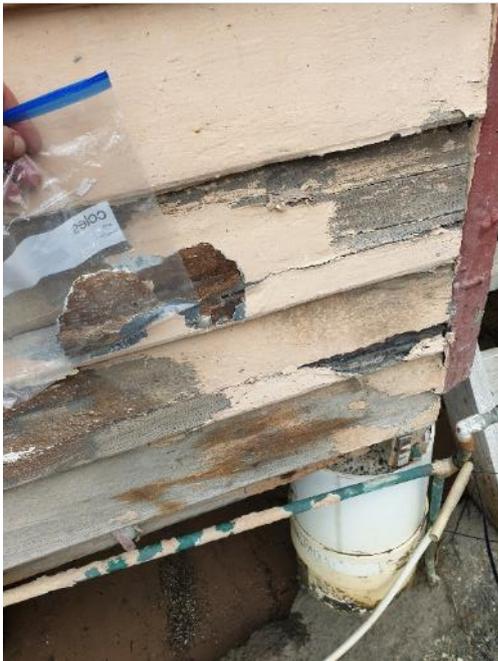
Photograph 67 shows an example of peeling paint being removed for testing.

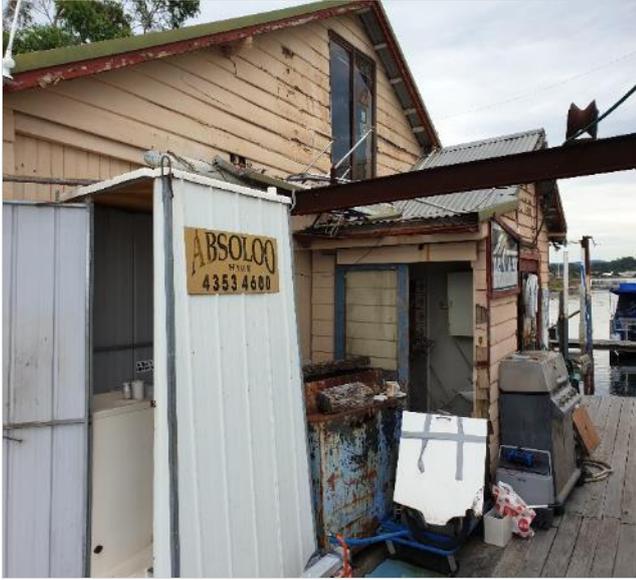
Photograph 71 shows the location of portaloos and rear outdoor shower.

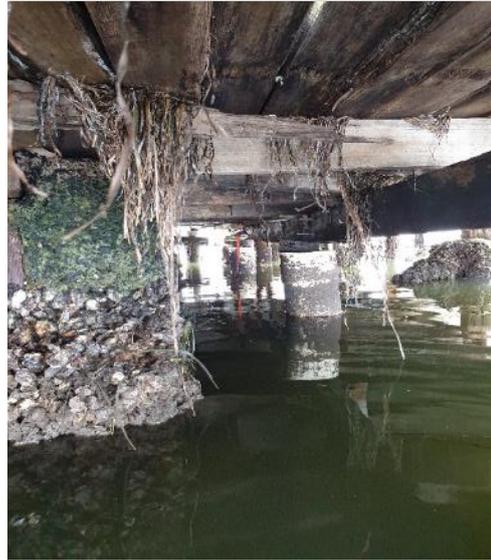
Photograph 72 shows an inspection of subfloor area confirmed no signs of waste water plumbing.

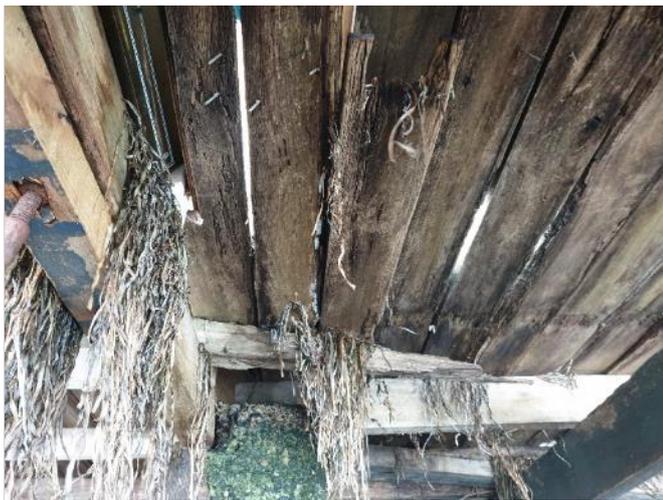
Photograph 73 shows no signs of portaloos as being discharged to waterway located below.

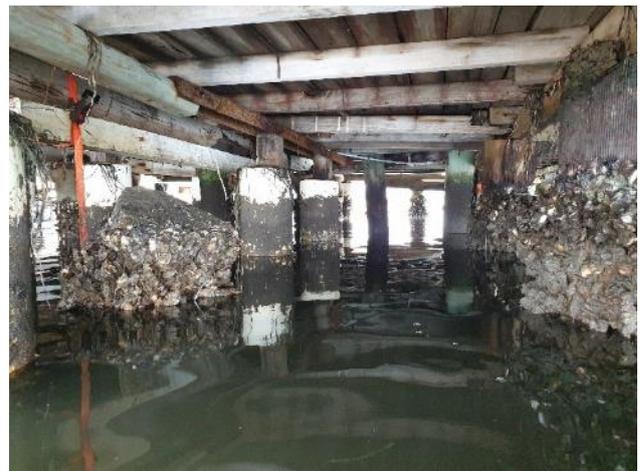
Photograph 74 shows further inspection of areas with no signs of waste water plumbing.

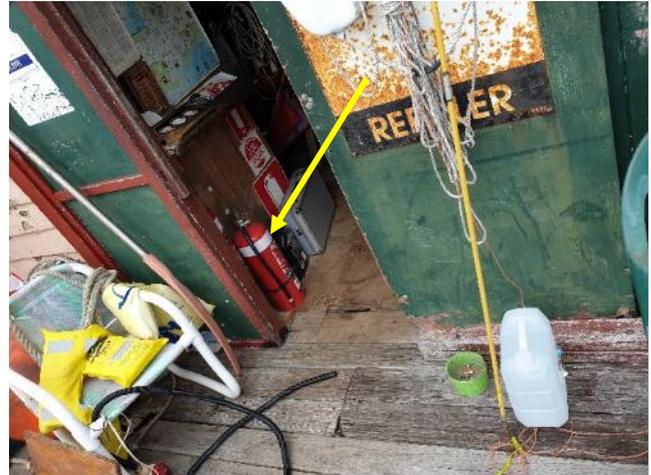
Photograph 82 shows 1x fire extinguisher located within doorway of boat shed.
